APPENDIX B PHOTOGRAPHIC RECORD

Fluvial Geomorphology Summary

Cardinal Creek - Reach C10

Location: City of Ottawa Date: November 24, 2006

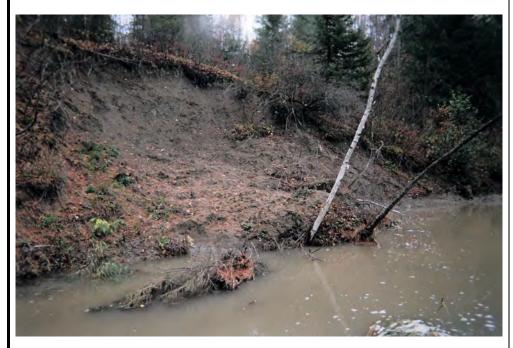
Photo 1.

Bank slump noted along Reach C10.

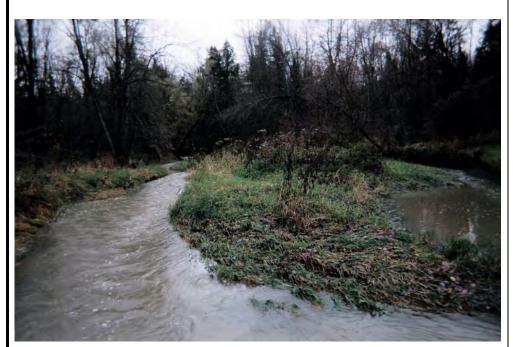
Photo 2.

Looking upstream towards a chute during high flow conditions.

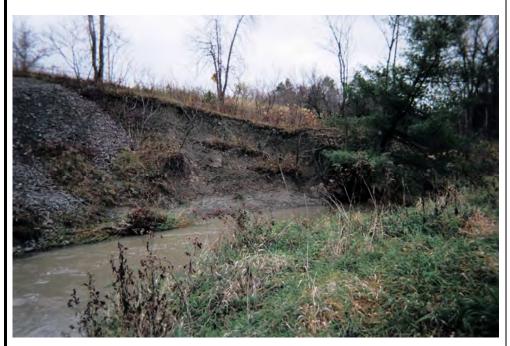
Photo 3.

Bank slump along left bank near Old Montreal Road. View looking downstream.

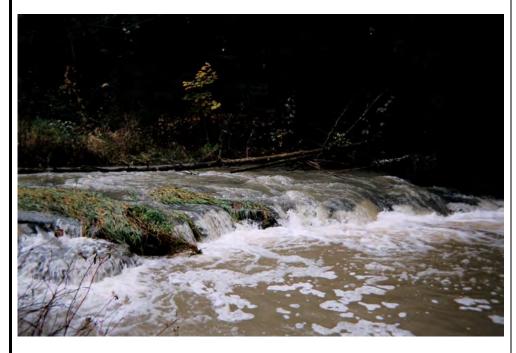
Photo 4.

Large knickpoint noted in the channel. Photo looking upstream.
