## 2018 Annual Report

Certificate of Property Use No. 0371-8TYQMY  
Lansdowne Park- Urban Park (Zone C)  
450 Queen Elizabeth Driveway (Part of 945 Bank Street)  
Ottawa, Ontario  
Project No. TZ10100106

March 2019

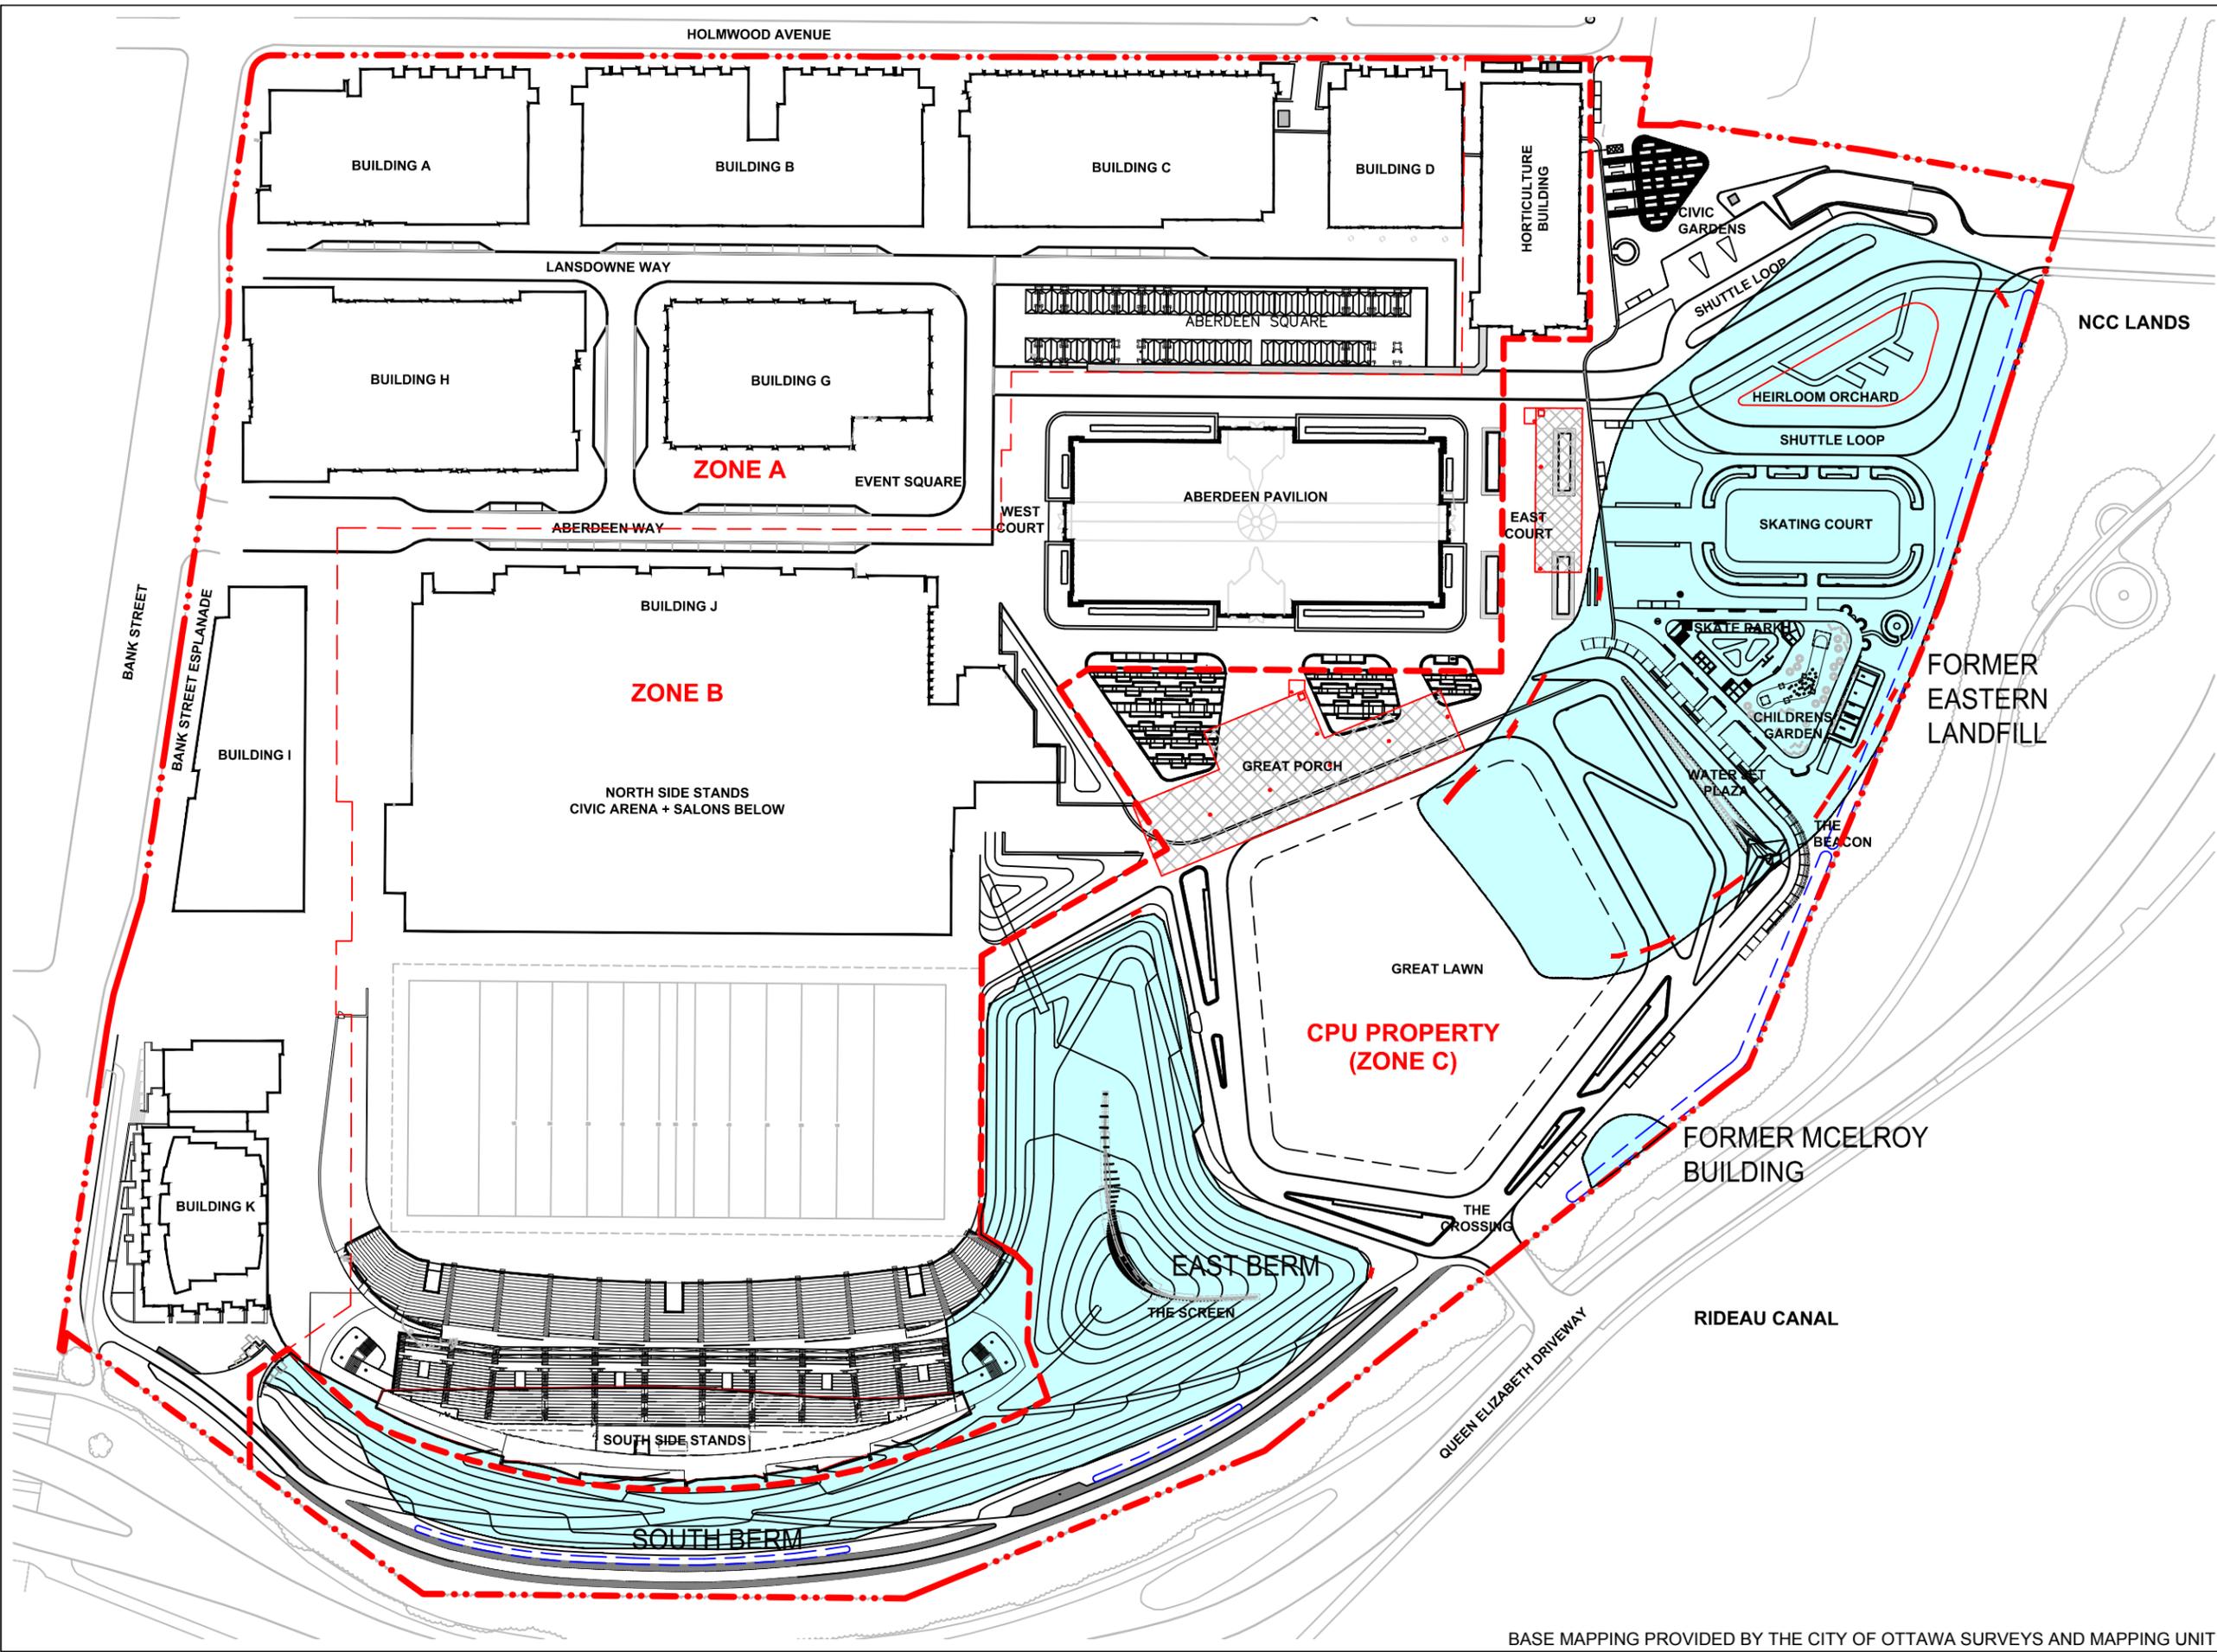
TITLE:	RISK MANAGEMENT MEASURES
PROJECT:	2018 ANNUAL REPORT
	LANSDOWNE PARK - CPU PROPERTY 450 QUEEN ELIZABETH DRIVEWAY OTTAWA, ONTARIO
CLIENT:	
DESIGNED BY:	KDH
DRAWN BY:	JFT
CHECKED BY:	KDH
DATE:	MARCH 2019
SCALE:	1 : 1,600
PROJECT NO:	TZ10100106
FIGURE NO:

In 2018, Wood conducted inspections of the RMM implemented in the area of the East and South Berms as part of the Inspection and Maintenance Plan developed for the Site to satisfy the requirements of Condition 4.2.8 of the CPU. Details of the inspections including photo logs are provided in the Risk Management Measures Inspection Logs in Appendix B. The extent of the RMM for the Berm areas is provided on Figure 3.

In 2018, Wood conducted inspections of the RMM implemented in the area of the former Eastern Landfill as part of the Inspection and Maintenance Plan developed for the Site to satisfy the requirements of Condition 4.2.8 of the CPU. Details of the inspections including photo logs are provided in the Risk Management Measures Inspection Logs in Appendix B. The extent of the RMM for the former Eastern Landfill area is provided on Figure 3.

In 2018, Wood conducted inspections of the RMM implemented in the area of the former McElroy Building as part of the Inspection and Maintenance Plan developed for the Site to satisfy the requirements of Condition 4.2.8 of the CPU. Details of the inspections including photo logs are provided in the Risk Management Measures Inspection Logs in Appendix B. The extent of the RMM for the former McElroy Building area is provided on Figure 3.

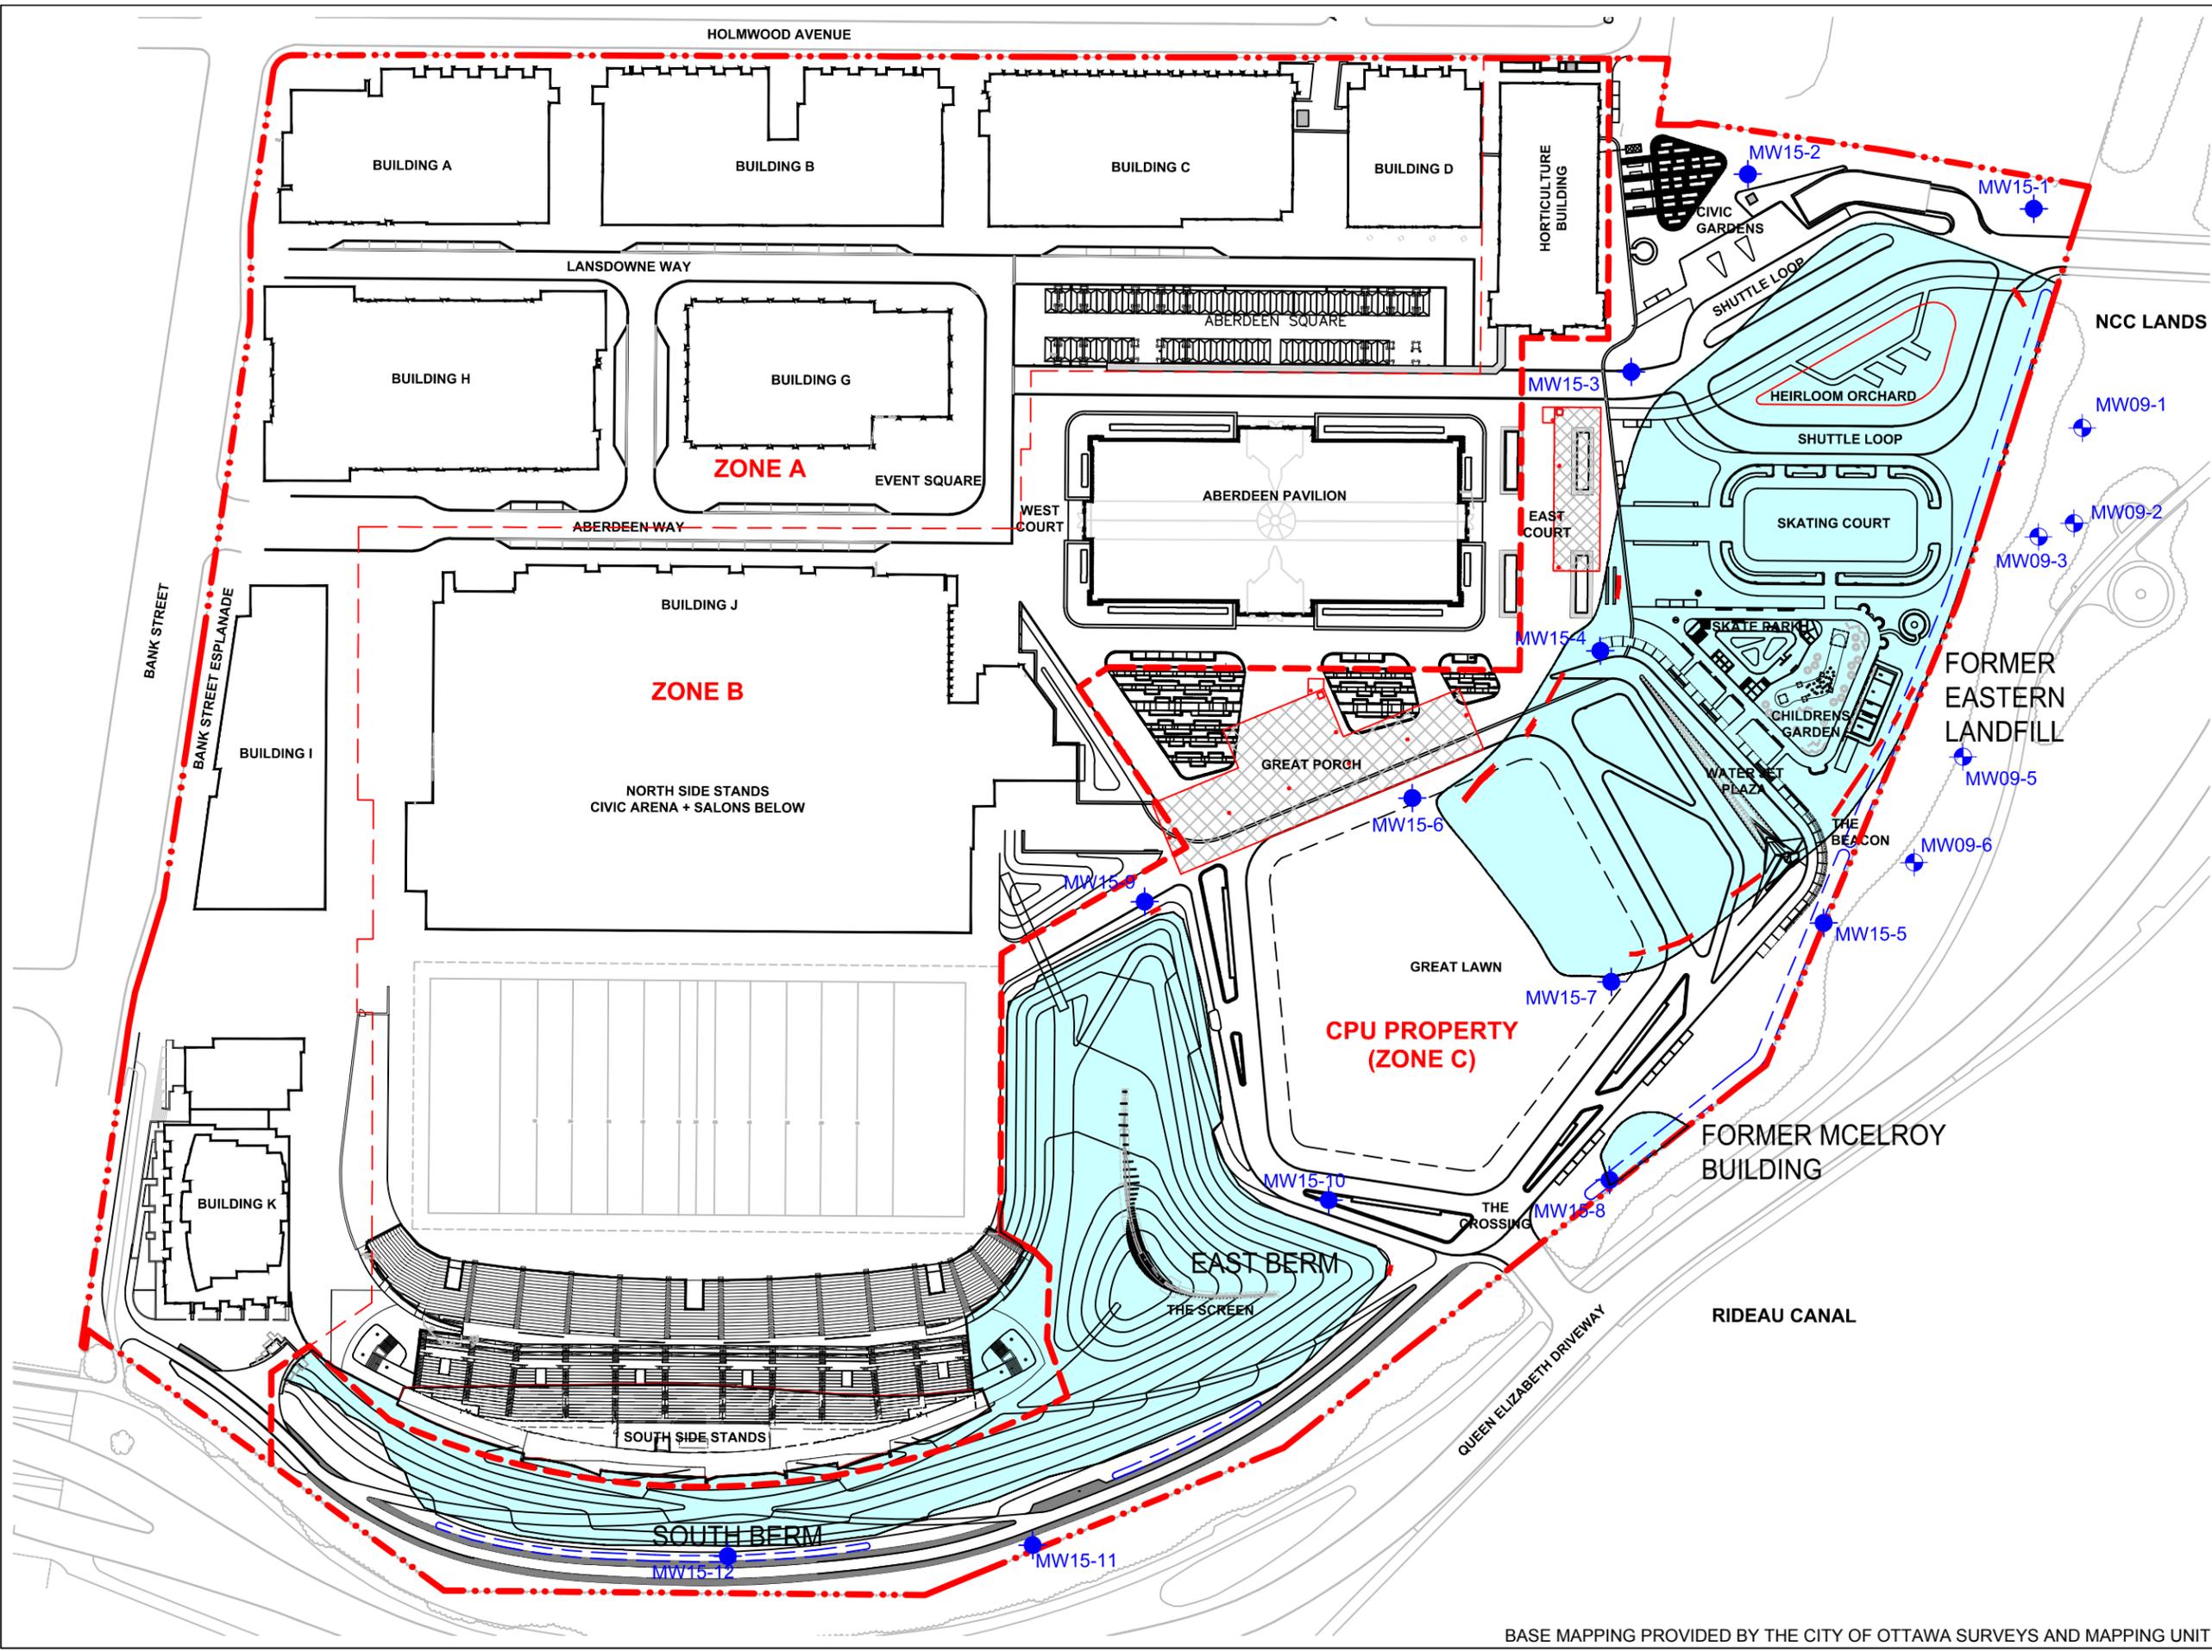
FIGURE NO:  
**4**

Groundwater monitoring was conducted on May 29<sup>th</sup>, 2018 and November 8<sup>th</sup>, 2018 and included all monitoring wells installed at the CPU Property, with the exception of MW15-8 which could not be monitored during the May 2018 event as it had been damaged during the construction of temporary stands for the Grey Cup. In addition to these monitoring wells, five monitoring wells located on the National Capital Commission (NCC) property to the immediate east were also monitored during the May 29<sup>th</sup> and November 8<sup>th</sup> monitoring events. The locations of the NCC monitoring wells are shown on Figure 4 and their construction details provided in Table 1.

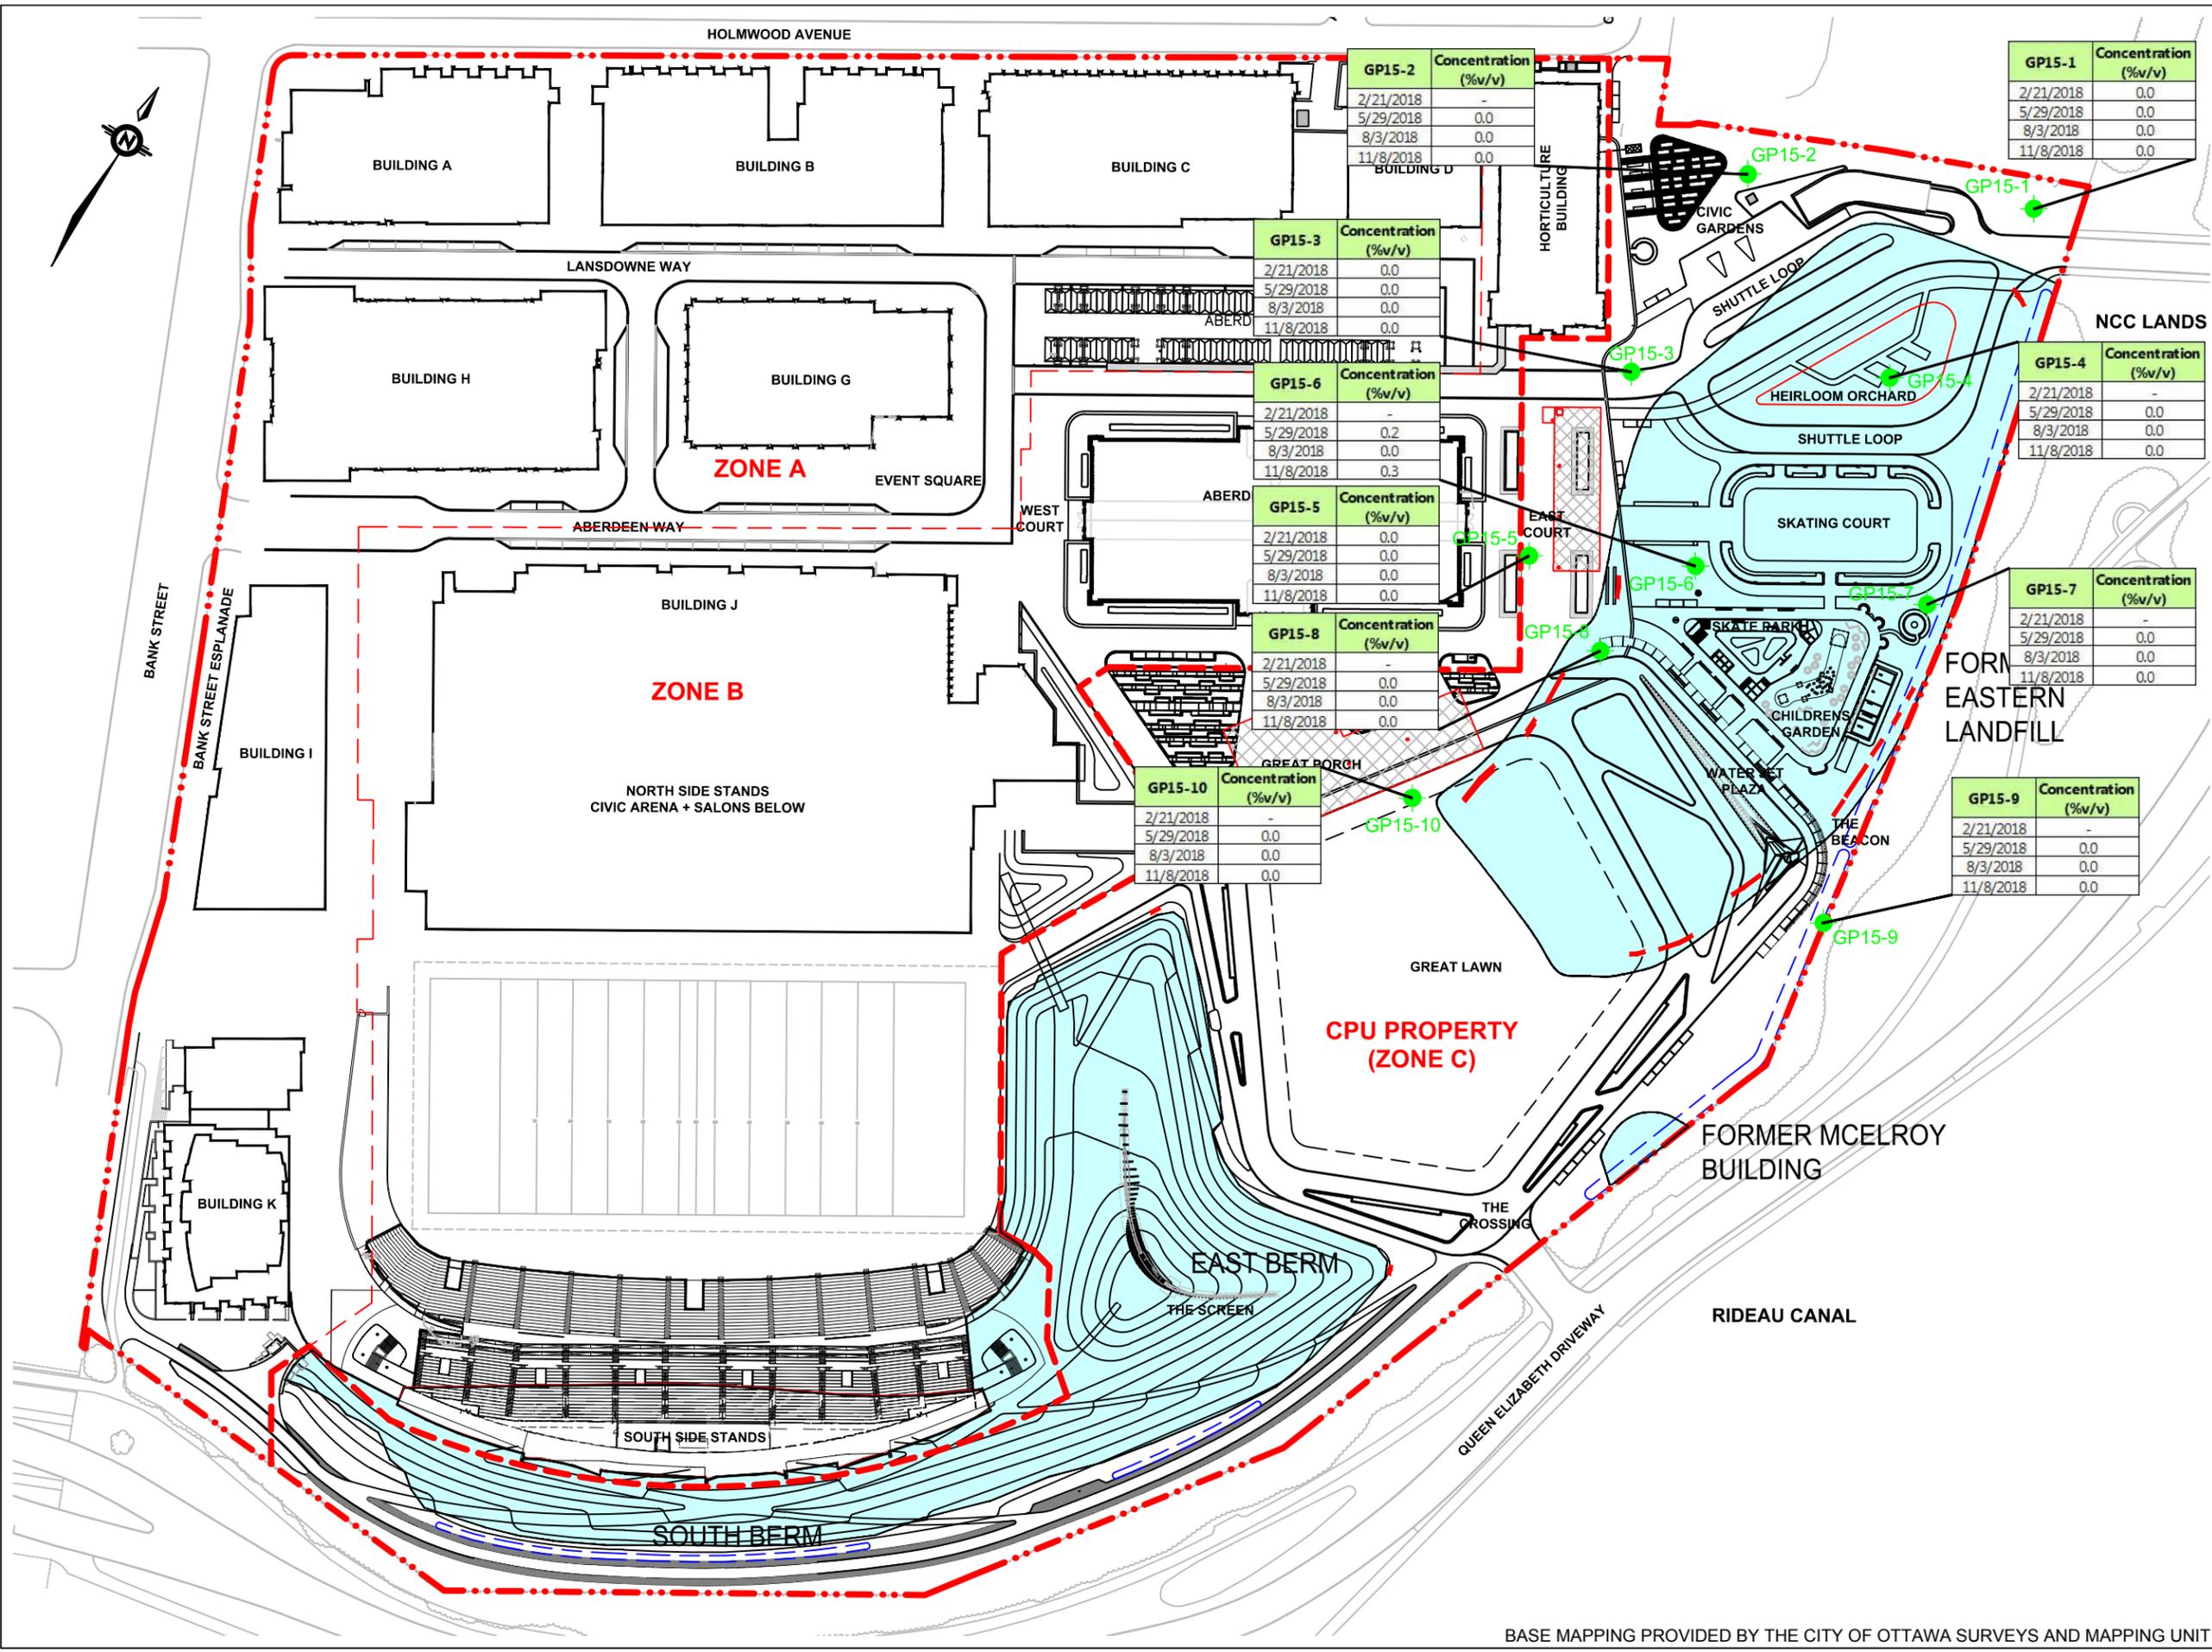
TITLE:	SUBSURFACE METHANE CONCENTRATIONS AT LANDFILL GAS PROBES
PROJECT:	2018 ANNUAL REPORT
	LANSDOWNE PARK - CPU PROPERTY 450 QUEEN ELIZABETH DRIVEWAY OTTAWA, ONTARIO
CLIENT:	
DESIGNED BY:	KDH
DRAWN BY:	JFT
CHECKED BY:	KDH
DATE:	MARCH 2019
SCALE:	1 : 1,600
PROJECT NO:	TZ10100106
FIGURE NO:

The results of the LFG monitoring program including LFG composition and subsurface pressure are summarized in Table 5 and are shown on Figure 7. Stable methane concentrations were detected at GP15-6 (0.2 vol. % in May, and 0.3 vol. % in November). Based on the methane concentrations noted above, the Site meets the on-site methane concentrations limits as outlined in O.Reg. 232/98 and the recommended methane alert levels provided in Procedure D-4-1.
