# **Ottawa LRT Independent Review Report**

April, 2022  
Confidential

# Ottawa LRT Independent Review Report

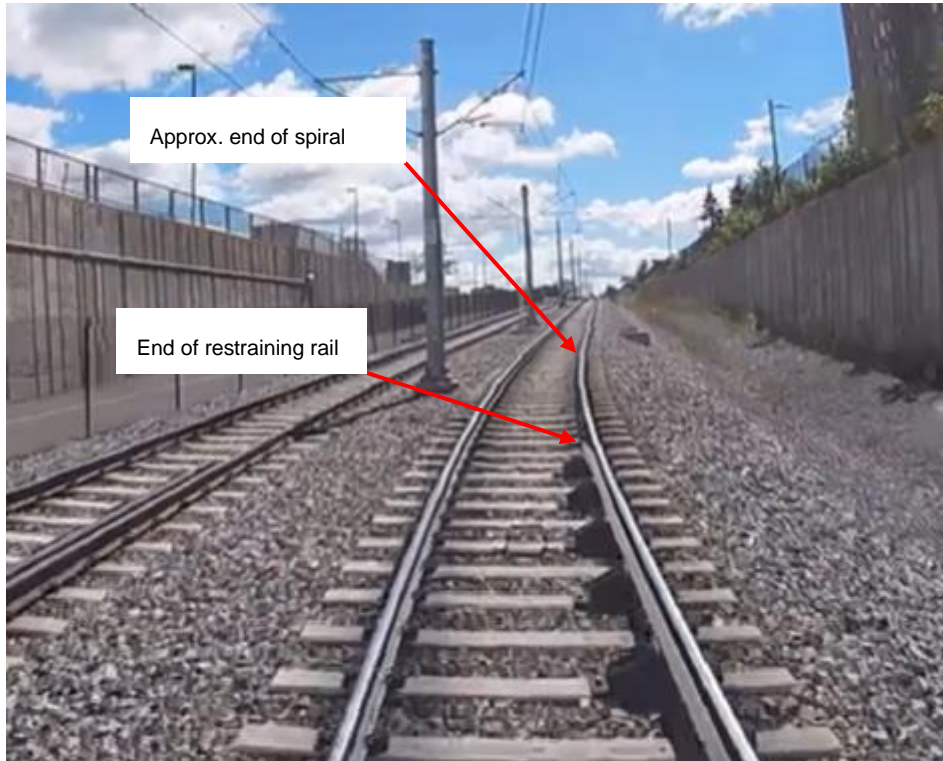
**Figure 3.5: Cab footage showing termination of the restraining rail within a spiral**

There will be an inherent stiffness differential within track that has three or four rails secured to ties with it being higher than that of a typical two rail arrangement and therefore increased ability to resist against forces as temperatures increase. There will also be additional weight to consider through these sections of track which will make the track more resistant to lateral loading.

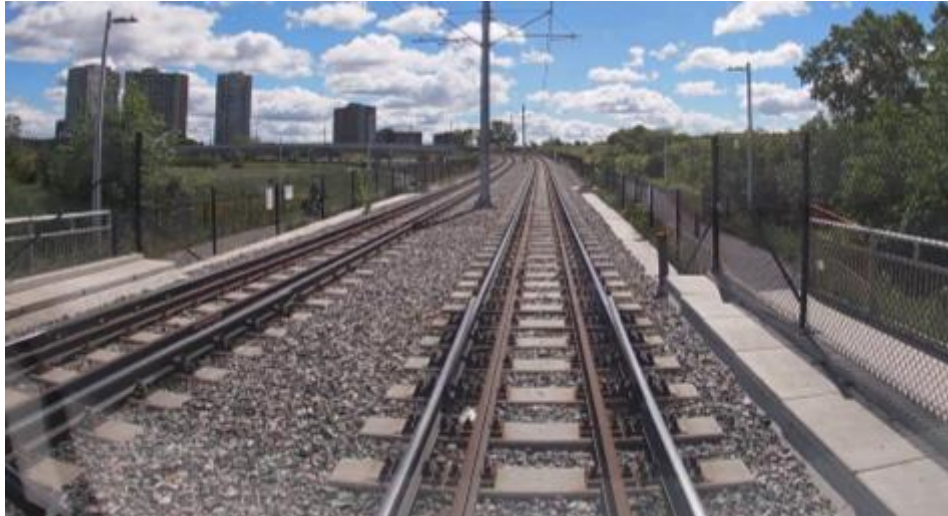
**Figure 3.7: Expansion joints installed in a “facing” position on the eastbound line**

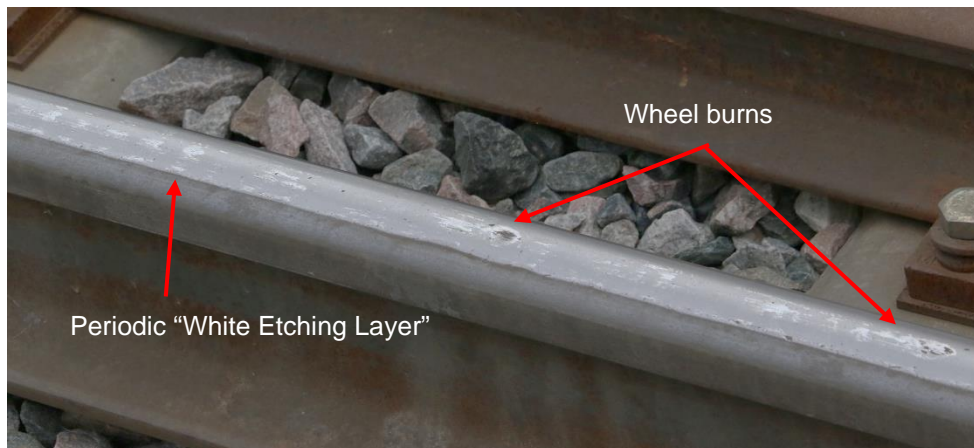
**Figure 3.14: Wheel Burns and Periodic Patches on Rail at Blair Terminus**

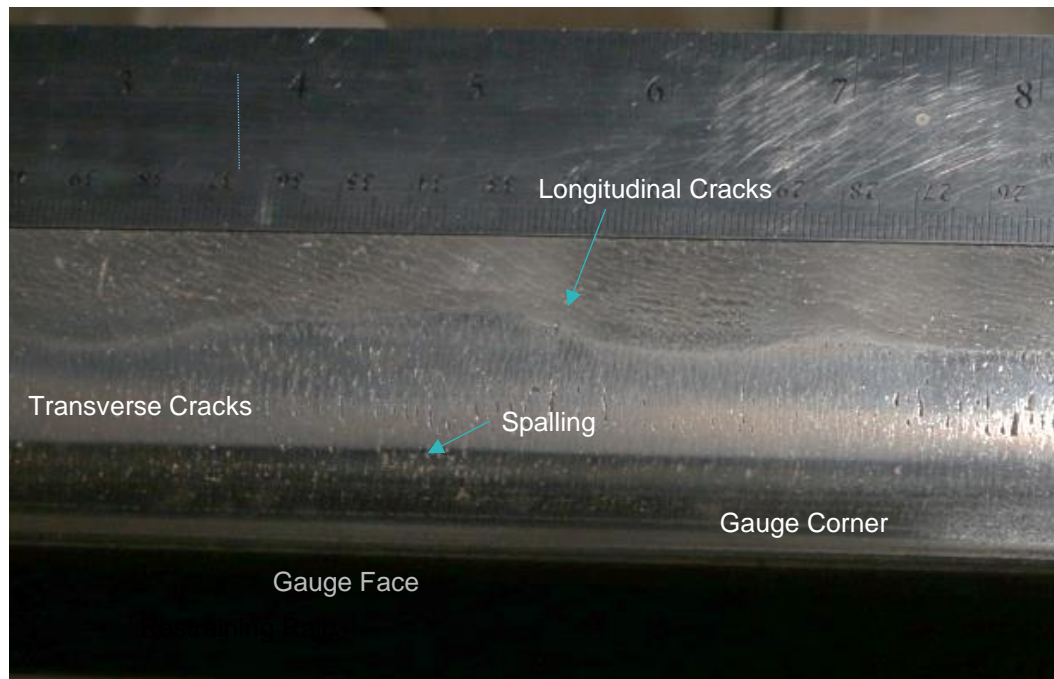
**Figure 3.17: Rolling Contact Fatigue on Low Rail of Curve 210 at 104+725**

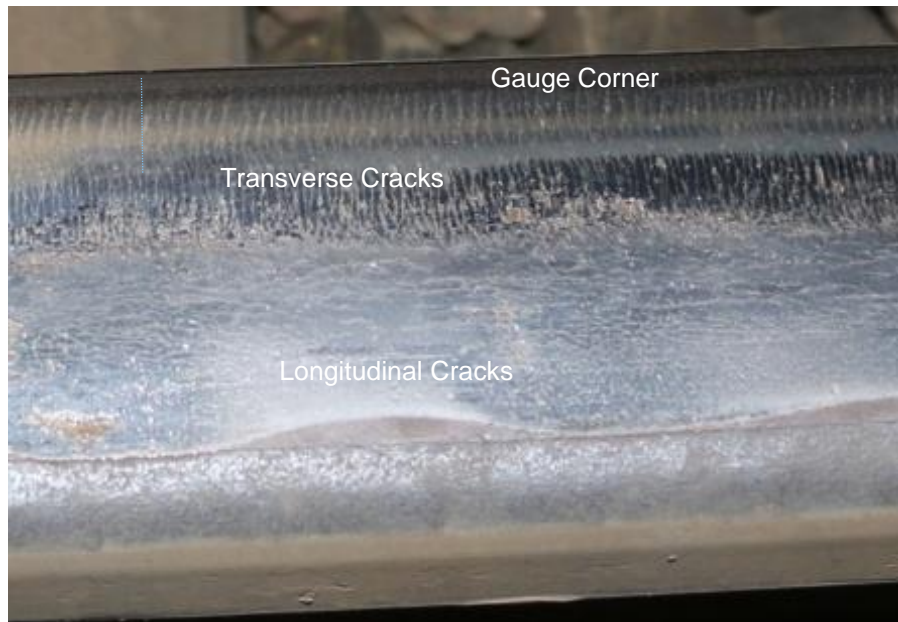
**Figure 3.18: Rolling Contact Fatigue on Low Rail of Curve 220 at 105+115**

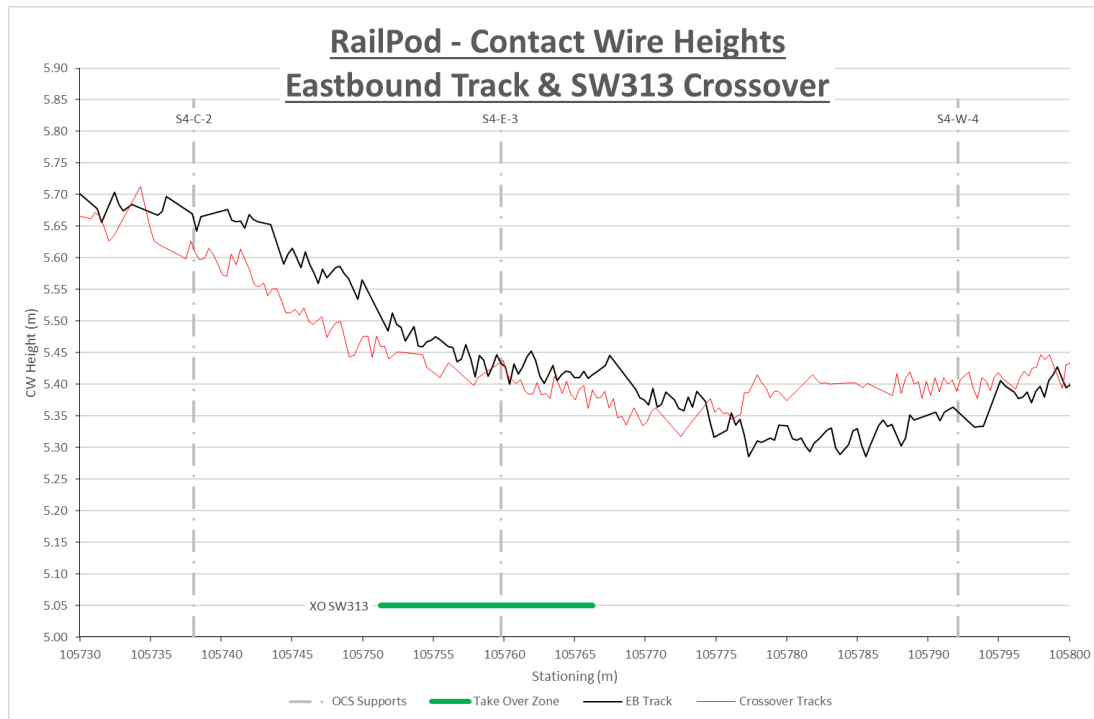
**TableFigure 3.36: RailPod Data Analysis of SW313 Crossover Wire Heights**

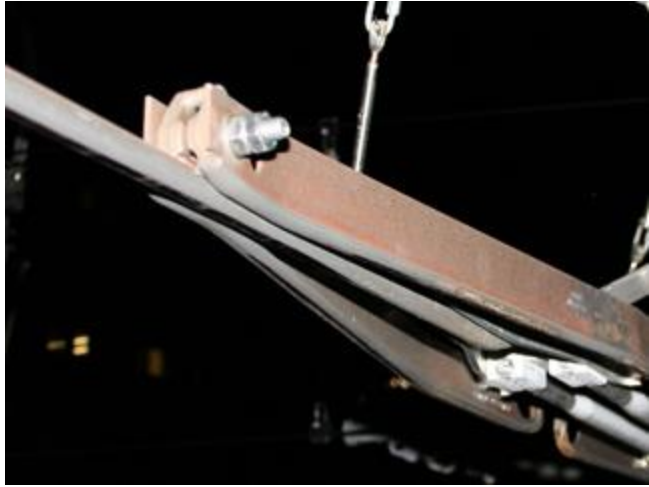
**Figure 3.41: Underside of Section Insulator**

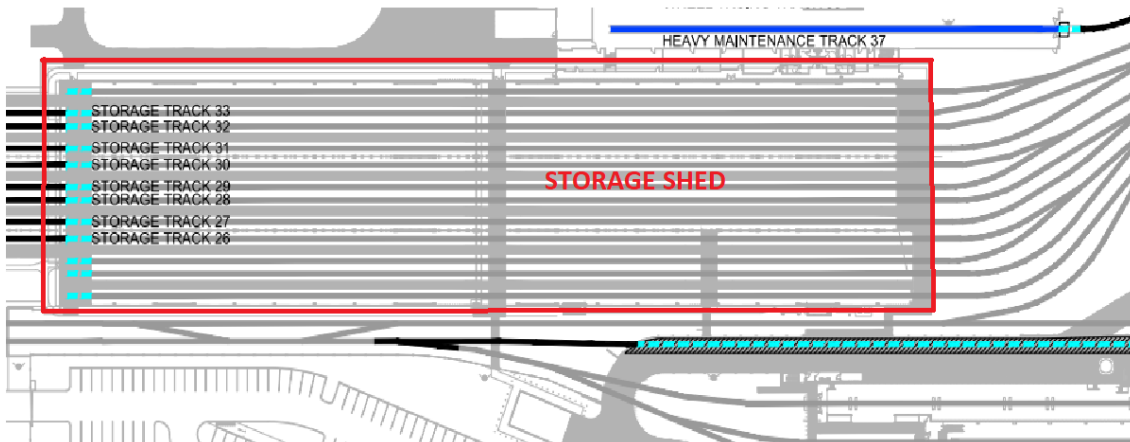
The storage shed consists of 12 stub ended tracks (**Figure 3.55**). The initial vehicle storage building had capacity to hold four LRVs on each track. An extension was added to the vehicle storage shed extending eight of the tracks allowing them to store a maximum of six LRVs on each of the eight extended tracks.

**Figure 3.55: Storage Shed**

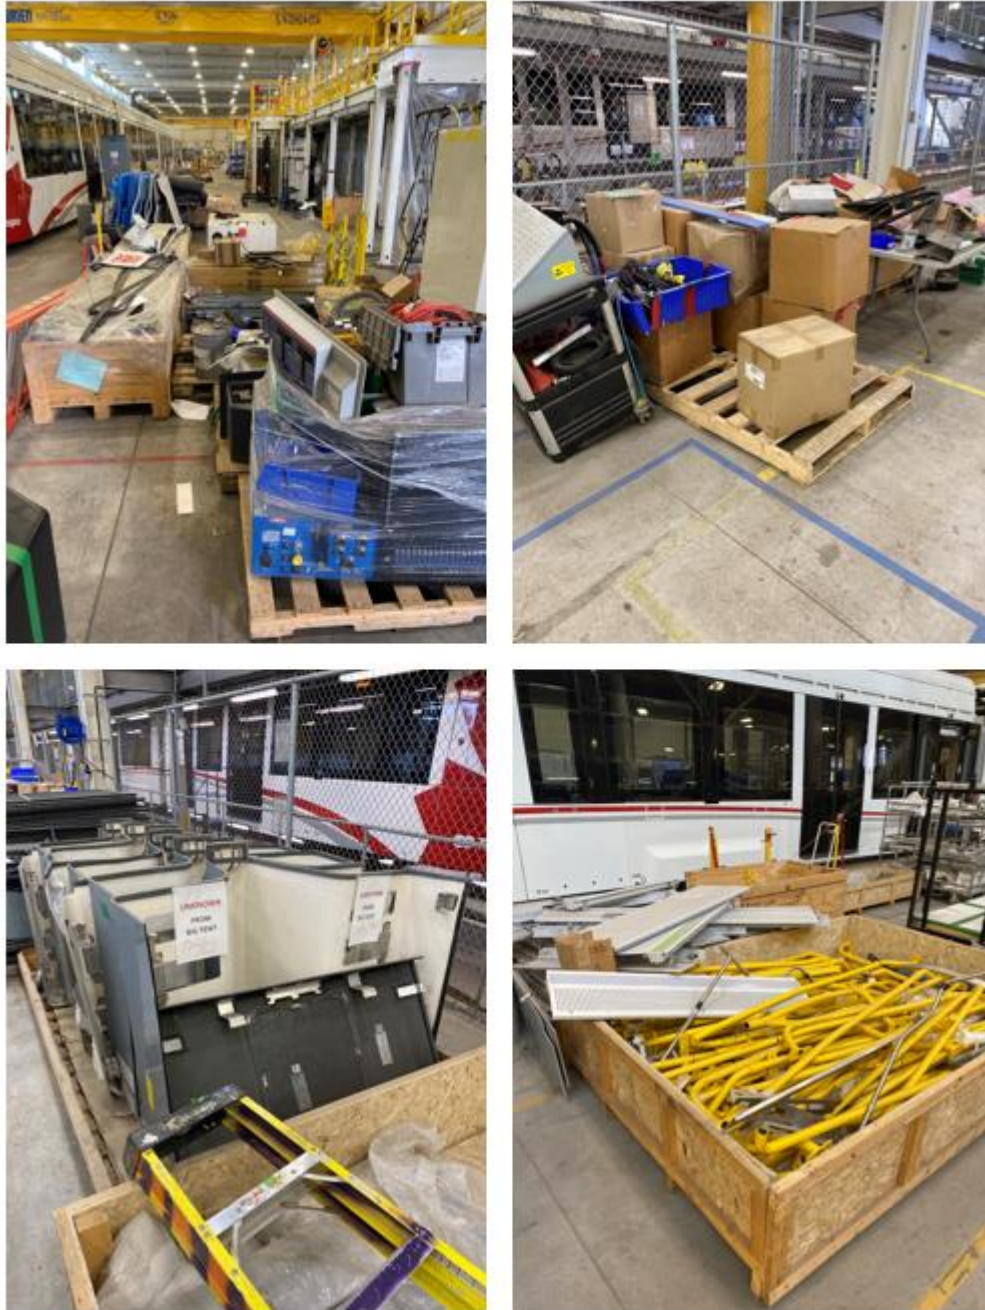
Figure 4.1: (a) (b) (c) (d): Parts Laying Out on the Floor Shop of MSF1 Next to Tracks 1 - 4

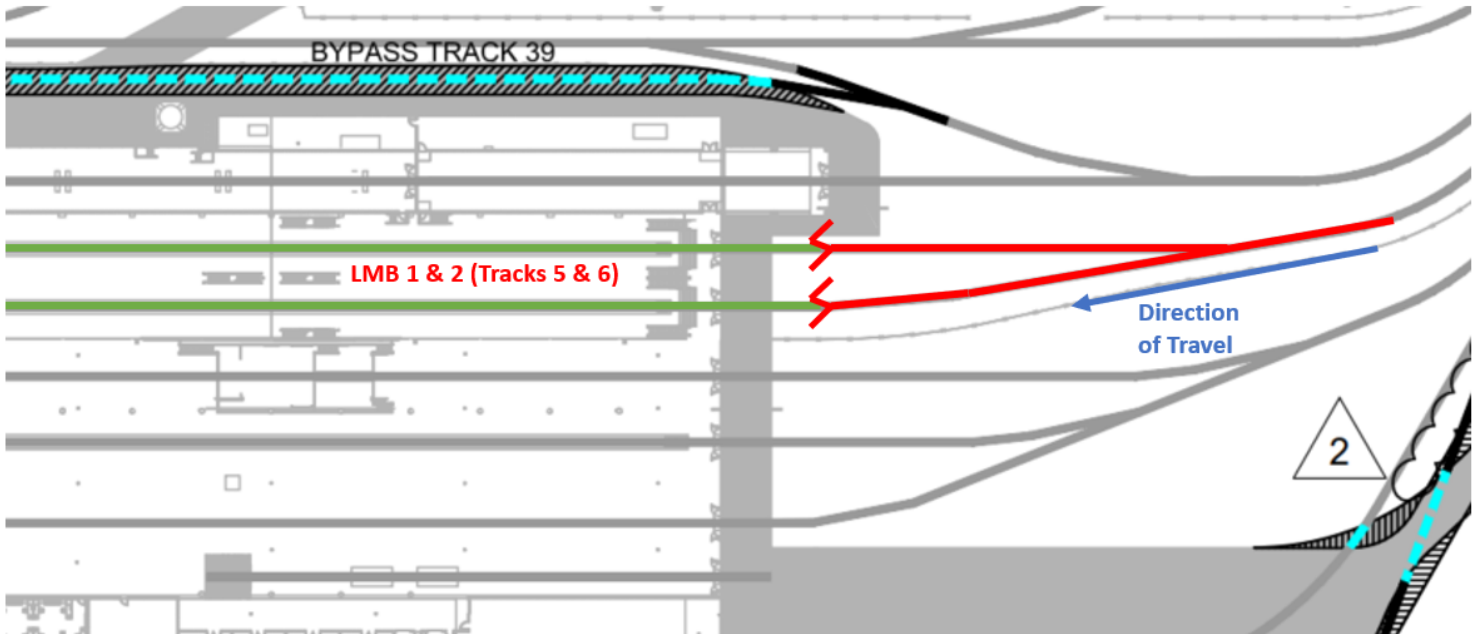
**Figure 4.5: MSF1 Access Issue to LMB 1 and 2 from East Side of Facility**

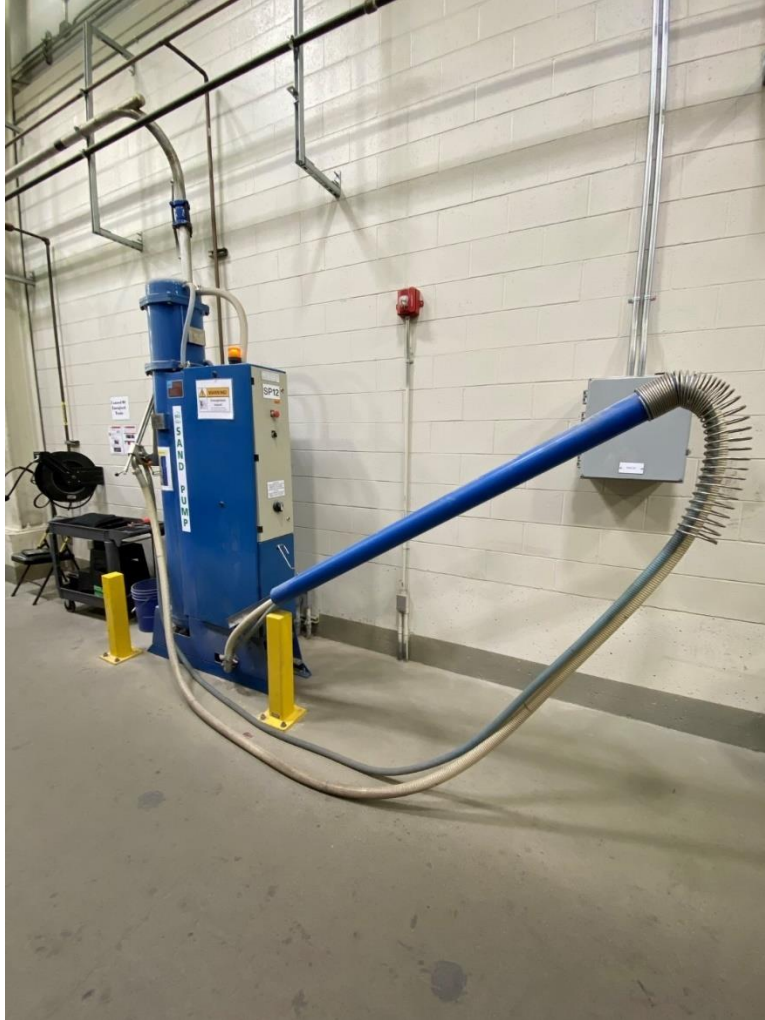
On track # 7, 12 sanding pumps are located, six on each side of the vehicle (**Figure 4.6**). Due to the location of the sanding pumps, the device was fitted with longer hoses to be able to reach the sanding box ports on the vehicle. The extra length on the hoses causes sharp edges and substantial rubbing with the floor, causing the hoses to break. This issue is controlled by the use of sacrificial conduits. The Mott MacDonald team was informed that the system suffers from constant clogs due to presence of moisture in the sand.

**Figure 4.6: Sanding Pump at Track #7**

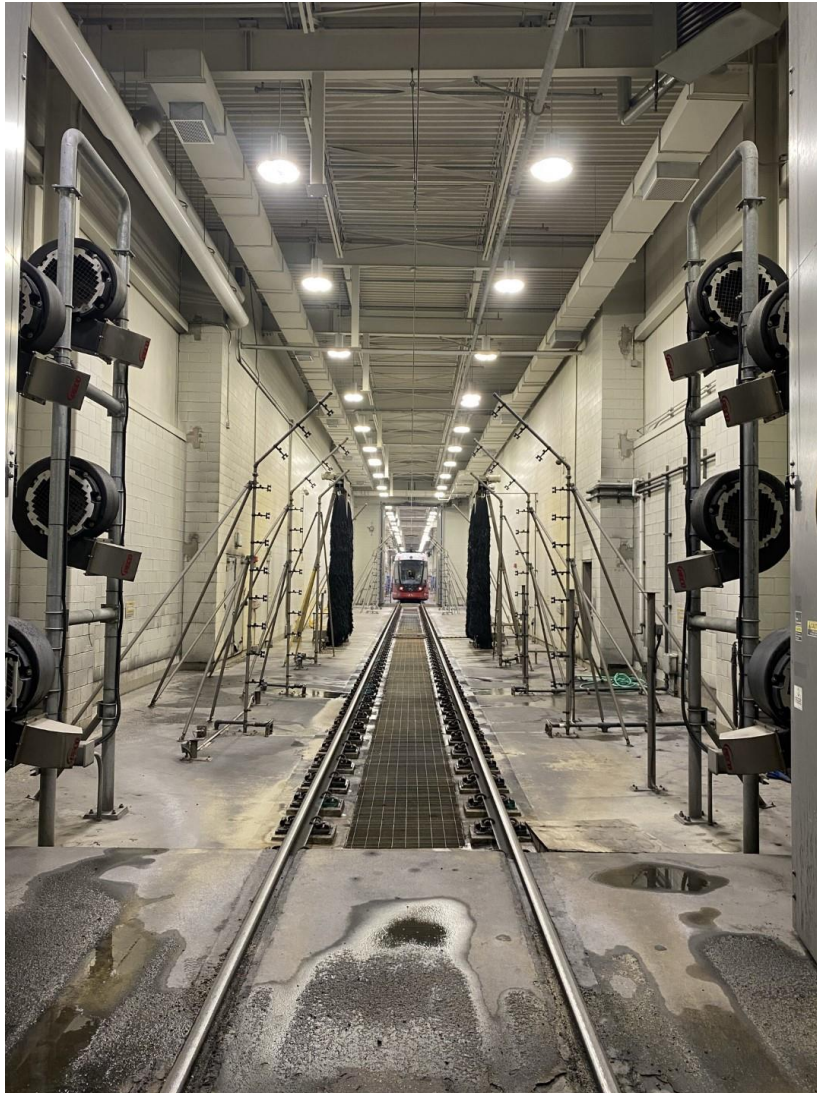
The carwash system is located on track #8 (**Figure 4.7**). The system can wash a consist of two vehicles without having to decouple the train, however, the system does not wash the front and rear cabs of the consist. Based on the Mott MacDonald team observations, the rinsing and blower systems’ performance are not optimal, leaving the vehicle wet and with detergent residue as it leaves the carwash track. This may also create problems during the winter when water on the bodysides and doors may freeze resulting in possible door seals sticking and creating door reliability issues.

**Figure 4.7: Carwash System at MSF1**

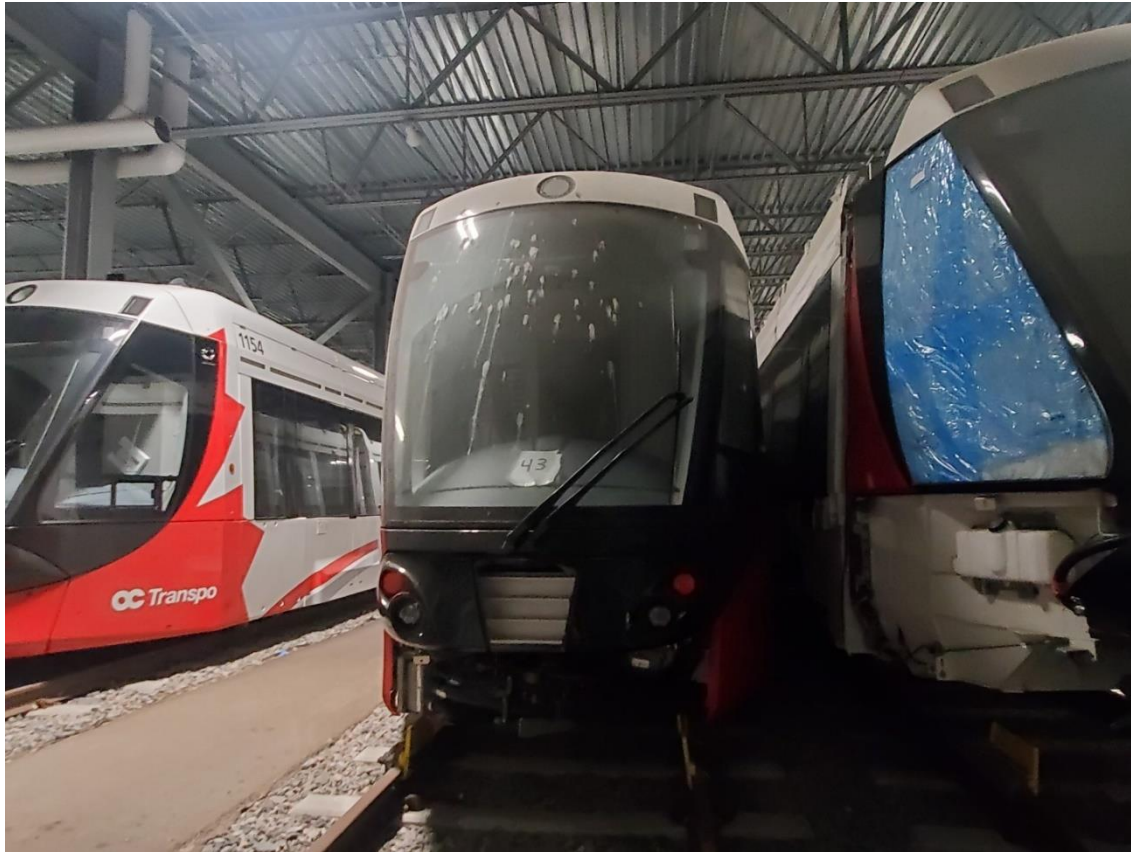
Additionally, if vehicles are parked next to another vehicle there is insufficient space for the vehicle side panels to be opened and for personnel to walk along the restricted access side of the vehicles, which is a safety concern (**Figure 4.11**).

**Figure 4.11: Limited Space Available Between Vehicles at the Storage Shed**

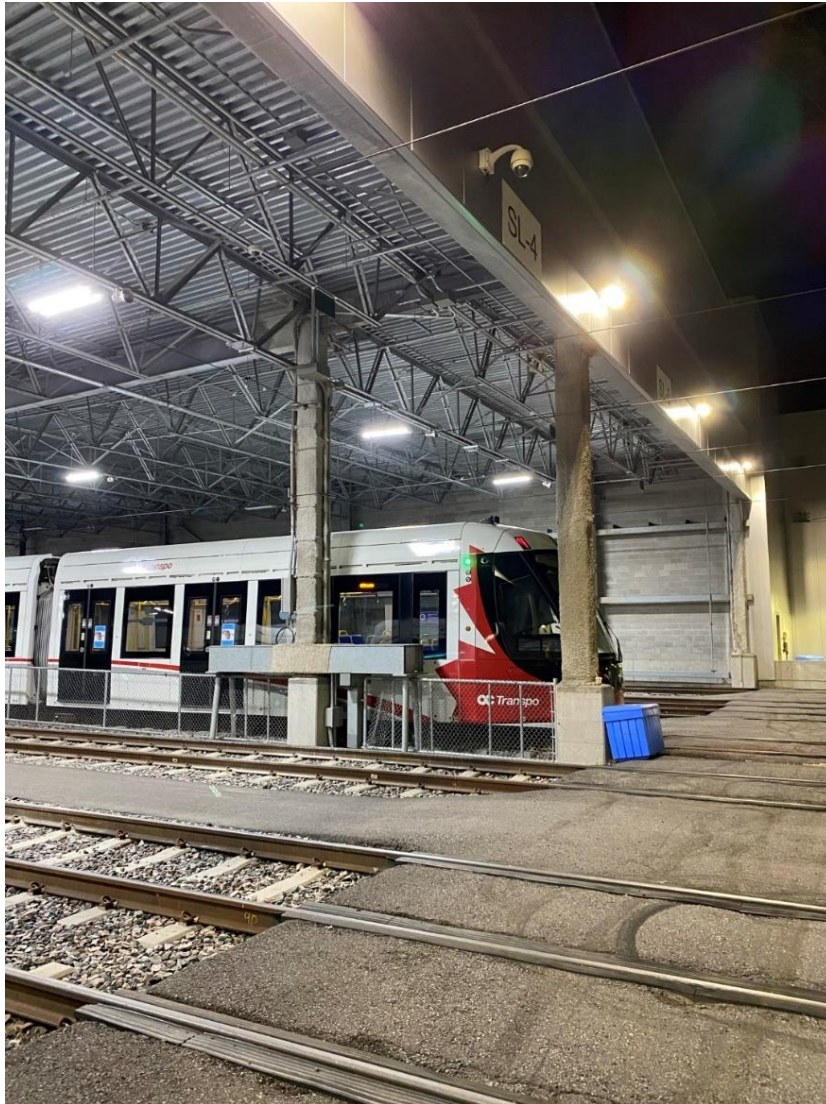
Another aspect that affects the movement of vehicles, especially during winter season, is the lack of doors at the storage shed (**Figure 4.12**) which is going to worsen the vehicle storage situation especially for those that are stopped long term due to missing parts and equipment especially for those that are open to the elements because of missing windows/panels. During winter conditions, snow can accumulate and enter the shed which makes the working area for staff both unpleasant and hazardous.

**Figure 4.12: Lack of Doors at Storage Shed**

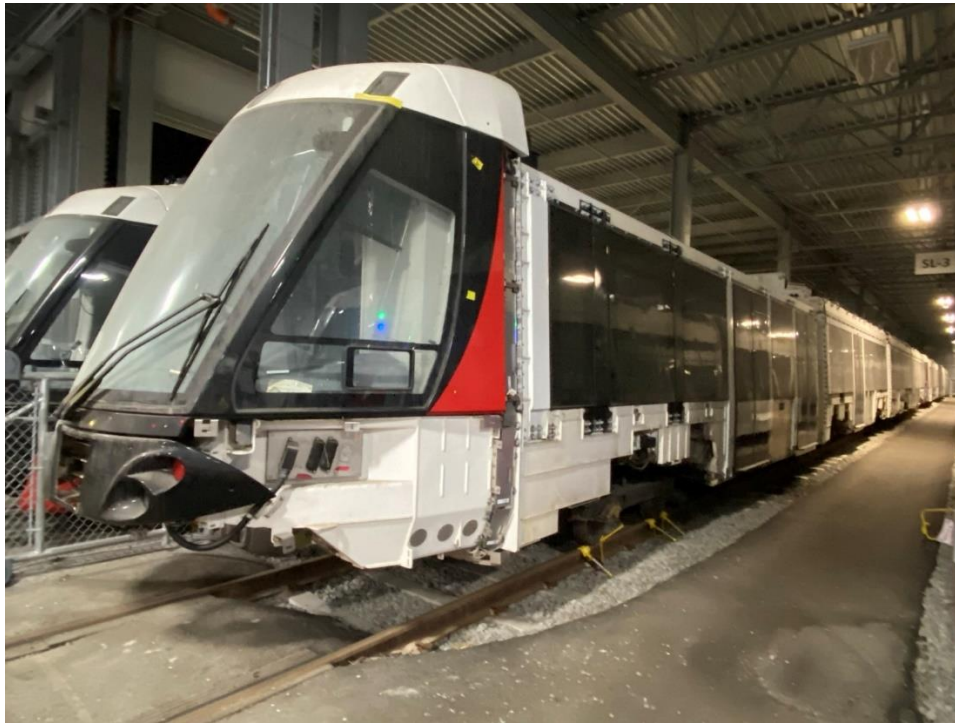
Mott MacDonald was informed that 1146 was the last vehicle to be built at Belfast Road before production was moved to Brampton. This vehicle does not have trucks installed and is missing exterior panels. The interior appears complete, but interior panels are open, which suggests that the interior equipment is either incomplete or has been partially removed. The interior and exterior bellows are not installed, with plywood covering the end portals. One of the cabs in the vehicle is missing the cab side windows, chip board panel covered by plastic are currently in place instead of cab windows.

**Figure 4.13: Vehicle Missing Side Panels, Coupler, Skirts and Roof Shrouds**

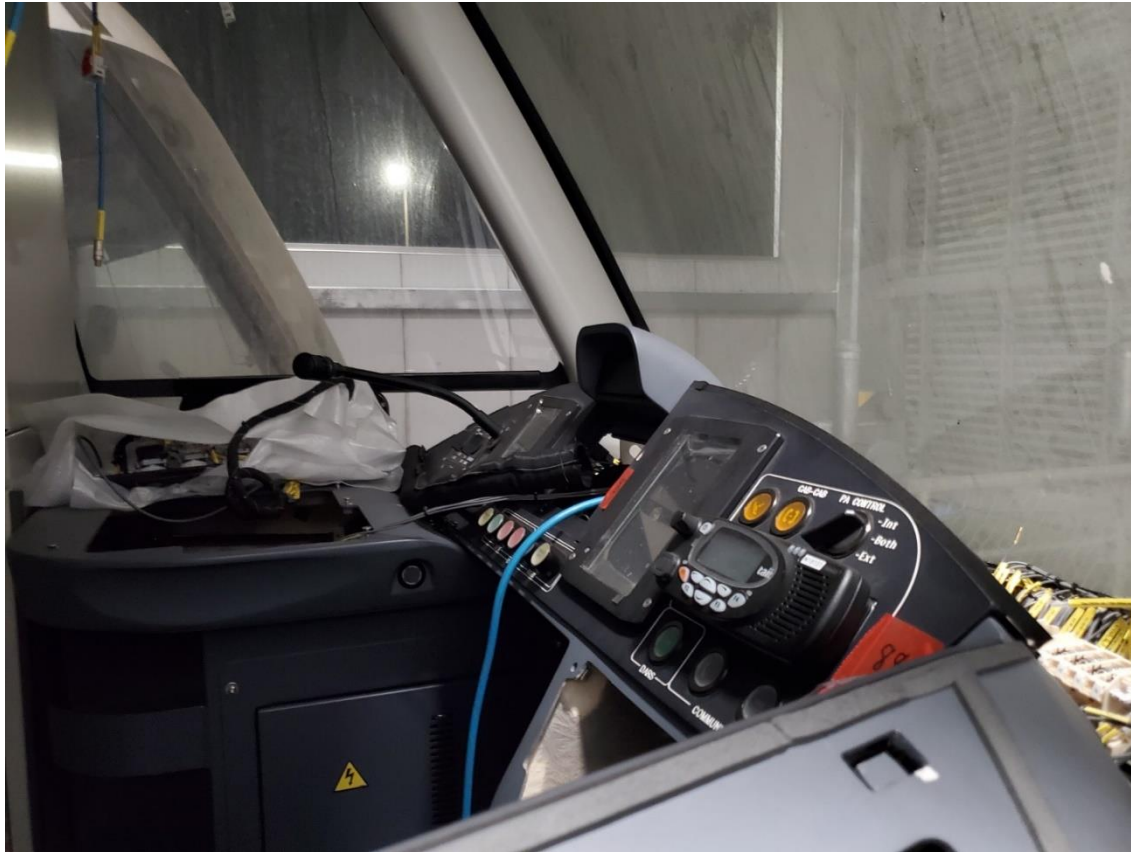
Vehicles 1135 and 1136, which are labelled as “1102 old” and “1108 old,” are the least complete vehicles. Neither have trucks installed. Both have incomplete exterior and interiors. At least one end of 1102 old does not have a coupler. 1108 old does not have a cab partition installed.

**Figure 4.14: Vehicle Missing Cab Components**

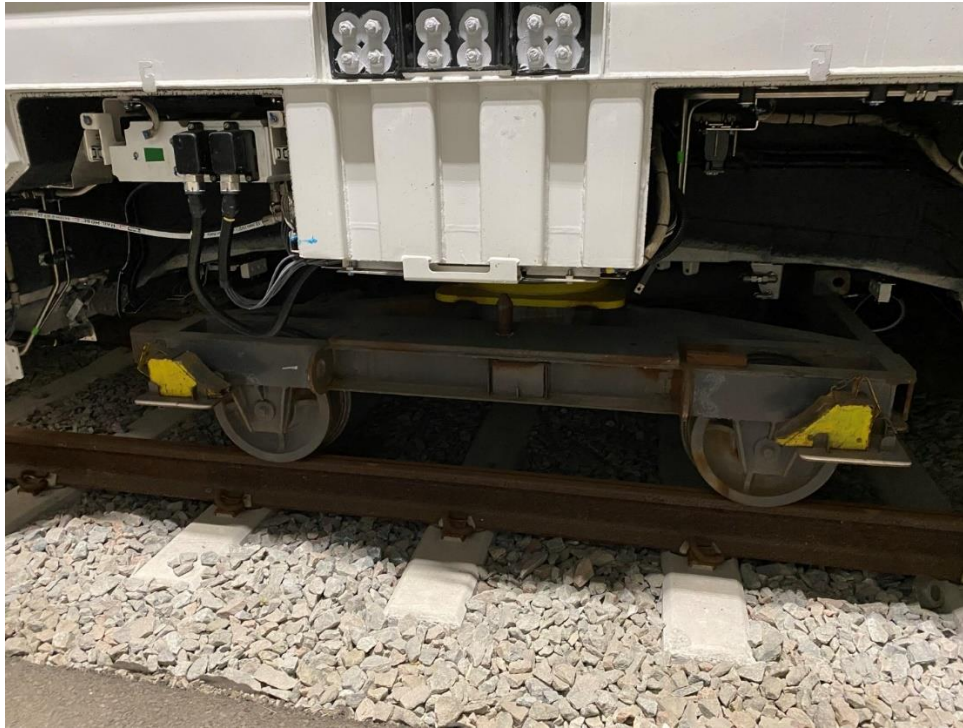
When asked about 1135 and 1136, Project Co indicated that these vehicles were used for qualification testing early in the project. When asked about returning them to a service ready state, we were told by Project Co staff in the MSF that there was the possibility that they would simply be replaced with new vehicles from Brampton as part of Stage 2. It is unclear how or why these vehicles were dis-assembled to this state after testing, or how configuration management has been exercised on the components removed. It is clear from the dust that these vehicles have not been moved for some time.

**Figure 4.15: Vehicle Missing Trucks**

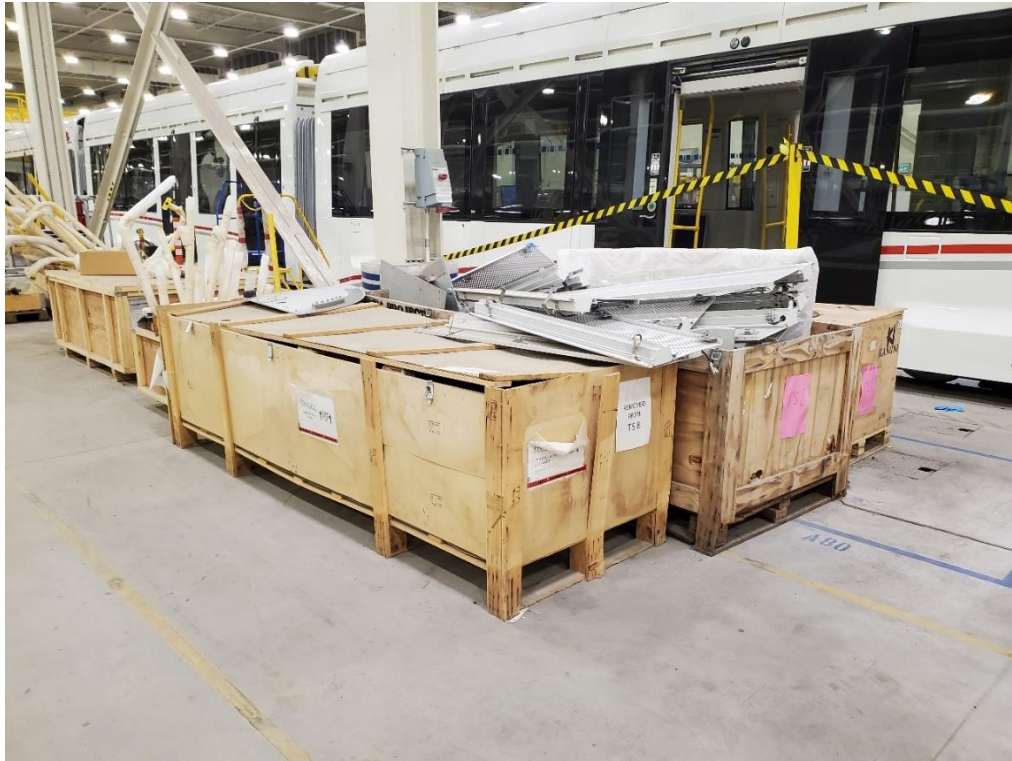
On the floor of MSF1 are a number of pallets, and crates. Some of these are labelled “removed from TS 8.” While unconfirmed, it could be inferred that at least some of these interior panels, stanchions and interior panels may have come from 1108 old.

**Figure 4.16: Crates in MSF1 Labelled "REMOVED FROM TS 8"**

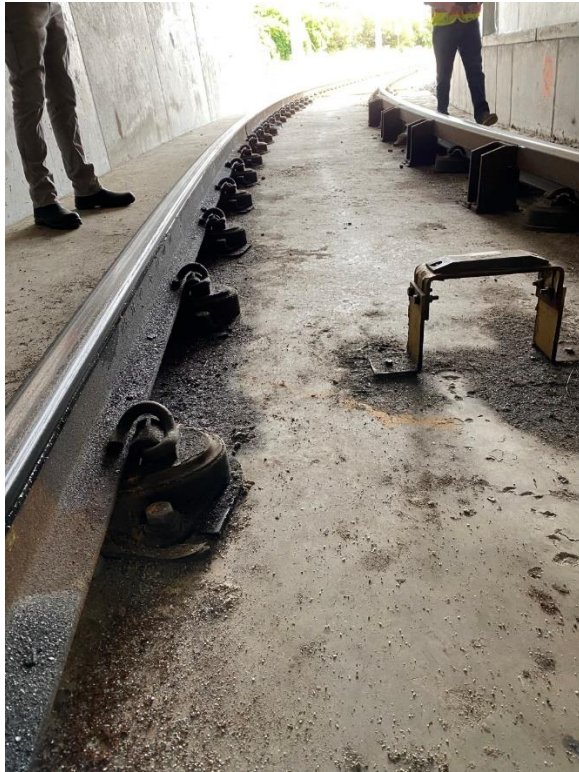
According to Alstom, grease is applied manually only on the yard at curve C19. However, evidence of grease on top of the rail is evident at other locations, specially at the end of the East Connector, where vehicles stop before proceeding to enter the main line. Due to the gradient at this location (Approx. 4-5%), and the presence of grease on top of the rail, wheel spin/slide occurs causing the automatic sanding system to activate. The continuous wheel spin/slide occurrences due to lack of traction between wheel and rail caused by the presence of grease on the rail is the reason for the large amount of sand accumulated at this location, refer to **Figure 4.21** to **Figure 4.23**.

**Figure 4.17: Grease Contamination at East Connector**

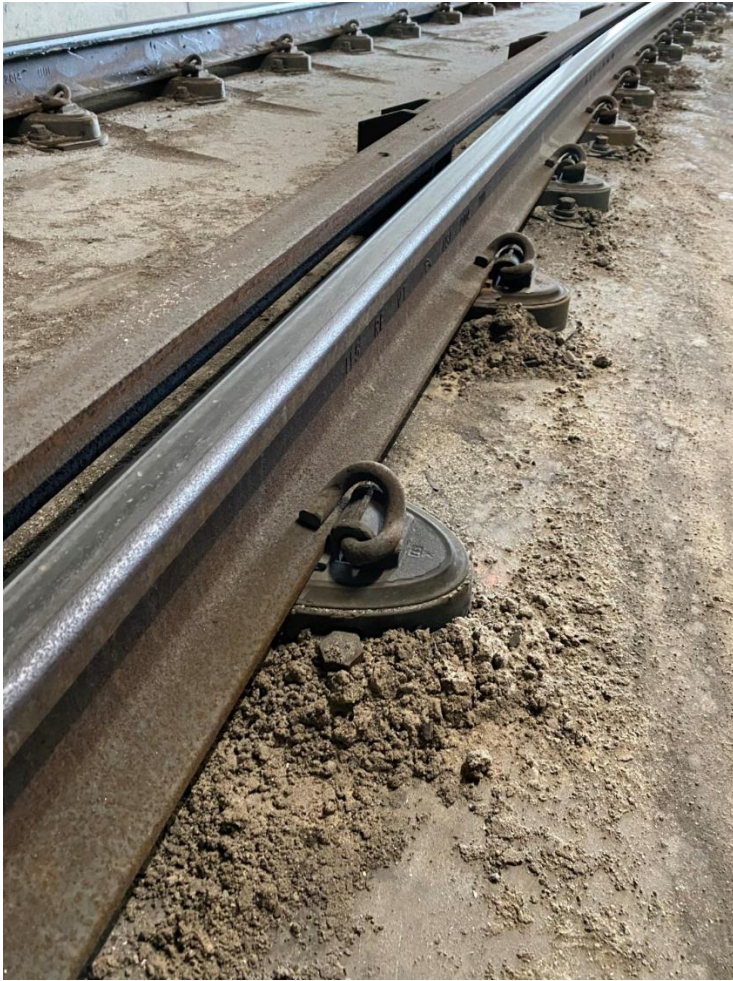
**Figure 4.19: Sand accumulated at East Connector Due to Excessive Wheel Spin/Slide Caused by Presence of Grease on Top of Rail**

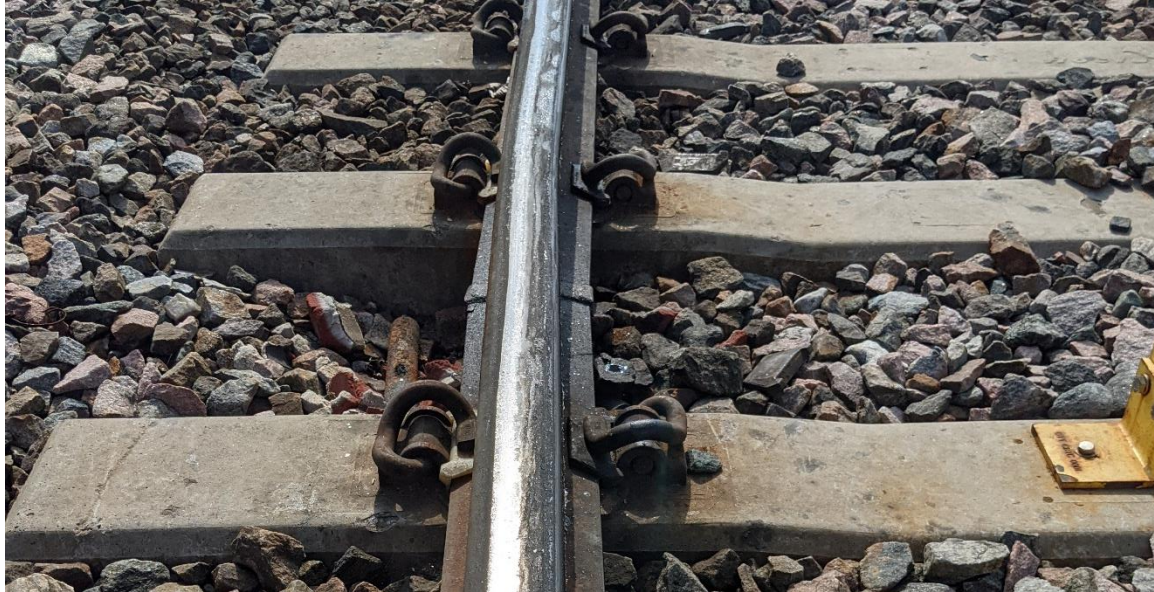
It is important to note that tight to gauge track on the small radius curves could lead to potential wheel flange climb resulting in derailment. The severe kinks in the rails will also prevent a smooth transition of the wheels on the outer rail and when combined with the tight track gauge may also contribute to potential derailment risks.

**Figure 4.21: Kinks at Weld Location (C19), Including Grease Contamination of the Top of Rail**

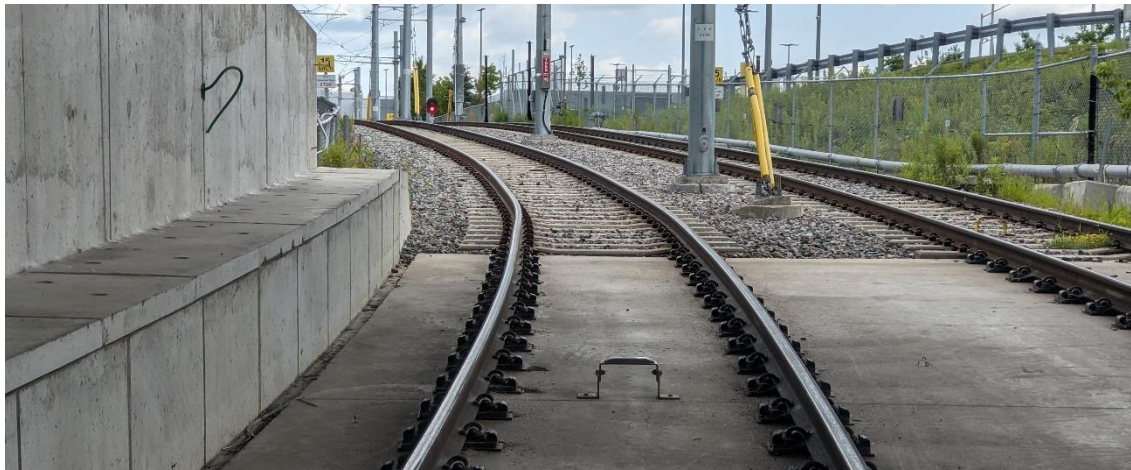
In addition to issues associated with the track gauge as listed in Section 4.4.1 above, general issues with the track geometry were found, most notably at the transition between ballast track and DFF track at the E/B and W/B Connector tracks (**Figure 4.26** and **Figure 4.27**).

**Figure 4.22: EB Connector, Track Geometry at Interface Between Ballast Track and DFF Track**

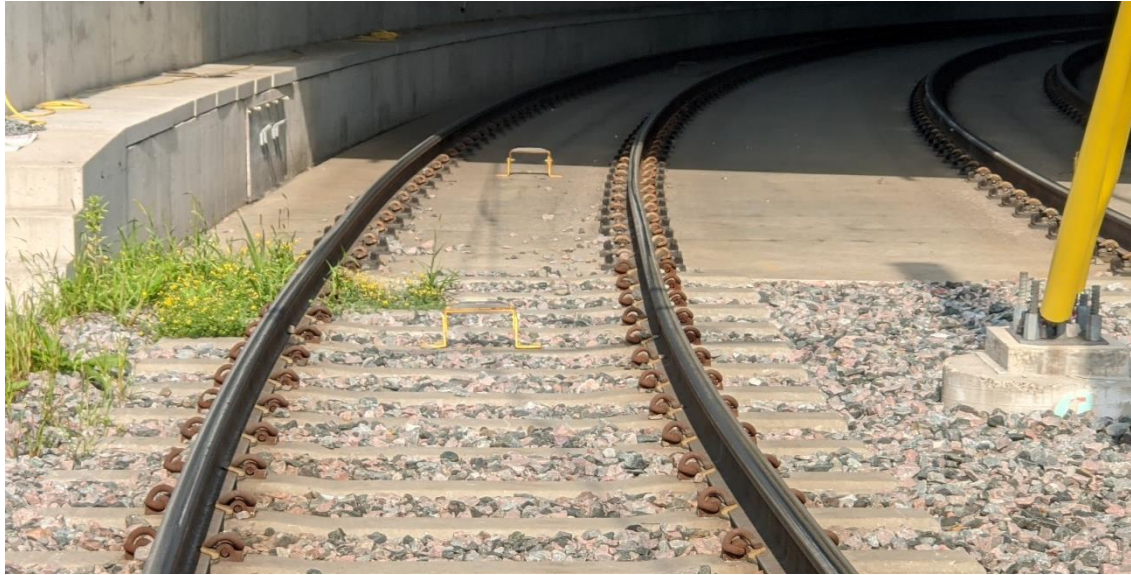
**Figure 4.23: WB Connector, Track Geometry at Interface Between Ballast Track and DFF Track**

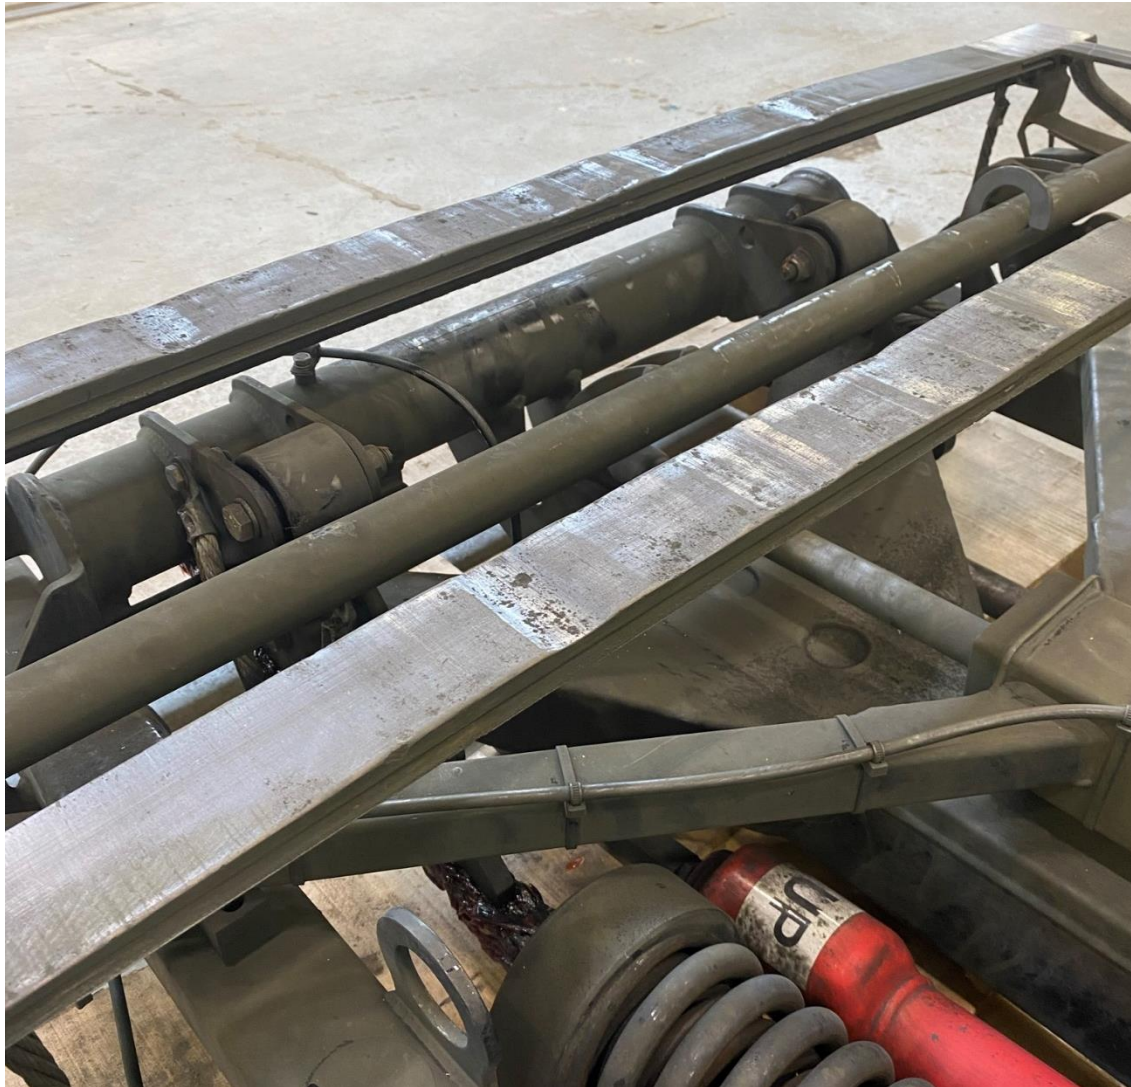
**Figure 4.24: Grooved Wear on Pantograph**

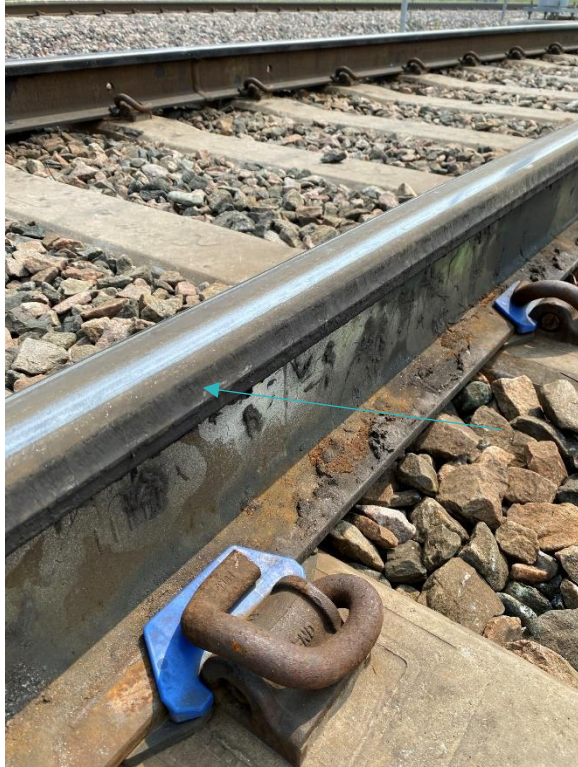
**Figure 5.2: Transposed Rail with Excessive Side Wear Now Moved to the Outside Edge**

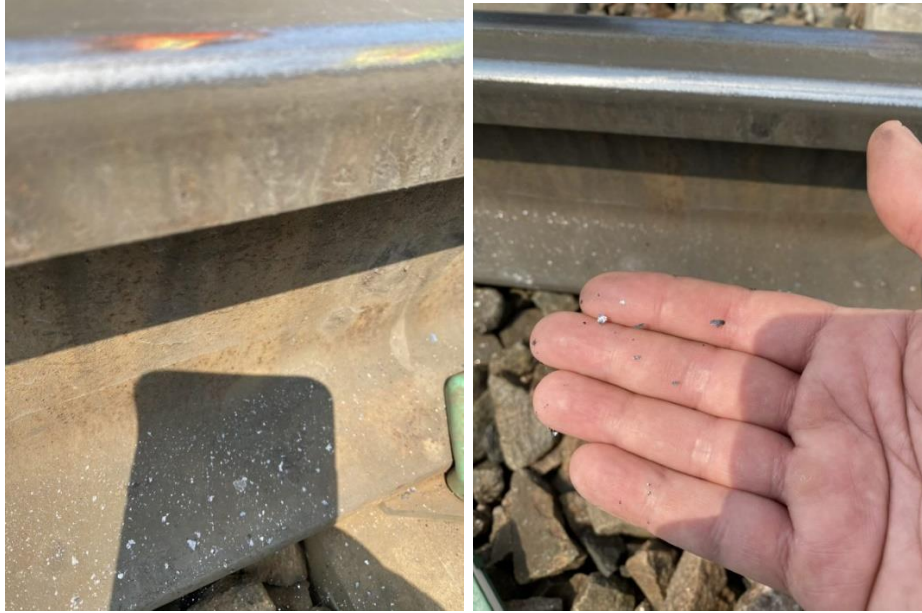
**Figure 5.3 & 5.4: Metal Shavings at Curve 19**

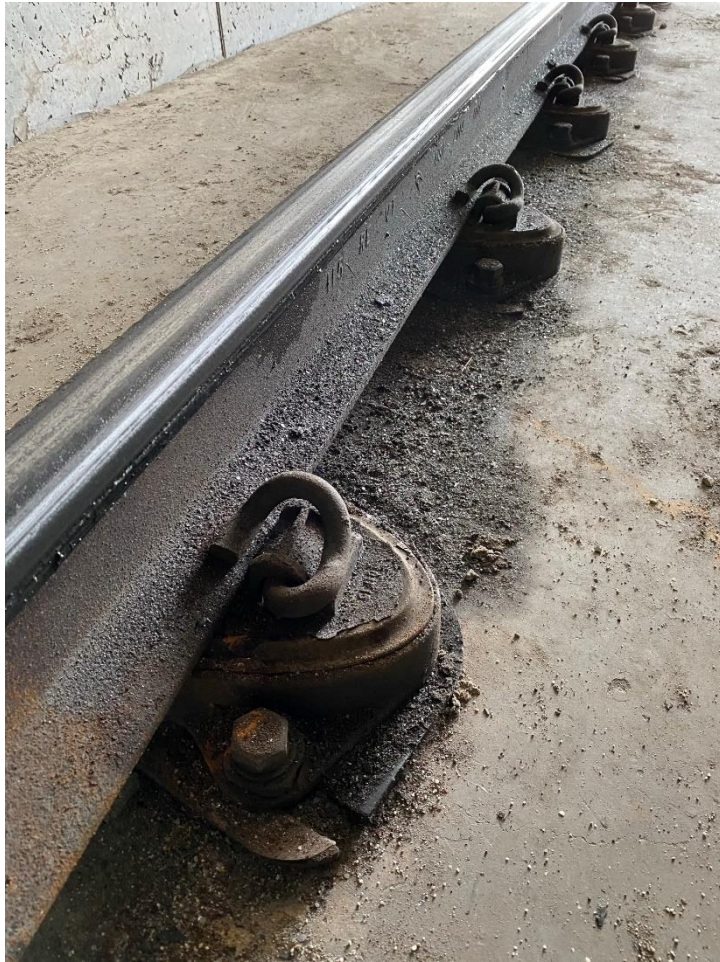
**Figure 5.6: Manual Grease Application Location at East Connector Tunnel**

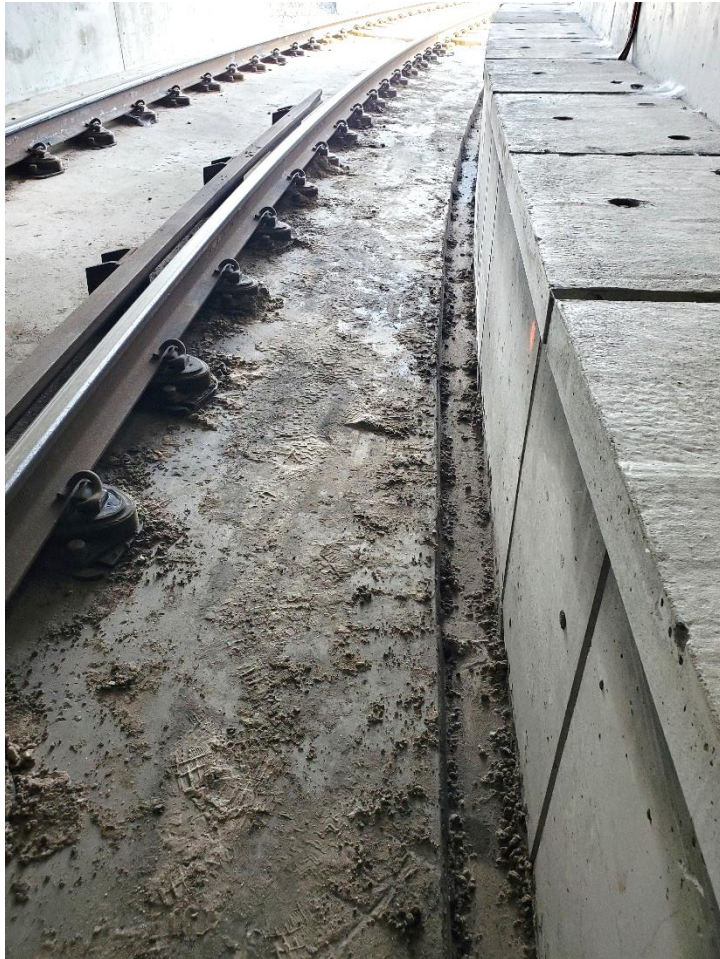
**Figure 5.9: Sand in East Connector Portal Tunnel**

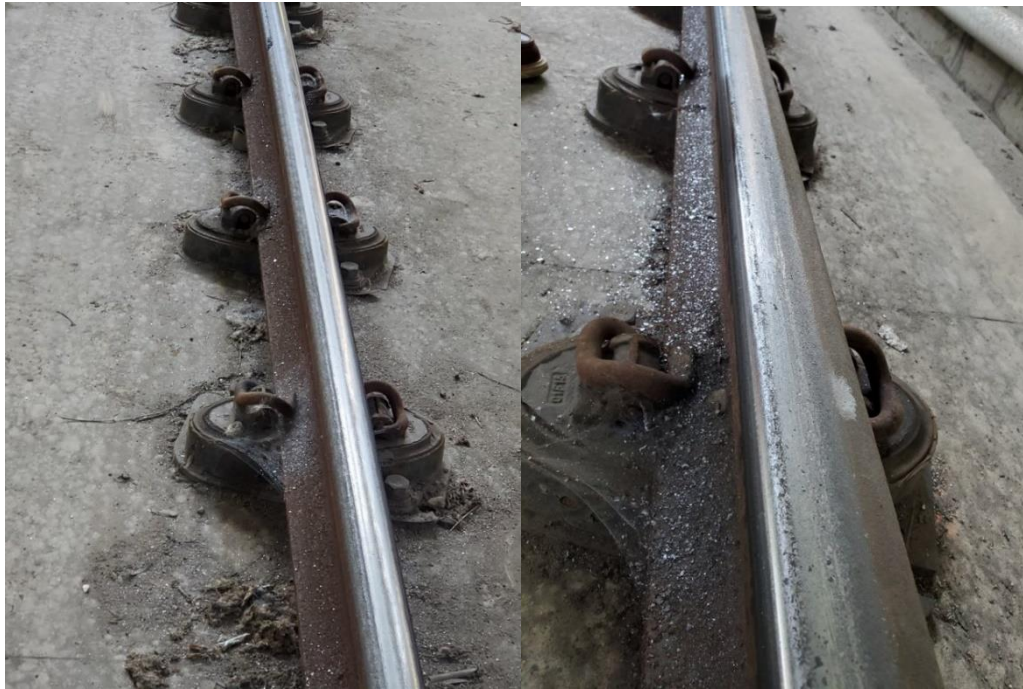
**Figure 5.10: Metal Shaving at East Connector Portal Tunnel**
