OC Transpo Transitway Station Design Safety Study

Independent Safety Study

Final Safety Study

September 2021

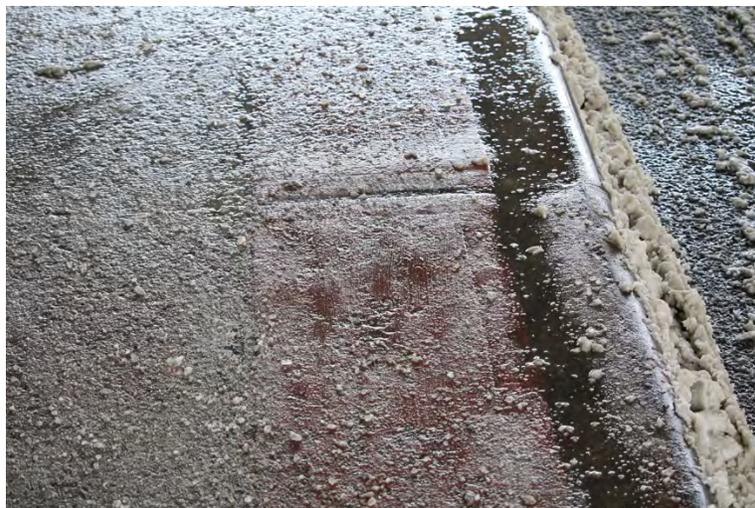
Issue 5: Service vehicle access curb letdown located at the nearside of station

The curb letdown or vehicular access for service vehicles to access the platform at the station is located at the approach side or nearside of the station. The location of this access provides a potential opportunity for an errant vehicle to easily mount the curb and intrude onto the platform at the station.

Replace the letdown curb on the approach end of the station platform with a 150mm high barrier curb. The letdown curb on the departure end of the station platform can remain.

Note potential design guideline implication – locate curb letdown far side of station and curb height should be higher at BRT Stations, namely a raised platform 200mm (8”) to 250mm (10”) (reference to APTA BRT Stations and Stops Recommended Practice).

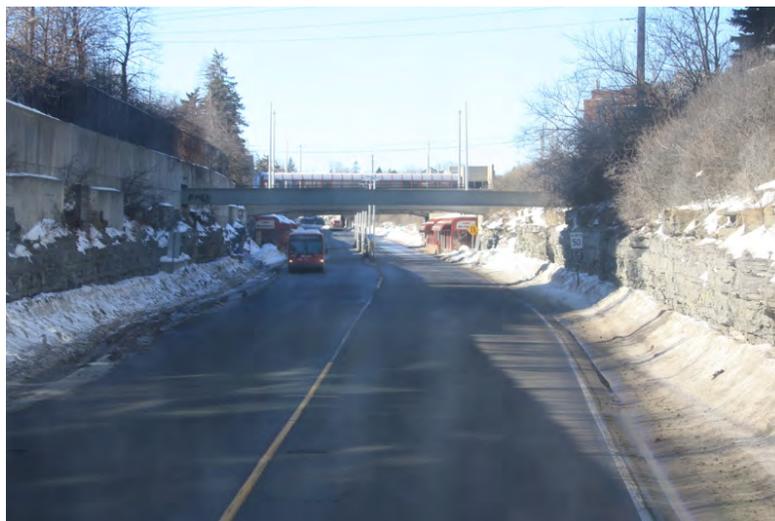
Along both the westbound and eastbound approaches to the station there can be light areas and shadows due to the angle of the sun and objects along the top of the cut section. This is a potential issue for patches of icing and inconsistent road surface friction during temperatures near freezing the point.

Low sun angles cannot be easily mitigated. Driver training, reduced speed and a higher level of winter maintenance are suggested for the short term. In the longer-term better drainage and a flashing beacon activated by a road surface sensor monitoring conditions such as ice and temperature are suggested.

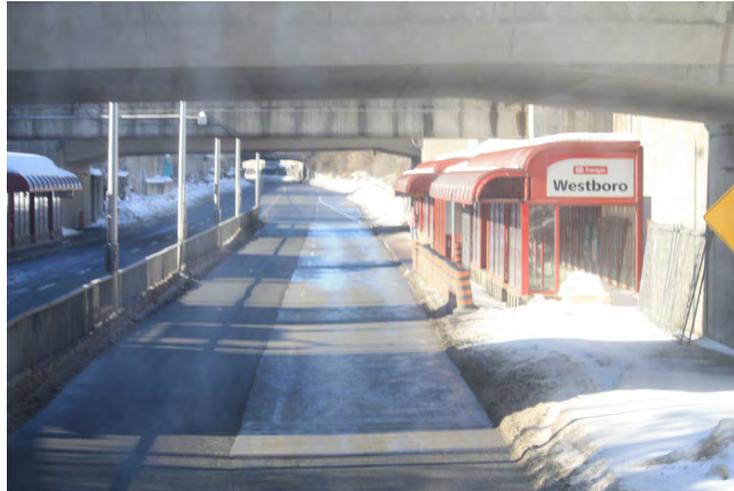
Issue 10: Water and ice on transitway surface cause glare

Patches of water and ice on the transitway can cause glare when the sun is positioned in the sky in line with the transitway.

During the site visit it was noticed that snow, which had accumulated on the curved roof resulted in snow and water from melting snow falling on the roadway. Eavestrough along the canopy edge is suggested to drain water away from falling on the Transitway.

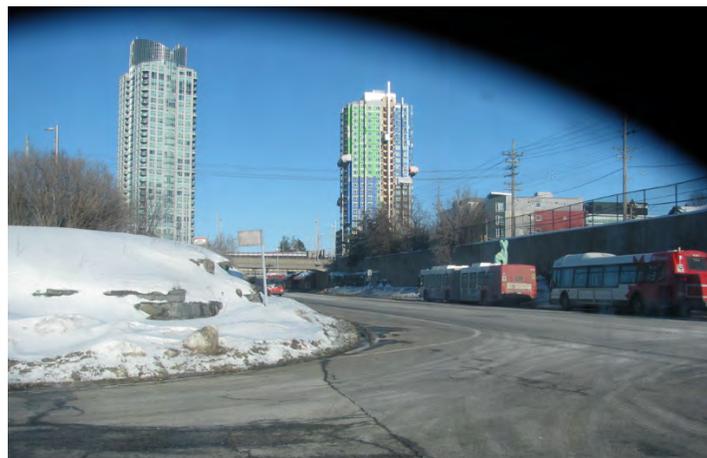
The local access road to the transitway just west of the station has limited sight distance to the east at the T-intersection. This can be an issue for vehicles entering onto the transitway for selecting a safe opportunity to enter onto the transitway within the traffic stream. Some transit vehicles were observed to be parked on the hatched area along the north side of the transitway, further reducing intersection sight distance to the east.

Install a flashing beacon activated by buses at the stop bar to warn westbound buses of the potential turning movement conflict would help reduce the potential for collisions. Install “No Stopping” signs along the north side of the transitway for the extent of the hatched area.

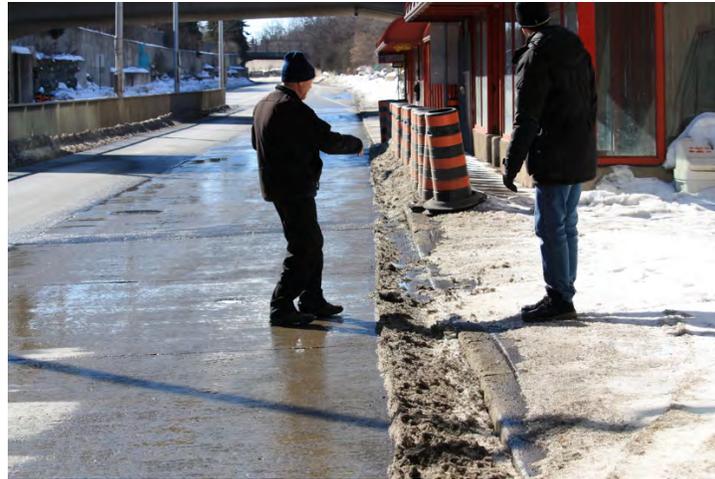
The curb letdown or vehicular access for service vehicles to access the platform at the station is located at the approach side or nearside of the station. The location of this access provides a potential opportunity for an errant vehicle to mount the curb and intrude onto the platform at the station.

Replace the letdown curb on the approach end of the station platform with a 150mm high barrier curb. The letdown curb on the departure end of the station platform can remain.

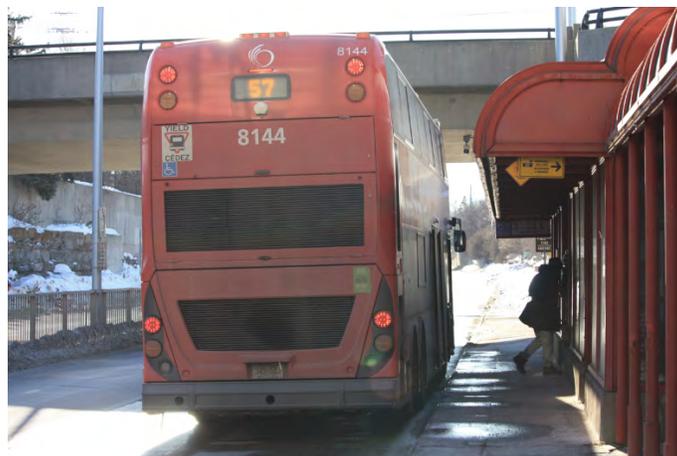
An overhead canopy protruding out from the frontage of the station in both the westbound and eastbound directions is located within the desirable Clear Zone of the transitway. The Clear Zone is a fixed-object-free area available to permit recovery by an errant vehicle. Where curb is used, the lateral offset to the hazard is measured from the face of the curb. Generally, in urban areas, a minimum of 0.5 metres offset is provided from the face of curb to fixed objects. However, in urban environments, past studies have shown that approximately 80 percent of roadside collisions involve objects with a lateral offset from the curb face equal to or less than 1.2 metres and approximately 90 percent of urban roadside collisions have lateral offsets less than or equal to 1.8 metres. The auditors note that US studies (FHWA) have shown that 20 percent of errant vehicles exceed clear zone distances. Therefore, a lateral offset of 1.2 metres to 1.8 metres from the curb face to fixed objects is desirable. The existing offset between the curb face and the canopy at this station was difficult to measure during the onsite audit, but the offset appears to be about 0.5 to 0.7 metres.

When a vehicle collides with a fixed object, the crash response safety systems of the vehicle, such as the bumper and vehicle frame crumpling to absorb energy, may possibly deflect the vehicle and / or reduce the severity of the crash for the vehicle occupants. However, these vehicle safety systems may not be engaged in crashes where the fixed object contacts the vehicle at a height higher than the vehicle's bumper.

Either reduce operating speed of buses to 20 km/h within the limits of the station to mitigate severity of possible collision with canopy or alternatively remove the canopy.

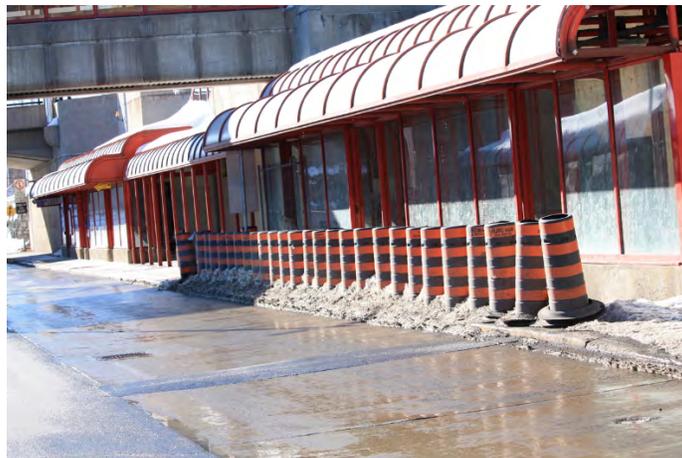
The convex shape of the roof and canopy at the station deposits snow and water onto the sidewalk and transitway surface at the station. This is a potential issue for icing during certain times of the year which could impact surface friction on the transitway and slipping/falling hazard on the sidewalk.

Remove canopy as it cannot be made frangible or shielded. Alternatively install an eave troughing to capture water dripping on the transitway.

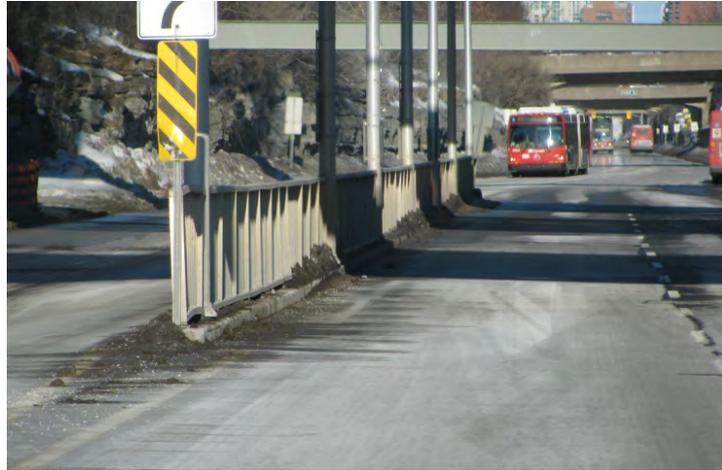
Unlike the median barriers at other station along the transitway, the median barrier at the Westboro Station is not designed to be a vehicle barrier. The purpose of the barrier is to discourage transit patrons from crossing the Transitway. This barrier would not deflect an errant vehicle from crossing over into the oncoming lanes.

Replace the median fencing with a TL-3 F-Shape 810mm concrete barrier and TL-3 crash cushion end treatments.

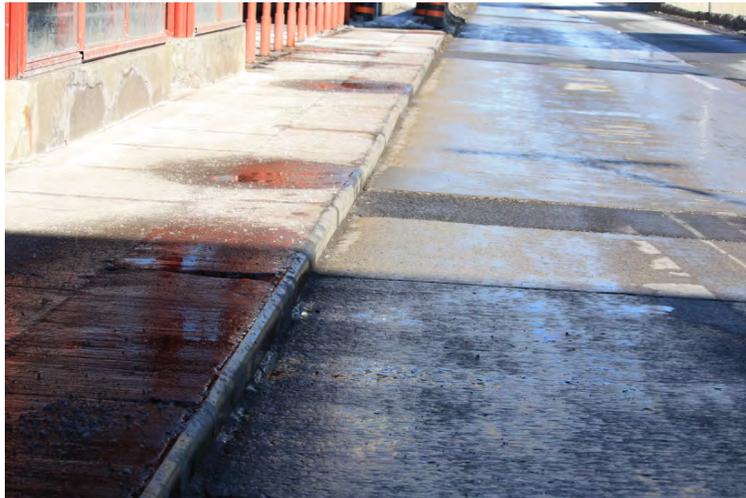
The edge of the station platform is delineated with a rustic-brown concrete colouring along the edge of the barrier curb. The contrast between the concrete sidewalk colouring and the edge delineation is not very conspicuous. This edge of the platform may not be discernable for people with vision impairments and / or the drivers approaching the station.

Install a high tonal tactile strip along the edge of the platform, in accordance with Accessibility for Ontarian with Disability Act (AODA) Guidelines. Noting that the colour is not specified in AODA, the standard high contrast colour for tactile strips in most jurisdictions in North America is yellow.

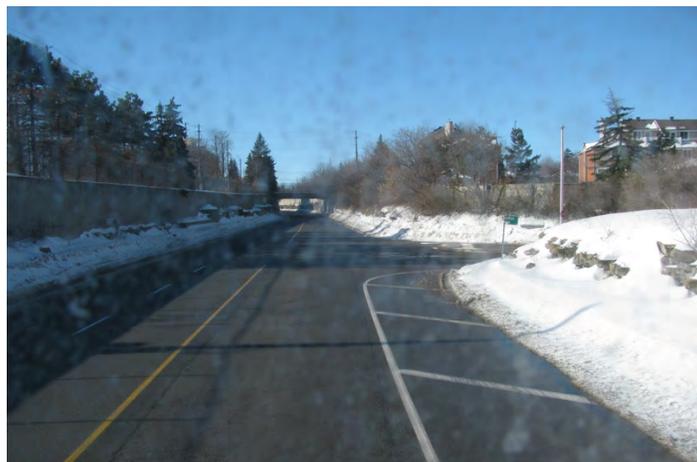
A gore area along the north side of the transitway just west of the station was recently installed as a measure to prohibit parking along this section of the transitway. Parked transit vehicles along this section of the transitway were limiting sight distance at the T-intersection just to the west. During the site audits at this and other station along this transitway, buses were observed parking in the gore area on a few occasions. This measure has not been effective for prohibiting parking.

In the immediate term install no stopping signs. In the longer term if bus drivers continue to park in the hatched area install drivable delineators 500mm offset from the outside of the edge line to prevent drivers from entering the hatched area.

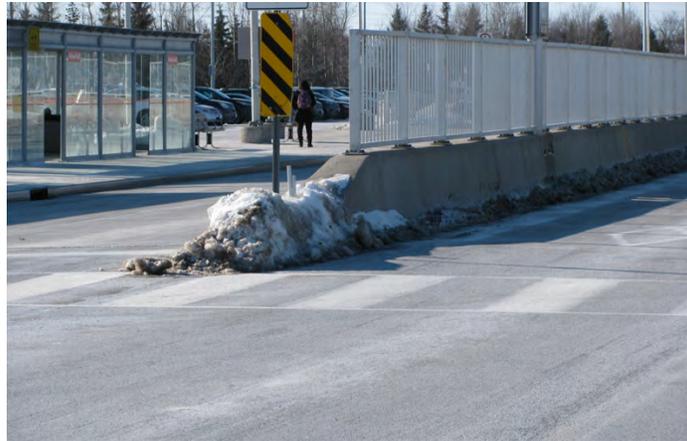
There is no energy attenuation at the median barrier ends at the entrances into the station. An errant vehicle could potentially rollover or be launched from a collision with the bull-nose end of the barrier.

Replace the sloped ends with an appropriate TL-3 crash cushion.

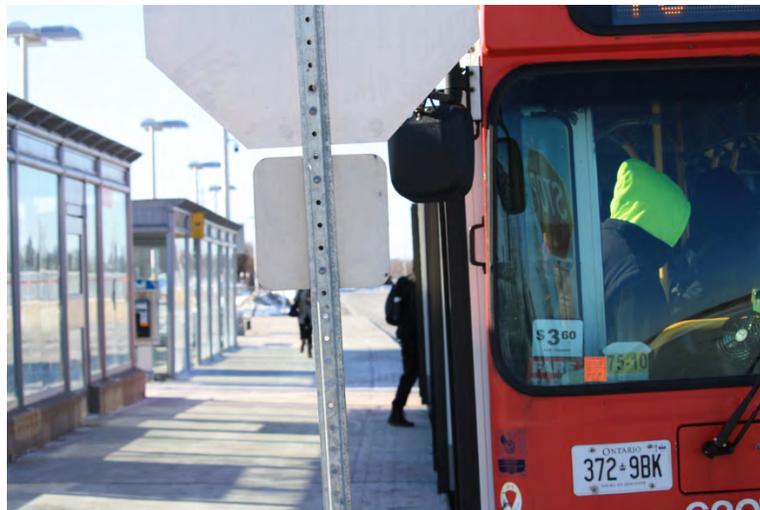
The STOP sign located in the southwest quadrant of the intersection at the station has been placed with the sign intruding onto the transitway. Buses proceeding away from the station could collide with the sign and the sign does show evidence of being struck. Consequently, some transit vehicles were observed to veer left into the adjacent when leaving the station of avoid hitting the sign. This could contribute to side-swipe collisions at the intersection.

Relocate stop sign 500mm from the face of curb.

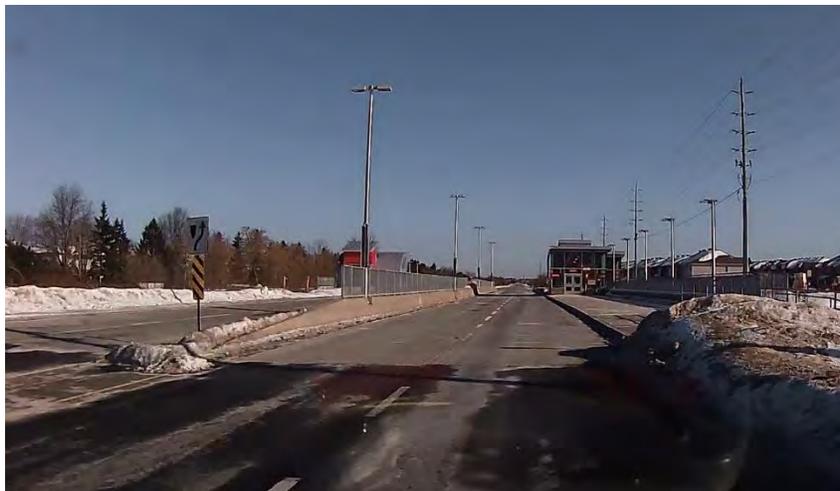
There is no energy attenuation at the median barrier ends at the entrances into the station. An errant vehicle could potentially rollover or be launched from a collision with the bull-nose end of the barrier.

Replace the sloped ends with appropriate TL-3 crash cushions.

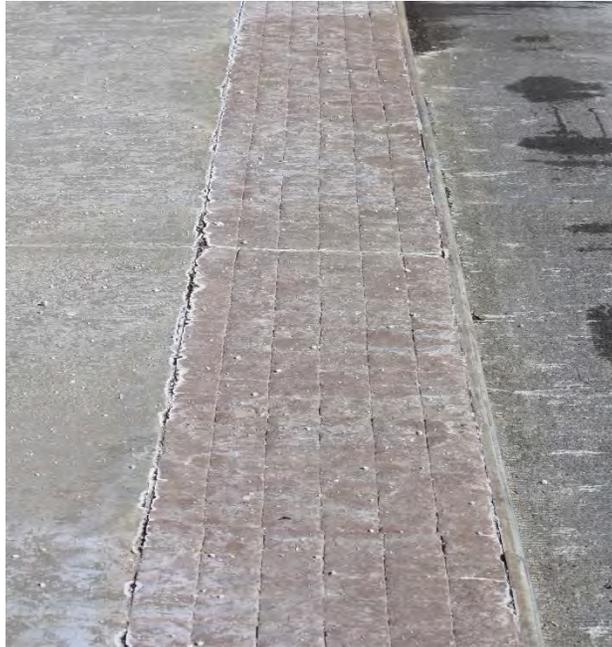
The edge of the station platform is delineated with a rustic-brown concrete colouring along the edge of the barrier curb. The contrast between the concrete sidewalk colouring and the edge delineation is not very conspicuous. This edge of the platform may not be discernable for people with vision impairments and / or the drivers approaching the station.

Install AODA approved high tonal contrast tactile surface. The suggested high contrast colour is yellow.

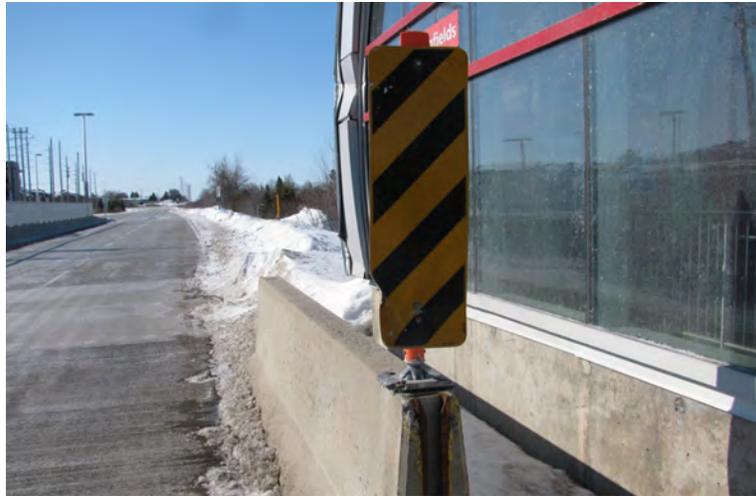
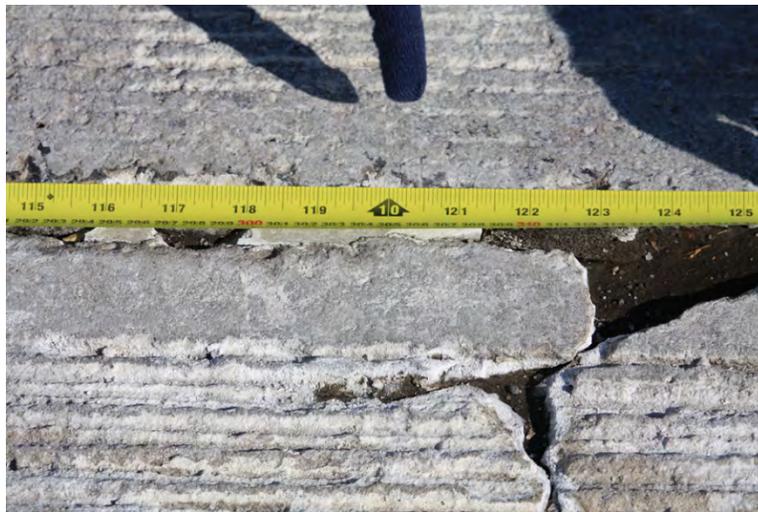
A concrete no-post barrier with a hazard marker has been installed on the road surface of the transitway along the right edge of the right travel lane directly beside the station building. A barrier has been installed in both the southbound and northbound directions. There is damage to the outside of the southbound station building which appears to be caused by a vehicle collision. This appears to be the rationale for the concrete barriers, to protect the station buildings from vehicle collisions. The station buildings are offset about 0.5 metres from the curb face of the transitway. The barriers are fix-objects and a potential hazard to vehicles on the transitway. There is no energy attenuation to lessen the impact of a collision with the barriers. The barriers also narrow the travel lane to 3.0 metres. Vehicles passing the barriers would need shy distance to comfortably avoid colliding with the barrier and this, coupled with the narrowness of the lane forces drivers to intrude into the adjacent lane in order to pass by the barrier.

Remove the concrete barriers with a blunt end. Install drivable delineators along the base of the building on a 200 mm white line to keep buses away the station and allow the bus to remain in the departure lane. Alternatively, remove the concrete barriers and install a low concrete curb against the base of the station. In either case remove the concrete barrier with the blunt end as it is a hazard.

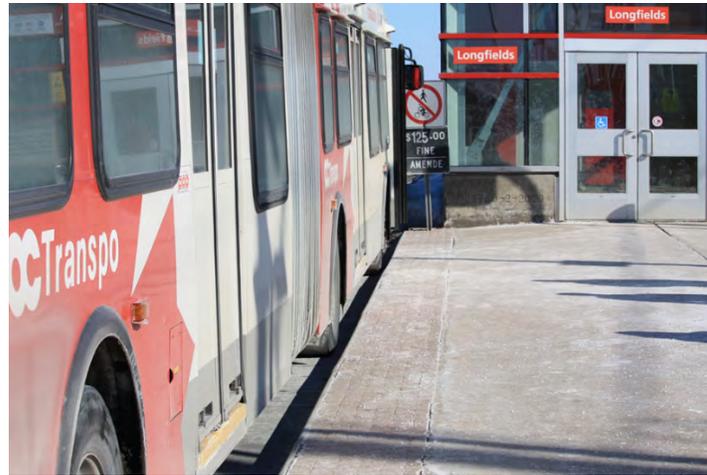
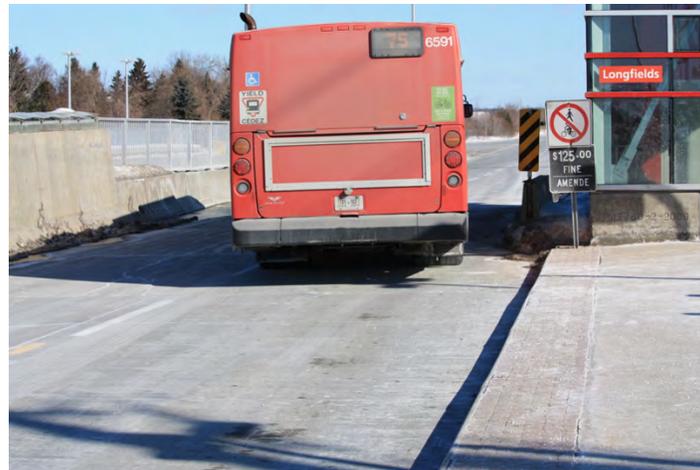
Transit vehicles leaving the station were observed to make abrupt turning maneuvers into the adjacent lane to avoid colliding with the concrete barrier. This presents several safety issues:

- Transit vehicles leaving the station in the right lane could potentially side swipe a transit vehicle travelling through the station in the left lane
- Transit vehicles leaving the station and immediately entering the left lane would potentially be travelling at a slower speed than an approaching transit vehicle travelling through the station in the left lane and this speed differential could contribute to a rear-end type collision
- The purpose of the right lane leaving the station is to allow transit vehicles to accelerate from a stopped position to the posted speed of the transitway and then merge safely into any traffic in the left lane.

Remove the concrete barriers with a blunt end. Install drivable delineators along the base of the building. On a 200 mm white line to keep buses away from the station and allow the bus to remain in the departure lane. Alternatively install a low concrete curb against the base of the station.

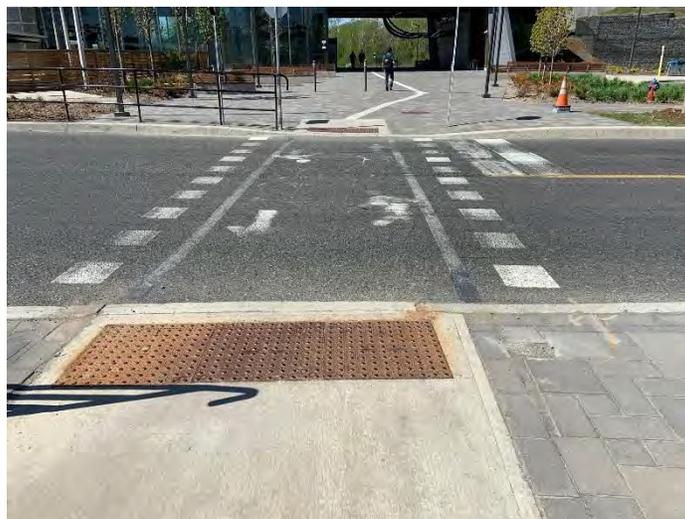
The crossing features stop signs and Ontario Traffic Manual (OTM) Book 18 mixed crossride markings. This tells users that the crossing is intended to be shared by pedestrians and cyclists, and that cyclists are not required to dismount.

Markings from a previous configuration were black-masked, contrary to City of Ottawa standard practices. The black paint has since worn off, causing the older crosswalk markings to show through. The most recent markings have also worn/faded, making them similar in appearance to the old markings. This has rendered the resulting visible markings non-standard, which could contribute to user confusion.

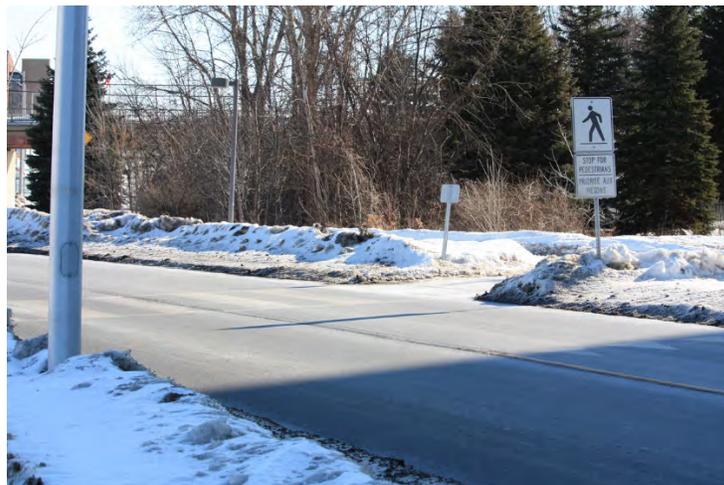
The crosswalk pavement markings and stop bars are barely visible. The poor condition of the pavement markings detracts from conspicuity of the crosswalk and could contribute to poor compliance of motorists to stop at the crosswalk.

Refresh the crosswalk pavement markings. Consider Thermoplastic as this appears to be a high use area.

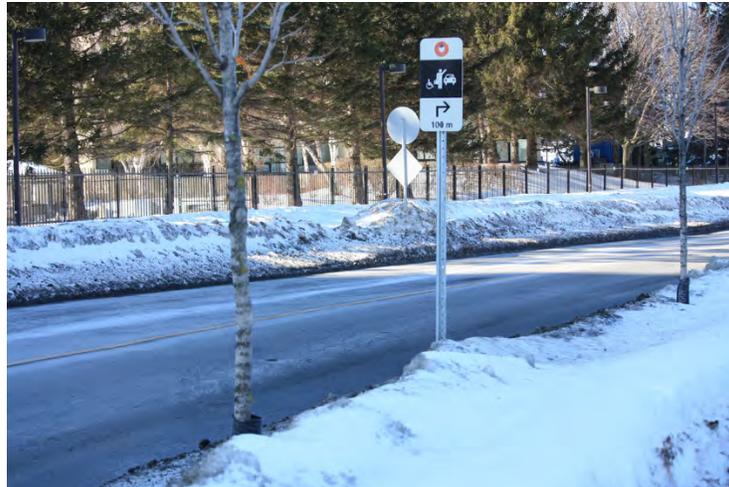
The information or guide sign to direct motorists to the passenger pick-up and drop-off area does not comply with the colour scheme, symbol usage, letter font and letter size for guide signs in Ontario. Consequently, this sign may not be immediately recognized by motorists as an information sign for the attention of motorists and a cause of confusion or missed information.

This is a guide sign and should comply with the Manual of Uniform Traffic Control Devices for Canada in terms of size, colour and shape for guide signs.

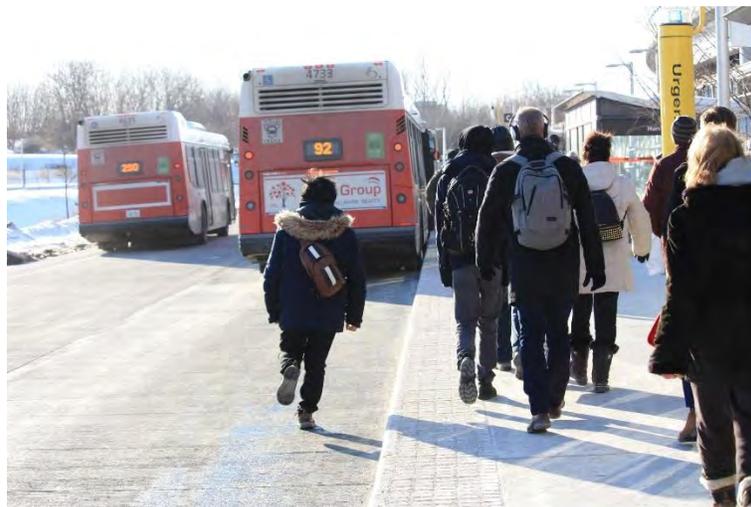
During the afternoon peak hour, the passenger platform to access bus routes leaving the station is very crowded. Some transit patrons were observed walking in the bus travel lanes to avoid the crowded platform. The walking path of these pedestrians conflicts with the path of transit vehicles and could result in potential collisions between pedestrians and transit vehicles.

Install a pedestrian railing 1000mm high and signs indicating do not walk on roadway.

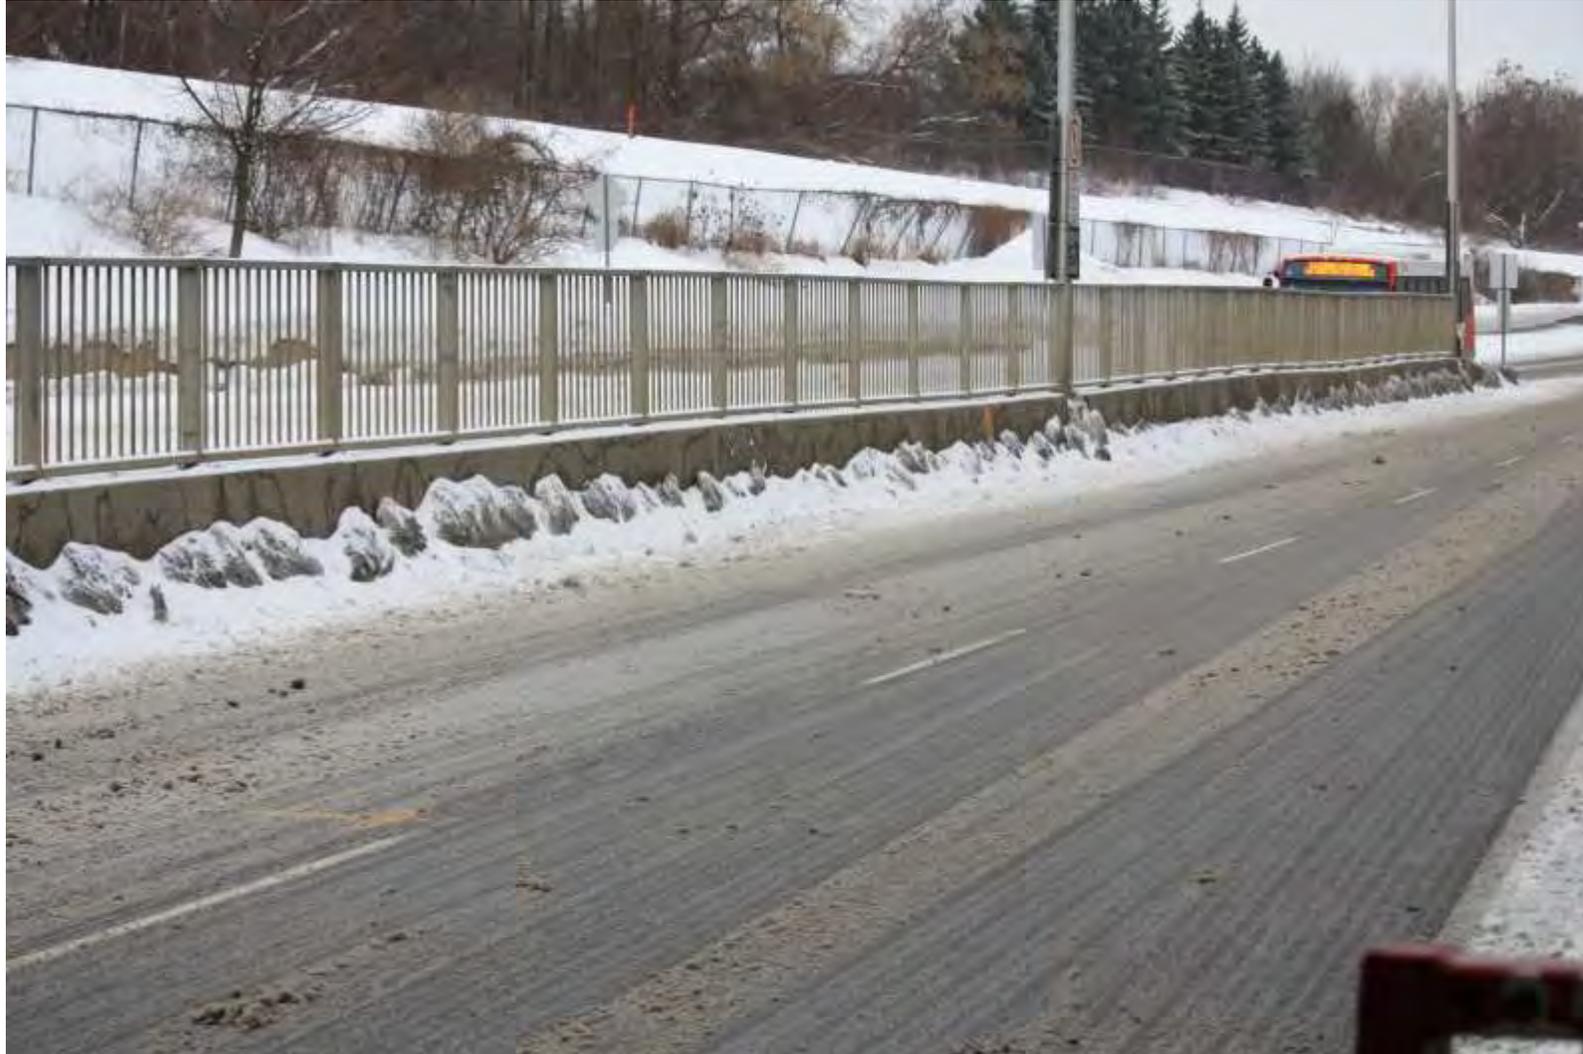
NO ENERGY ATTENUATION AT MEDIAN BARRIER

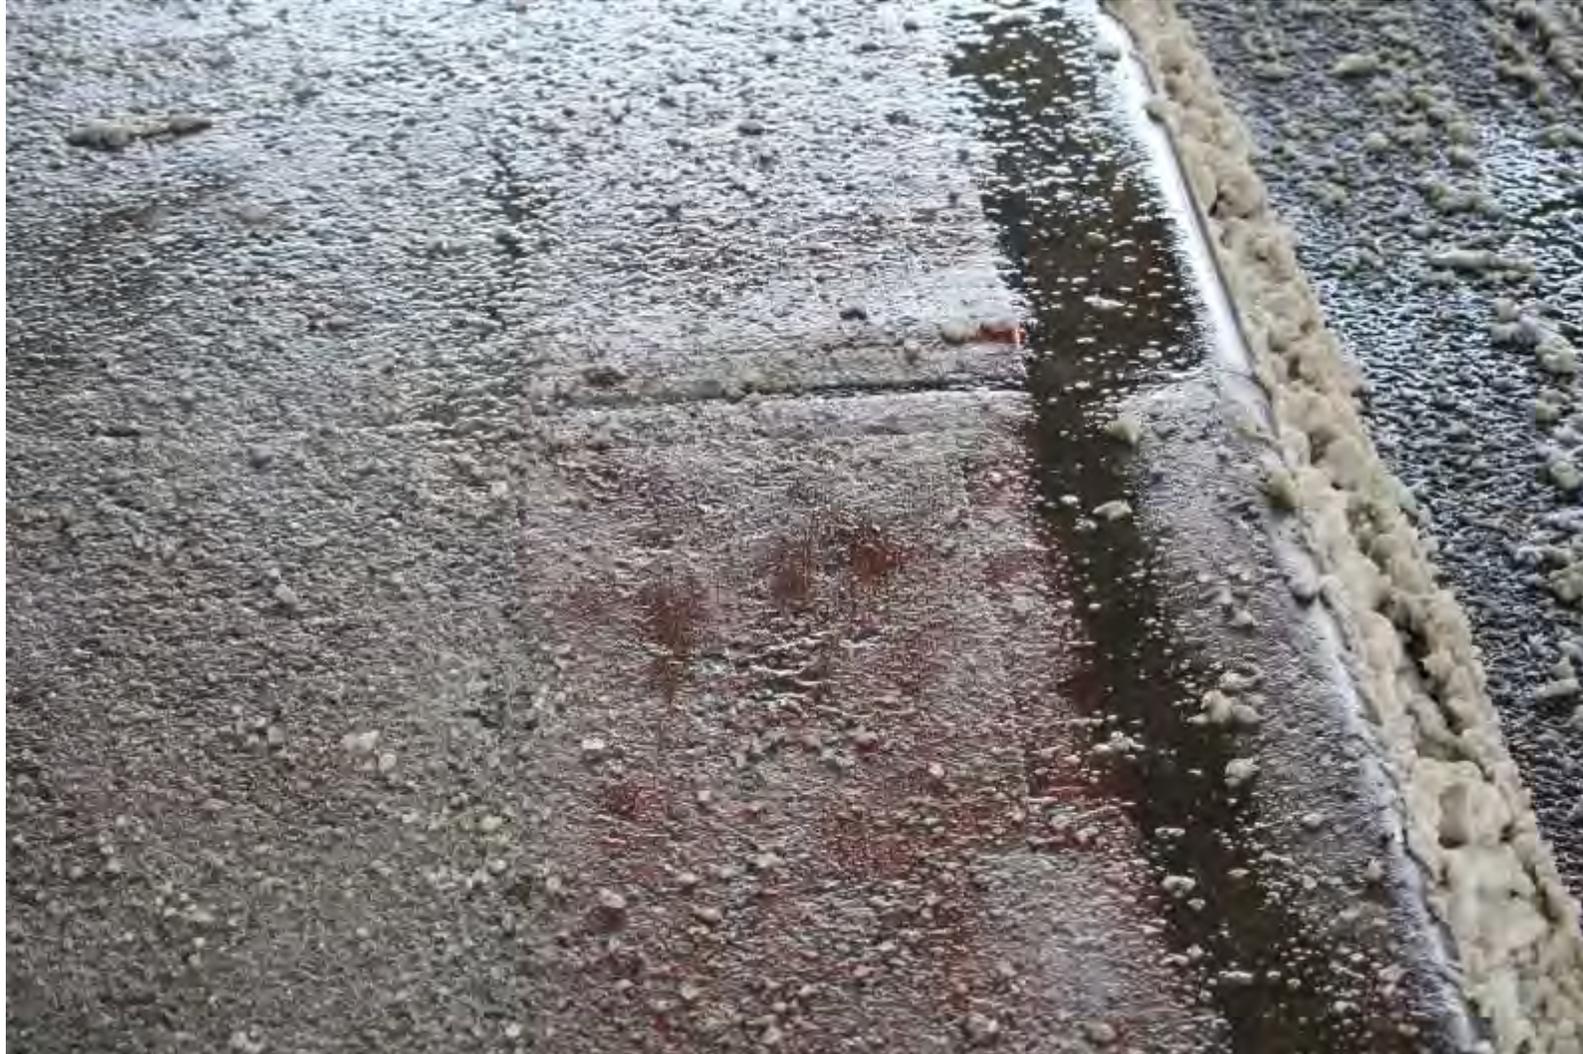
SERVICE VEHICLE CURB LETDOWN LOCATION

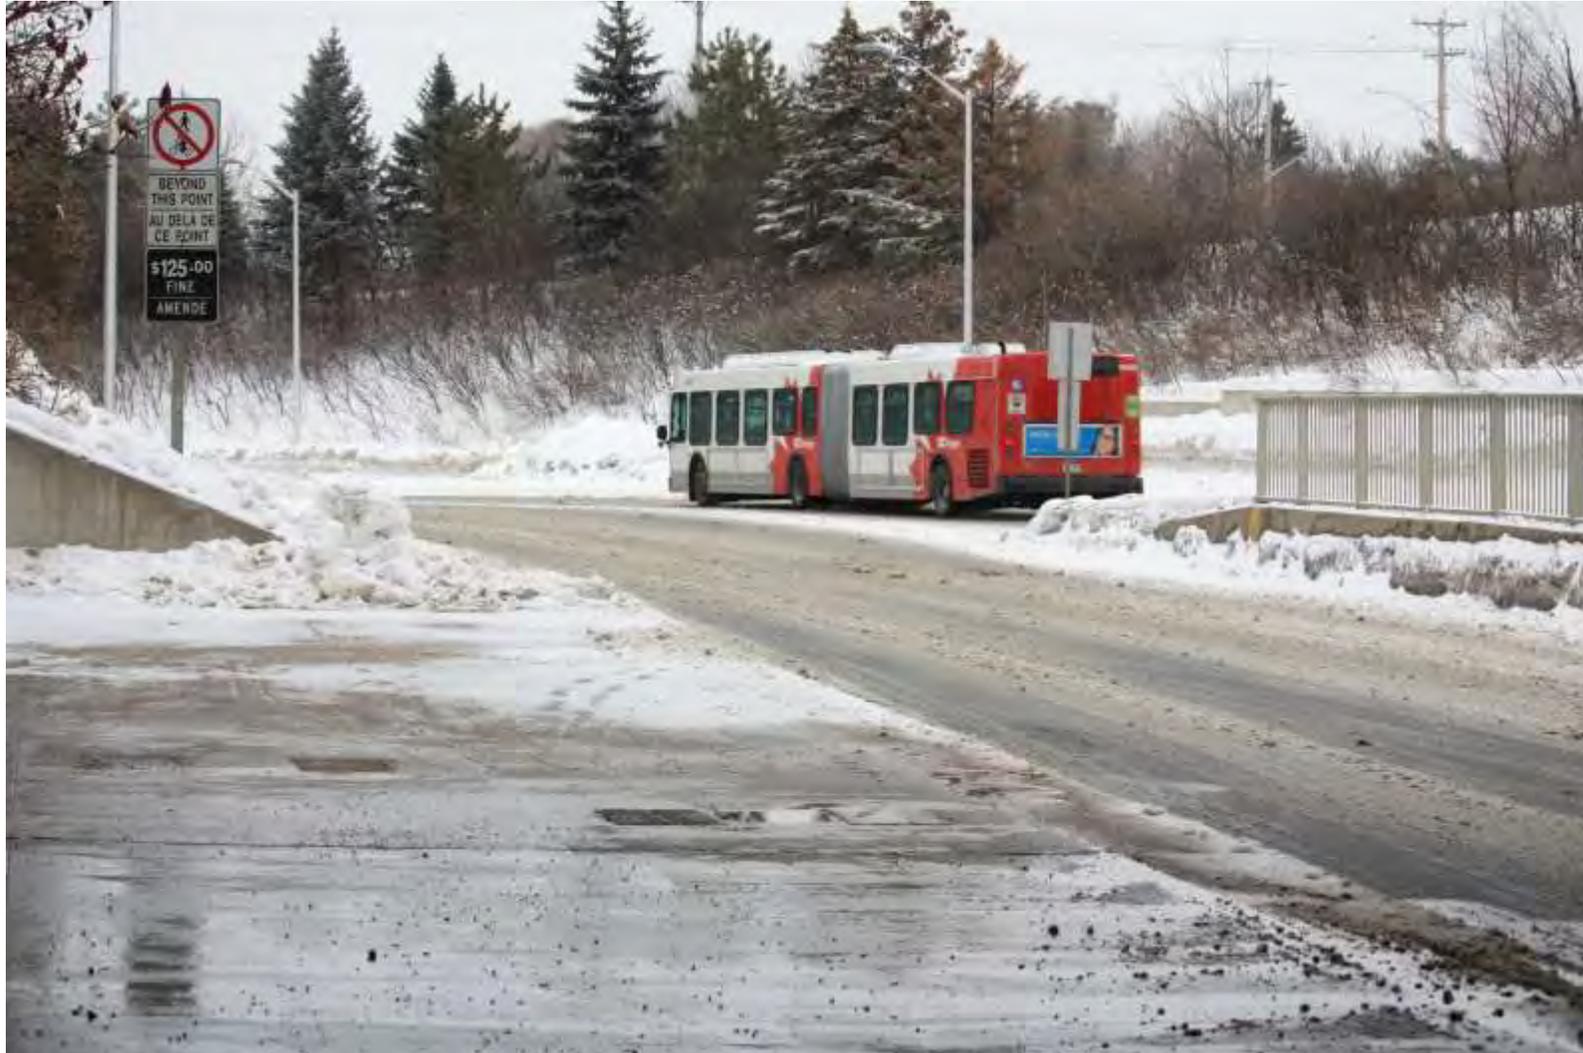
NO PROTECTION FOR TRANSIT PATRONS ON PLATFORM

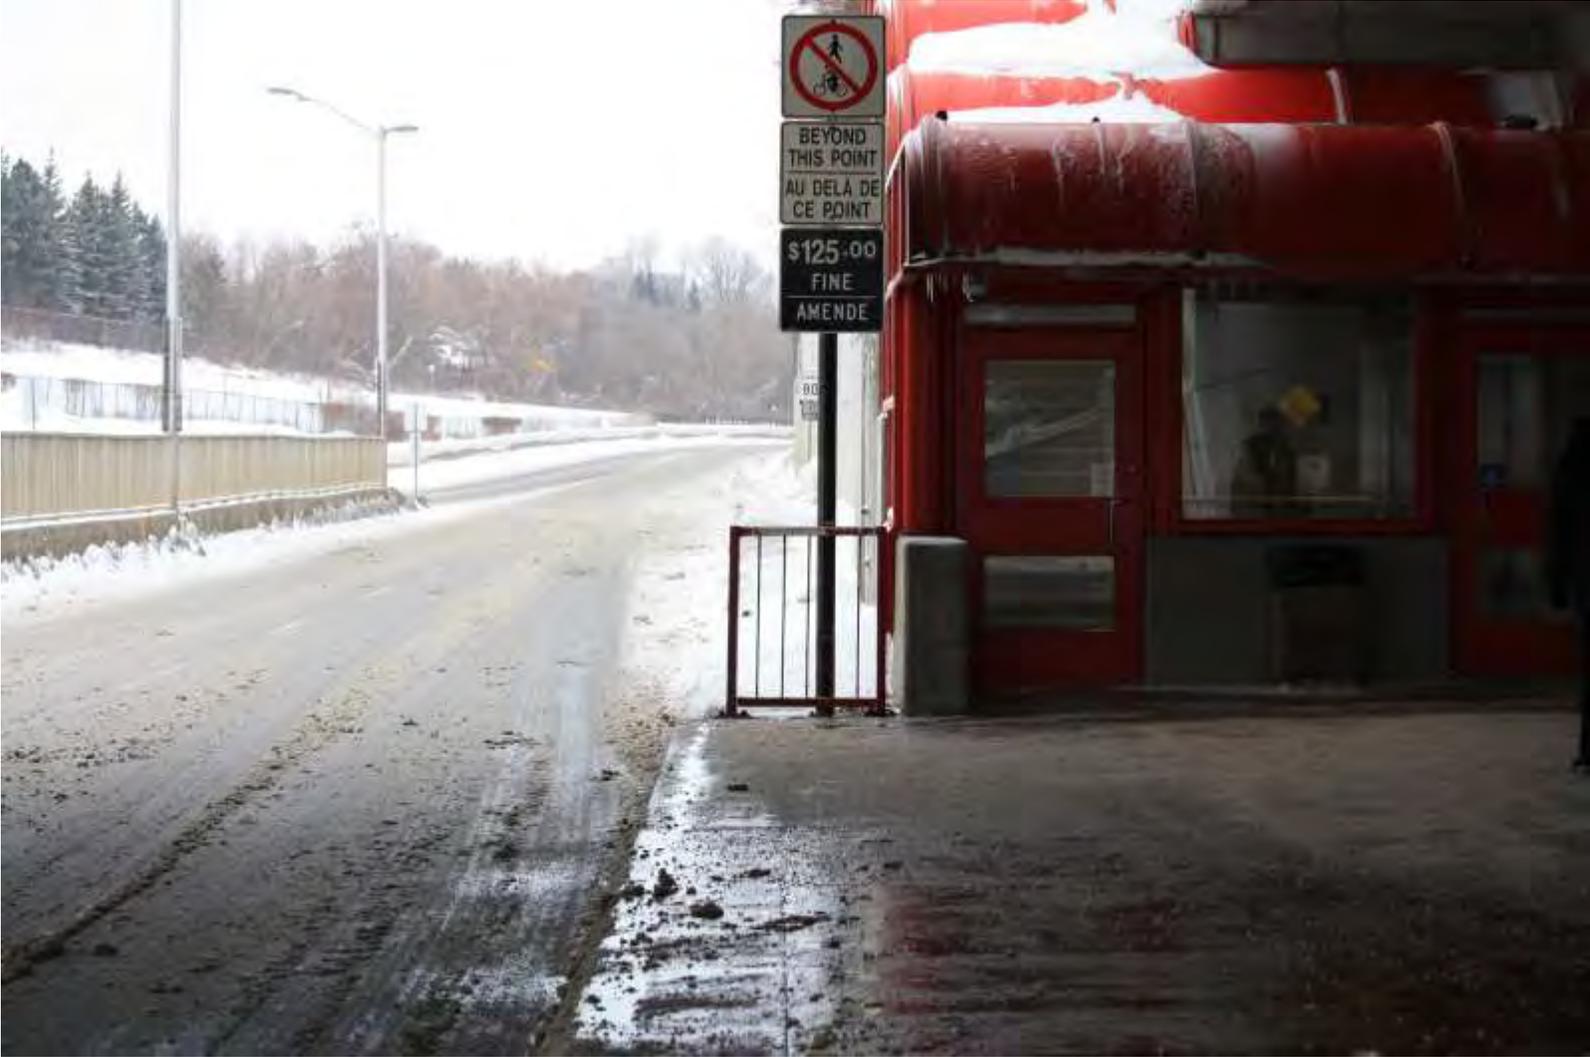
CONCRETE ABUTMENT BLUNT END IN CLEAR ZONE

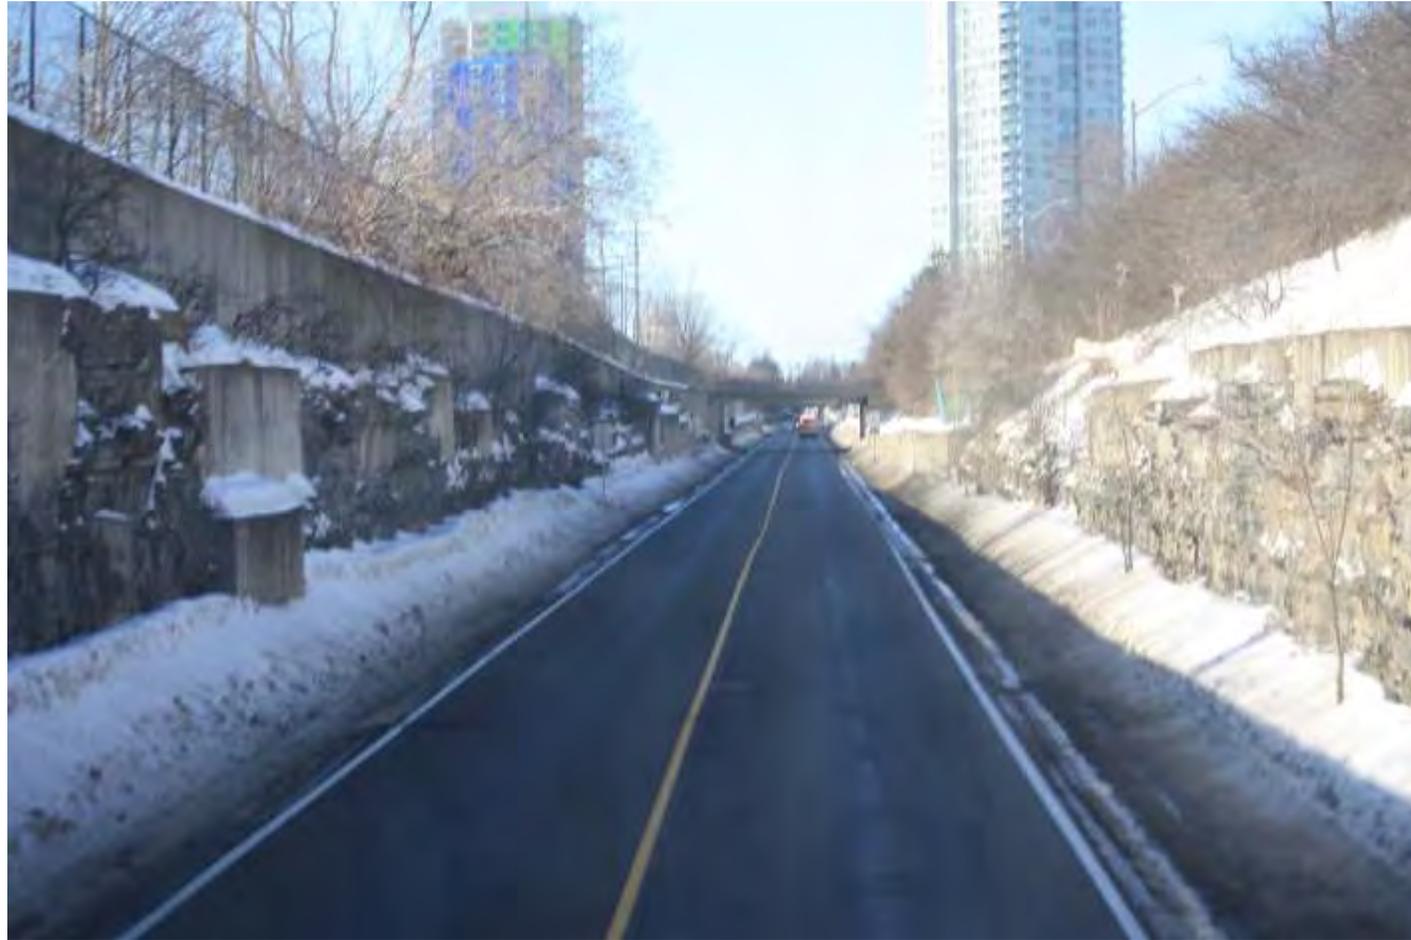
ROCK CUTS AND WALL SURFACE PROTRUSIONS

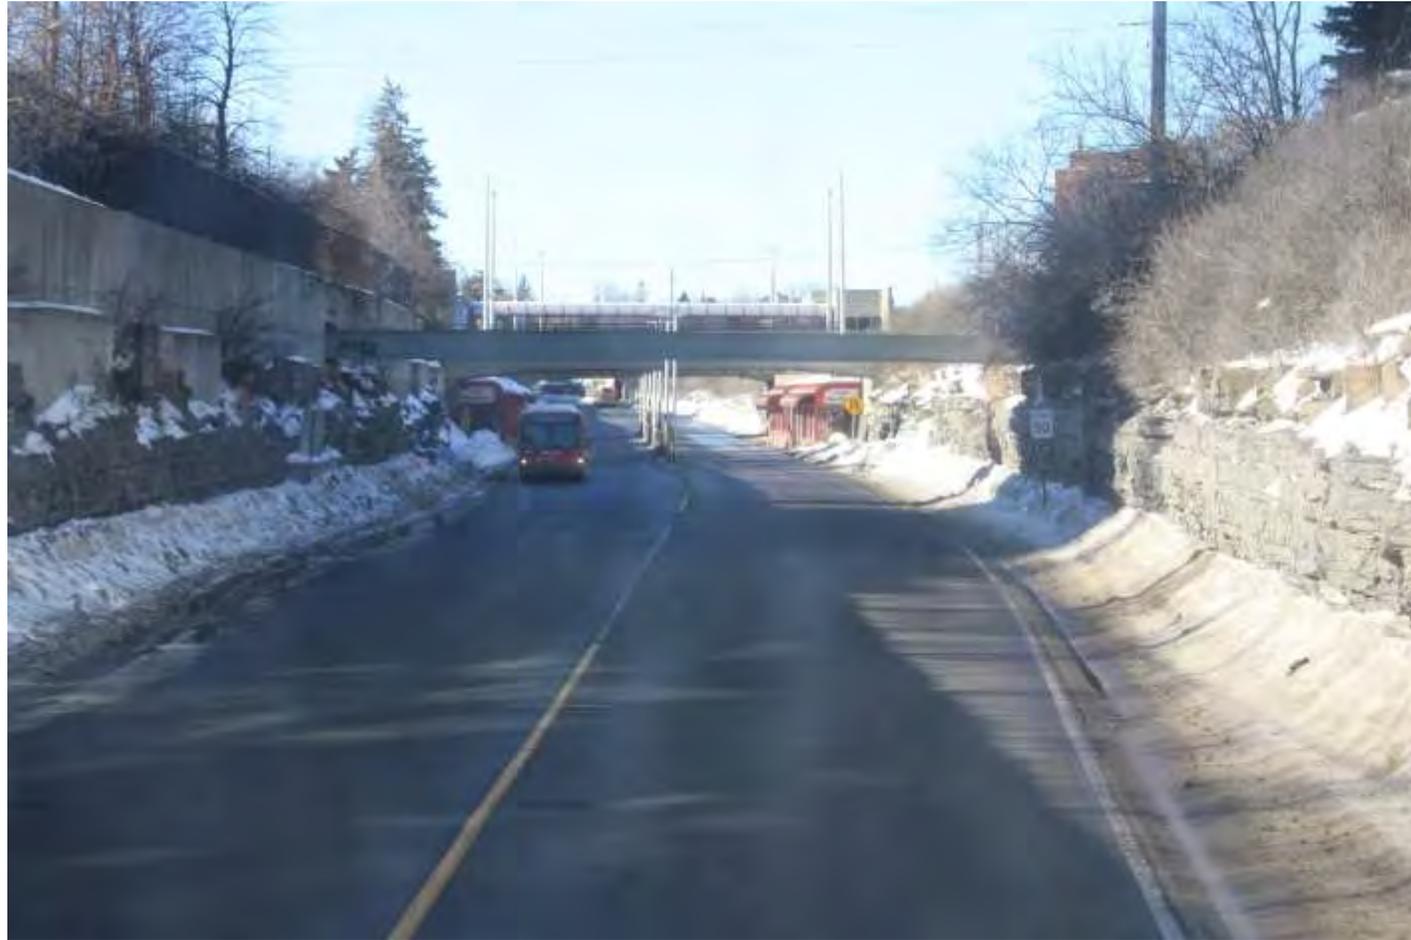
LIGHT AND SHADOWS DUE TO SUN ANGLE

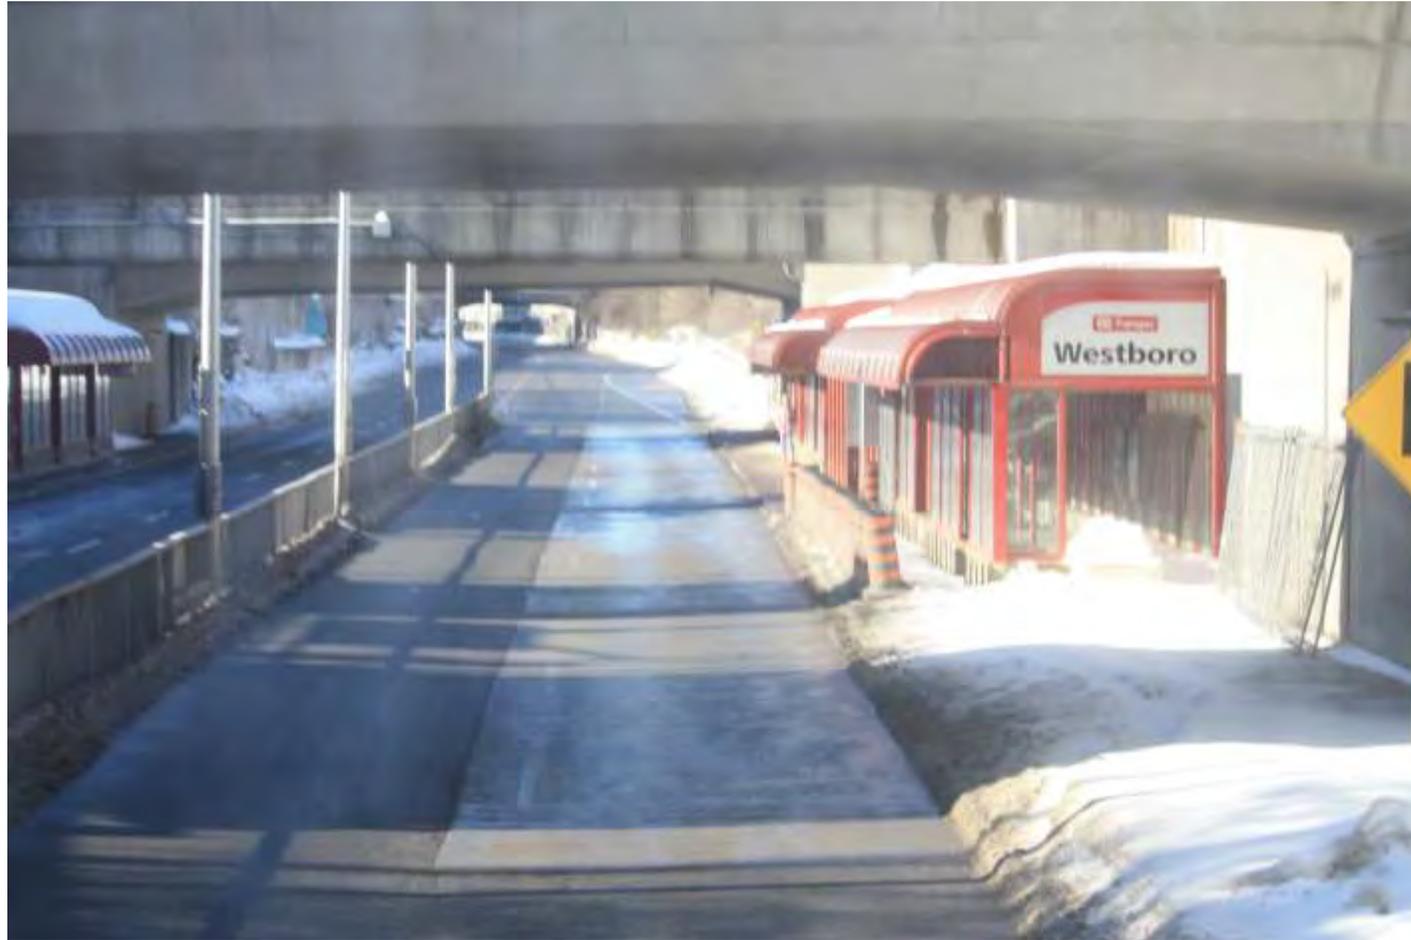
WATER AND ICE ON TRANSITWAY CAUSING GLARE
