OC Transpo Transitway Station Design Safety Study

Independent Safety Study

Final Safety Study

September 2021

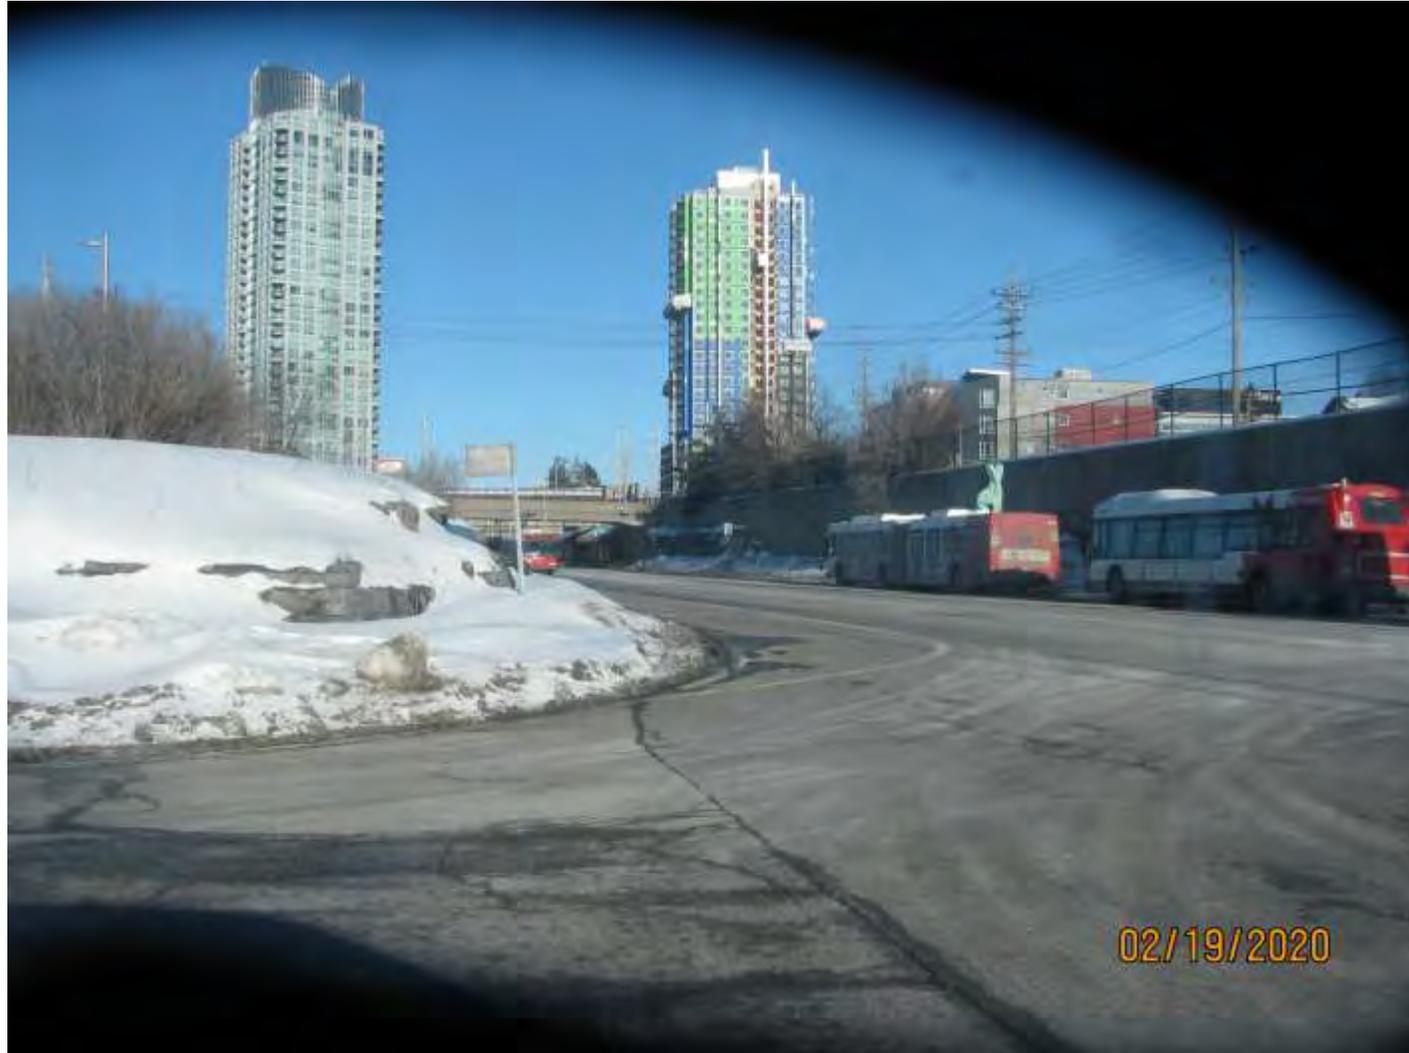
INTERSECTION SIGHT DISTANCE

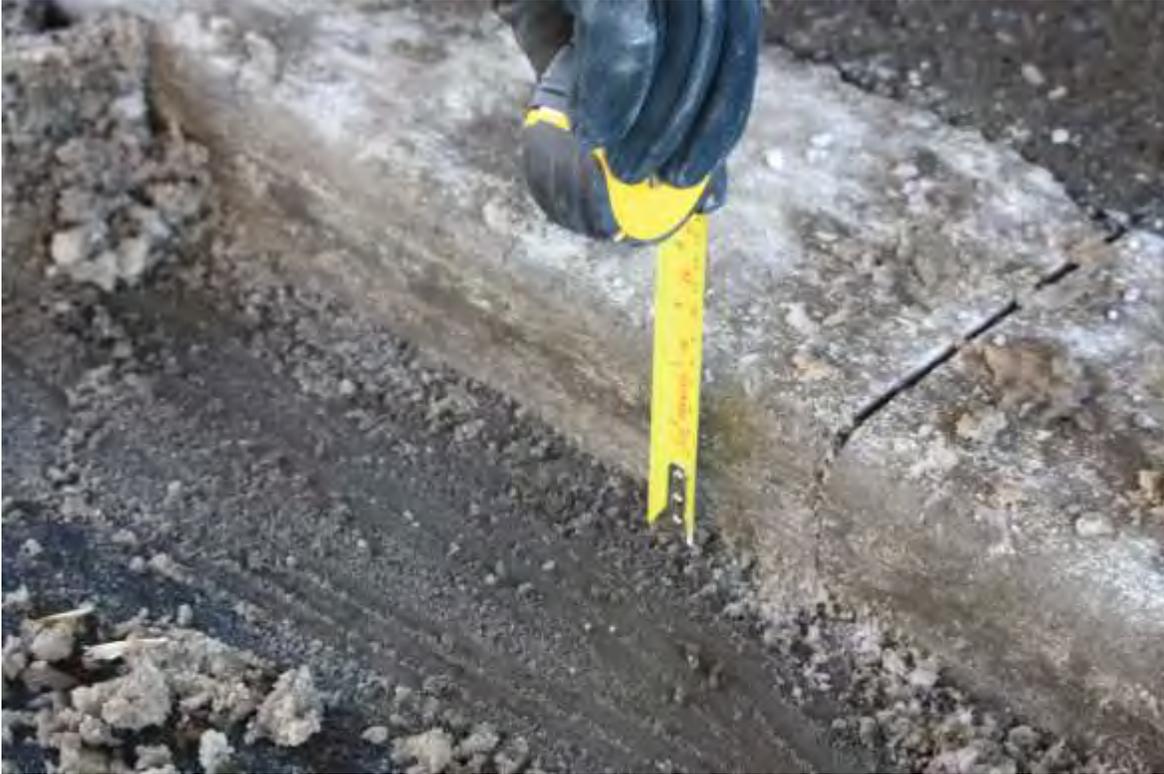
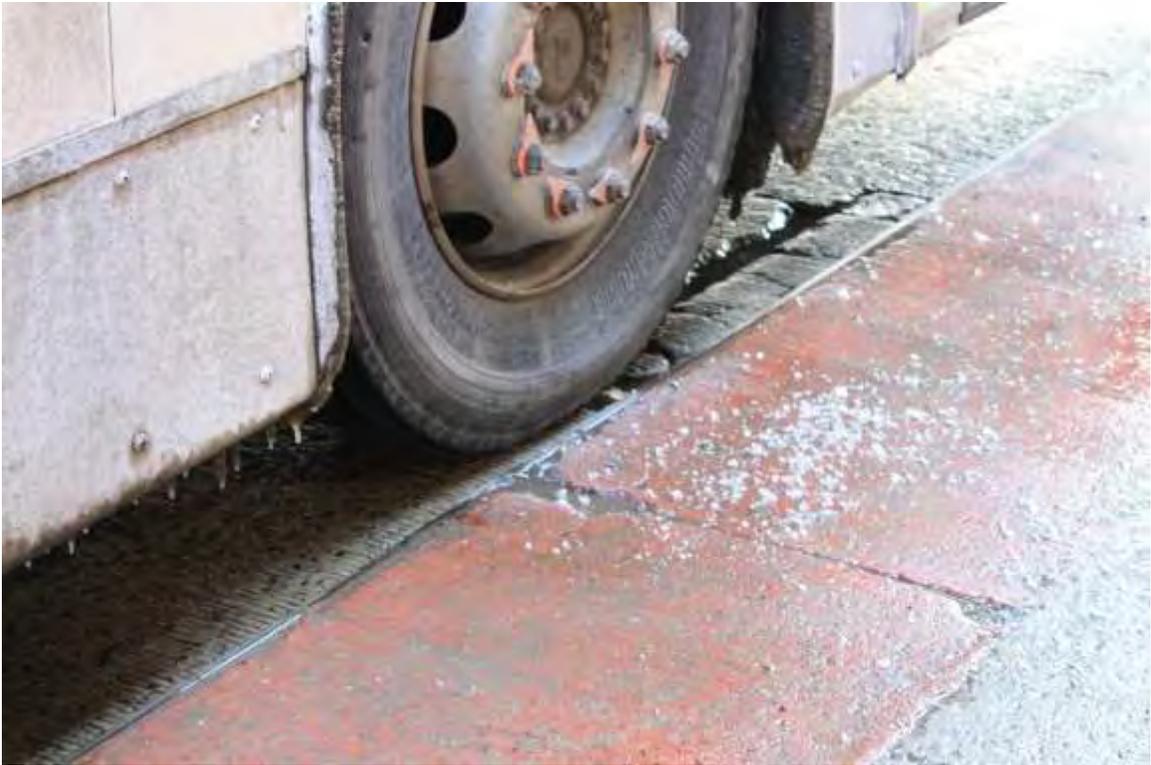
CURB HEIGHT AT STATION

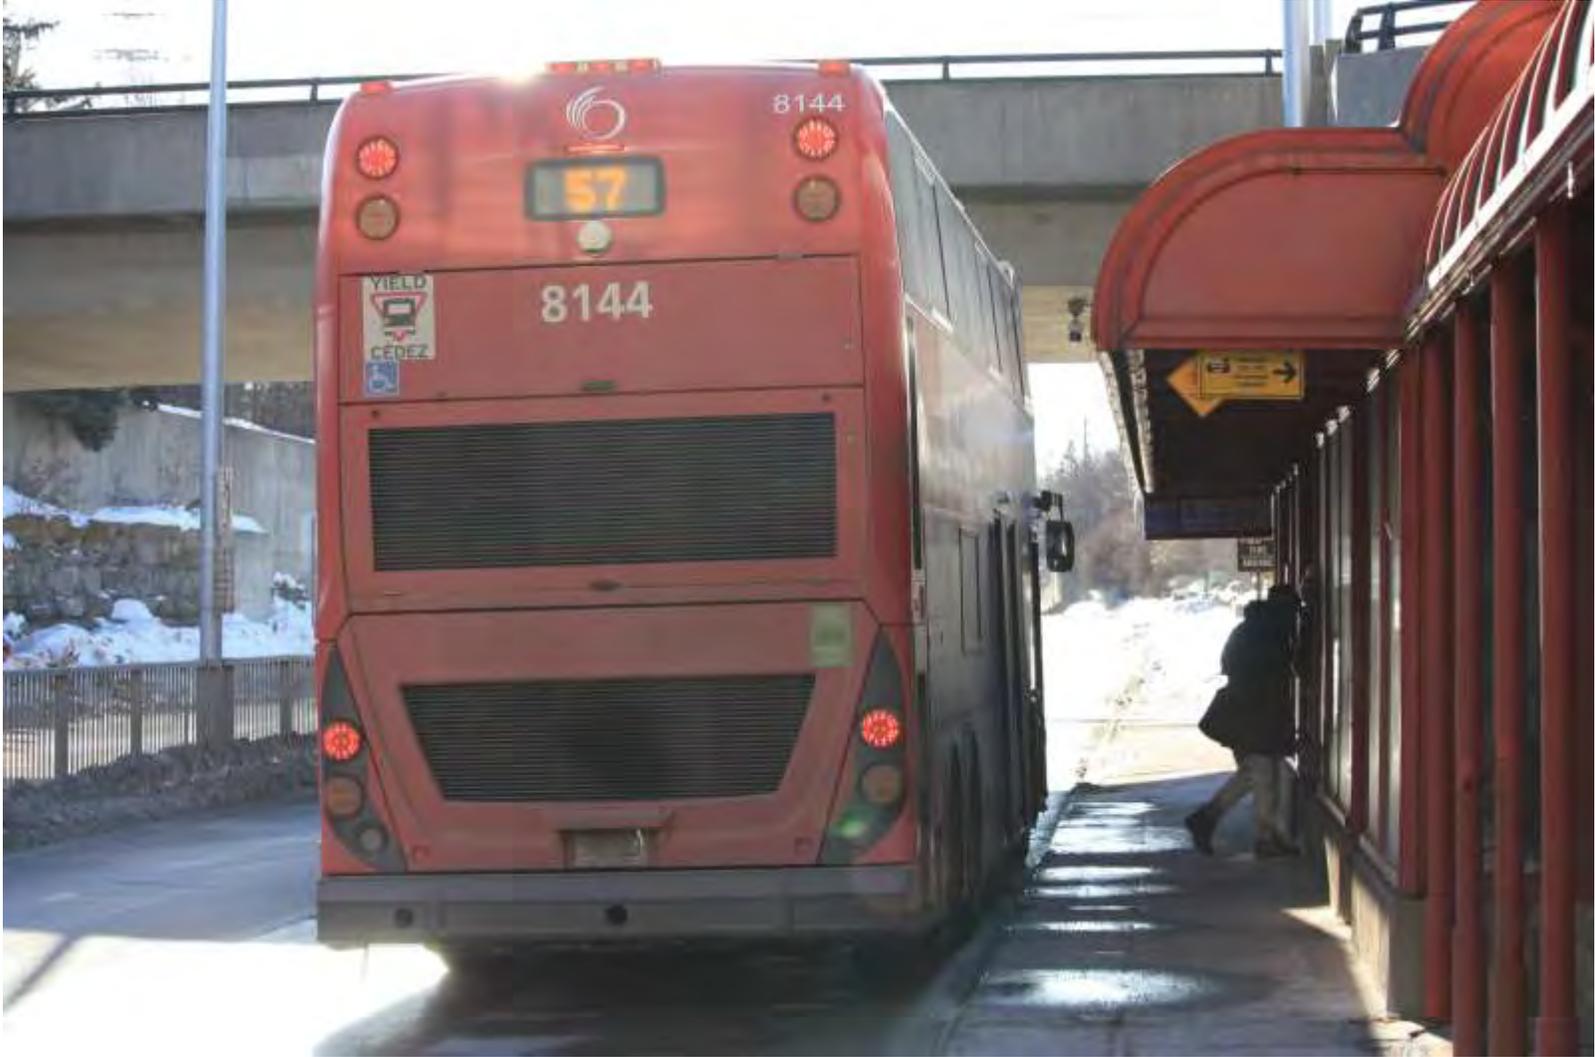
OVERHEAD CANOPY LOCATED WITHIN CLEAR ZONE

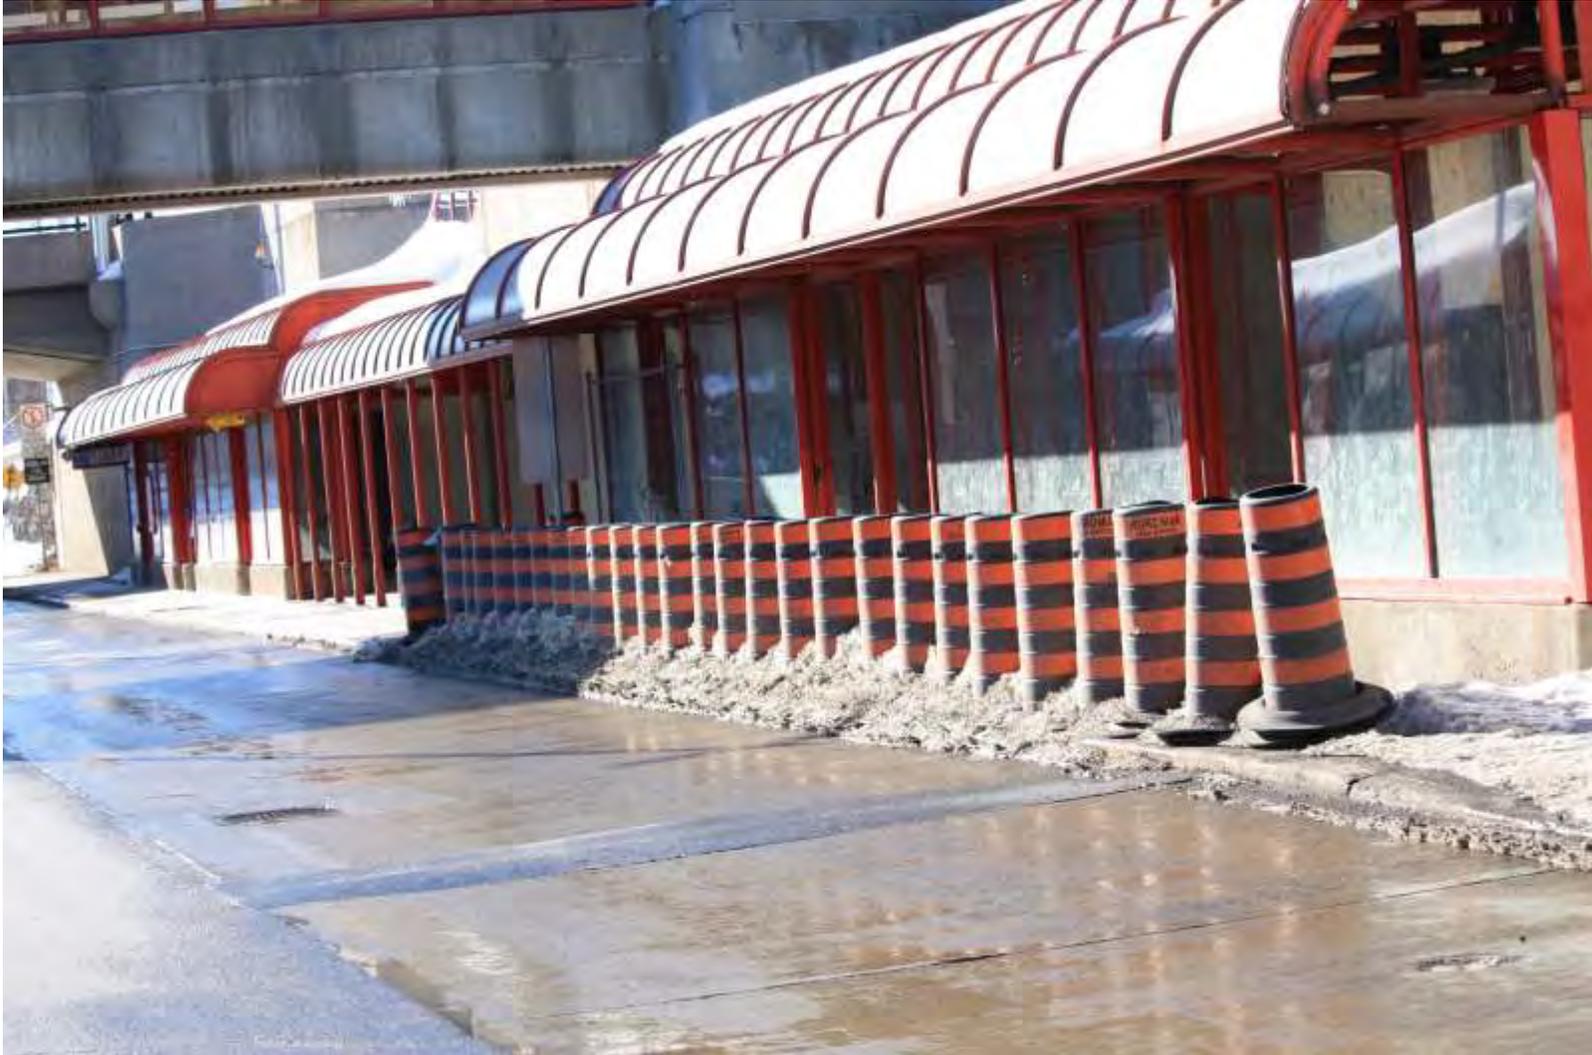
CURVED SHAPE OF CANOPY

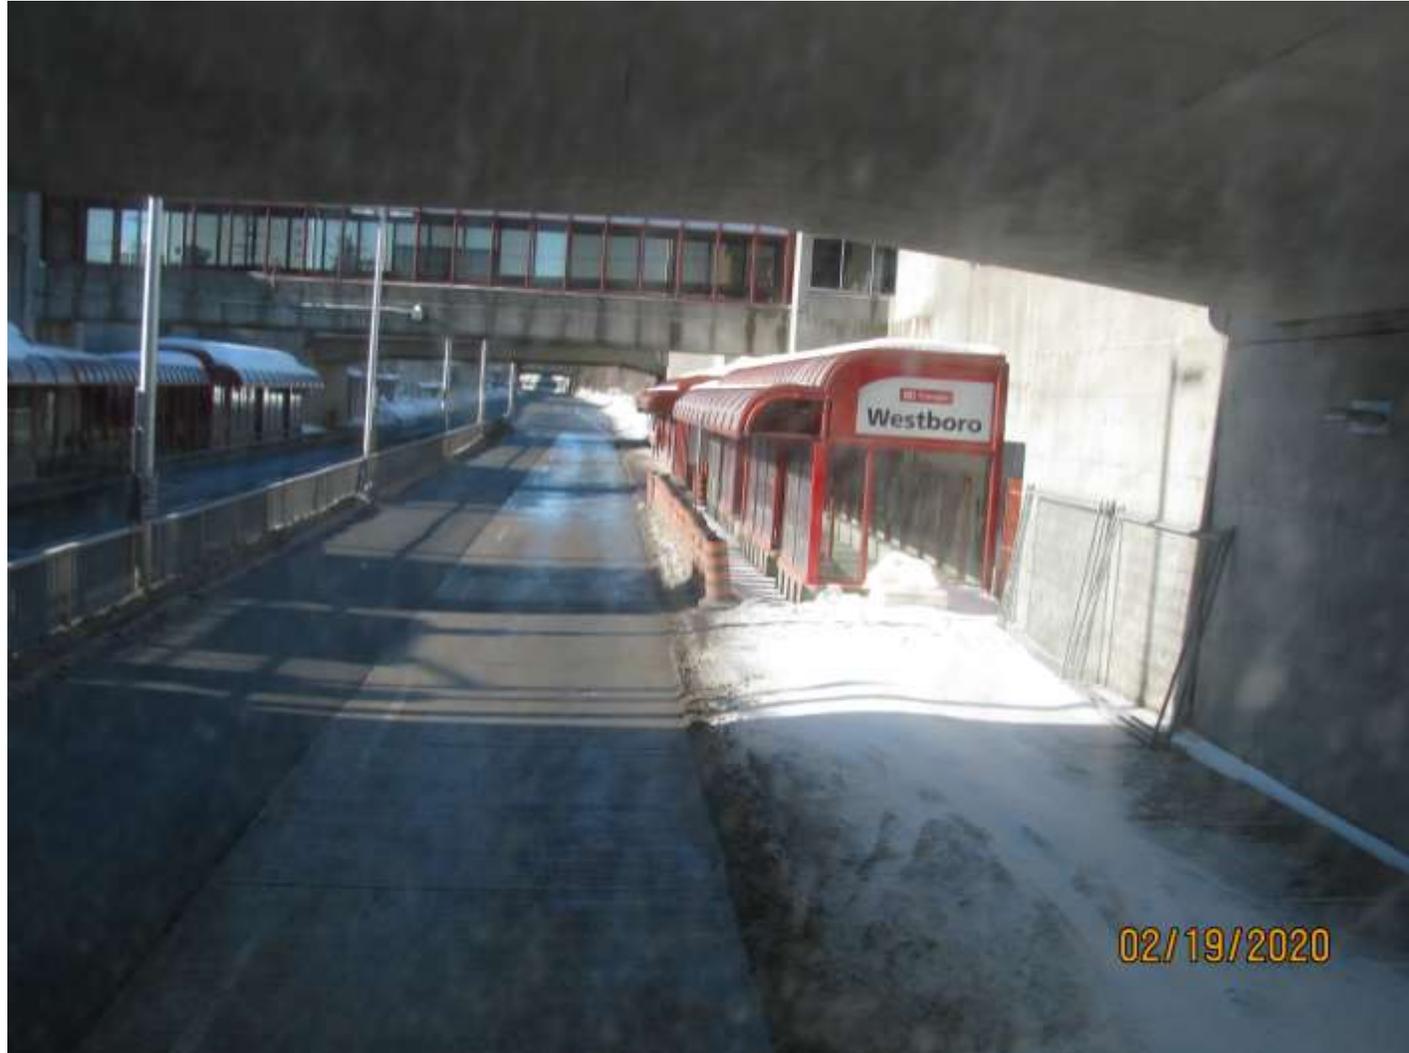
PEDESTRIAN BRIDGE CREATING SHADOW ON TRANSITWAY

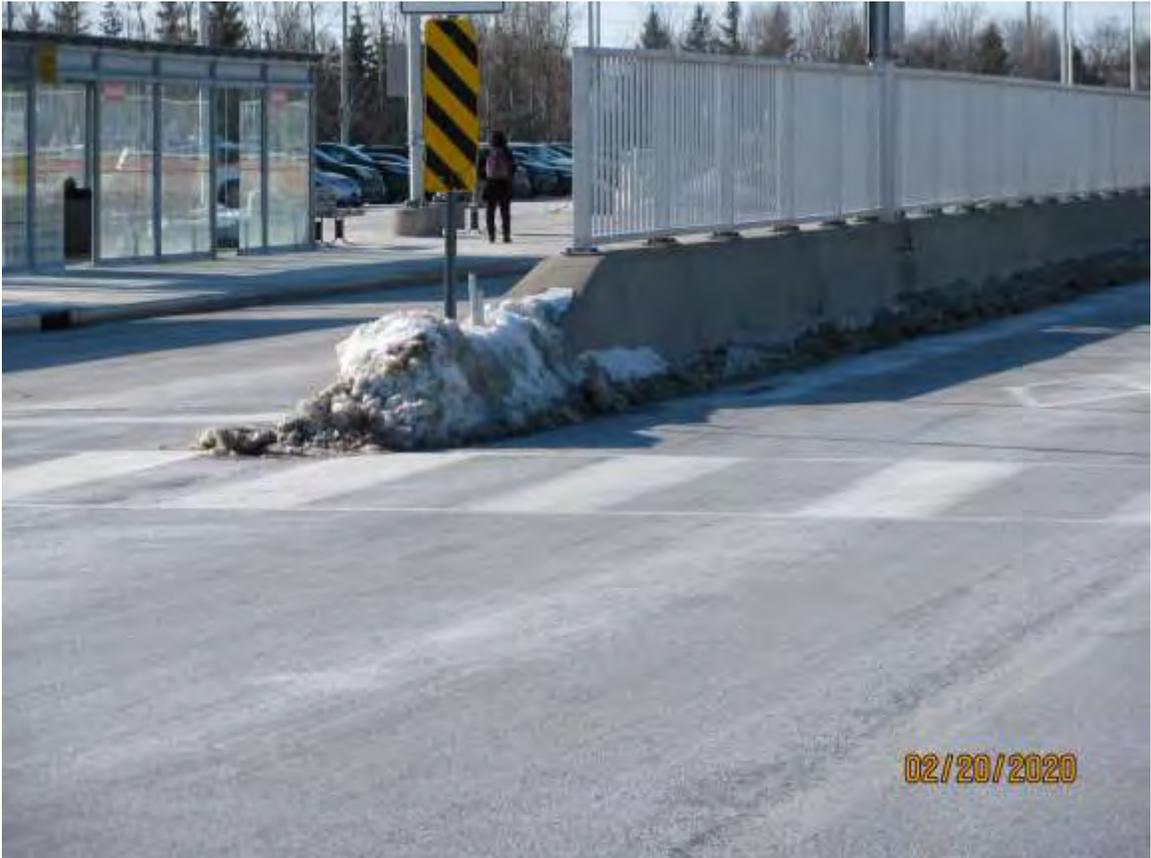
NO ENERGY ATTENUATION AT MEDIAN BARRIER

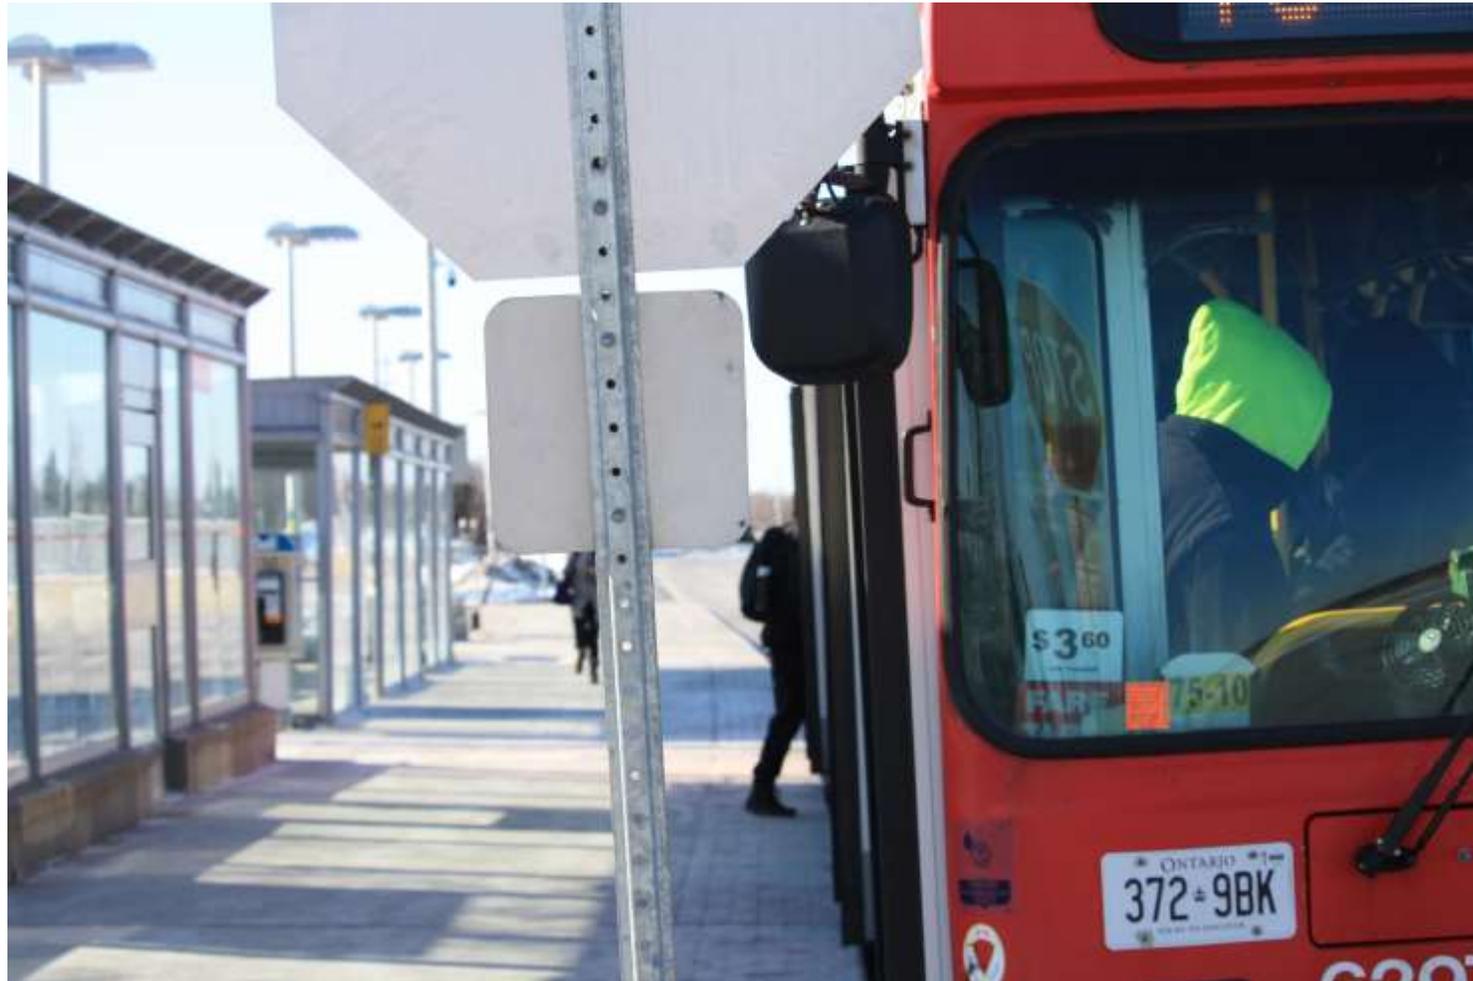
STOP SIGN INTRUSION ONTO TRANSITWAY LANE

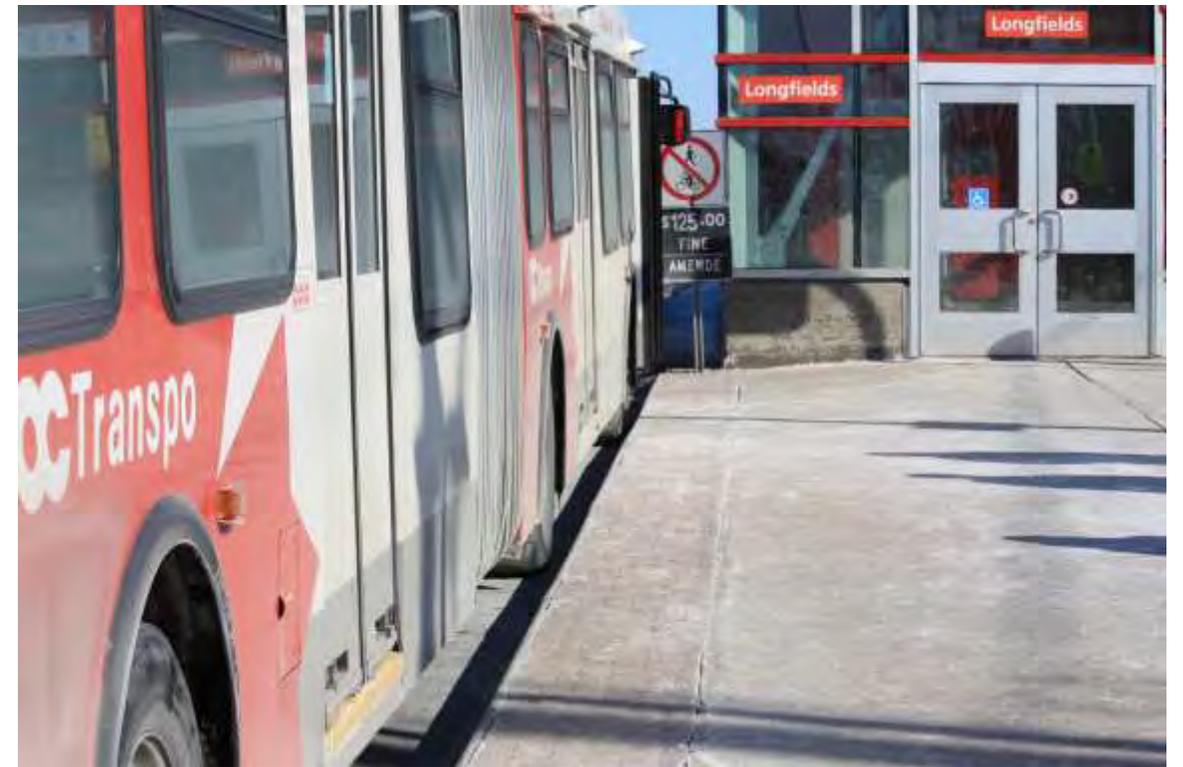
ABRUPT BUS MANEUVER DUE TO BARRIER

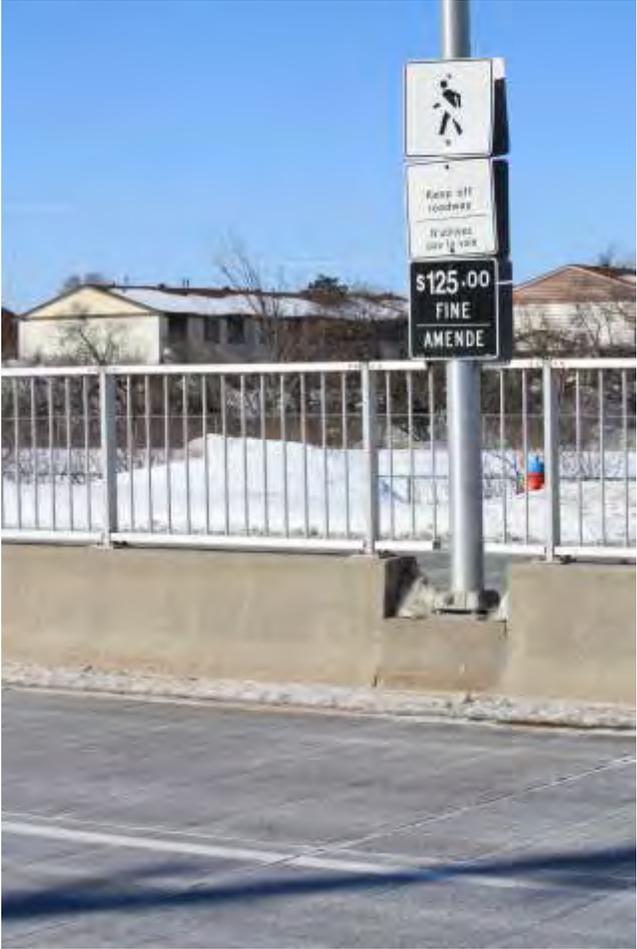
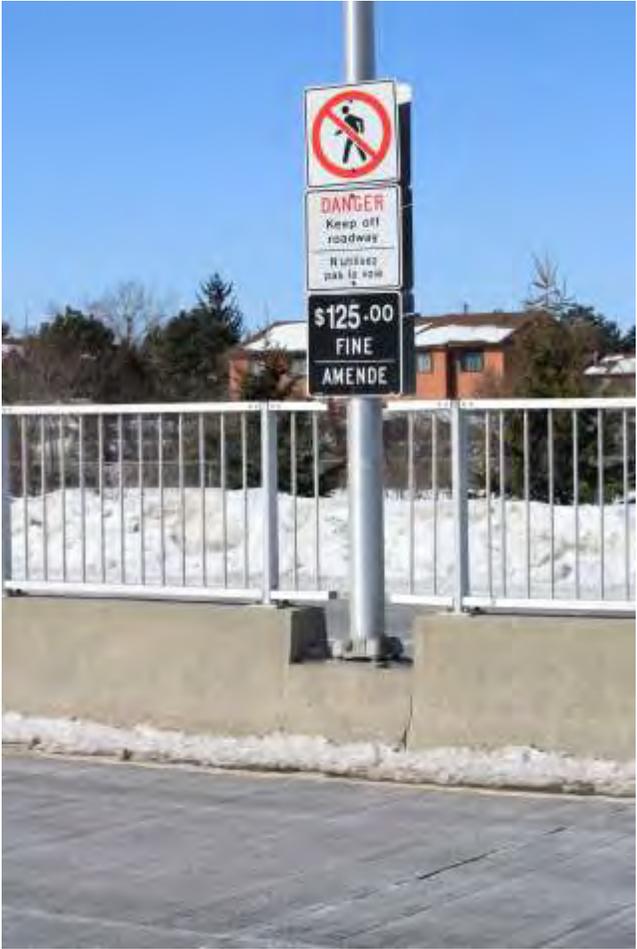
FADED SIGNS

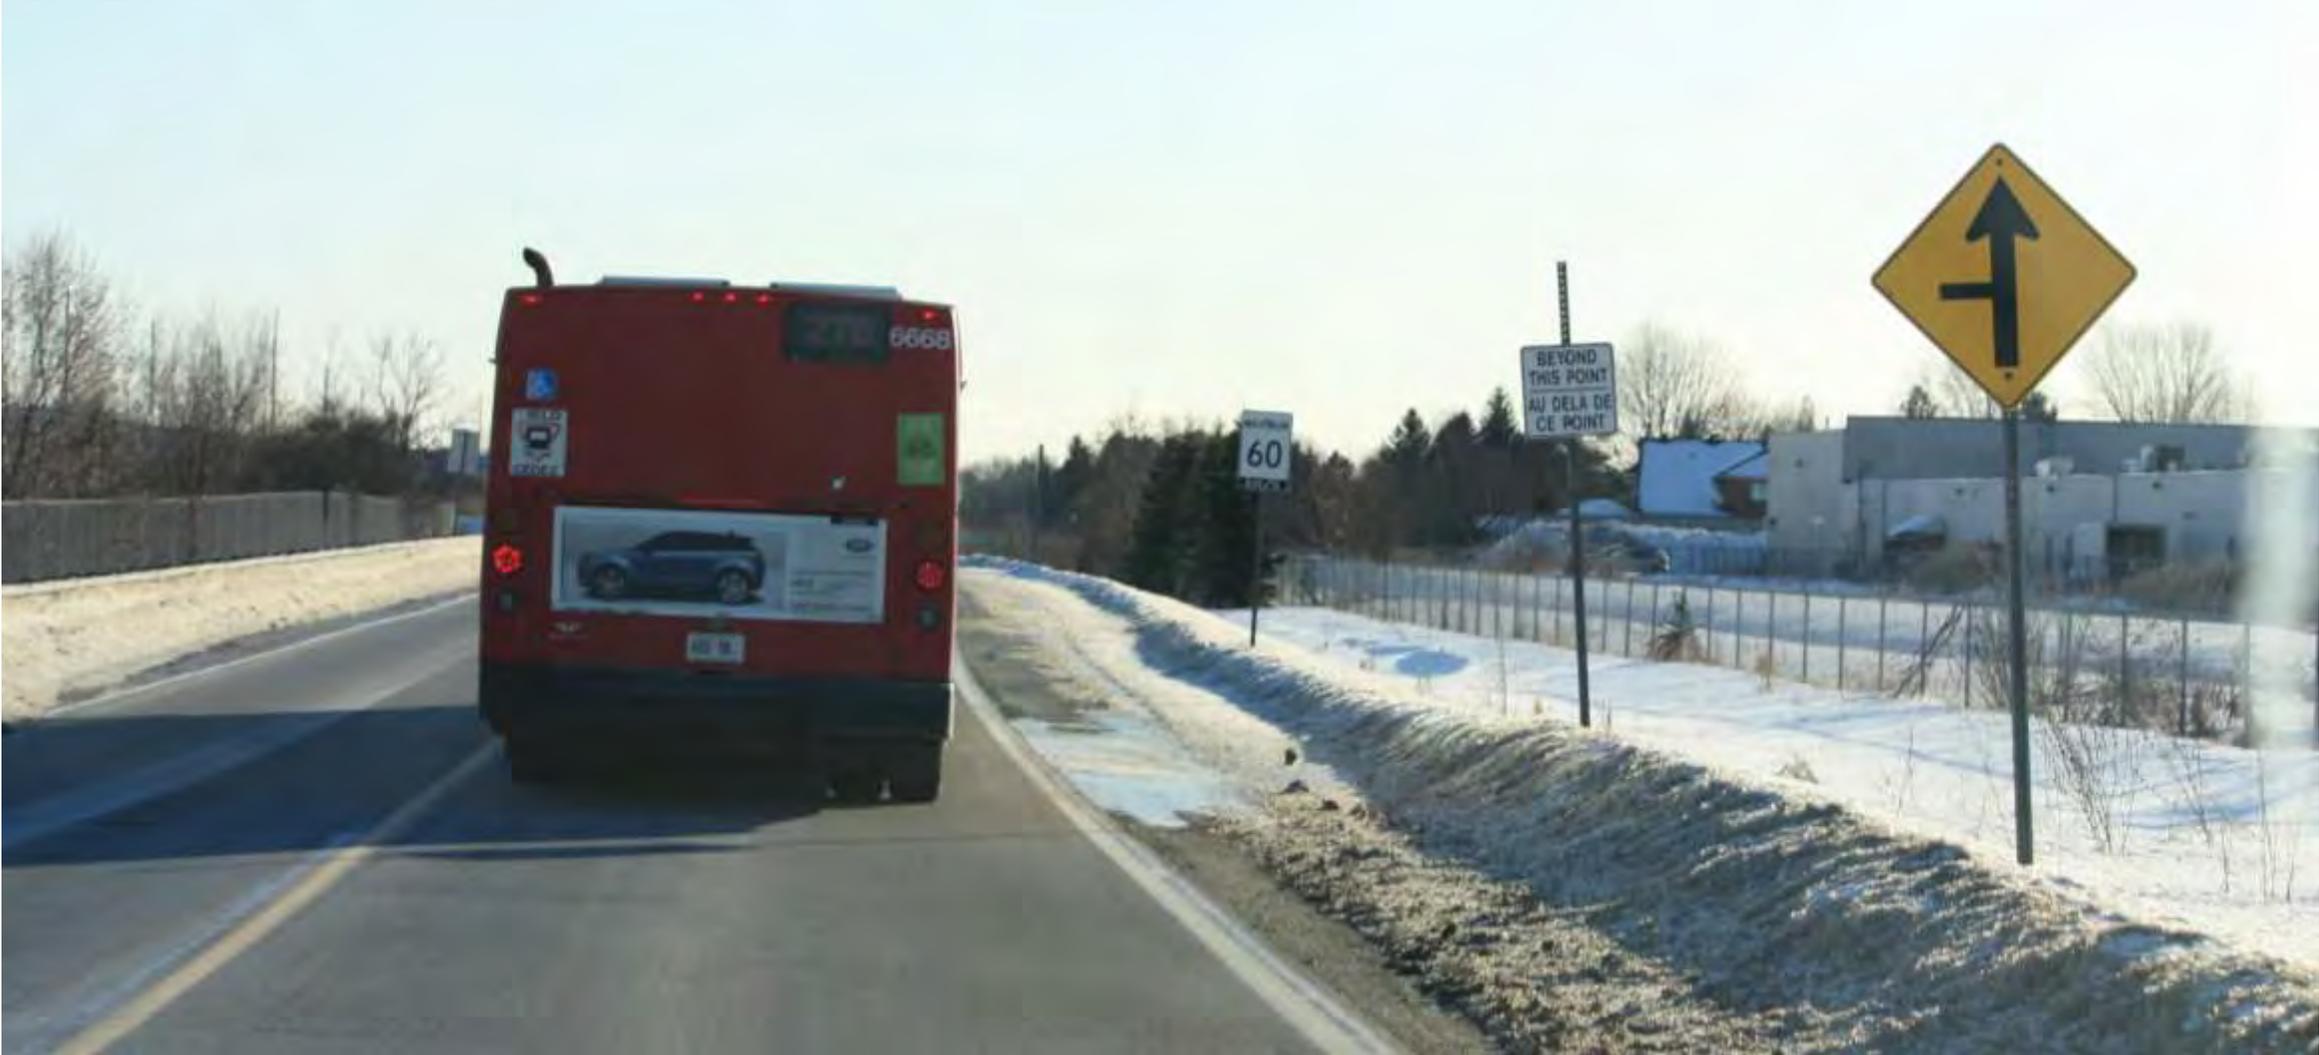
MISSING NO ENTRY SIGN

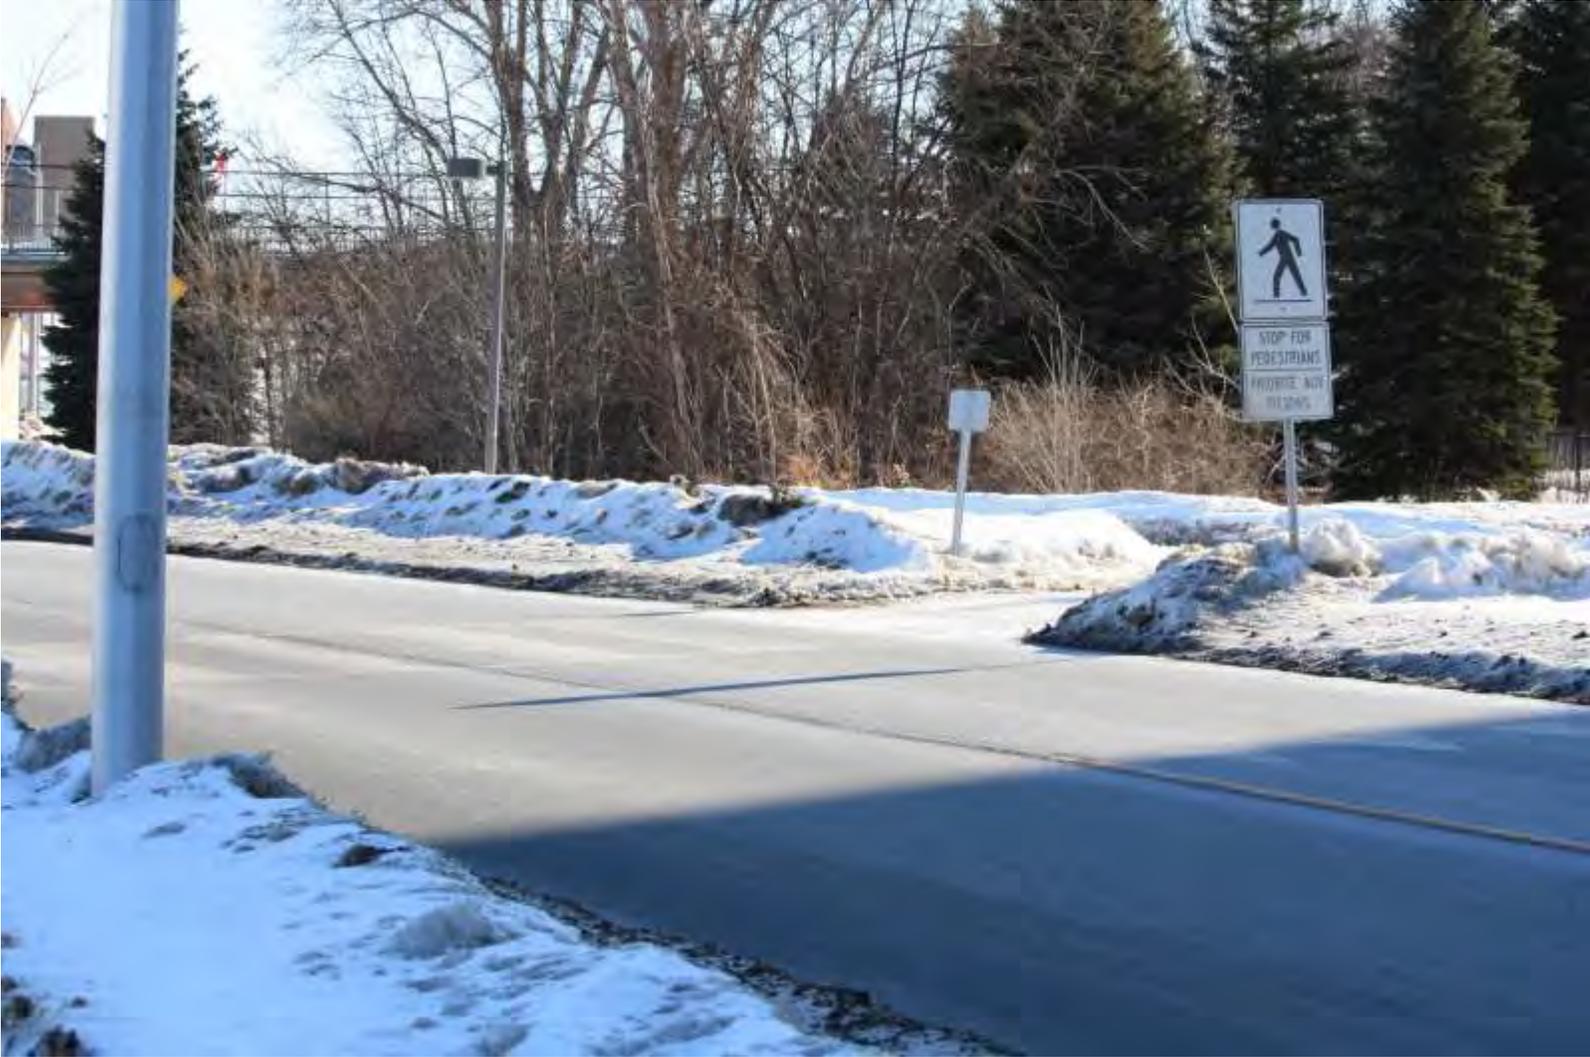
COURTESY CROSSWALK – FADED ROAD MARKINGS

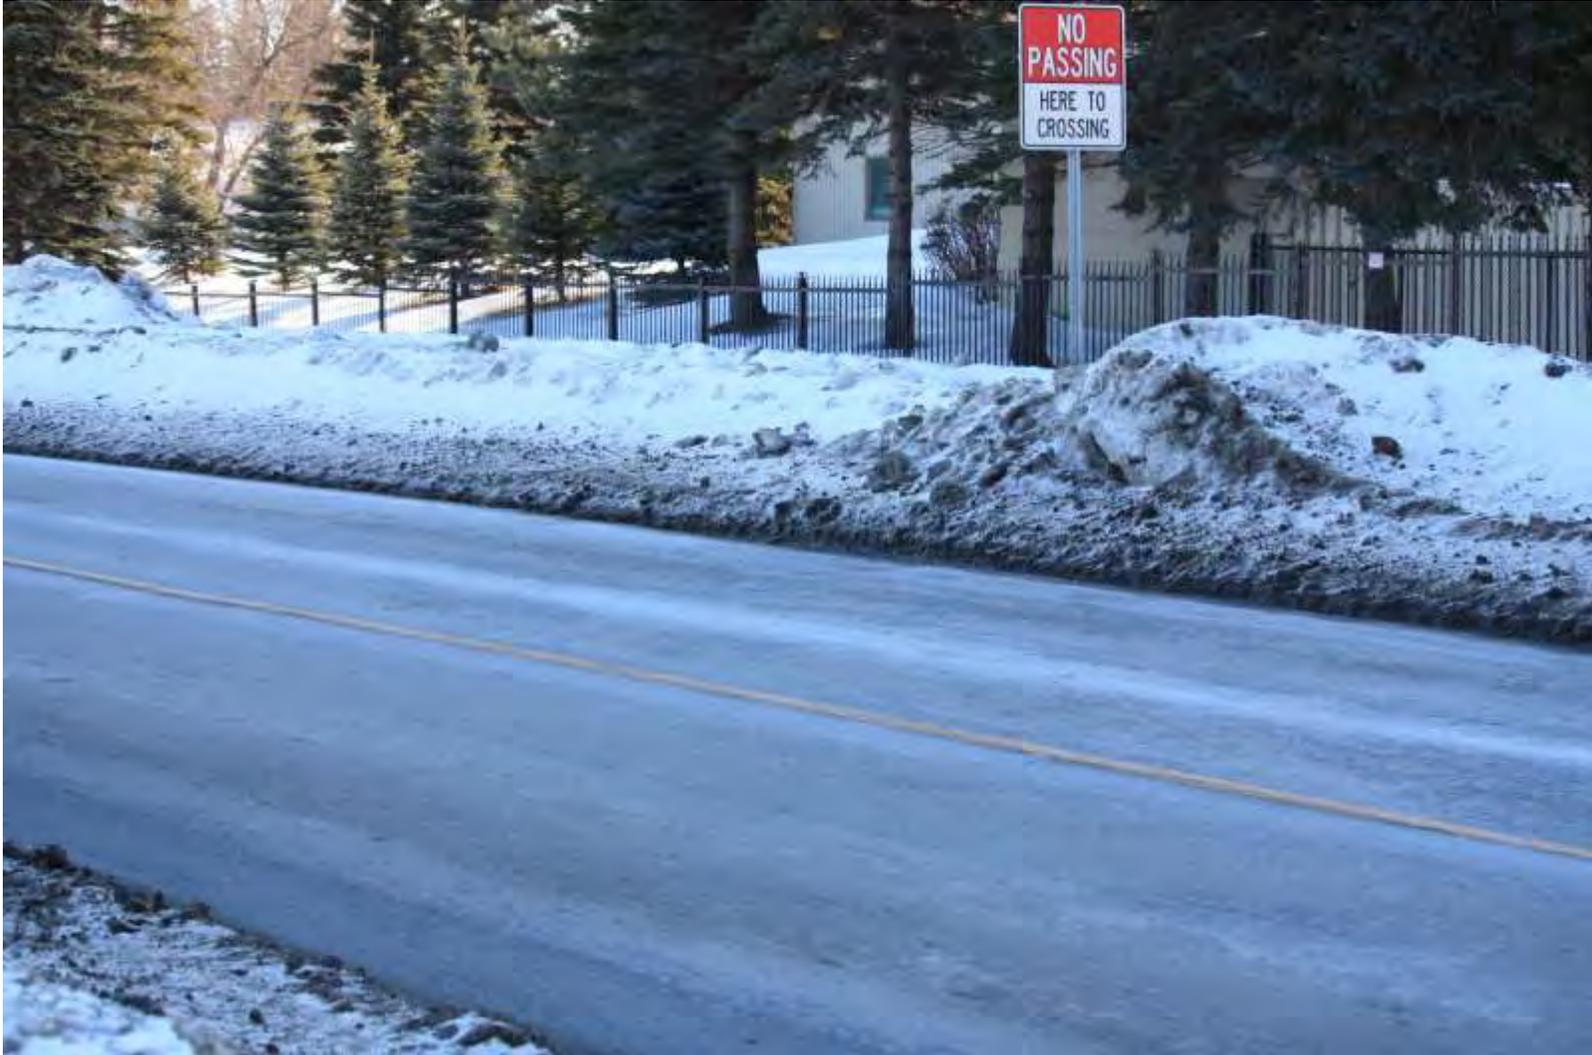
CONFLICTING ROAD MARKINGS AND ROADSIDE SIGNING

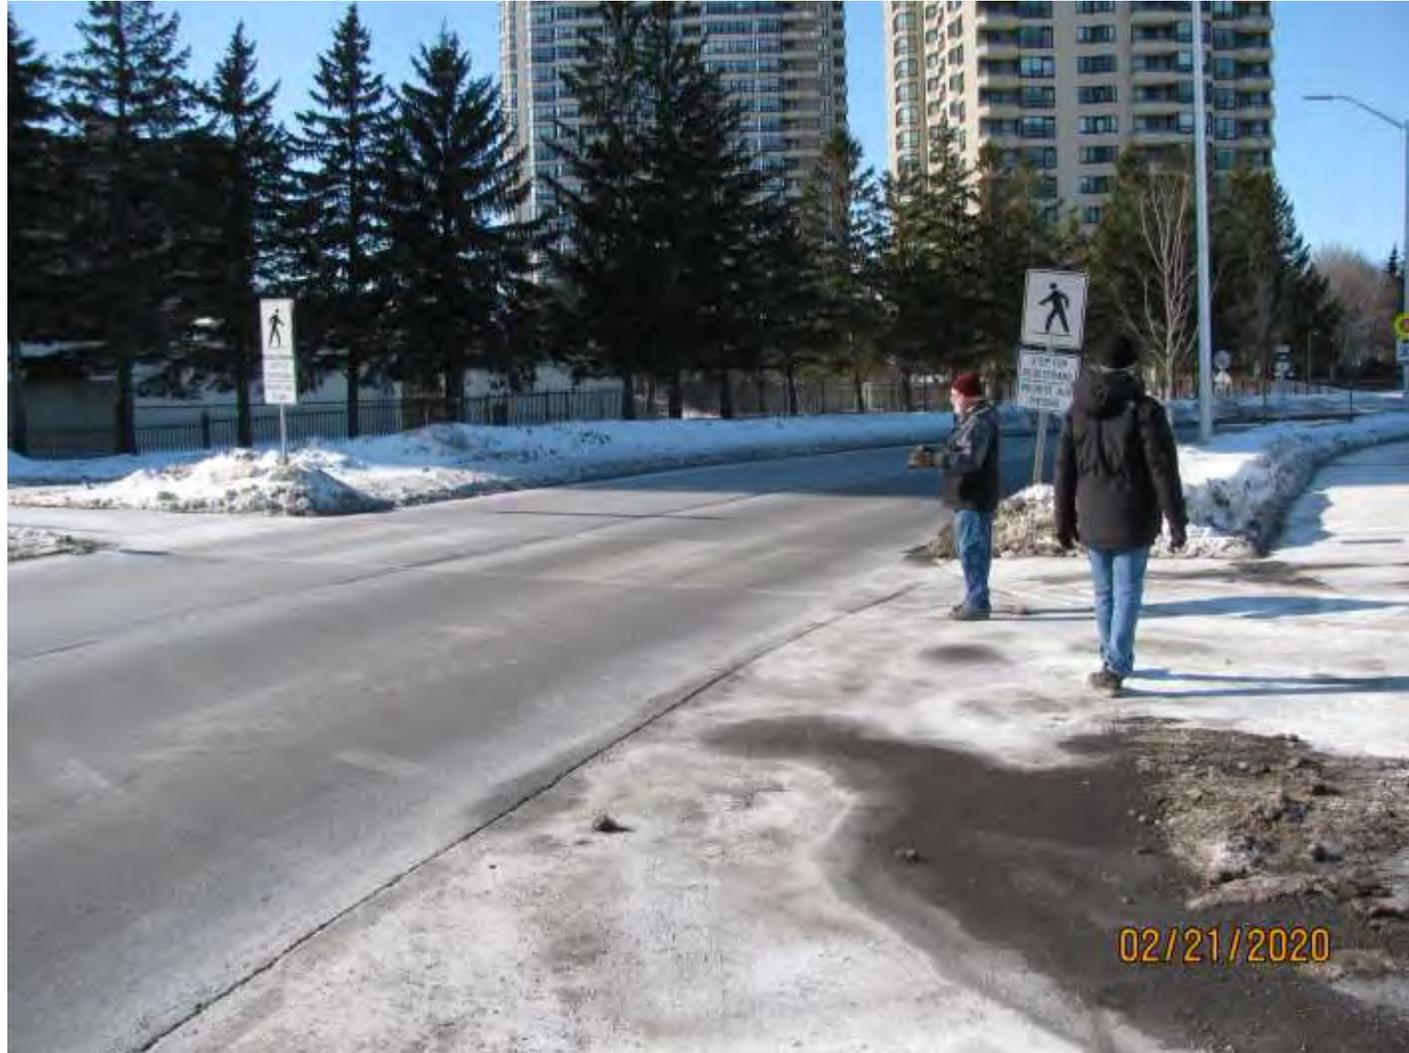
LUMINAIRES NOT LOCATED AT CROSSING
