OC Transpo Transitway Station Design Safety Study

Independent Safety Study

Final Safety Study

September 2021

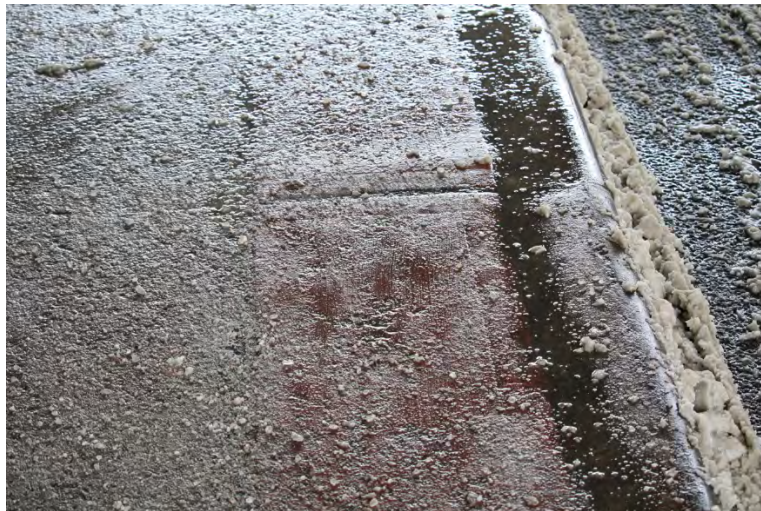
The curb letdown or vehicular access for service vehicles to access the platform at the station is located at the approach side or nearside of the station. The location of this access provides a potential opportunity for an errant vehicle to easily mount the curb and intrude onto the platform at the station.

Suggestions:

Replace the letdown curb on the approach end of the station platform with a 150mm high barrier curb. The letdown curb on the departure end of the station platform can remain.

Note potential design guideline implication – locate curb letdown far side of station and curb height should be higher at BRT Stations, namely a raised platform 200mm (8”) to 250mm (10”) (reference to APTA BRT Stations and Stops Recommended Practice).

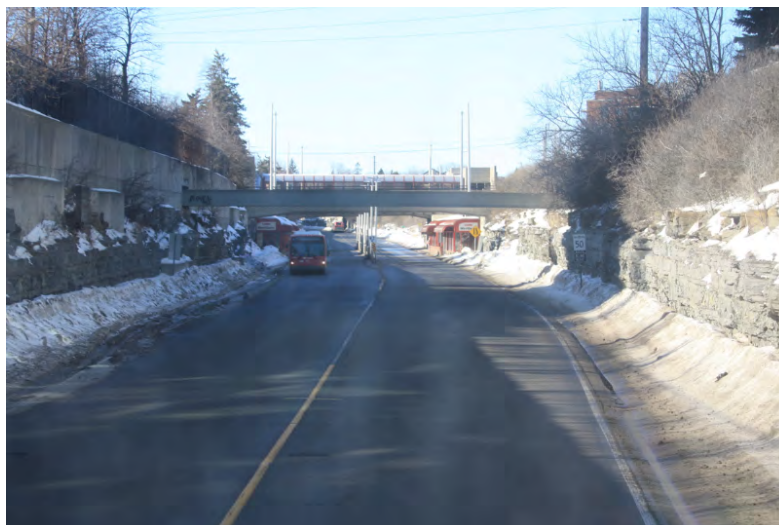
Along both the westbound and eastbound approaches to the station there can be light areas and shadows due to the angle of the sun and objects along the top of the cut section. This is a potential issue for patches of icing and inconsistent road surface friction during temperatures near freezing the point.

Suggestions:

Low sun angles cannot be easily mitigated. Driver training, reduced speed and a higher level of winter maintenance are suggested for the short term. In the longer-term better drainage and a flashing beacon activated by a road surface sensor monitoring conditions such as ice and temperature are suggested.

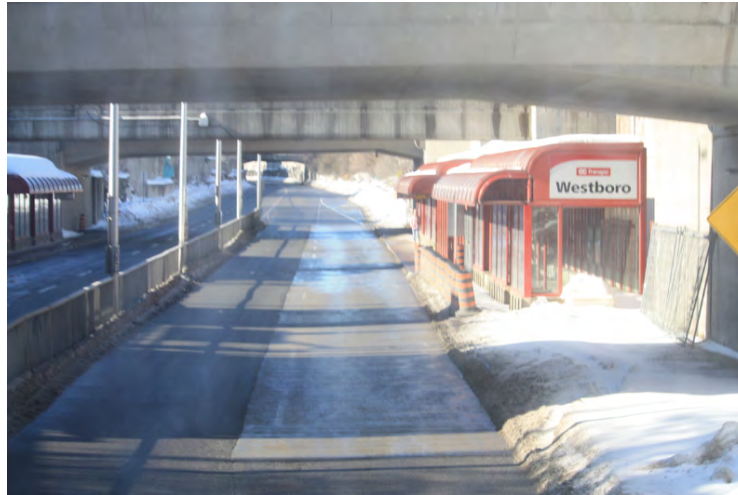
Issue 10: Water and ice on transitway surface cause glare

Patches of water and ice on the transitway can cause glare when the sun is positioned in the sky in line with the transitway.

Suggestions:

During the site visit it was noticed that snow, which had accumulated on the curved roof resulted in snow and water from melting snow falling on the roadway. Eavestrough along the canopy edge is suggested to drain water away from falling on the Transitway.

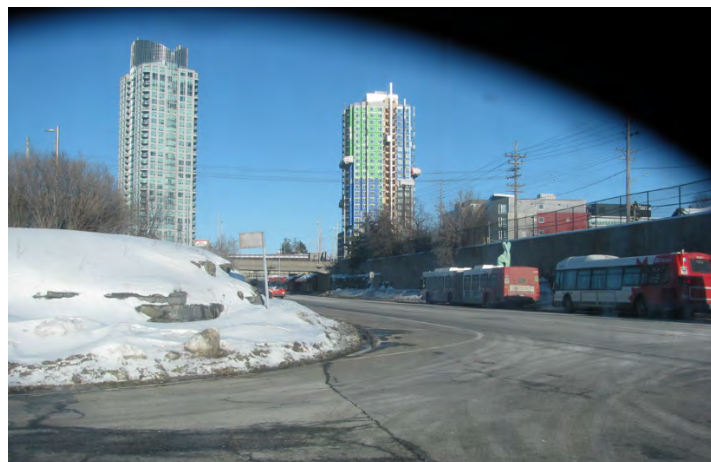
The local access road to the transitway just west of the station has limited sight distance to the east at the T-intersection. This can be an issue for vehicles entering onto the transitway for selecting a safe opportunity to enter onto the transitway within the traffic stream. Some transit vehicles were observed to be parked on the hatched area along the north side of the transitway, further reducing intersection sight distance to the east.

Suggestions:

Install a flashing beacon activated by buses at the stop bar to warn westbound buses of the potential turning movement conflict would help reduce the potential for collisions. Install “No Stopping” signs along the north side of the transitway for the extent of the hatched area.

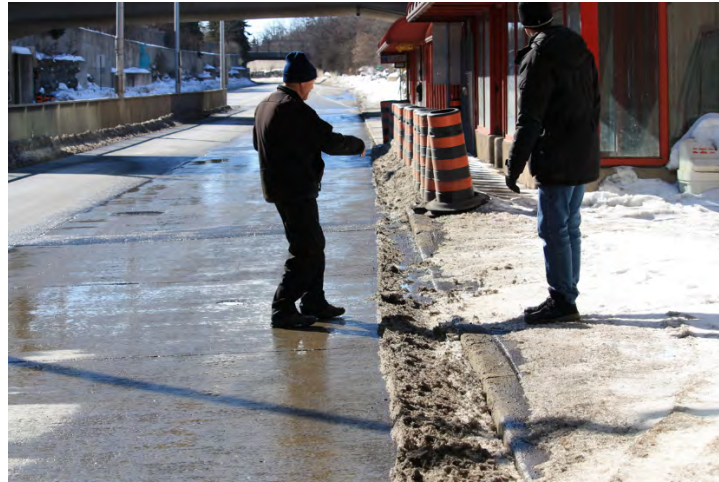
The curb letdown or vehicular access for service vehicles to access the platform at the station is located at the approach side or nearside of the station. The location of this access provides a potential opportunity for an errant vehicle to mount the curb and intrude onto the platform at the station.

Suggestions:

Replace the letdown curb on the approach end of the station platform with a 150mm high barrier curb. The letdown curb on the departure end of the station platform can remain.

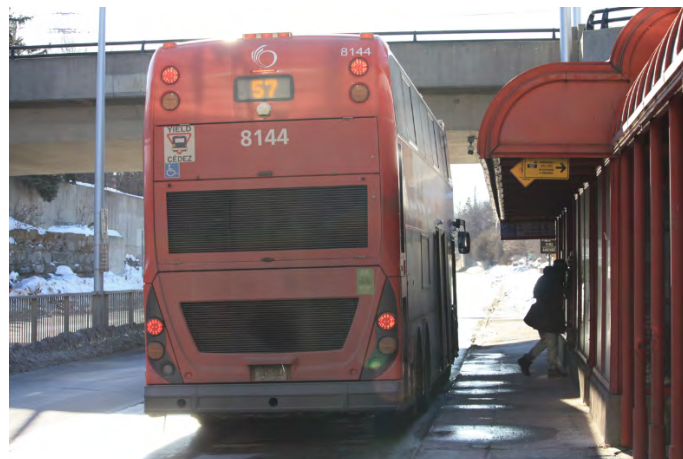
An overhead canopy protruding out from the frontage of the station in both the westbound and eastbound directions is located within the desirable Clear Zone of the transitway. The Clear Zone is a fixed-object-free area available to permit recovery by an errant vehicle. Where curb is used, the lateral offset to the hazard is measured from the face of the curb. Generally, in urban areas, a minimum of 0.5 metres offset is provided from the face of curb to fixed objects. However, in urban environments, past studies have shown that approximately 80 percent of roadside collisions involve objects with a lateral offset from the curb face equal to or less than 1.2 metres and approximately 90 percent of urban roadside collisions have lateral offsets less than or equal to 1.8 metres. The auditors note that US studies (FHWA) have shown that 20 percent of errant vehicles exceed clear zone distances. Therefore, a lateral offset of 1.2 metres to 1.8 metres from the curb face to fixed objects is desirable. The existing offset between the curb face and the canopy at this station was difficult to measure during the onsite audit, but the offset appears to be about 0.5 to 0.7 metres.

When a vehicle collides with a fixed object, the crash response safety systems of the vehicle, such as the bumper and vehicle frame crumpling to absorb energy, may possibly deflect the vehicle and / or reduce the severity of the crash for the vehicle occupants. However, these vehicle safety systems may not be engaged in crashes where the fixed object contacts the vehicle at a height higher than the vehicle's bumper.

Suggestions:

Either reduce operating speed of buses to 20 km/h within the limits of the station to mitigate severity of possible collision with canopy or alternatively remove the canopy.

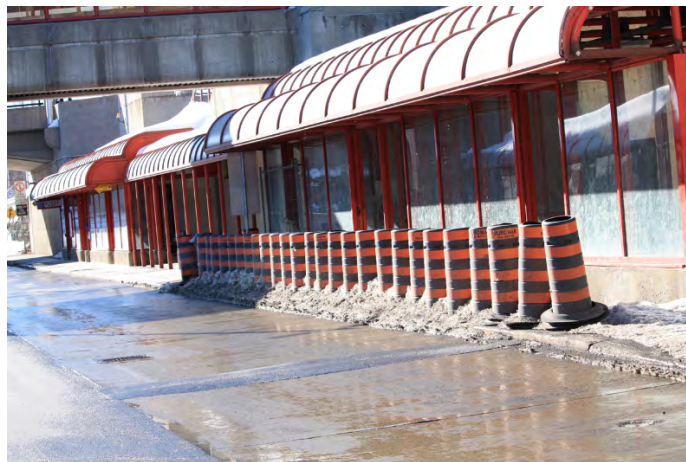
The convex shape of the roof and canopy at the station deposits snow and water onto the sidewalk and transitway surface at the station. This is a potential issue for icing during certain times of the year which could impact surface friction on the transitway and slipping/falling hazard on the sidewalk.

Suggestions:

Remove canopy as it cannot be made frangible or shielded. Alternatively install an eavestrough to capture water dripping on the transitway.

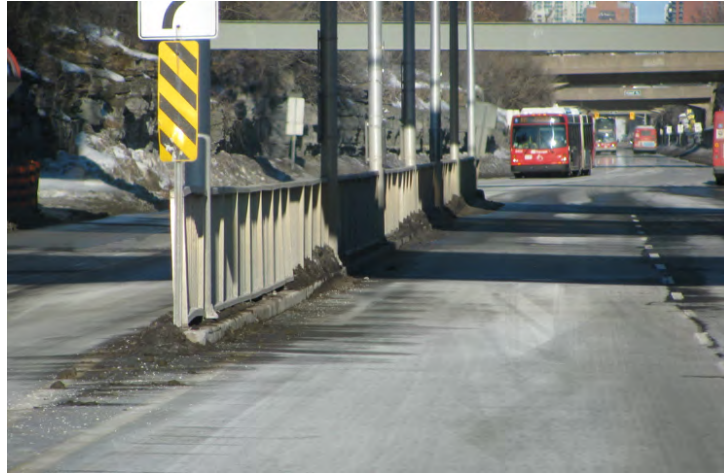
Unlike the median barriers at other station along the transitway, the median barrier at the Westboro Station is not designed to be a vehicle barrier. The purpose of the barrier is to discourage transit patrons from crossing the Transitway. This barrier would not deflect an errant vehicle from crossing over into the oncoming lanes.

Suggestions:

Replace the median fencing with a TL-3 F-Shape 810mm concrete barrier and TL-3 crash cushion end treatments.

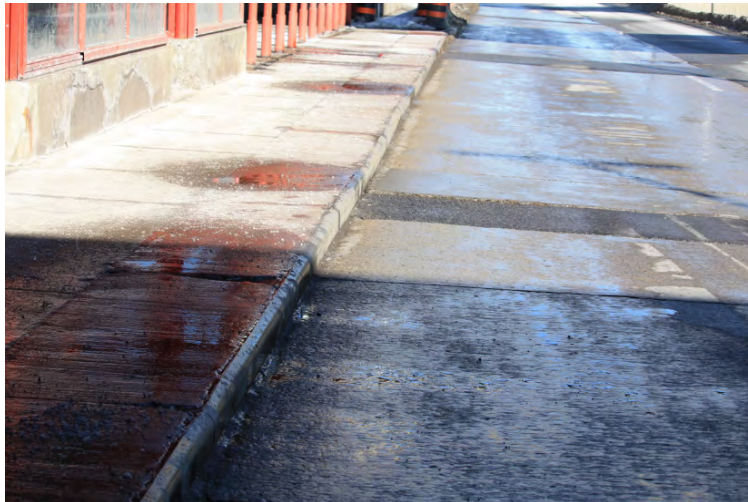
The edge of the station platform is delineated with a rustic-brown concrete colouring along the edge of the barrier curb. The contrast between the concrete sidewalk colouring and the edge delineation is not very conspicuous. This edge of the platform may not be discernable for people with vision impairments and / or the drivers approaching the station.

Suggestions:

Install a high tonal tactile strip along the edge of the platform, in accordance with Accessibility for Ontarians with Disability Act (AODA) Guidelines. Noting that the colour is not specified in AODA, the standard high contrast colour for tactile strips in most jurisdictions in North America is yellow.

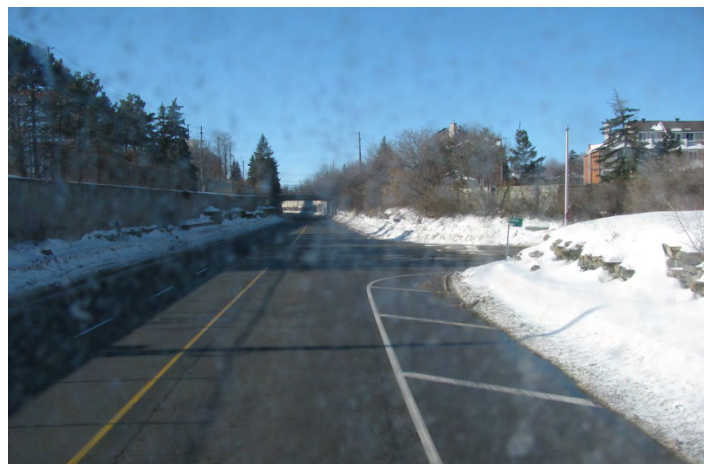
A gore area along the north side of the transitway just west of the station was recently installed as a measure to prohibit parking along this section of the transitway. Parked transit vehicles along this section of the transitway were limiting sight distance at the T-intersection just to the west. During the site audits at this and other station along this transitway, buses were observed parking in the gore area on a few occasions. This measure has not been effective for prohibiting parking.

Suggestions:

In the immediate term install no stopping signs. In the longer term if bus drivers continue to park in the hatched area install drivable delineators 500mm offset from the outside of the edge line to prevent drivers from entering the hatched area.

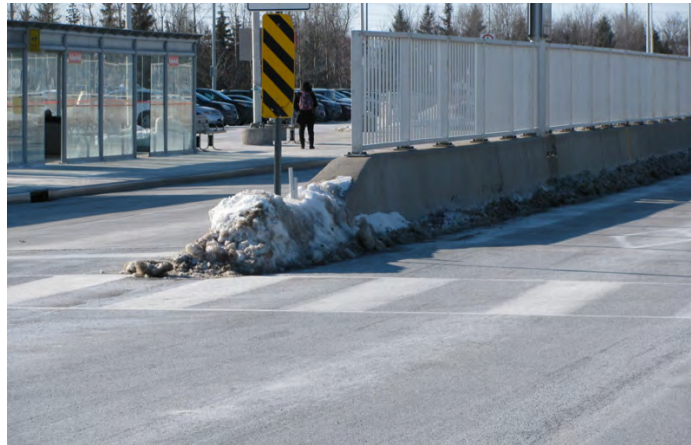
There is no energy attenuation at the median barrier ends at the entrances into the station. An errant vehicle could potentially rollover or be launched from a collision with the bull-nose end of the barrier.

Suggestions:

Replace the sloped ends with an appropriate TL-3 crash cushion.

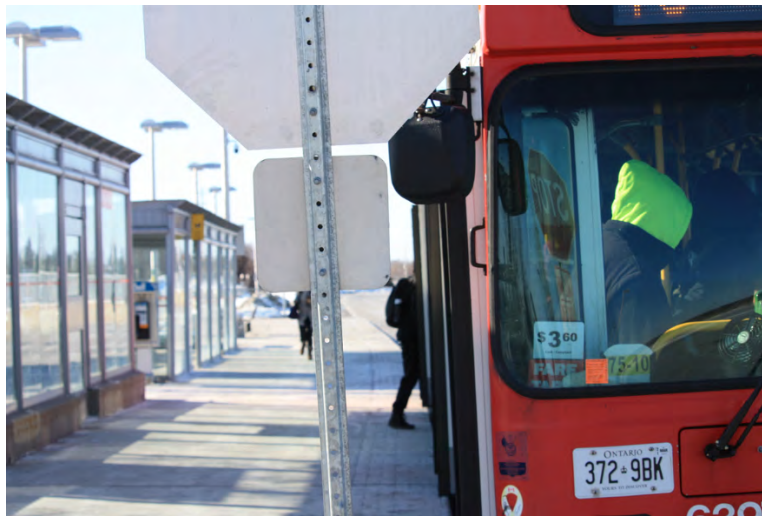
The STOP sign located in the southwest quadrant of the intersection at the station has been placed with the sign intruding onto the transitway. Buses proceeding away from the station could collide with the sign and the sign does show evidence of being struck. Consequently, some transit vehicles were observed to veer left into the adjacent when leaving the station of avoid hitting the sign. This could contribute to side-swipe collisions at the intersection.

Suggestions:

Relocate stop sign 500mm from the face of curb.

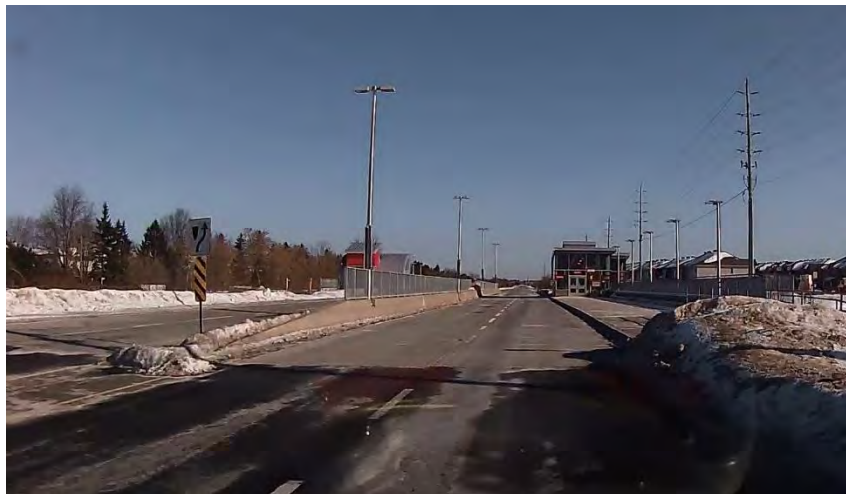
There is no energy attenuation at the median barrier ends at the entrances into the station. An errant vehicle could potentially rollover or be launched from a collision with the bull-nose end of the barrier.

Suggestions:

Replace the sloped ends with appropriate TL-3 crash cushions.

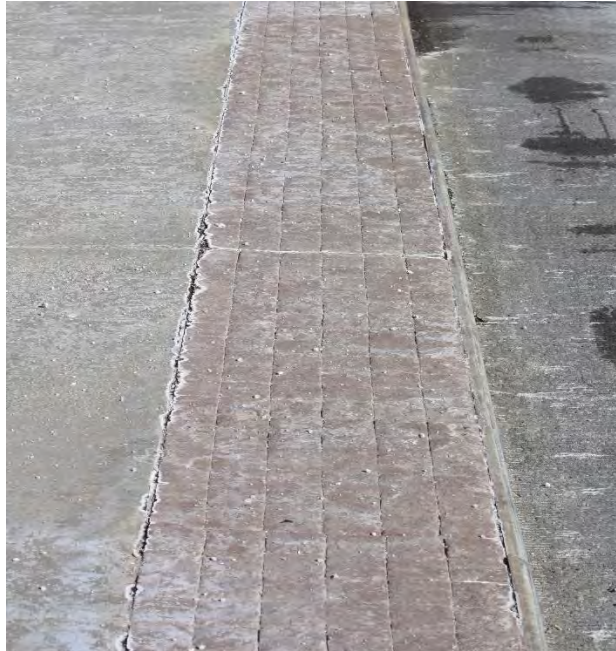
The edge of the station platform is delineated with a rustic-brown concrete colouring along the edge of the barrier curb. The contrast between the concrete sidewalk colouring and the edge delineation is not very conspicuous. This edge of the platform may not be discernable for people with vision impairments and / or the drivers approaching the station.

Suggestions:

Install AODA approved high tonal contrast tactile surface. The suggested high contrast colour is yellow.

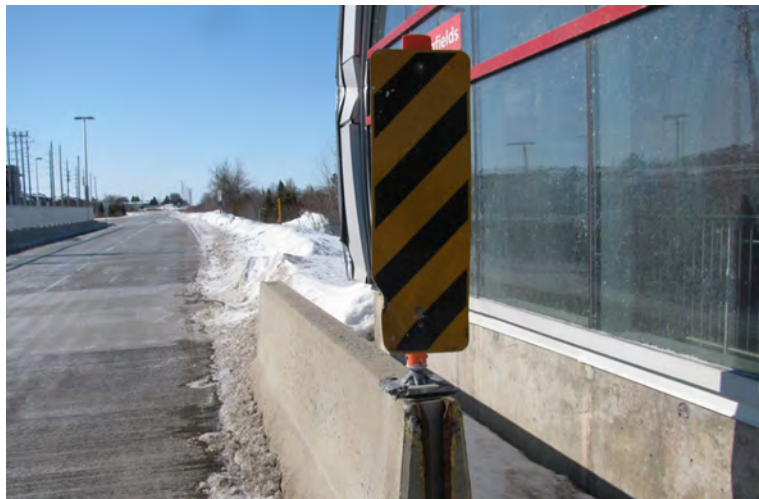
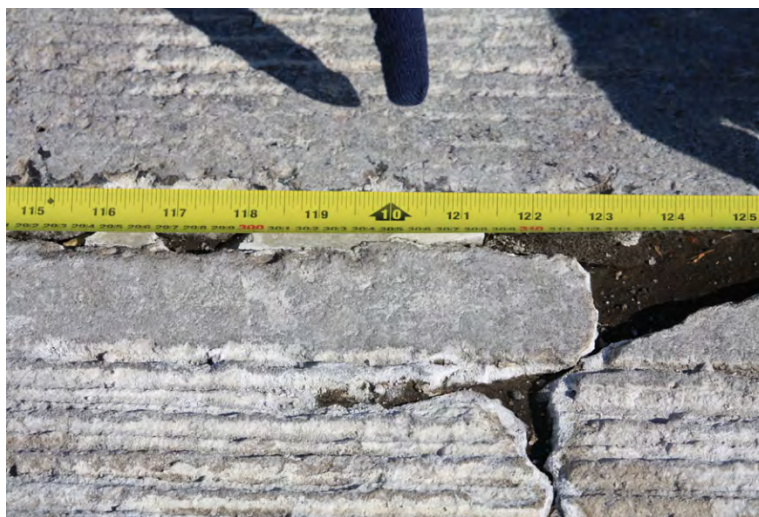
A concrete no-post barrier with a hazard marker has been installed on the road surface of the transitway along the right edge of the right travel lane directly beside the station building. A barrier has been installed in both the southbound and northbound directions. There is damage to the outside of the southbound station building which appears to be caused by a vehicle collision. This appears to be the rationale for the concrete barriers, to protect the station buildings from vehicle collisions. The station buildings are offset about 0.5 metres from the curb face of the transitway. The barriers are fix-objects and a potential hazard to vehicles on the transitway. There is no energy attenuation to lessen the impact of a collision with the barriers. The barriers also narrow the travel lane to 3.0 metres. Vehicles passing the barriers would need shy distance to comfortably avoid colliding with the barrier and this, coupled with the narrowness of the lane forces drivers to intrude into the adjacent lane in order to pass by the barrier.

Suggestions:

Remove the concrete barriers with a blunt end. Install drivable delineators along the base of the building on a 200 mm white line to keep buses away the station and allow the bus to remain in the departure lane. Alternatively, remove the concrete barriers and install a low concrete curb against the base of the station. In either case remove the concrete barrier with the blunt end as it is a hazard.

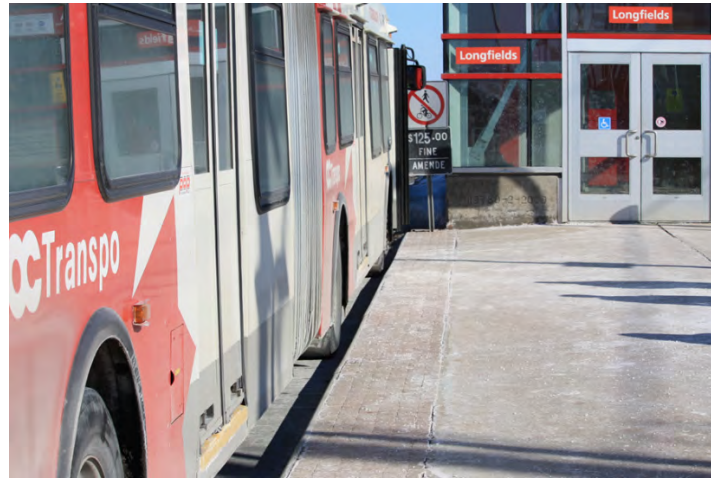
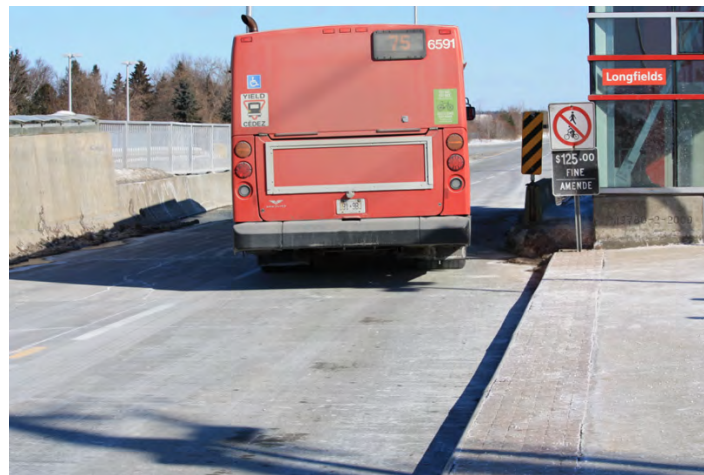
Transit vehicles leaving the station were observed to make abrupt turning maneuvers into the adjacent lane to avoid colliding with the concrete barrier. This presents several safety issues:

- Transit vehicles leaving the station in the right lane could potentially side swipe a transit vehicle travelling through the station in the left lane
- Transit vehicles leaving the station and immediately entering the left lane would potentially be travelling at a slower speed than an approaching transit vehicle travelling through the station in the left lane and this speed differential could contribute to a rear-end type collision
- The purpose of the right lane leaving the station is to allow transit vehicles to accelerate from a stopped position to the posted speed of the transitway and then merge safely into any traffic in the left lane.

Suggestions:

Remove the concrete barriers with a blunt end. Install drivable delineators along the base of the building. On a 200 mm white line to keep buses away from the station and allow the bus to remain in the departure lane. Alternatively, install a low concrete curb against the base of the station.

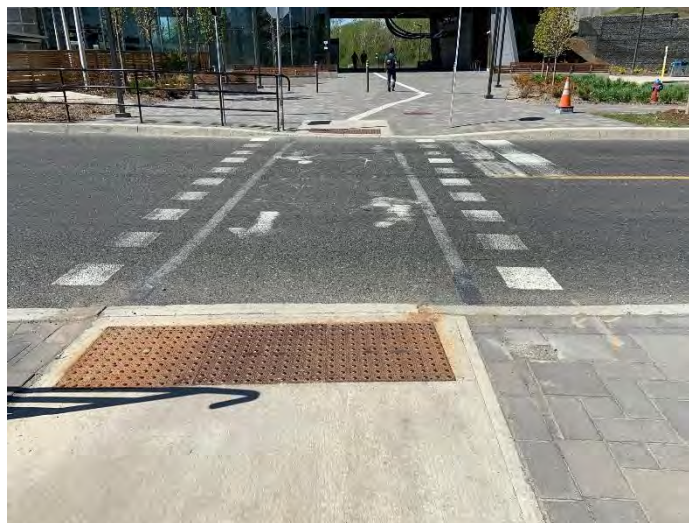
The crossing features stop signs and Ontario Traffic Manual (OTM) Book 18 mixed crossride markings. This tells users that the crossing is intended to be shared by pedestrians and cyclists, and that cyclists are not required to dismount.

Markings from a previous configuration were black-masked, contrary to City of Ottawa standard practices. The black paint has since worn off, causing the older crosswalk markings to show through. The most recent markings have also worn/faded, making them similar in appearance to the old markings. This has rendered the resulting visible markings non-standard, which could contribute to user confusion.

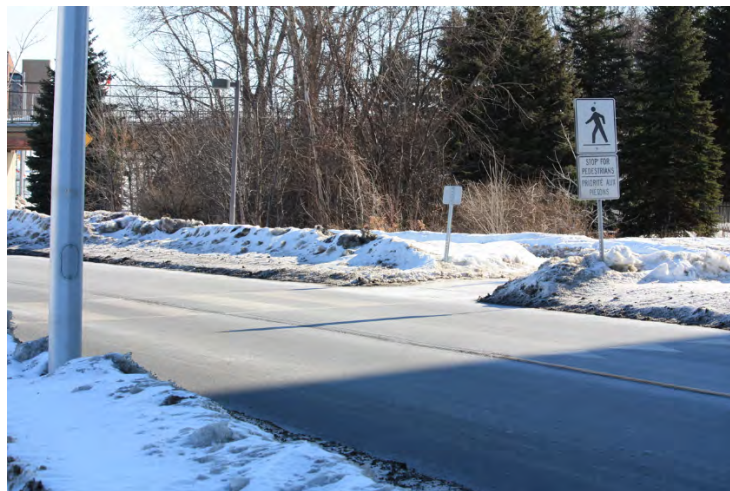
The crosswalk pavement markings and stop bars are barely visible. The poor condition of the pavement markings detracts from conspicuity of the crosswalk and could contribute to poor compliance of motorists to stop at the crosswalk.

Suggestions:

Refresh the crosswalk pavement markings. Consider Thermoplastic as this appears to be a high use area.

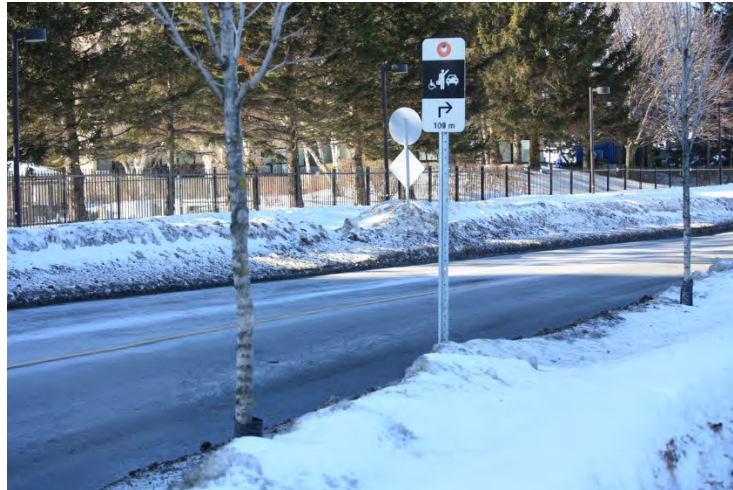
The information or guide sign to direct motorists to the passenger pick-up and drop-off area does not comply with the colour scheme, symbol usage, letter font and letter size for guide signs in Ontario. Consequently, this sign may not be immediately recognized by motorists as an information sign for the attention of motorists and a cause of confusion or missed information.

Suggestions:

This is a guide sign and should comply with the Manual of Uniform Traffic Control Devices for Canada in terms of size, colour and shape for guide signs.

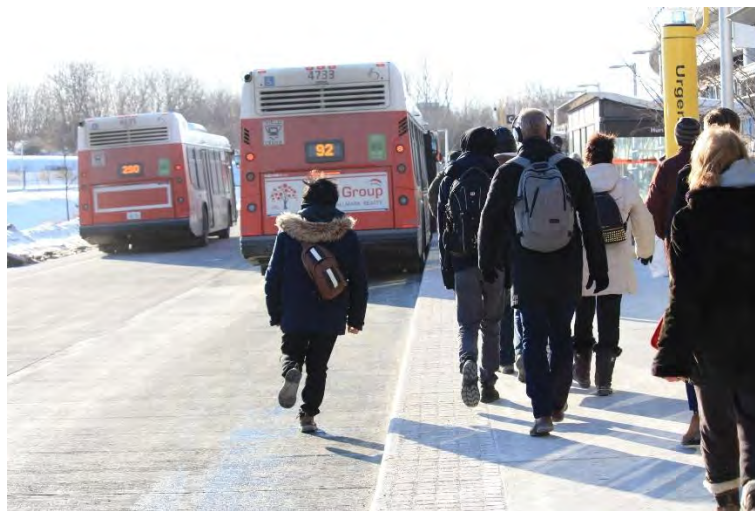
During the afternoon peak hour, the passenger platform to access bus routes leaving the station is very crowded. Some transit patrons were observed walking in the bus travel lanes to avoid the crowded platform. The walking path of these pedestrians conflicts with the path of transit vehicles and could result in potential collisions between pedestrians and transit vehicles.

Suggestions:

Install a pedestrian railing 1000mm high and signs indicating do not walk on roadway.

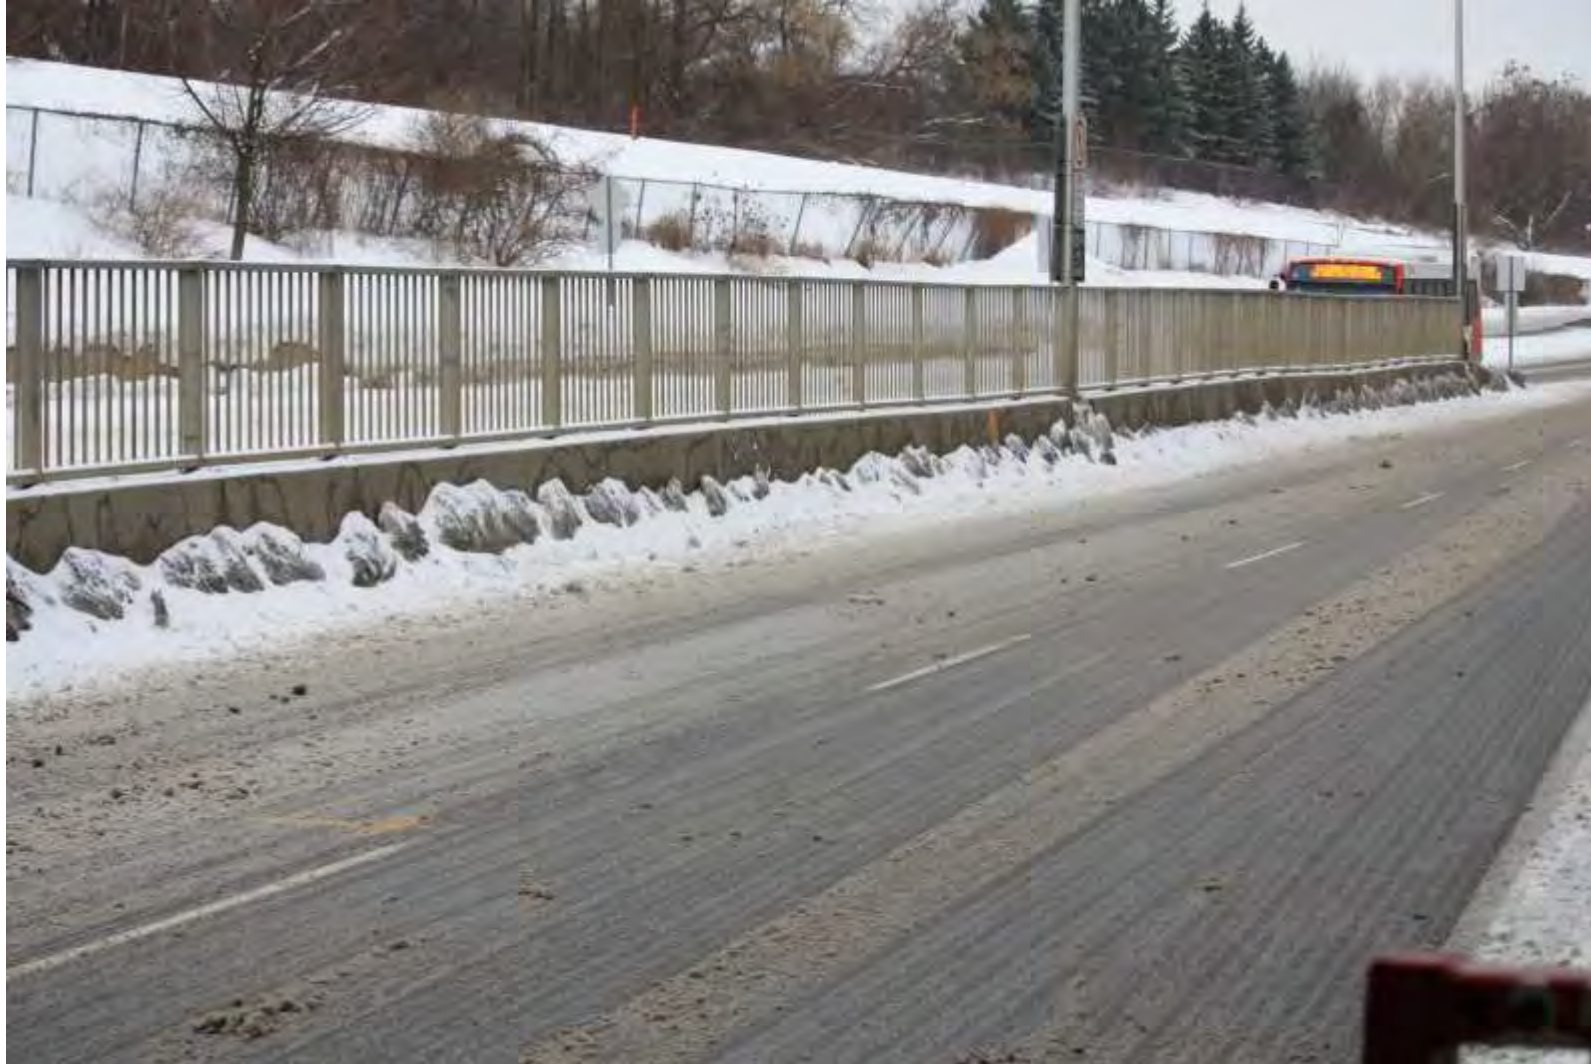
NO ENERGY ATTENUATION AT MEDIAN BARRIER

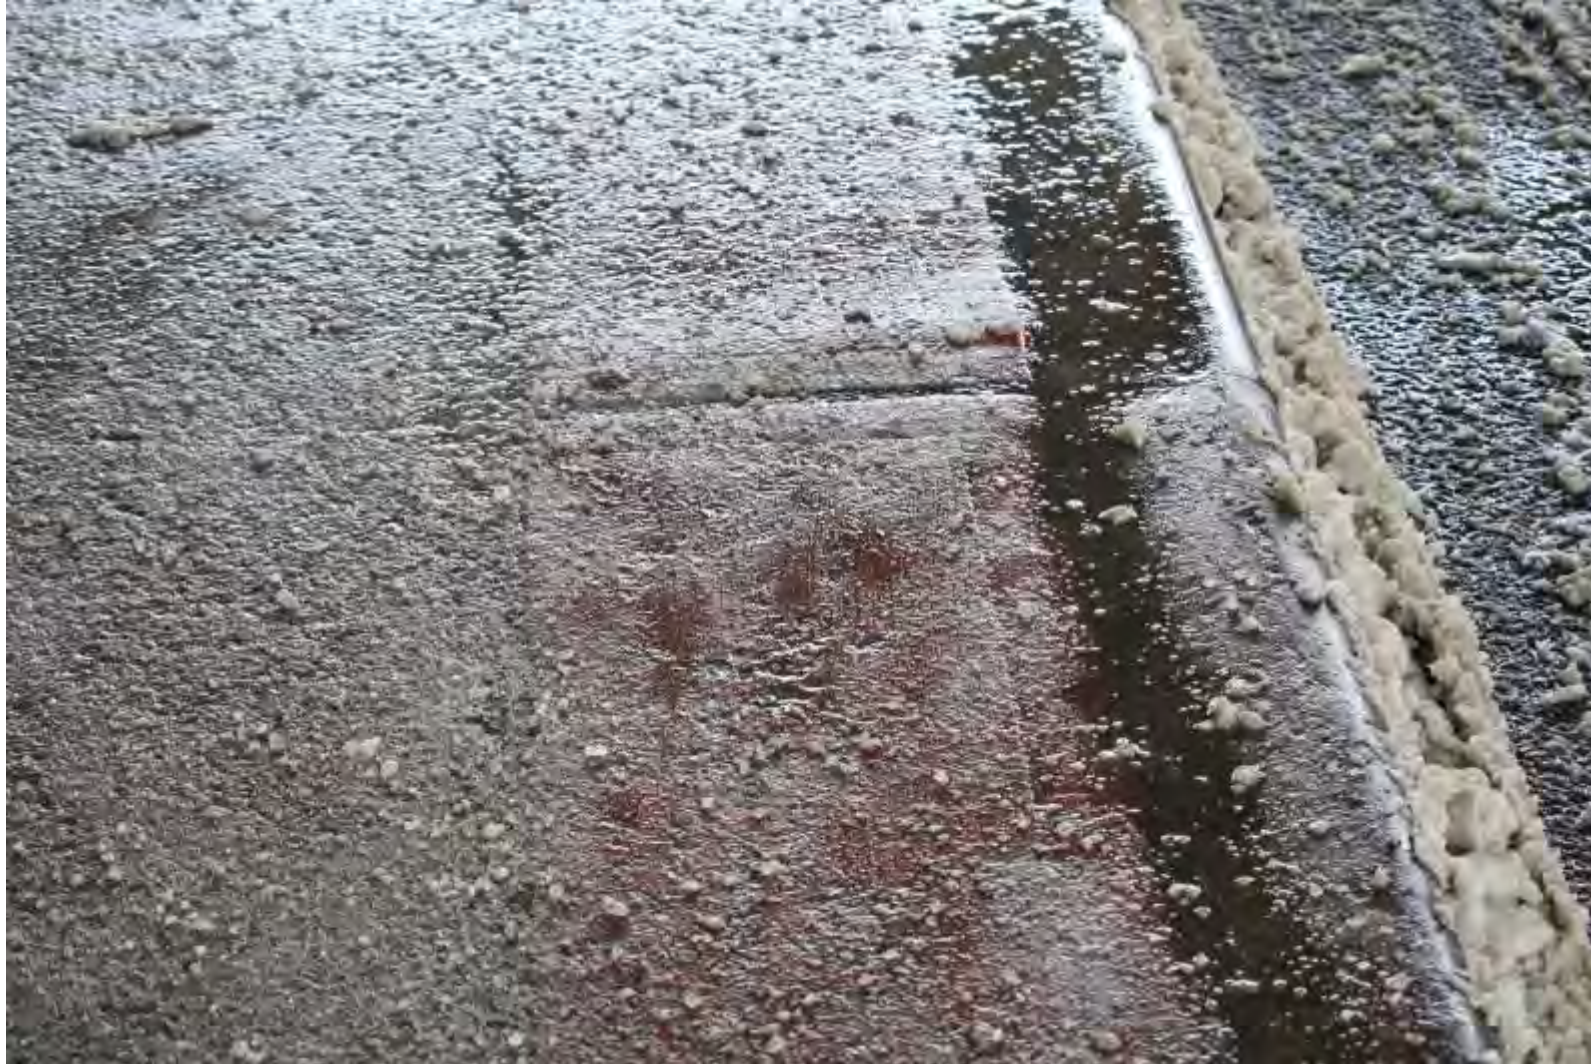
SERVICE VEHICLE CURB LETDOWN LOCATION

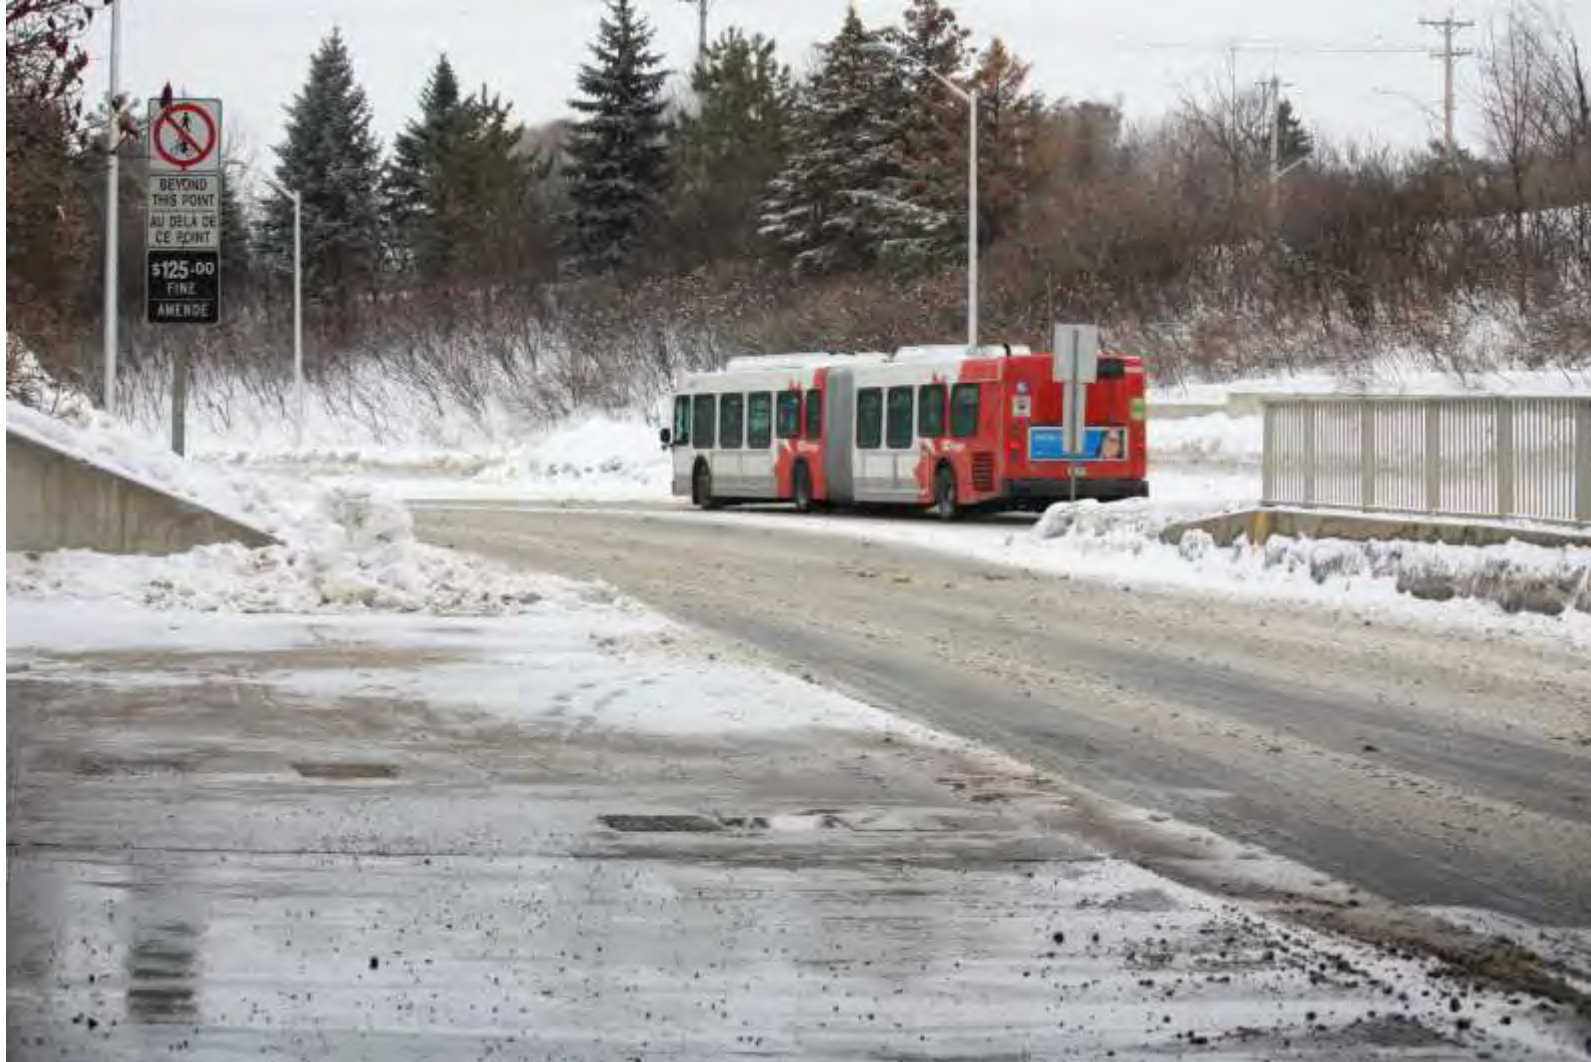
NO PROTECTION FOR TRANSIT PATRONS ON PLATFORM

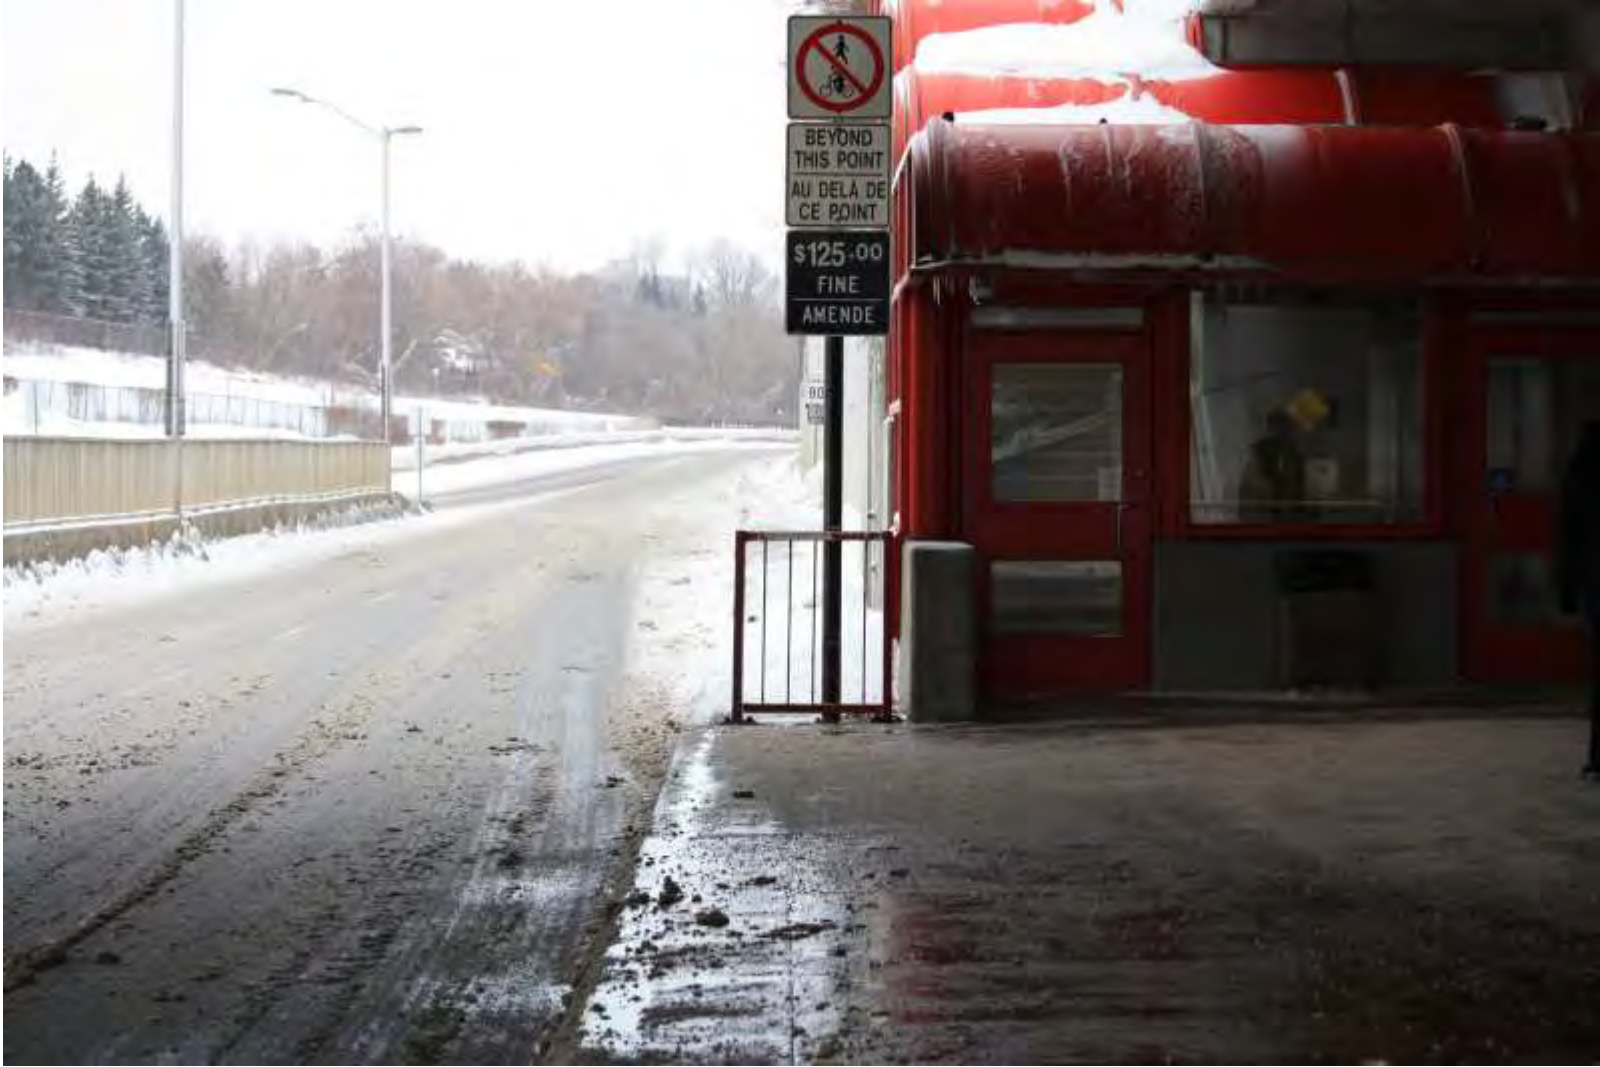
CONCRETE ABUTMENT BLUNT END IN CLEAR ZONE

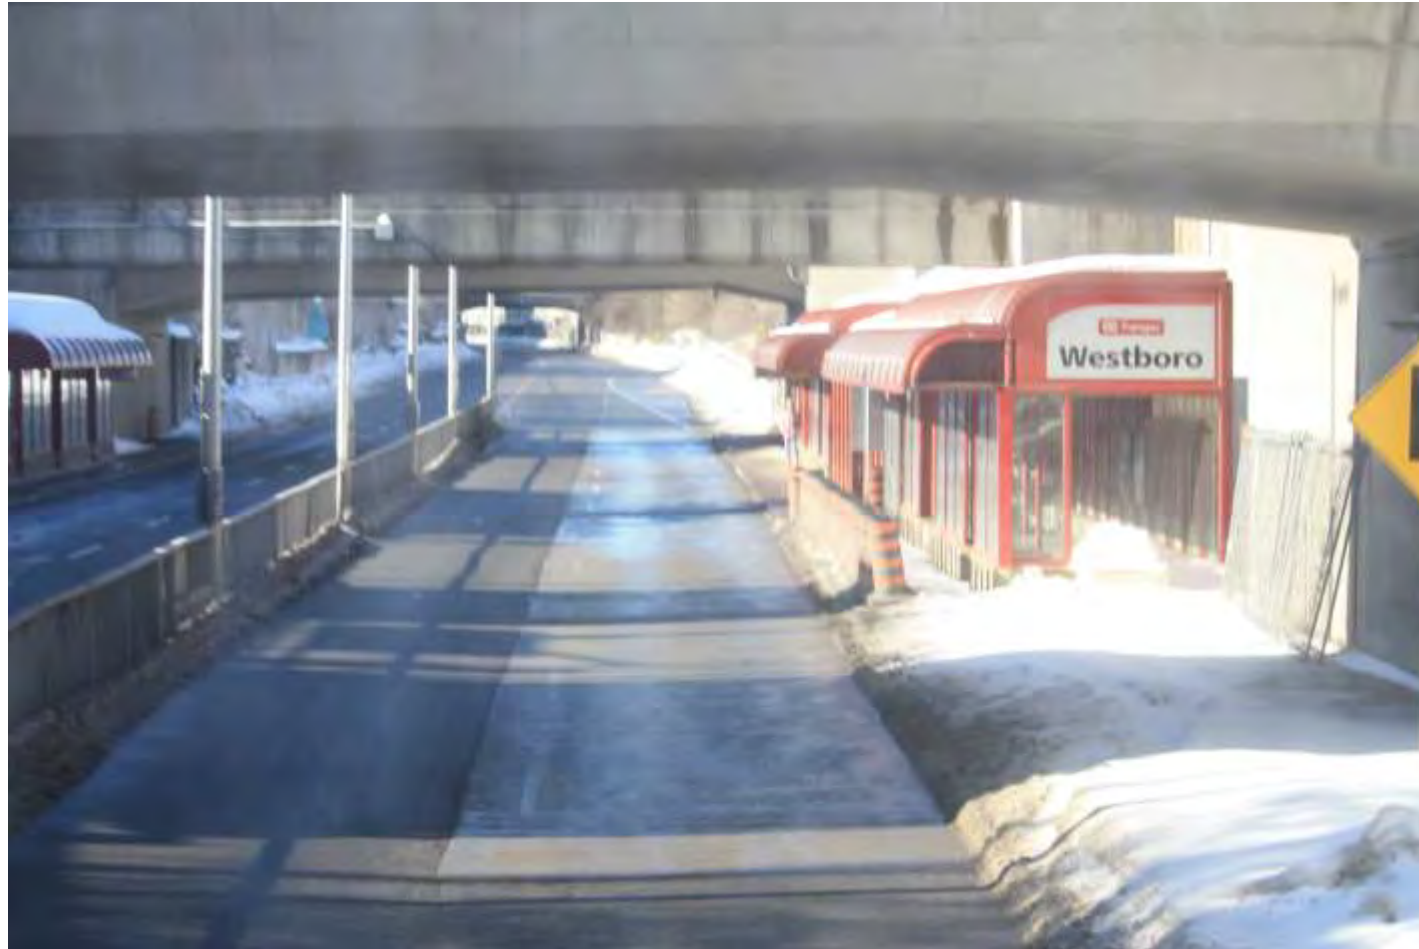
WATER AND ICE ON TRANSITWAY CAUSING GLARE

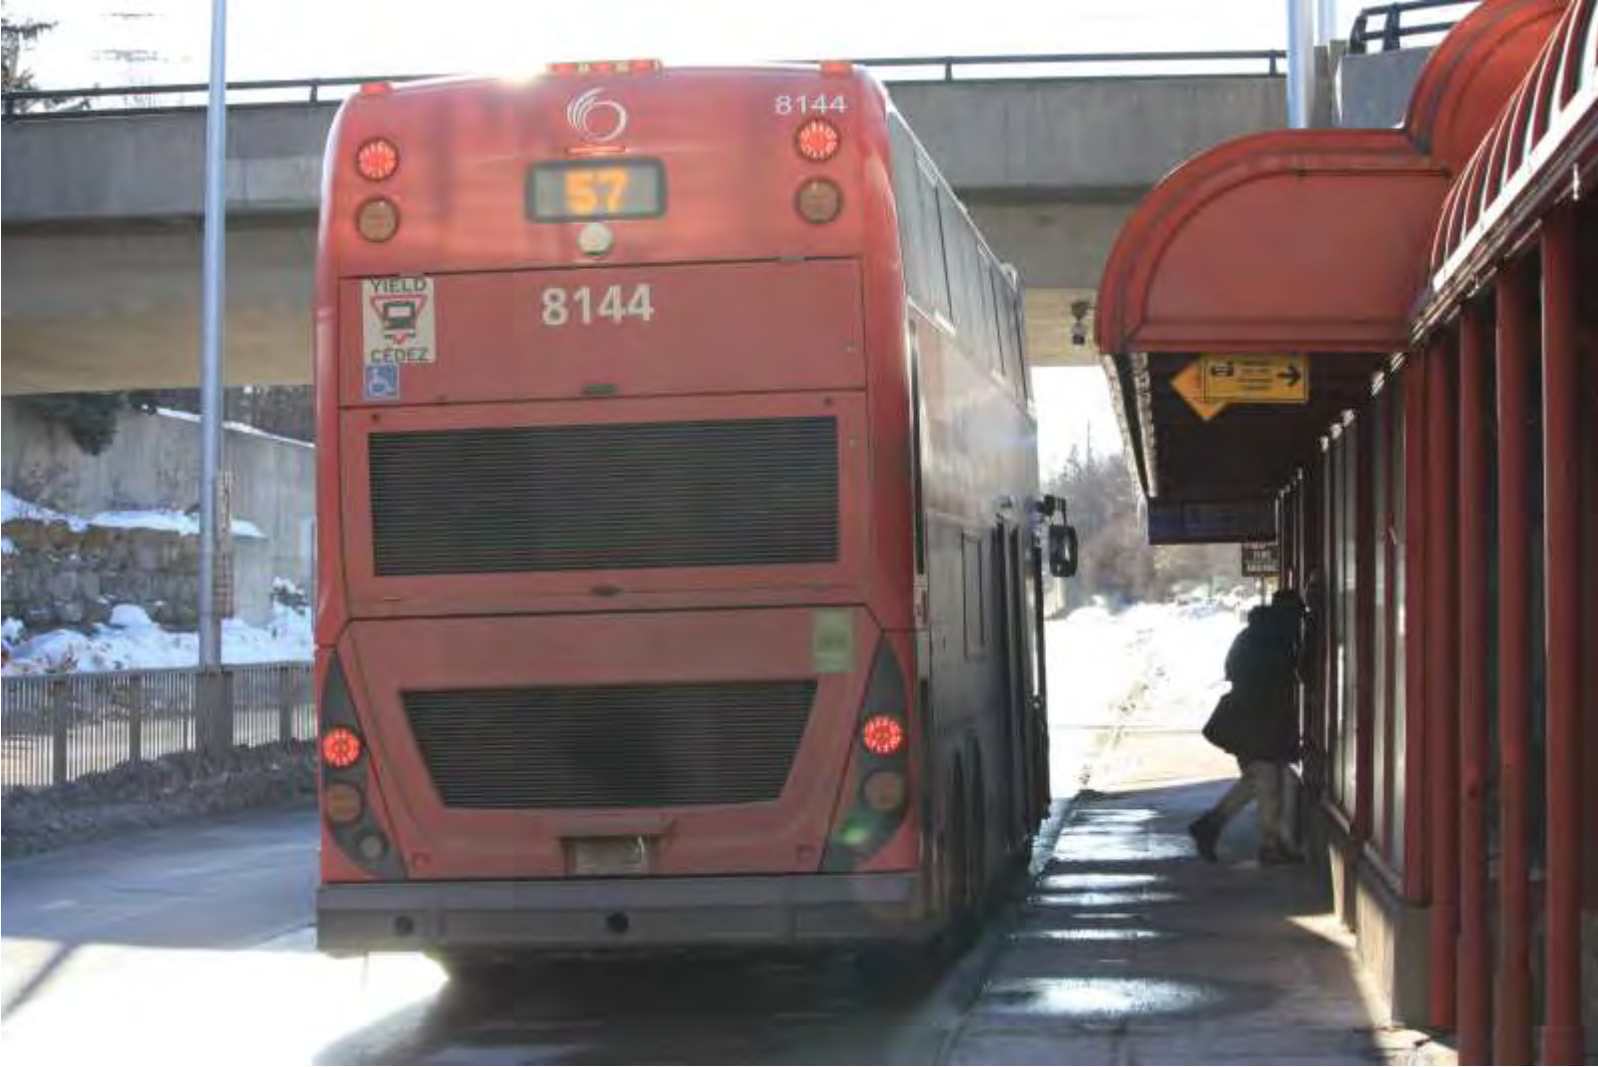
OVERHEAD CANOPY LOCATED WITHIN CLEAR ZONE

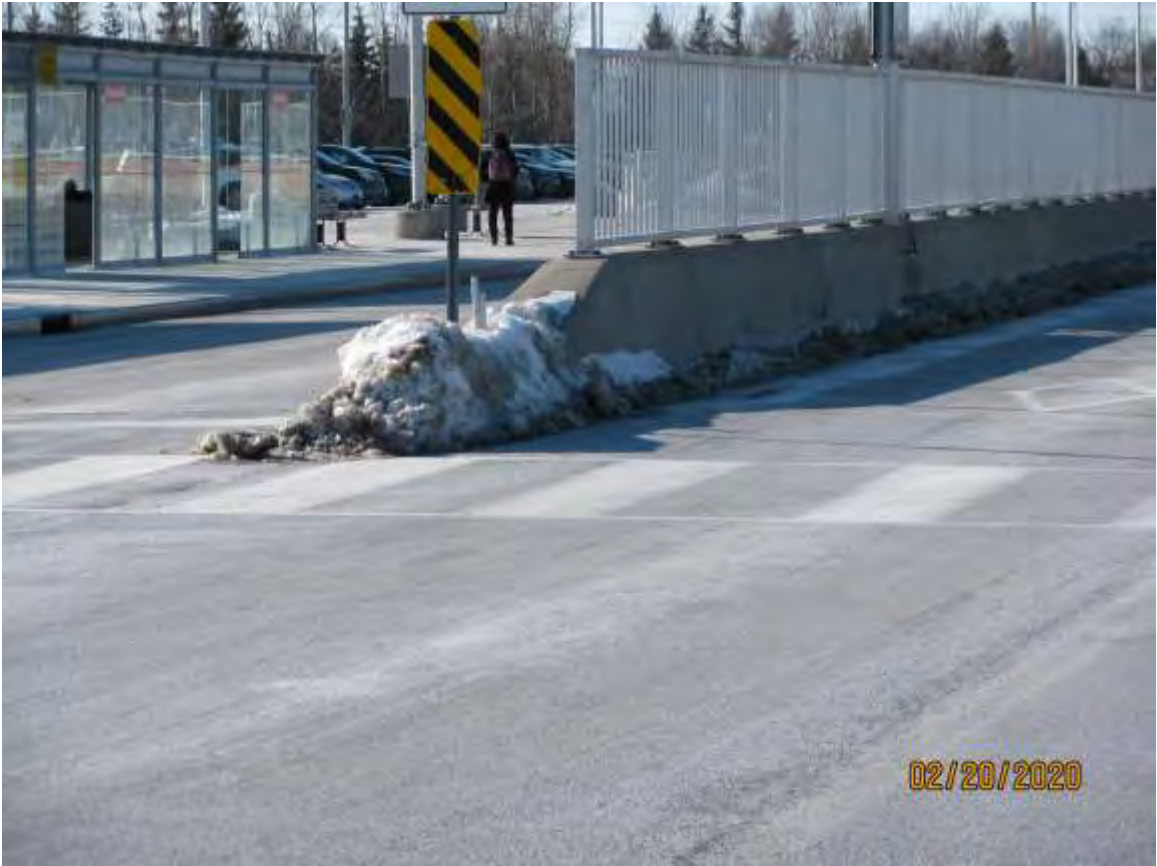
NO ENERGY ATTENUATION AT MEDIAN BARRIER
