OC Transpo Transitway Station Design Safety Study

Independent Safety Study

Final Safety Study

September 2021

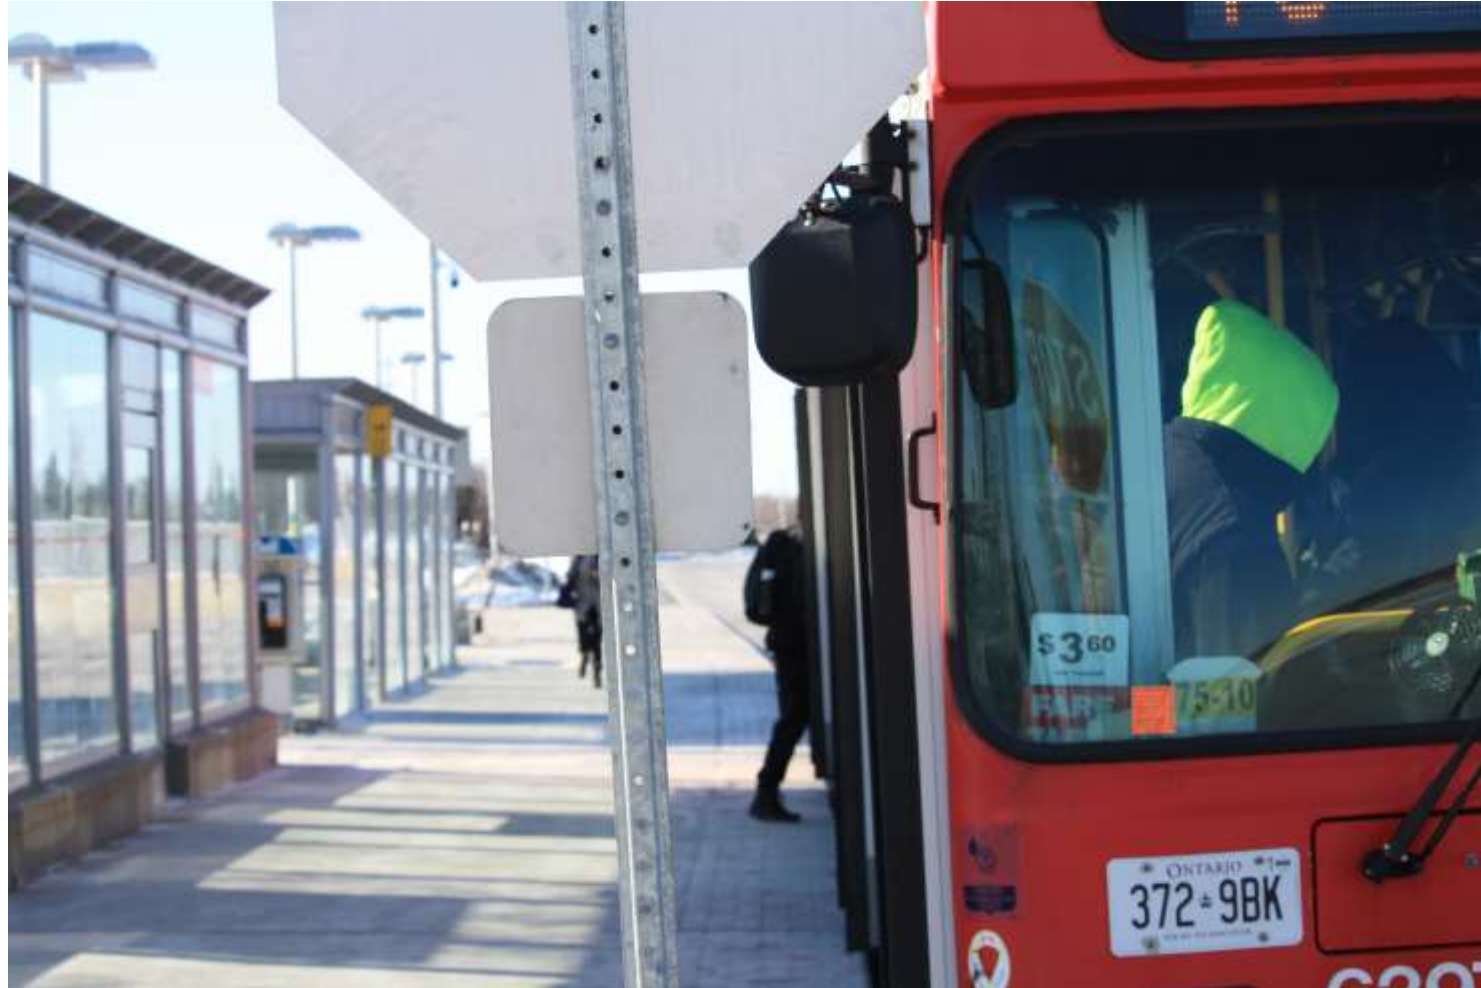
STOP SIGN INTRUSION ONTO TRANSITWAY LANE

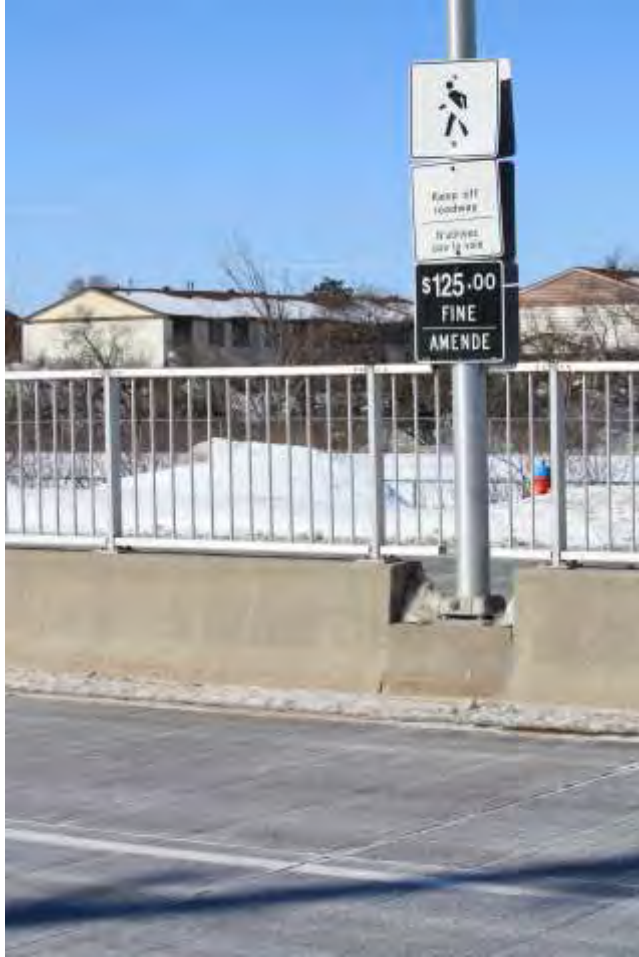
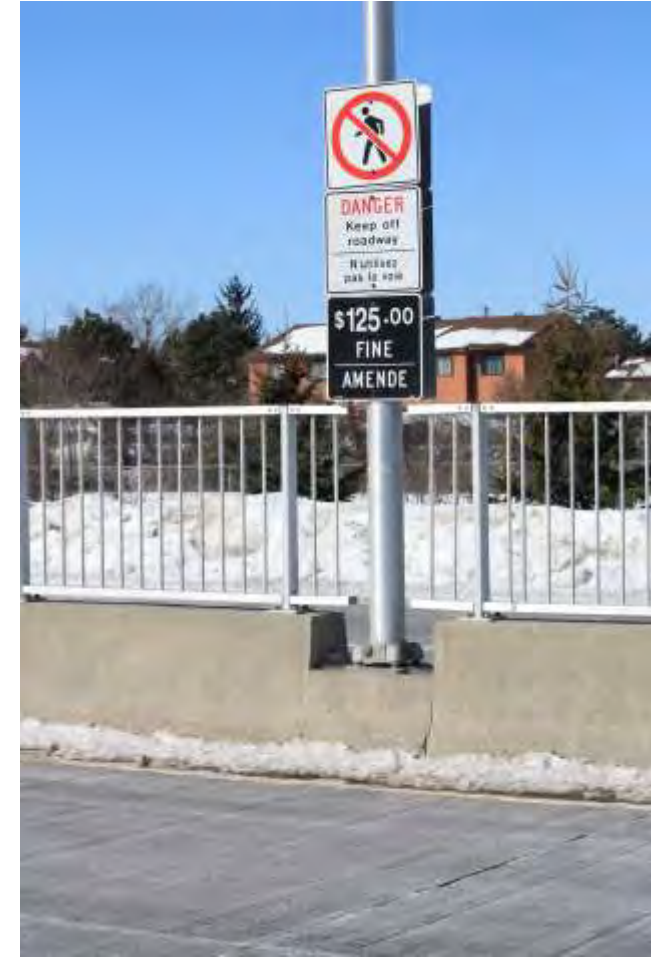
FADED SIGNS

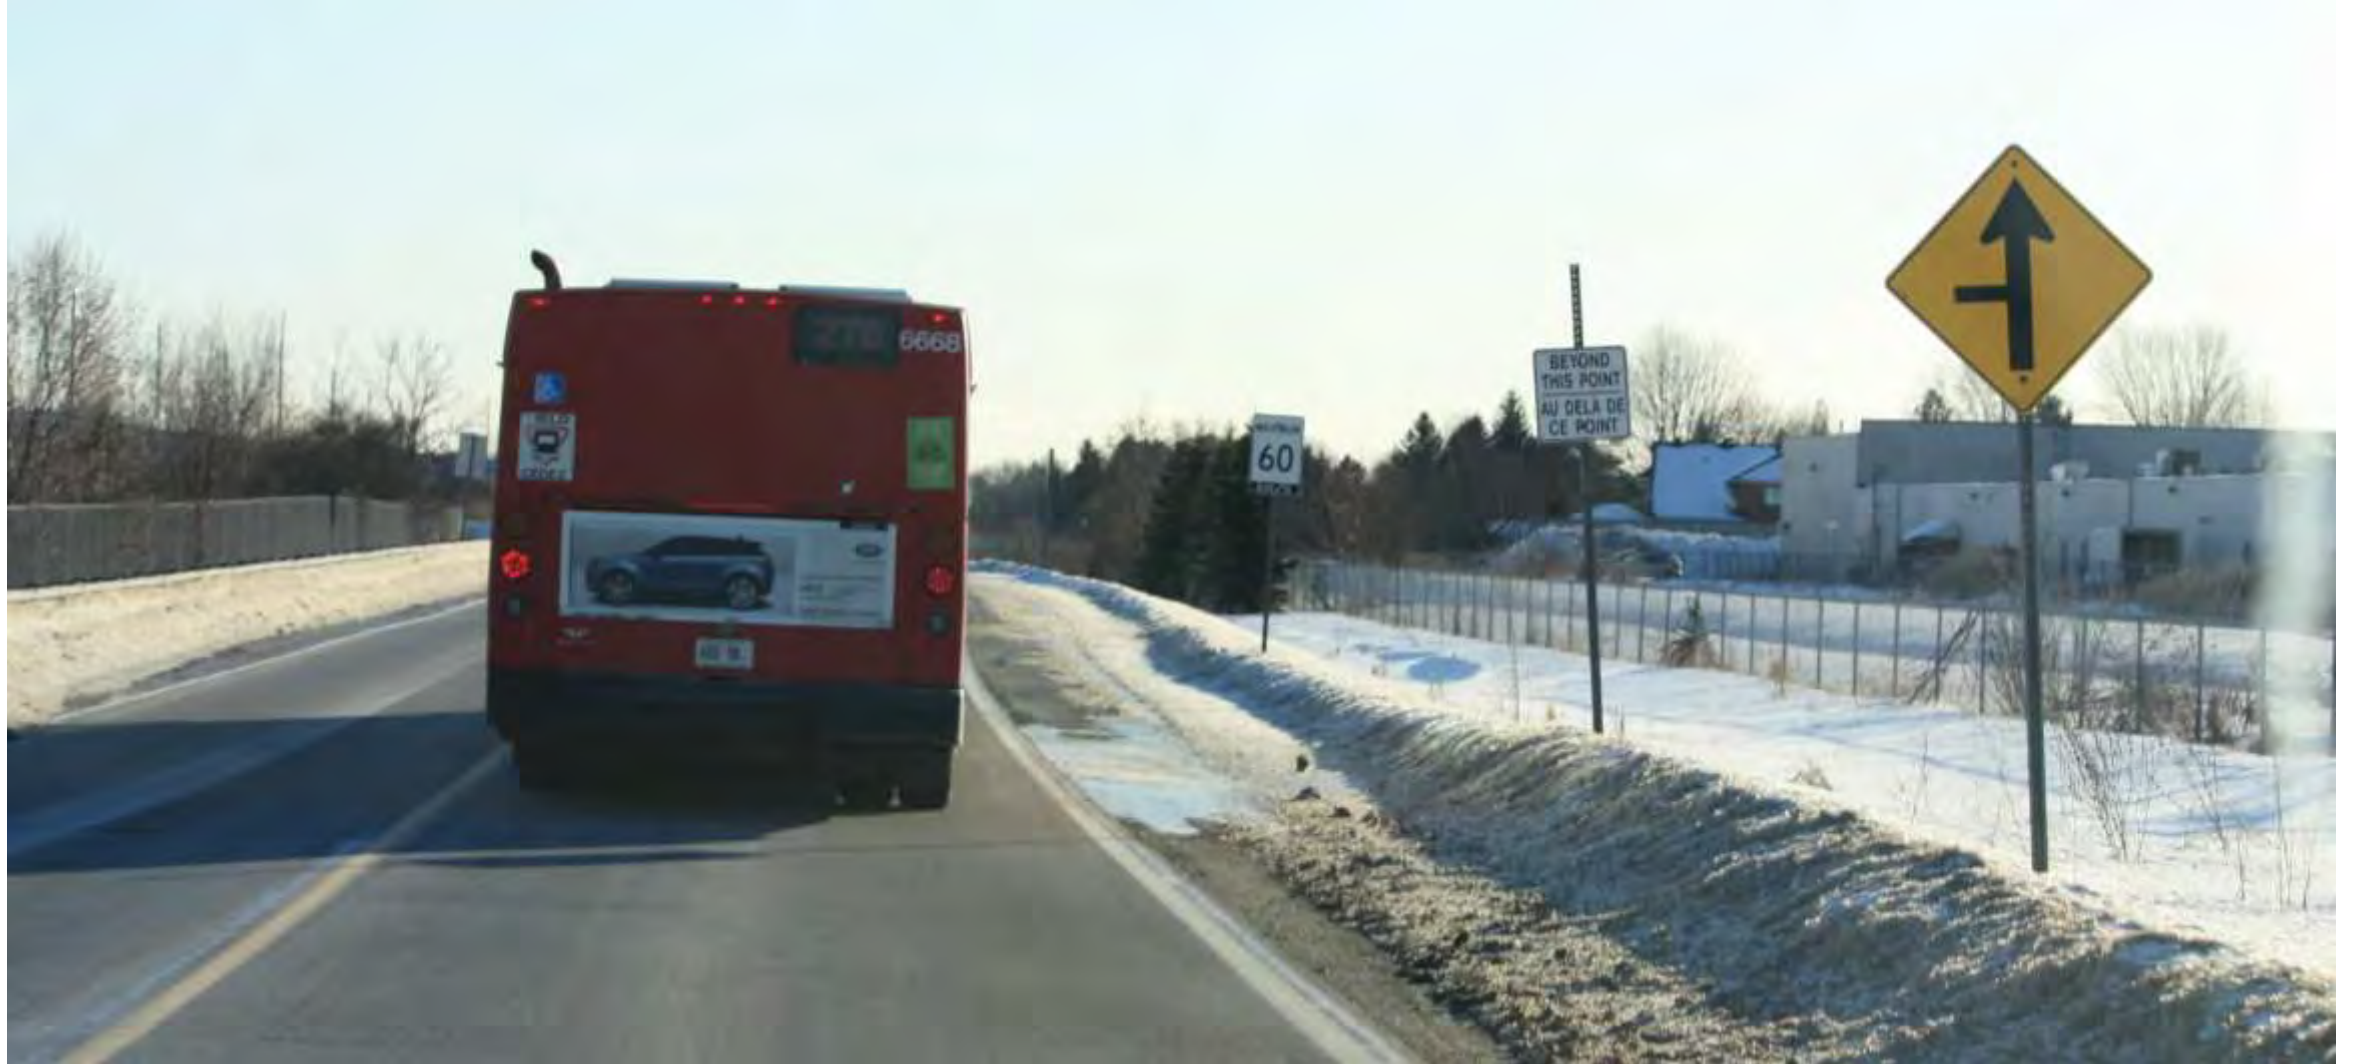
MISSING NO ENTRY SIGN

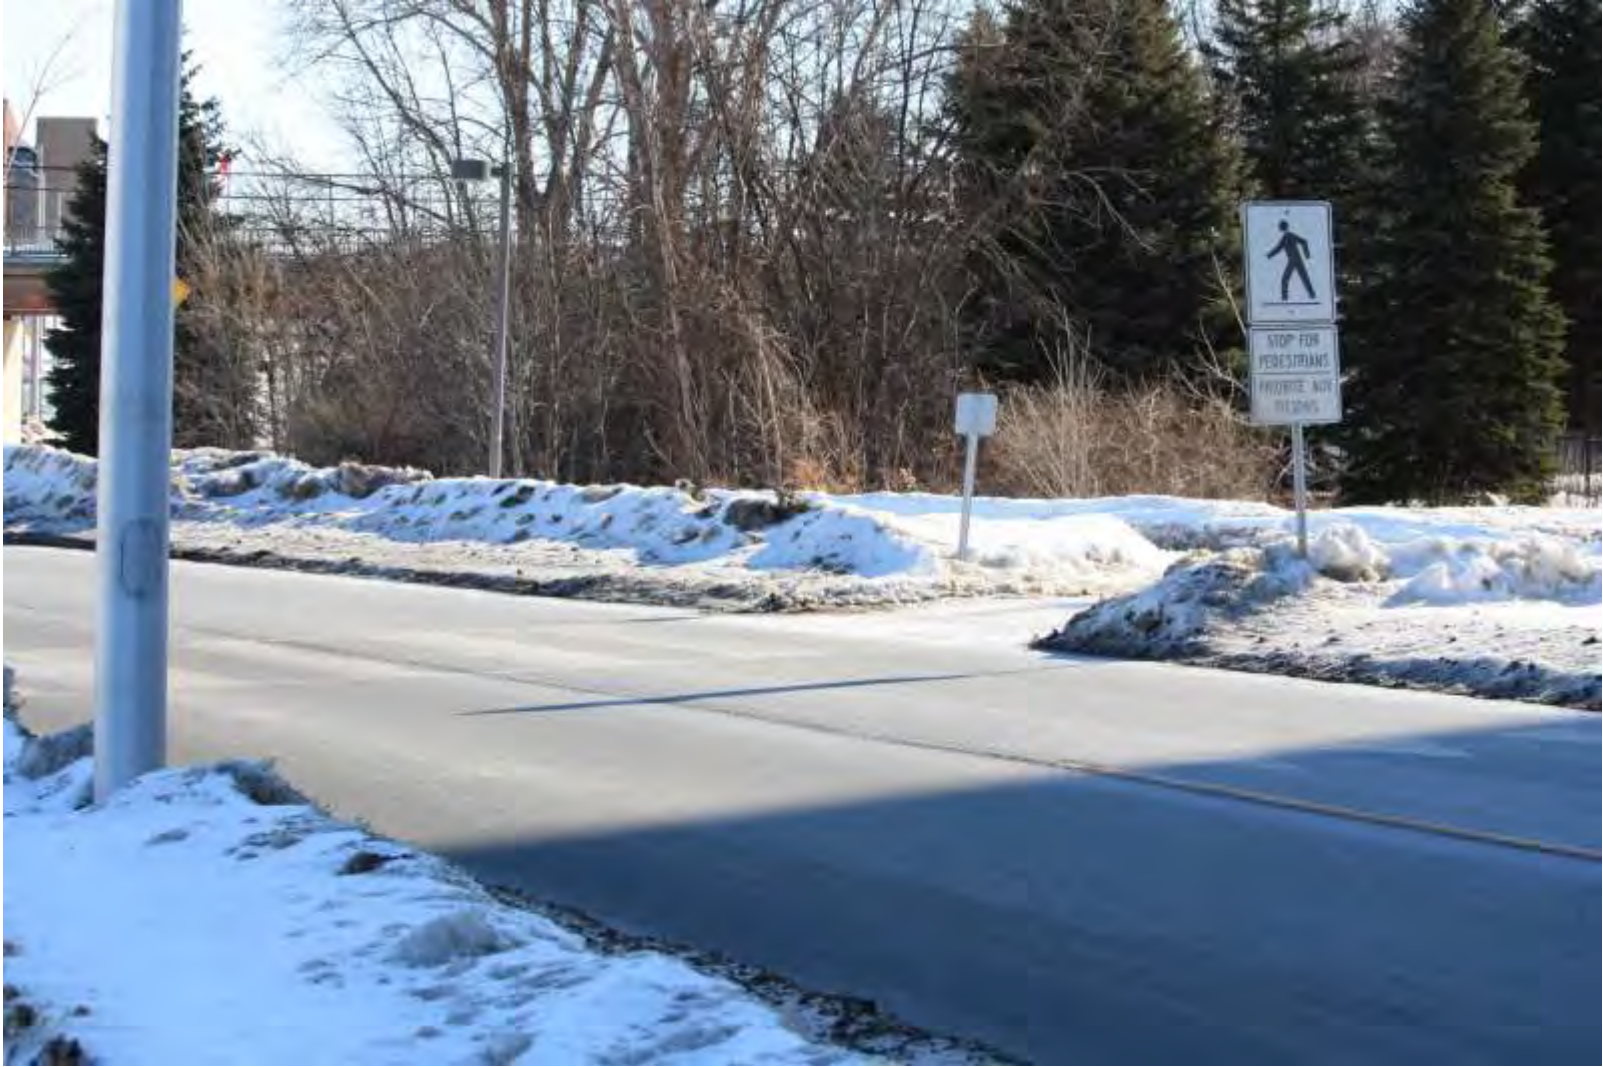
COURTESY CROSSWALK – FADED ROAD MARKINGS

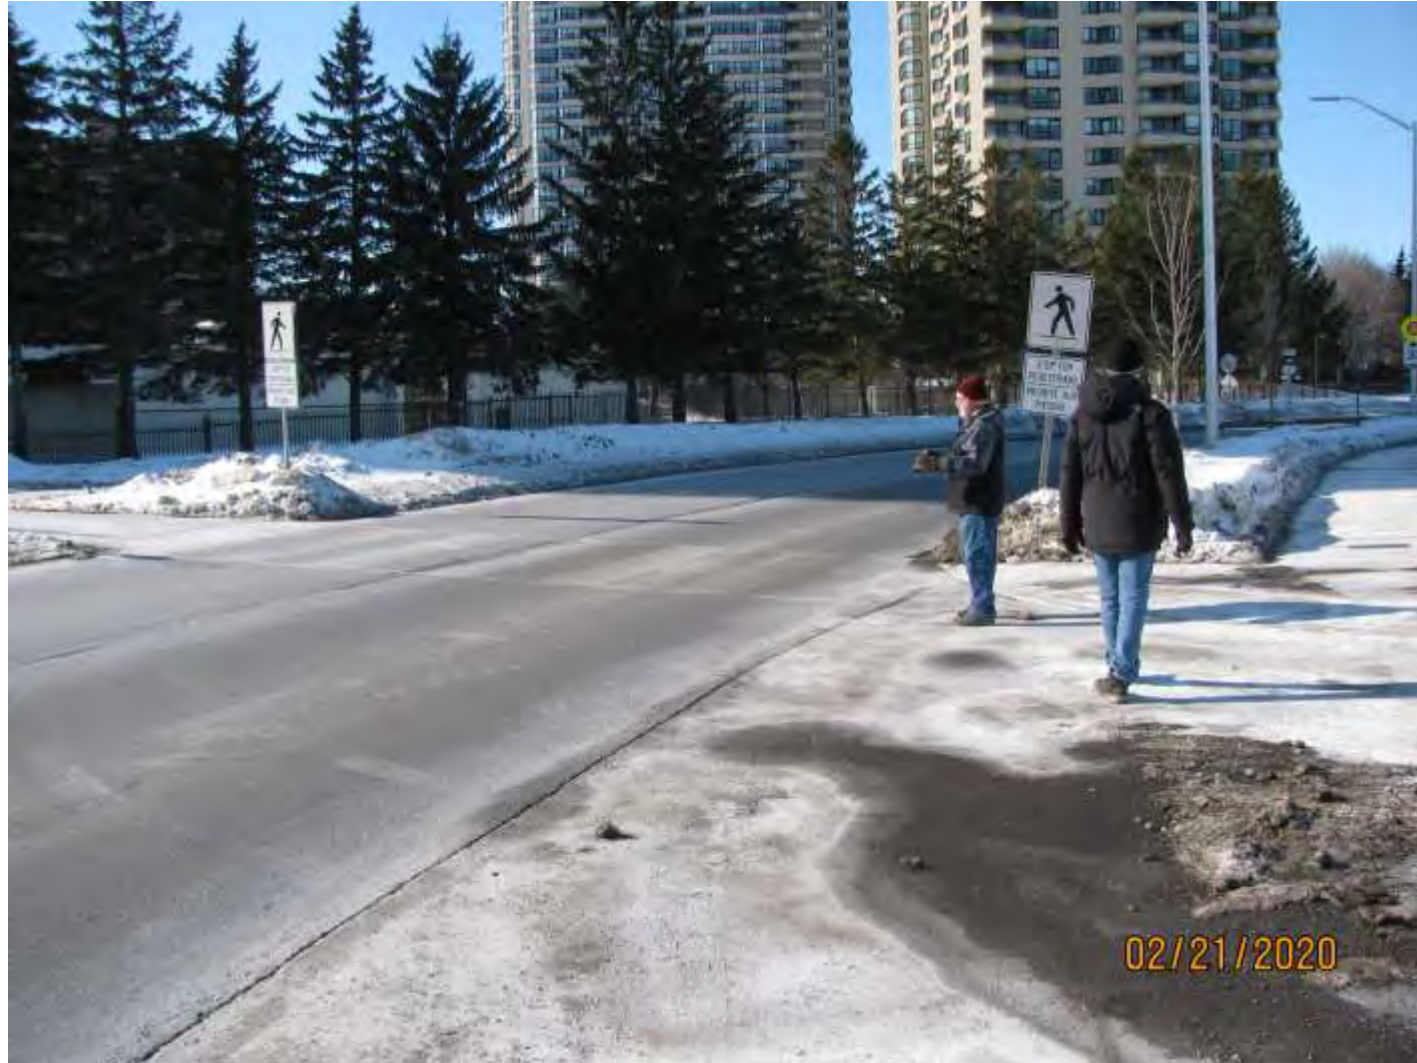
LUMINAIRES NOT LOCATED AT CROSSING
