Office of the Auditor General

2010 Audit of the Mackenzie King Bridge Rehabilitation

Tabled at Audit Committee – November 26, 2015

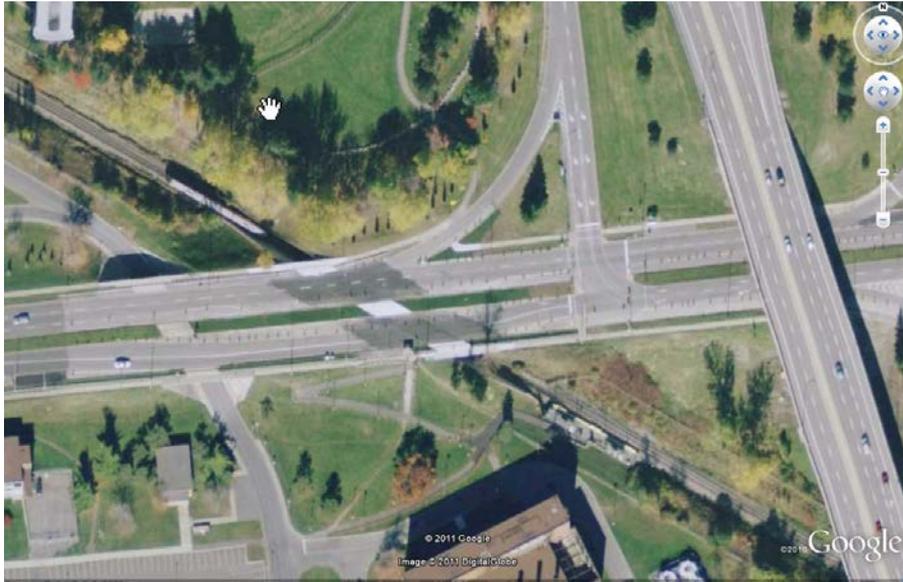
During the course of the audit we learned that Rosphalt was applied to a second structure in 2008, namely the Heron Road overpass over the O-Train line, located about 140m west of the Airport Parkway (see **Figure 4.1**).

According to the City, the RMHMA on this structure has broken up severely on the eastbound lanes but not on the westbound bus lane. The main difference between the two lanes is the existence of a bus stop a few meters east of the bridge (see **Figure 4.2**), a bus-only lane, and traffic lights only 60m east of the bridge on the eastbound lanes; the westbound traffic does not stop on or near the bridge and there is no westbound bus lane.

Figure 4.1 - Heron Road Overpass LRT (dark pavement)

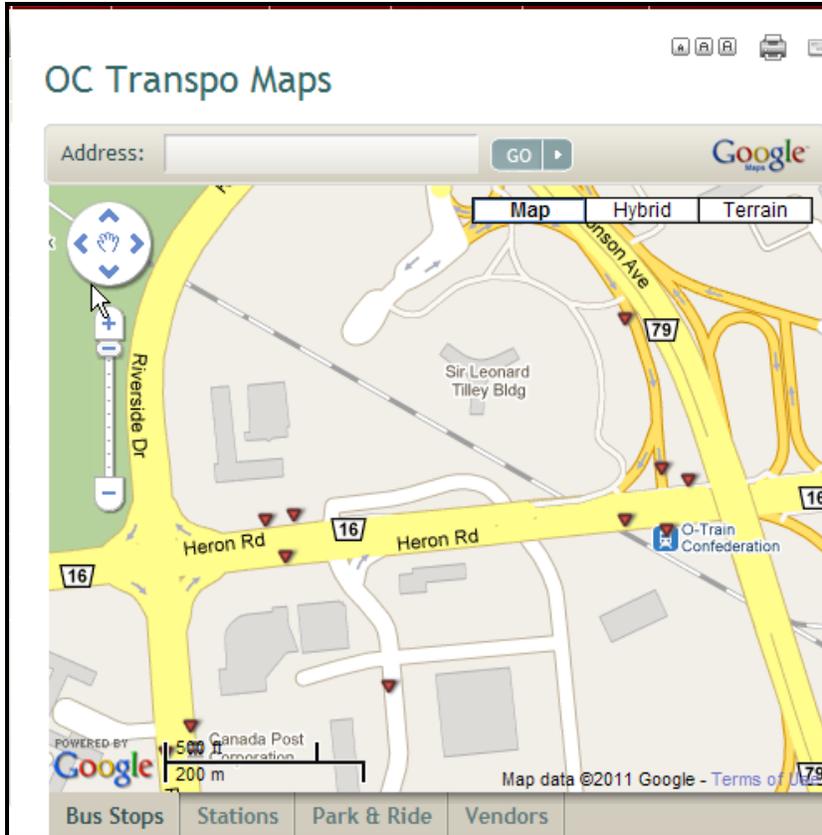
Figure 4.2 - Location of Bus Stops near the Heron Road Overpass LRT
