**Ottawa Light Rail Transit
Project, Confederation Line**

**Investigation and Root Cause
Analysis of June 8, 2016
Sinkhole on Rideau Street**

**Report Status (Final Draft)
Revision No. 2**

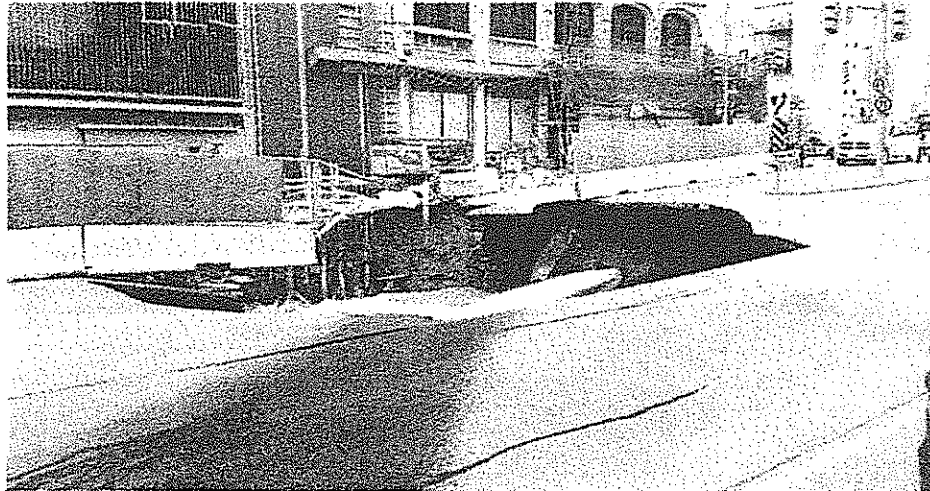
Figure 1-1: Sinkhole on Rideau St. Looking SW at 10 Rideau St.

- The surface manifestation of the sinkhole initiated on the south side of Rideau Street approximately 2 to 4 meters east of the west running tunnel face, and progressed to the north side of Rideau Street. The exact time of the initial surface manifestations of the sinkhole is uncertain based on available information, however by 10:30 to 10:35 AM the sinkhole had expanded across the southern half of Rideau Street. Refer to **Figure 1-1** and **Figure 1-2**.

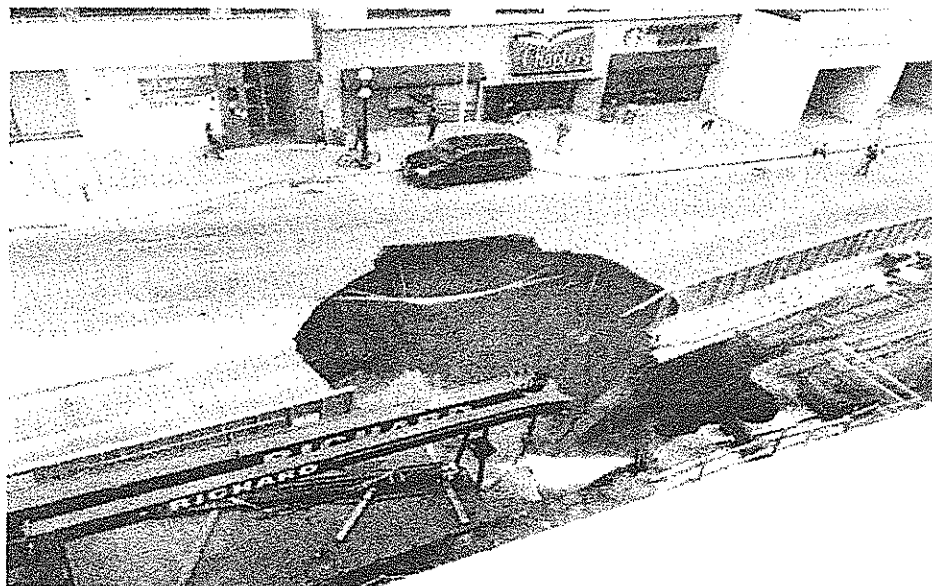
Figure 1-2: Sinkhole on Rideau St. Looking North at 47-57 Rideau St
