February 3, 2023

**Subject: Rail Transportation Safety Advisory Letter 01/23 (occurrence R22H0037)  
Ongoing failures of cartridge roller bearing assemblies on Ottawa Light Rail  
Transit vehicles**

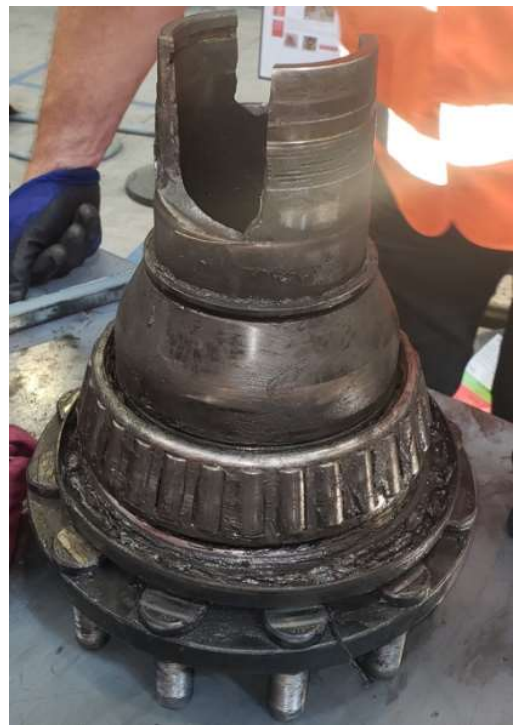
**Figure 3. Light rail vehicle 1127 failed axle hub (Source: TSB)**

On 23 July 2022, while inspecting all 20 of the LRV cartridge assemblies for free play, the assembly on the disc brake of axle 1 on BM1 (wheel position 1) displayed 10 times the maximum limit of free play. The assembly was removed, and further examination identified that the axle hub was damaged so severely that catastrophic failure was likely to occur had it remained in service (Figure 3).

The failed axle hub from LRV 1127 was examined at the TSB laboratory under both optical and scanning electron (SEM) microscopes. Under SEM examination, the fracture surfaces exhibited indications of beach marks, which are synonymous with classic fatigue failures. The fracture initiation point was identified at the chamfered end of the axle hub.

The inner roller bearing cone raceway of the large cone assembly was fractured. The fracture was an instantaneous overstress fracture and was not caused by fatigue. The raceway fracture surfaces displayed the presence of oxidation, which suggests that the raceway fracture was present for some time prior to the axle hub failure. The cone raceway exhibited some spalling, which most likely occurred as a result of the fracture.

During the cartridge assembly examinations, areas of heat discolouration were observed on several components, and the condition of some grease samples suggested that the assemblies had been subjected to a higher-than-average heat event, likely related to a deteriorating cartridge assembly condition.

In summary, the 3 cartridge assemblies examined by the TSB exhibited numerous failure modes. The modes included fatigue fractures, rolling contact fatigue, surface wear, impact wear, environmental erosion, and frictional wear. The observed damage was widely spread throughout the cartridge assemblies and was not limited to any one particular component. Consequently, it was not possible to determine which of the observed failure mechanisms occurred first. However, based on the observations made, the following can be stated:

Since the LRV 1127 axle A disc brake side cartridge assembly axle hub failed within an interval shorter than 7500 km (4393 km) from the previous inspection, on 29 July 2022, Alstom revised the cartridge assembly free play inspection intervals for OLRT LRVs as follows:

- The 7500 km inspection interval to be maintained on all axles with cumulative mileage below 175 000 km.
- Axles for the 3 middle LRV bogies to be inspected every 3750 km when mileage exceeds 175 000 km.
- Axles for motor bogie at each end of the LRV are to be replaced when cumulative mileage exceeds 175 000 km.
