Appendix B – Photographs

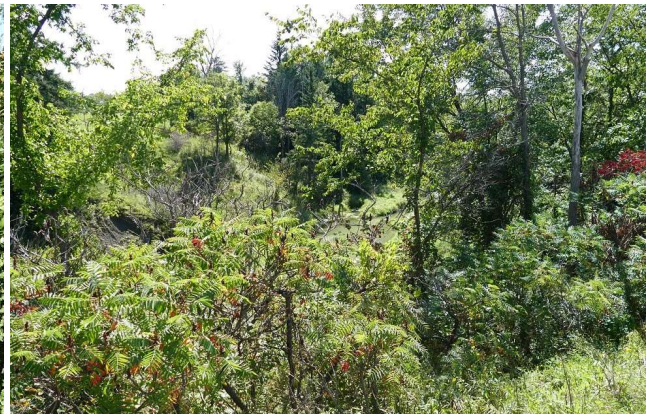
Beckett's Creek – views downstream (1) and upstream (2, 3) of mainstem as visible from Regional Road 174; views are partially obscured by trees and shrubs. Photo 2 shows evidence of slope failure on the southeast bank. Views downstream (4) and upstream (5) from Old Montréal Road. Steep embankments and gully erosion evident upstream (6) and downstream (7, 8) along Old Montréal Road.

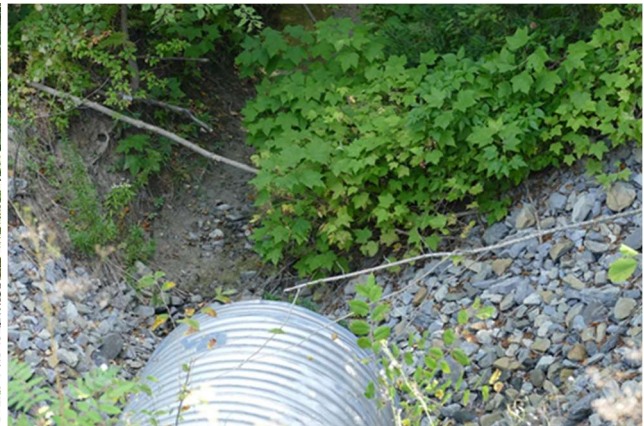
28

Beckett's Creek Tributaries – views downstream (23) and upstream (24) from Birchgrove Road north of Etienne Road. Views downstream (25) and across fields (26) from Sarsfield Road south of Beaton Road. Significant woodland visible on the horizon (26). Views downstream (27) and upstream (28) from Canaan Road, south of Oakwood Drive, showing very minimal flows.
