Office of the Auditor General/ Bureau du vérificateur general

AUDIT OF EIGHT SPECIFIC BUILDING CODE SERVICES FILES

2009

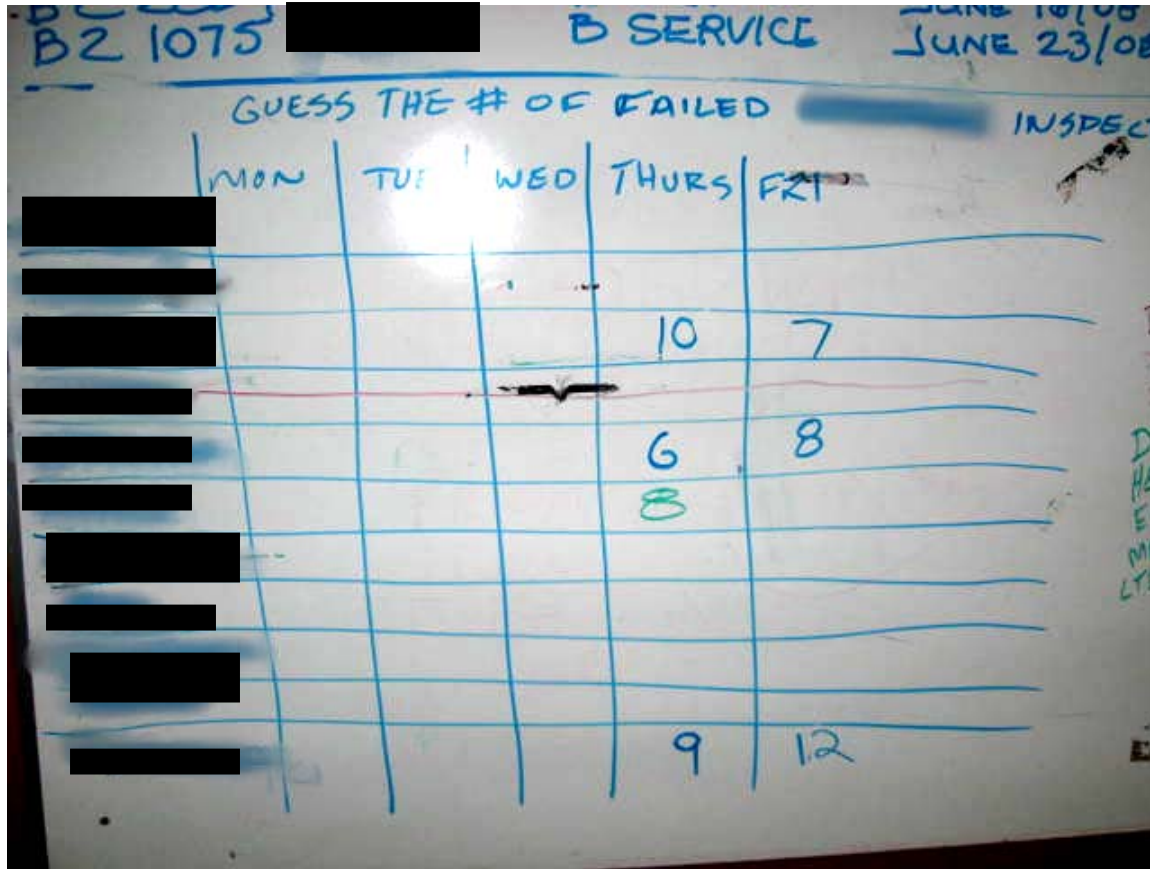
Saved as: [REDACTED] H Drive Contents \ Operational \ Misc [REDACTED] Lottery.jpg

- We observed that a management employee had saved on his H drive (personal network drive) on June 6, 2008 a photograph of an office pool under filename: “(name of builder) Lottery.jpg”. Per the photograph, it appears that 11 of this program manager’s subordinates may have been speculating on the number of inspections a specific developer would fail from June 16 to 23, 2008. Below is the photograph of the office pool.

FIGURE 1: PHOTOGRAPH OF OFFICE POOL, “GUESS THE NUMBER OF FAILED INSPECTIONS”
