City View Drainage Study

November 2022

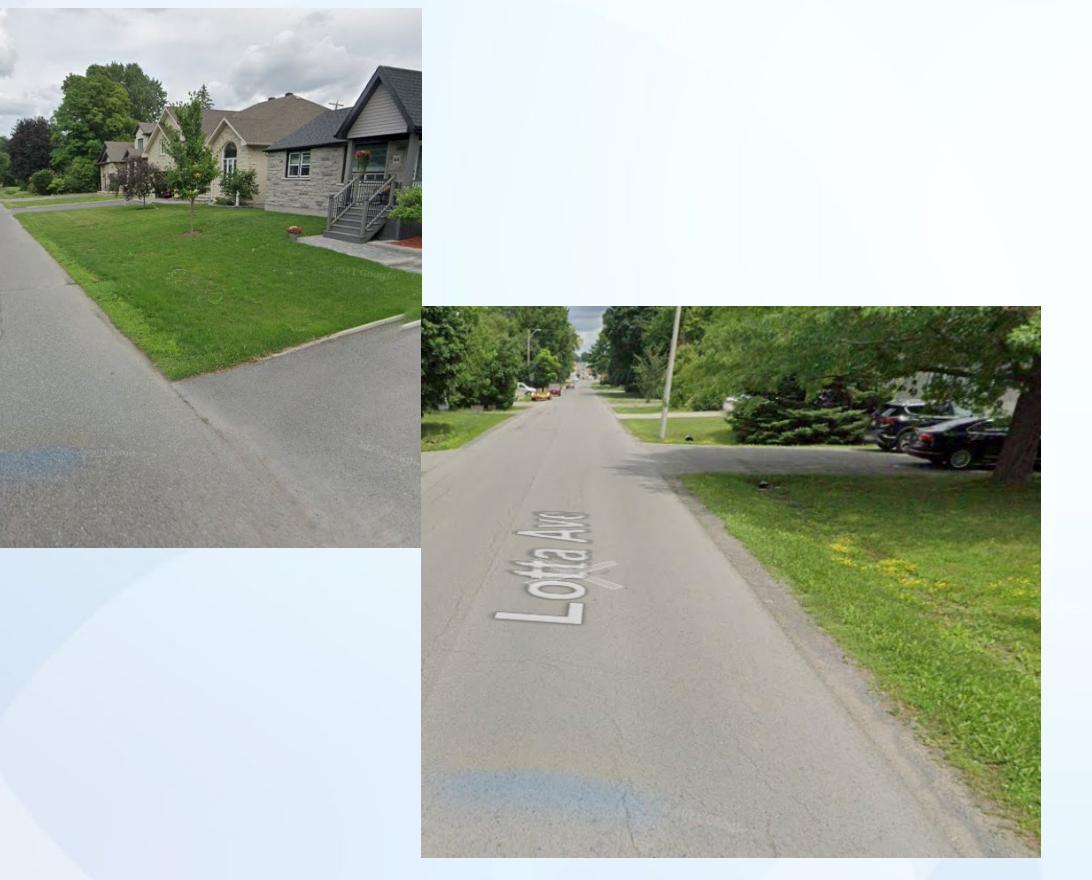
Background – Drainage issues

- Ditch infills (Nepean permits and illegal)
- Sedimentation of ditches (lack of cleaning)
- Lack of proper outlet for sump pumps

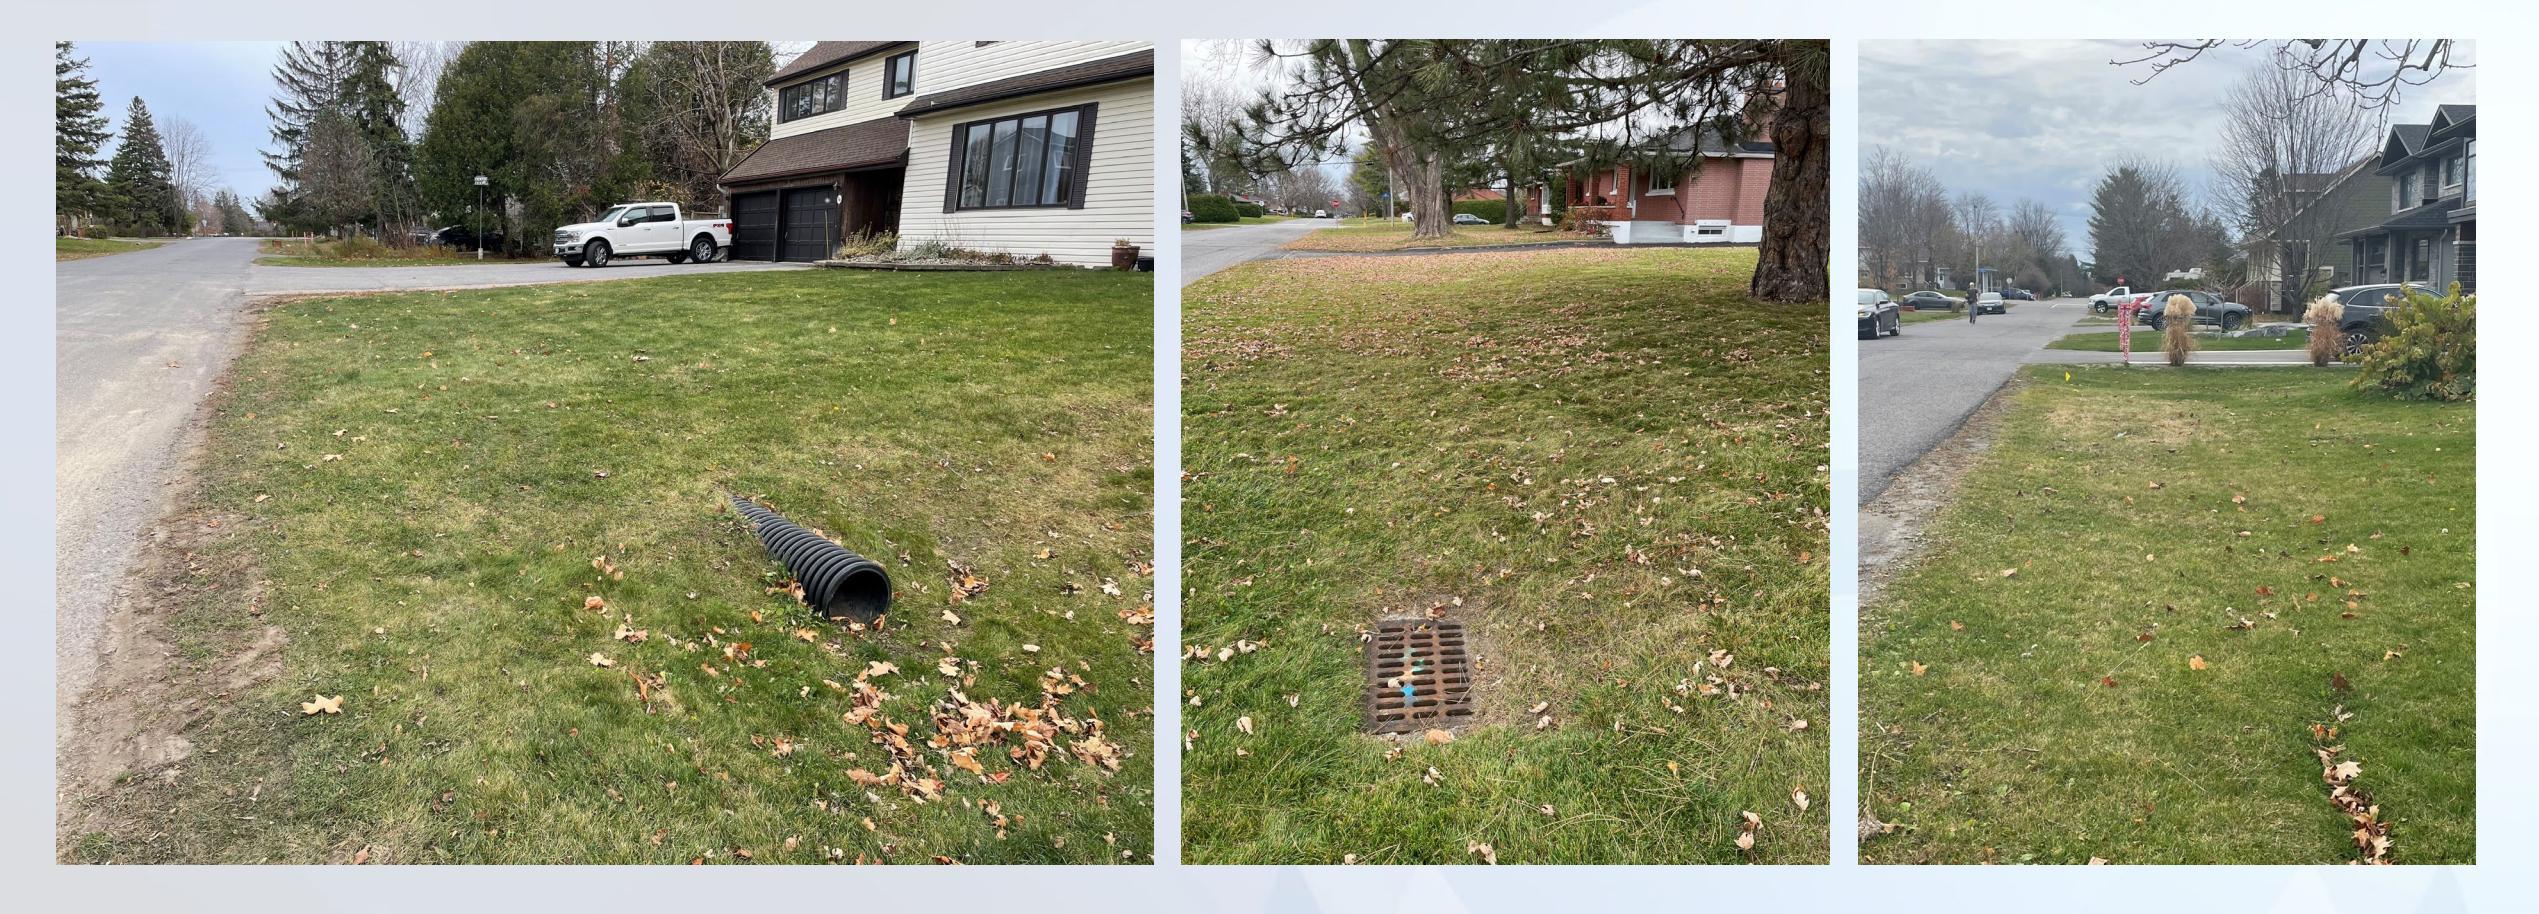
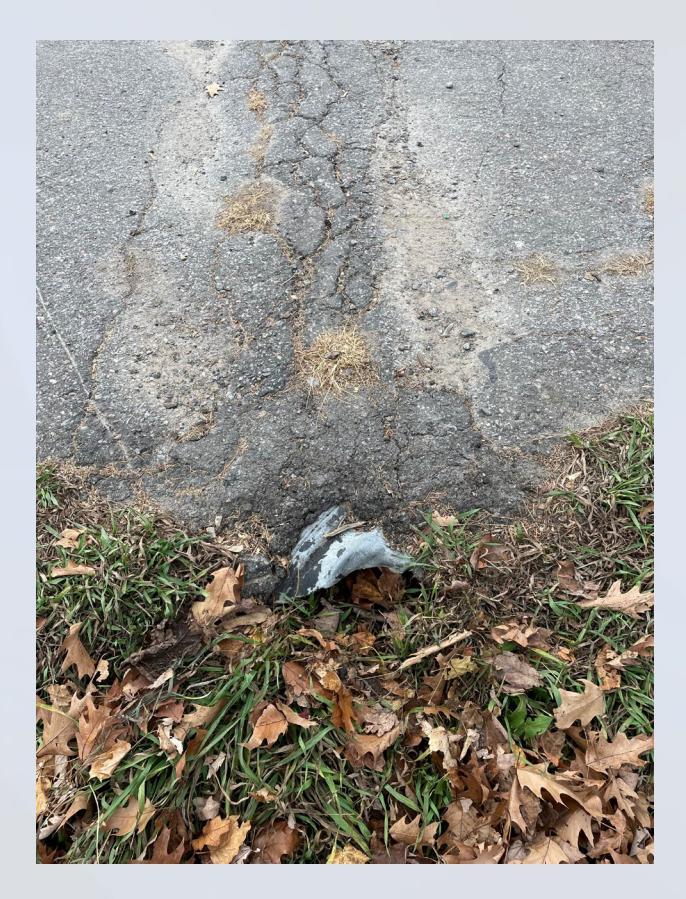
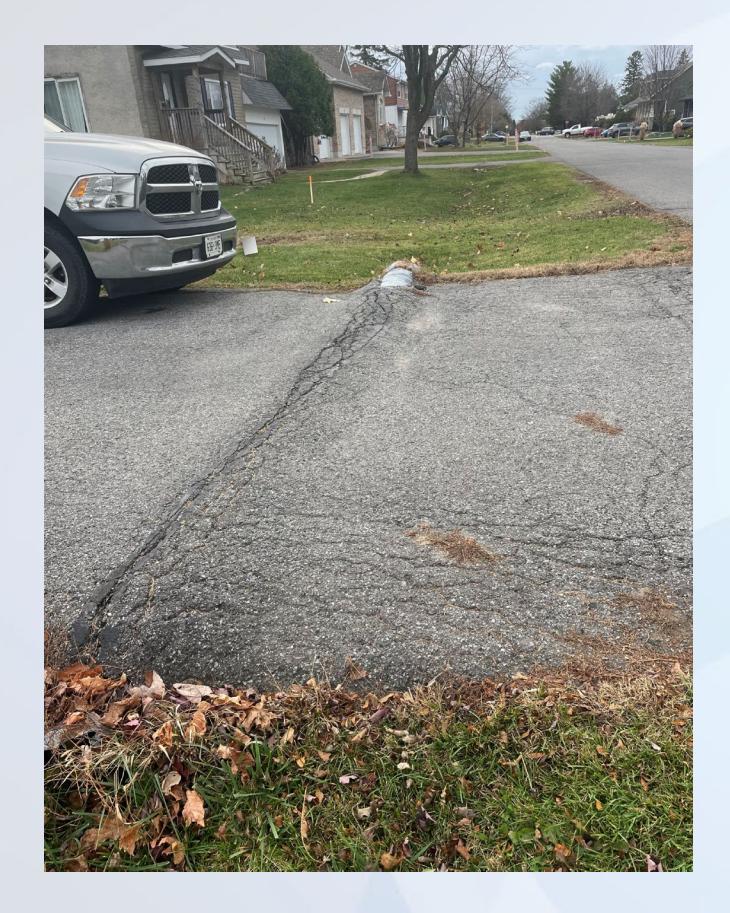
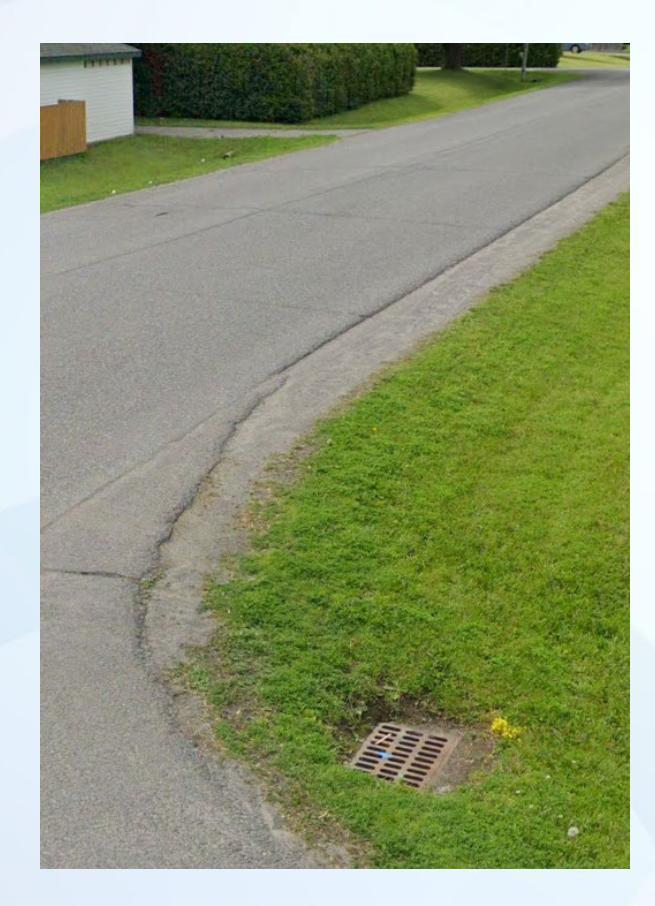
Issues found

- Lack of consistency and connectivity
- Informal Ditch piping systems
- Filled in ditches, blocked or buried culverts
- Various culvert sizes and extensions
- Poor condition road crossing culverts
- Lack of adequate outlets
- Widespread ponding
