City of Ottawa - Kanata & Downtown Ottawa Aerial Thermography and Quantification Aggregate Analysis Interim Report

December 19, 2023

Ottawa Thermal Imaging Report

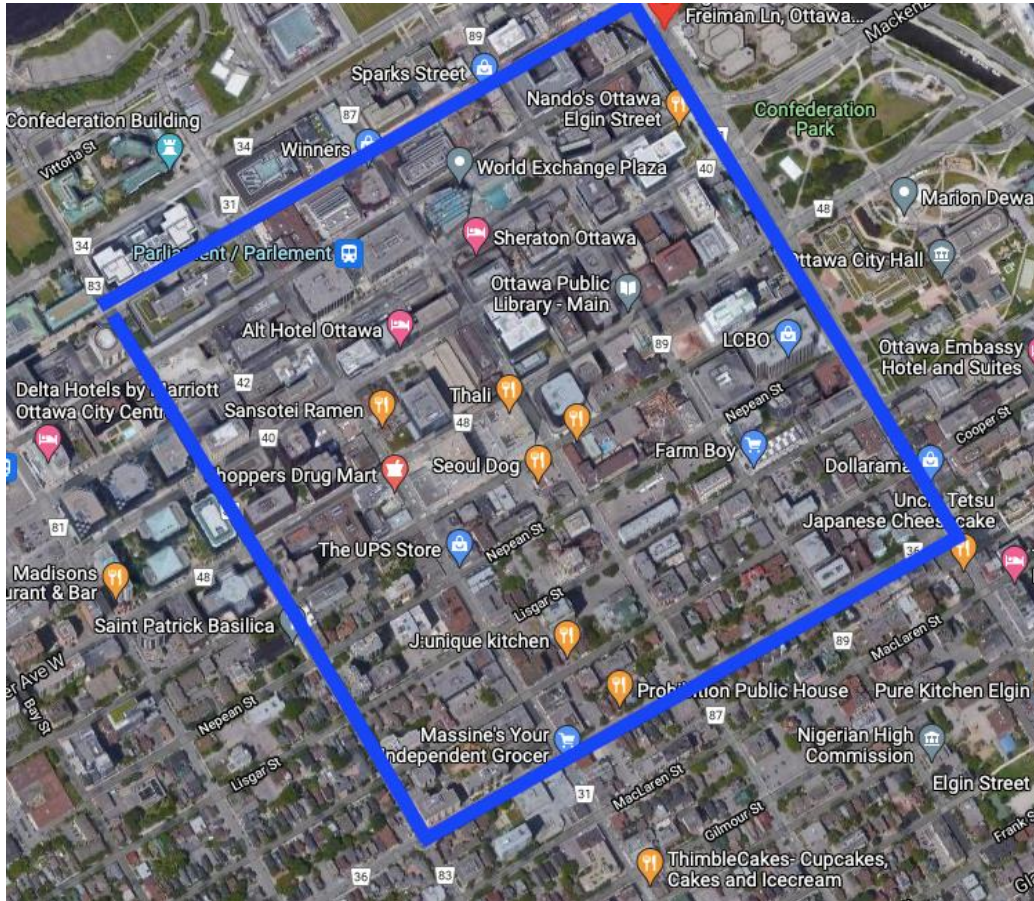
Facade scanning operation for Area 1 (Downtown Ottawa) illustrated below was conducted on November 27, 2022.

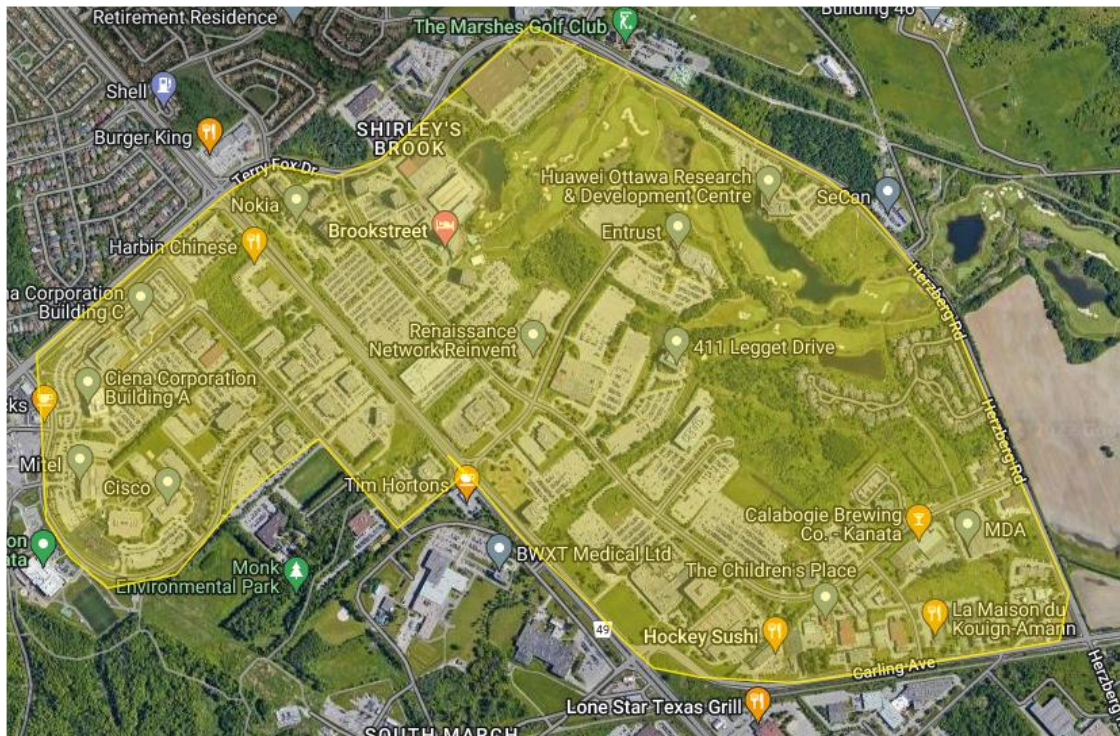
Facade scanning operation for Area 2 (Kanata North) illustrated below was conducted on November 28, 2022.

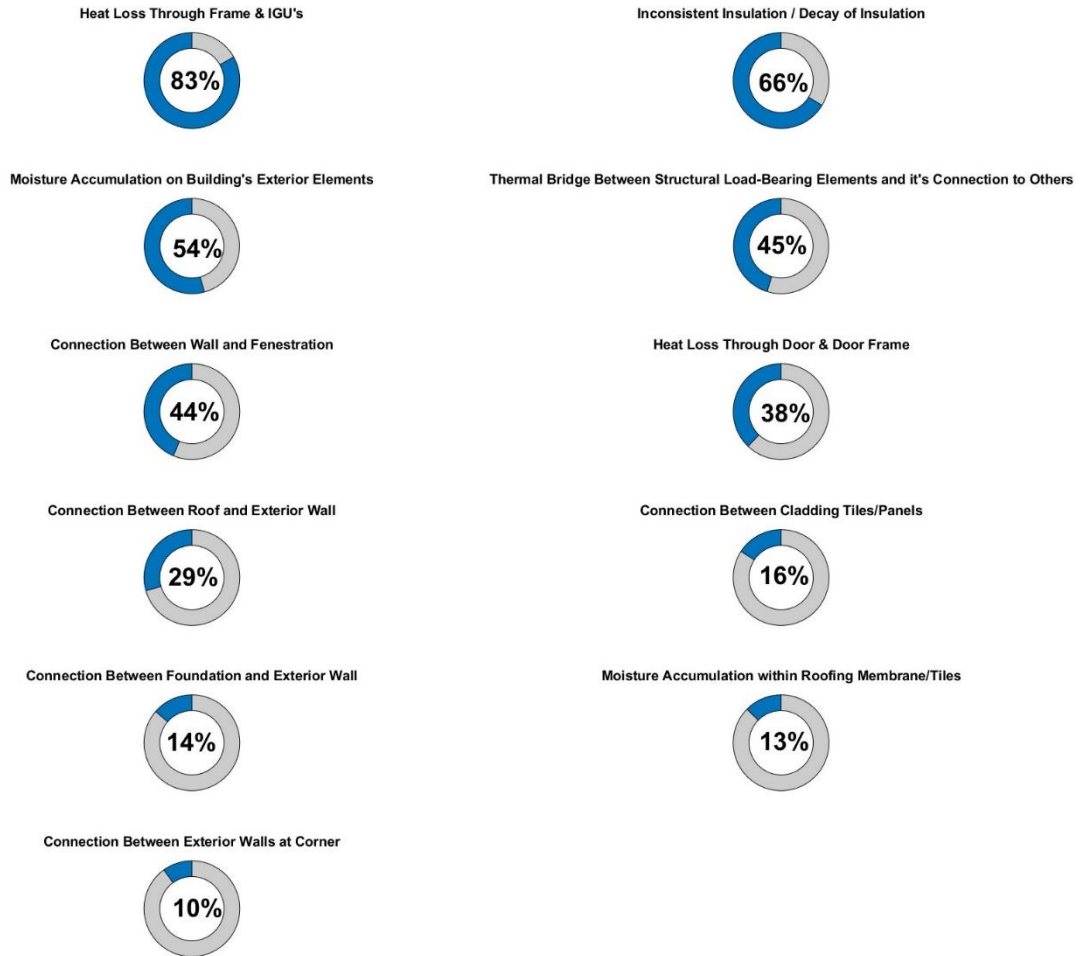
Figure 1: Summary of Issues Found in All Buildings

Every building analyzed across the two catchment areas showed at least one instance of a building envelope issue. The three most frequently found issues in buildings were:

- Heat Loss Through Frame & IGUs
- Inconsistent Insulation / Decay of Insulation
- Moisture Accumulation on Building's Exterior Elements

Issue Type	Number of Buildings Found	Number of Occurrences
"Heat Loss Through Frame & IGU's"	158	320
"Inconsistent Insulation / Decay of Insulation"	126	266
"Moisture Accumulation on Building's Exterior Elements"	103	276
"Thermal Bridge Between Structural Load-Bearing Elements and its Connection to Others"	86	144
"Connection Between Wall and Fenestration"	83	137
"Heat Loss Through Door & Door Frame"	72	90
"Connection Between Roof and Exterior Wall"	56	70
"Connection Between Cladding Tiles/Panels"	30	48
"Connection Between Foundation and Exterior Wall"	26	26
"Moisture Accumulation within Roofing Membrane/Tiles"	24	31
"Connection Between Exterior Walls at Corner"	19	21

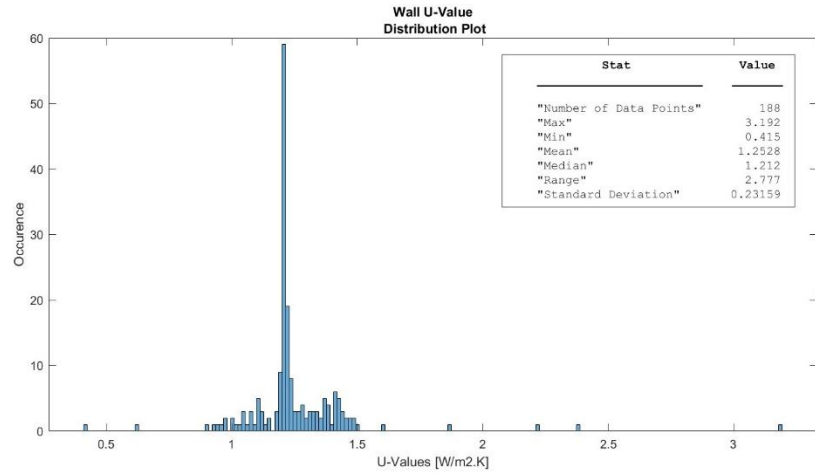
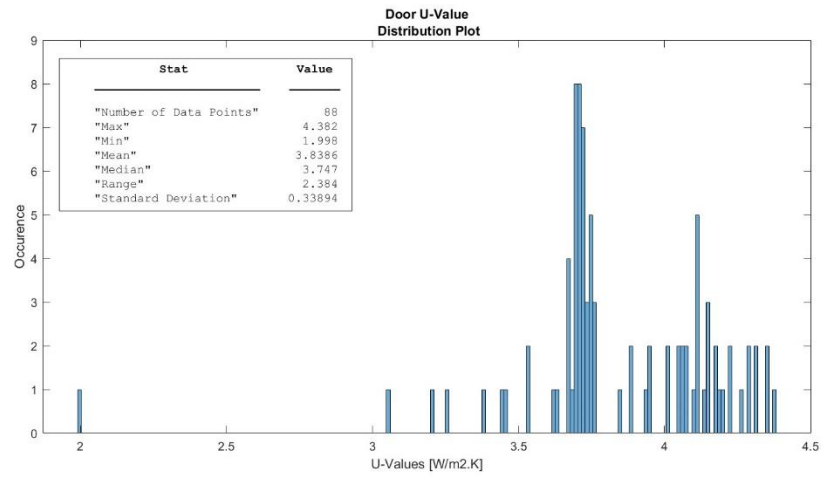
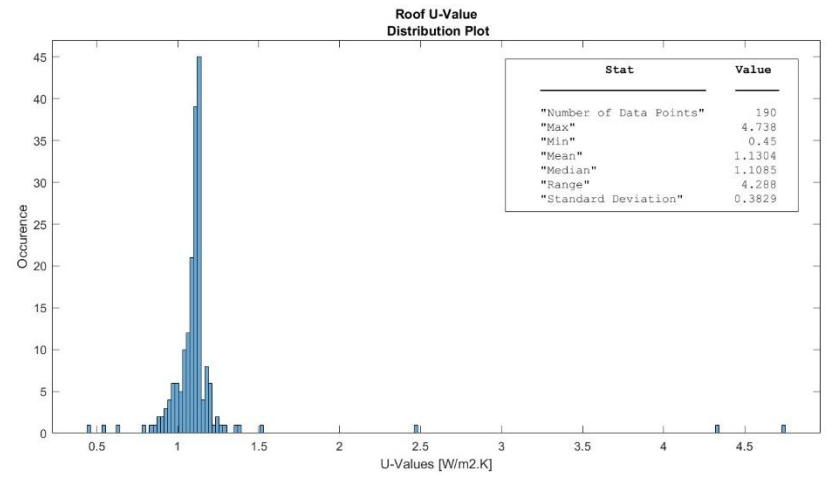
Figure 2: Summary of U-Values of All Buildings

Figure 2 below shows distribution plots for the U-values of walls, windows, doors, and roof for all the buildings in the two catchment areas. Each plot contains the following metrics:

Building Envelope Element - Downtown Ottawa	U-Value (W/m^2K)	% Difference vs Building Code	% Difference vs EEP
Wall	1.27	411	212
Window	3.27	127	N/A
Door	3.86	170	N/A
Roof	1.14	570	243

Building Envelope Element - Kanata	U-Value (W/m^2K)	% Difference vs Building Code	% Difference vs EEP
Wall	1.20	385	199
Window	3.26	127	N/A
Door	3.80	167	N/A
Roof	1.11	555	237

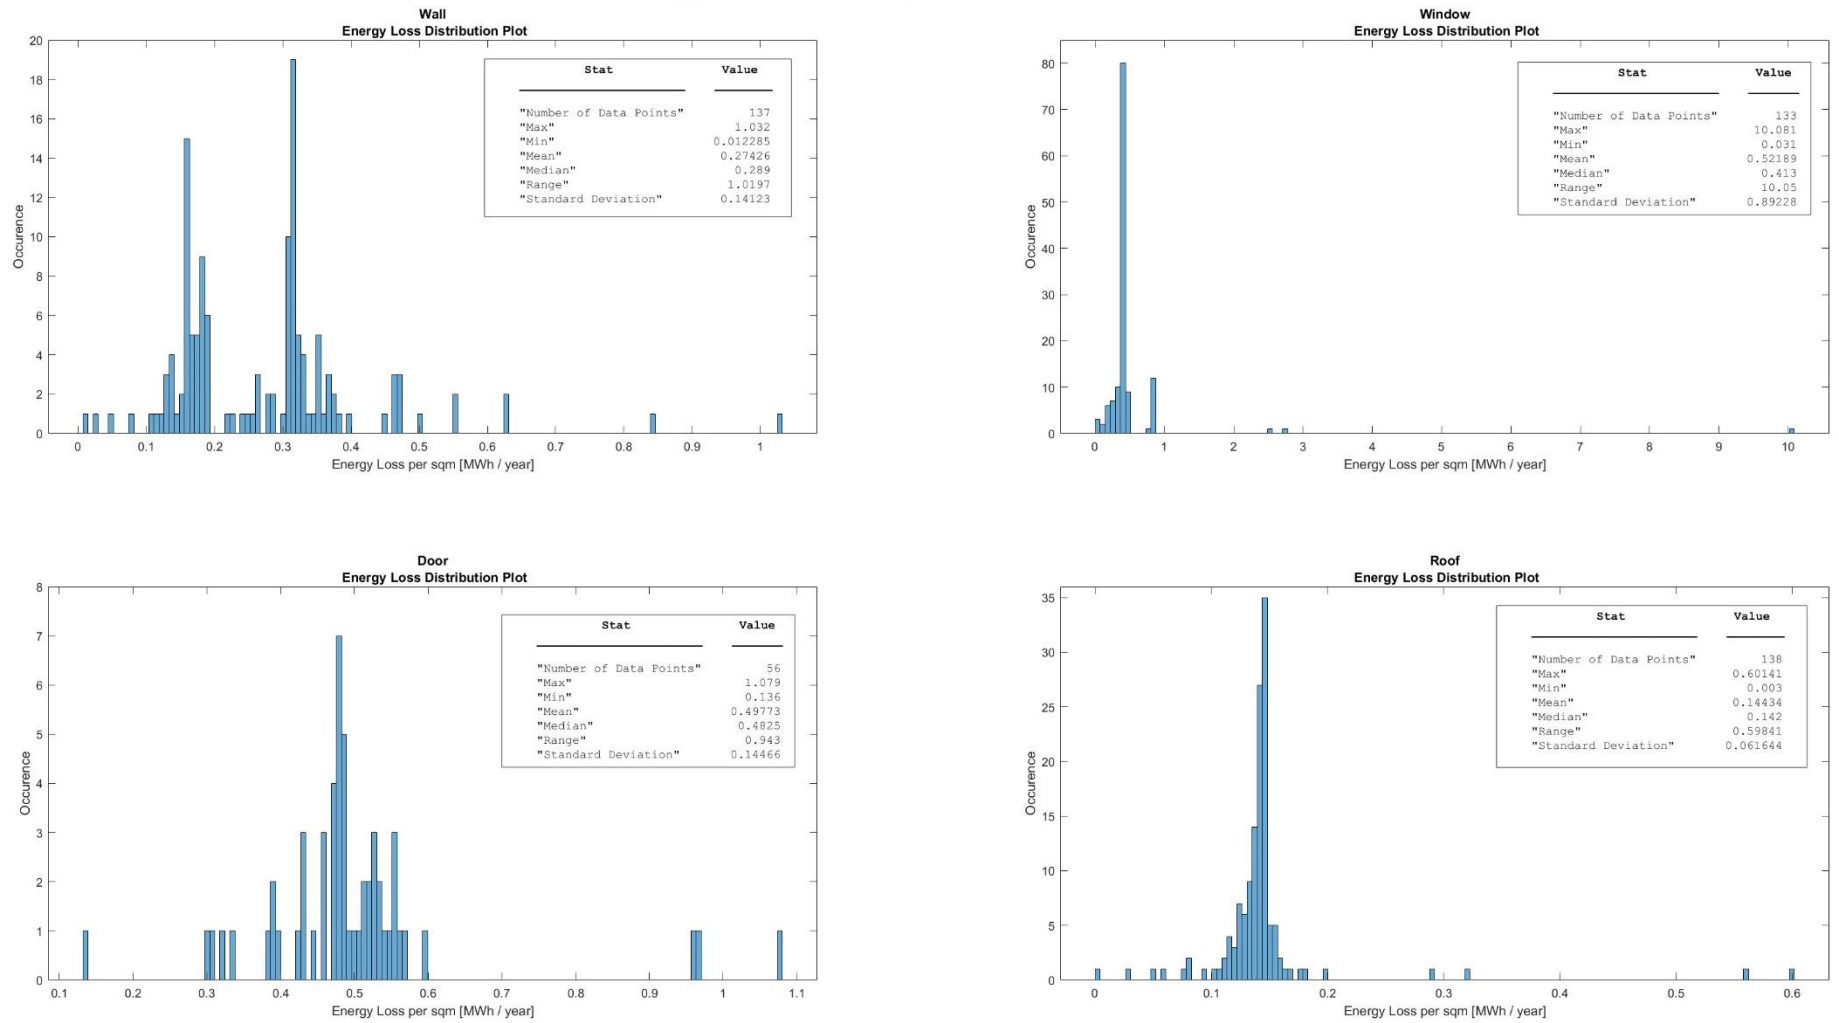
Figure 7: Distribution Plot for Annual Energy Loss for Different Building Elements in the Downtown Catchment

Figure 7 and Figure 8 show the distribution plot for the annual energy loss values per square metre of different building elements.

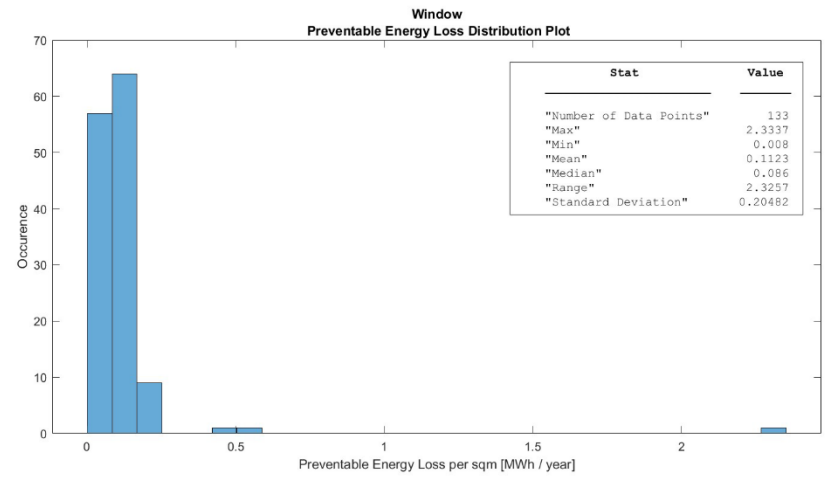
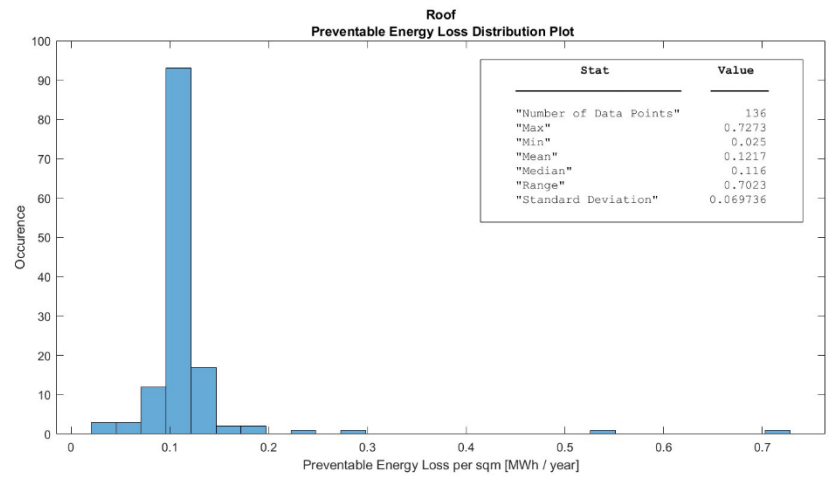
Figure 9: Distribution Plot for Annual Preventable Energy Loss for Different Building Elements in the Downtown Catchment

Figure 9 and Figure 10 show the distribution plot for the annual preventable energy loss per square metre of different building elements.

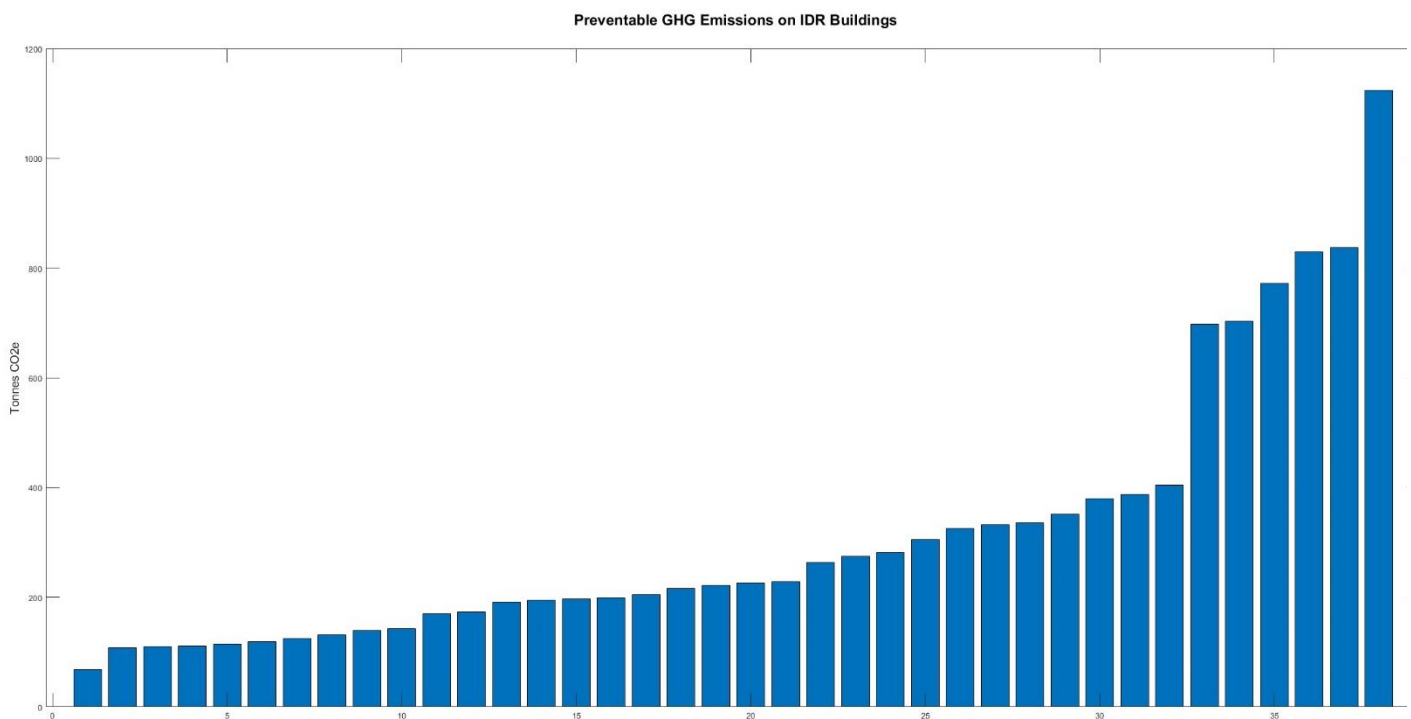
The method of heating/cooling for the properties was not known and it is assumed that all heating is with gas. As a result, a single conversion factor of 49 kgCO₂e/GJ from the GHG equivalencies calculator from Energy Star Performance Manager (ESPM) Emission Factors for natural gas was used for the calculations. No assumptions have been made regarding the buildings energy consumption as this information was not available for any of the buildings under investigation. The numbers reported in this section are solely the preventable GHG emissions based on the preventable energy loss calculations in the previous section 5.5.

The graph below illustrates the distribution of total preventable GHG emissions from the 38 buildings under consideration:

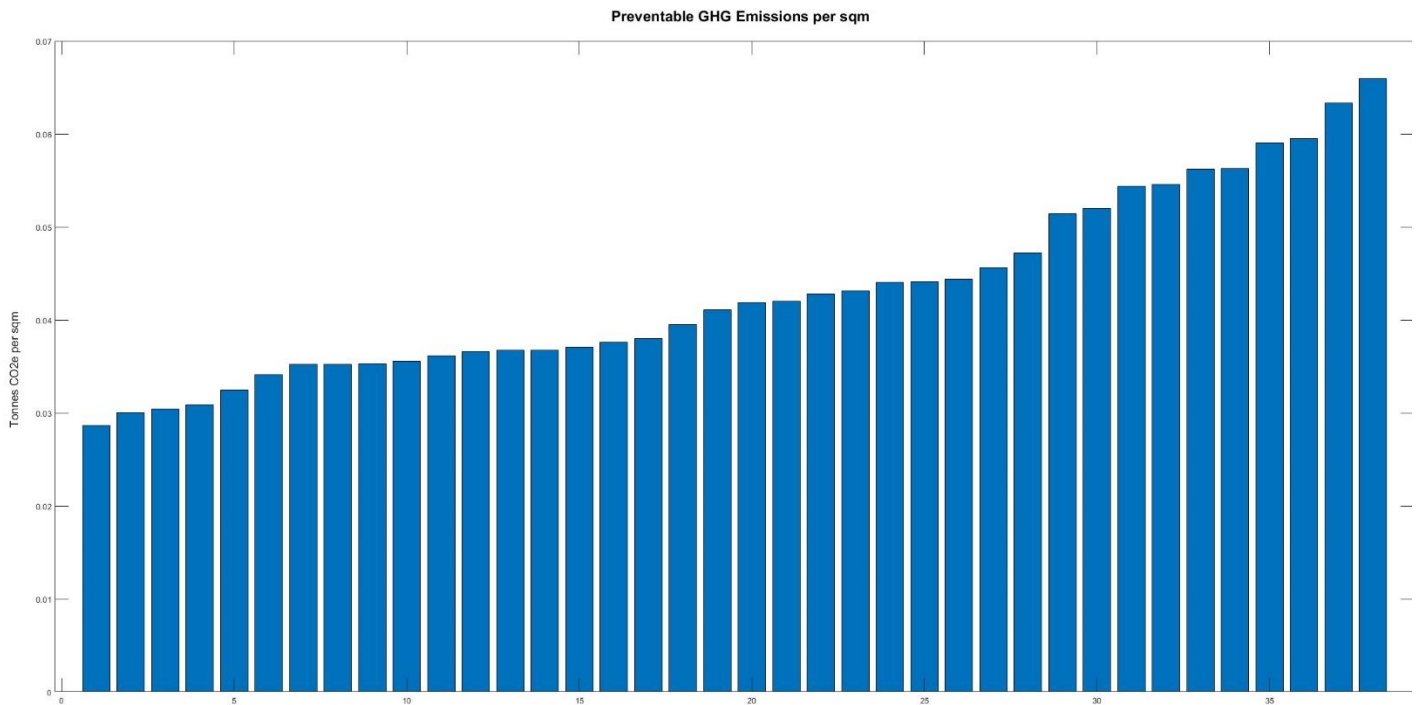
The following graph shows the distribution of preventable GHG emissions normalized to the total area of each of the 38 buildings:

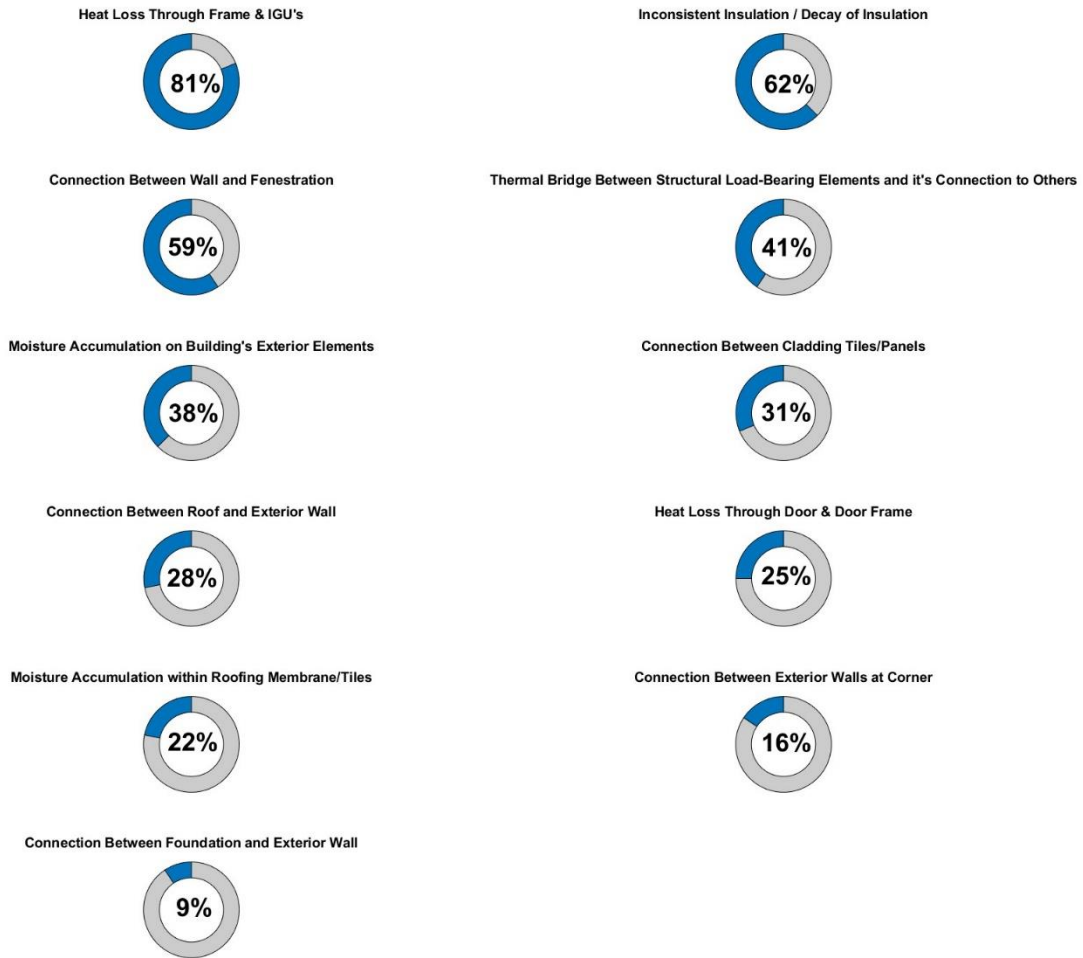
Figure 17: Summary of Issues in Downtown Catchment - Vintage Group 2

Issue Type	Number of Buildings Found	Number of Occurrences
"Heat Loss Through Frame & IGU's"	26	45
"Inconsistent Insulation / Decay of Insulation"	20	30
"Connection Between Wall and Fenestration"	19	30
"Thermal Bridge Between Structural Load-Bearing Elements and its Connection to Others"	13	27
"Moisture Accumulation on Building's Exterior Elements"	12	27
"Connection Between Cladding Tiles/Panels"	10	12
"Connection Between Roof and Exterior Wall"	9	13
"Heat Loss Through Door & Door Frame"	8	10
"Moisture Accumulation within Roofing Membrane/Tiles"	7	11
"Connection Between Exterior Walls at Corner"	5	5
"Connection Between Foundation and Exterior Wall"	3	3

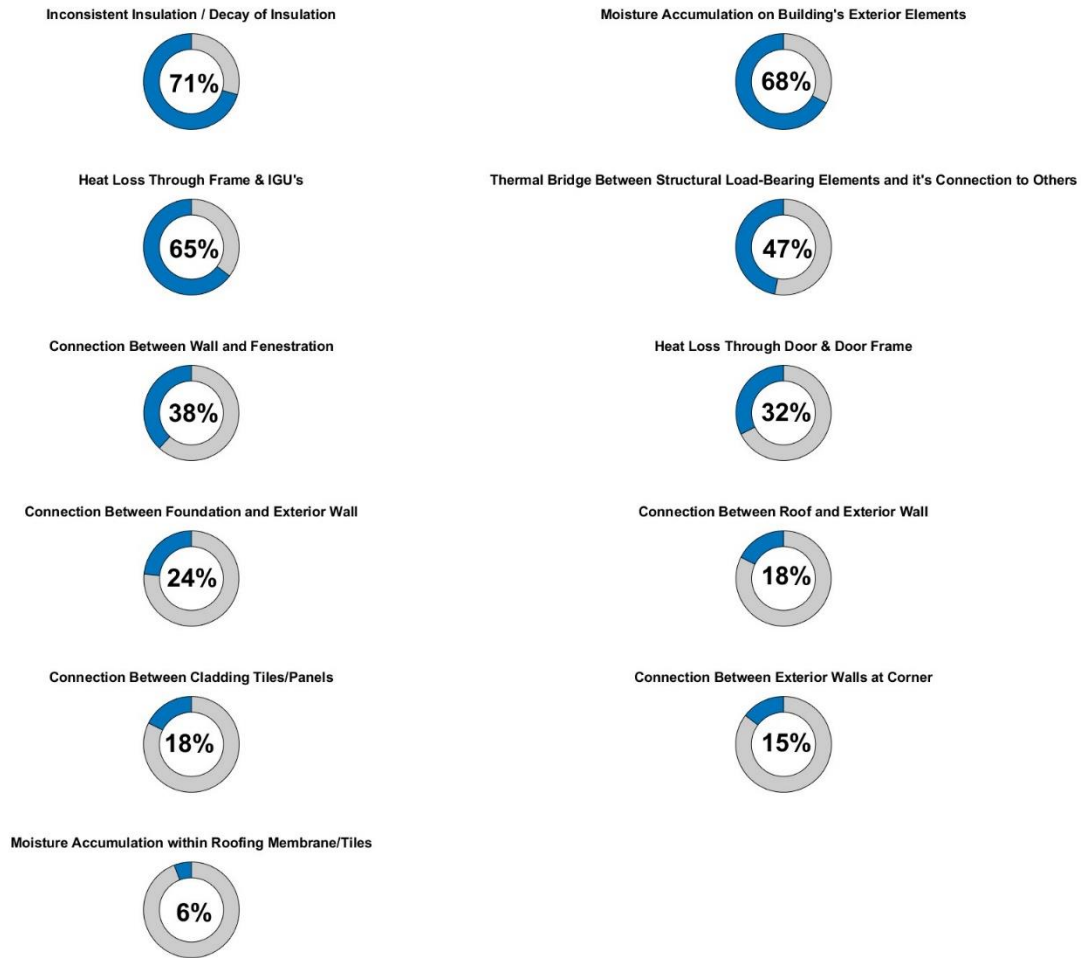
Figure 19: Summary of Issues in Downtown Catchment - Vintage Group 4

Issue Type	Number of Buildings Found	Number of Occurrences
"Inconsistent Insulation / Decay of Insulation"	24	45
"Moisture Accumulation on Building's Exterior Elements"	23	67
"Heat Loss Through Frame & IGU's"	22	35
"Thermal Bridge Between Structural Load-Bearing Elements and it's Connection to Others"	16	21
"Connection Between Wall and Fenestration"	13	25
"Heat Loss Through Door & Door Frame"	11	14
"Connection Between Foundation and Exterior Wall"	8	8
"Connection Between Roof and Exterior Wall"	6	9
"Connection Between Cladding Tiles/Panels"	6	9
"Connection Between Exterior Walls at Corner"	5	7
"Moisture Accumulation within Roofing Membrane/Tiles"	2	2

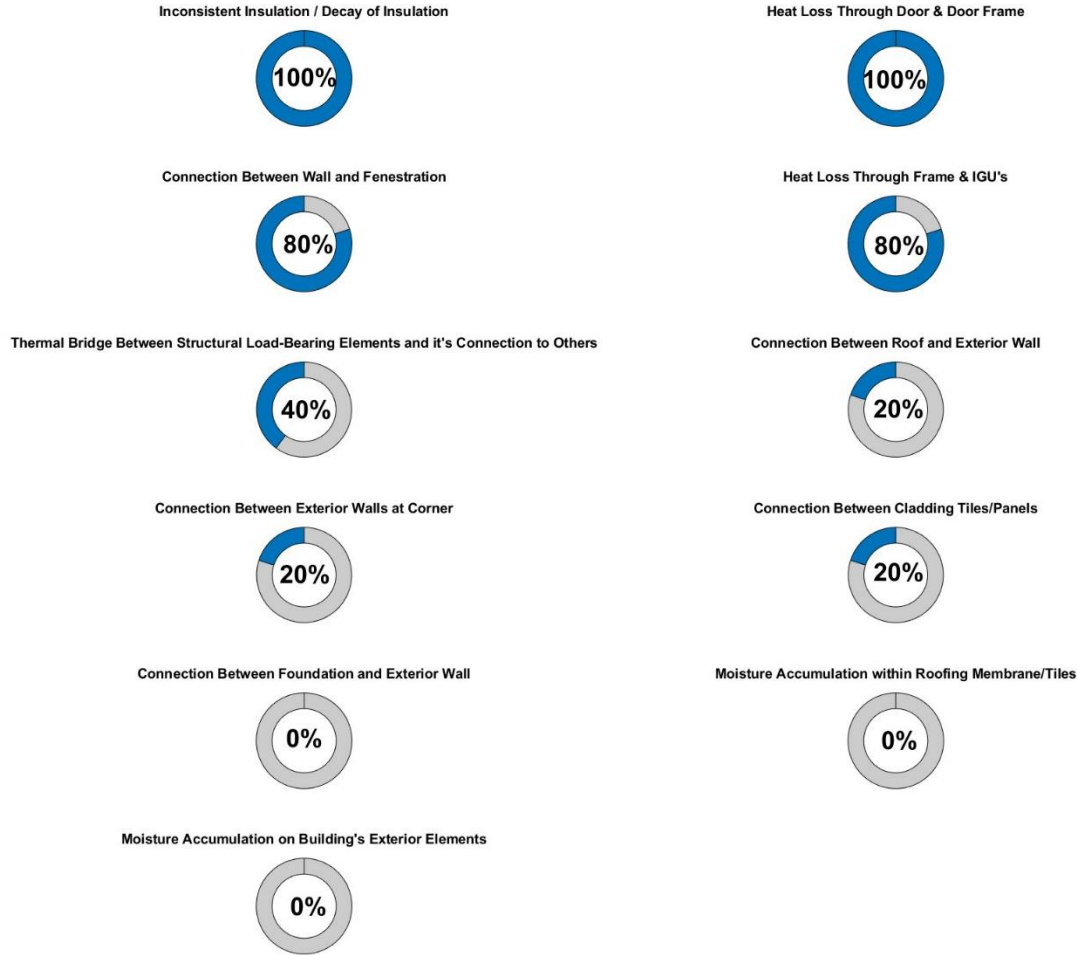
Figure 21: Summary of Issues in Kanata Catchment – Vintage Group 1

Issue Type	Number of Buildings Found	Number of Occurrences
"Inconsistent Insulation / Decay of Insulation"	5	18
"Heat Loss Through Door & Door Frame"	5	9
"Connection Between Wall and Fenestration"	4	5
"Heat Loss Through Frame & IGU's"	4	10
"Thermal Bridge Between Structural Load-Bearing Elements and it's Connection to Others"	2	10
"Connection Between Roof and Exterior Wall"	1	1
"Connection Between Exterior Walls at Corner"	1	1
"Connection Between Cladding Tiles/Panels"	1	3
"Connection Between Foundation and Exterior Wall"	0	0
"Moisture Accumulation within Roofing Membrane/Tiles"	0	0
"Moisture Accumulation on Building's Exterior Elements"	0	0

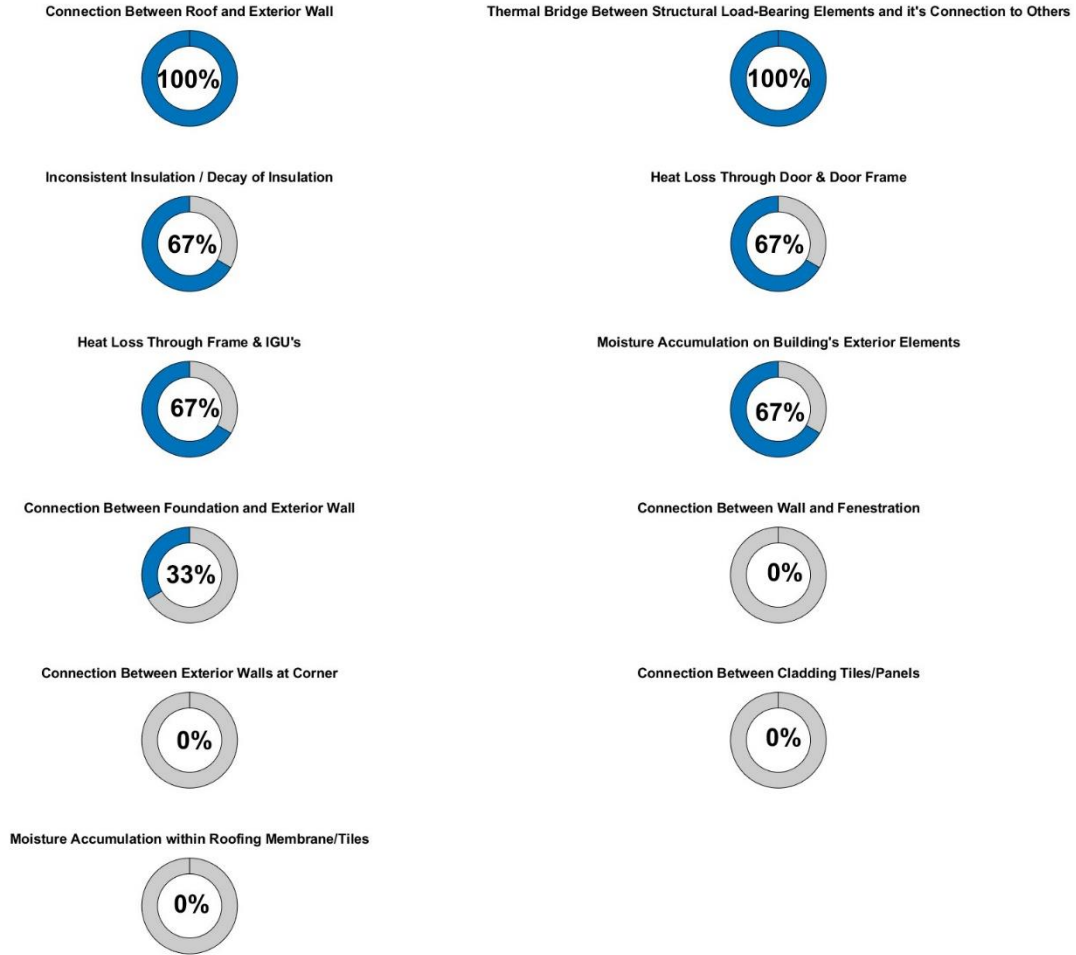
Figure 23: Summary of Issues in Kanata Catchment – Vintage Group 3

Issue Type	Number of Buildings Found	Number of Occurrences
"Connection Between Roof and Exterior Wall"	3	3
"Thermal Bridge Between Structural Load-Bearing Elements and its Connection to Others"	3	3
"Inconsistent Insulation / Decay of Insulation"	2	7
"Heat Loss Through Door & Door Frame"	2	4
"Heat Loss Through Frame & IGU's"	2	2
"Moisture Accumulation on Building's Exterior Elements"	2	4
"Connection Between Foundation and Exterior Wall"	1	1
"Connection Between Wall and Fenestration"	0	0
"Connection Between Exterior Walls at Corner"	0	0
"Connection Between Cladding Tiles/Panels"	0	0
"Moisture Accumulation within Roofing Membrane/Tiles"	0	0
