**Re: 2022 Annual Report, Certificate of Property Use (CPU 0371-8TYQMY)  
Lansdowne Park, Urban Park (Zone C)  
450 Queen Elizabeth Drive (Part of 945 Bank Street),  
Ottawa, Ontario**

# 2022 ANNUAL REPORT – CERTIFICATE OF PROPERTY USE NO. 0371-8TYQMY LANSDOWNE URBAN PARK (ZONE C)

PROJECT NO.: TZ10100106  
DATE: MARCH 8, 2023

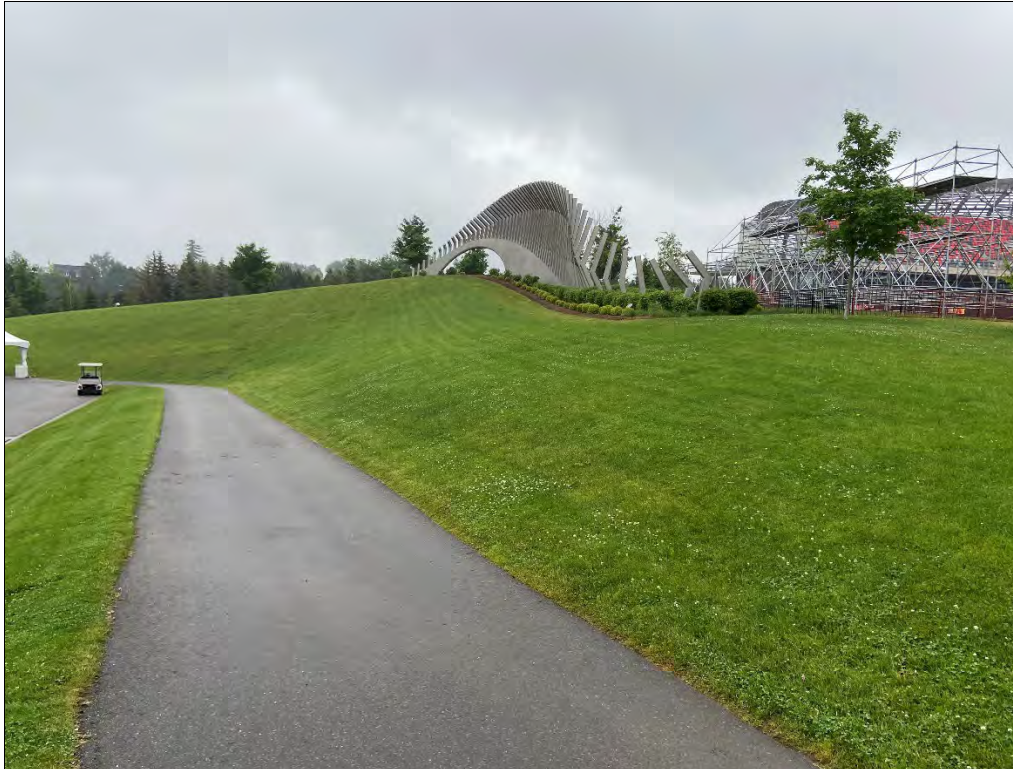
**Photo 1:**

East Berm: General view of the east side of the berm.

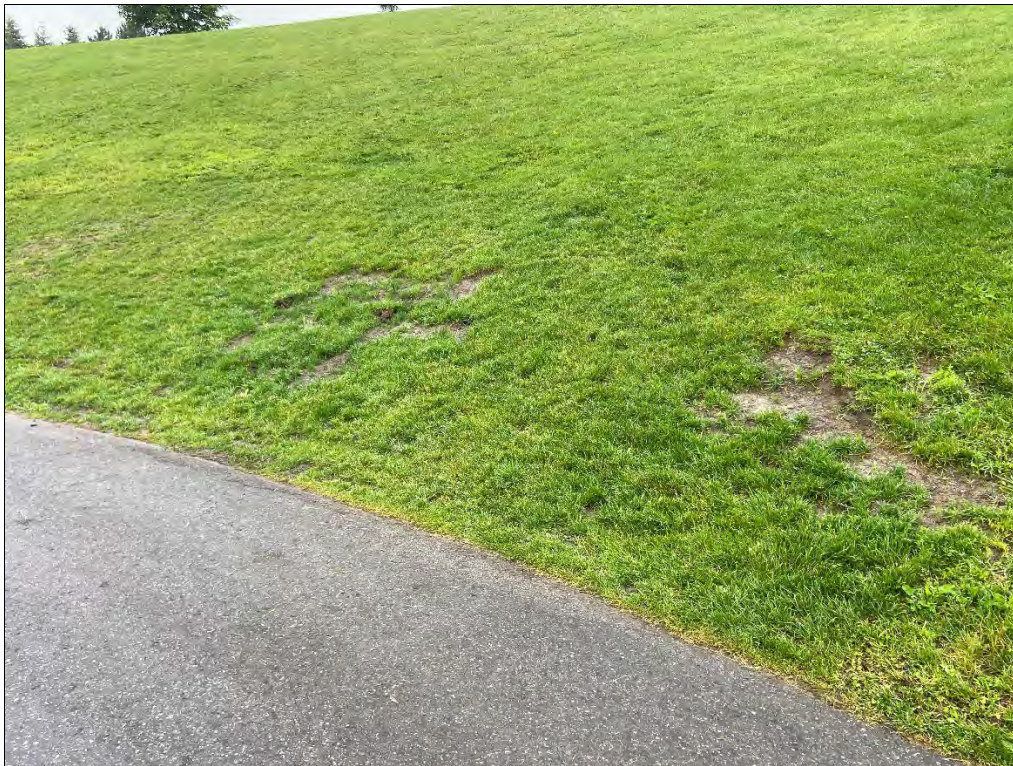
**Photo 2:**

East Berm: General view of the steeper sloped areas along the pedestrian pathway on the east side of the berm.  
Note small areas of bare soil.

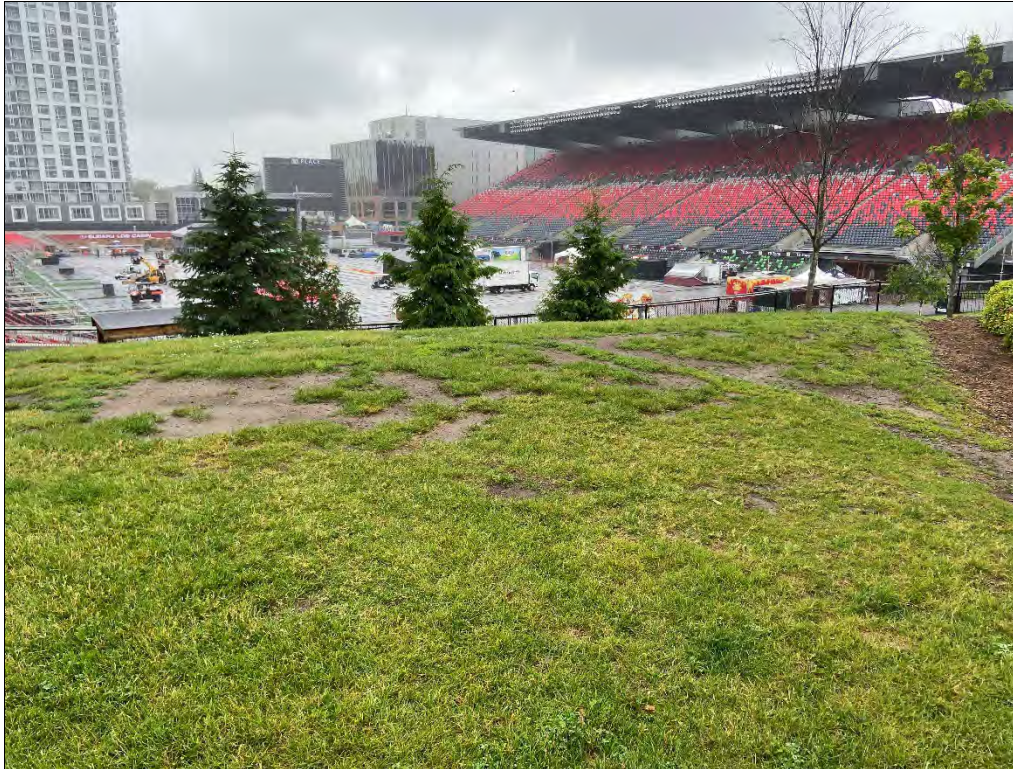
**Photo 3:**

East Berm: Areas of bare soil were observed at the top of the berm east and west of the Art Screen.

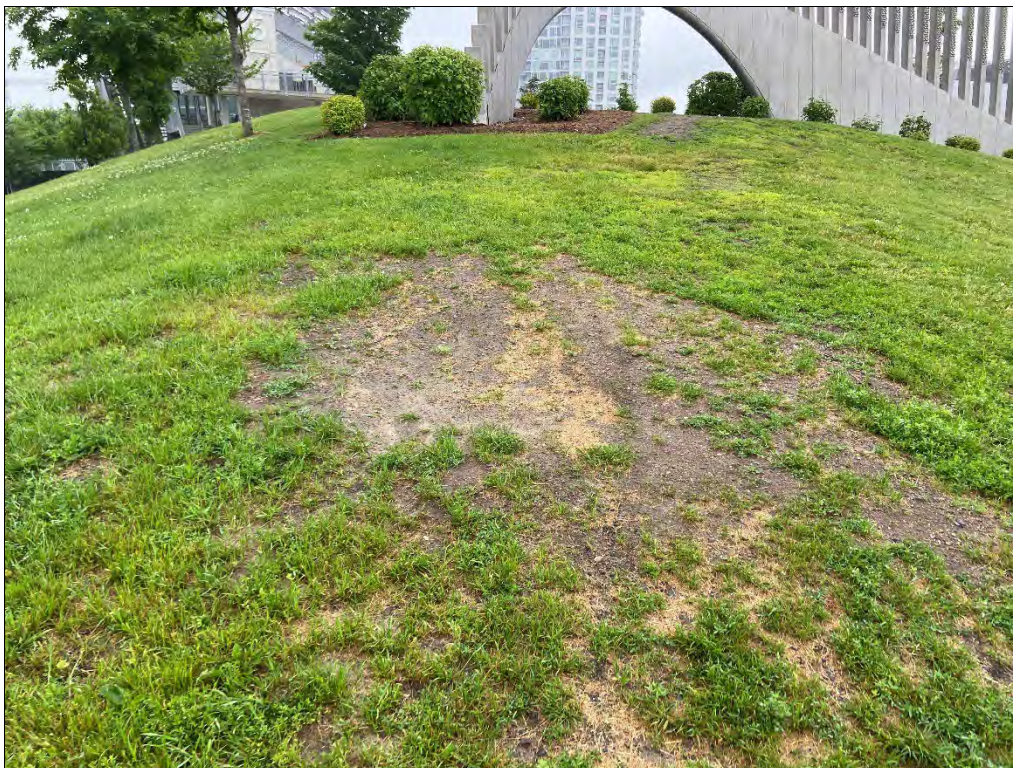
**Photo 4:**

East Berm: Area of bare soil where a previous excavation was completed to allow the advancement of a geotechnical borehole through the berm.

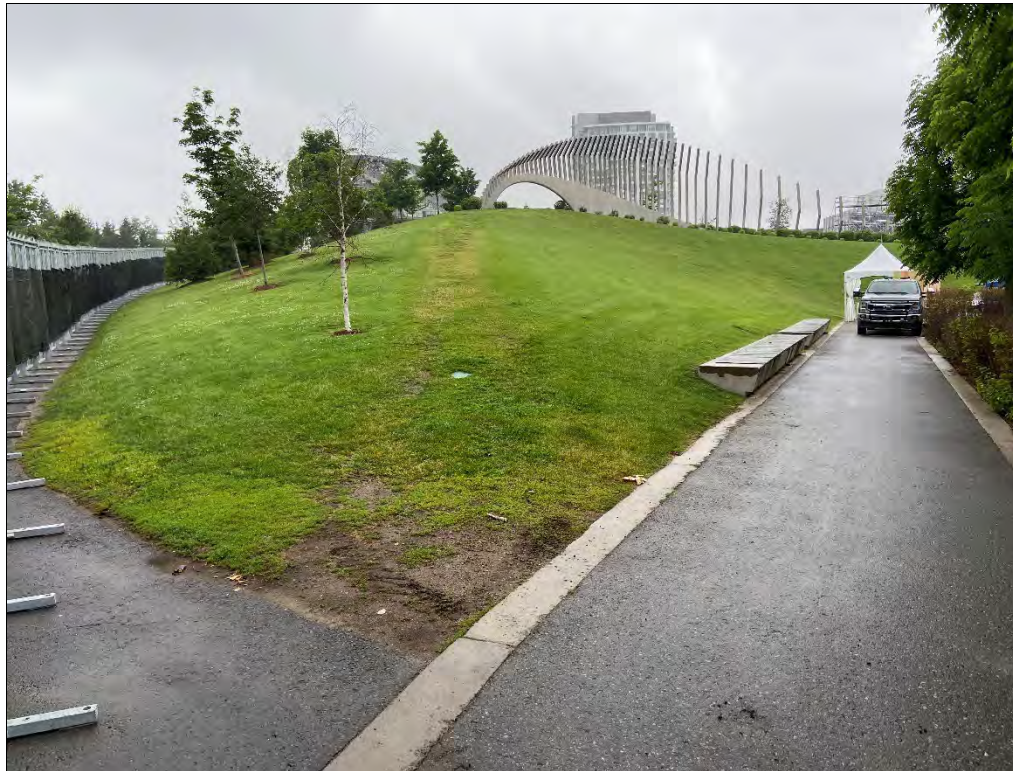
**Photo 5:**

East Berm: A worn path with areas of bare soil was observed along the ridge of the east arm of the berm.

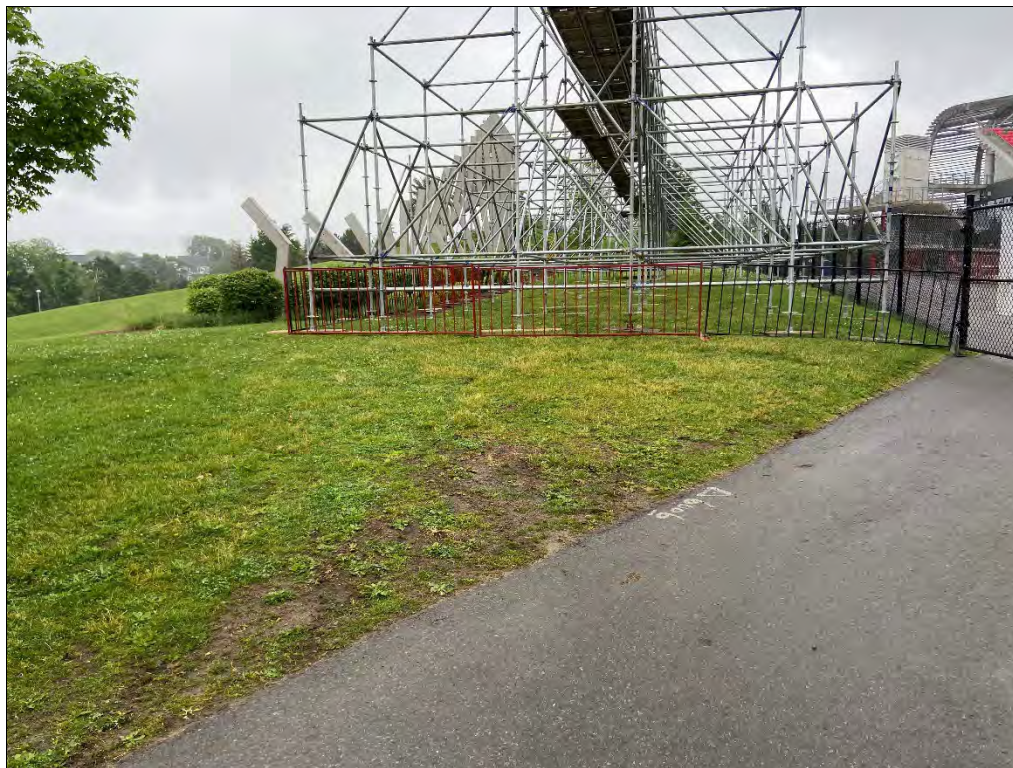
**Photo 6:**

East Berm: A temporary structure was erected west of the Art Screen and areas of bare soil were observed leading to the structure.

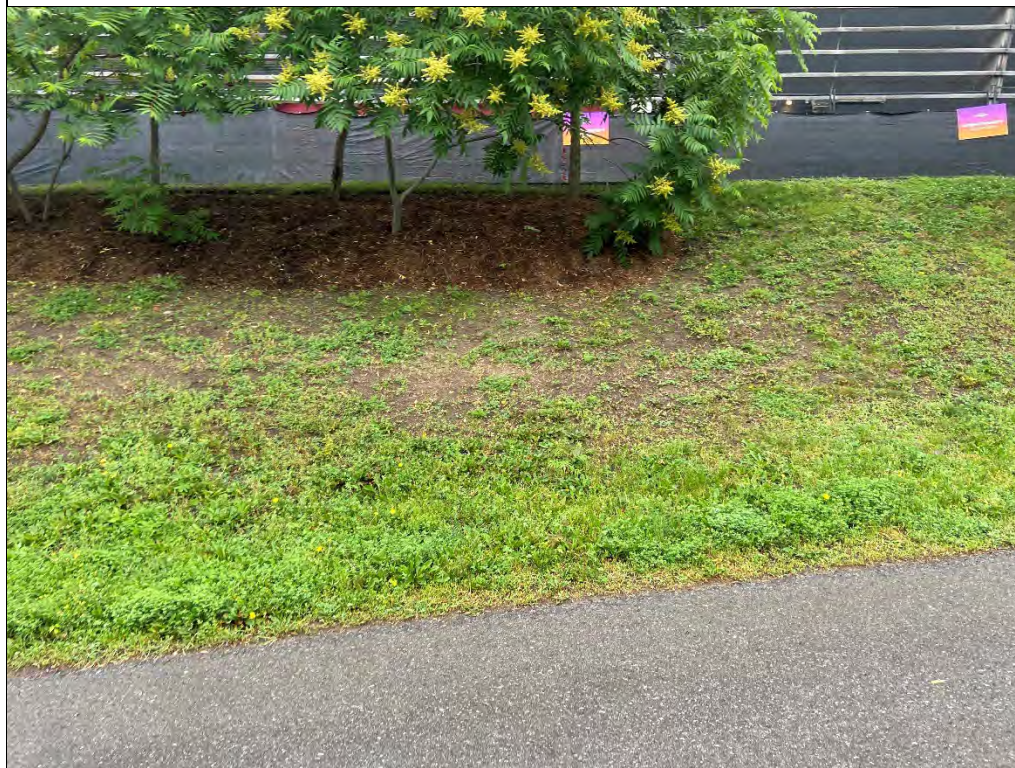
**Photo 8:**

South Berm: Bare soil observed on the western portion of the berm near the top.

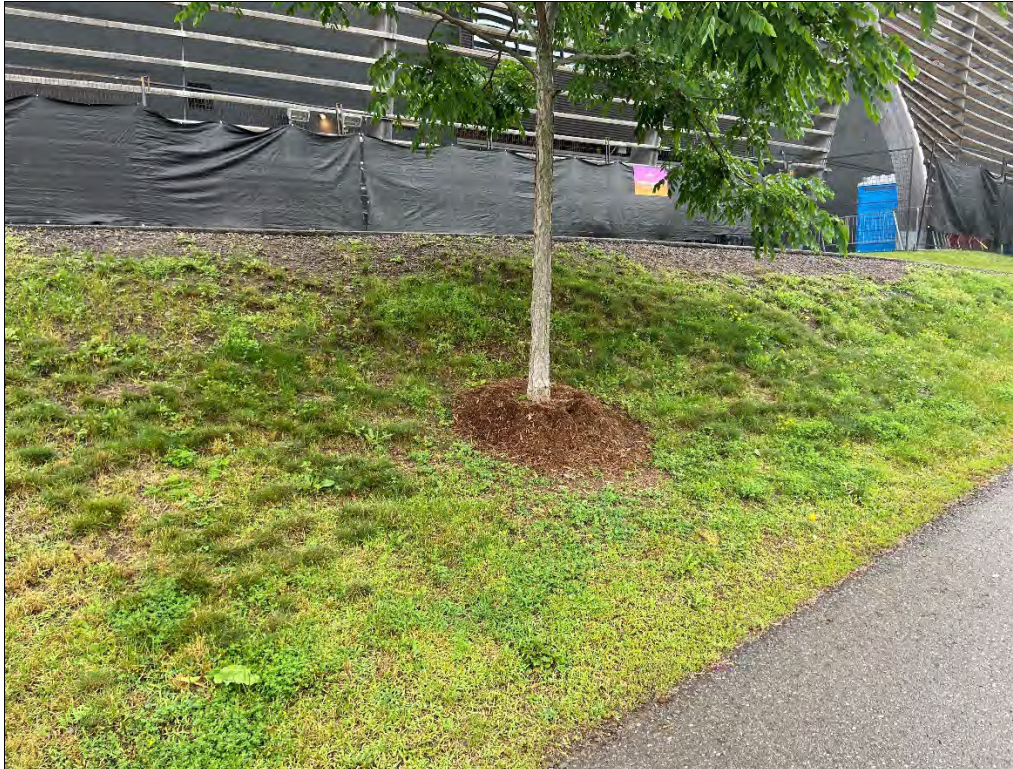
**Photo 9:**

South Berm: Clumps of soil eroding from areas near the top of the of the central portion of the berm.

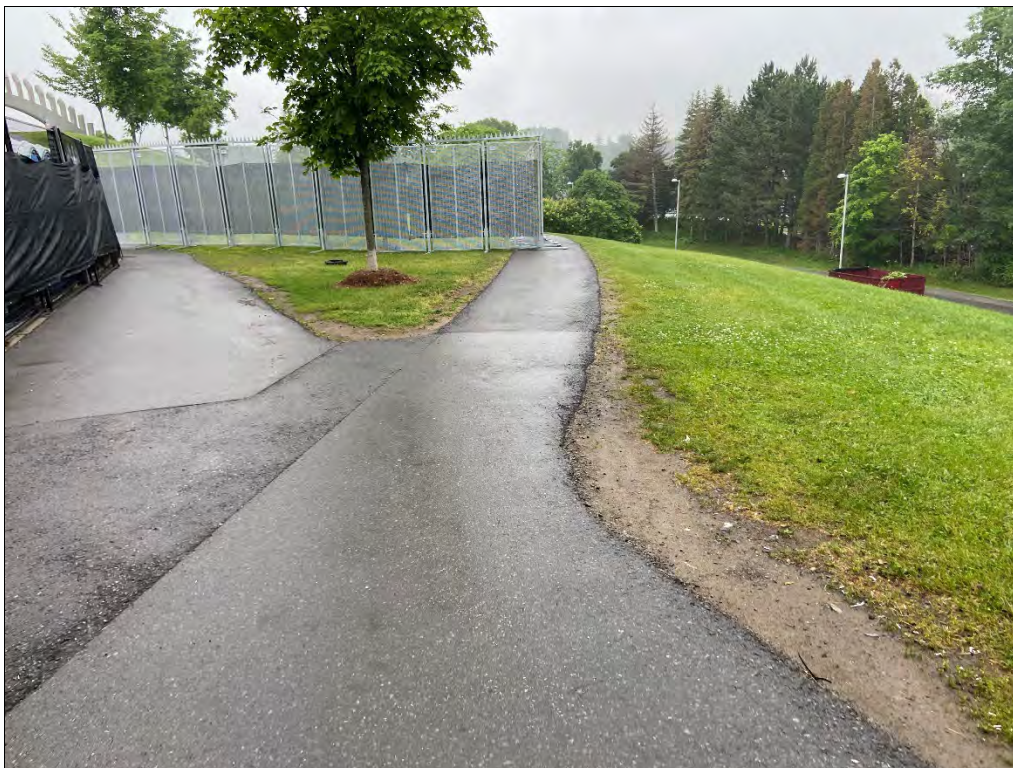
**Photo 10:**

South Berm: Areas of bare soil along paths on the berm.

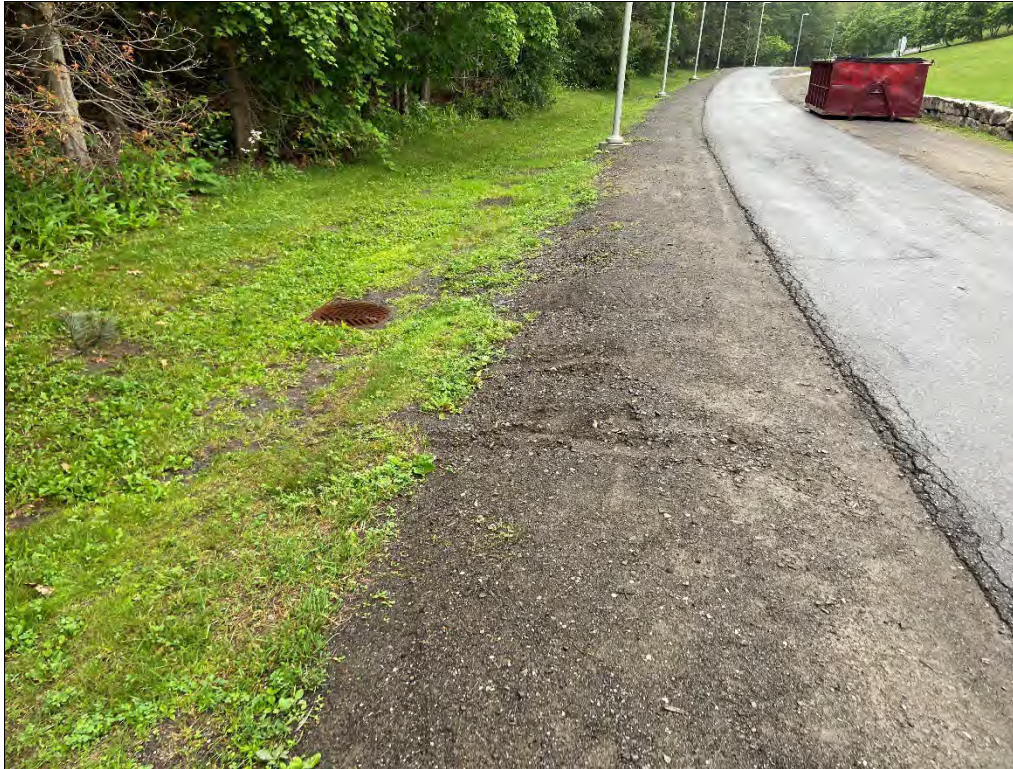
**Photo 11:**  
South Drainage Swale: General view of the swale. Road base material has eroded into the swale.

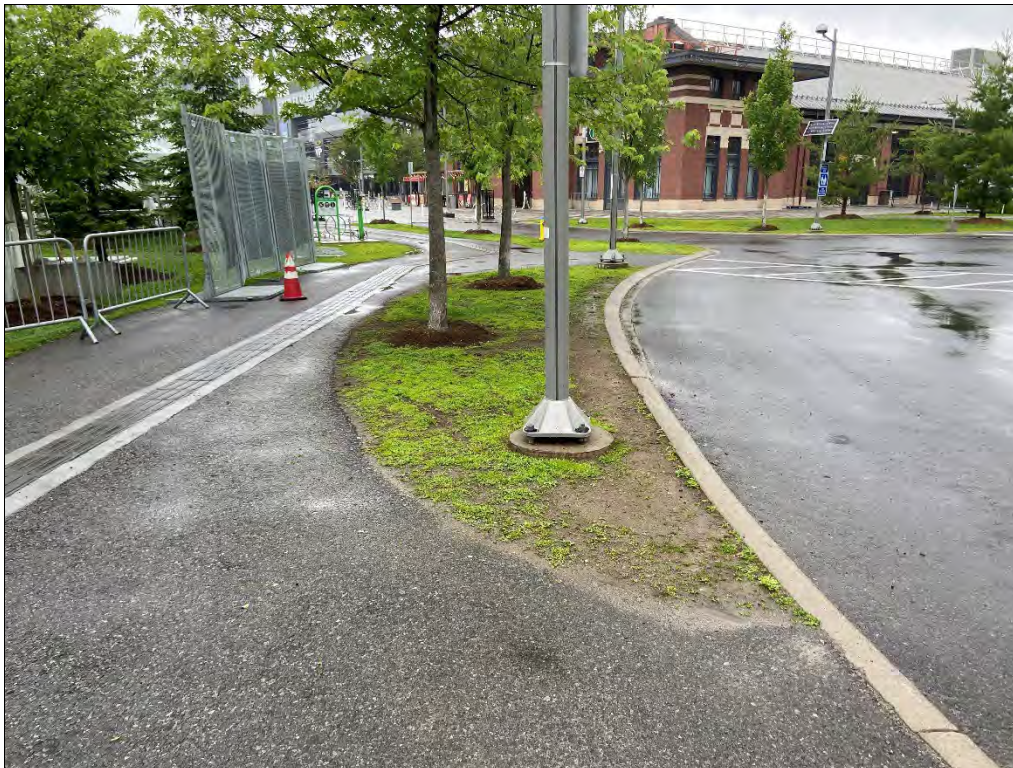
**Photo 12:**  
Former Eastern Landfill: Bare soil along pathways and roadways at the north end of the former landfill west of the Orchard.

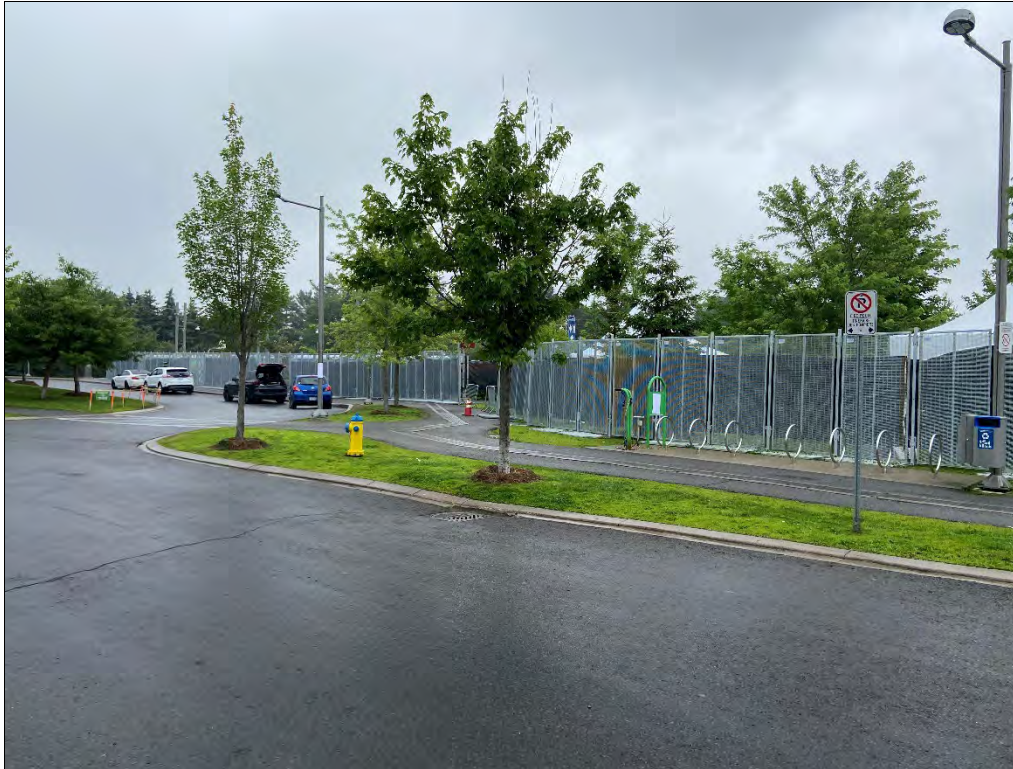
**Photo 13:**  
Former Eastern Landfill: The majority of the former landfill was fenced-off and occupied in preparation of the Escapade Music Festival.

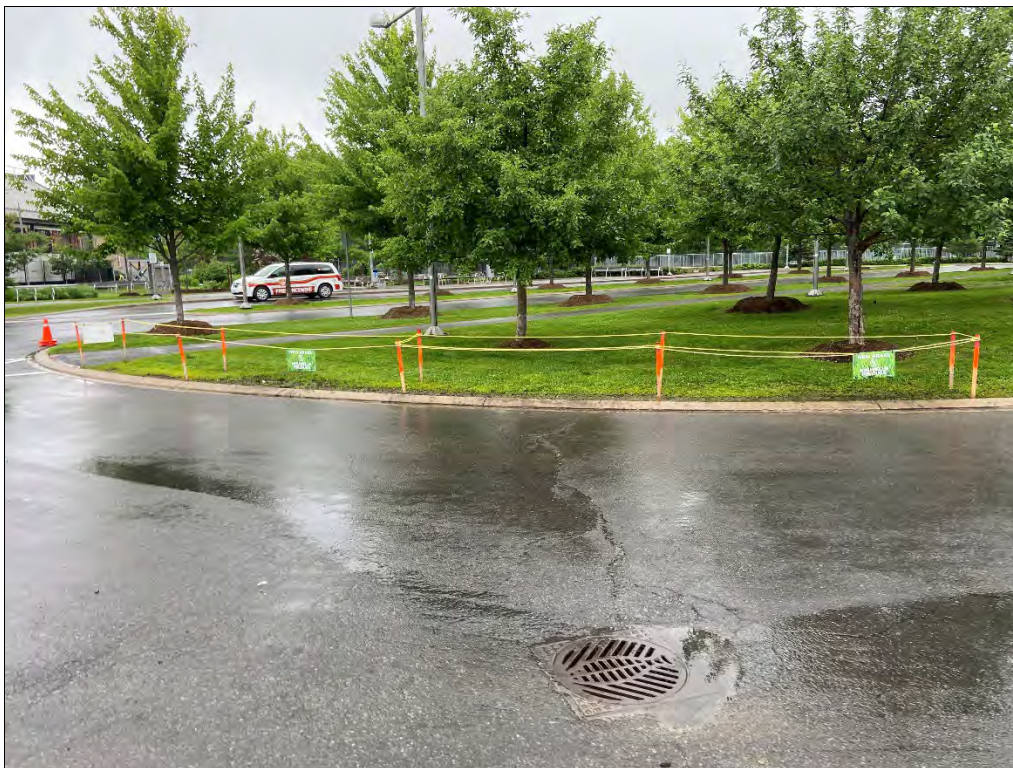
**Photo 14:**  
Former Eastern Landfill: Damaged areas of the cover in the Orchard were repaired.

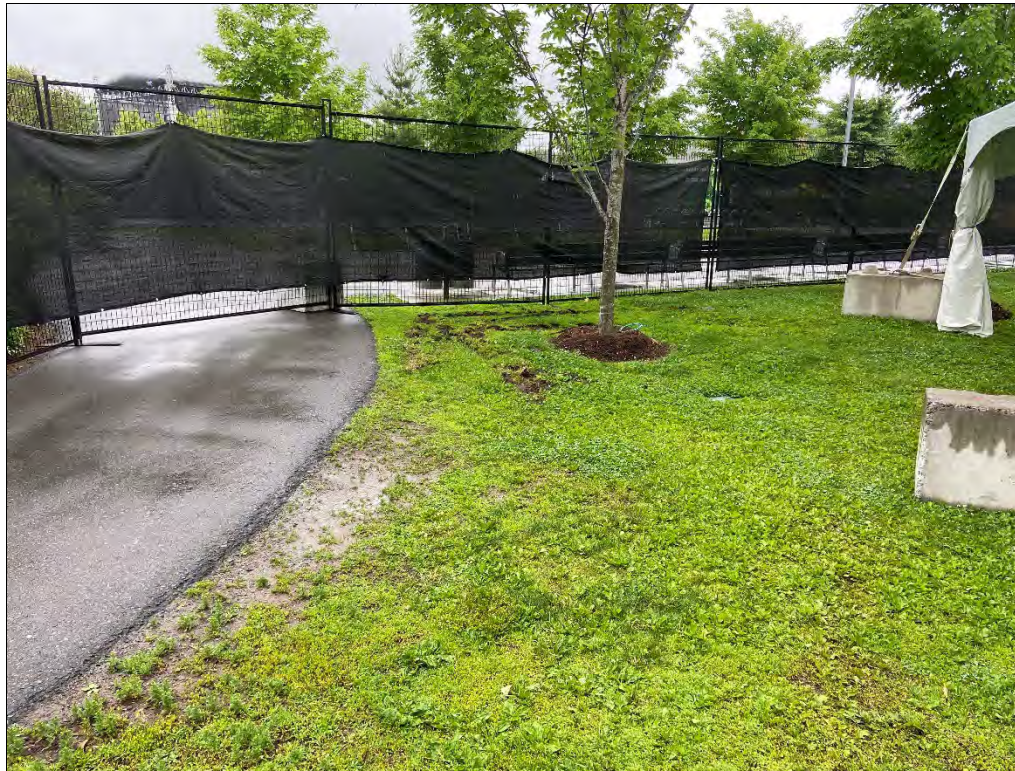
**Photo 15:**  
Former Eastern Landfill: Small areas of bare soil and stressed vegetation were observed in high traffic areas around the Skate Park and Children's Garden.

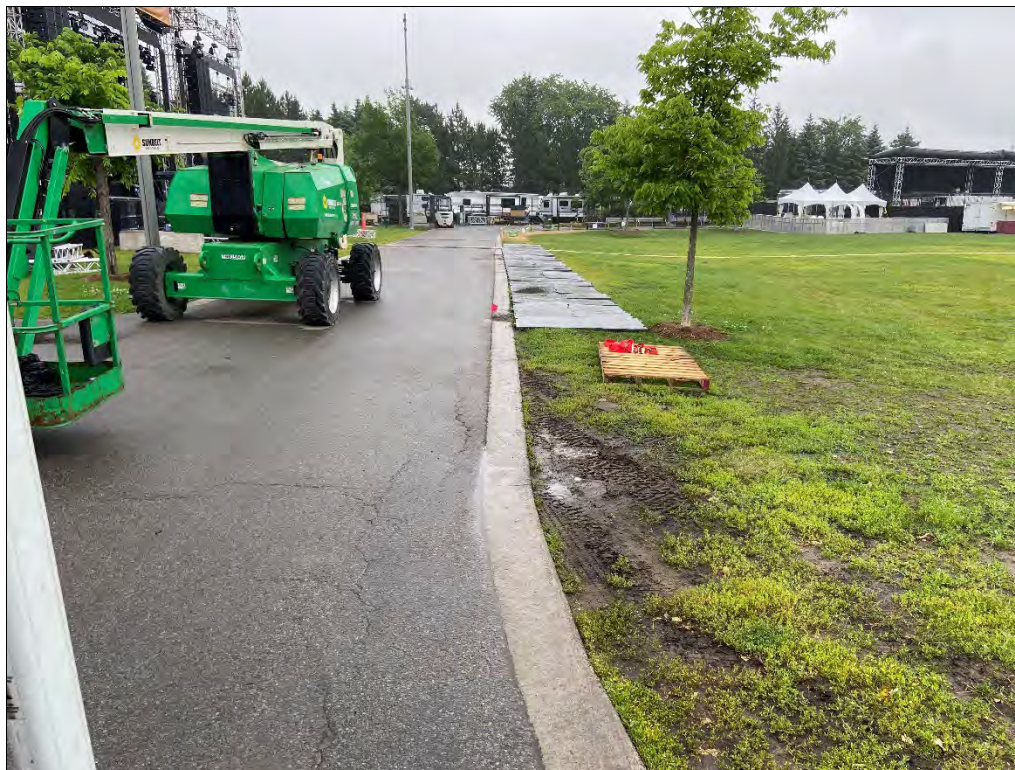
**Photo 16:**  
Former Eastern Landfill: Areas of bare soil and stressed vegetation south of the ring road at the north end the Great Lawn. Tire ruts were observed in this area and it was partially covered in preparation for the Escapade Music Festival.

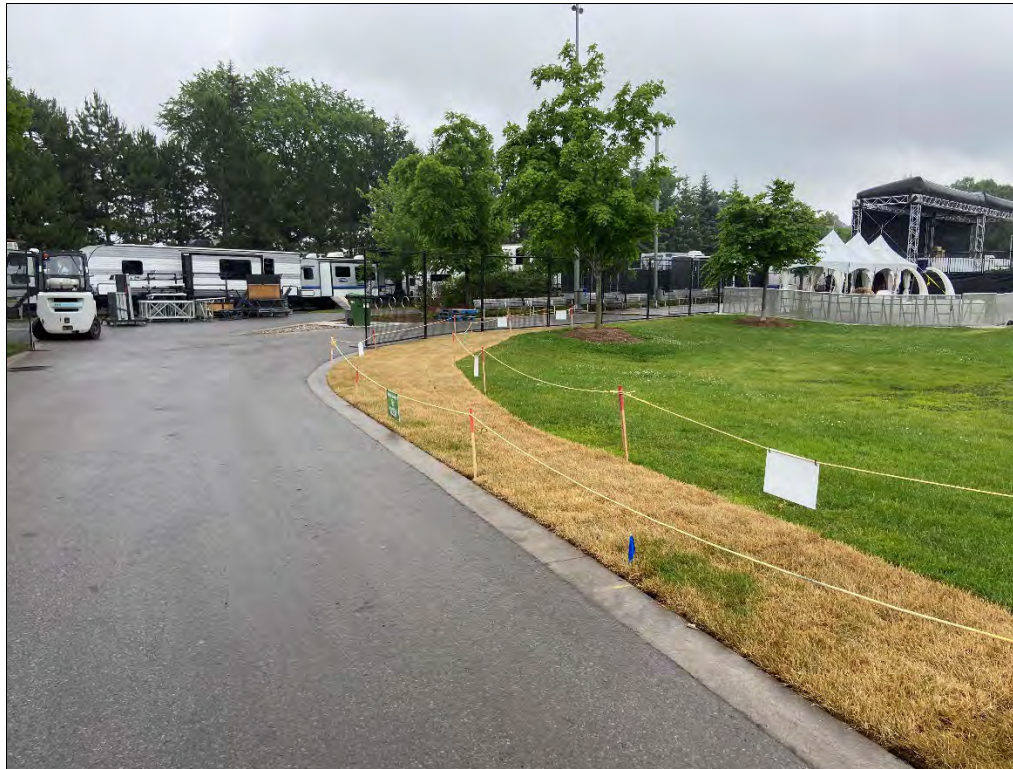
**Photo 15:**

Former Eastern Landfill: Damaged areas of cover at the north end of the Great Lawn were repaired.

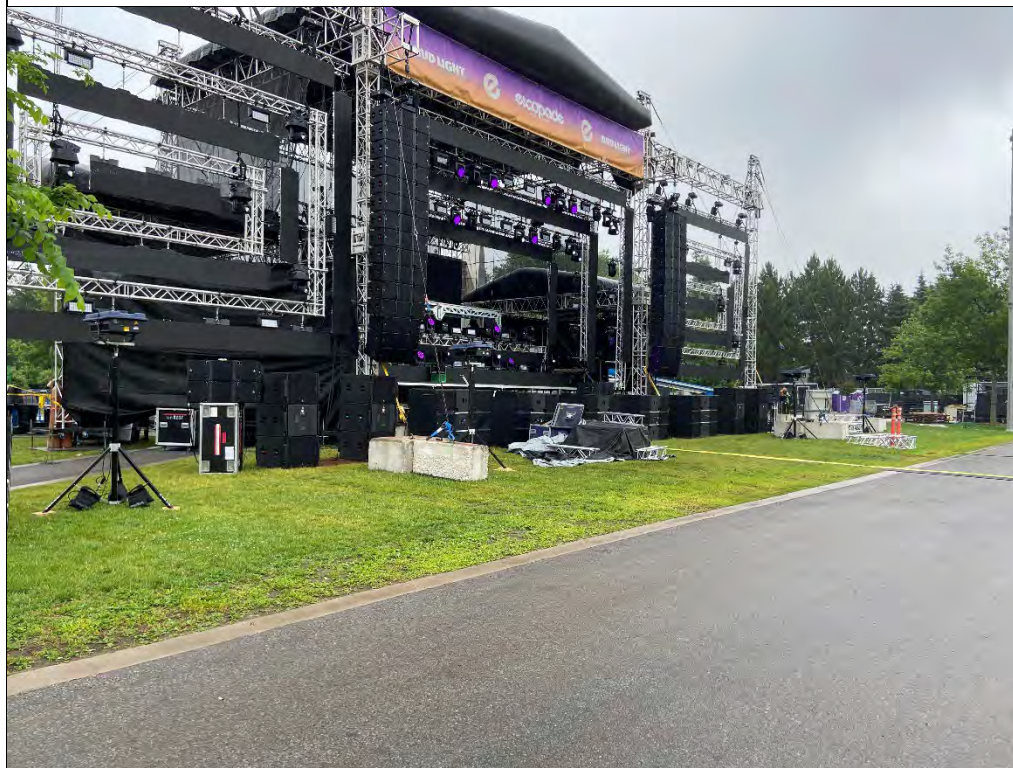
**Photo 16:**

Former Eastern Landfill: The stage for the Escapade Music Festival was erected south of the Water Plaza. Area is covered with equipment.

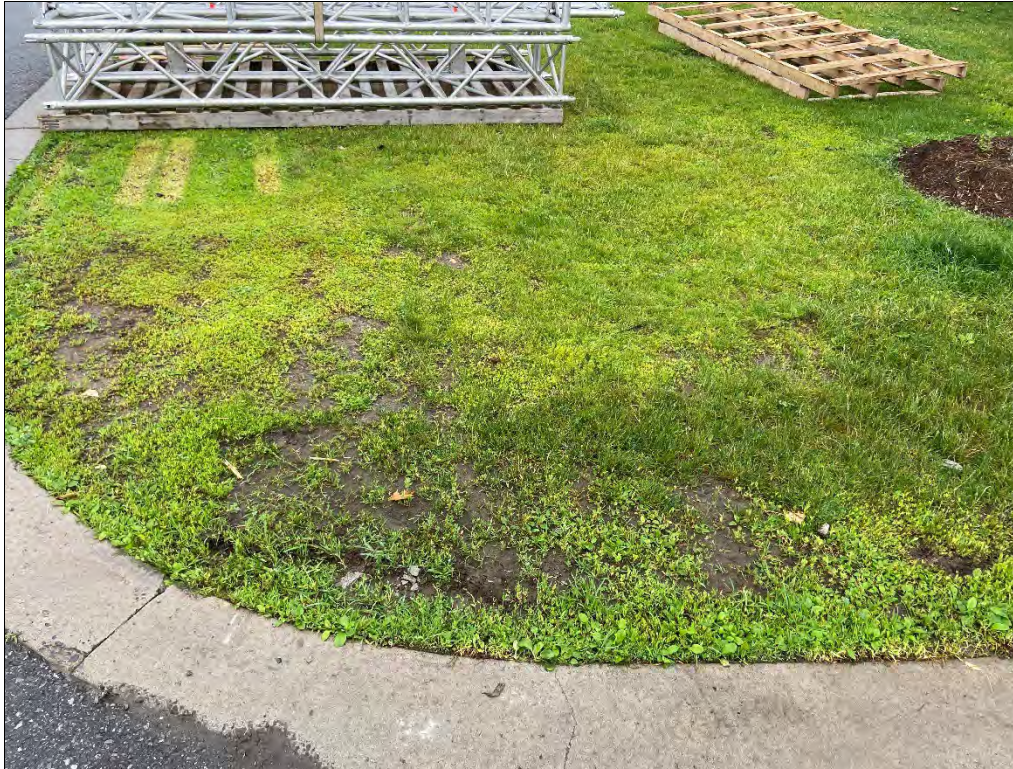
**Photo 17:**  
Former Eastern  
Landfill: Area of bare  
soil and stressed  
vegetation  
southwest of Water  
Plaza.

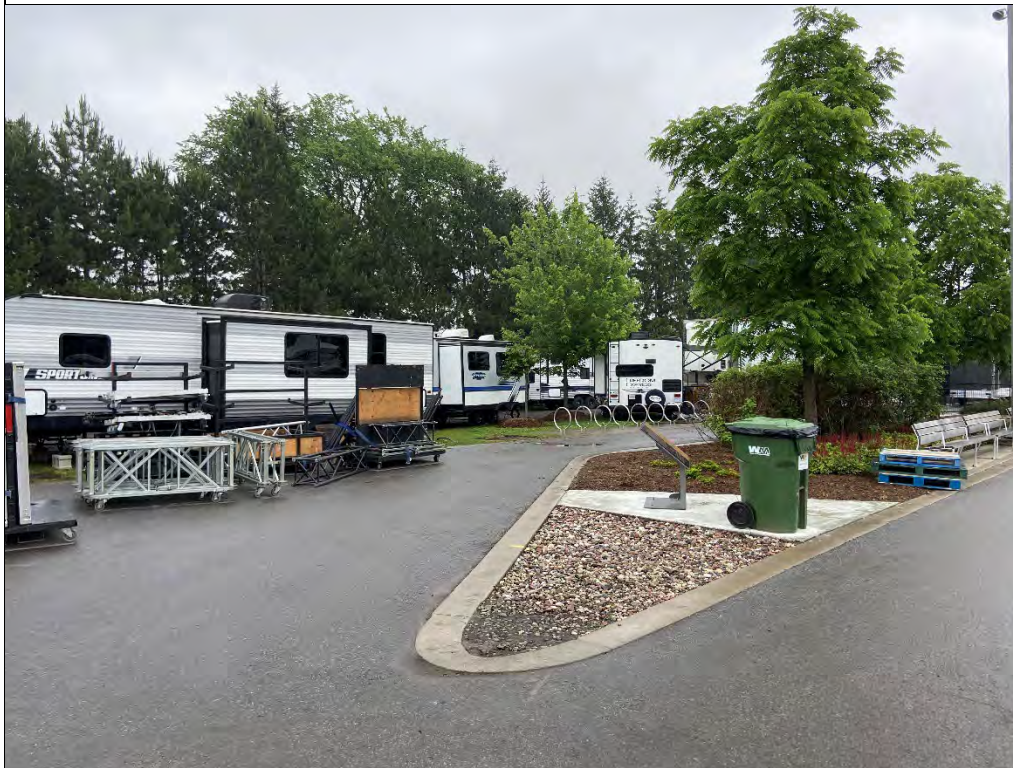
**Photo 18:**  
Former McElroy  
Building: The area is  
being occupied for  
the Escapade Music  
Festival.

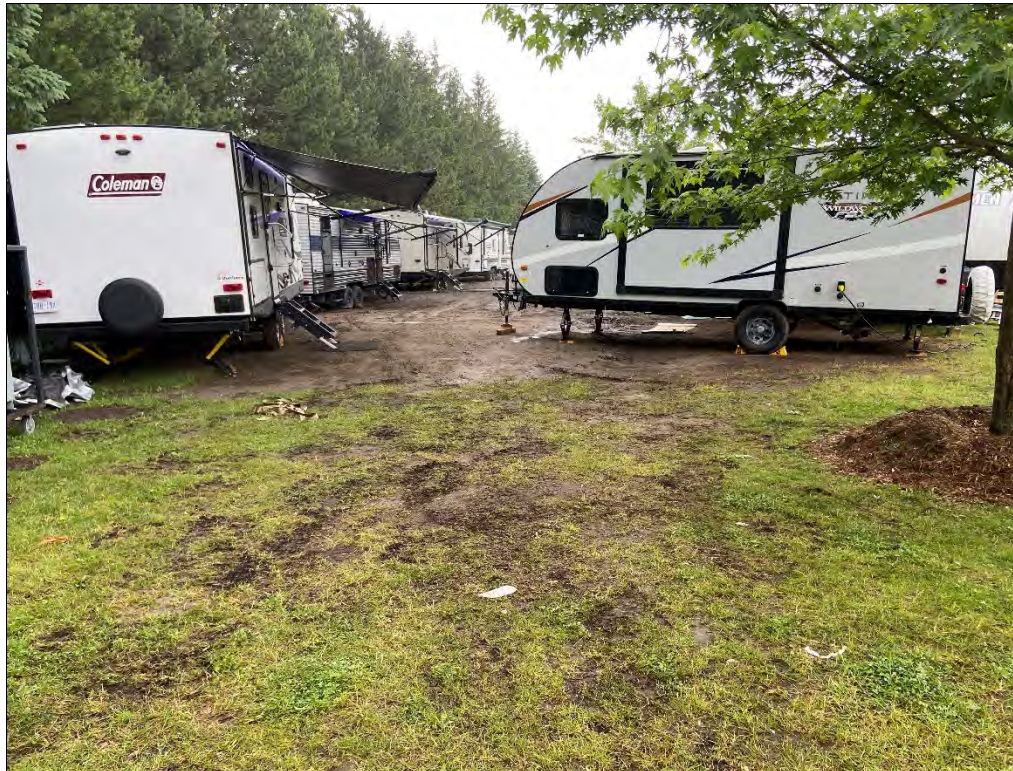
**Photo 19:**  
Former McElroy Building/Eastern Perimeter Drainage Swale: Areas of bare soil near trailers used for the Escapade Music Festival.

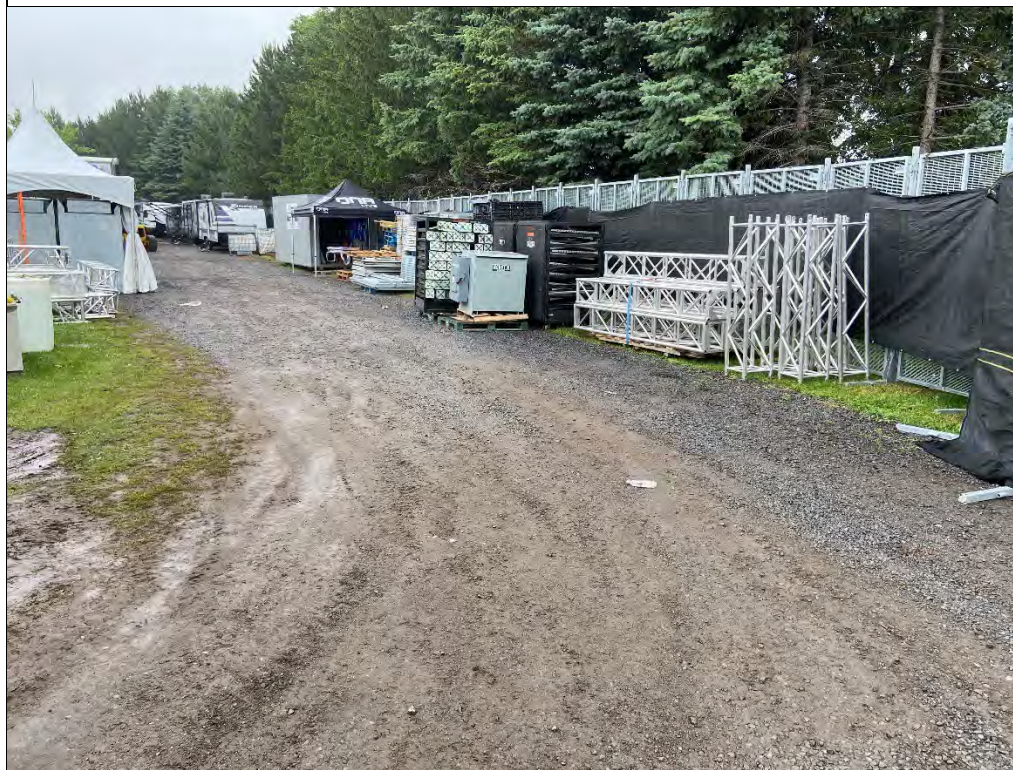
**Photo 20:**  
Eastern Perimeter Drainage Swale: Some areas of bare soil and tire ruts were observed adjacent the granular resurfaced area. These areas are also being used to store material/equipment.

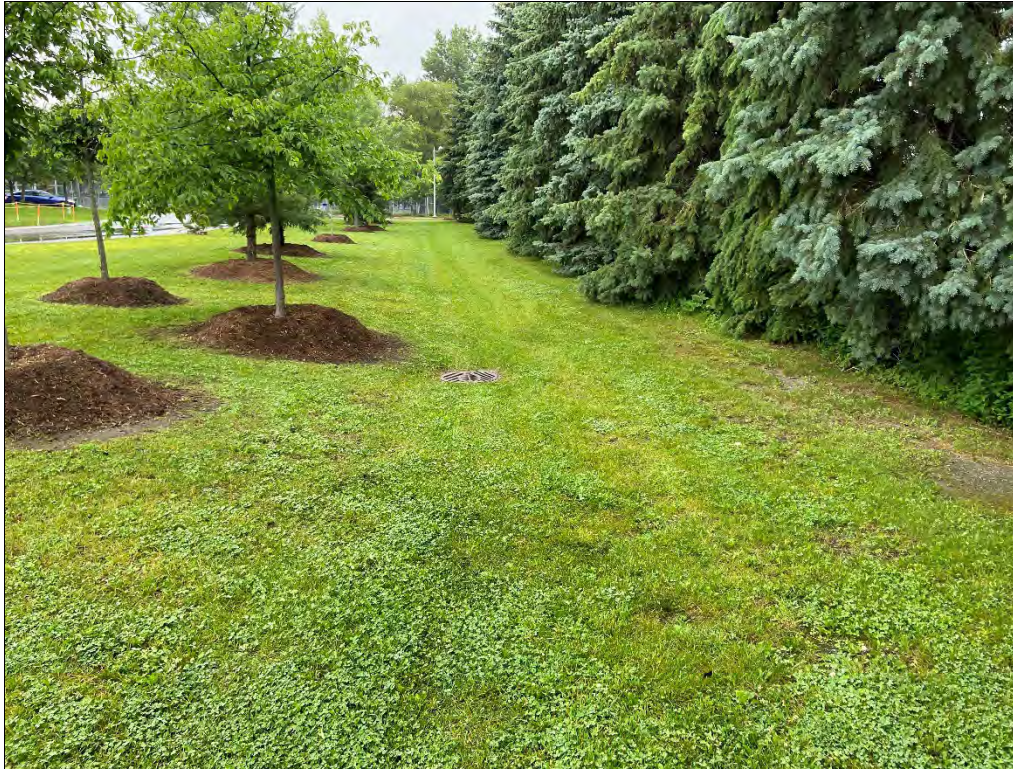
**Photo 21:**  
Eastern Perimeter  
Drainage Swale:  
General view of the  
swale east of the Ice  
Rink and Heirloom  
Orchard. Small areas  
of bare soil were  
observed in the area  
of the utility trench  
previously excavated  
within the swale.

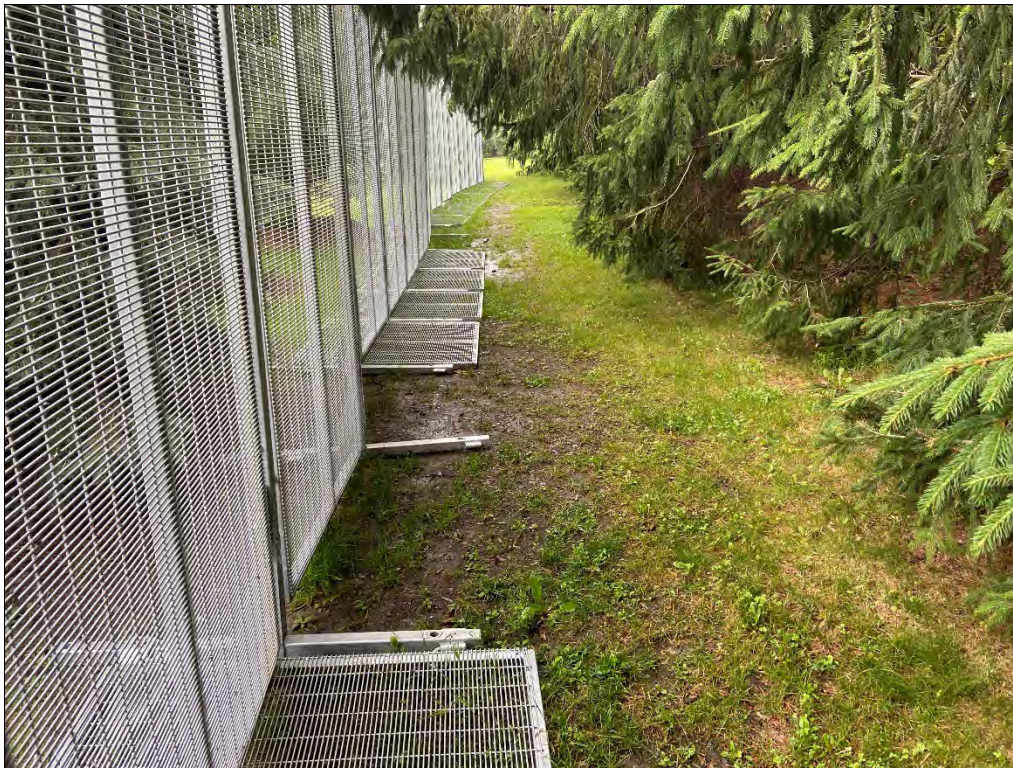
**Photo 22:**  
Eastern Perimeter  
Drainage Swale:  
General view of the  
swale east of the  
Children's Play Area.  
Some areas of bare  
soil were observed  
along the property  
boundary where a  
fence has been  
erected for the  
Escapade Music  
Festival.

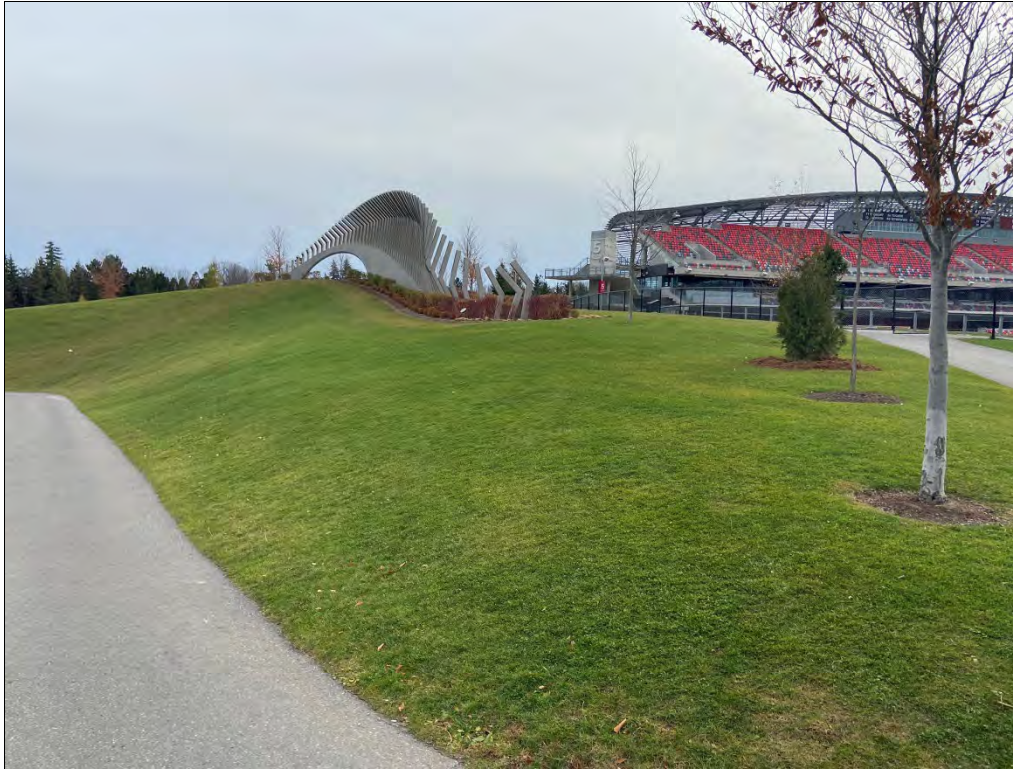
**Photo 1:**  
East Berm: General  
view of the east side  
of the berm.

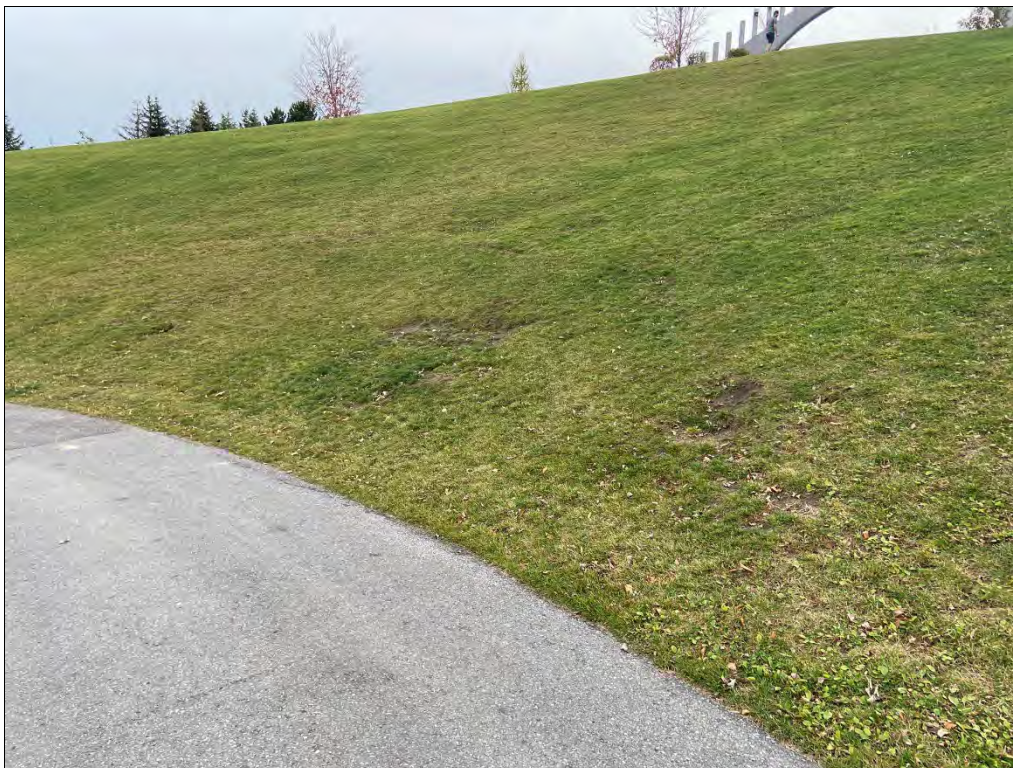
**Photo 2:**  
East Berm: General  
view of the steeper  
sloped areas along  
the pedestrian  
pathway on the east  
side of the berm.  
Note small areas of  
bare soil.

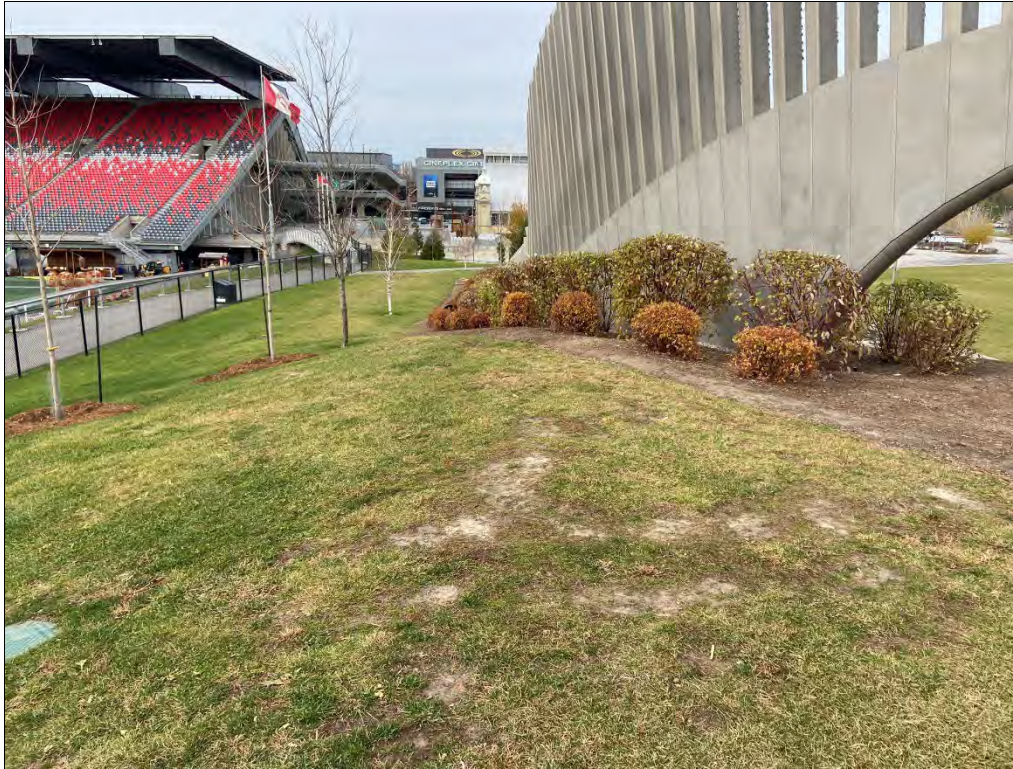
**Photo 3:**

East Berm: Areas of bare soil were observed at the top of the berm east and west of the Art Screen.

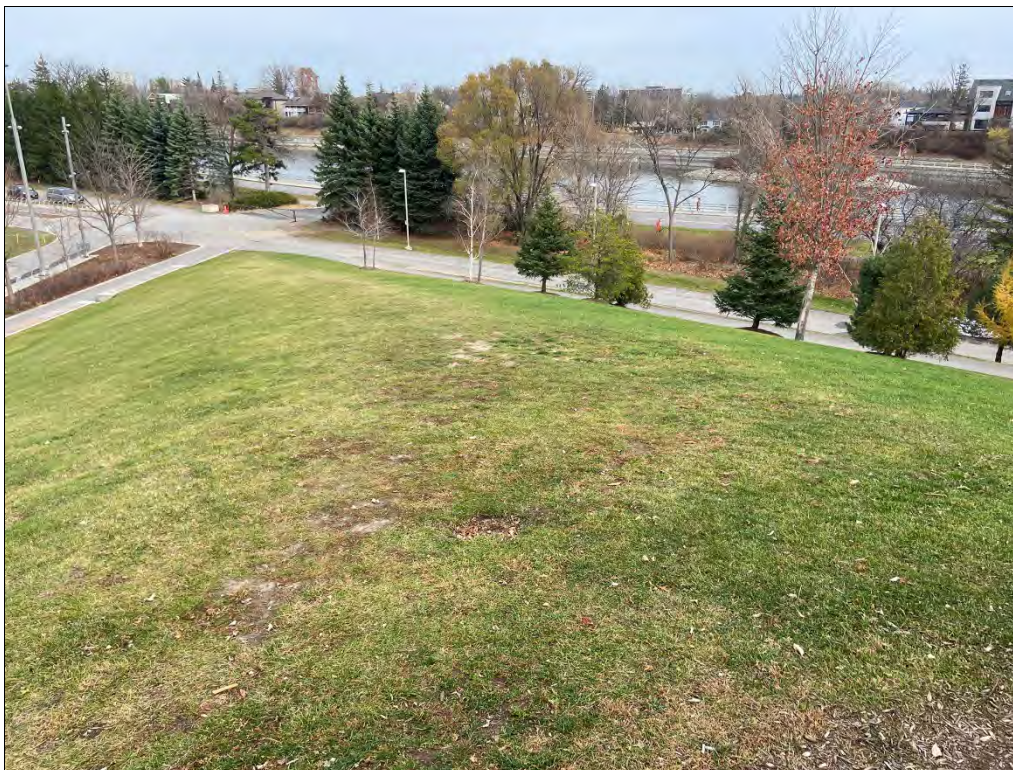
**Photo 4:**

East Berm: Area of bare soil where a previous excavation was completed to allow the advancement of a geotechnical borehole through the berm.

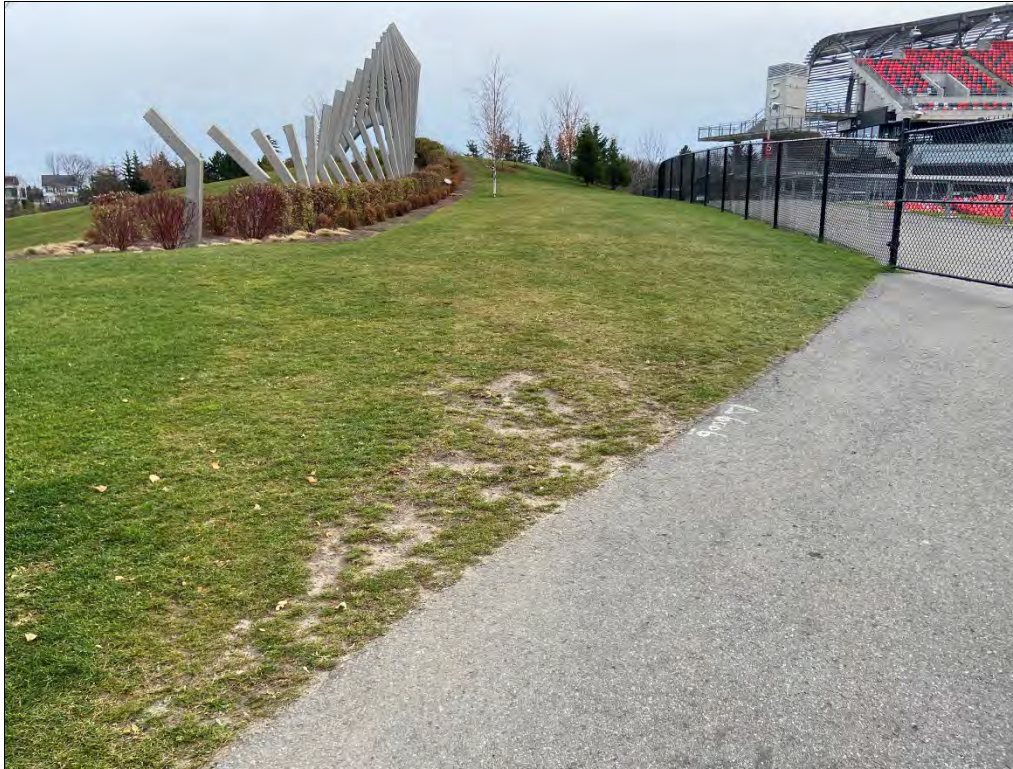
**Photo 5:**  
East Berm: Areas of bare soil west of the Art Screen near the pedestrian pathway.
