**Re: 2022 Annual Report, Certificate of Property Use (CPU 0371-8TYQMY)  
Lansdowne Park, Urban Park (Zone C)  
450 Queen Elizabeth Drive (Part of 945 Bank Street),  
Ottawa, Ontario**

# 2022 ANNUAL REPORT – CERTIFICATE OF PROPERTY USE NO. 0371-8TYQMY LANSDOWNE URBAN PARK (ZONE C)

PROJECT NO.: TZ10100106  
DATE: MARCH 8, 2023

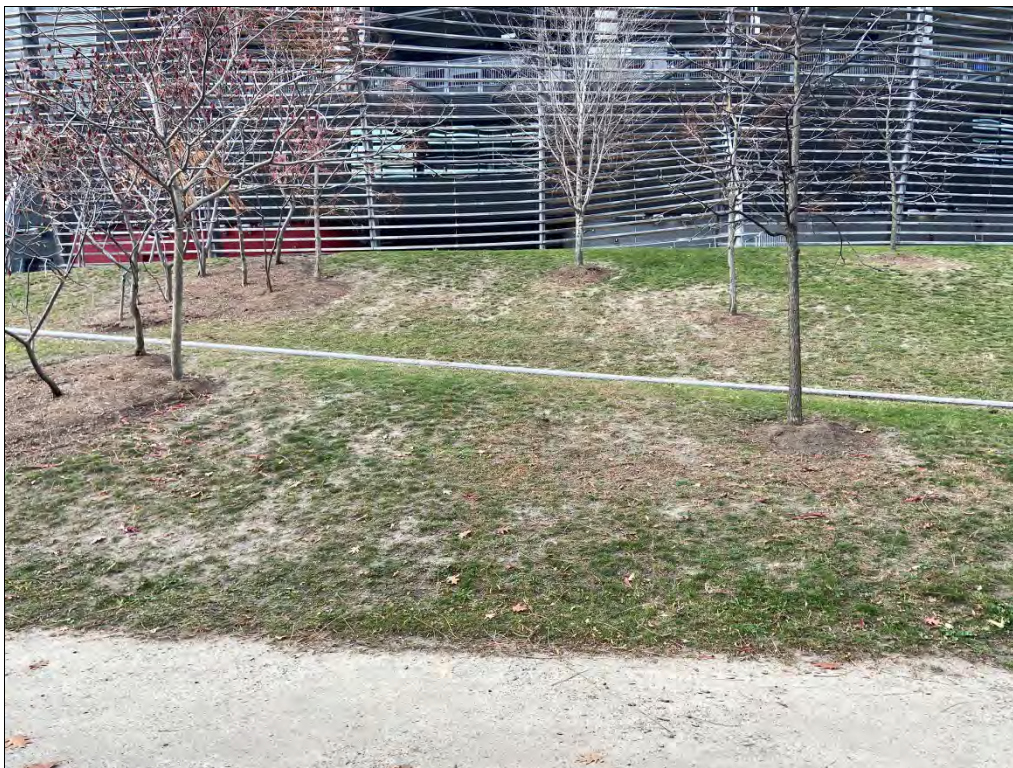
**Photo 6:**  
South Berm: General view of berm conditions. Areas of bare soil were observed throughout the berm.

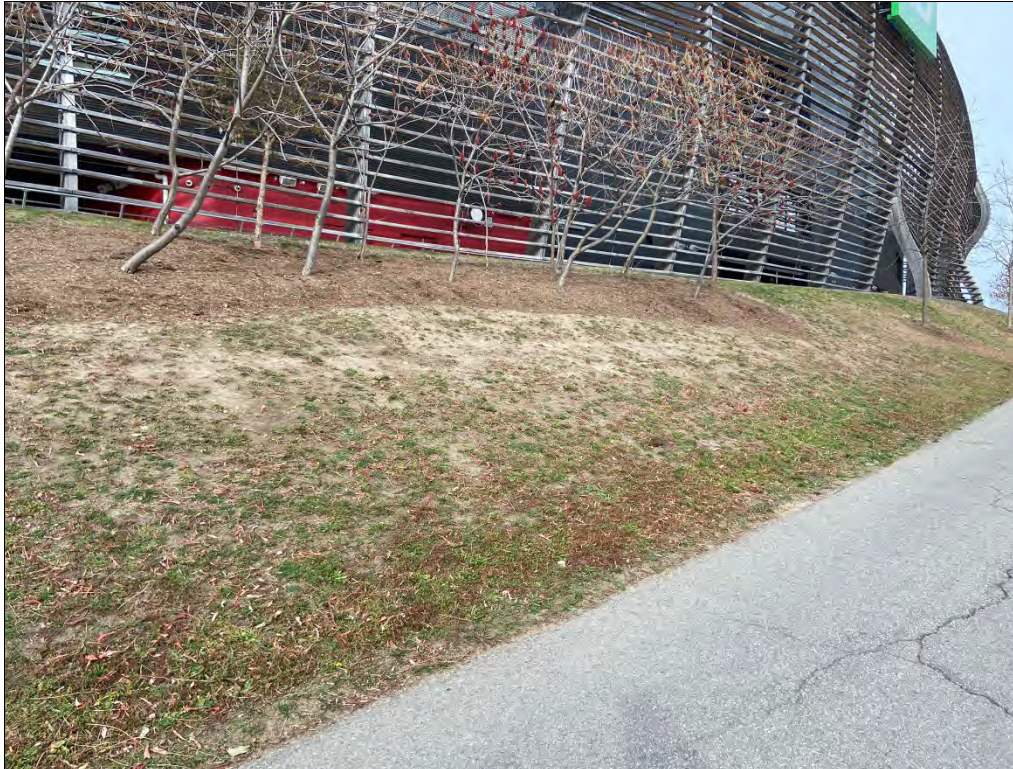
**Photo 7:**

South Berm: Bare soil observed on the western portion of the berm near the top.

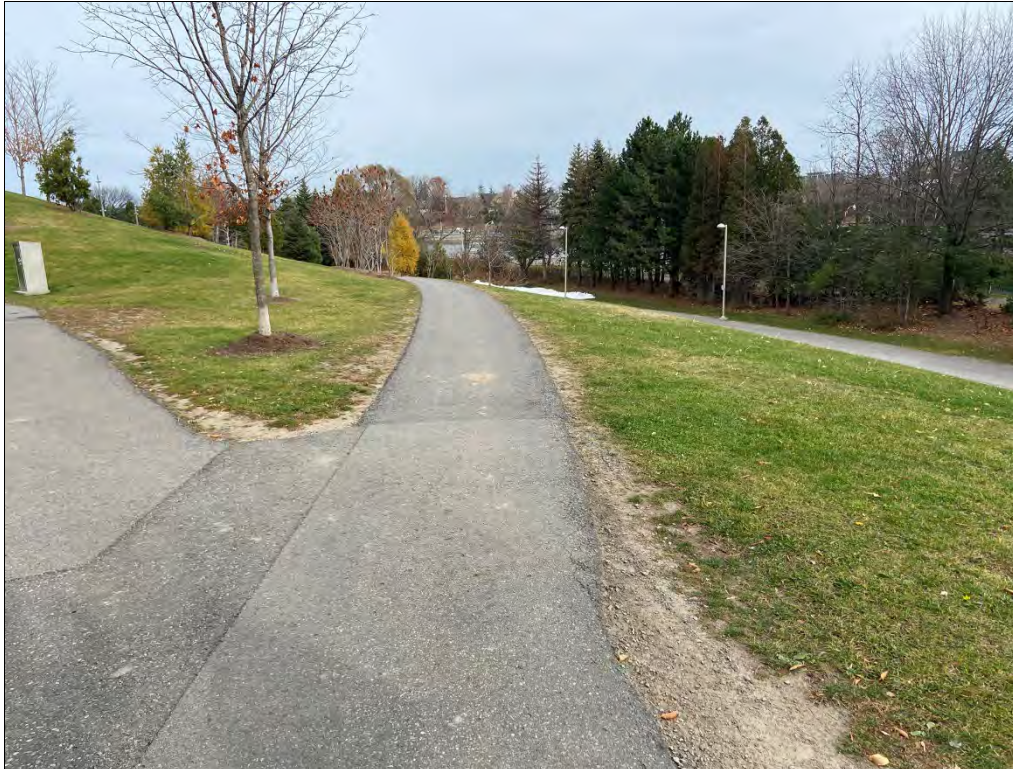
**Photo 9:**  
South Berm: Areas of bare soil along paths on the berm.

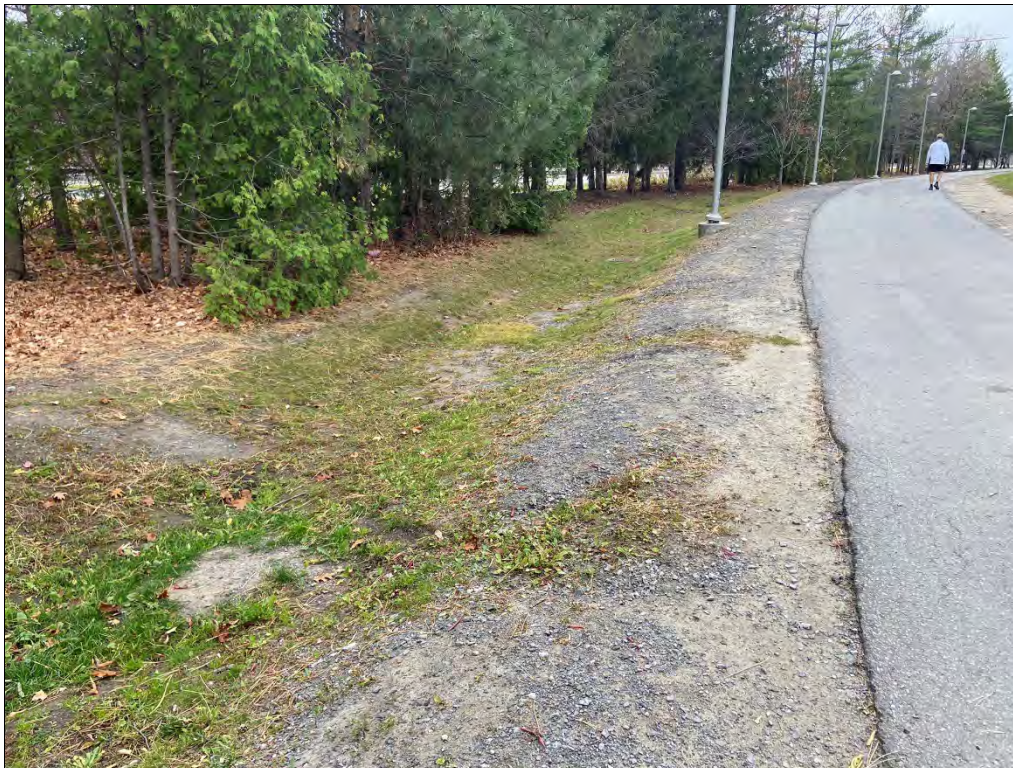
**Photo 10:**  
South Drainage Swale: General view of the swale. Road base material has eroded into the swale.

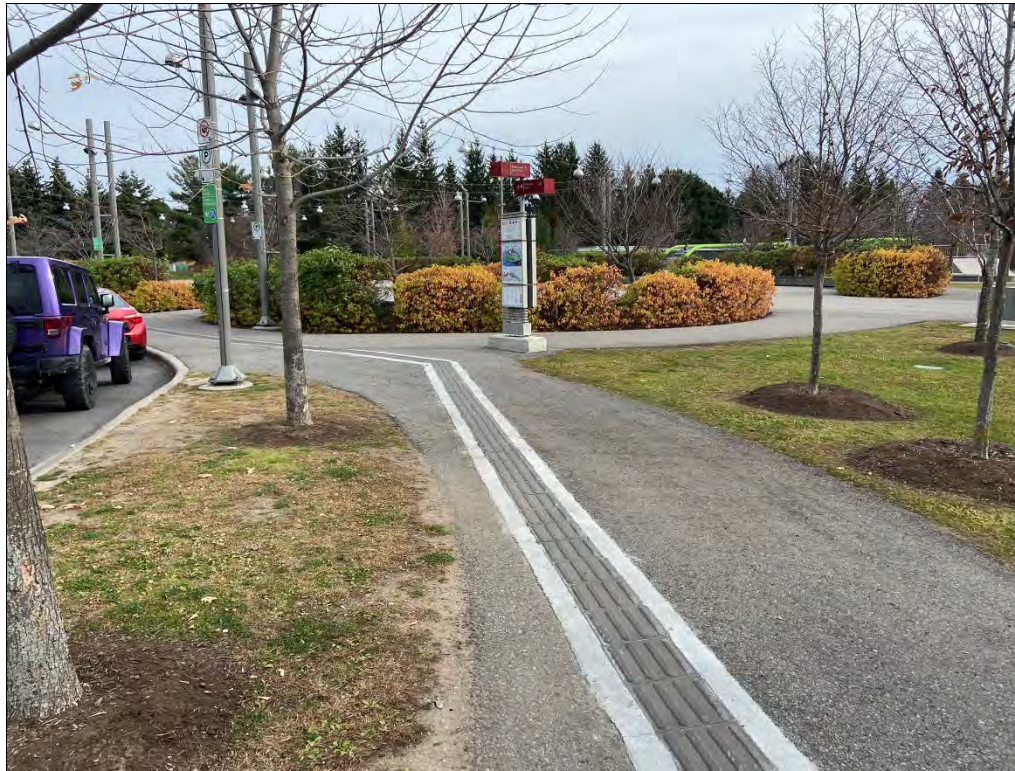
**Photo 11:**  
Former Eastern  
Landfill: Bare soil  
along pathways and  
roadways at the  
north end of the  
former landfill west  
of the Orchard.

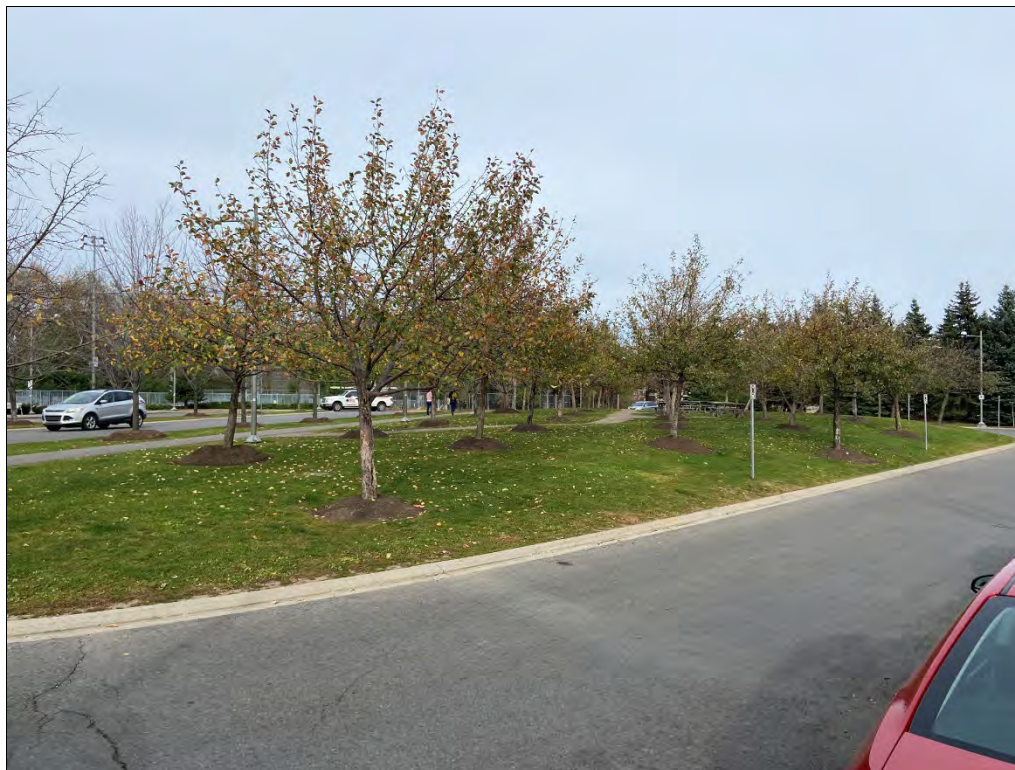
**Photo 12:**  
Former Eastern  
Landfill: Cover in the  
Orchard area along  
the roadway repaired  
in the Spring.

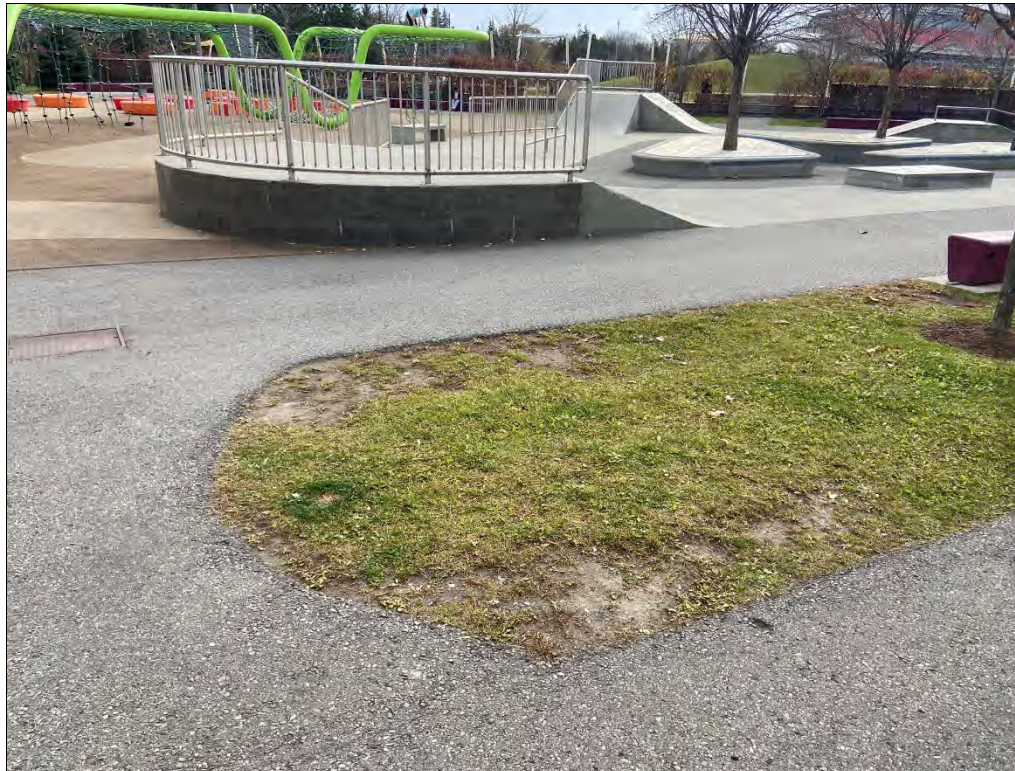
**Photo 13:**  
Former Eastern Landfill: Small areas of bare soil and stressed vegetation were observed in high traffic areas around the Skate Park and Children's Garden.

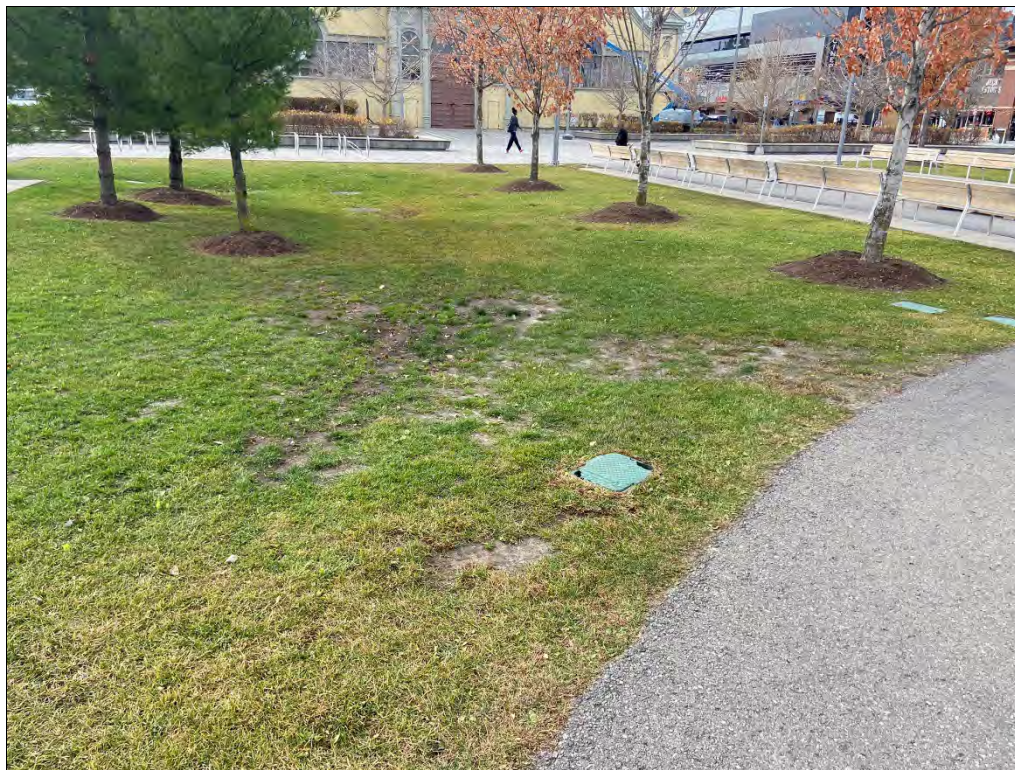
**Photo 14:**  
Former Eastern Landfill: Small areas of bare soil and stressed vegetation were observed south of the Ice Rink area.

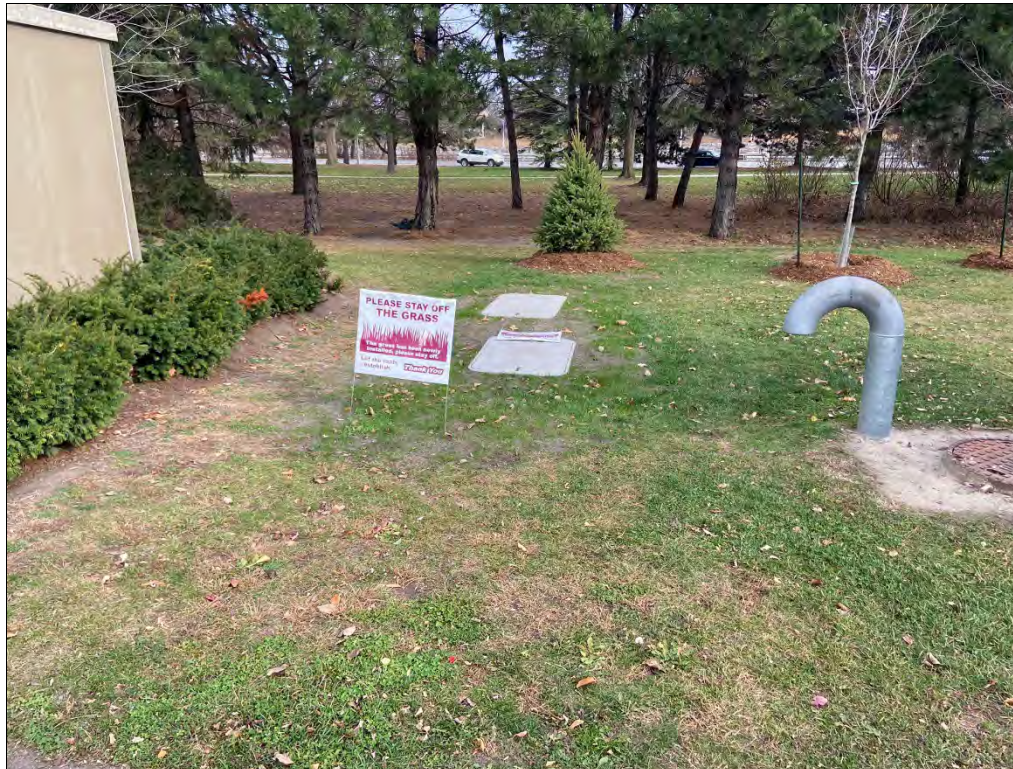
**Photo 15:**  
Former Eastern Landfill: Recent excavation to install in ground utility boxes disturbed the cover east of the Children's Garden.

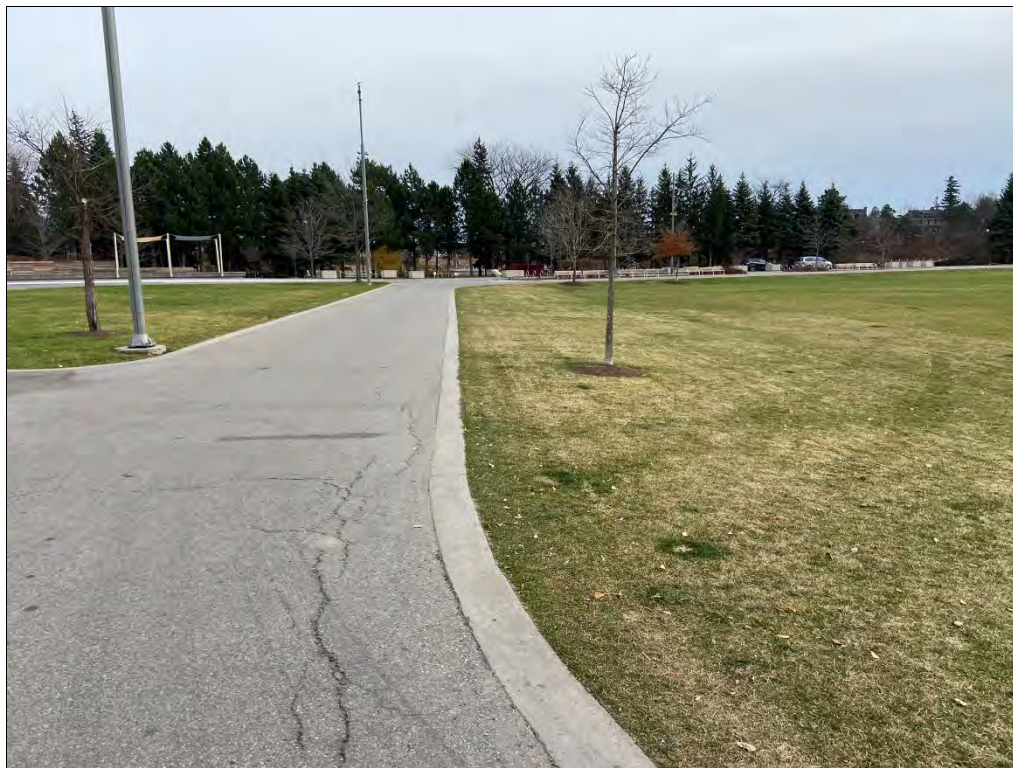
**Photo 16:**  
Former Eastern Landfill: Areas of stressed vegetation south of the ring road at the north end of the Great Lawn.

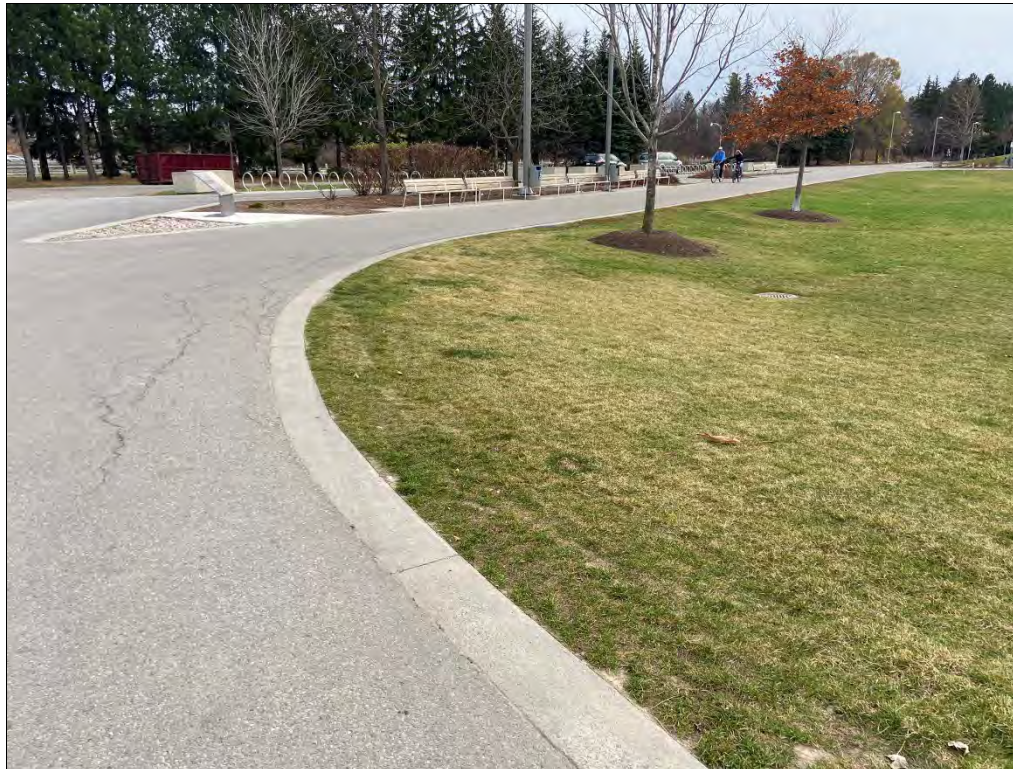
**Photo 15:**  
Former Eastern  
Landfill: Soil cover at  
the northeast east of  
the Great Lawn  
repaired in the  
Spring.

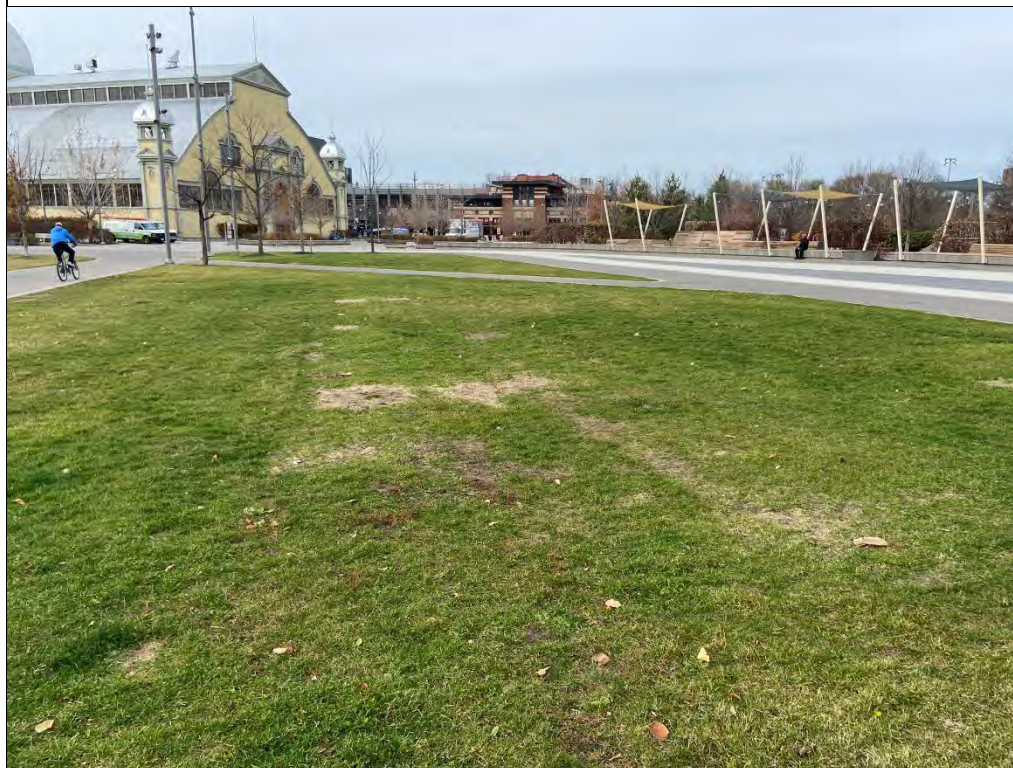
**Photo 16:**  
Former Eastern  
Landfill: Stressed  
vegetation and  
areas of bare soil  
where infrastructure  
for events is  
routinely erected  
south of the Water  
Plaza.

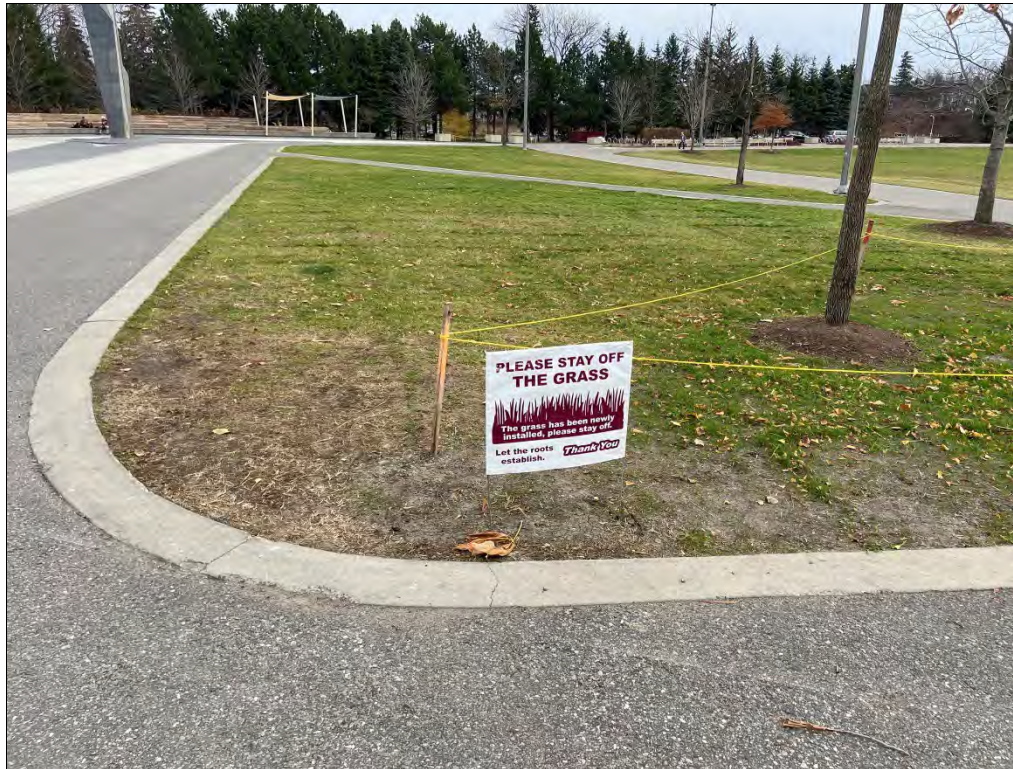
**Photo 17:**  
Former Eastern Landfill: Area of bare soil and stressed vegetation under repair southwest of Water Plaza.

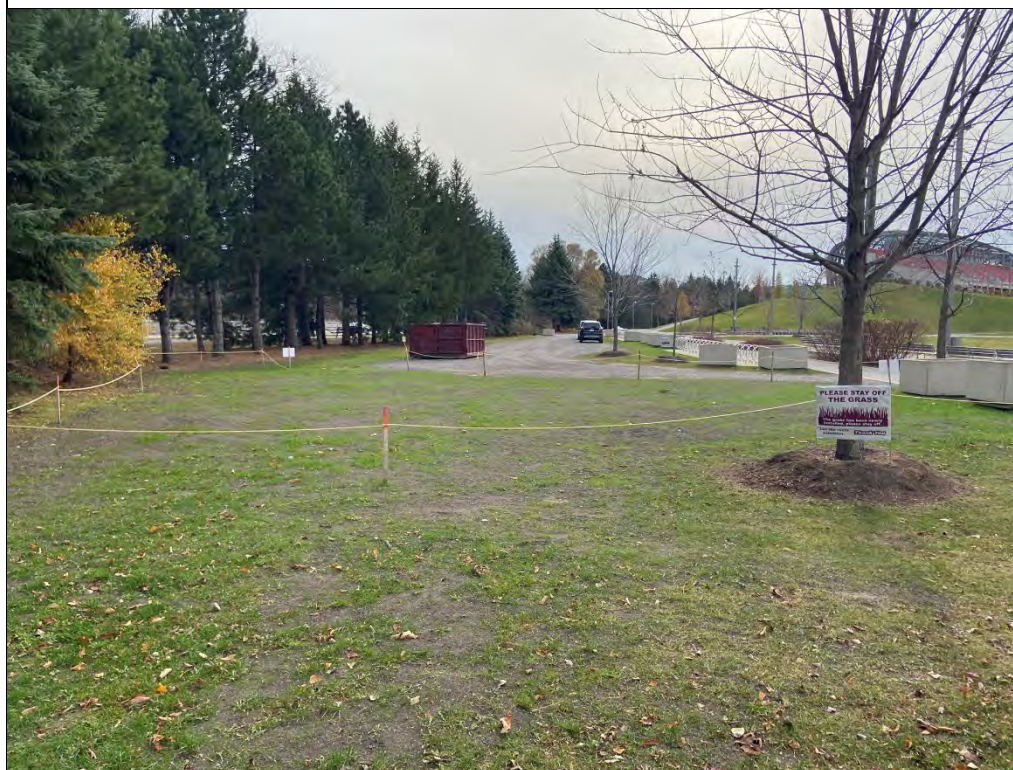
**Photo 18:**  
Former McElroy Building: Bare soil and stressed vegetation were observed in this area routinely used as a staging area for events or work at the Site. The cover is currently under repair.

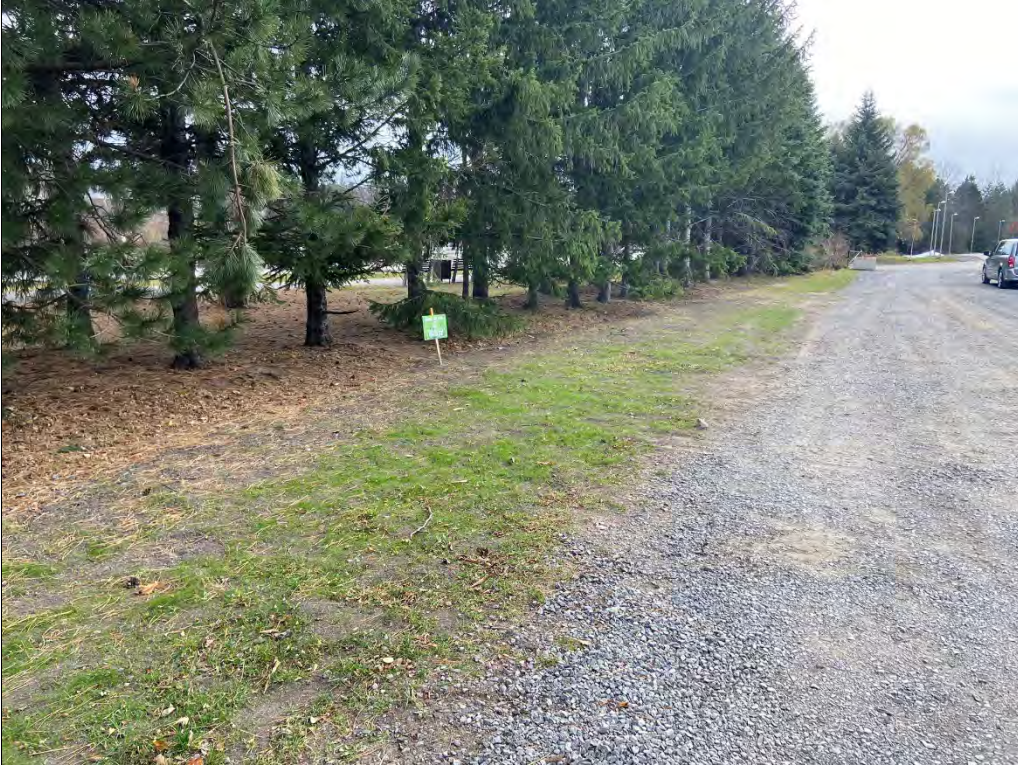
| | <p><b>Photo 19:</b><br/>Former McElroy Building/Eastern Perimeter Drainage Swale: Bare soil and stressed vegetation east of the Great Lawn. This area is routinely used as a staging area for events or work at the Site.</p> <p><b>Direction:</b><br/>Southeast</p> |

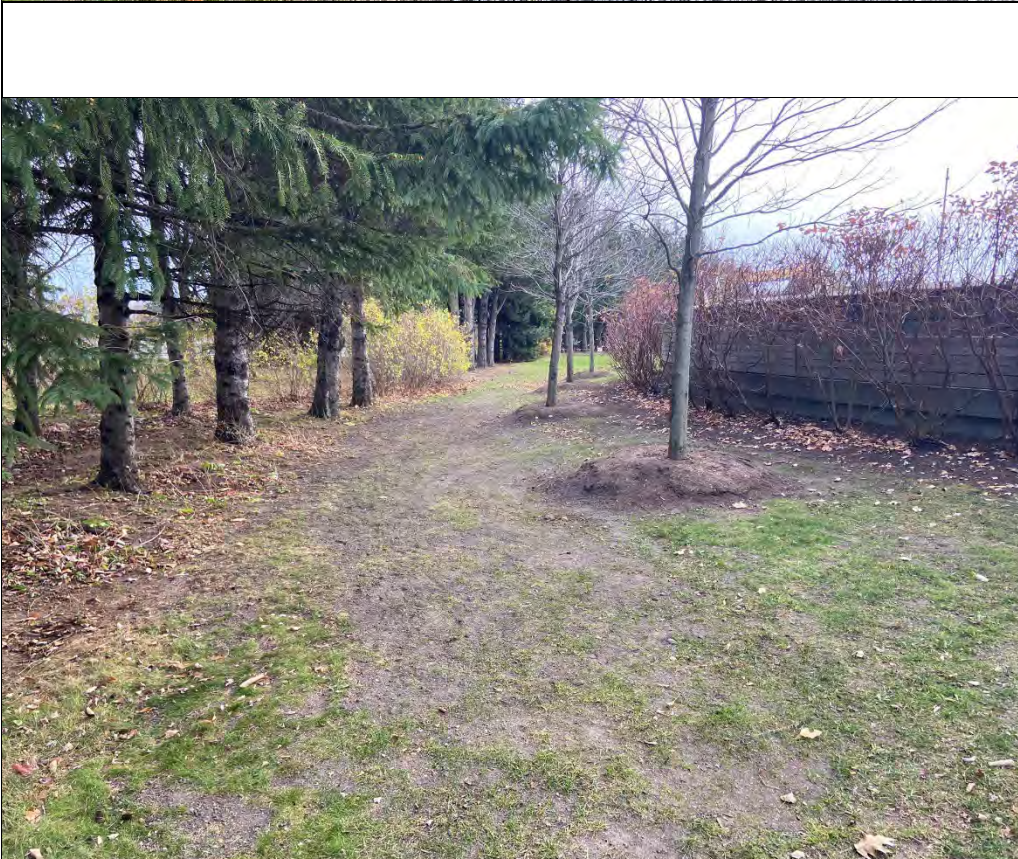
| | <p><b>Photo 20:</b><br/>Eastern Perimeter Drainage Swale: Areas of bare soil and stressed vegetation east of the Water Plaza.</p> <p><b>Direction:</b><br/>Southeast</p> |

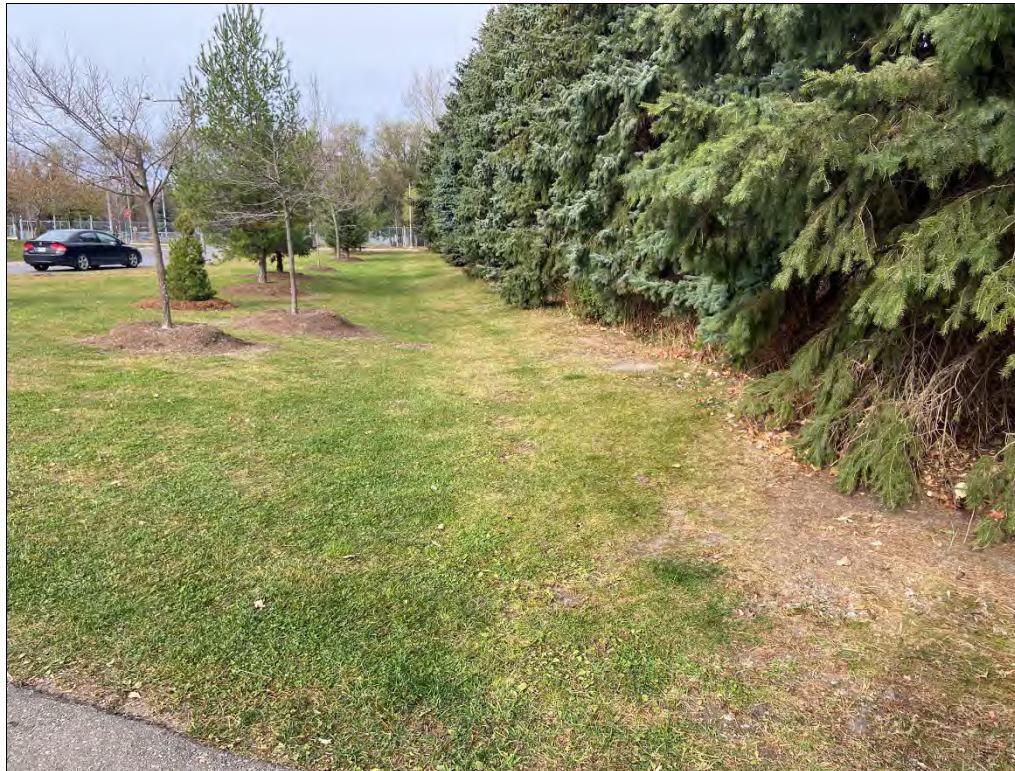
**Photo 21:**

Eastern Perimeter Drainage Swale:  
General view of the swale east of the Ice Rink and Heirloom Orchard. Small areas of bare soil were observed in the area of the utility trench previously excavated within the swale.

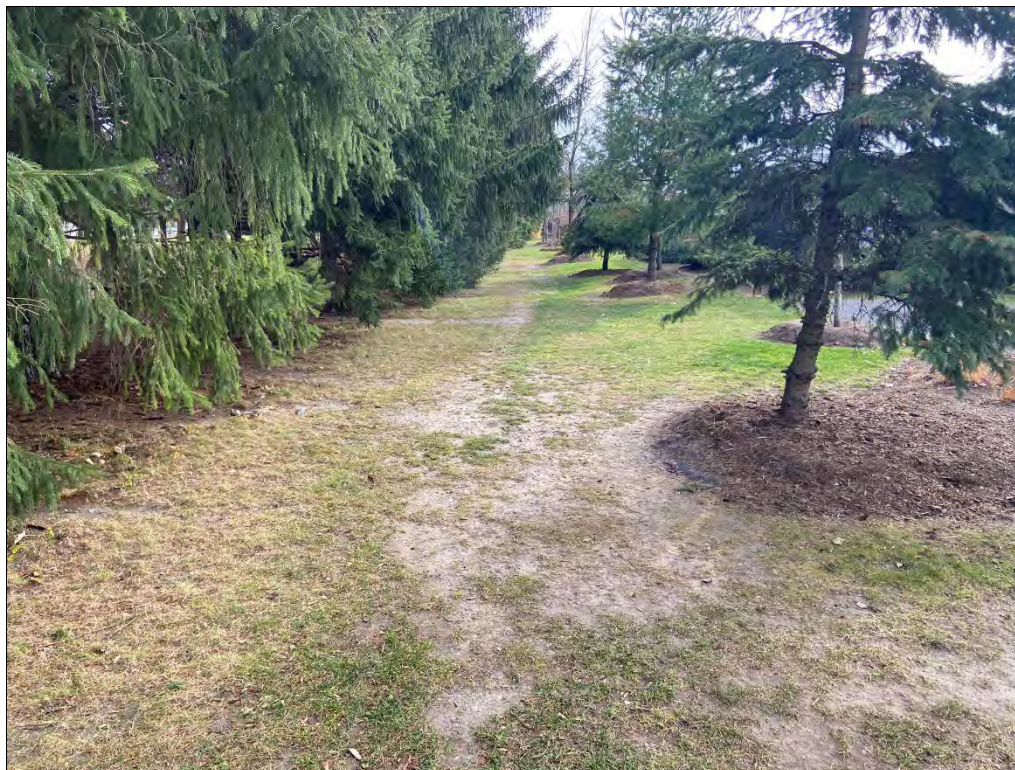
**Photo 22:**

Eastern Perimeter Drainage Swale:  
General view of the swale east of the Children's Play Area. Some areas of bare soil were observed along the property boundary.
