Transitway Station Design Safety Audit – Analysis of Findings

Final Report

OC Transpo
City of Ottawa

September 28, 2021

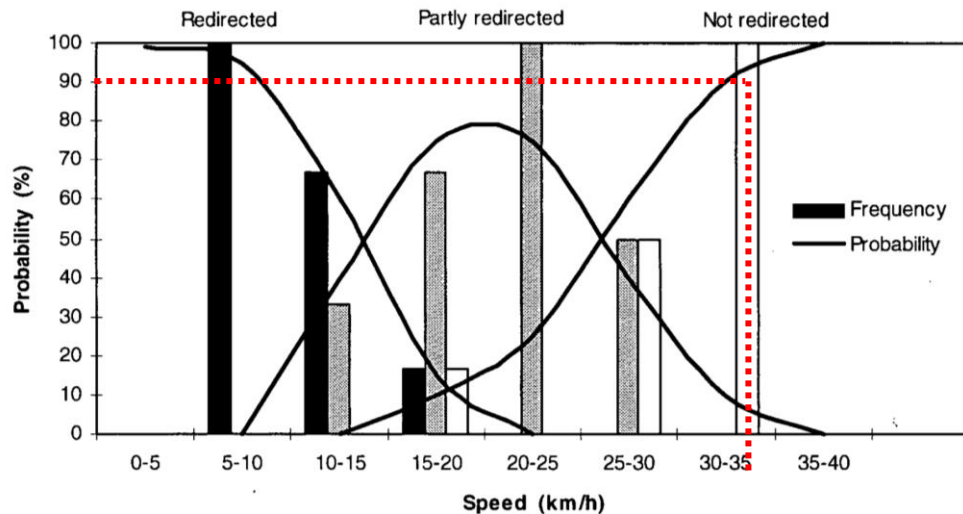
FIGURE 2: Probability of Redirection When Striking a 150 mm Barrier Curb at an Approach Angle of 5°

Whether a roadside curb is likely to redirect an errant vehicle, is dependent on many factors, including but not limited to, the curb height and shape, the angle of departure from the roadway, the vehicle speed at impact with the curb, and the vehicle specifications (mass, tire size, etc.). Full-scale tests on the redirection capabilities of 150 mm high barrier-type curbs indicates that these elements of the roadside have almost no ability to redirect errant vehicles at speeds above 26 km/h, regardless of the angle of departure (see Figure 2).⁶ Therefore, while the idea of replacing the depressed curb with a 150 mm barrier curb is intuitively appealing, the research indicates that this action is not likely to mitigate the identified safety issue.

The above assertion is also supported by the prevailing guidelines on roadside safety in Ontario⁷. These guidelines state that curbs are commonly used to control drainage, reduce maintenance operations, and delineate the travelled way, and that curbs do not have significant redirection capability. Moreover, the guidelines state, if an errant vehicle is spinning or slipping sideways an impact with a curb may cause the vehicle to become airborne or cause the vehicle to trip and rollover. In brief, the purpose of a curb is drainage and delineation – not redirection of errant vehicles. The guidelines also note that curbs are often used in low-speed urban environments to discourage drivers from *deliberately* departing a roadway. This is not an issue on the Transitway, which is closed to the general driving population.

It is recommended that OC Transpo take no action on relocating the service bay to downstream of the station due to the limited effectiveness of barrier curbs in redirecting errant vehicles. It is also recommended that, when the station is reconstructed, the guidelines for service bay placement and design conform to the prevailing best practices.

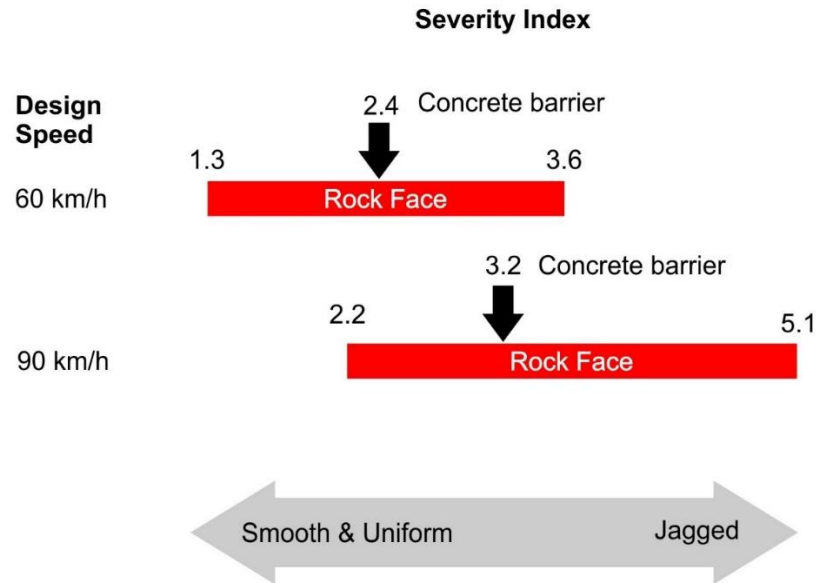
FIGURE 3: Severity Indices for Rock Cuts and Concrete Barriers

A jagged rock face increases the potential for higher severity crash in the event that an errant vehicle makes contact with the rock face. However, it is not axiomatic that an exposed rock face is a more severe hazard than a concrete barrier located 1.0 metres from the travelled way. According to the Roadside Design Guide the severity indices for rock cuts and concrete barriers are as shown in Figure 3.⁹

Whether the concrete barrier is a less severe hazard than the rock face is very much dependent on the smoothness of the rock face. The difference between smooth and jagged is not defined in the Roadside Design Guide. Moreover, because the proposed concrete barrier would be located closer to the Transitway, the barrier would result in a higher frequency of crashes than the exposed rock face. Hence, installing a traffic barrier may be detrimental to safety if crashes with the rock face are infrequent.

⁹ A severity index is a number from zero to ten used to categorize the potential severity of an encroachment or impact by an errant vehicle for a range of design speeds over a variety of surfaces and slopes, fixed objects and natural features within the roadside environment. The number is used for evaluating alternative safety treatments. A severity index of 10 indicates that impact with the roadside object will almost certainly result in a fatal crash; a severity index of 0 suggests the likely outcome of any crash will be property damage only.

The initial condition was assumed to have a jagged rock face with a severity index of 5.1, while the scaled rock face was assumed to be smooth, with a severity index of 2.2. Based on the above parameters, the crash frequency is (as expected) greatest when a concrete barrier is placed adjacent to the Transitway to shield the rock face. Furthermore, while the severity of the crashes decreases when compared to the existing condition, the cost of installing the barrier, and the limited service life of the Transitway at this location (less than one year, according to City staff), makes the installation of the barrier economical unattractive (i.e., the benefit-cost ratio is less than 1.0). Similarly, the cost of scaling the rock has to be less than \$77.50/linear metre of rock face in order for the benefit-cost ratio to be favourable. This unit price seems highly unlikely.

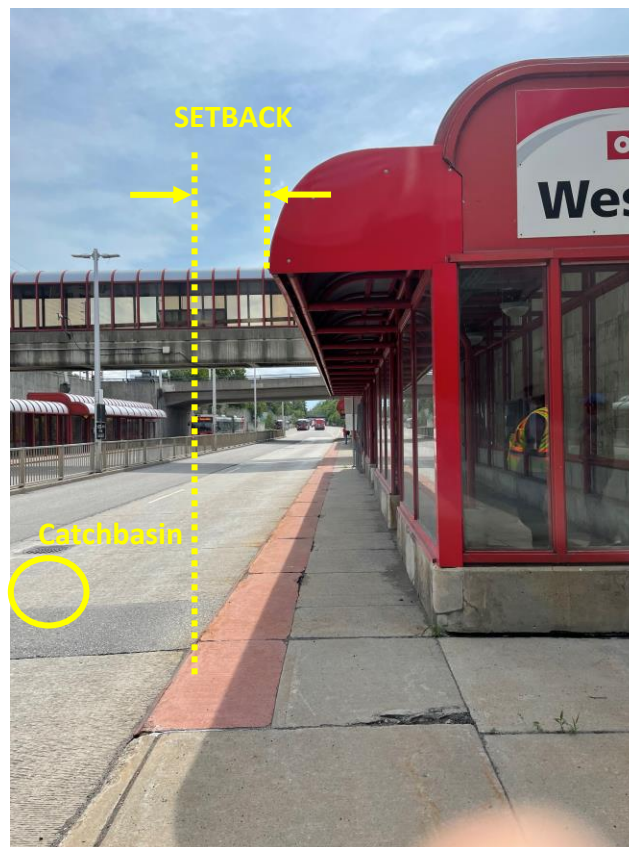
FIGURE 4: Westboro Station Canopy

The edge of the canopy is actually set back about 0.5 metres from the face of the Transitway curb and rain/snow is deposited onto the station platform (and not directly onto the Transitway). The drainage system of the station is purposely designed so that surface water from the platform is drained onto the Transitway towards the median (see Figure 4). Unless the proposed eavestrough is directed to an underground pipe that is connected to a subdrain, the eavestrough would simply concentrate the roof runoff at a single point, creating a potentially more dangerous condition.

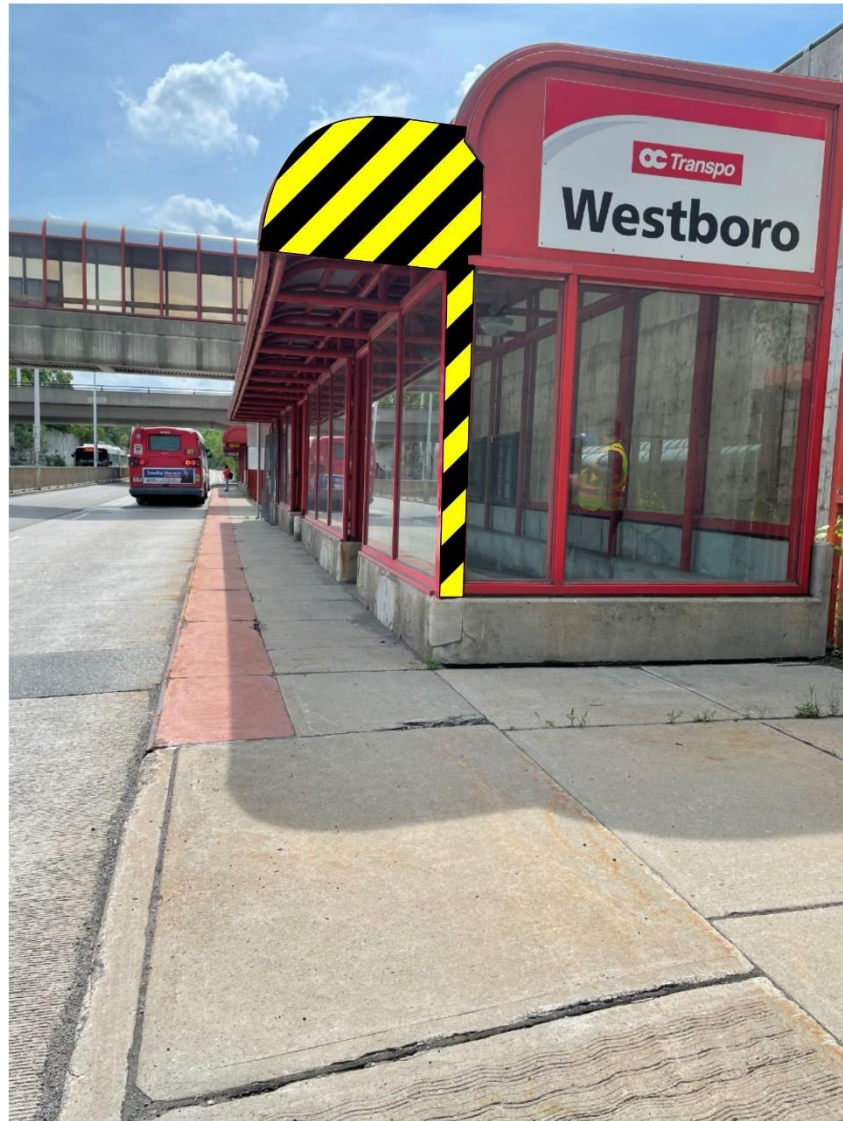
FIGURE 5: Proposed Object Markings

OBJECT MARKER (Wa-33). However, with structures that are located within the clear zone, the OBJECT MARKER is usually replaced with alternating yellow and black diagonal markings placed directly on the structure (see Figure 5). Markings such as those shown in Figure 5 are a reasonable mitigation measure.

It is recommended that, rather than remove the canopy or reduce the operating speed of buses to 20 km/h, OC Transpo mark the canopy with black and yellow striped markings similar to those used on low clearance structures (see Figure 5).

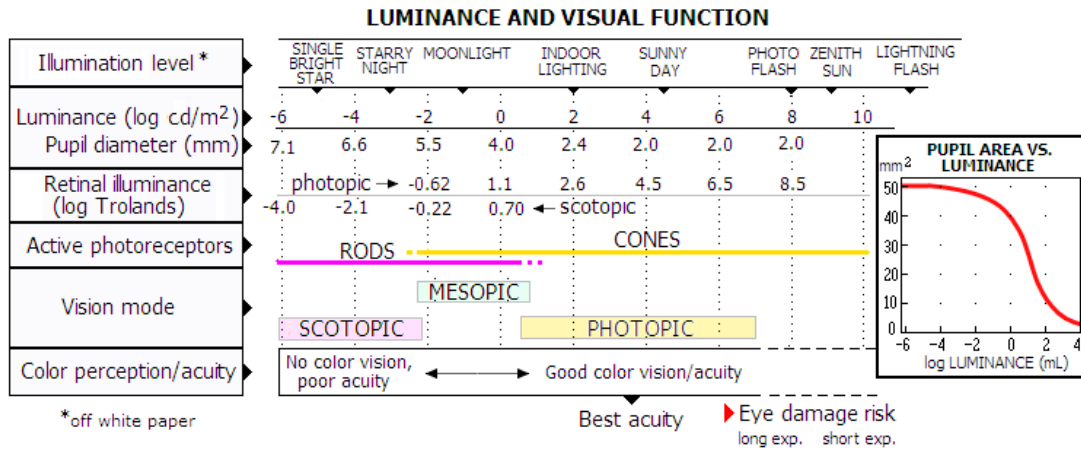
FIGURE 6: Luminance and Visual Function

to light). Different photoreceptors are used in light and dark conditions respectively, and a rapid transition can cause periods of temporary visual impairment as the eye switches from one type of photoreceptor to the other type (see Figure 6).

The ambient light in the shadow of the pedestrian bridge, even on the brightest day, is still likely to be in the range of typical indoor lighting. This being the case, operators on the Transitway would still be using photopic vision and visual impairment due to light adaption is not likely.
