## **Appendix D – City Stream Watch and RVCA Reports**

# Mud Creek 2014 Summary Report

In 2014, permission was granted to survey 78 sections (7.8 km) of Mud Creek as part of the City Stream Watch monitoring activities. The following is a summary of observations made by staff and volunteers along those 78 sections.

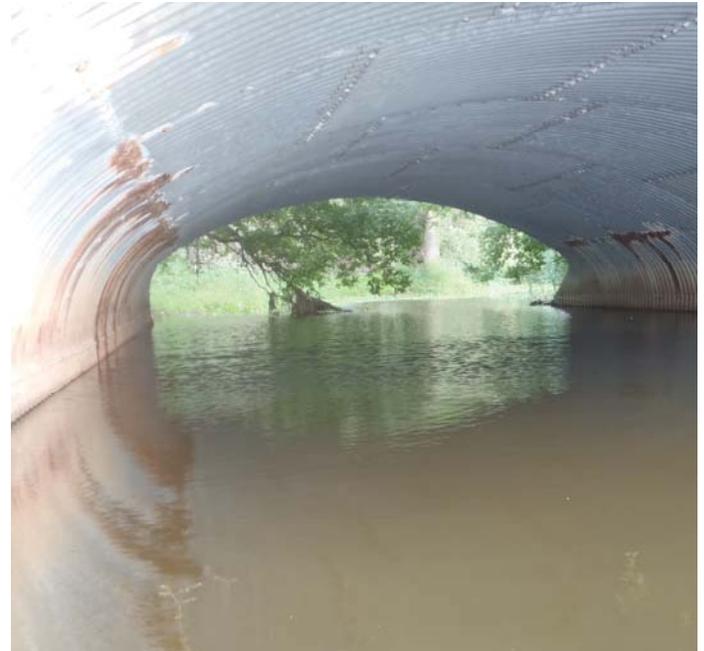
A highly altered section of Mud Creek which runs through a culvert

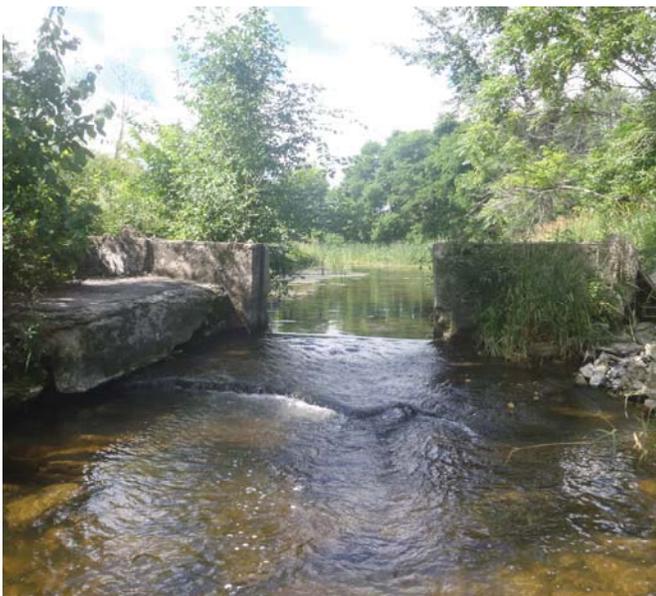
A seasonal weir observed along Mud Creek

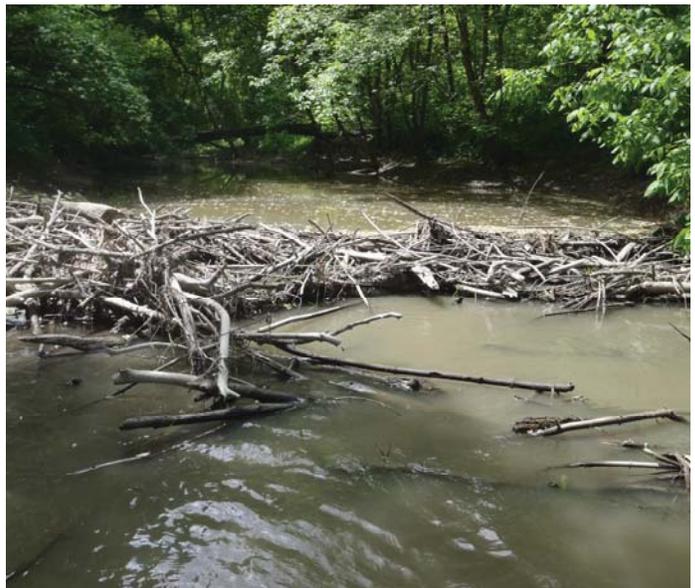
An abandoned beaver dam observed on Mud Creek

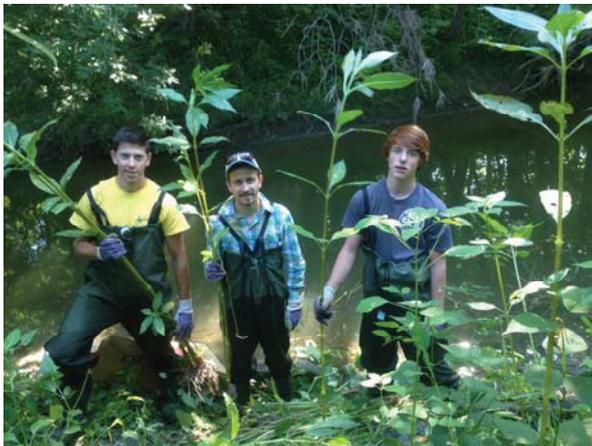
A patch of Himalayan Balsam was observed during stream surveys this year on Mud Creek. City Stream Watch staff returned to the site with one volunteer for three hours to remove the plants. Ten paper yard waste bags were filled with Himalayan Balsam plants and 50m of shoreline was successfully cleared of the invasive species before it spread any further along the stream banks.

Volunteer and staff removing Himalayan Balsam along Mud Creek
