**Re: 2021 Annual Report, Certificate of Property Use (CPU 0371-8TYQMY)  
Lansdowne Park, Urban Park (Zone C)  
450 Queen Elizabeth Drive (Part of 945 Bank Street),  
Ottawa, Ontario**

# 2021 Annual Report - Certificate of Property Use No. 0371-8TYQMY

Lansdowne Park- Urban Park (Zone C)  
450 Queen Elizabeth Driveway (Part of 945 Bank Street), Ottawa, Ontario  
Project No. TZ10100106

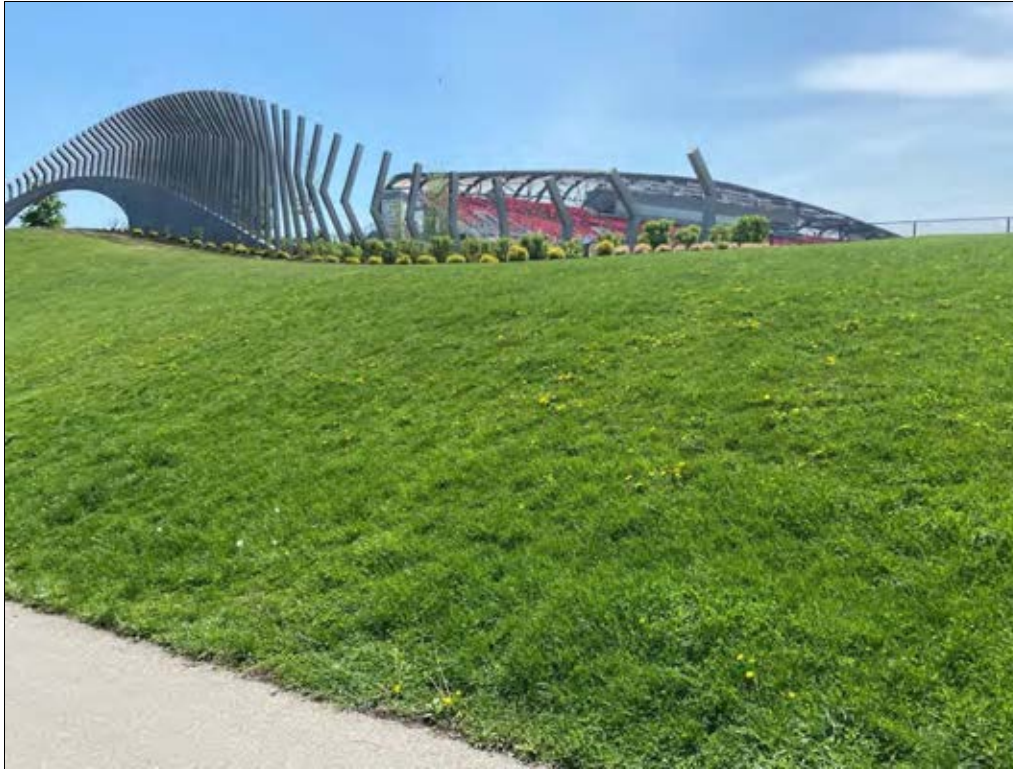
**Photo 1:**

East Berm: General view of the east side of the berm.

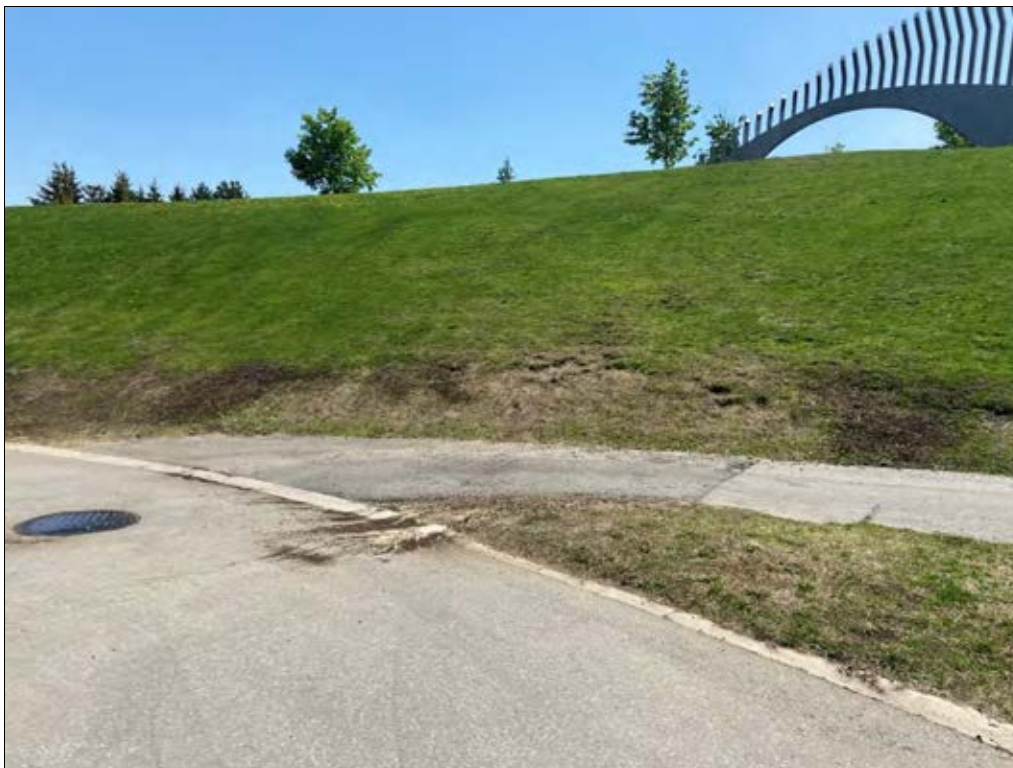
**Photo 2:**

East Berm: Small areas of bare soil were observed on steeper sloped areas along the pedestrian pathway on the east side of the berm.

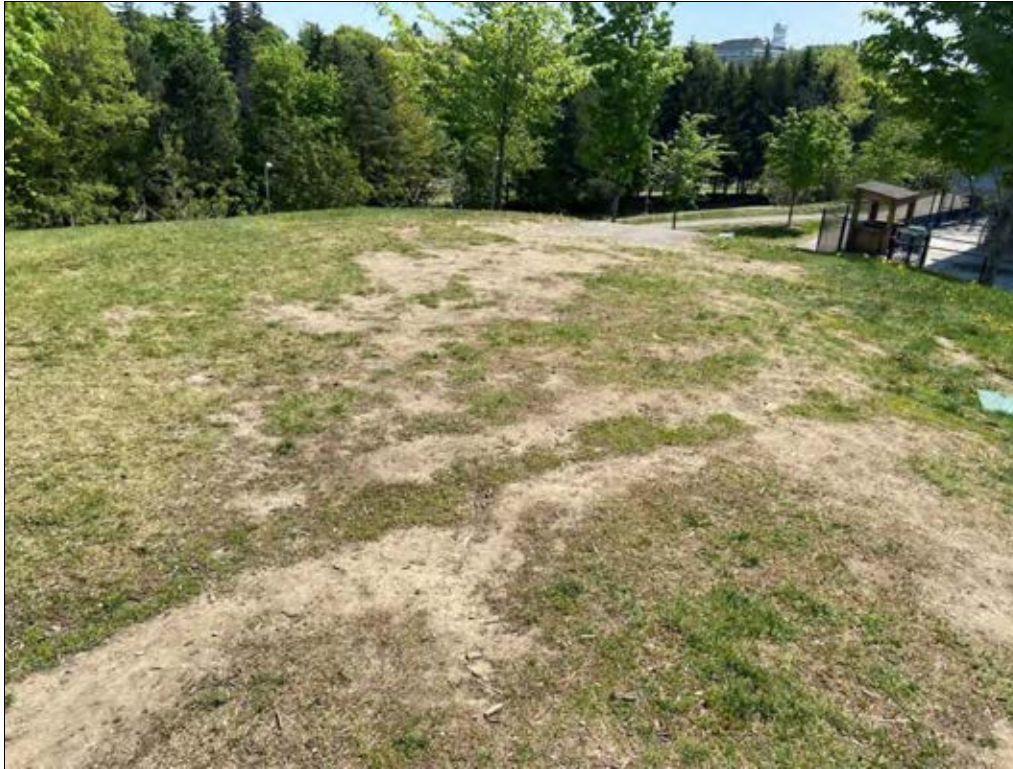
**Photo 3:**

East Berm: Areas of bare soil were observed at the top of the berm east and west of the Art Screen.

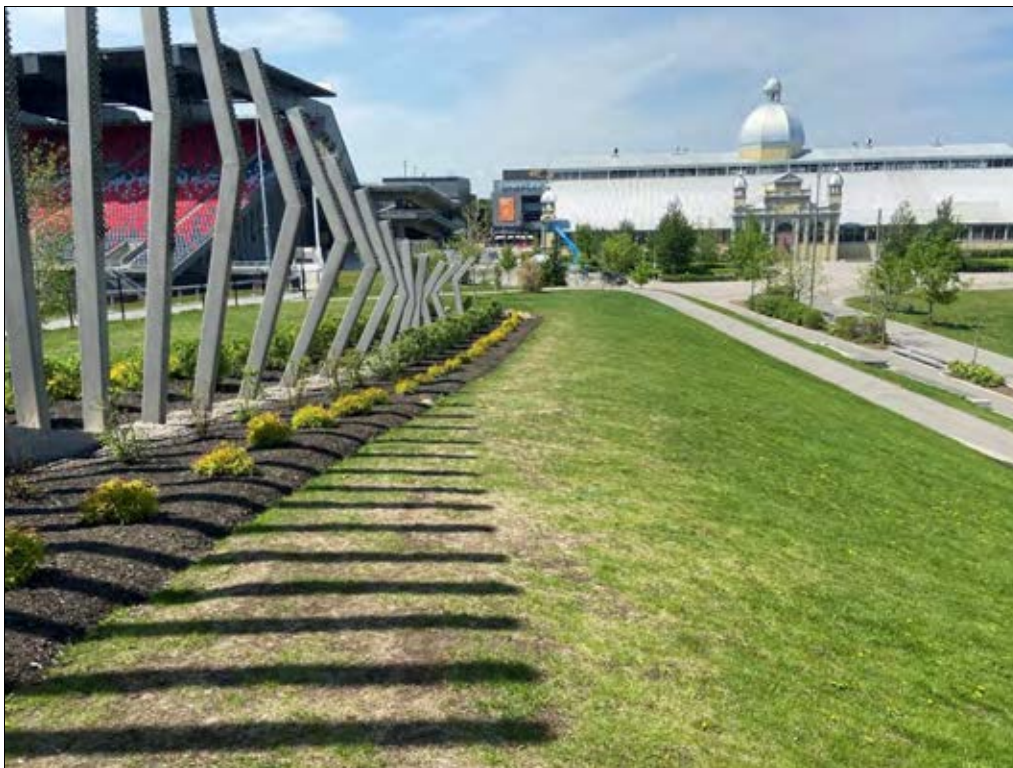
**Photo 4:**

East Berm: Bare soil and stressed vegetation were observed on the flat areas east of the Art screen inferred to be from foot traffic.

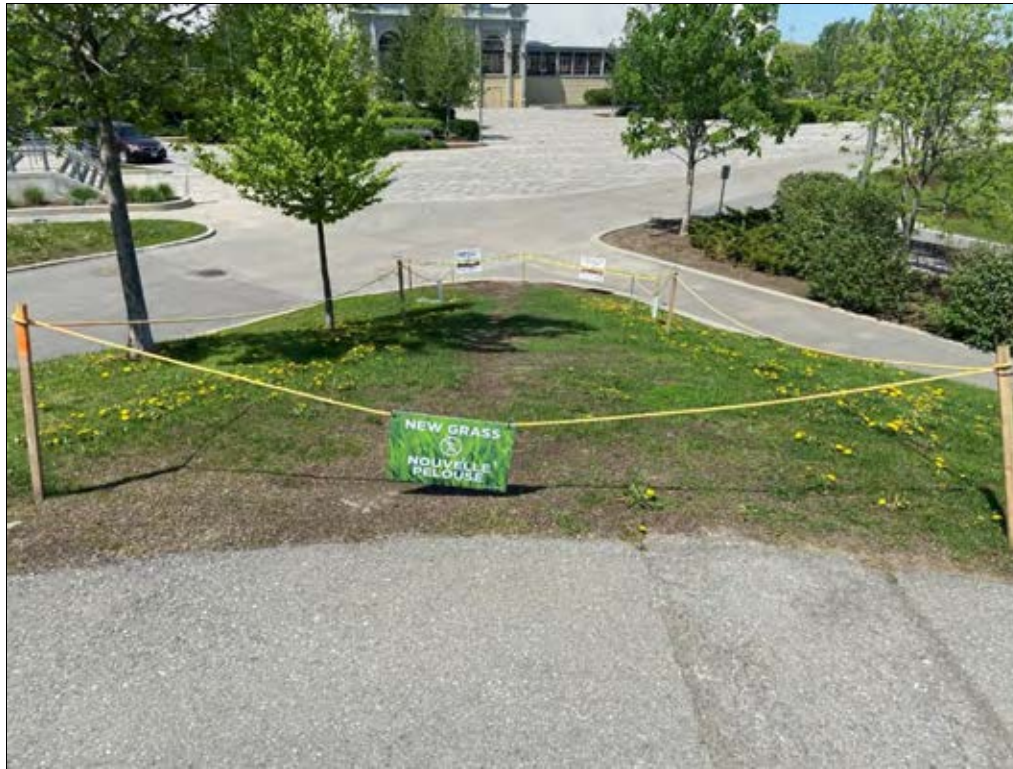
**Photo 5:**

East Berm: The area north of the pedestrian path at the north end berm had been reseeded.

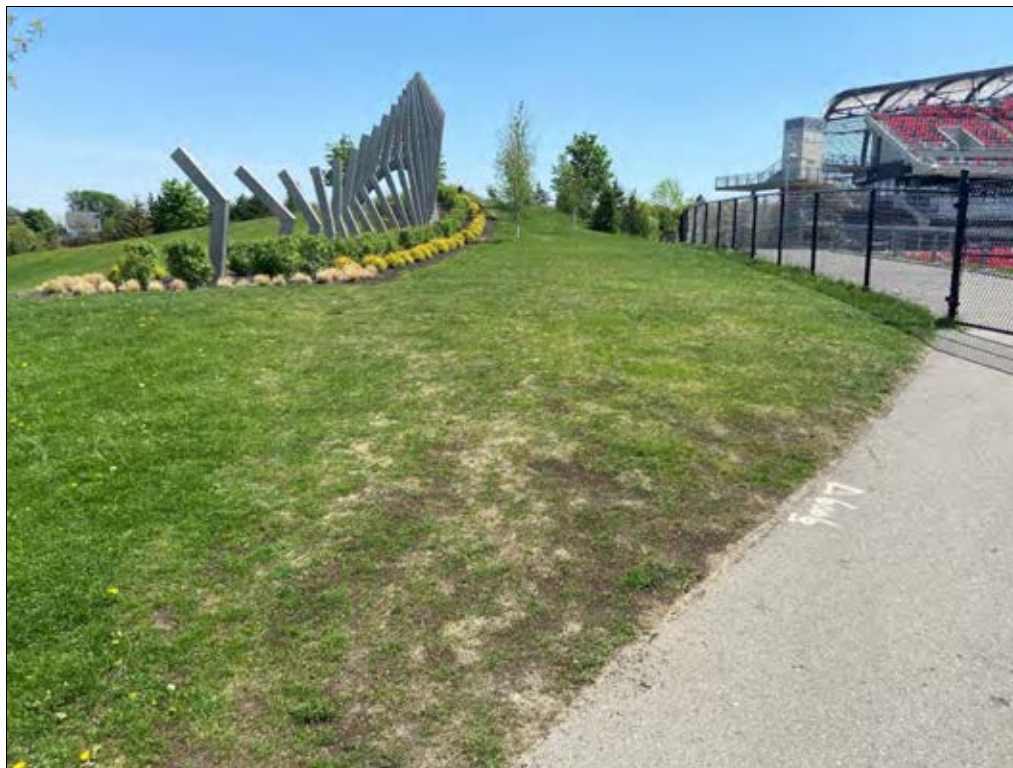
**Photo 6:**

East Berm: Area of bare soil and stressed vegetation at the north end of the Art screen inferred to be from foot traffic.

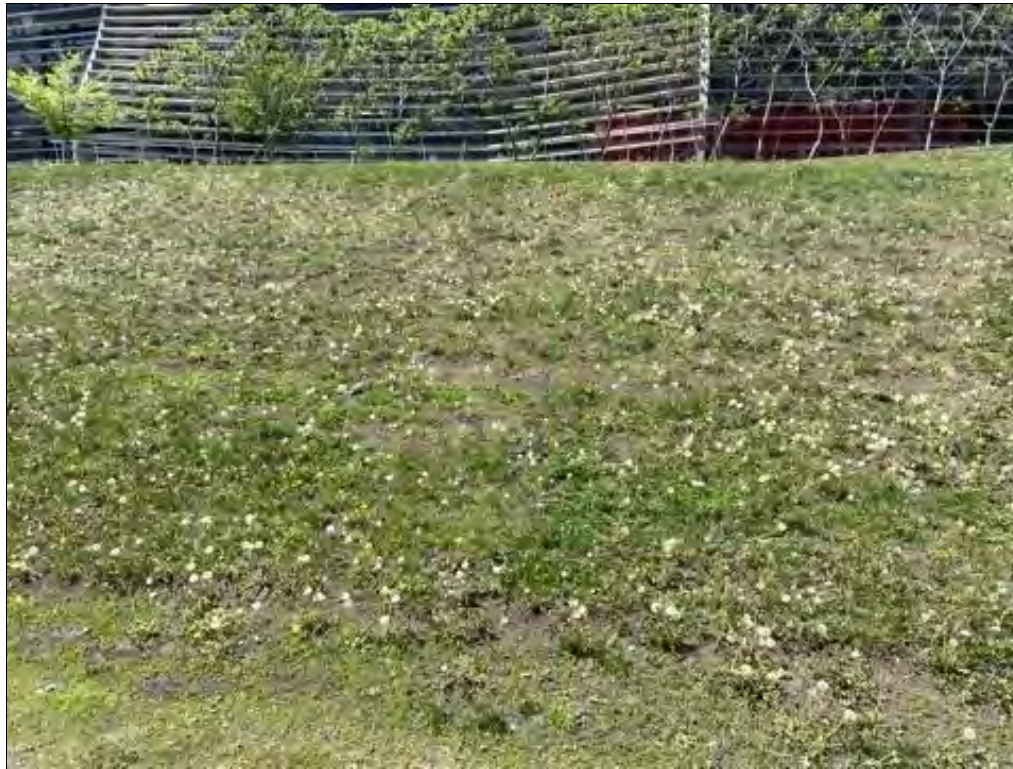
**Photo 7:**

South Berm: General view of berm conditions. Areas of bare soil were observed throughout the berm.

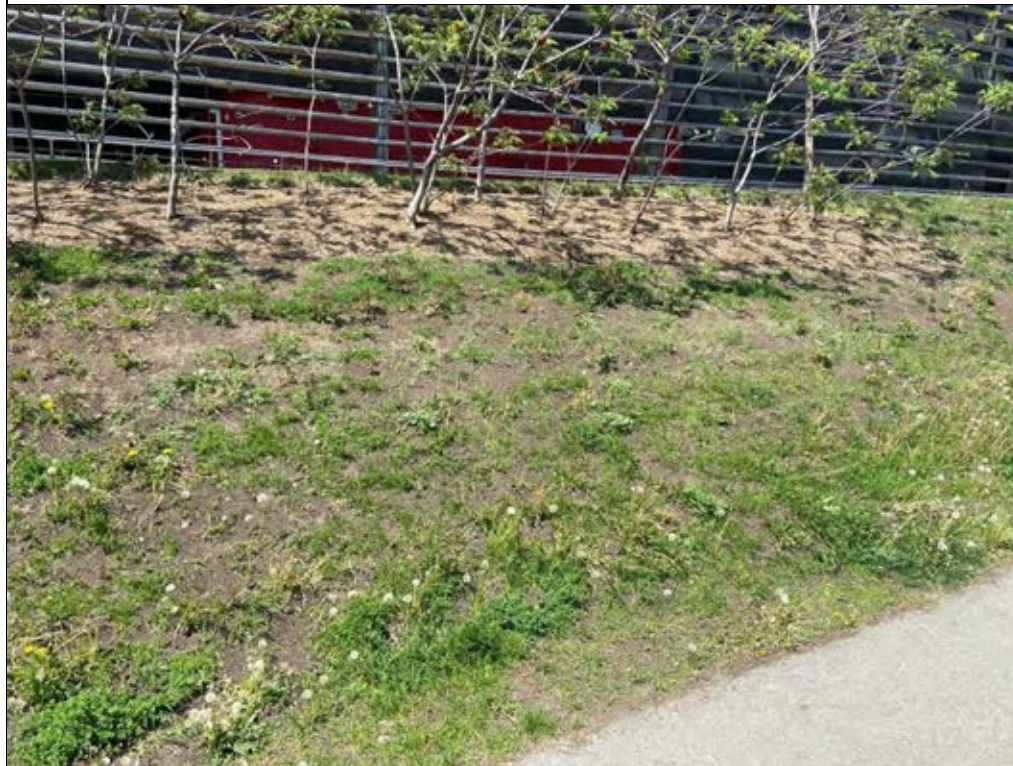
**Photo 8:**

South Berm: Bare soil observed on the western portion of the berm near the top.

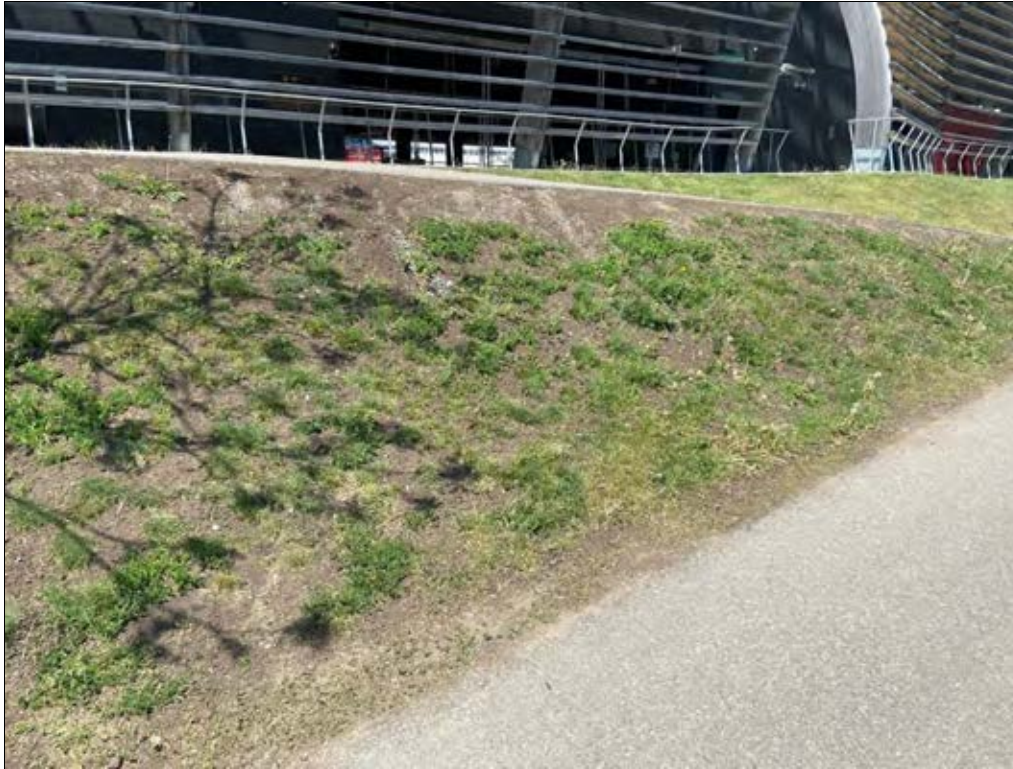
**Photo 9:**

South Berm: Clumps of soil eroding from areas near the top of the of the central portion of the berm.

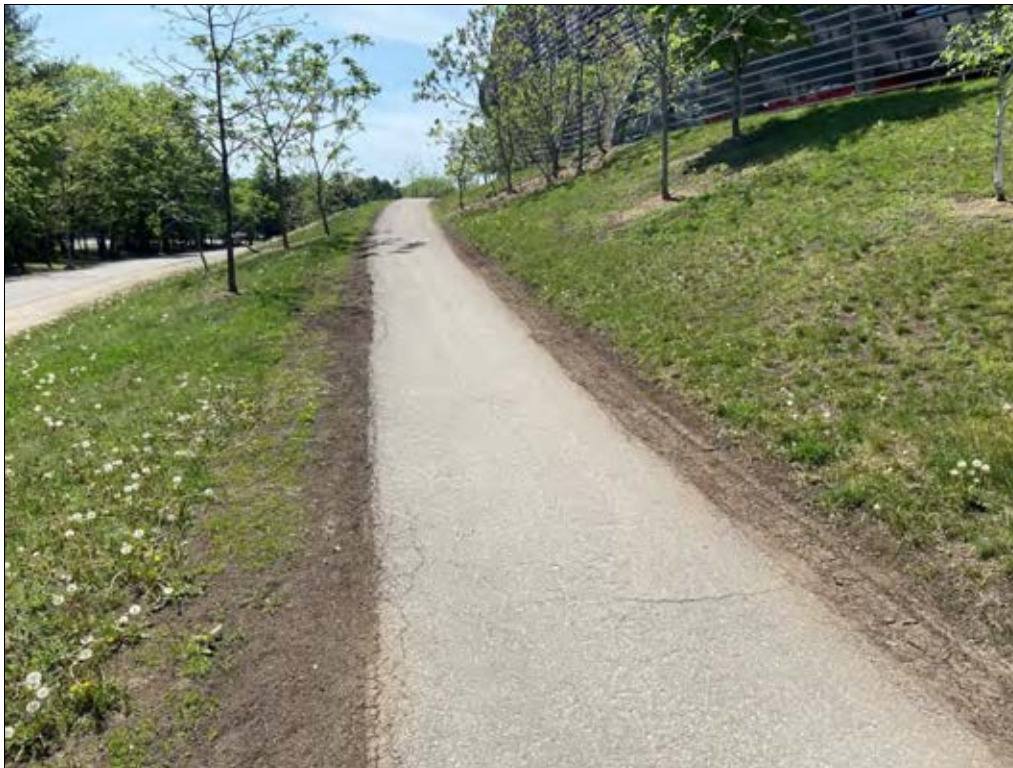
**Photo 10:**

South Berm: Areas of bare soil and tire ruts along paths on the berm.

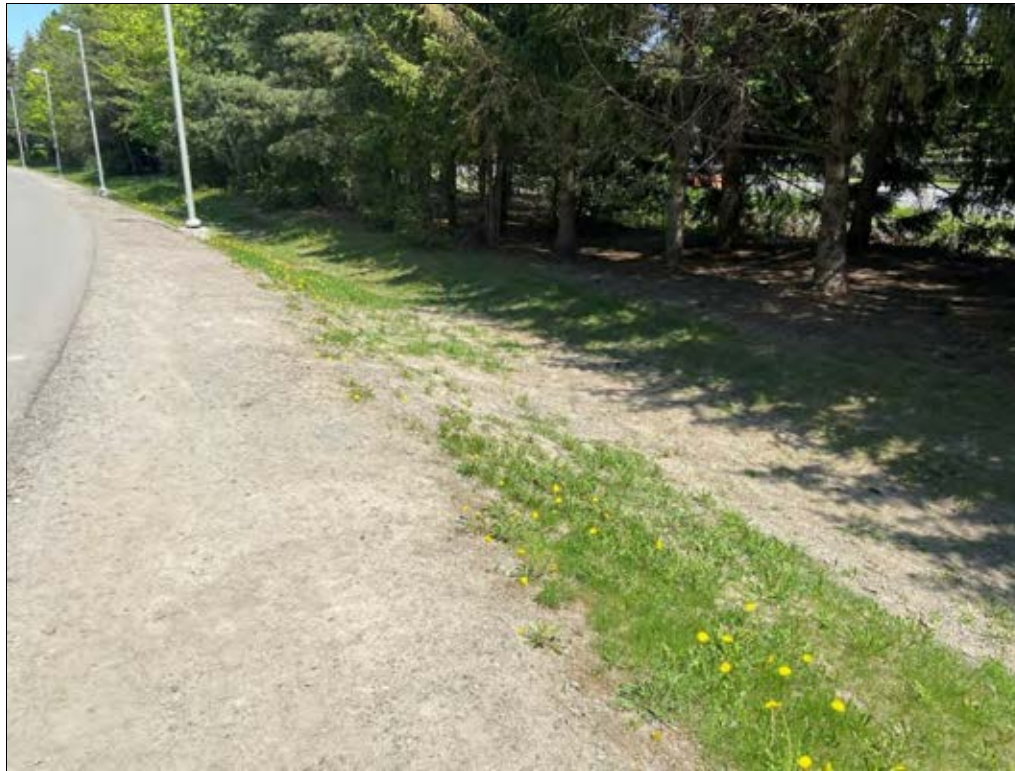
**Photo 11:**  
South Drainage  
Swale: General view  
of the swale. Road  
base material has  
eroded into the  
swale.

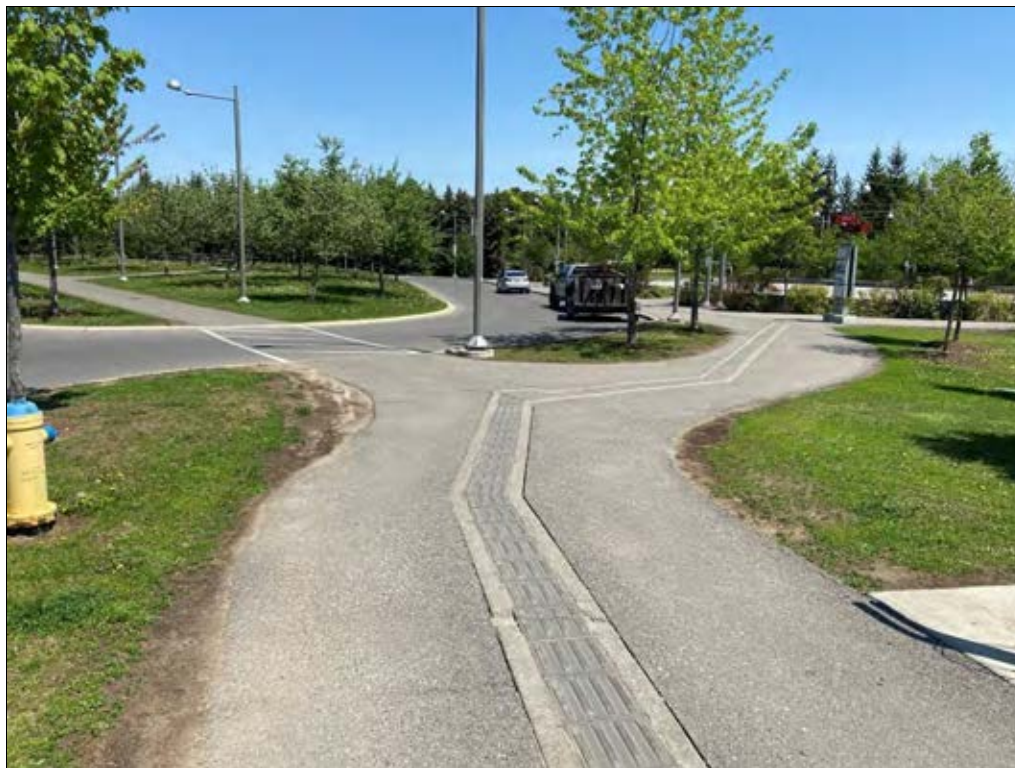
**Photo 12:**  
Former Eastern  
Landfill: Bare soil and  
stressed vegetation  
along pathways at  
the north end of the  
former landfill west  
of the Orchard.

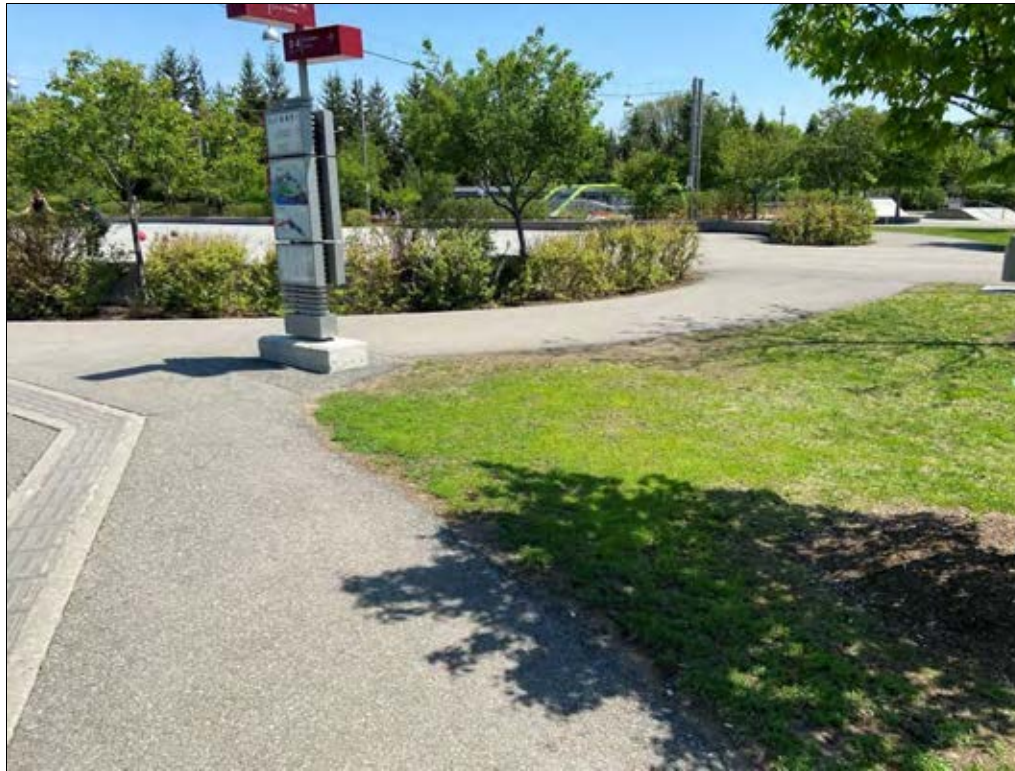
**Photo 13:**  
Former Eastern  
Landfill: Small areas  
of bare soil and  
stressed vegetation  
along the paths  
around the ice rink.

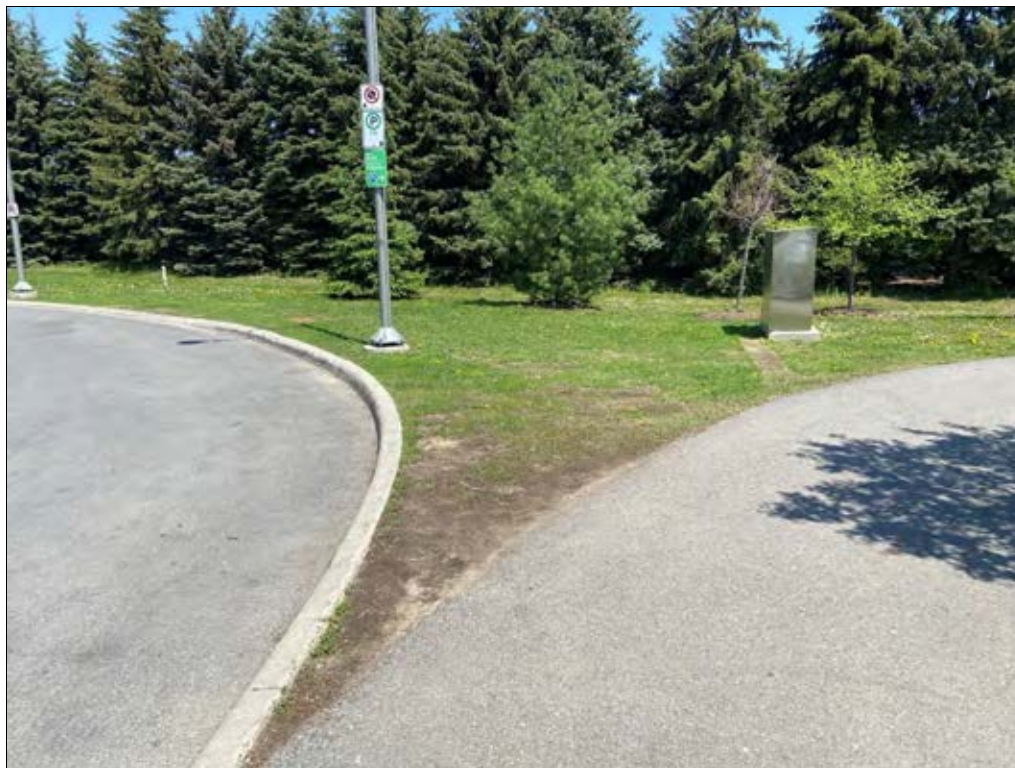
**Photo 14:**  
South Drainage  
Swale: Area of bare  
soil in high traffic  
area north of the ice  
rink.

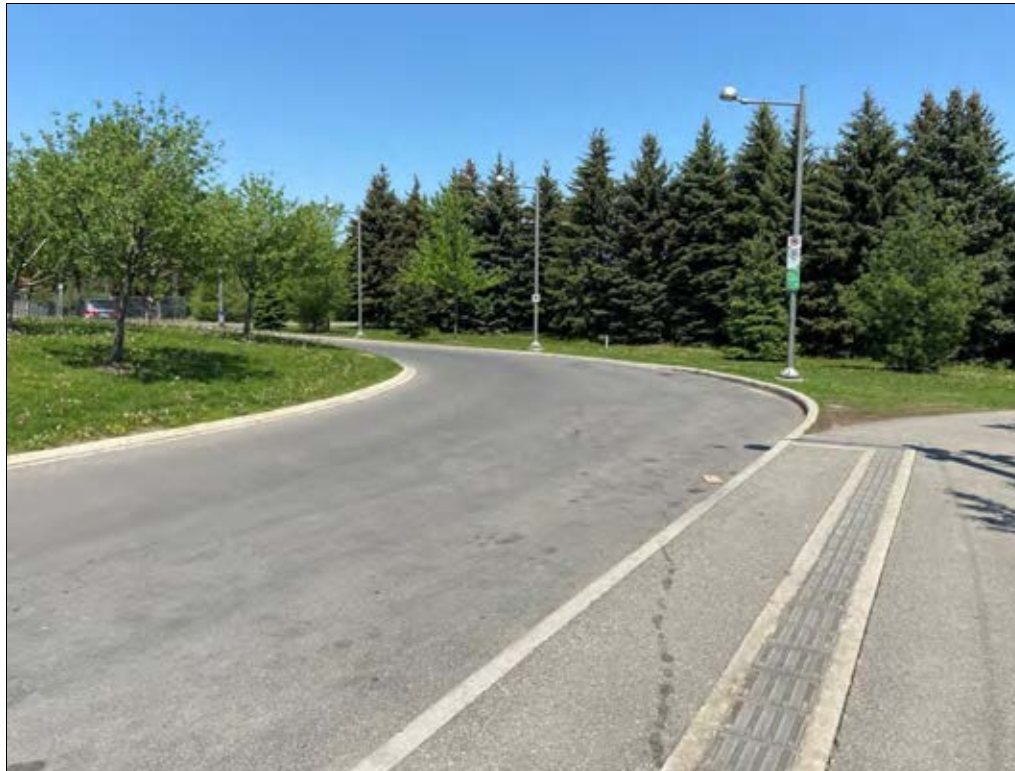
**Photo 15:**

Former Eastern Landfill: The cover in the area of the Orchard is in good condition.

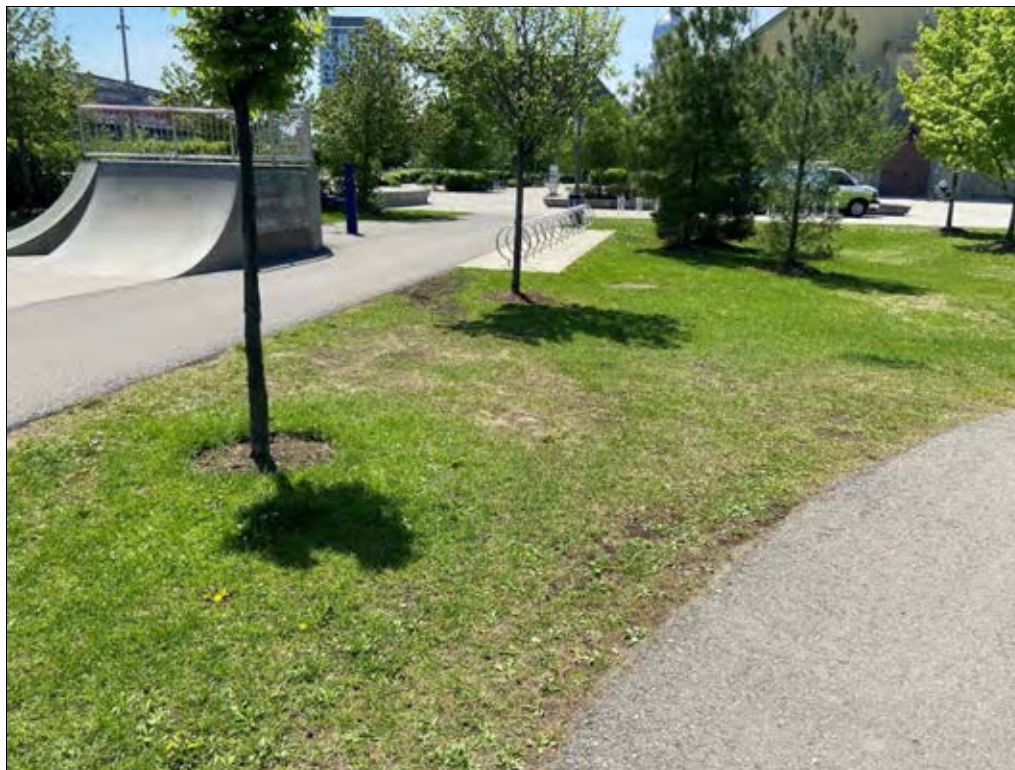
**Photo 16:**

Former Eastern Landfill: Small areas of bare soil and stressed vegetation were observed in high traffic areas around the Skate Park and Children's Garden.

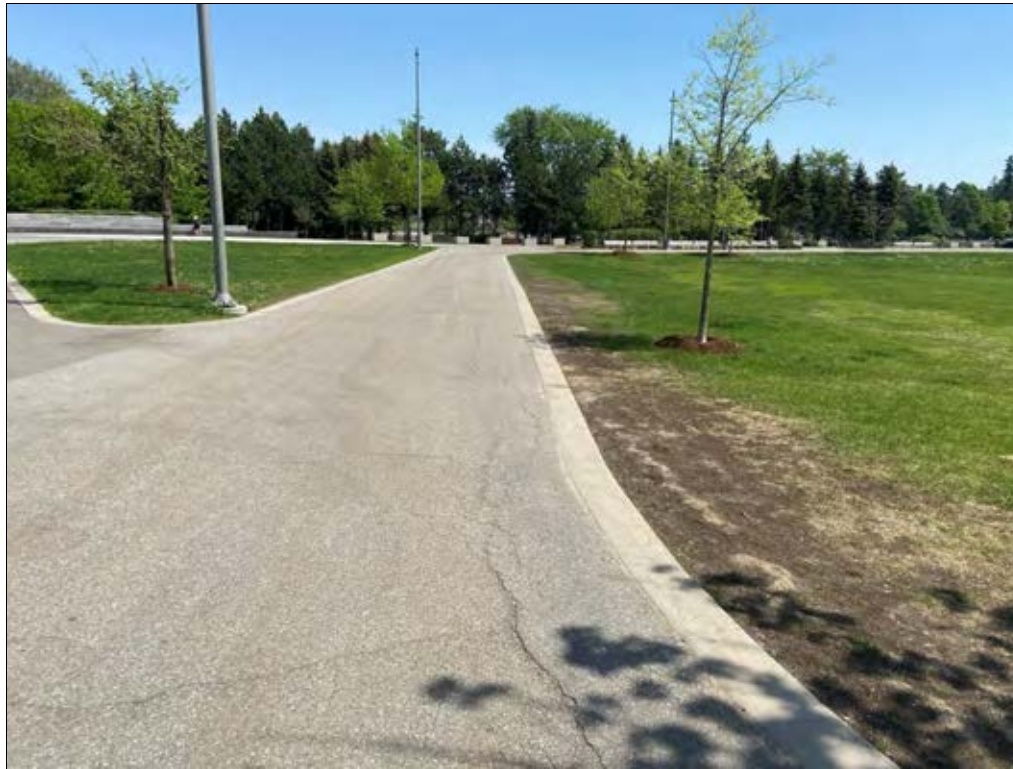
**Photo 17:**  
Former Eastern  
Landfill: Areas of  
bare soil and  
stressed vegetation  
south of the ring  
road at the north  
end the Great Lawn.

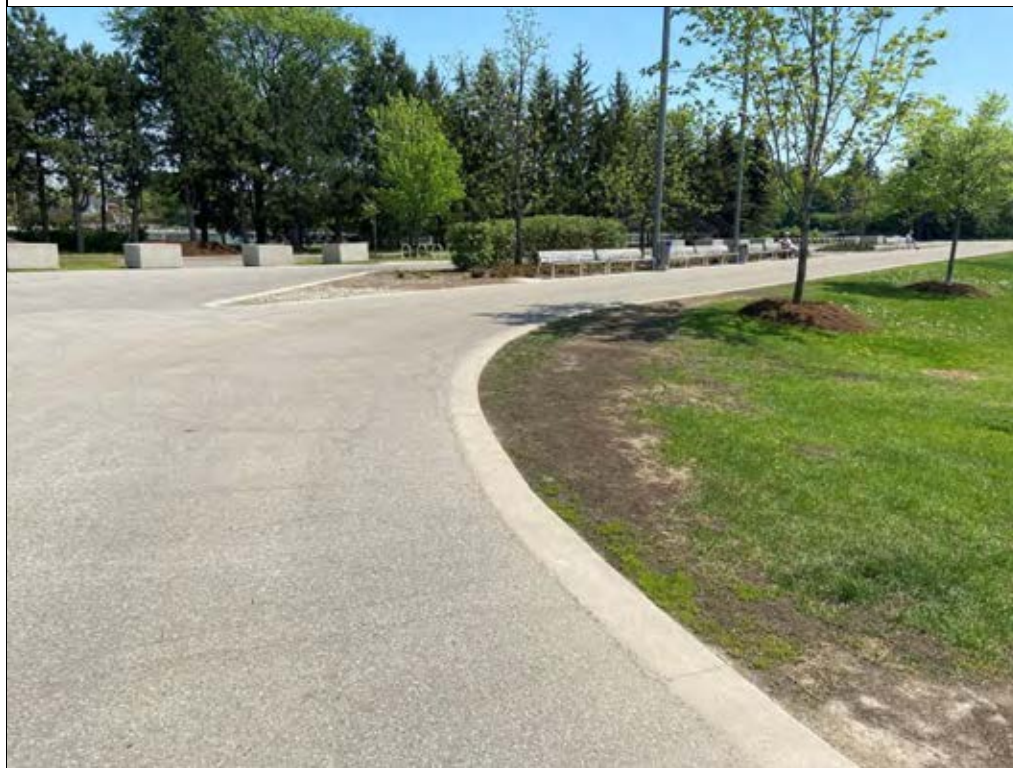
**Photo 18:**  
Former Eastern  
Landfill: Area of bare  
soil and stressed  
vegetation at the  
northeast end of the  
Great Lawn.

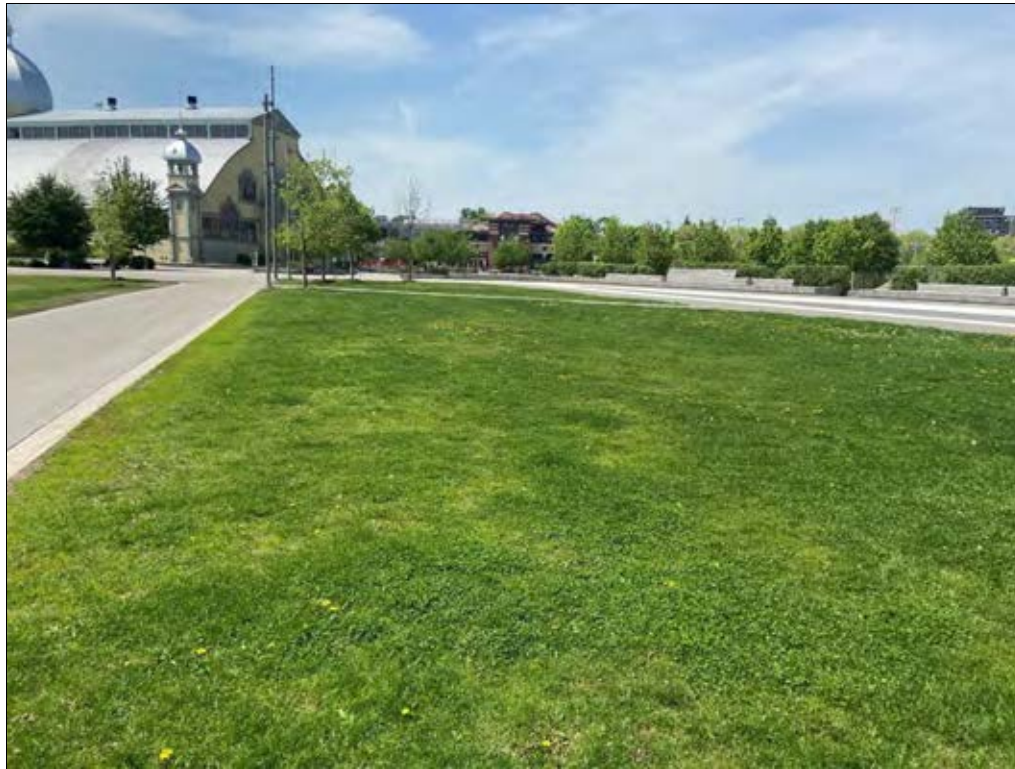
**Photo 19:**

Former Eastern Landfill: The soft landscaped area south of the Water Plaza are in fair to good condition.

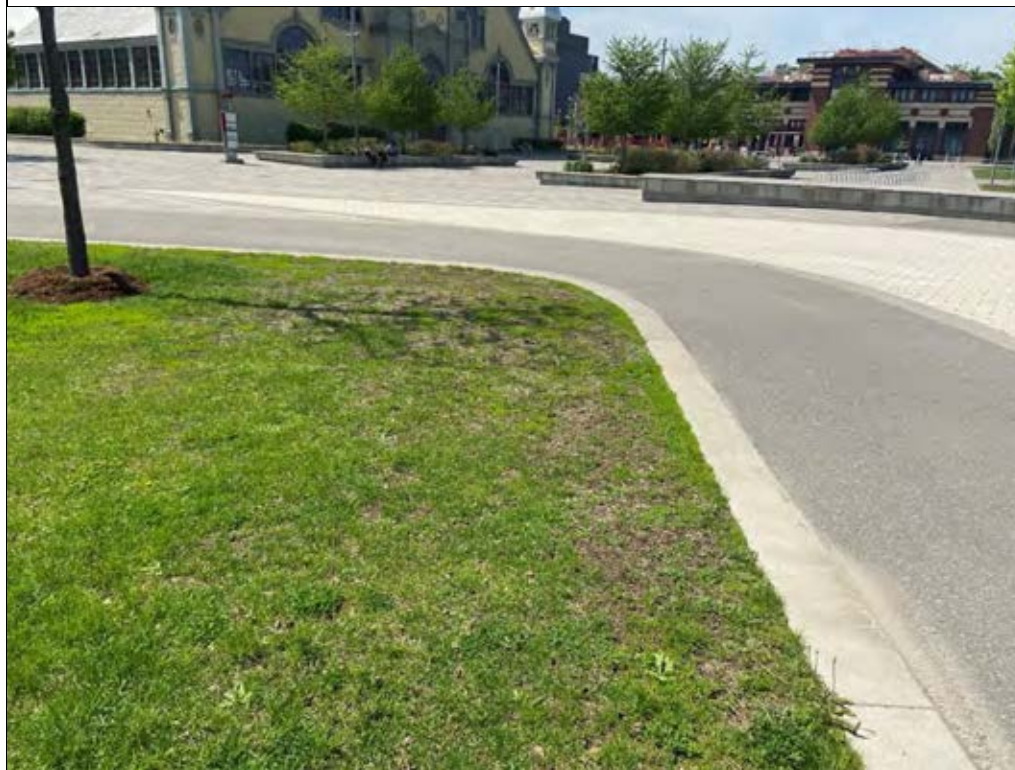
**Photo 20:**

Former Eastern Landfill: Area of bare soil and stressed vegetation southwest of Water Plaza.

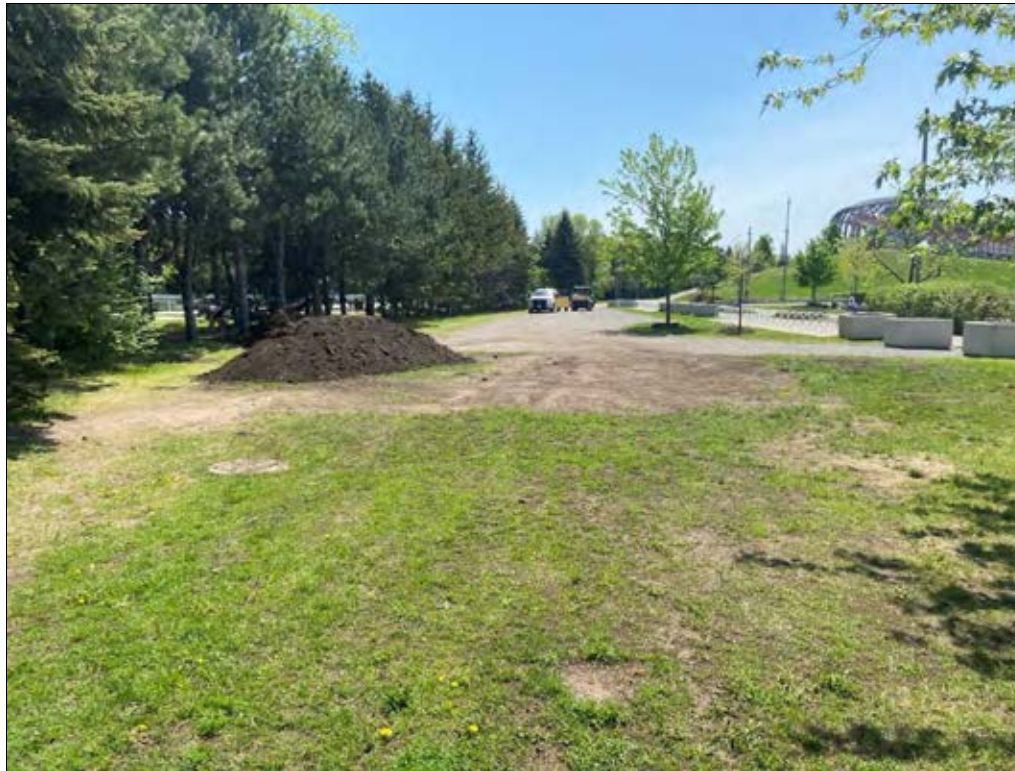
**Photo 21:**

Former McElroy Building: This area is used as a staging area for vehicles and material. Bare soil and stressed vegetation was observed in areas as used to stockpile landscaping materials.

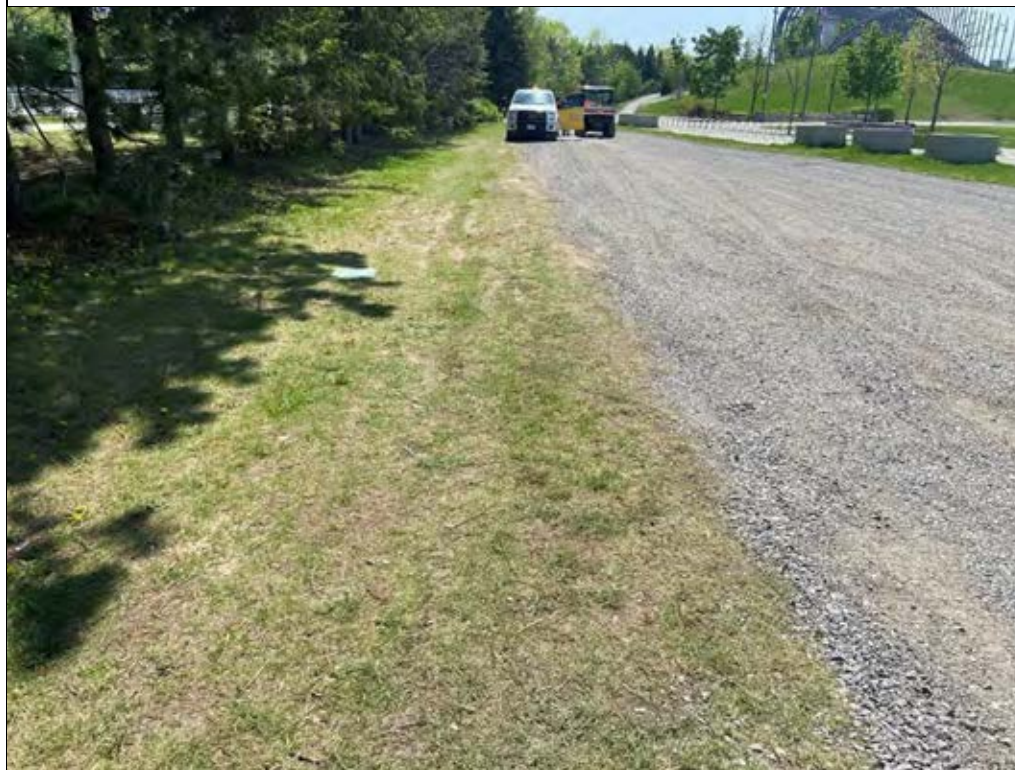
**Photo 22:**

Eastern Perimeter Drainage Swale: Some areas of bare soil and tire ruts were observed adjacent the granular resurfaced area.

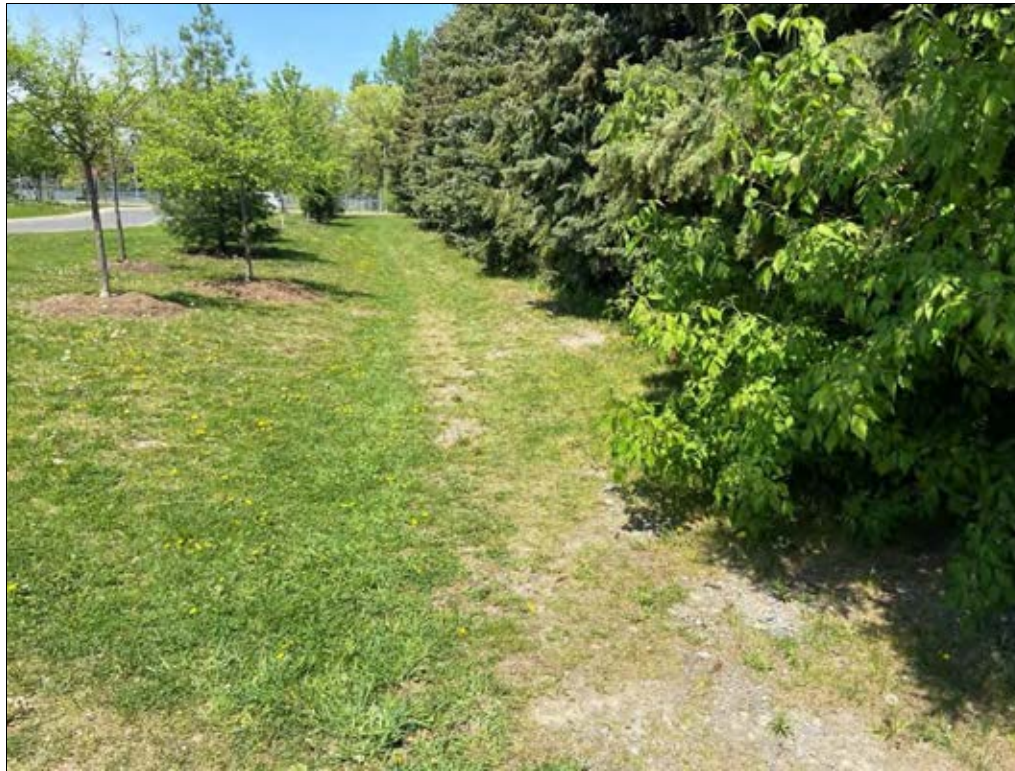
**Photo 23:**

Eastern Perimeter Drainage Swale:  
General view of the swale east of the Ice Rink and Heirloom Orchard. Areas of bare soil were observed in the area of the utility trench previously excavated within the swale.

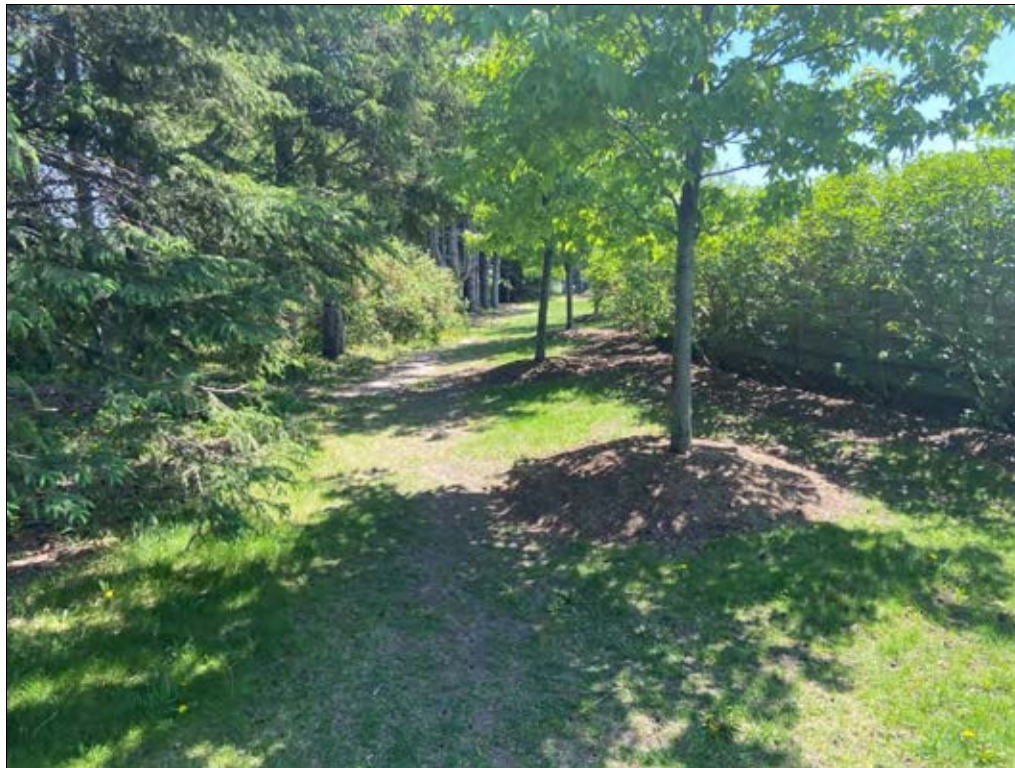
**Photo 24:**

Eastern Perimeter Drainage Swale:  
General view of the swale east of the Water Plaza. Some areas of bare soil were observed along the property boundary.

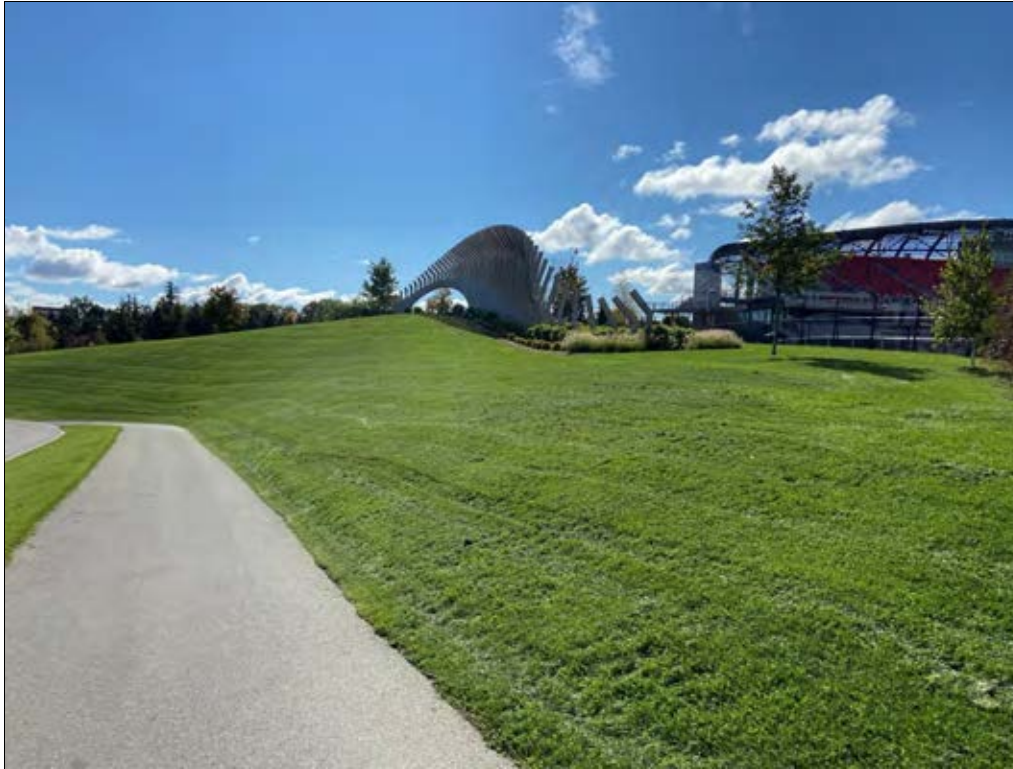
**Photo 1:**

East Berm: General view of the east side of the berm.

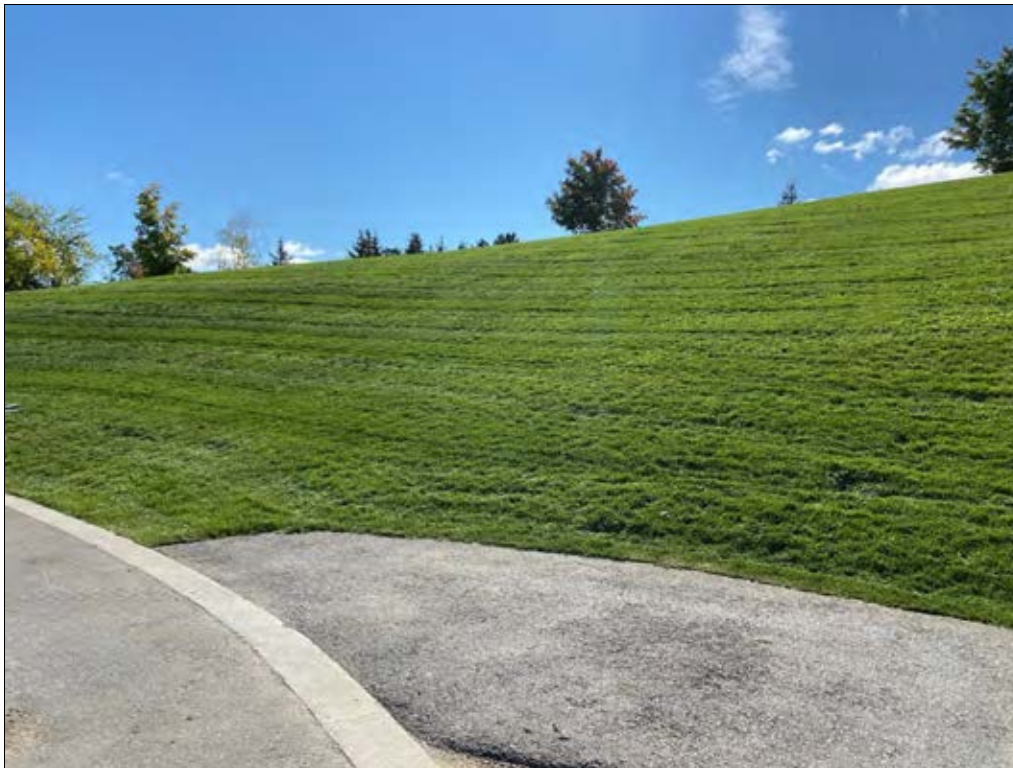
**Photo 2:**

East Berm: General view of the steeper sloped areas along the pedestrian pathway on the east side of the berm.

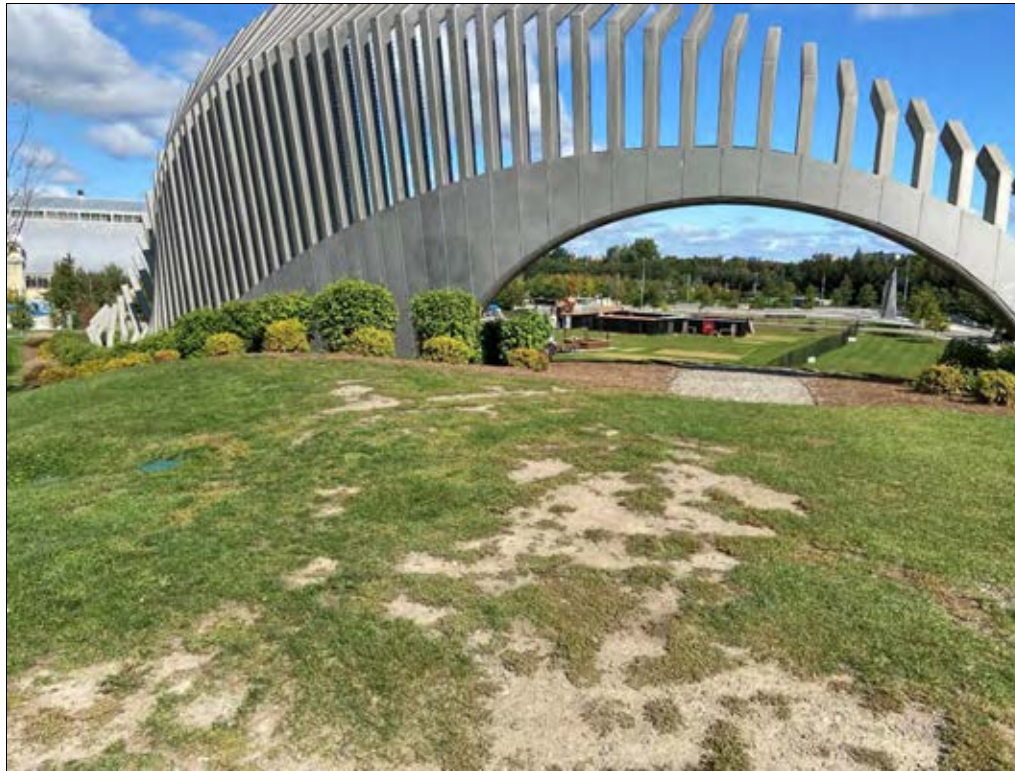
**Photo 3:**

East Berm: Areas of bare soil were observed at the top of the berm east and west of the Art Screen.

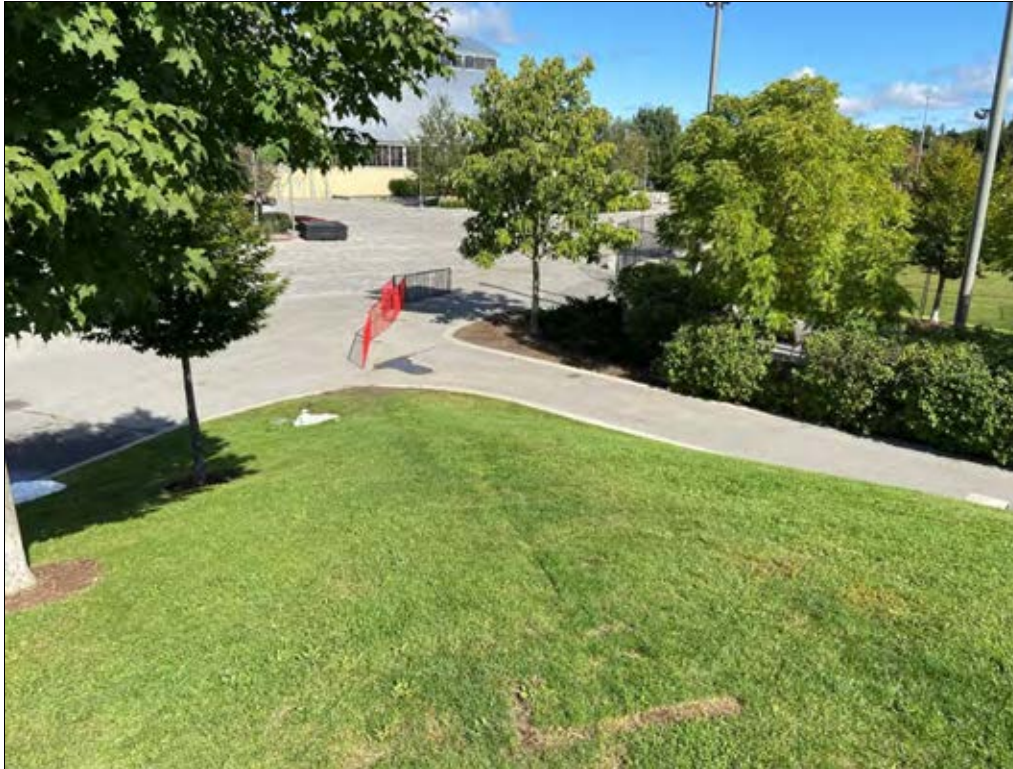
**Photo 5:**

East Berm:  
Conditions at the  
north of the  
pedestrian path at  
the north end berm  
have improved after  
efforts to reseed the  
area in the spring.
