**Re: 2021 Annual Report, Certificate of Property Use (CPU 0371-8TYQMY)  
Lansdowne Park, Urban Park (Zone C)  
450 Queen Elizabeth Drive (Part of 945 Bank Street),  
Ottawa, Ontario**

# 2021 Annual Report - Certificate of Property Use No. 0371-8TYQMY

Lansdowne Park- Urban Park (Zone C)  
450 Queen Elizabeth Driveway (Part of 945 Bank Street), Ottawa, Ontario  
Project No. TZ10100106

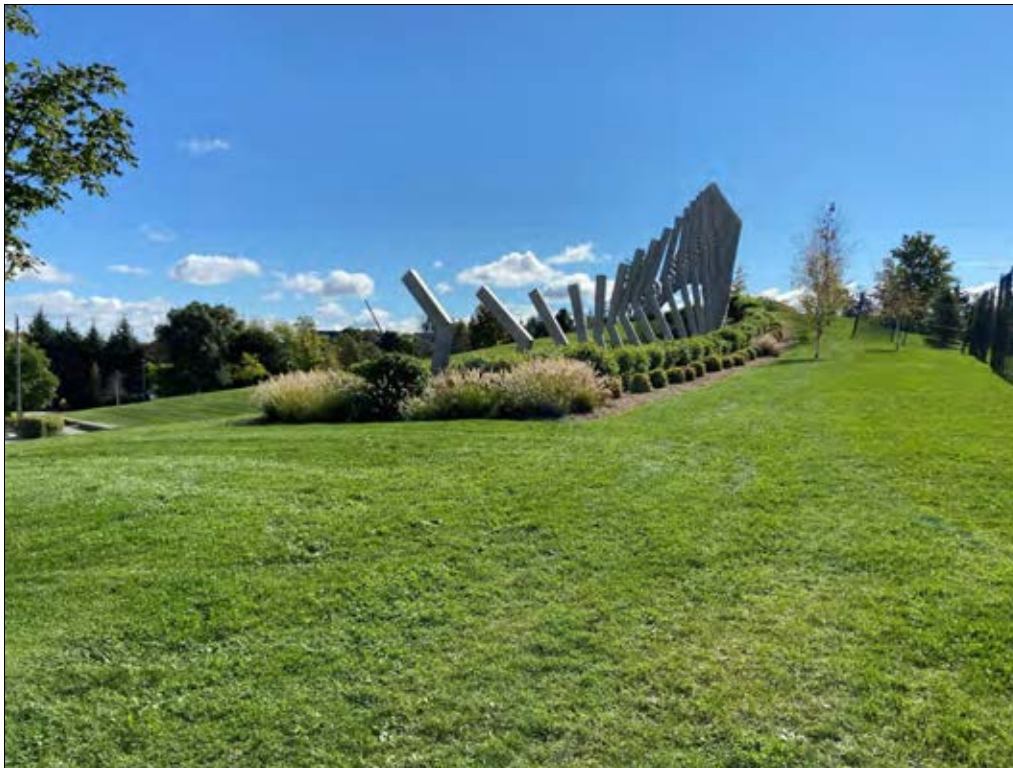
**Photo 6:**

East Berm: General  
view of the north end  
of the Art Screen.

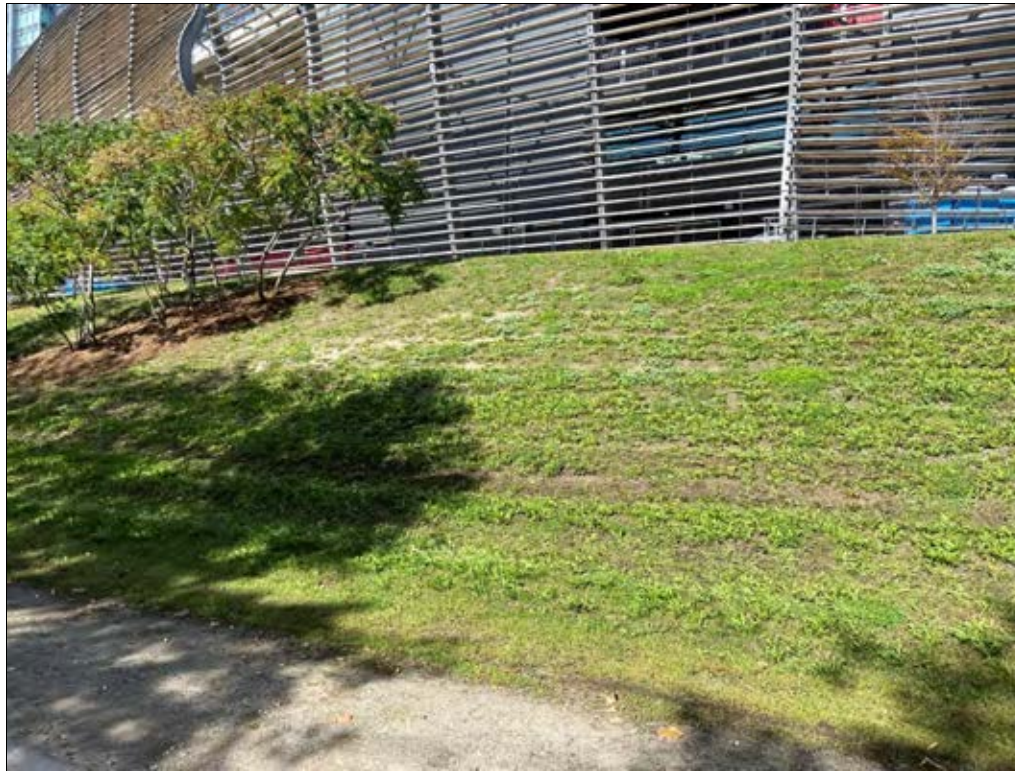
**Photo 7:**

South Berm: General view of berm conditions. Areas of bare soil were observed throughout the berm.

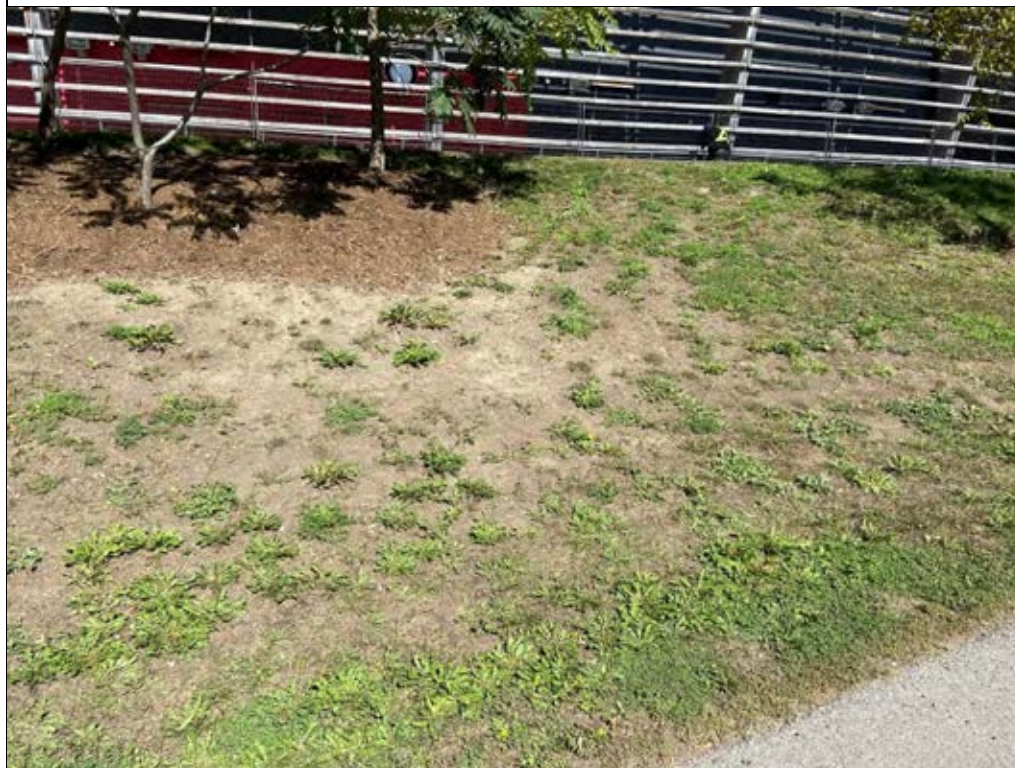
**Photo 8:**

South Berm: Bare soil observed on the western portion of the berm near the top.

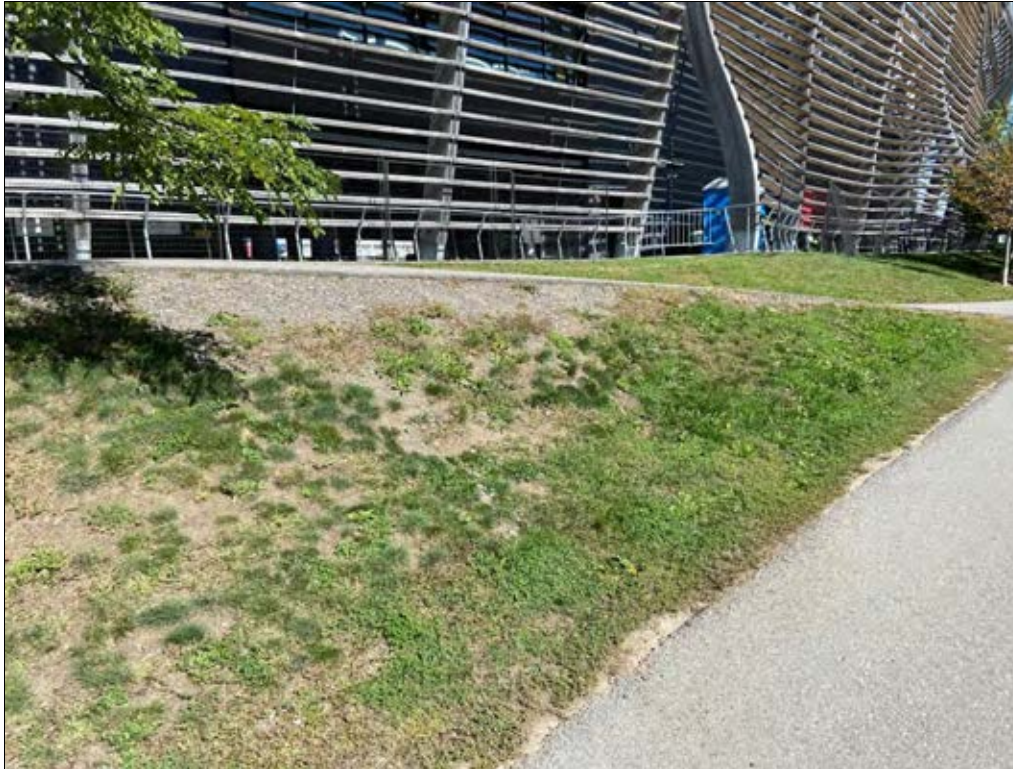
**Photo 9:**

South Berm: Clumps of soil eroding from areas near the top of the of the central portion of the berm.

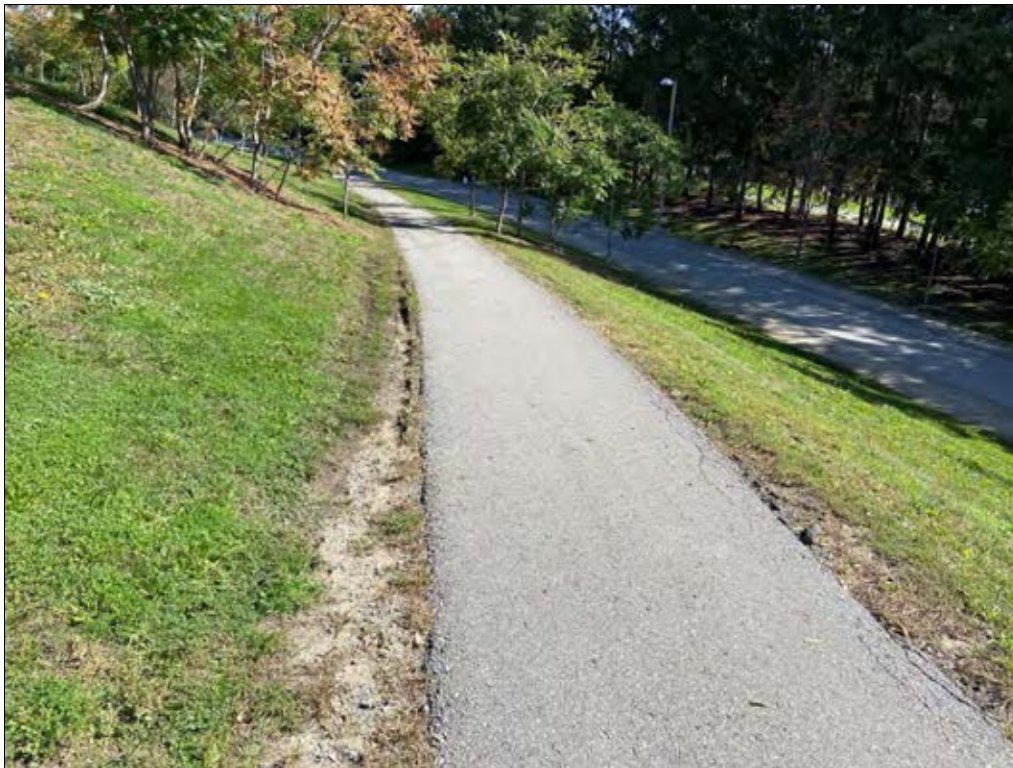
**Photo 10:**

South Berm: Areas of bare soil and tire ruts along paths on the berm.

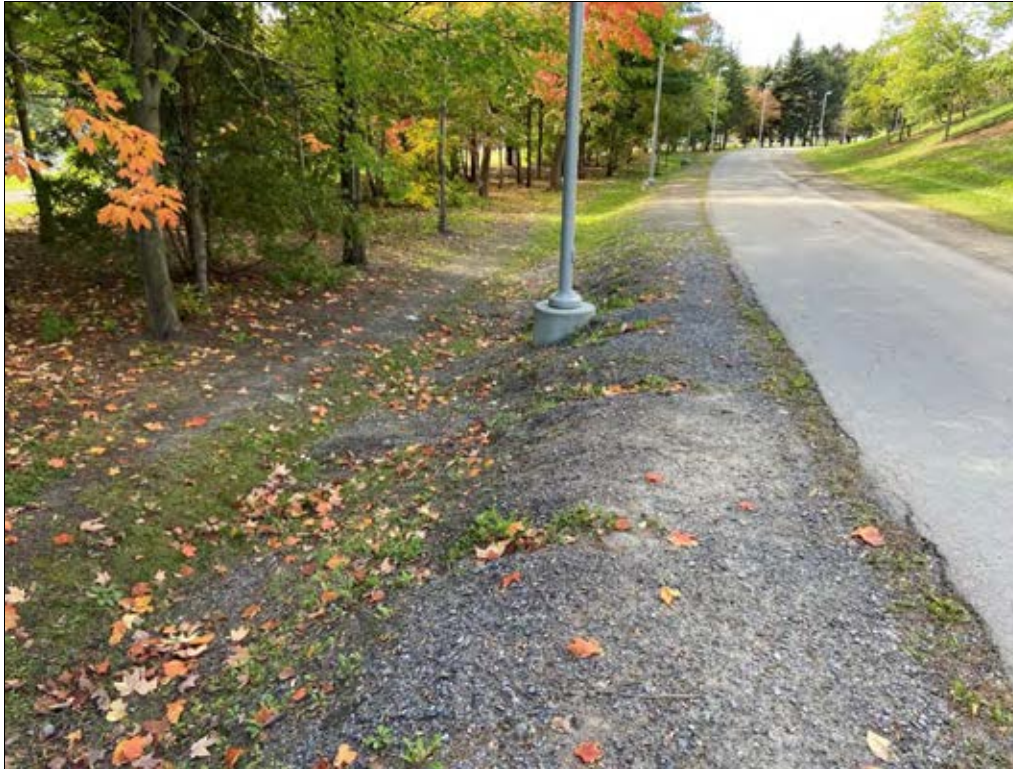
**Photo 11:**  
South Drainage  
Swale: General view  
of the swale. Road  
base material has  
eroded into the  
swale.

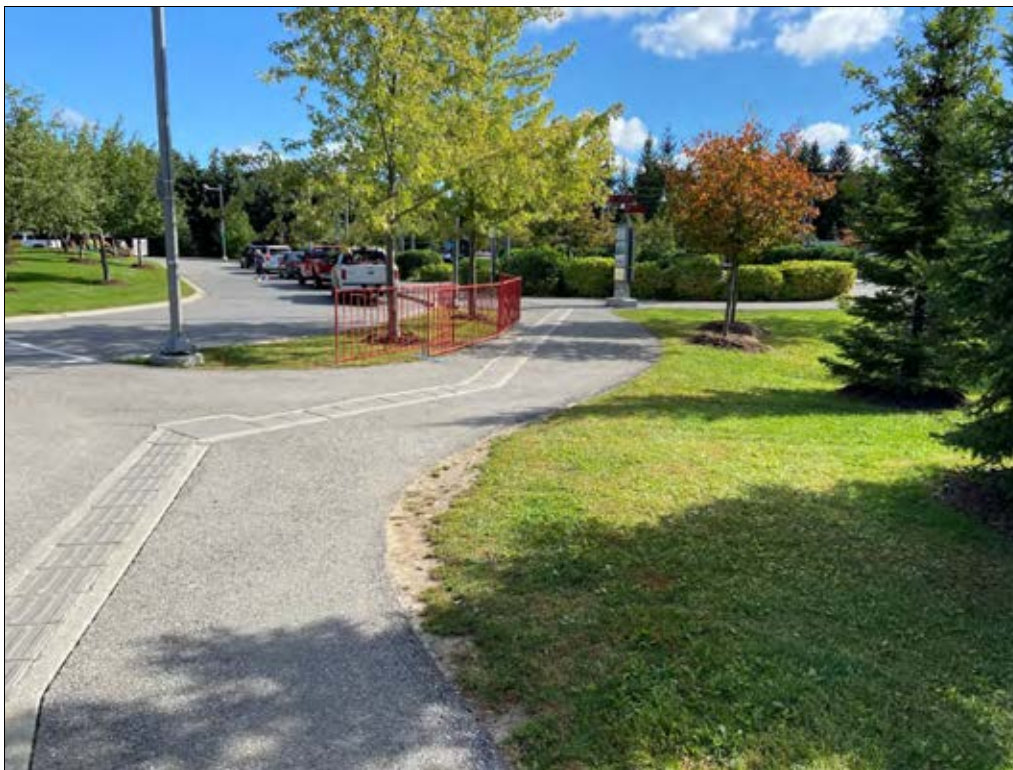
**Photo 12:**  
Former Eastern  
Landfill: Bare soil and  
stressed vegetation  
along pathways at  
the north end of the  
former landfill west  
of the Orchard.

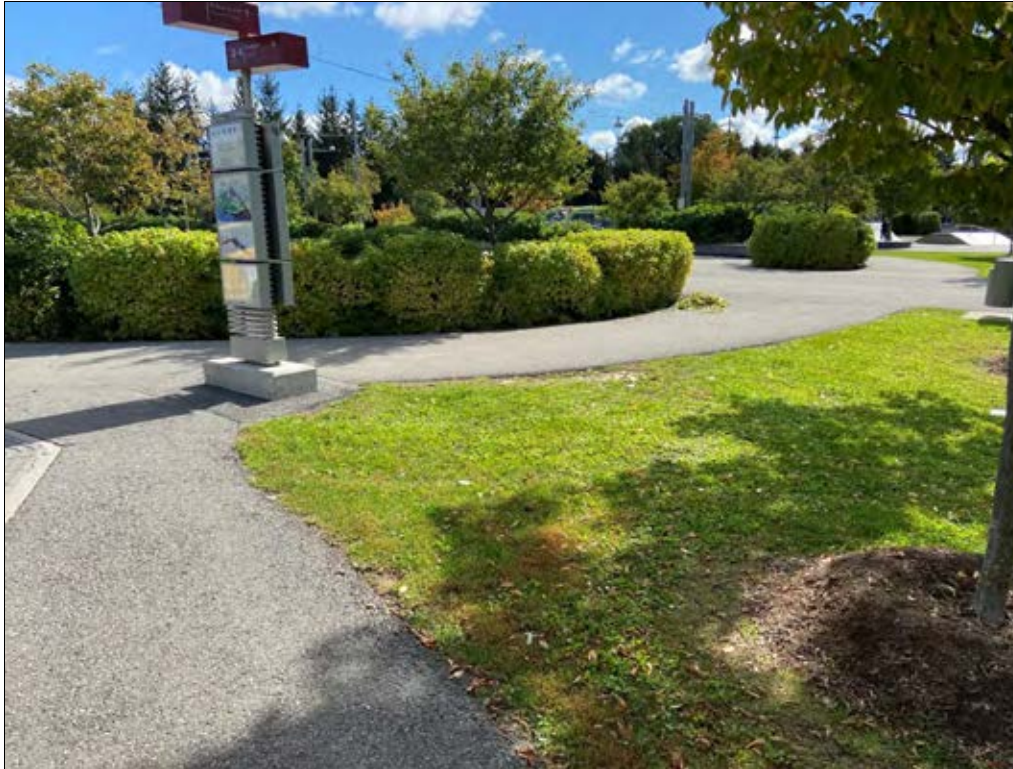
**Photo 13:**  
Former Eastern  
Landfill: Small areas  
of bare soil and  
stressed vegetation  
along the paths  
around the ice rink.

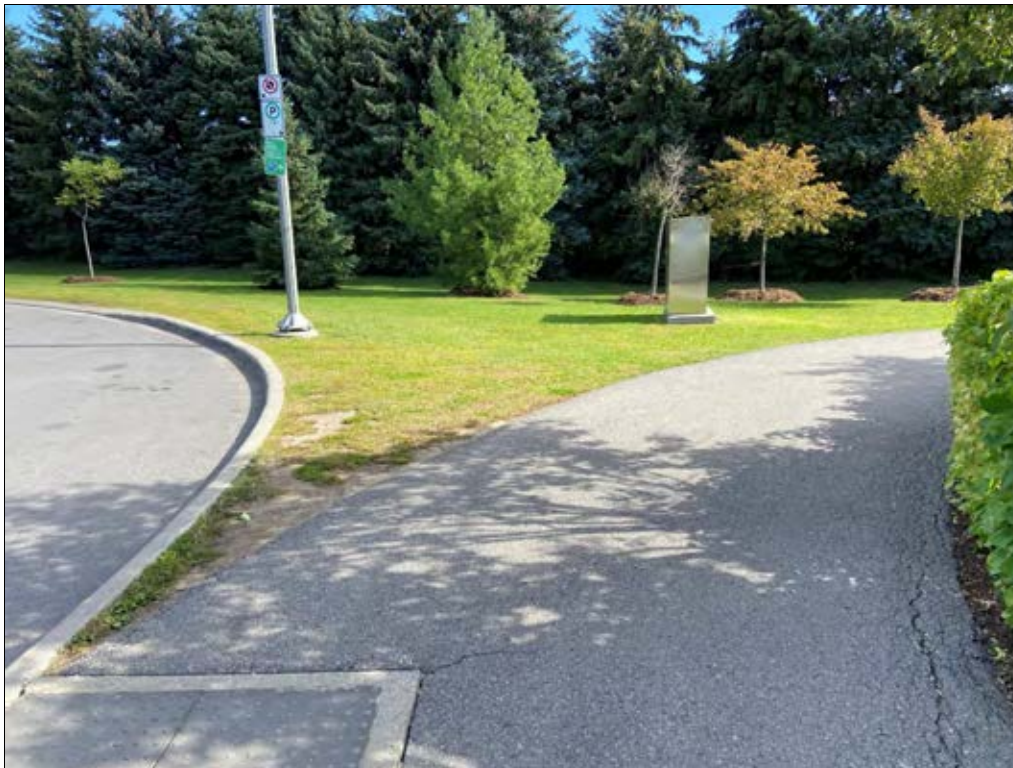
**Photo 14:**  
South Drainage  
Swale: Area of bare  
soil in high traffic  
area north of the ice  
rink.

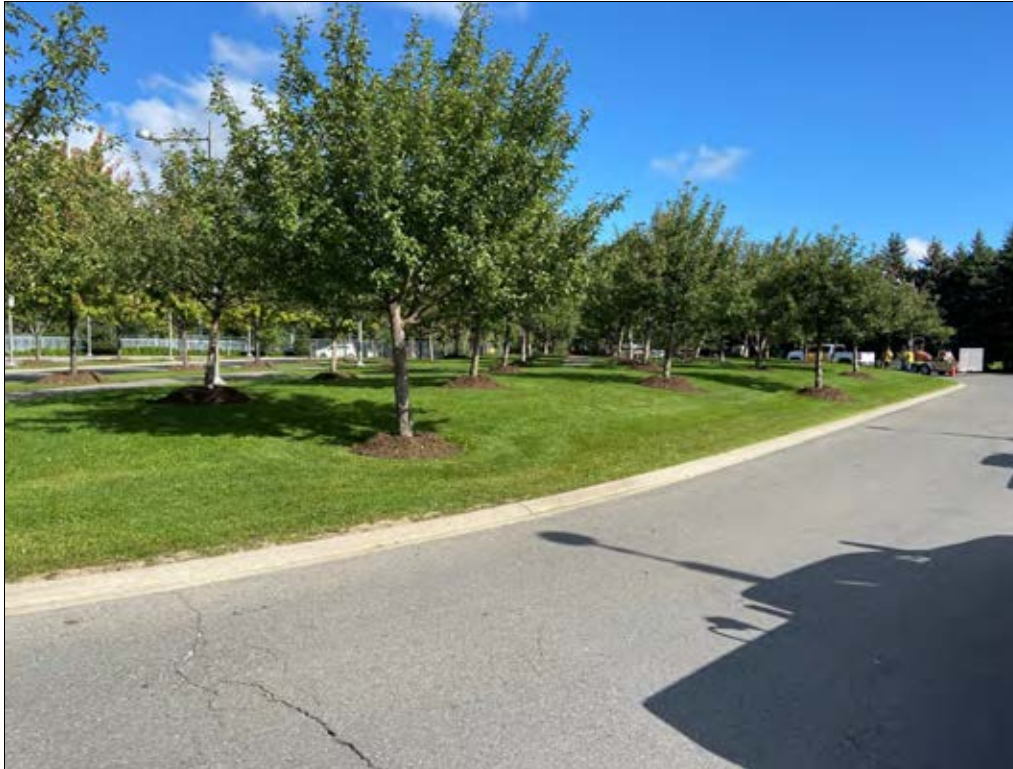
**Photo 15:**

Former Eastern Landfill: The cover in the area of the Orchard is in good condition.

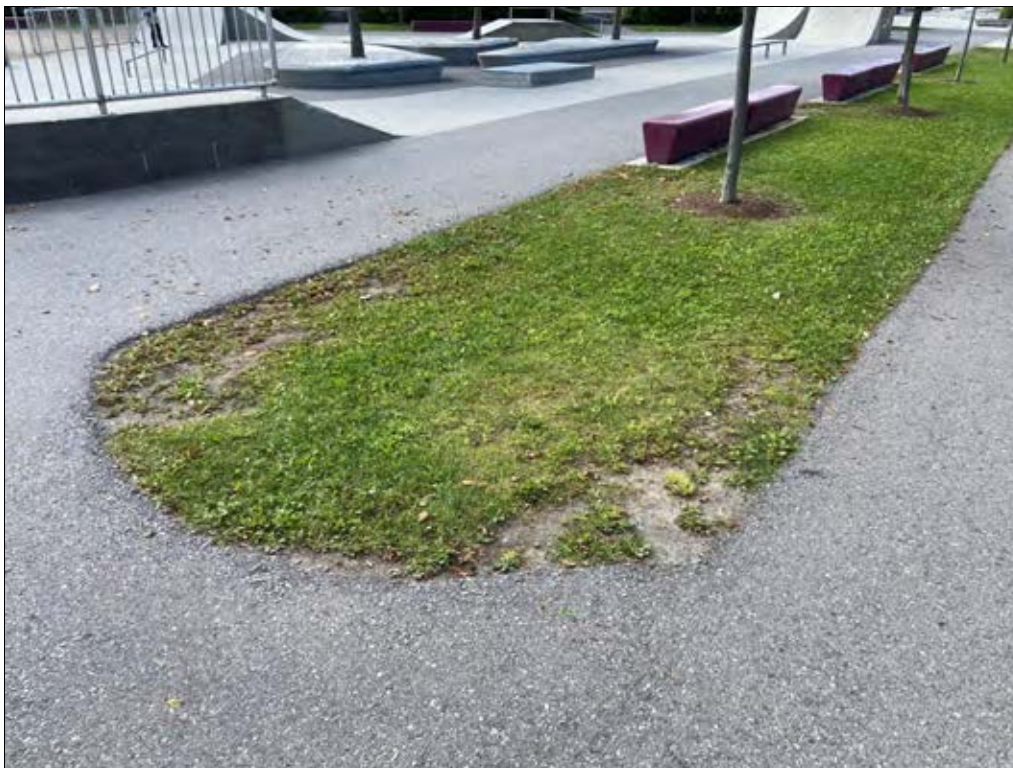
**Photo 16:**

Former Eastern Landfill: Small areas of bare soil and stressed vegetation were observed in high traffic areas around the Skate Park and Children's Garden.

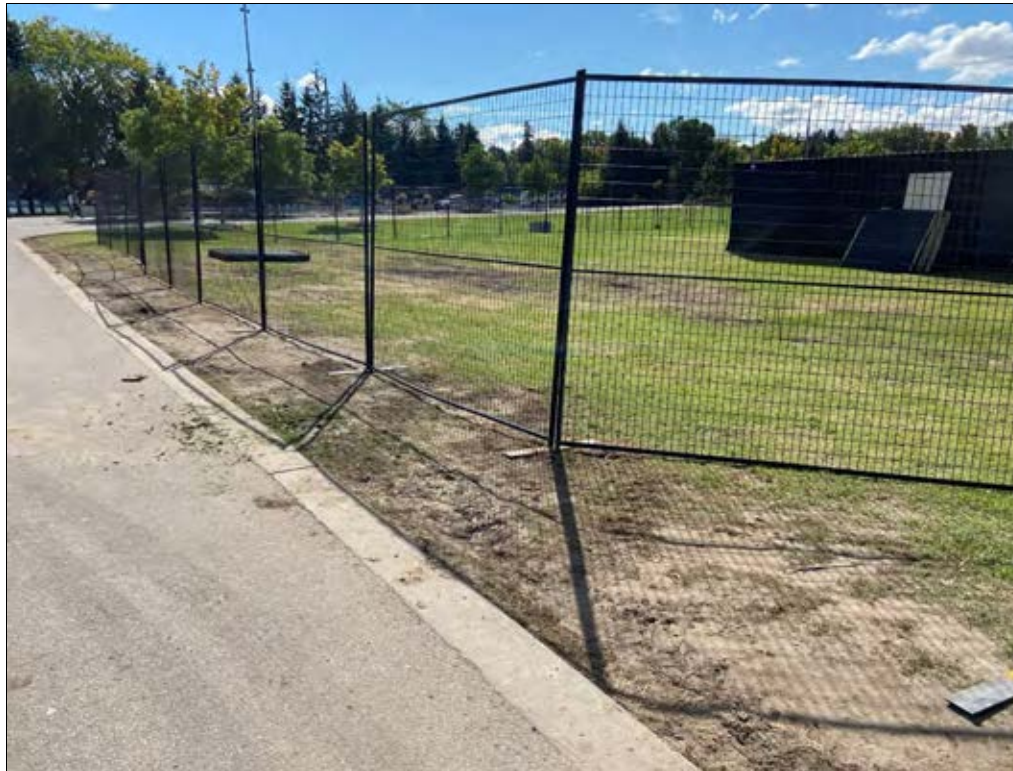
**Photo 15:**

Former Eastern Landfill: Areas of bare soil and stressed vegetation south of the ring road at the north end the Great Lawn. This area was recently disturbed by CityFolk and Bluesfest music festivals. "The Sawmill" attraction by Saunders Farm was being setup in the Great Lawn.

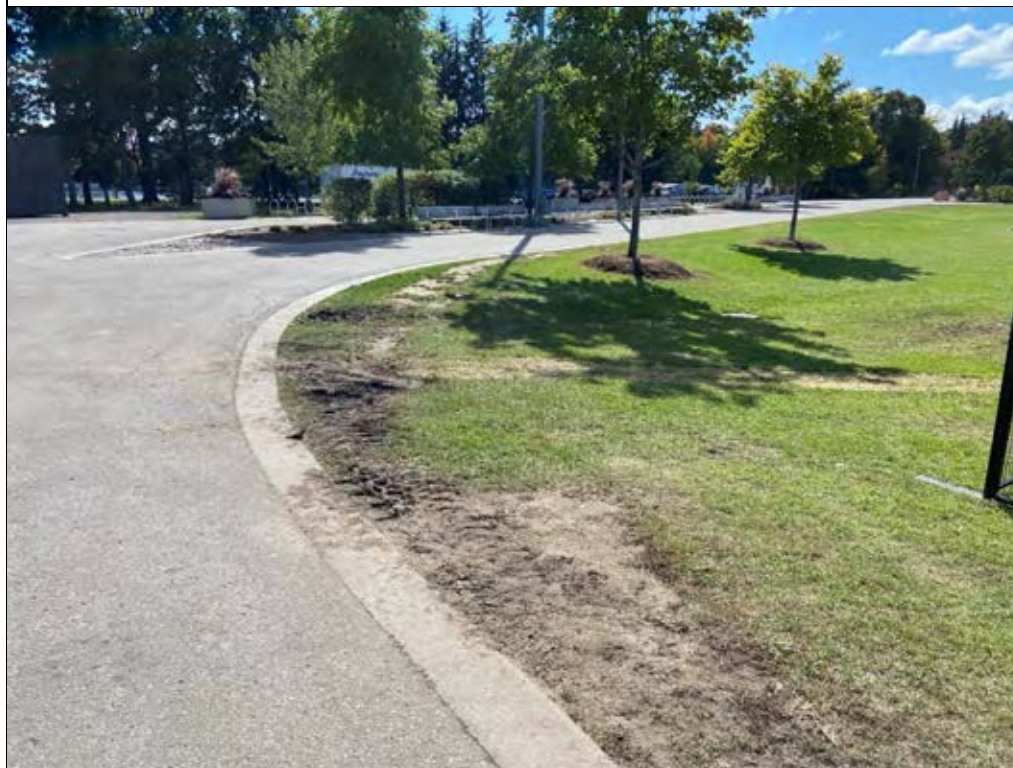
**Photo 16:**

Former Eastern Landfill: Area of bare soil and stressed vegetation at the northeast end of the Great Lawn.

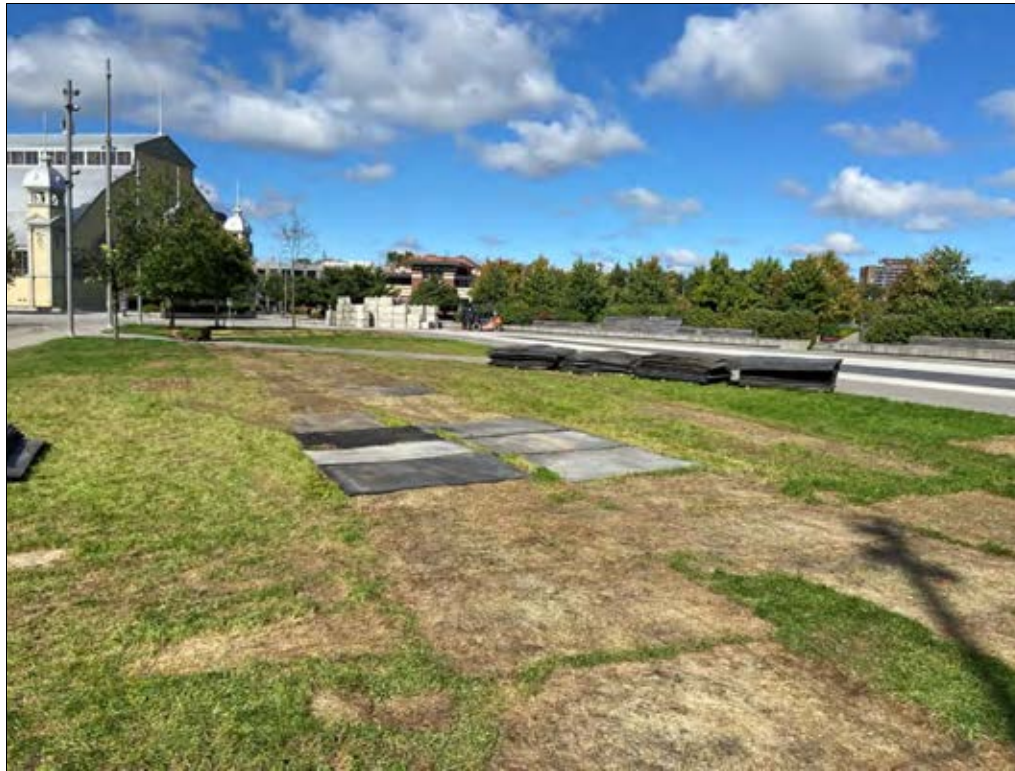
**Photo 17:**  
Former Eastern Landfill: Bare soil and stressed vegetation at the soft landscaped area south of the Water Plaza. This area was used for CityFolk and Bluesfest music festivals.

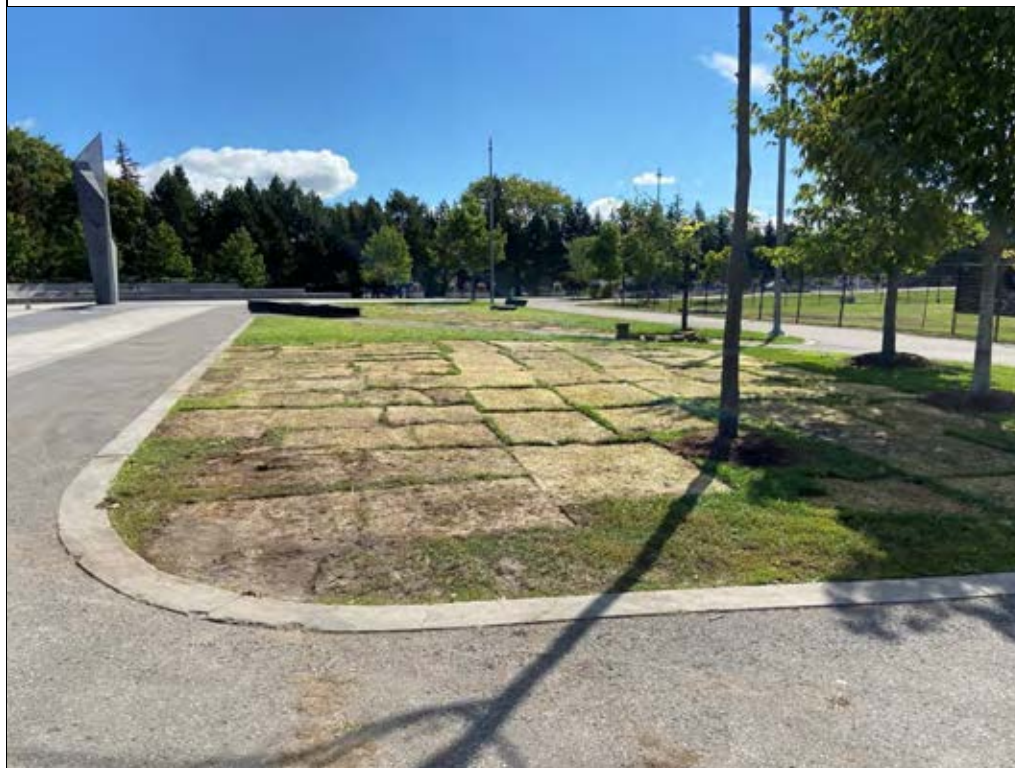
**Photo 18:**  
Former Eastern Landfill: Area of bare soil and stressed vegetation southwest of Water Plaza. This area was used for CityFolk and Bluesfest music festivals.

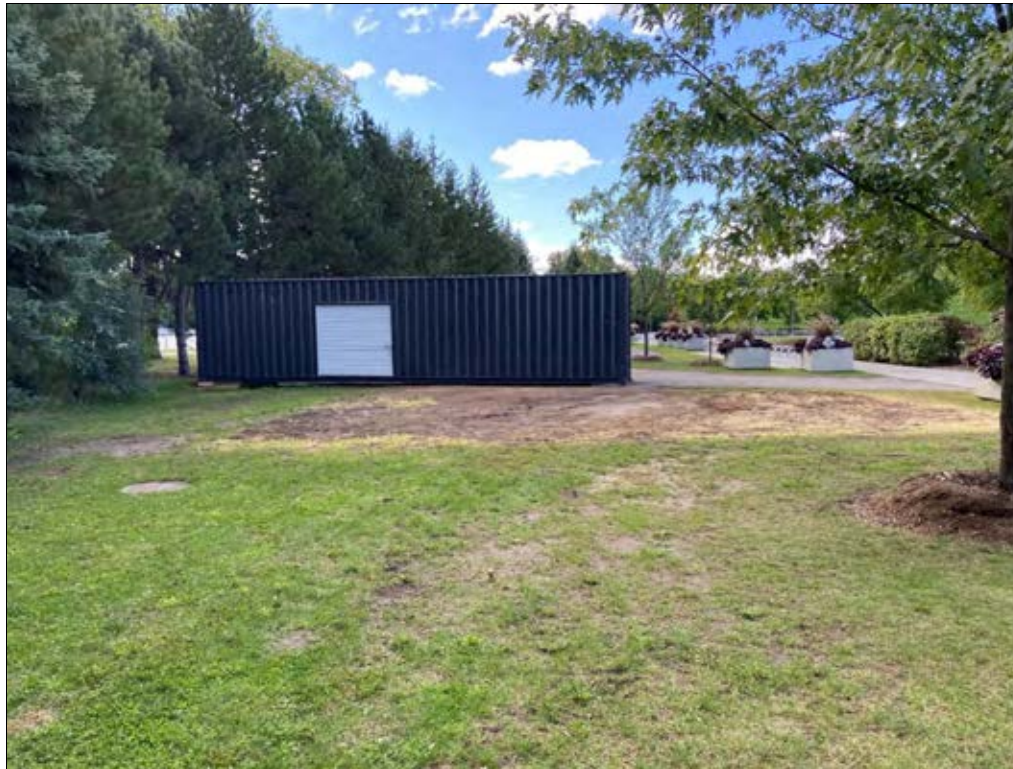
**Photo 19:**  
Former McElroy Building: This area is used as a staging area for vehicles and material. Bare soil and stressed vegetation was observed in areas used to stockpile landscaping materials.

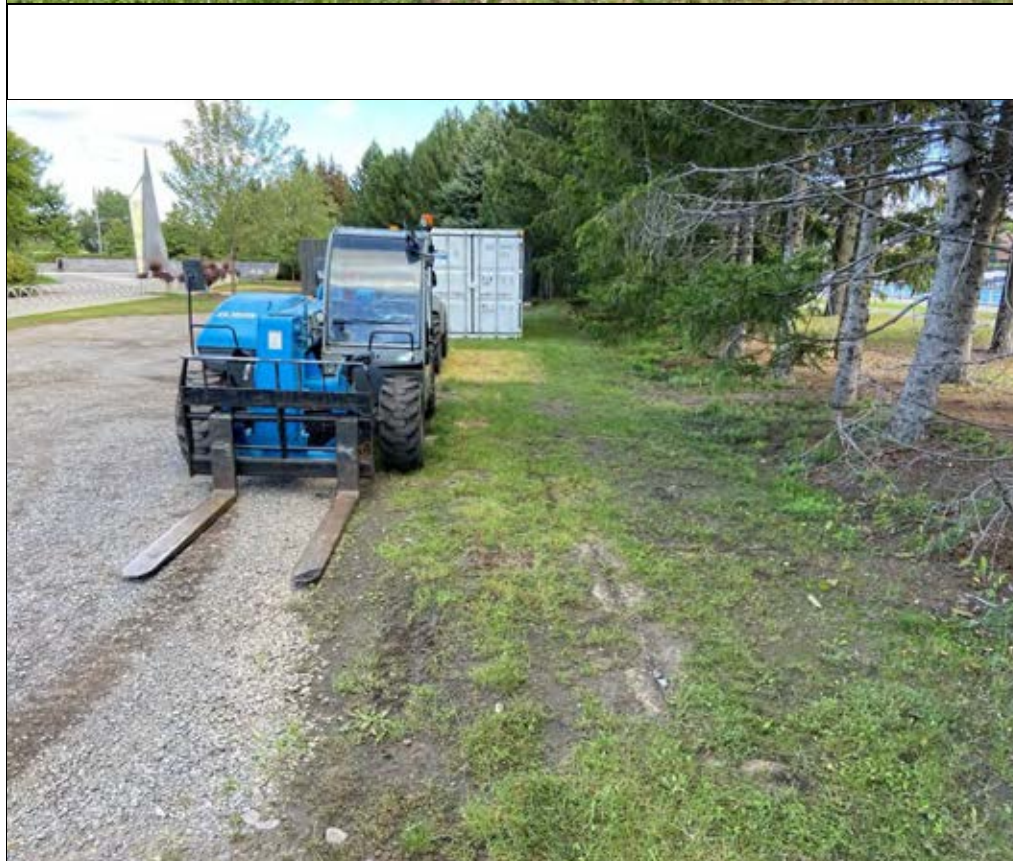
**Photo 20:**  
Eastern Perimeter Drainage Swale: Some areas of bare soil and tire ruts were observed adjacent the granular resurfaced area.

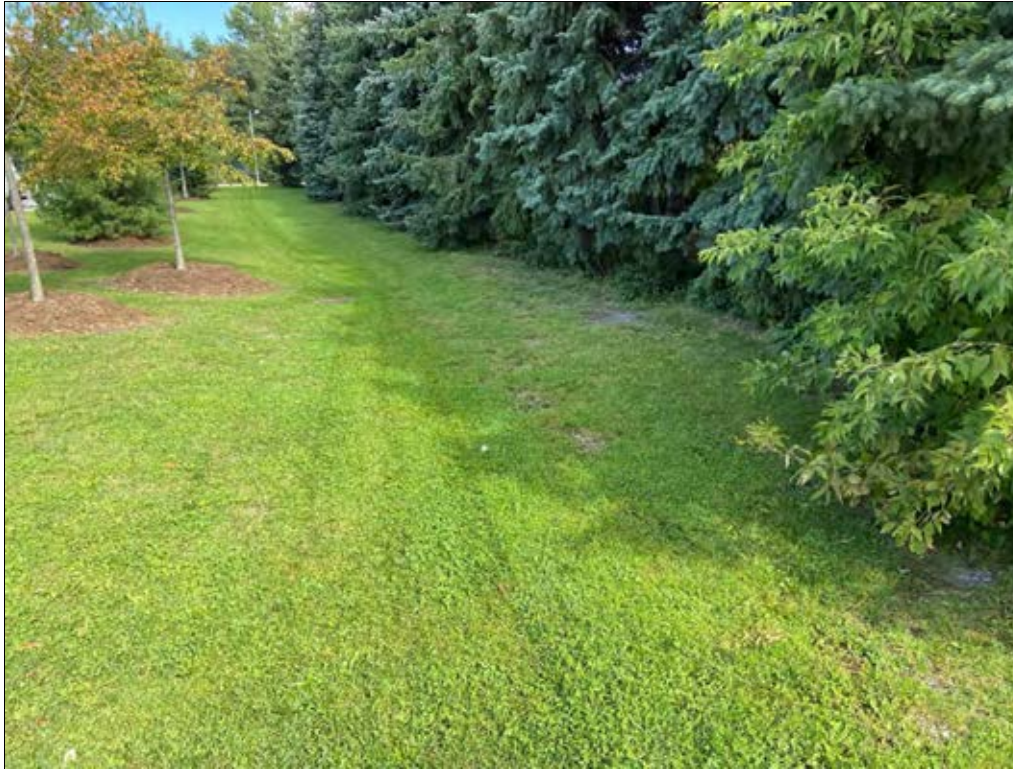
**Photo 21:**  
Eastern Perimeter  
Drainage Swale:  
General view of the  
swale east of the Ice  
Rink and Heirloom  
Orchard. Small areas  
of bare soil were  
observed in the area  
of the utility trench  
previously excavated  
within the swale.

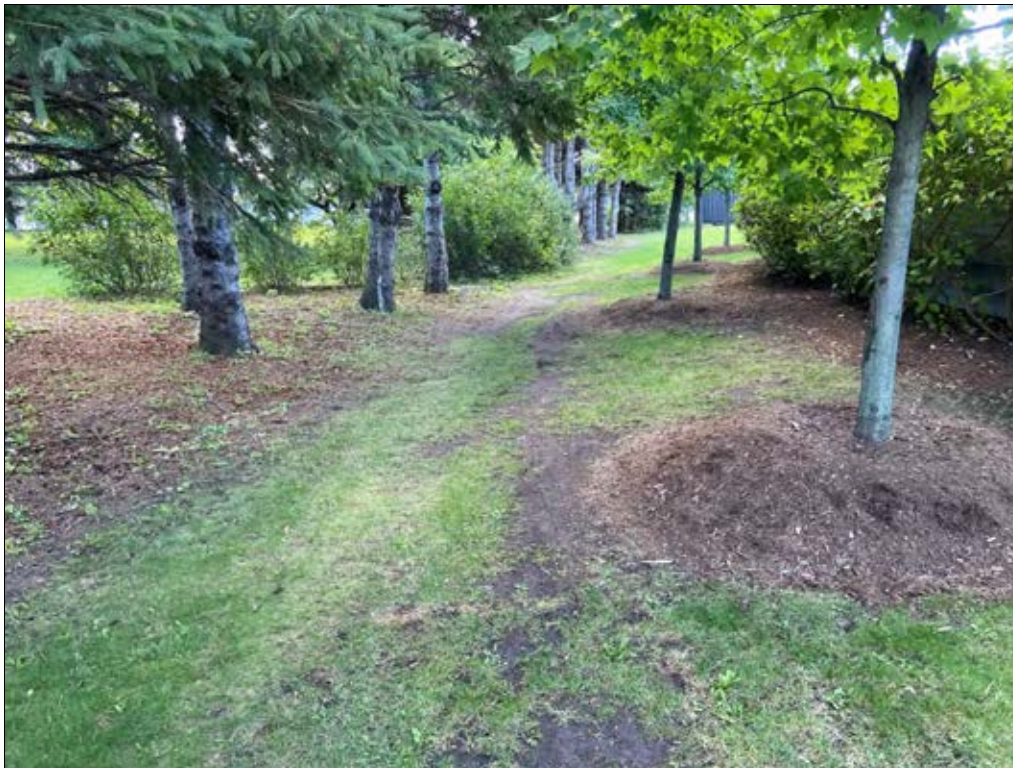
**Photo 22:**  
Eastern Perimeter  
Drainage Swale:  
General view of the  
swale east of the  
Water Plaza. Some  
areas of bare soil  
were observed along  
the property  
boundary.

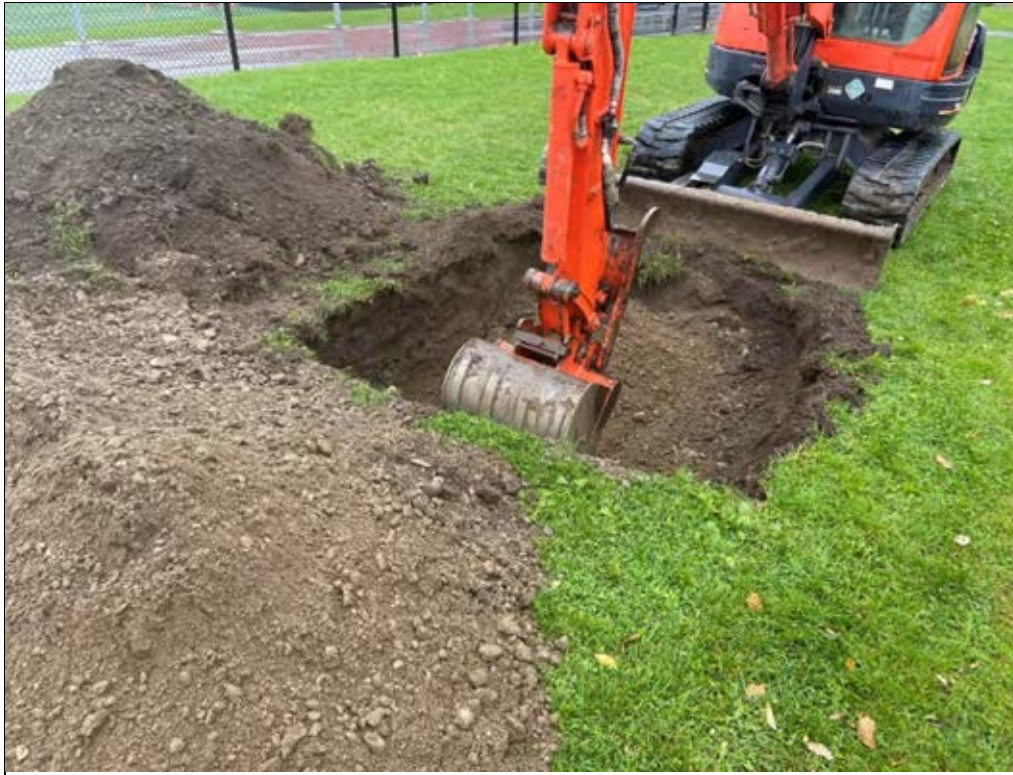
**Photo 1:**

General view of the initial excavation to expose the geotextile at one of the proposed borehole locations.

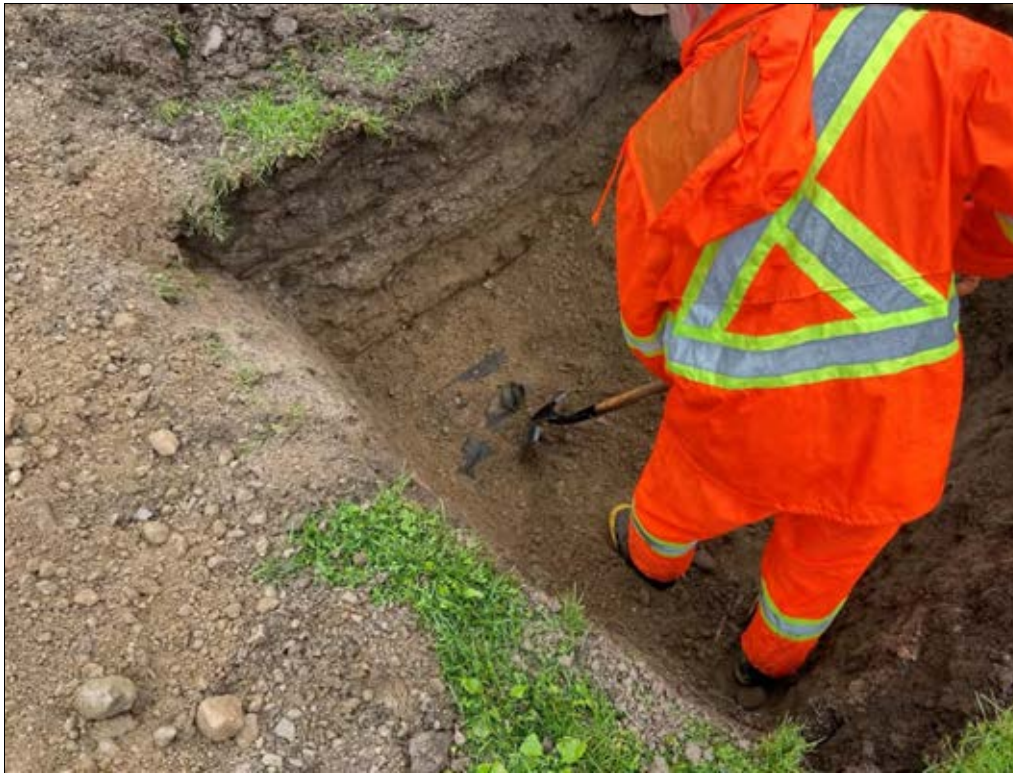
**Photo 2:**

Exposing geotextile by hand.

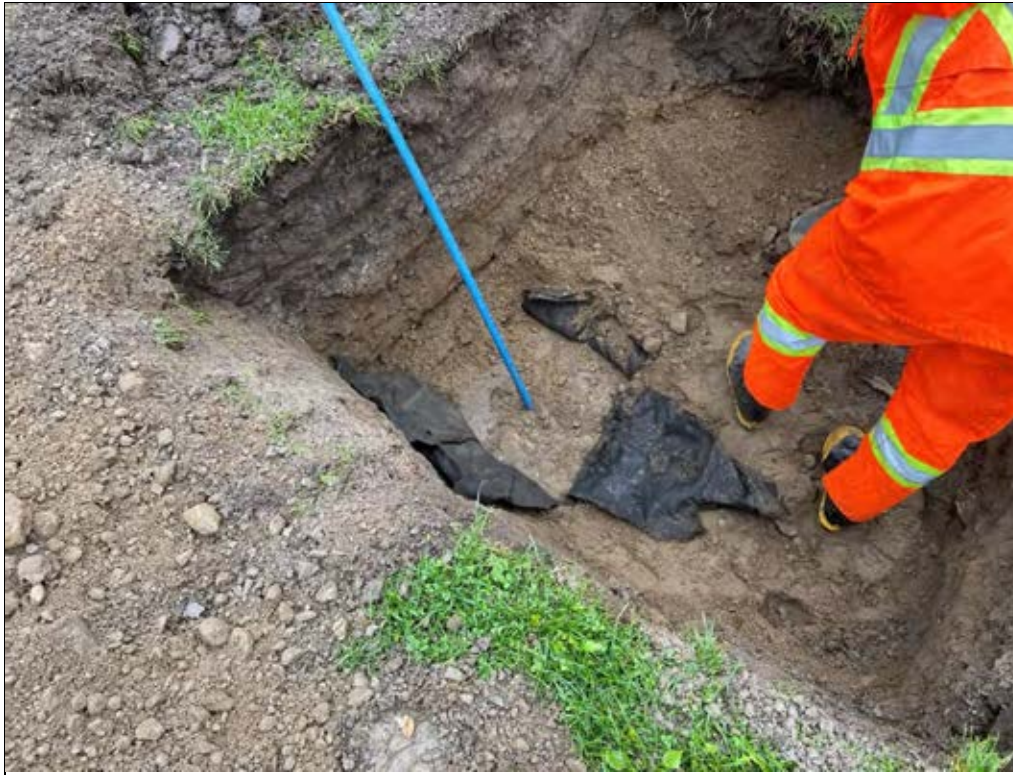
**Photo 3:**

Cutting back the geotextile and marking the centre of the hole.

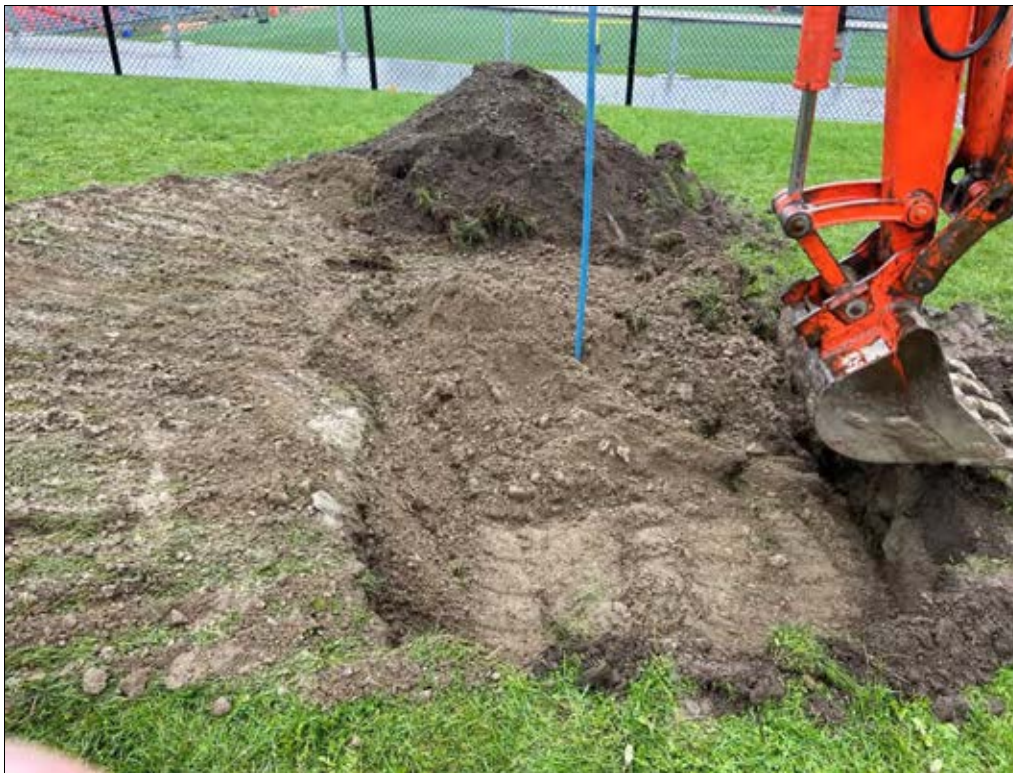
**Photo 4:**

Backfilling the hole in preparation for drilling.

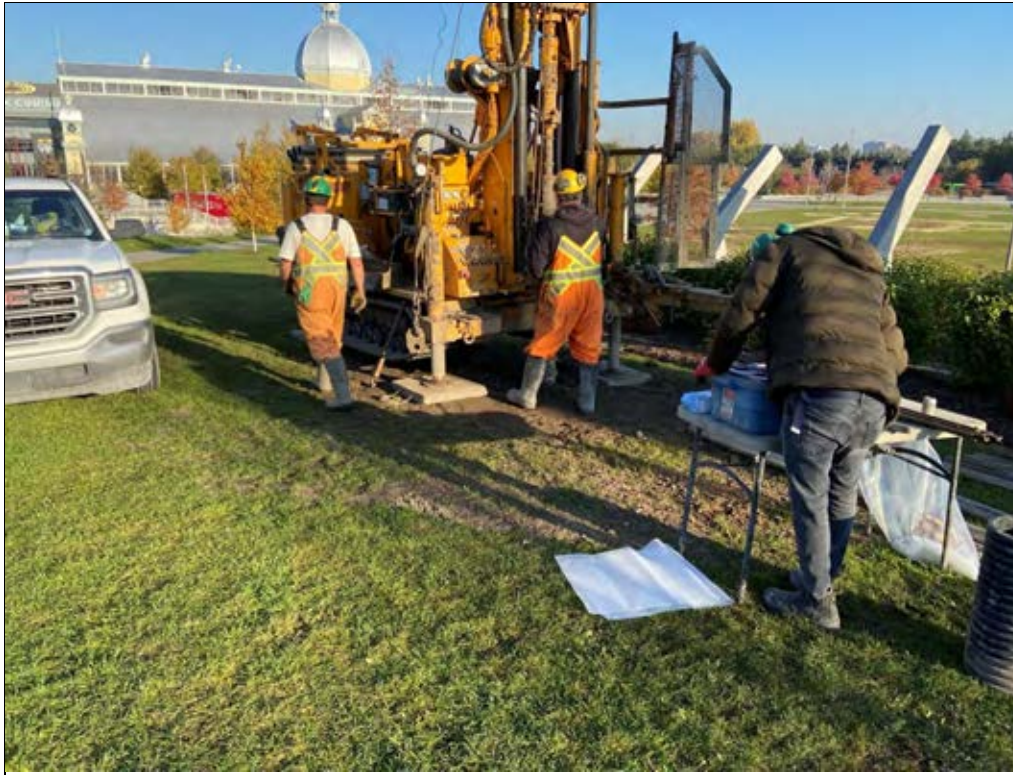
**Photo 5:**

Inspection during drilling activities to ensure the geotextile was not disturbed by the auger.

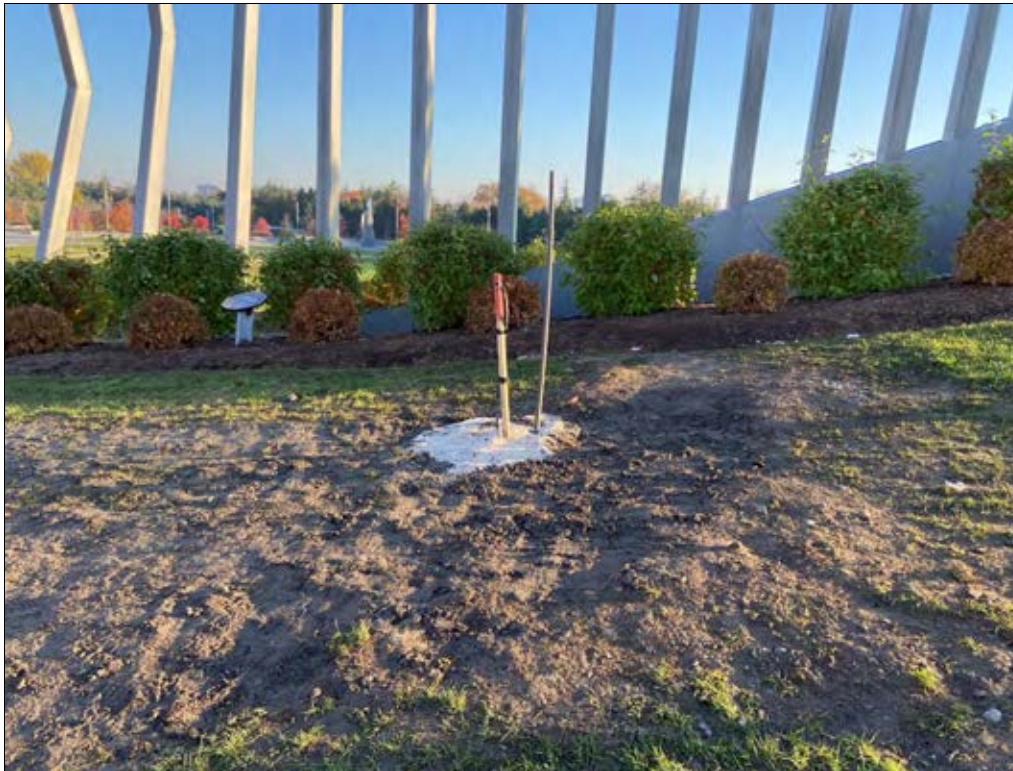
**Photo 6:**

General view of a borehole location after being drilled.

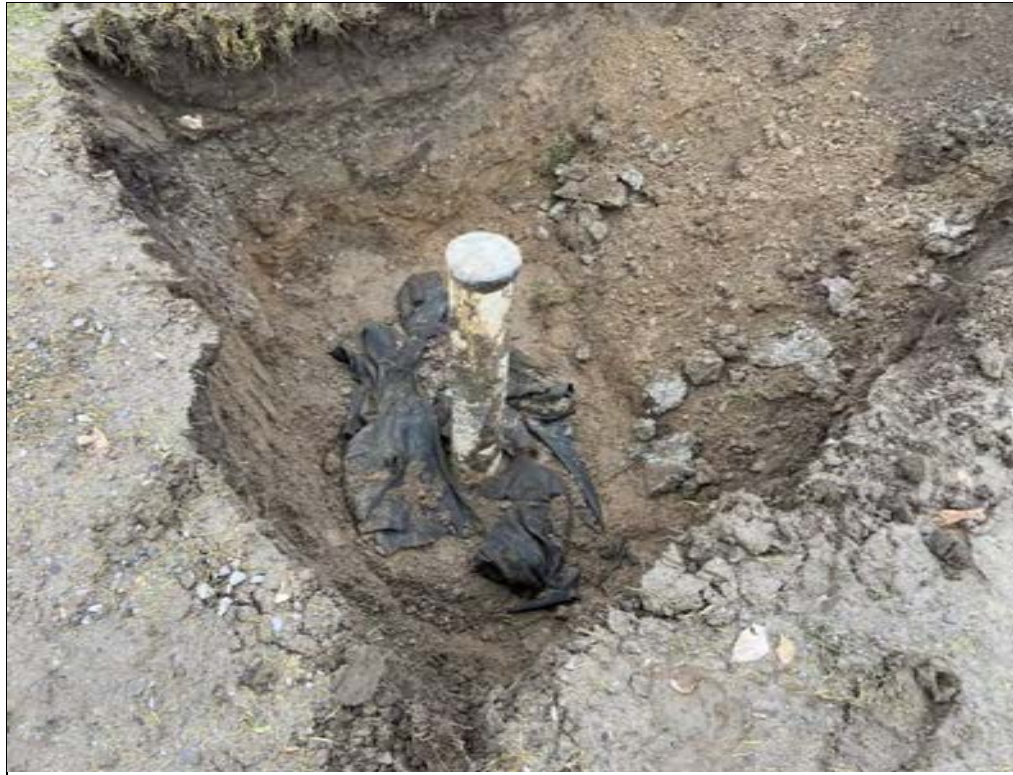
**Photo 7:**

General view of reinstatement activities. Borehole location was re-excavated, and geotextile was folded back down.

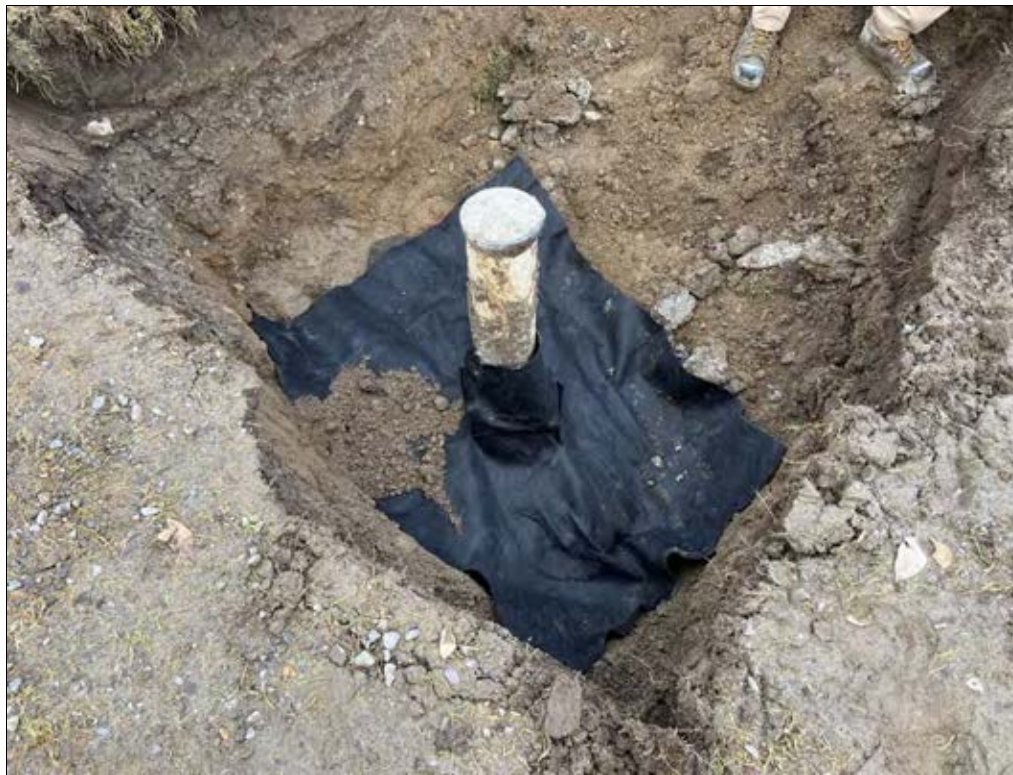
**Photo 8:**

General view of geotextile patch. New geotextile was brought up around the groundwater monitoring well protective casing and placed over cuts in the geotextile.
