Appendix F:
Desktop Environmental Site Assessment

DATE October 23, 2015**PROJECT No.** 1404896**TO** Christopher A. Gordon, P.Eng.
Parsons Corporation**FROM** Maria Staneva and
Tim Robertson, Golder Associates Ltd.**EMAIL** mstaneva@golder.com,
trobertson@golder.com**DESKTOP ENVIRONMENTAL SITE ASSESSMENT, DOWNTOWN OTTAWA TRUCK TUNNEL
OTTAWA, ONTARIO**

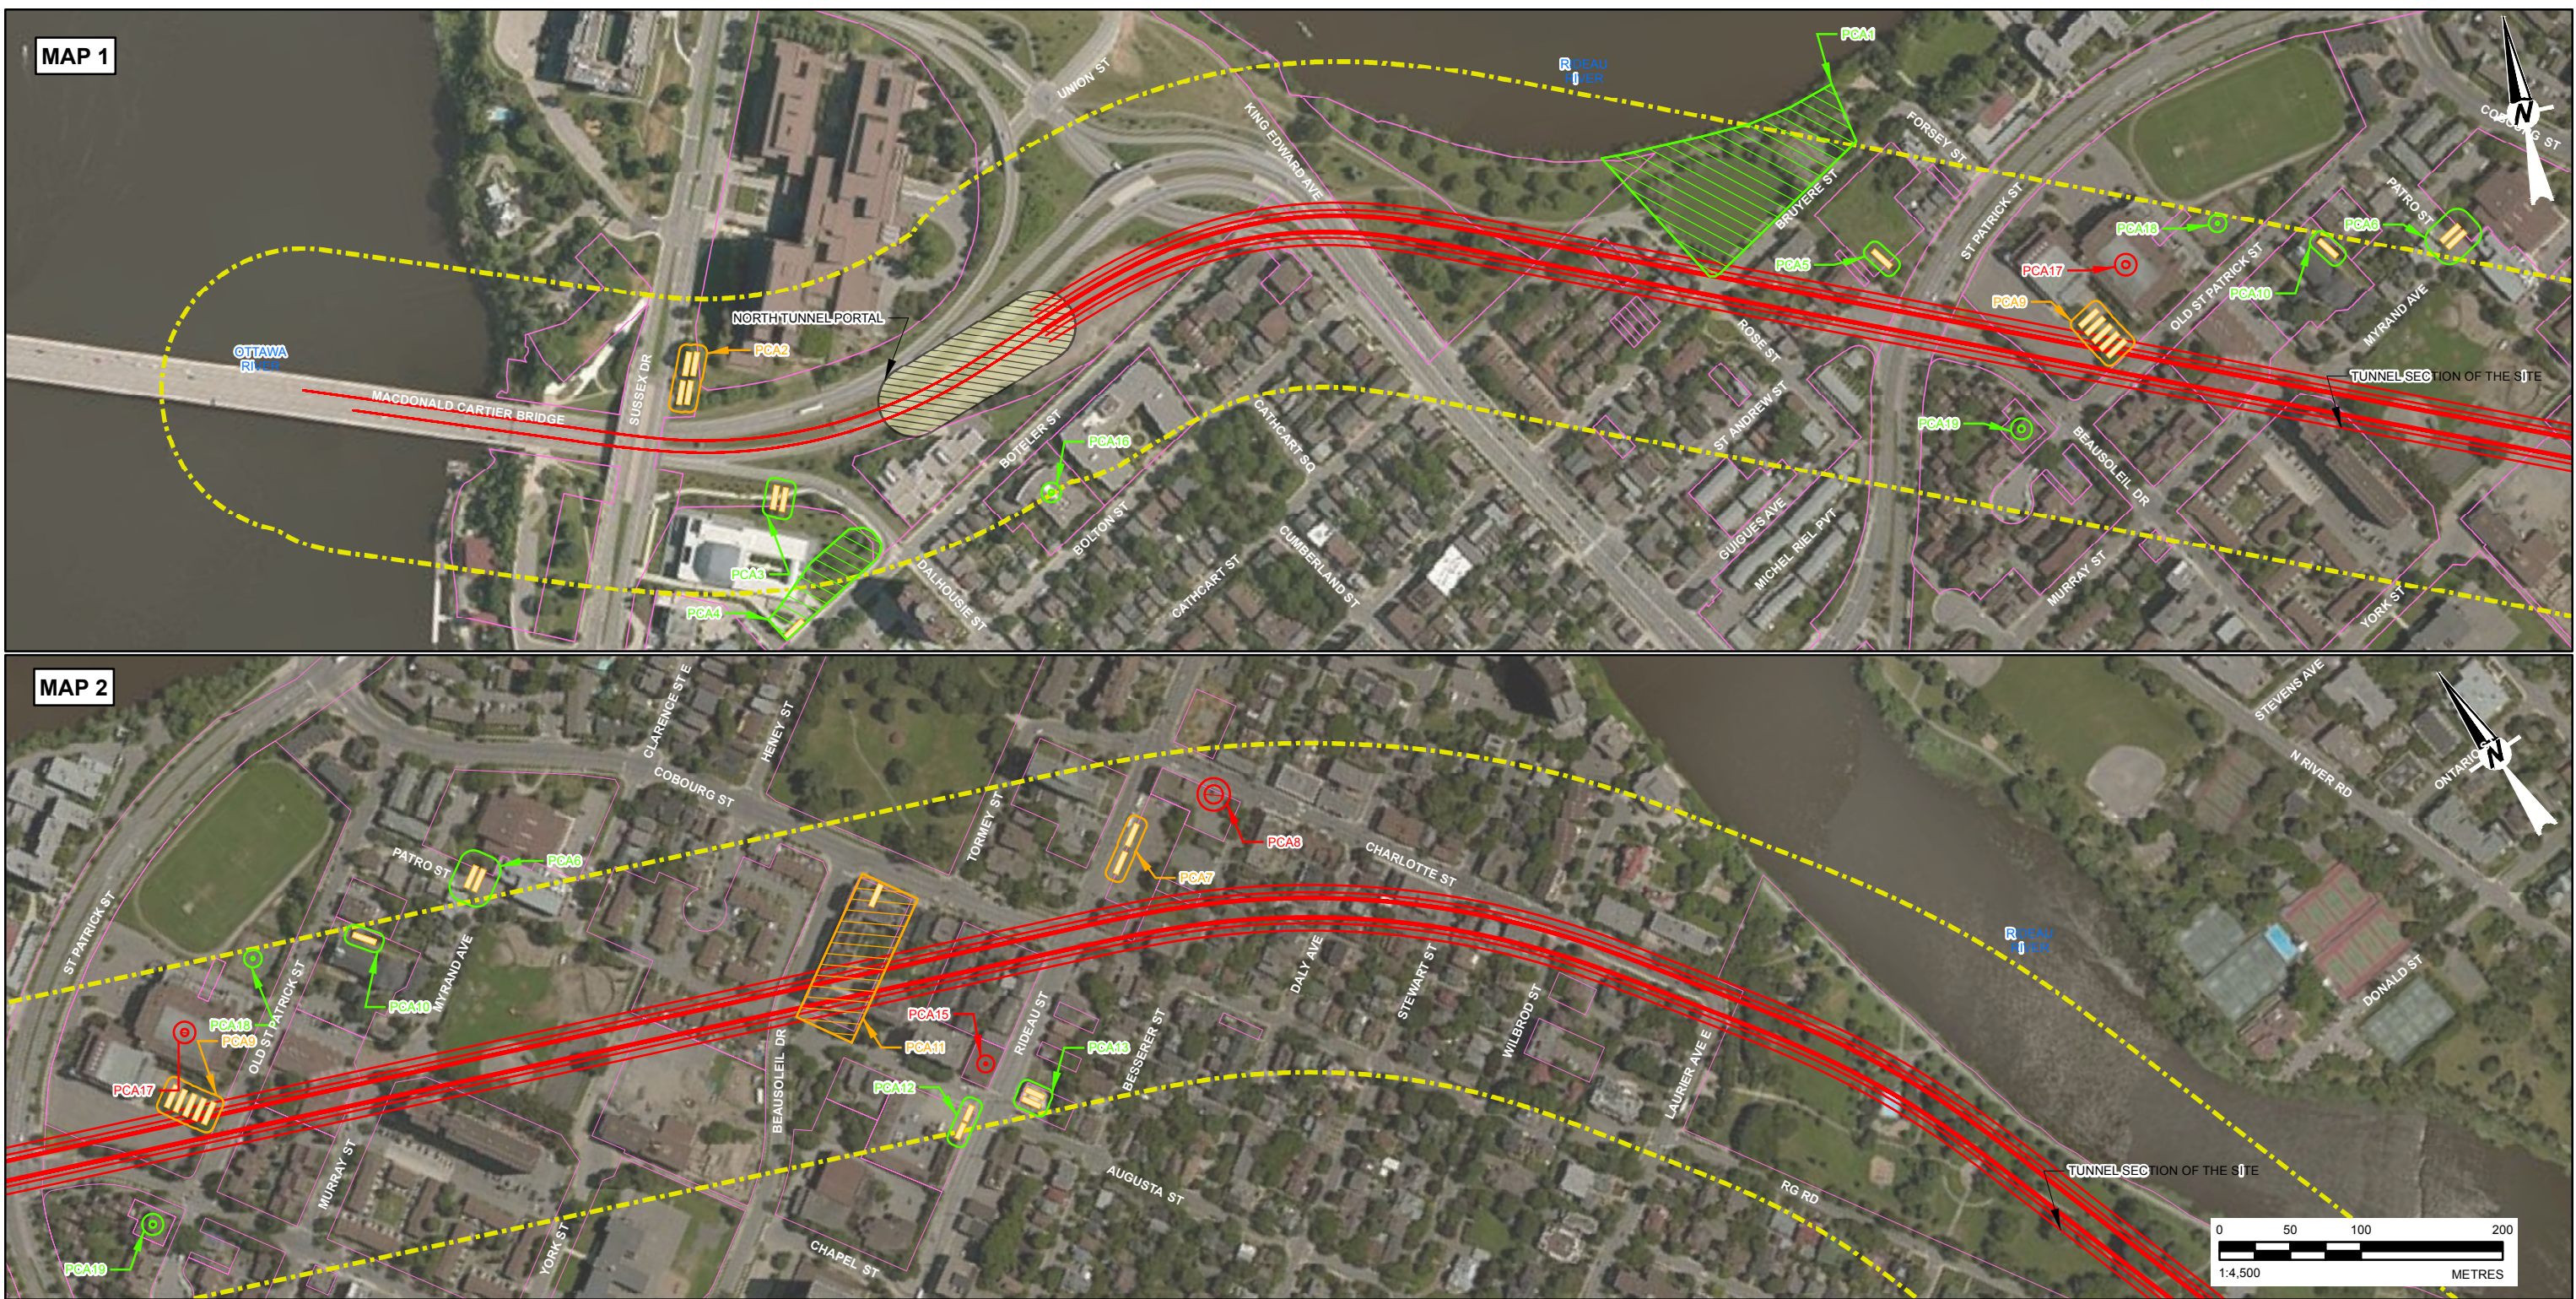
CLIENT		PARSONS	
PROJECT		DOWNTOWN OTTAWA TRUCK TUNNEL	
TITLE		POTENTIALLY CONTAMINATING ACTIVITIES, DOWNTOWN OTTAWA TRUCK TUNNEL	
CONSULTANT		YYYY-MM-DD	2015-10-21
		DESIGNED	---
		PREPARED	JEM/BR
		REVIEWED	MS
		APPROVED	TDR
PROJECT NO.	PHASE	REV.	FIGURE
1404896	2000	0	1a

PCA6 - FORMER AUTO GARAGE WITH TWO USTs AND SUBSEQUENTLY AUTO BODY REPAIRS.

PCA18 - FORMER LAUZON SERVICE CENTRE AND ROULEAU SERVICE CENTRE (MOTOR VEHICLE REPAIR SHOPS)

PCA19 - FORMER PENNOCK'S GARAGE (MOTOR VEHICLE REPAIR SHOP)

Attachments: Figures 1a and 1b – Potentially Contaminating Activities
Appendix A – City of Ottawa Historical Land Use Inventory

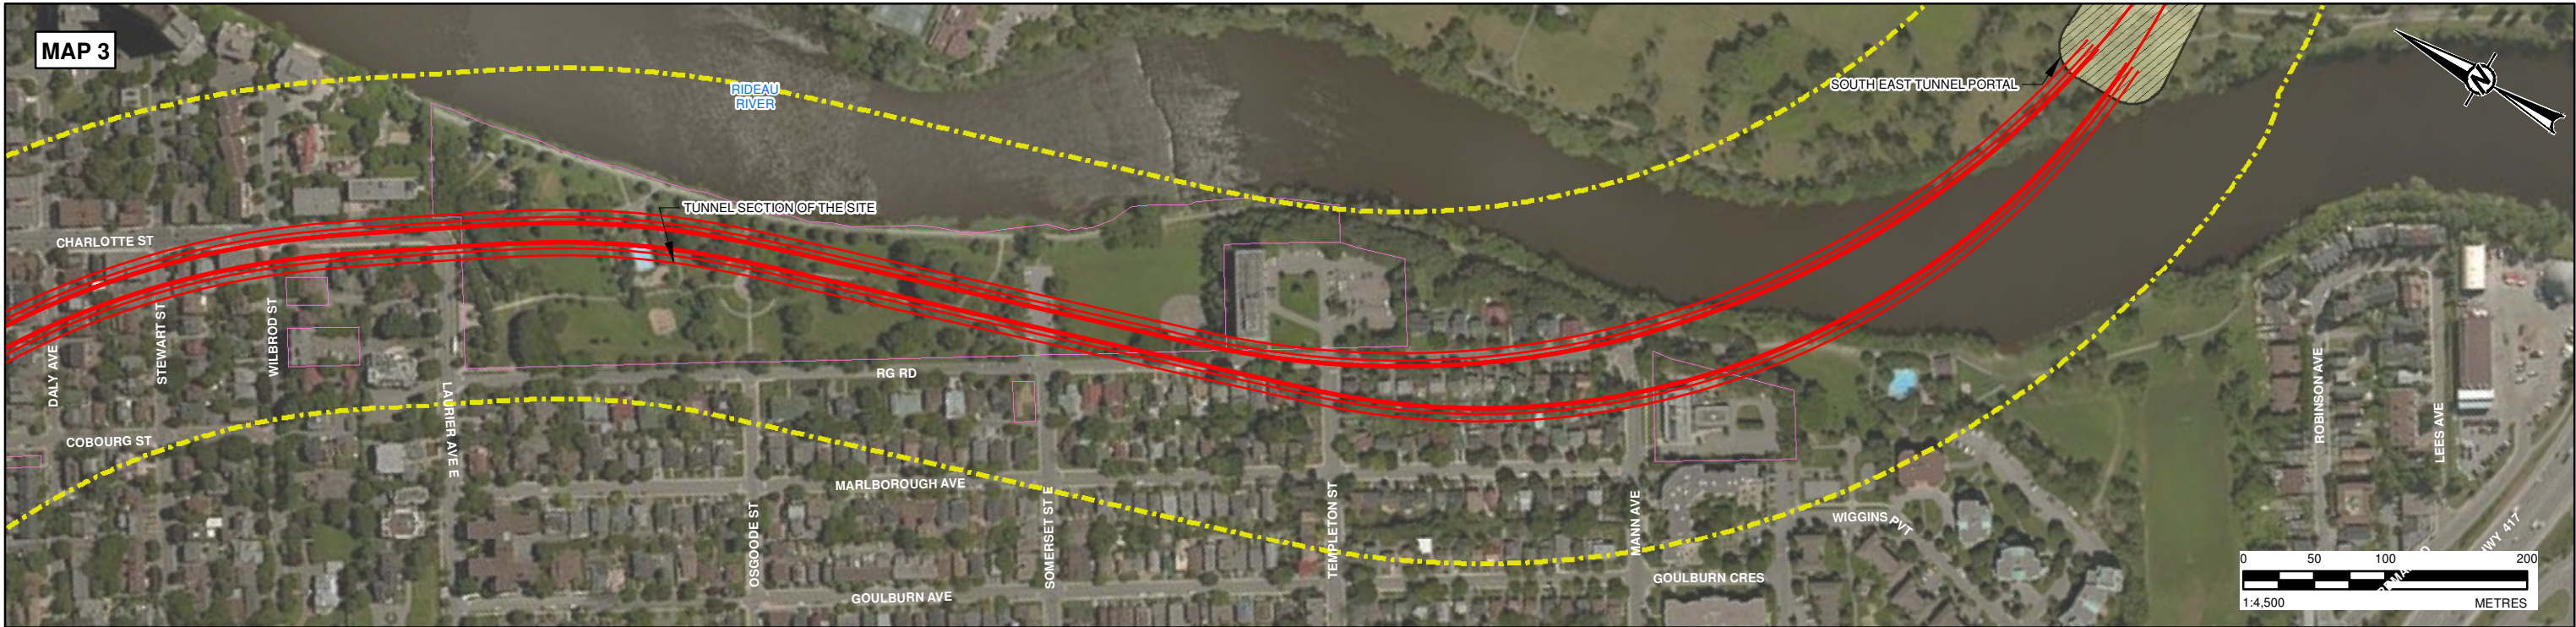
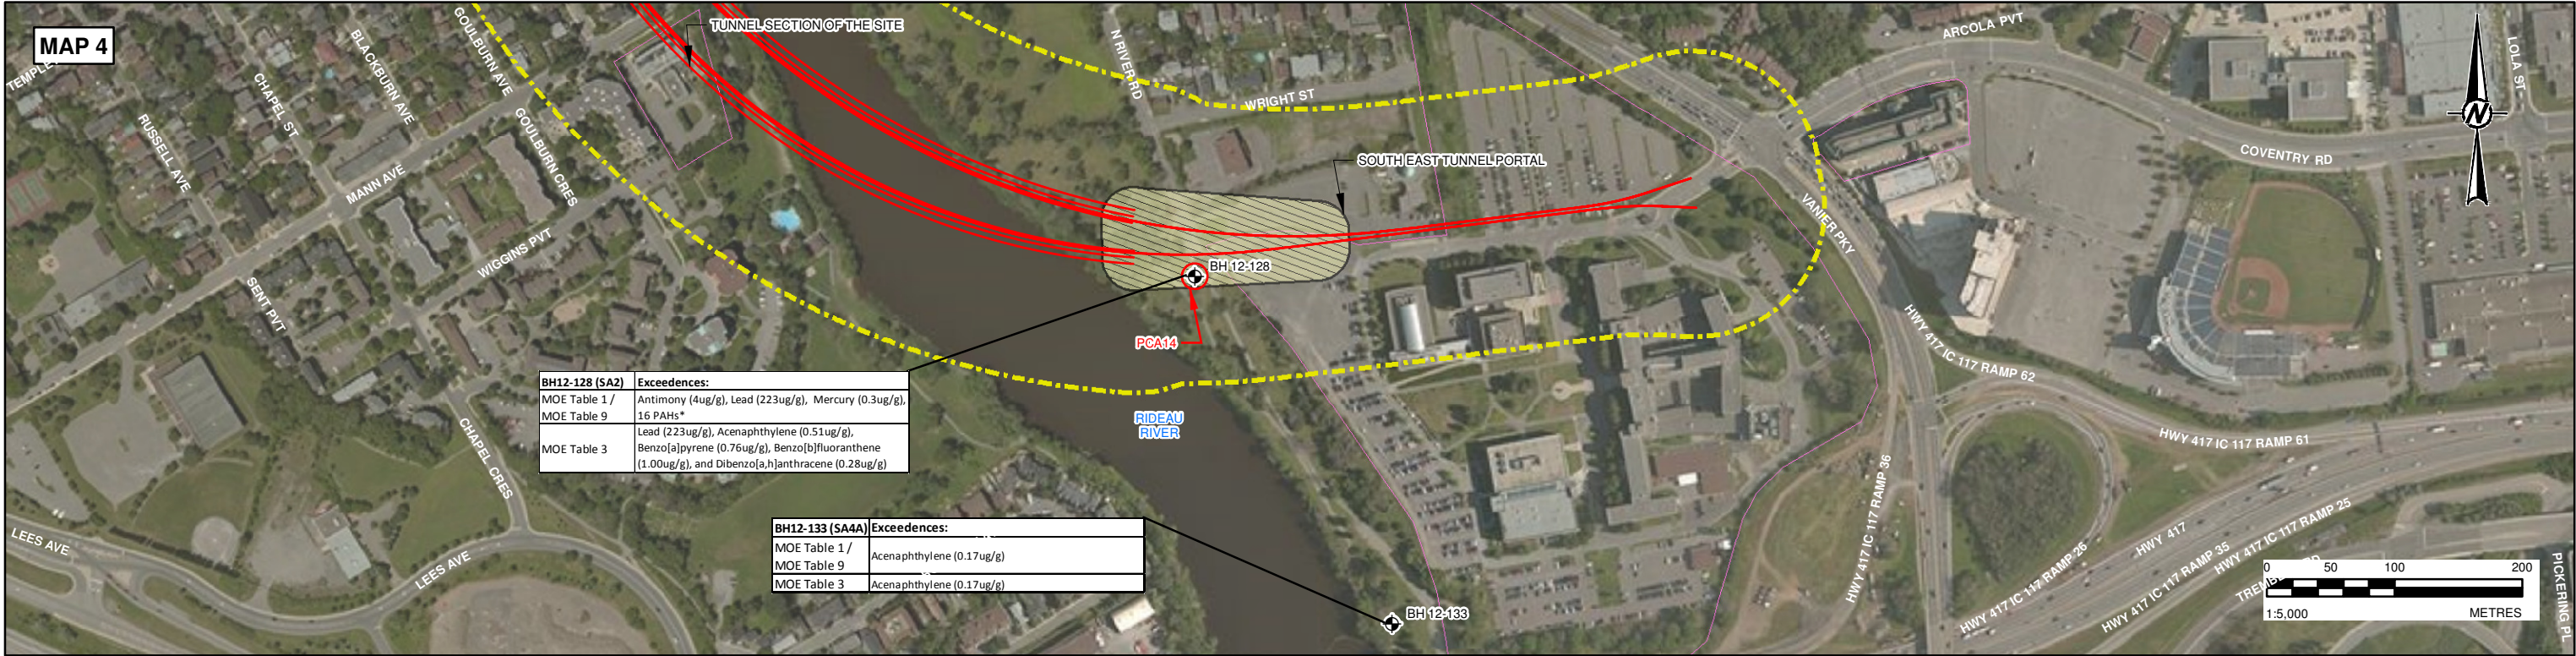
- GEO-ENVIRONMENTAL BOREHOLES (2013 GOLDER, PHASE II ESA) WHERE METALS AND/OR PAHs EXCEEDANCES ABOVE MOE TABLE 3 STANDARDS WERE IDENTIFIED IN THE FILL.
- SITE
- STUDY AREA (100 m BUFFER)
- PORTAL
- HLUI
