Transitway Station Design Safety Audit – Analysis of Findings

Final Report

Transitway Station Design Safety Audit – Analysis of Findings
Ottawa, Ontario, Canada

September 28, 2021

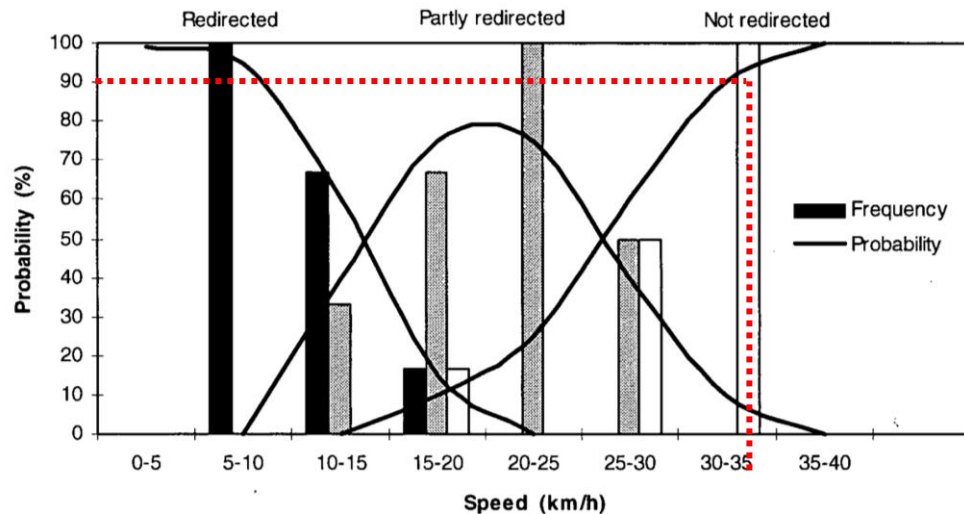
FIGURE 2: Probability of Redirection When Striking a 150 mm Barrier Curb at an Approach Angle of 5°

Whether a roadside curb is likely to redirect an errant vehicle, is dependent on many factors, including but not limited to, the curb height and shape, the angle of departure from the roadway, the vehicle speed at impact with the curb, and the vehicle specifications (mass, tire size, etc.). Full-scale tests on the redirection capabilities of 150 mm high barrier-type curbs indicates that these elements of the roadside have almost no ability to redirect errant vehicles at speeds above 26 km/h, regardless of the angle of departure (see Figure 2).⁶ Therefore, while the idea of replacing the depressed curb with a 150 mm barrier curb is intuitively appealing, the research indicates that this action is not likely to mitigate the identified safety issue.

It is recommended that OC Transpo take no action on relocating the service bay to downstream of the station due to the limited effectiveness of barrier curbs in redirecting errant vehicles. It is also recommended that, when the station is reconstructed, the guidelines for service bay placement and design conform to the prevailing best practices.

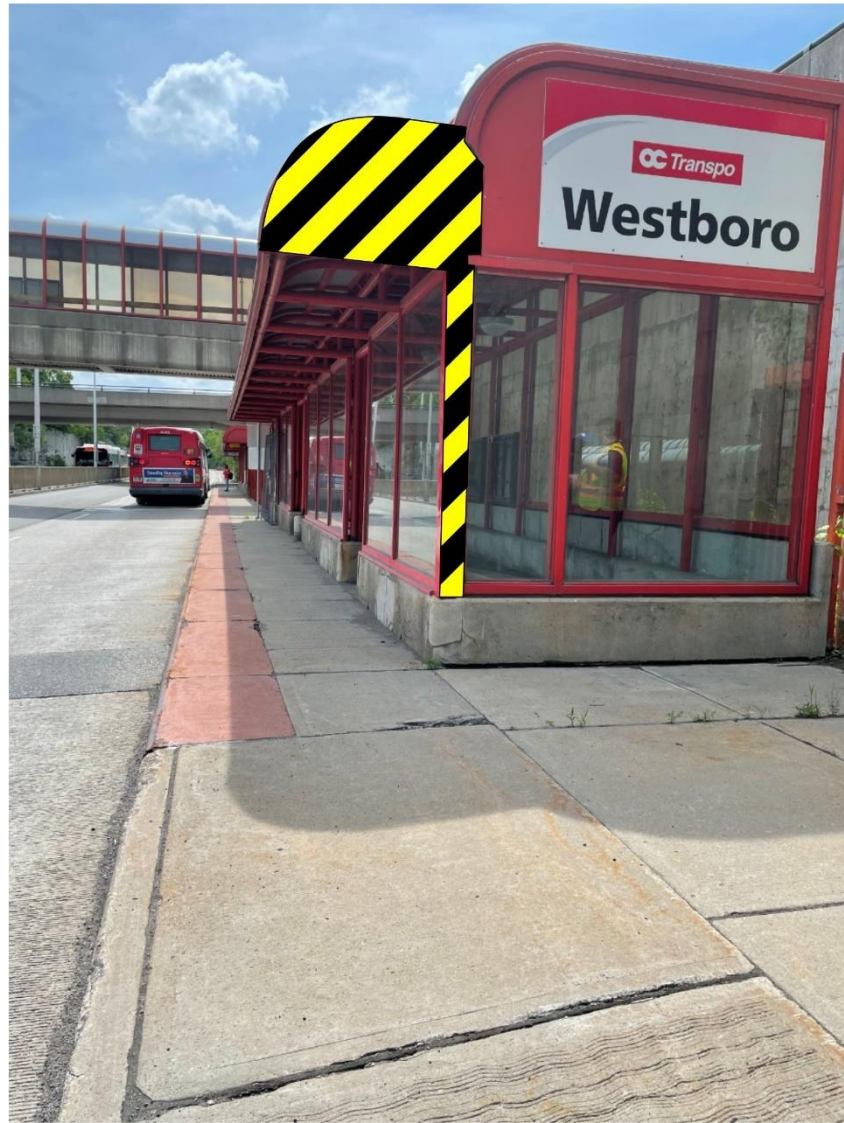
FIGURE 5: Proposed Object Markings

OBJECT MARKER (Wa-33). However, with structures that are located within the clear zone, the OBJECT MARKER is usually replaced with alternating yellow and black diagonal markings placed directly on the structure (see Figure 5). Markings such as those shown in Figure 5 are a reasonable mitigation measure.

It is recommended that, rather than remove the canopy or reduce the operating speed of buses to 20 km/h, OC Transpo mark the canopy with black and yellow striped markings similar to those used on low clearance structures (see Figure 5).

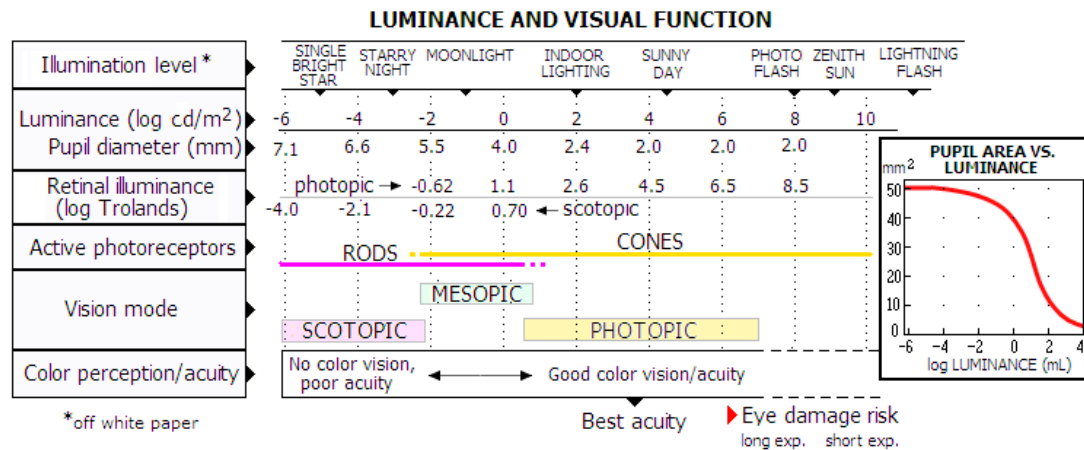
FIGURE 6: Luminance and Visual Function

to light). Different photoreceptors are used in light and dark conditions respectively, and a rapid transition can cause periods of temporary visual impairment as the eye switches from one type of photoreceptor to the other type (see Figure 6).

The ambient light in the shadow of the pedestrian bridge, even on the brightest day, is still likely to be in the range of typical indoor lighting. This being the case, operators on the Transitway would still be using photopic vision and visual impairment due to light adaption is not likely.

It is recommended that OC Transpo take no action on erecting a sun screen but continue best efforts to ensure that the windscreens of all buses on the Transitway are as clean as possible to reduce the impacts of glare from the sun.
