## **Appendix C – Rideau Valley Conservation Authority's City Stream Watch Reports**

# Becketts Creek 2011 Summary Report

# Becketts Creek 2017 Catchment Report

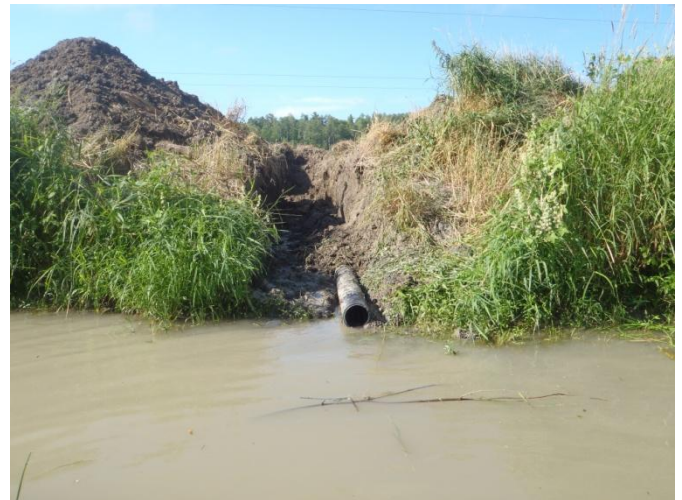
Figure 2. Classes of Anthropogenic Alterations Occurring along Becketts Creek

Figure 2 illustrates the classes of anthropogenic alterations observed along Becketts Creek. Of the 158 sections sampled, 57 percent of the stream remained without any human alteration. Sections considered natural, but with some anthropogenic changes made up nine percent of the sections sampled, and 20 percent accounted for sections that were considered “altered” but still had natural features. Fourteen percent of the sampled areas were “highly altered” with few natural portions. Areas that were listed as “altered” or “highly altered” were associated with road crossings, culverts, stormwater inputs, channelized sections or areas that had little or no buffer and little aquatic or wildlife habitat.

Photo of an anthropogenic alteration along Becketts Creek

Between 2006 and 2011, anthropogenic alterations along Becketts Creek have increased. Part of the change is likely related to a difference in the macro stream protocol used. In 2010, anthropogenic alterations were further defined, which would have caused some land uses to shift categories. Most of the alterations along Becketts Creek can be attributed to its reduced buffer between the creek and human influence, which occurs in many areas that were surveyed. Other areas classified as altered include road crossings, shoreline armoring and tile drains. During 2011 surveys, active buffer removals in some areas were observed.

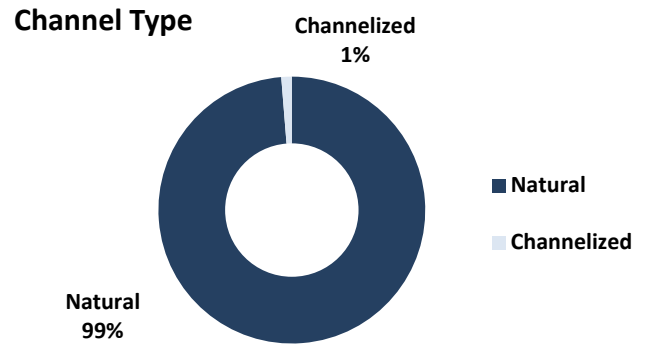
Figure 4. Channel Type Observed Along Becketts Creek

Streams are naturally meandering systems and move over time, and there are varying degrees of sinuosity (curviness), depending on the creek. However, in the past, humans have altered creeks and channelized areas, which can be quite detrimental to stream function and health. Only one percent of Becketts Creek was considered channelized.

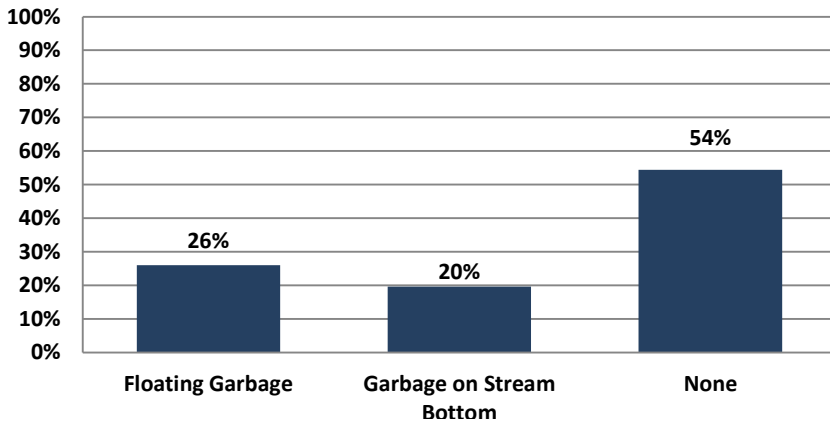
Figure 14. Frequency of Pollution/Garbage Occurring in Becketts Creek

Figure 14 demonstrates the incidence of pollution/garbage in Becketts Creek. Pollution and garbage in the stream is assessed visually and noted for each section where it is observed. Fifty-four percent of sections surveyed did not have any garbage. Twenty-six percent had floating garbage and 20 percent had garbage on the stream bottom, although it was not observed in large quantities. No observations of oil and gas trails or unusual colouration of the channel were made. The most common type of garbage observed were plastic items (wrappers, cups, bottles, etc.). Other types of garbage observed included tires, metal rebar, styrofoam, aluminum cans, glass, plywood, garbage can, shovel, pool, CD packaging, asphalt, car, cardboard, copper wire, buckets, propane tanks, paint cans, old oil drums, aluminum siding, appliances, beach balls, bicycle, sled, plastic sheeting and tarps.

The amount of garbage on Becketts Creek has decreased in the compared areas. In 2006, 66 percent of the sections surveyed were garbage free, and in 2011, it increased by seven percent. In 2006, one percent had oil and gas trails, but it was not in the compared section. In 2011, a lot of garbage occurred outside the compared areas, and therefore, is not reflected in the comparison but is still an issue.

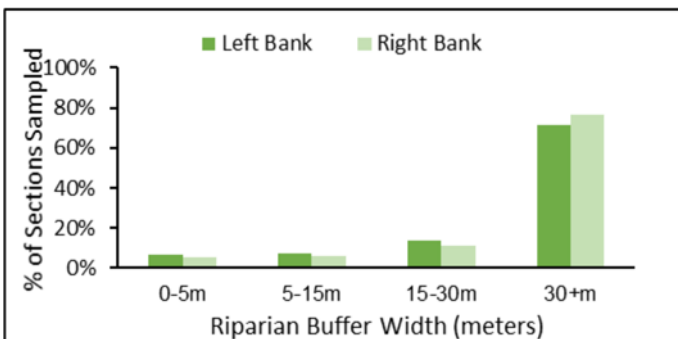
Figure 2 Vegetated buffer width along Becketts Creek

Figure 2 demonstrates buffer conditions along the left and right banks of the surveyed sections of Becketts Creek. Buffers greater than 30 meters were present along 71 percent of the left bank and 76 percent of the right bank. A 15 to 30 meter buffer was present along 14 percent of the left bank and 11 percent of the right bank; five to 15 meter buffers were observed along eight percent of the left bank and six percent of the right bank. A five meter buffer or less was present along seven percent of the left banks and five percent of the right bank.

Improvements of buffer are needed, particularly in the agricultural areas and near roadway intersections where buffers are lower than the recommended guidelines.

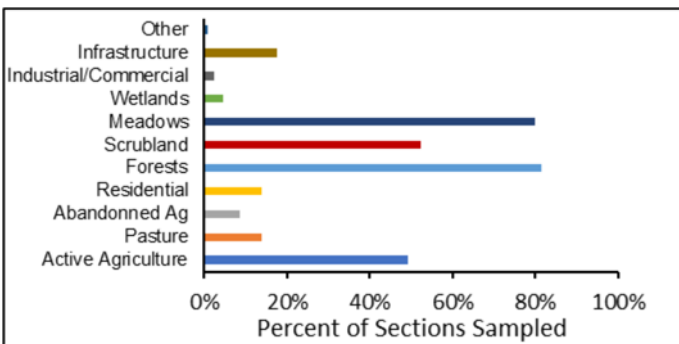
**Figure 4** Adjacent land use 100 m from each shoreline and percentage of presence along Becketts Creek

Meadows and forest were present in 80 percent and 82 percent of the sections surveyed, being the most common land use found. Scrubland was present in 52 percent of the surveyed areas, and wetland was present in five percent of sections.

Aside from the natural areas, the most common land use in the catchment was agricultural, with 49 percent of the sections containing active agriculture, eight percent abandoned agriculture and 14 percent of the sections had pasture land present. Other uses observed included 18 percent of surveyed areas with infrastructure (such as roads); residential areas were observed in 14 percent; and industrial or commercial use was identified in two percent of the adjacent lands.

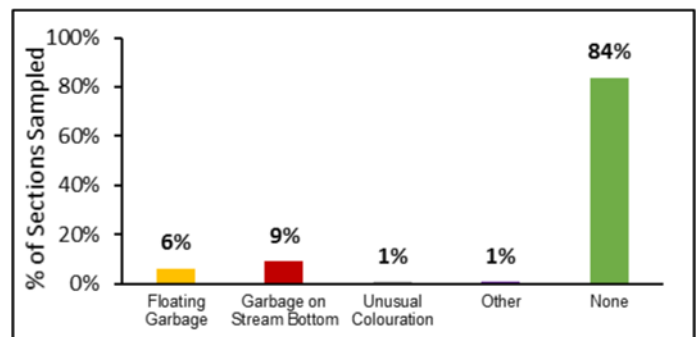
Figure 21 Pollution observed within Becketts Creek

Figure 21 shows the types of pollution observed in Becketts Creek. The levels of garbage found in the main portion of the stream were low, with 84 percent of sections surveyed containing no garbage. In the 16 percent of sections that were polluted, most garbage observed were styrofoam, plastics, cans, and tires.

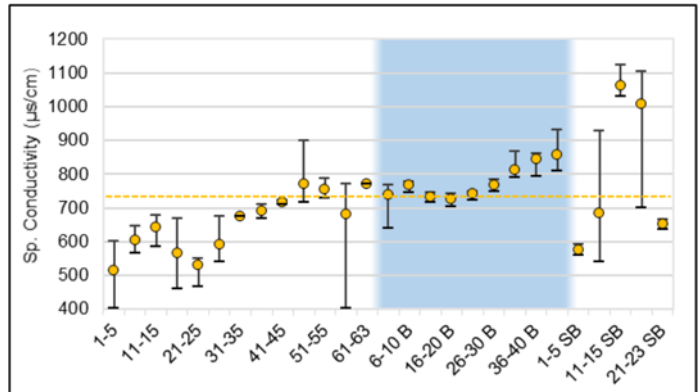
Figure 23 shows specific conductivity levels in Becketts Creek, the average level is depicted by the dashed line (720  $\mu\text{S}/\text{cm}$ ). Notable variability was observed at the mouth, (sec. 1-5) likely influenced by the Ottawa River; and by drainage in agricultural zones and runoff from roadway crossings (sec. 56-60, 6-10 SB, 16-20 SB).

**Figure 23** Conductivity ranges in sections of Becketts Creek: 1-63 main stem, 1-44 branch (B) in blue, 1-23 south branch (SB)

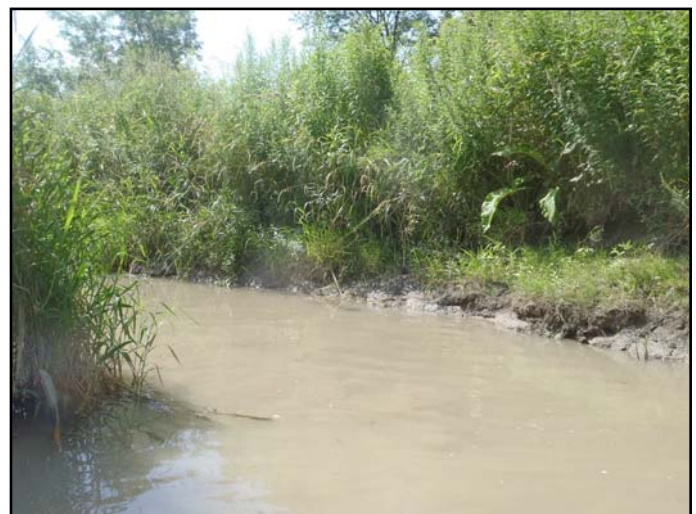
Site on Becketts Creek with **impaired** oxygen conditions

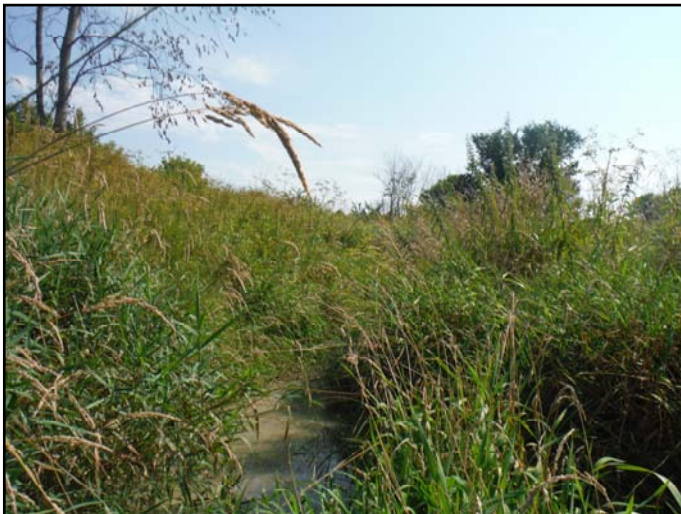
Section of Becketts Creek upstream of Sarsfield Road with highly elevated conductivity levels

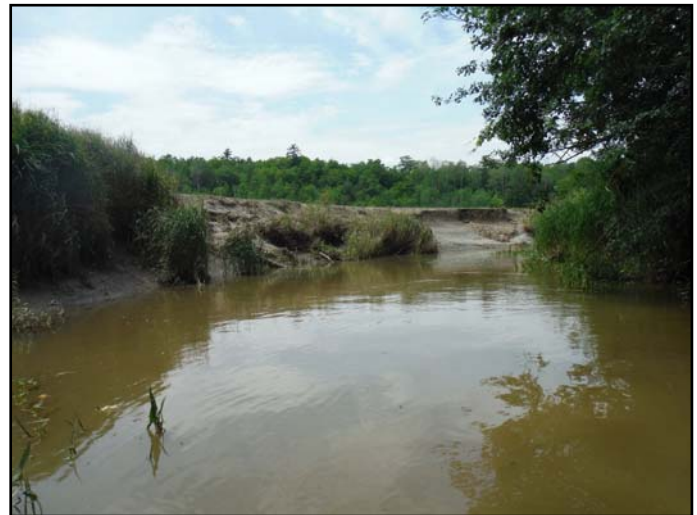
Section of Becketts Creek upstream of Birchgrove Road that would benefit from buffer enhancement to improve shoreline conditions and water quality.

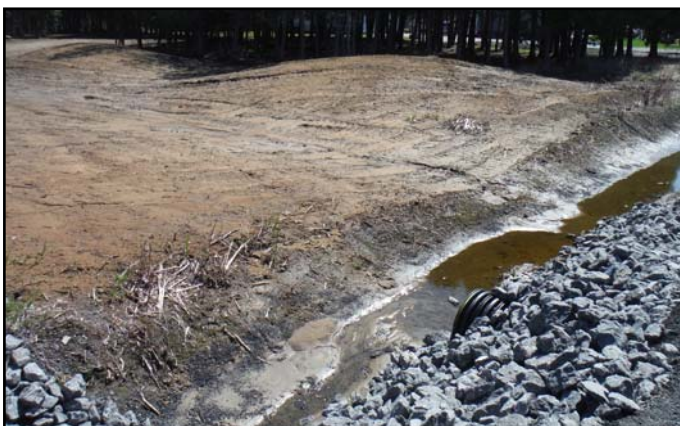
Extensive sediment deposition observed on Joannise Road
