Appendix B – Photos

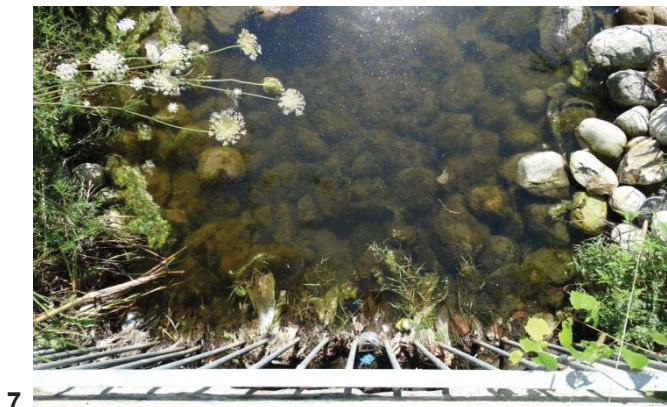
7

Mahogany Creek – views downstream and upstream along creek corridor from Manotick Main Street (1, 2), Bridgeport Avenue (3, 4) and Century Road East (5, 6). Storm sewer outlet at Potter Drive (7) drains eastwards (8) to Mahogany Creek near Manotick Main Street. Photo 1 shows outlet of Mahogany Creek to the Rideau River immediately downstream (east) of Manotick Main Street. Photo 8 shows pedestrian path and footbridge installed in fall 2014. Photos 1-7 taken August 7, 2014; Photo 8 taken Sept. 25, 2015.

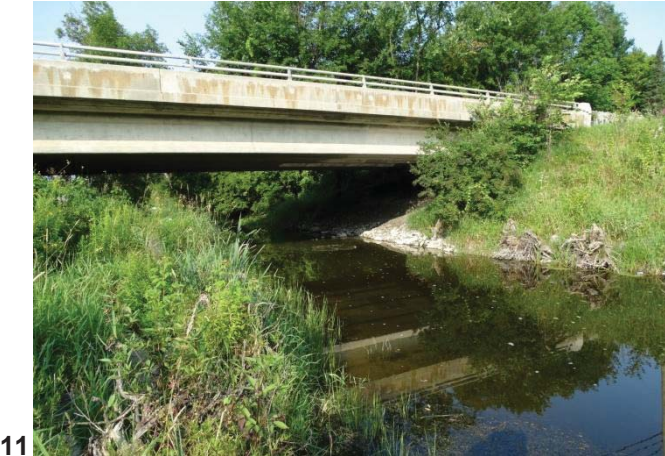
11

Mud Creek – views downstream (9) and upstream (10) from Rideau Valley Drive, showing outlet to Rideau River (9). Rideau Valley Drive bridge crossing (11) located immediately upstream of outlet to Rideau River. Shoreline naturalisation planting area identified on City property along the east side of Rideau Valley Drive (12).

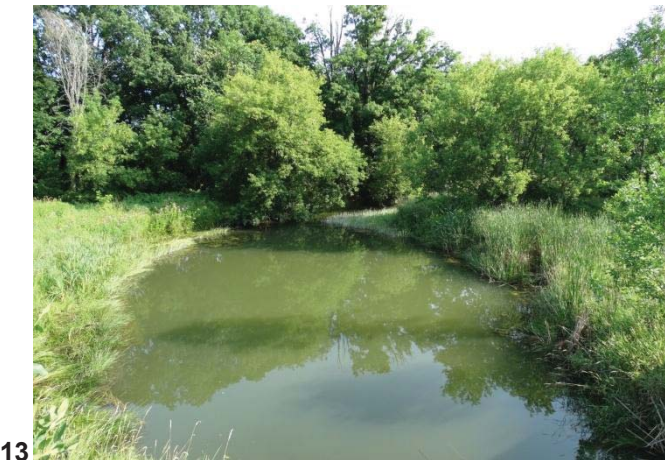
13

Views downstream (13, 14) and upstream (15) from Bankfield Road, showing large pooled section (13) that changes to a shallow riffle farther downstream (14).

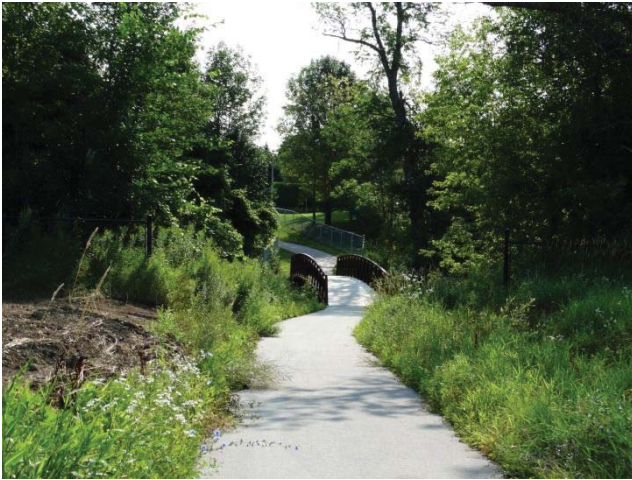
Mud Creek – views downstream (16) and upstream (17) from pedestrian footbridge (18) linking McManus Avenue and Carrison Drive.

The RVCA has identified potential erosion control opportunities downstream of this bridge crossing, and riparian planting opportunities along this section of the creek as far upstream as Gray Willow Drive.

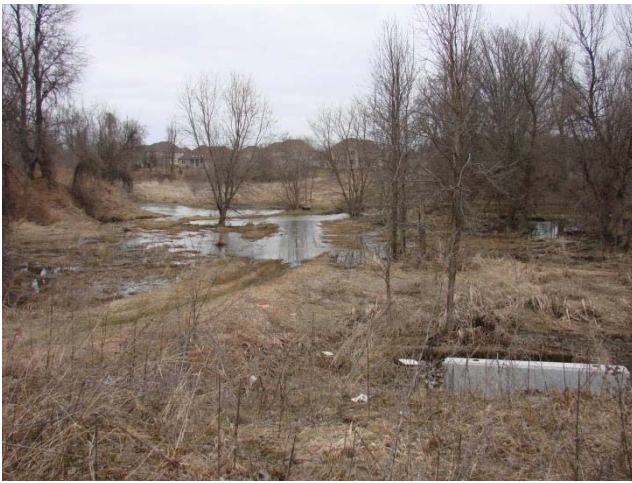
Mud Creek – informal crossing (ford) between Gray Willow Drive and Carrison Drive, as seen from the western valley slope. Photo 19 was taken on April 13, 2011 and shows the stormwater outfall installed as part of the Special Design Area development. Photo 20 was taken on July 29, 2014 and shows dense vegetation growth within the valley. This crossing is located on a City-owned road allowance. It provides access for farm equipment to reach the western Mahogany Community lands, as well as public access across the creek. However, local residents have indicated that improvements to the crossing are needed. The RVCA has identified potential fish habitat enhancement and riparian planting opportunities just downstream of this crossing.

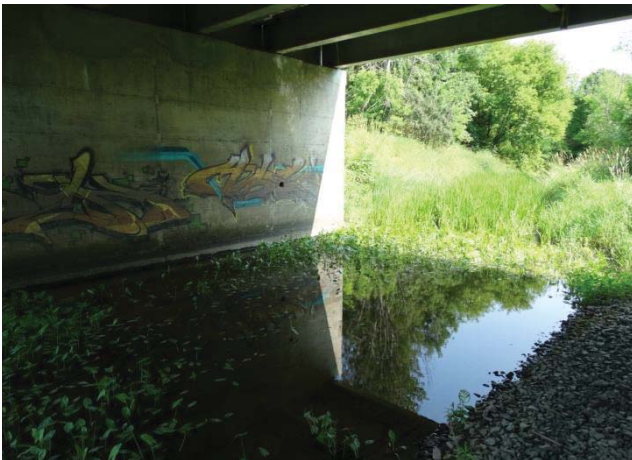
Photo 27 shows Mud Creek under Second Line Road South bridge. Barn swallows were observed nesting here (see Photo 47).

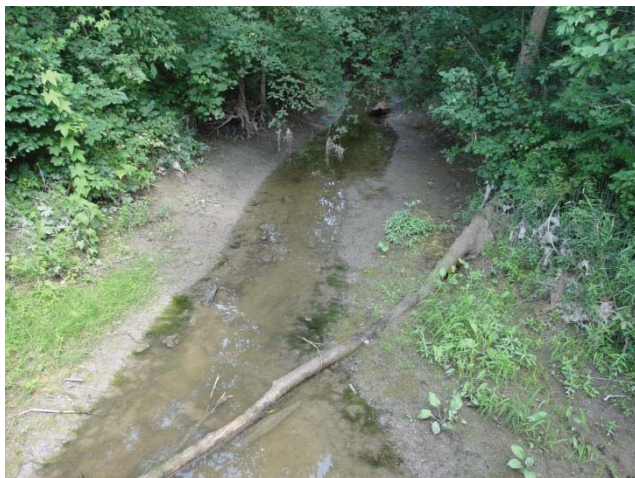
Photos 30 and 31 show downstream view from Third Line Road North prior to and following municipal drain maintenance work.

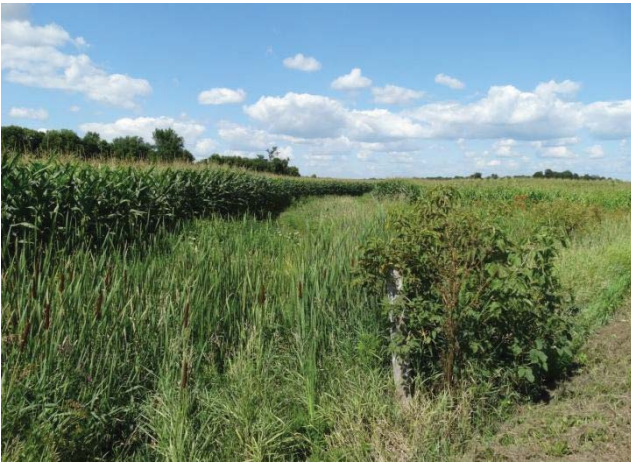
Photos 37 and 38 show downstream view from Carsonby Road West, east of Fourth Line Road, prior to and following tile drain installation.

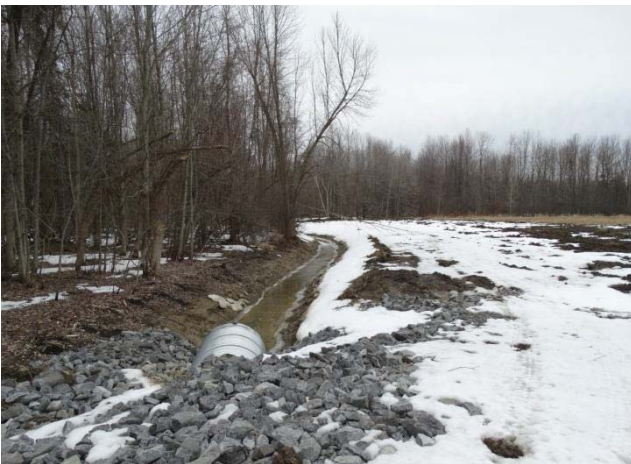
Photo 39 shows site of recent culvert replacement and other maintenance work along David Adams Drain.
