# City of Ottawa - Kanata & Downtown Ottawa Aerial Thermography and Quantification Aggregate Analysis Interim Report

December 19, 2023

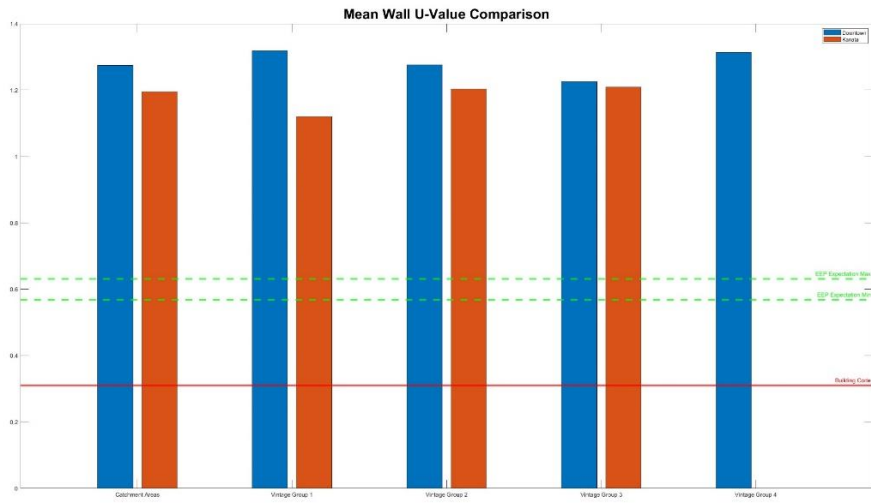
Figure 3: Comparison of Mean Wall U-values of All Buildings against Existing Building Code and EEP

- Wall: 0.310 W/m<sup>2</sup>K
- Roof: 0.20 W/m<sup>2</sup>K
- Window: 2.56 W/m<sup>2</sup>K
- Door: 2.27 W/m<sup>2</sup>K

Based on this dataset, the average building envelopes are performing 75% worse compared to current building code (based on the walls which are most of the envelope), all of which are significantly worse than current building code (Ontario Building Code 2017).

In the current database, only 2 buildings have wall U-values that meet the EEP expectations. Similarly, only 3 buildings have roof U-values that are within the EEP expected limits.

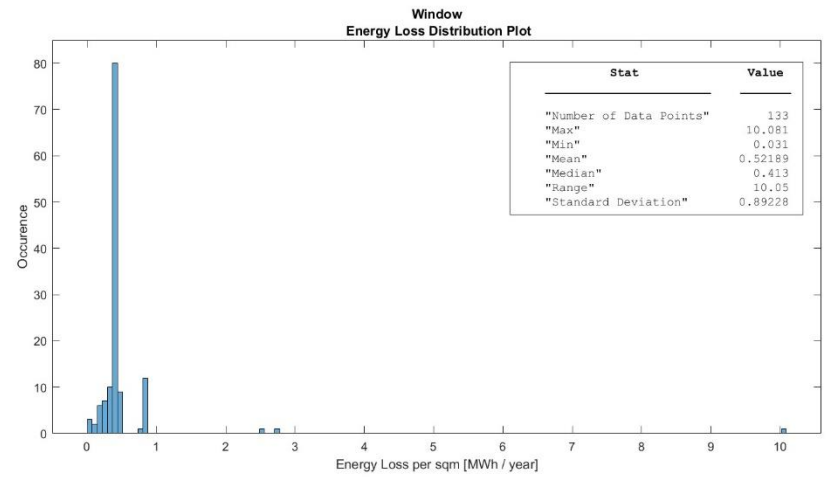
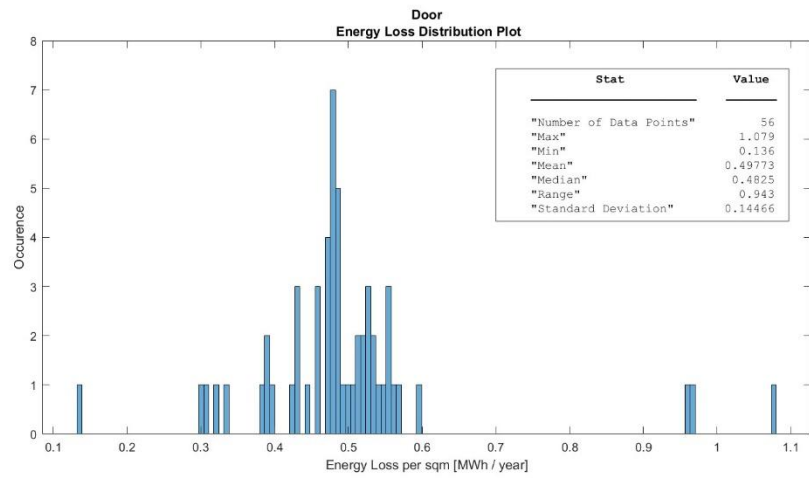
Figure 7: Distribution Plot for Annual Energy Loss for Different Building Elements in the Downtown Catchment

Figure 7 and Figure 8 show the distribution plot for the annual energy loss values per square metre of different building elements.

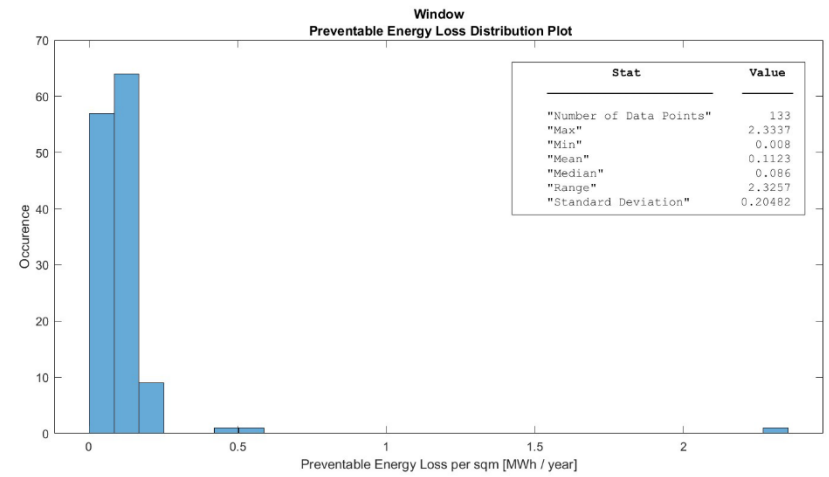
Figure 9: Distribution Plot for Annual Preventable Energy Loss for Different Building Elements in the Downtown Catchment

Figure 9 and Figure 10 show the distribution plot for the annual preventable energy loss per square metre of different building elements.

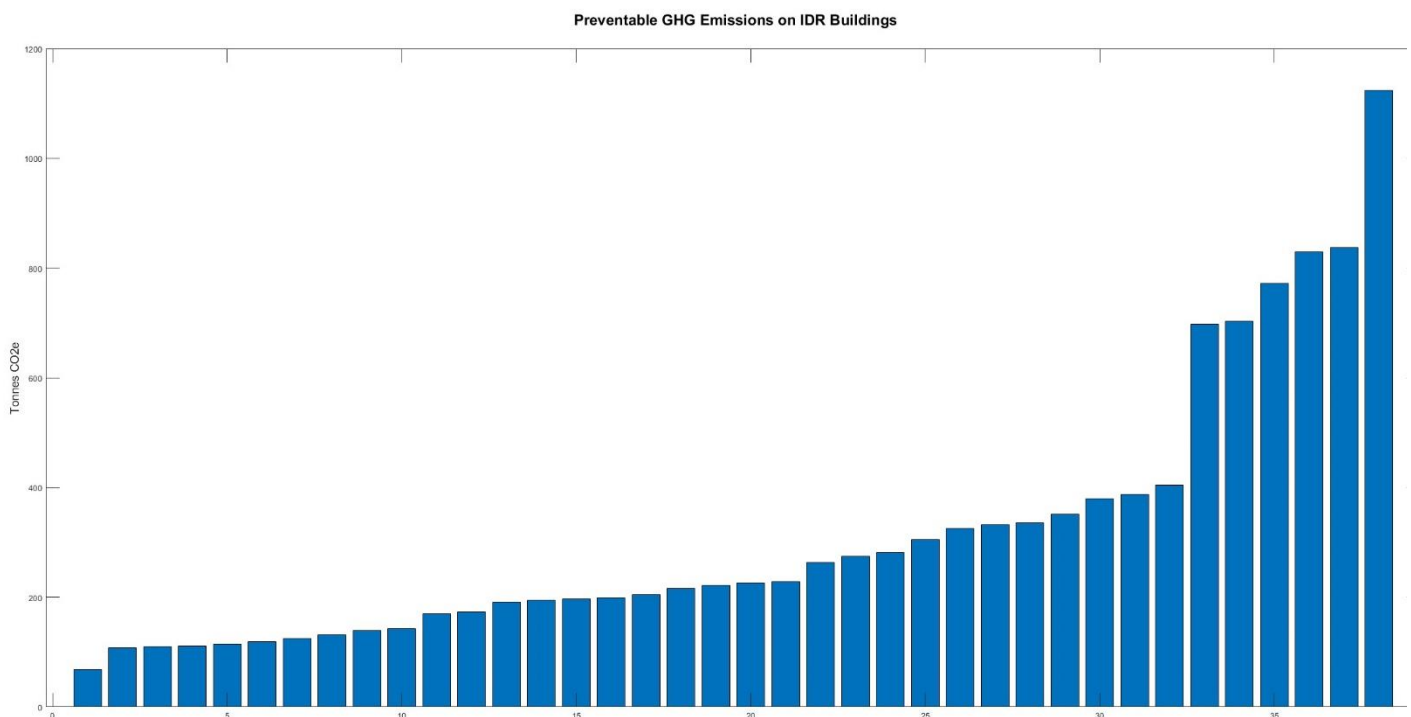
The method of heating/cooling for the properties was not known and it is assumed that all heating is with gas. As a result, a single conversion factor of 49 kgCO<sub>2</sub>e/GJ from the GHG equivalencies calculator from Energy Star Performance Manager (ESPM) Emission Factors for natural gas was used for the calculations. No assumptions have been made regarding the buildings energy consumption as this information was not available for any of the buildings under investigation. The numbers reported in this section are solely the preventable GHG emissions based on the preventable energy loss calculations in the previous section 5.5.

The graph below illustrates the distribution of total preventable GHG emissions from the 38 buildings under consideration:

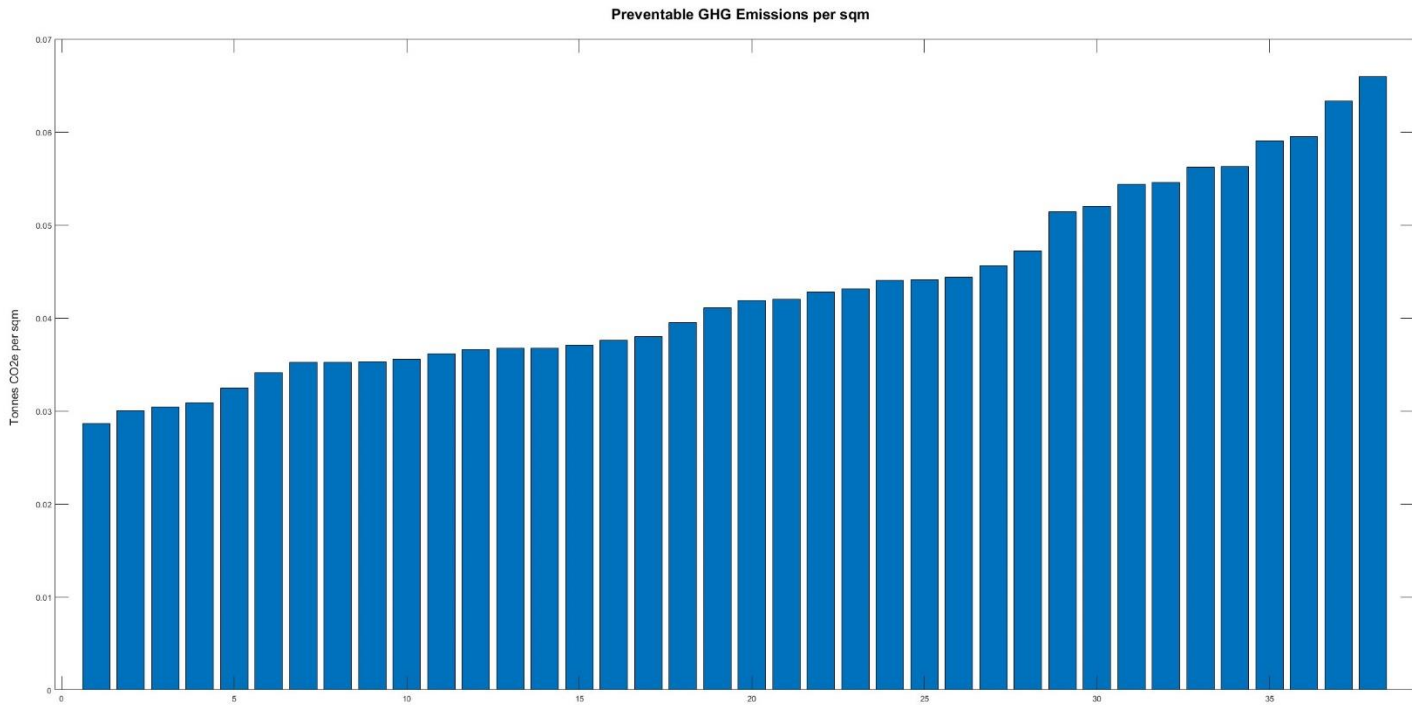
The following graph shows the distribution of preventable GHG emissions normalized to the total area of each of the 38 buildings:
