# **Ottawa LRT Independent Review Report**

April, 2022  
Confidential

# Ottawa LRT Independent Review Report

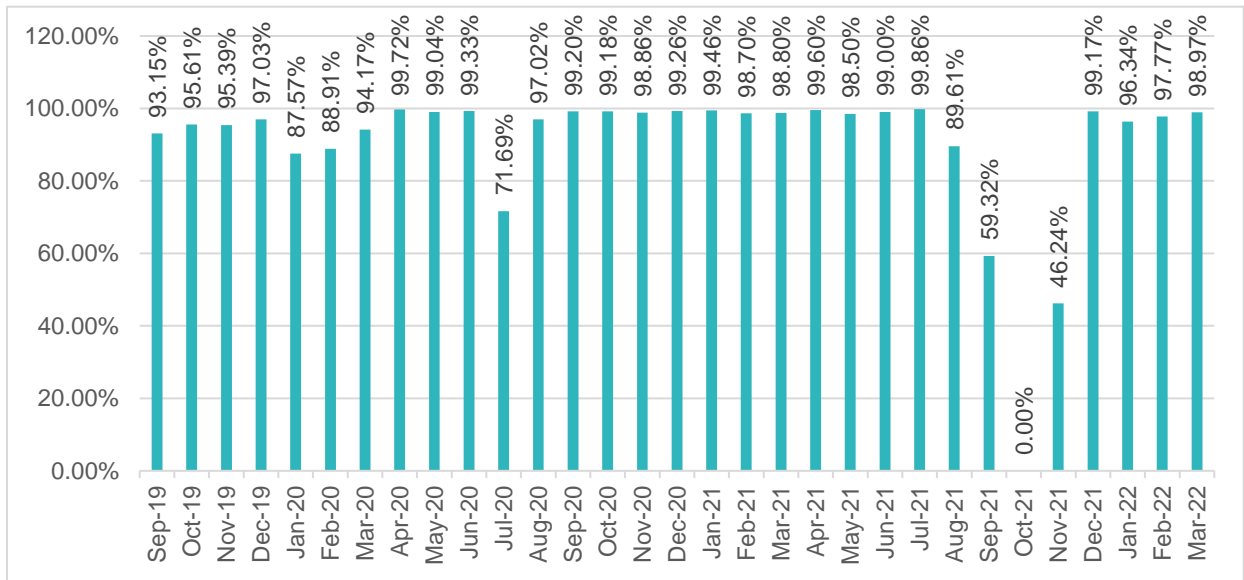
**Figure 2.1: Aggregate Vehicle Kms Availability Ratios since September 2019**

As shown in **Figure 2.1** the Aggregate Vehicle Kms Availability Ratio remained below the 98.0% threshold (hence incurring Failure Points) during 15 of the 31 months (September 2019 to March 2020, July and September 2020, August to November 2021, and January and February 2022) reviewed as part of this analysis.

As captured in **Figure 2.1** below, the Aggregate Vehicle Kms Availability Ratios remained below the 98.0% ratio threshold (hence incurring Failure Points) during 15 of the 31 months between September 2019 and March 2022. More specifically, the 98.0% target was not achieved in September 2019 to March 2020, July and September 2020, August to November 2021, or January 2022 and February 2022.

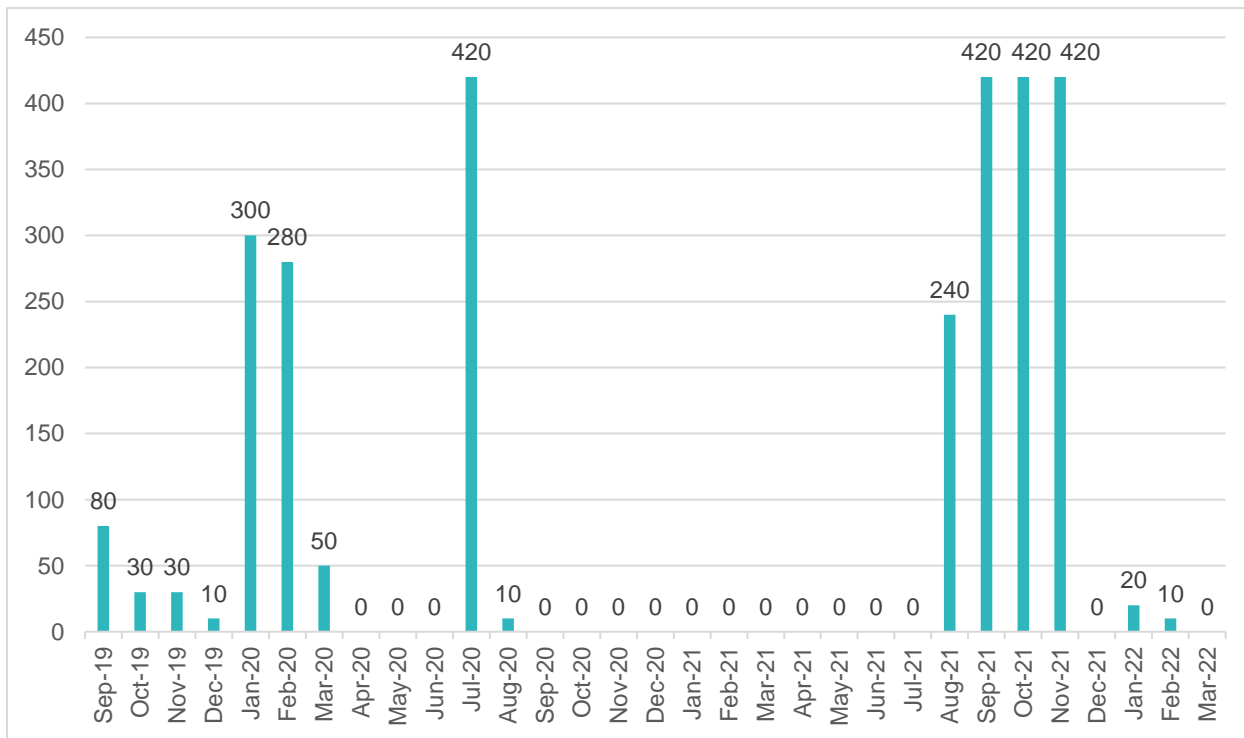
**Figure 2.2: Vehicle Kms Availability Failure Points since September 2019**

The performance of Vehicle Kms Availability was notably poor in January 2020, February 2020, July 2020, and August to November 2021, when services were offline because of investigations related to malfunctions (including cracks in the wheels of the vehicles and derailments).

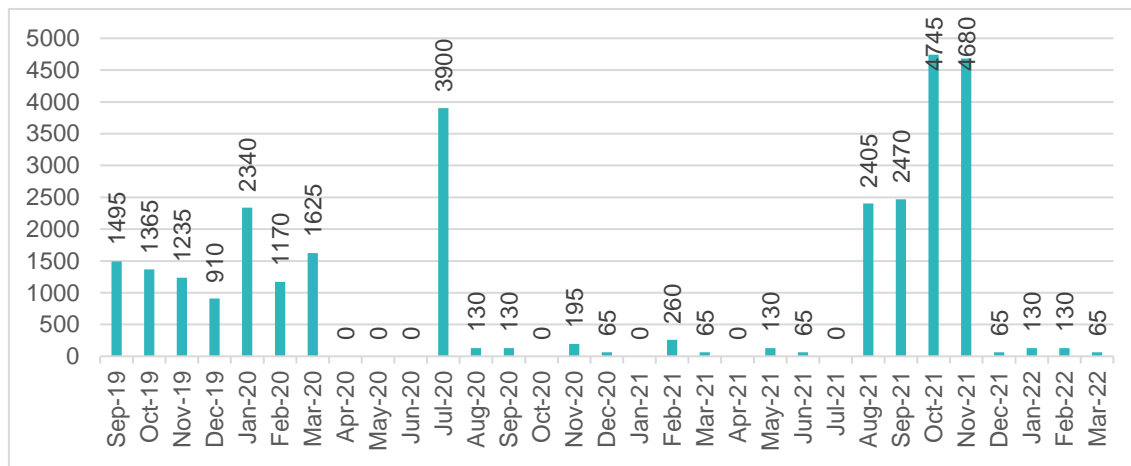
**Figure 2.3: System Events Availability Failure Points since September 2019**

Unlike the Vehicle Kms Availability Ratio that measures performance monthly, the System Events assess Vehicles Kms Availability Ratios during peak periods (morning and afternoon) and over single days. In general, System Events tend to be recorded when the Vehicle Kms Availability Ratio is performing poorly. Failure Points for System Events were notably high prior to April 2020, in July 2020, and from August to November 2021, which is a similar trend to that of the Vehicles Kms Availability and is driven by services being offline because of investigations related to malfunctions (including cracks in the wheels of the vehicles and derailments). Failure Points for System Events are captured in **Figure 2.3**.

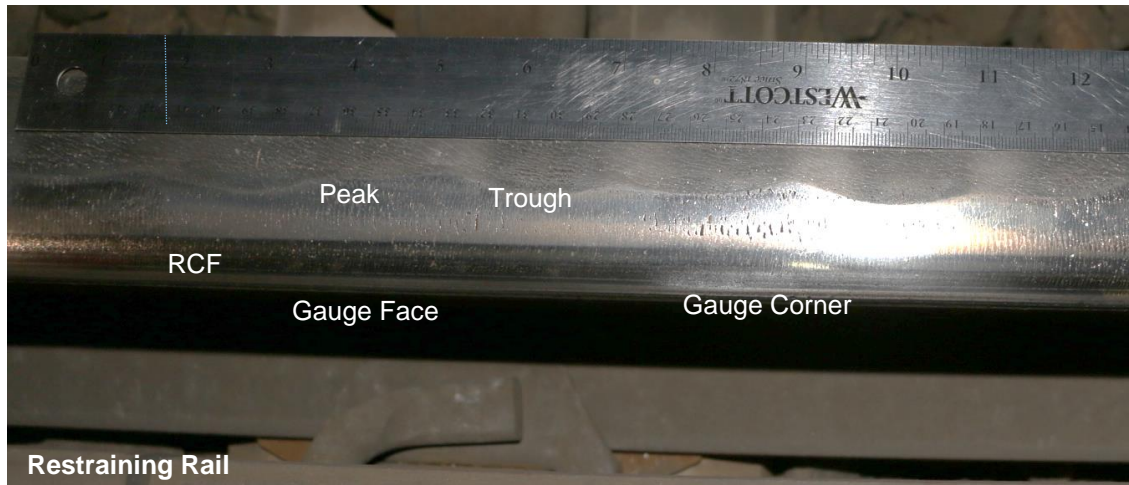
**Figure 3.8: Corrugation on Low Rail of Curve 210 at 104+725**

Corrugation on the low rail is located near the crown of the rail, **Figure 3.8**, **Figure 3.9** and **Figure 3.11**. There is also wheel contact on the gauge corner and the gauge face shown by the shiny polished surface. In contrast, corrugation on the high rails extends from the crown of the rail through the gauge and down the gauge face in the form of periodic side wear **Figure 3.10** and **Figure 3.12**. **Figure 3.12**: Corrugation on High Rail of Curve 330 at 108+685 Figure 3.12: Corrugation on High Rail of Curve 330 at 108+685 shows two types of corrugation on the high rail, a long wavelength at the gauge corner with a shorter wavelength on the crown. There is evidence of plastic deformation occurring in the trough of the corrugation with plastic flow of the rail surface towards the field side away from the gauge corner, **Figure 3.9**. There is also some evidence of material breaking away “spalling” from the surface of the trough, **Figure 3.11**.

RCF in the form of head checks is present on the low rail on some curves, **Figure 3.8**, and **Figure 3.9**. No RCF is present on the high rail on the photographs examined.

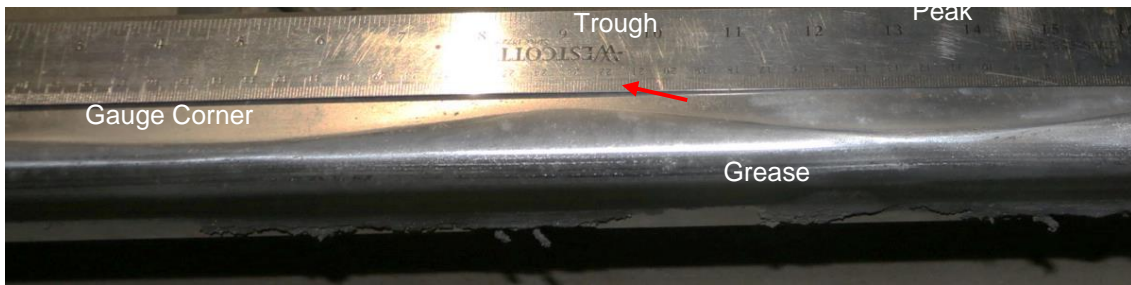
**Figure 3.10: Corrugation on High Rail of Curve 220 at 105+115**

Grease appears to be present on some curves, **Figure 3.10** and **Figure 3.13**, even though no track side lubricator is present, it is unclear if this is from the on board lubrication system or if it has been manually applied. Although the diagrams in the wheel flats report are not clear the locations with corrugation do not appear to be associated with low levels of adhesion<sup>4</sup>.

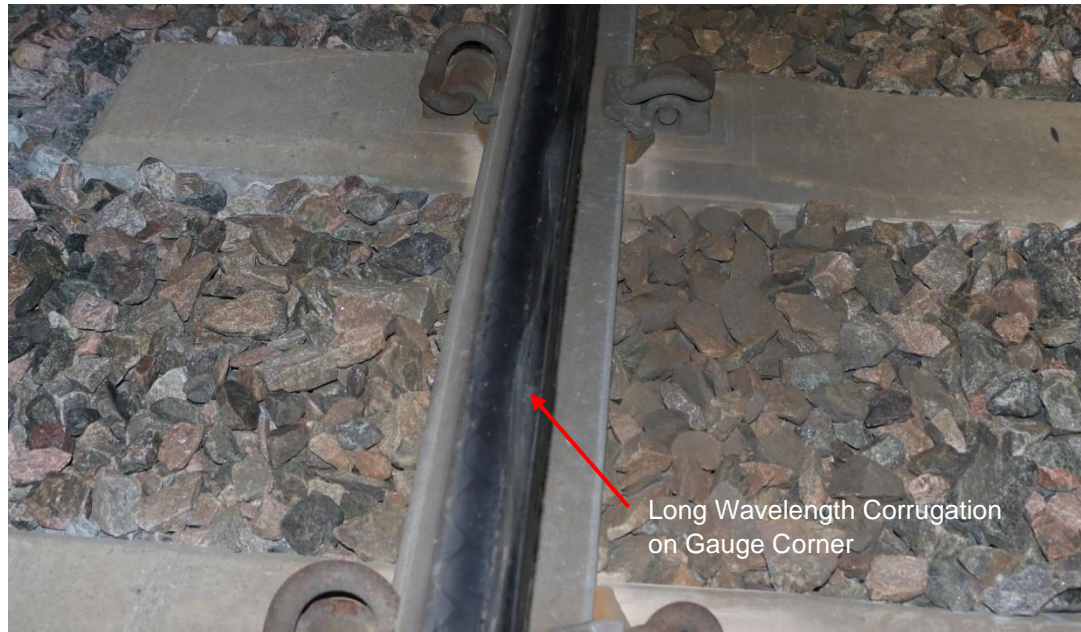
**Figure 3.12: Corrugation on High Rail of Curve 330 at 108+685**

The truck orientation through the curve results in a high angle of attack between the leading axle and the rail, resulting in high contact forces and hence, rail damage. The presence of two bands of corrugation with different wavelengths on E/B-330 and W/B-330 curves, **Figure 3.12**, provides further evidence for the difference in wheel/rail contact between axles on the same truck. With the gauge corner wear and corrugation likely to be produced by the leading axle and the corrugation on the crown of the rail by the trailing axle.

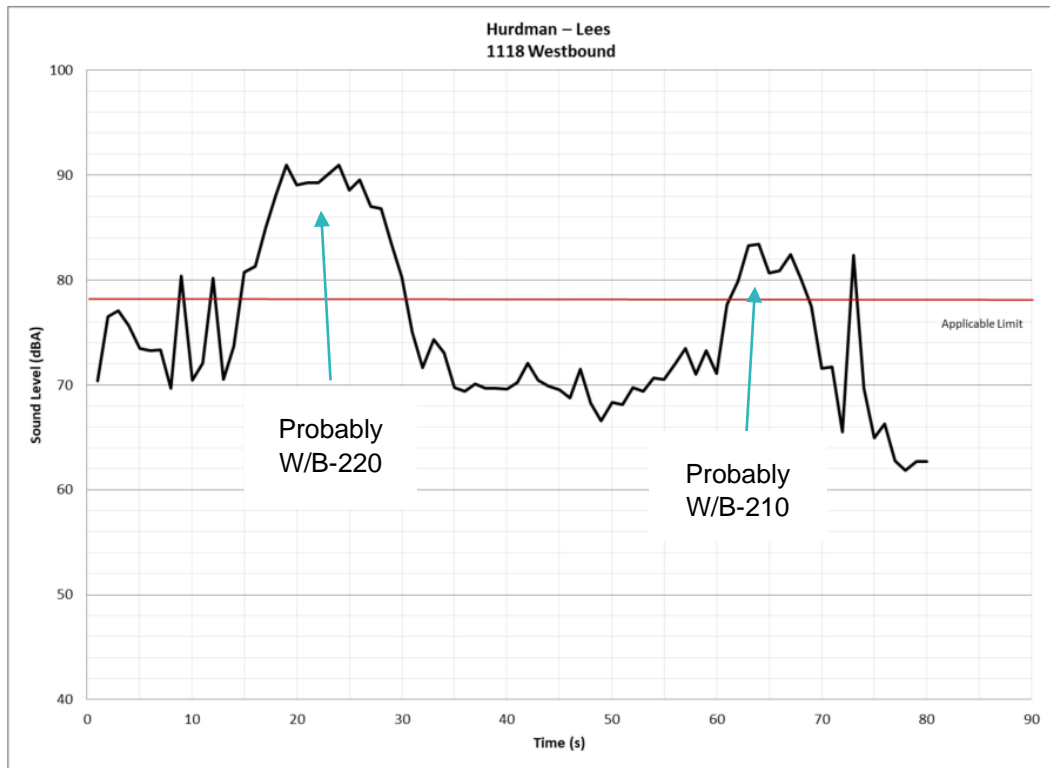
**Figure 3.16: Noise Measurement between Hurdman and Leeds for Westbound track**

The noise results are summarized as plots against the time between stations, an example is shown in **Figure 3.16**. As the results are measured against time without knowing the exact speed of the train during measurements it is not possible to determine the exact locations where the noise exceeds the maximum allowable values. Calculating from the average speed given in the report it is possible to determine that many of the noise and vibration peaks that exceed the limit are likely to be associated with the tight radius curves on the System where corrugation is present. The highest noise level measured is 91dB (exceeding the limit of 78dB) on the westbound track between Hurdman and Lees is likely to be associated with curve W/B-220. The locations with high noise levels also show high values of vibration.

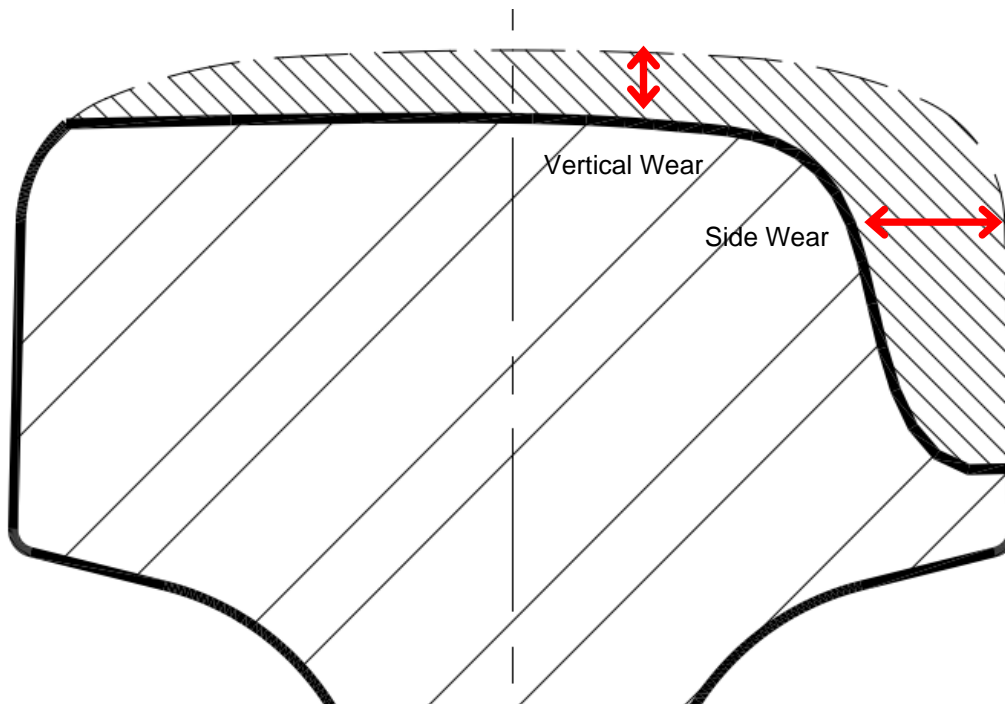
**Figure 3.19: Schematic of Rail Wear**

The PA sets wear limits of 5/8” (15.9mm) vertically and horizontally (side wear). (**Figure 3.19: Schematic of Rail Wear**) Project Co Trackwork Maintenance Manual (RES-22-0-0000-MAN-000) gives limits of 12mm vertical and 9mm for side wear which are much less than maximum recommended limits in the APTA standard.

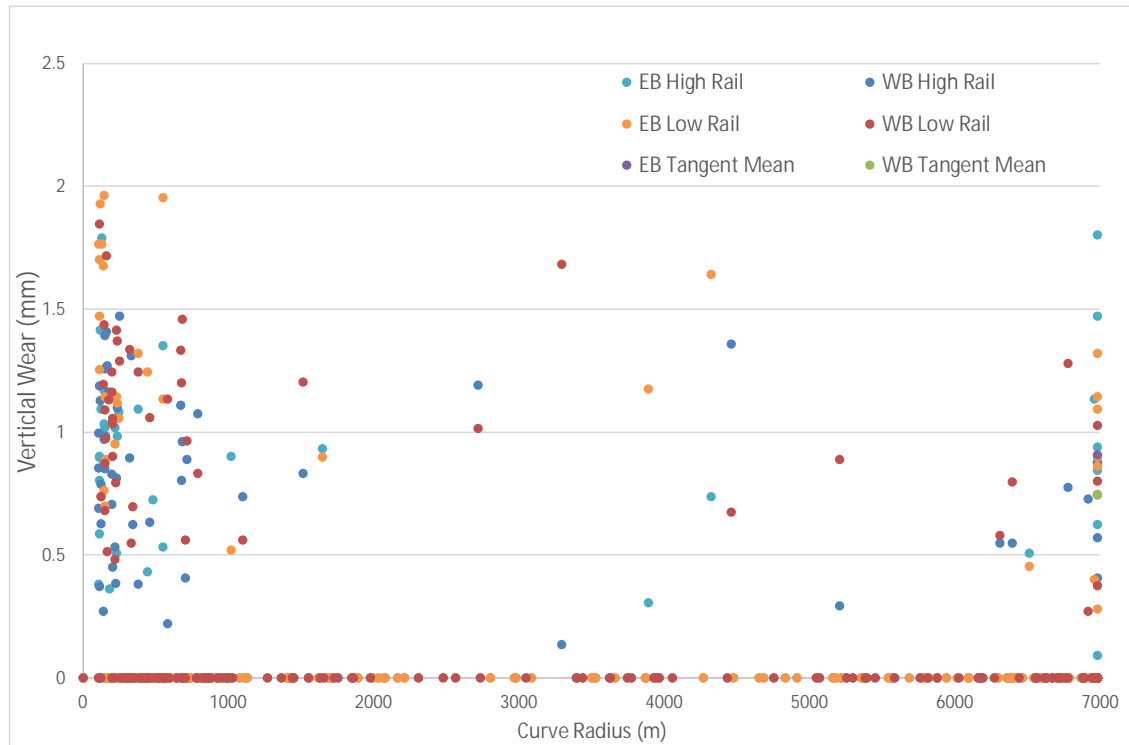
Due to this issue with the measurement manual filtering of accurate measurements have been made for the majority of curves and selected tangent sections, the results are plotted against curve radius in **Figure 3.23** Figure 3.23: RailPod Vertical Wear against Curve Radius for vertical wear, **Figure 3.24** and **Figure 3.25** for side wear. Tangent track is shown at 7000m.

The vertical wear of the rail shows wide variance between 0.5mm and 2mm with no obvious trend with curve radius. In contrast, side wear is greater on the tighter radius curves compared to shallow curves and tangent track. This is especially pronounced for the high rail where it is

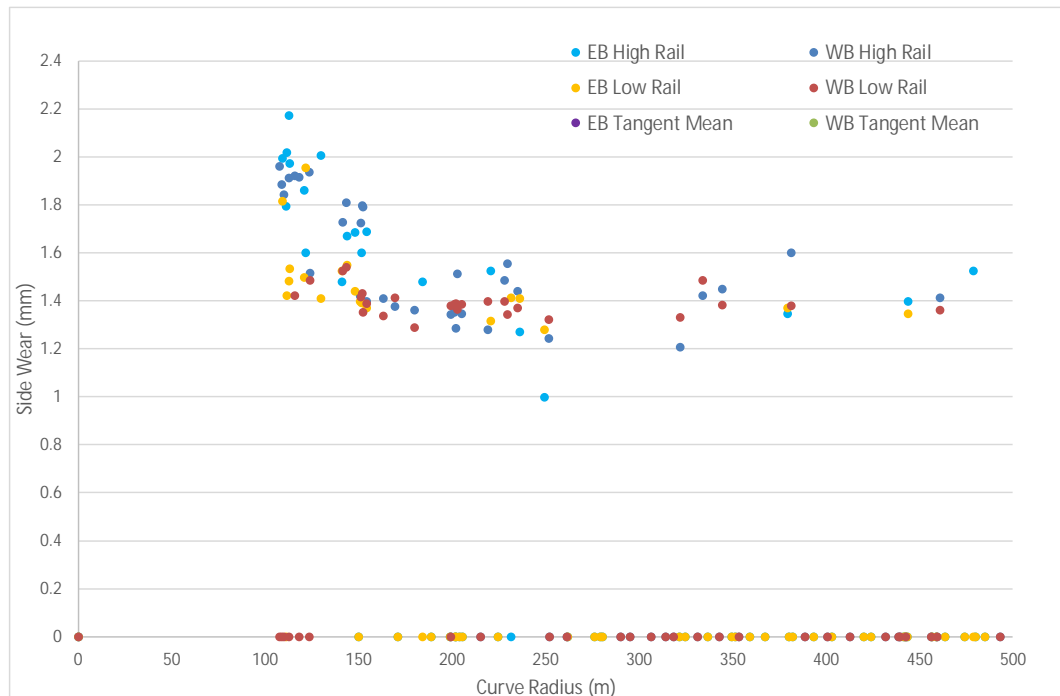
**Figure 3.25: RailPod Side Wear against Curve Radius Less than 500m**

around 0.5-0.7mm greater. Even on the low rail of the tightest curves there is a slight increase of 0.1-0.2mm, **Figure 3.25**. The reason that side wear on tangent track is not zero and the large spread in vertical wear is probably due to the manufacturing tolerance of the rail and measurement error.

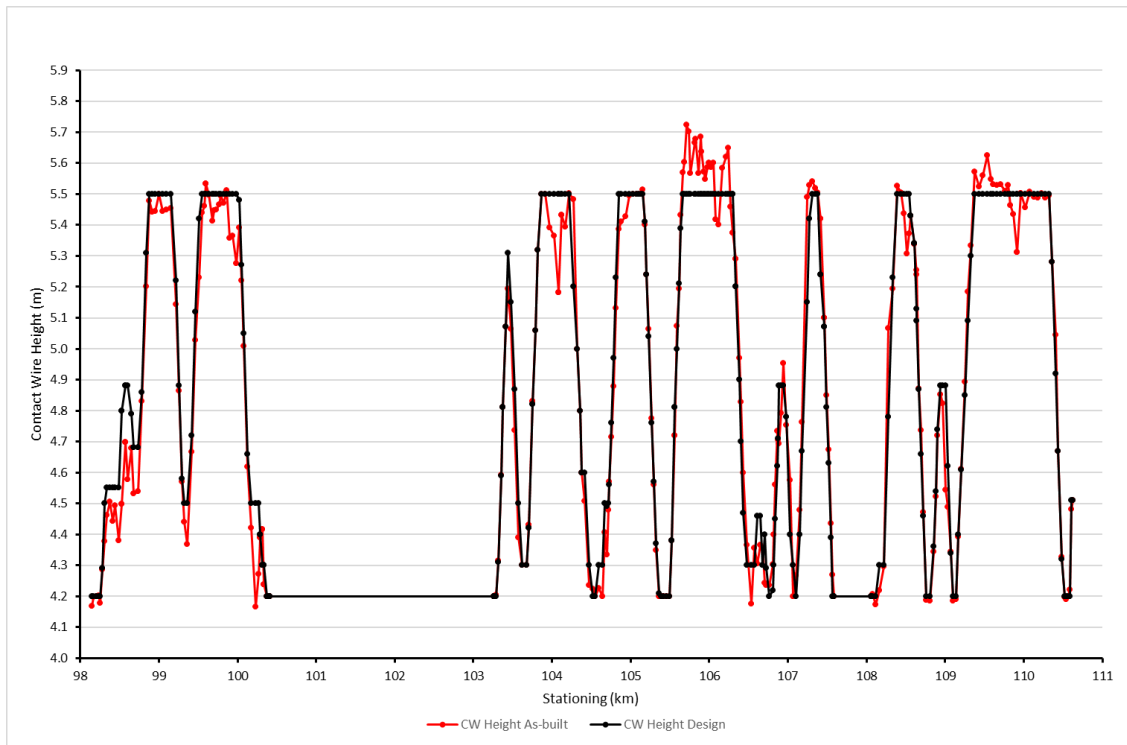
**Figure 3.27: As-built v Design Contact Wire Height – Eastbound Track**

Contact wire heights were reviewed in both the eastbound and westbound directions. **Figure 3.27** is provided to show graphically the eastbound contact wire heights (and is a reasonable proxy for the similar westbound representation). The as-built profiles (in red) are typical to those presented in the Alstom report.

It is noted that the contact wire heights may have been adjusted on site during construction due to other infrastructure as-built conditions, for instance at or near tunnel portals or overhead municipal bridges. Based on PA Schedule 15-2 Part 4 Article 8, there are a number of locations that do not meet the installation tolerance of -13 mm to + 25 mm, for open route sections. Note data for the tunnels sections was not available at the time of the analysis.

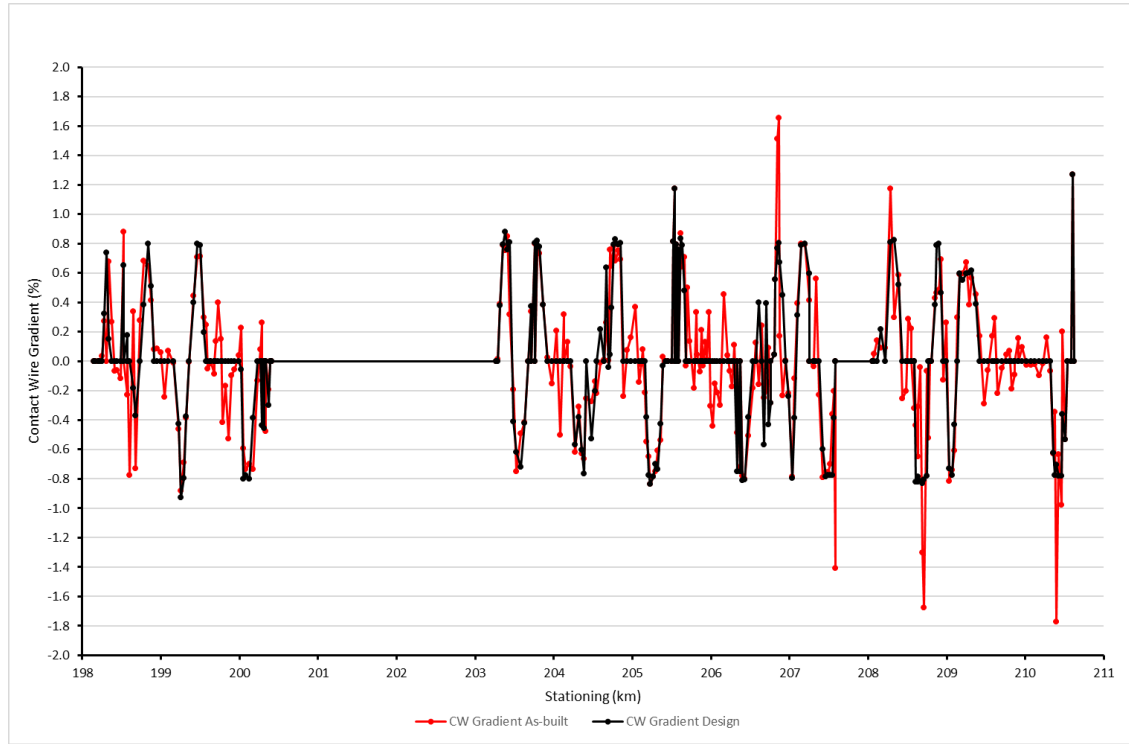
**Figure 3.28: As-built v Design Contact Wire Gradient - Westbound**

Contact wire gradients were also reviewed in both the eastbound and westbound directions. The contact wire gradient for the westbound track is shown graphically in **Figure 3.28**, and is a reasonable proxy for the findings for the eastbound track. The allowable design grading for both eastbound and westbound tracks (ref CAN/CSA C22.3 No. 8-M9, as per Table 4-8.5 in PA Schedule 15-2 Part 4 Article 8, Section 8.5 (c) (i)) is replicated in Table 3.2.

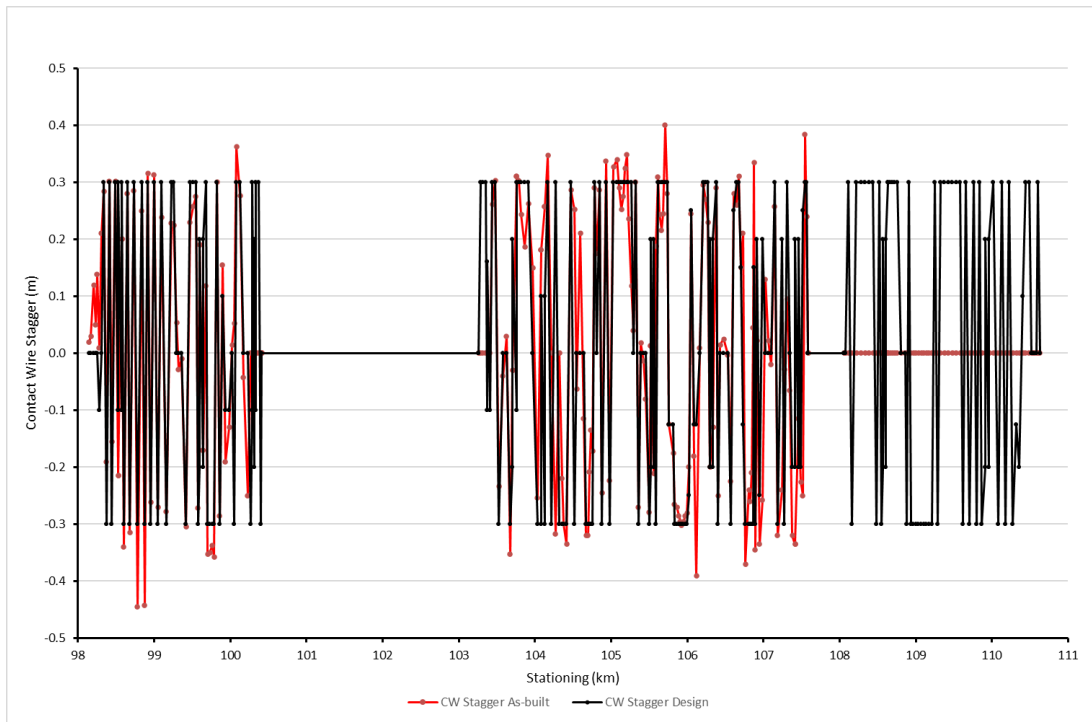
**Figure 3.29: As-Built v Design Contact Wire Stagger – Eastbound Track**

Based on the maximum allowable design gradient for the main line of 0.8%, it can be seen in **Figure 3.29** and **Figure 3.30** that there are areas where the design and as-built contact wire grading does not meet the requirements of the Project Agreement Schedule 15-2 Part 4, Article 8. The implications of excessive grading can be either a reduction or increase in the contact force on the pantograph, which can lead to:

The as-built contact wire stagger for both the eastbound and westbound tracks were compared with the design and are shown graphically in **Figure 3.29** and **Figure 3.30**.

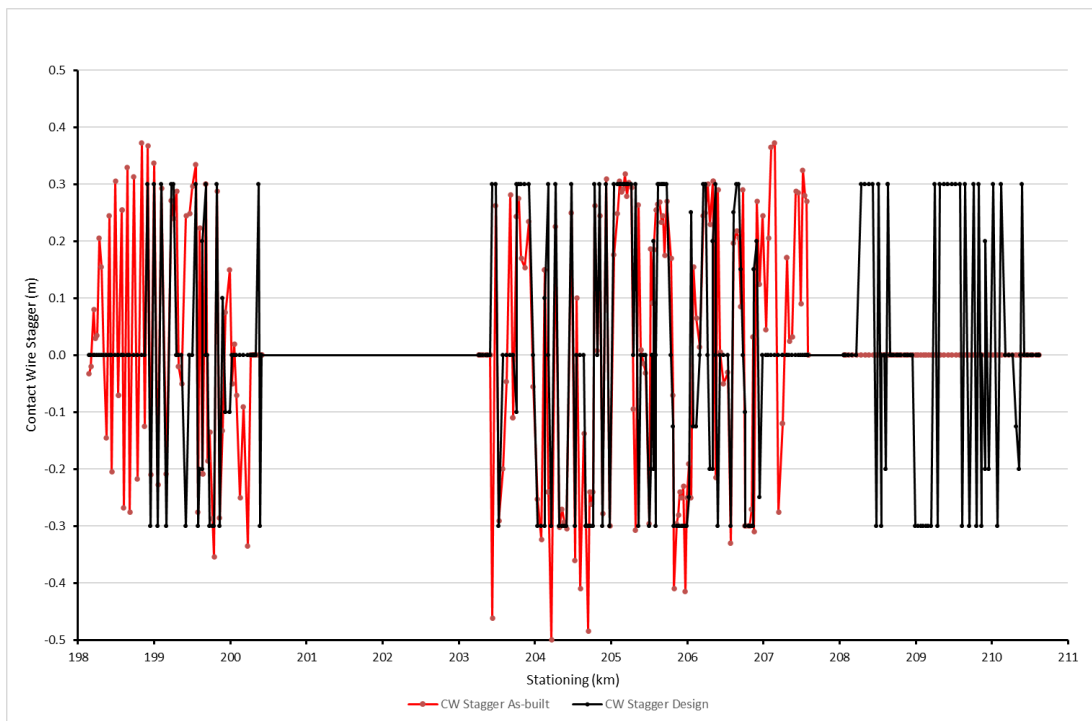
**Figure 3.30: As-built v Design Contact Wire Stagger – Westbound Track**

Based on PA Schedule 15-2 Part 4 Article 8, there are a number of locations that do not meet the installation tolerance of -25 mm to + 25 mm. This has resulted in the staggers being either smaller or greater than the design and could affect the contact wire/pantograph interface. Note the as-built and design values for the tunnel sections were not available at the time of the analysis and has not subsequently been provided.

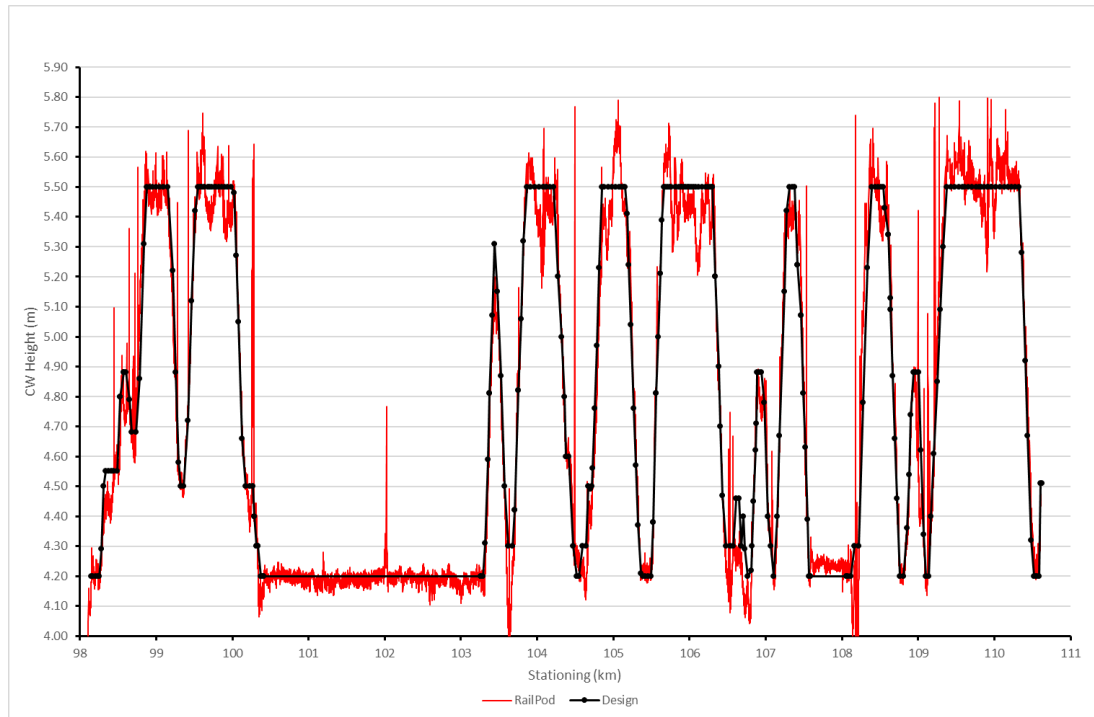
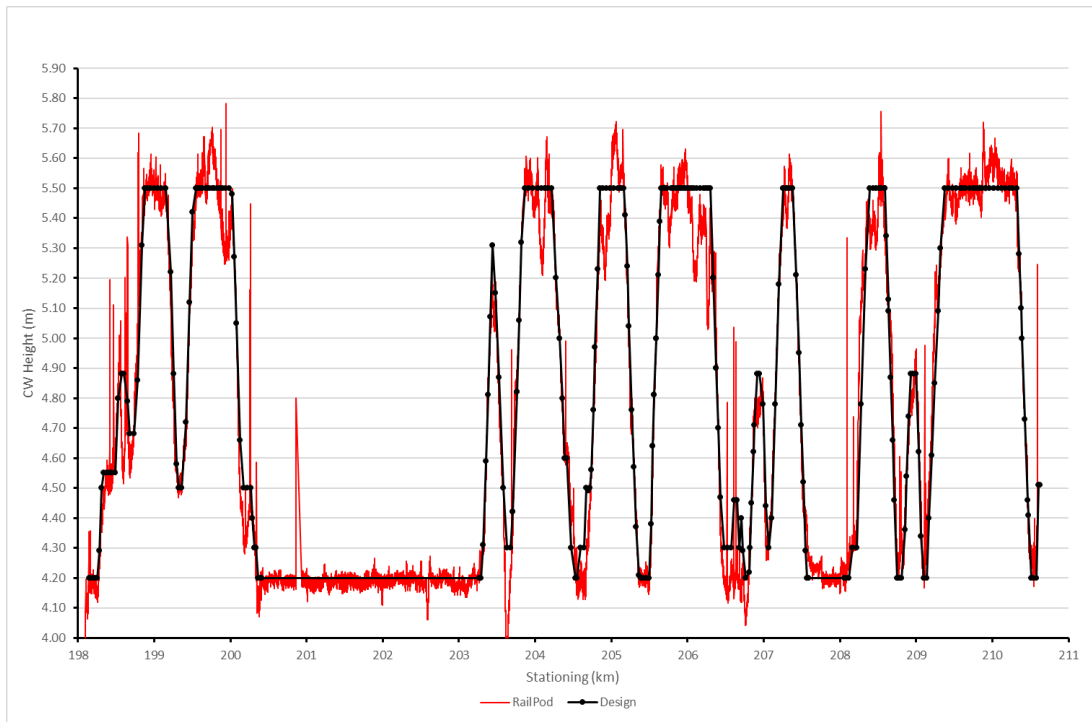
A comparison of the RailPod contact wire height data, measured in September 2020 and part in February 2021, for both the eastbound and westbound tracks, was compared to the Project Co design, similar to that in section 3.2.1.5 and are shown in **Figure 3.31** and **Figure 3.32**. Note that some spikes occur as shown within the RailPod data due to gaps in the OCS or potentially due excessive movement of the measuring machine and can be disregarded.

Based on the new as-built data, after the modifications had been carried out, and the RailPod survey, it is evident that the overall OCS has been improved and that, at these locations, the contact wire heights and grading are more in line with the design. However, there are still a number of locations that do not meet the grading or tolerance requirements, as specified in PA Schedule 15-2 Part 4, Article 8. And so, while the risks listed above may have been reduced, it is not possible to say that they have been brought into alignment with PA requirements.

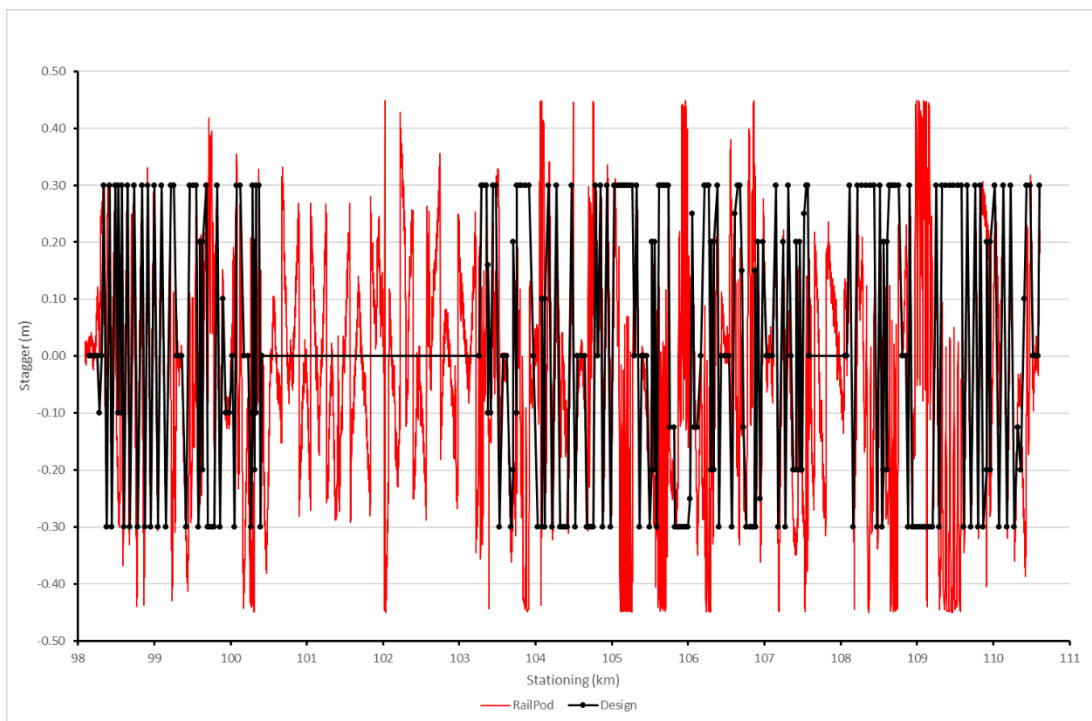
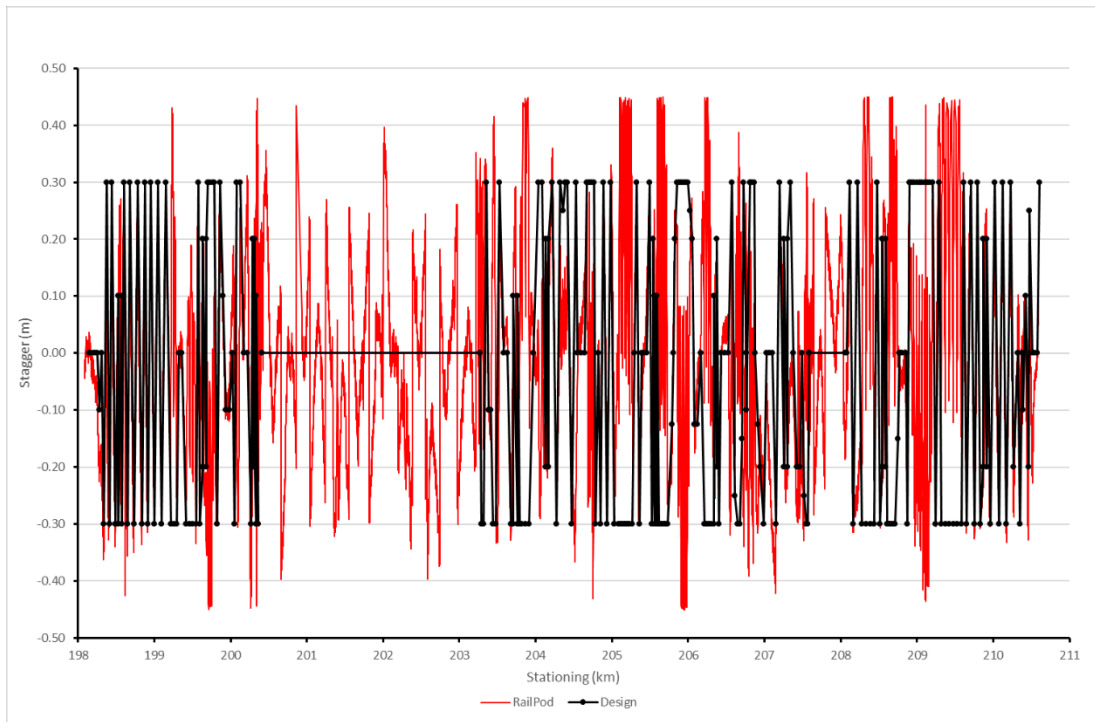
A similar exercise was carried out using the RailPod data for the stagger of the contact wire and is shown graphically in **Figure 3.33** and **Figure 3.34**.

It can be seen on the basis of the charts provided that there is an overall improvement of the OCS, but again, there are still a number of locations that do not meet the requirements of PA Schedule 15-2 Part 4, Article 8.

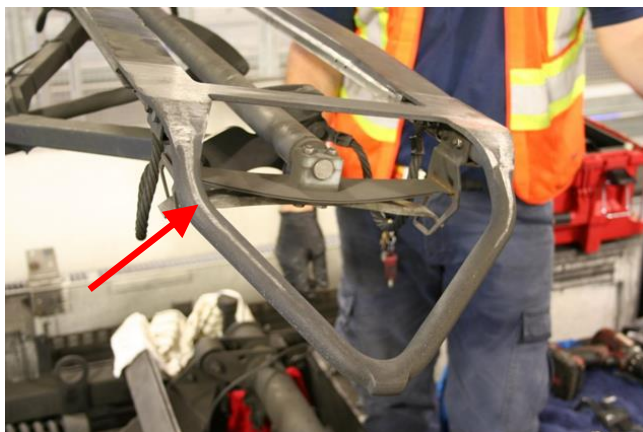
**Figure 3.35: Wear on Pantograph Horn**

Observations have shown that the pantograph horn is hitting the contact wire at crossovers and turnouts, causing undue wear **Figure 3.35**.

In addition, there is a risk, with extreme temperature ranges experienced in Ottawa and the potential of additional ice loading, that the pantograph could hook-over the crossover contact wire and cause major damage to the OCS and pantograph including:

- Broken/bent cantilevers
- Contact and messenger wire ripped down and or broken
- Damaged or broken dropper and jumper wires
- Broken/deformed pantograph head and arm assemblies

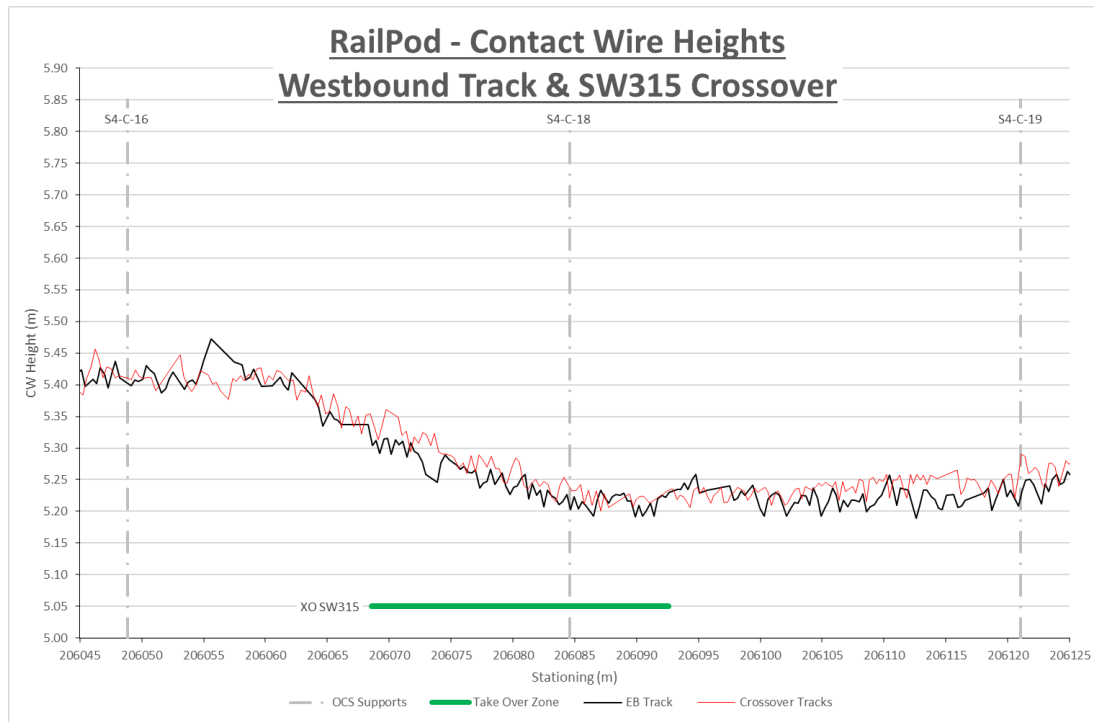
**Figure 3.37: RailPod Data Analysis of SW315 Crossover Wire Heights**

Similarly where the take-over is satisfactory, SW315 crossover on the westbound track, as observed in the video, reference Gx060037-6 at 52 seconds in, and the RailPod data as shown in **Figure 3.37**.

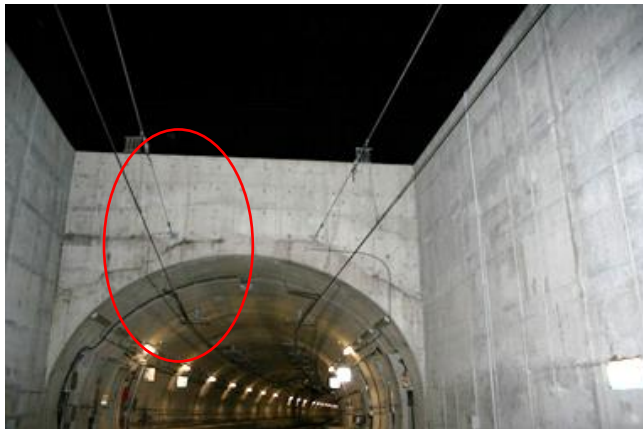
**Figure 3.38: Messenger Wire to OCR Jumper Wire**

The continuity of the messenger wire and contact wire are critical to supply the required current to the light rail vehicles without overloading any one individual wire **Figure 3.38**. To reduce the likelihood of a failure, the existing installation should be checked as soon as reasonably practical, and additional jumpers installed as necessary.

In accordance with Good Industry Practice for design and construction, Mott MacDonald recommended that messenger wires be bonded to the aluminium OCR at all OCS to OCR transitions, at both downtown tunnel portals and on both side of St-Laurent station over both tracks. The bonds installed should provide, as a minimum, equal ampacity to the messenger wire, reference Calgary LRT, Conductor Rail Installation Design Manual.

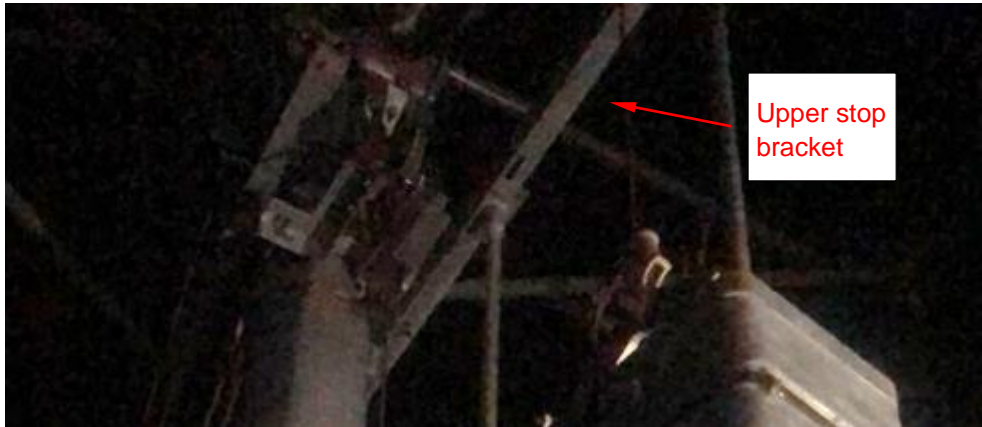
**Figure 3.42: Upper Stop Support Bracket**

- The low and high stop support brackets, as seen in **Figure 3.42**, the low stop support angle is installed in a different orientation and the high stop support bracket angle appears to be a different size.
- The guide tube to support angle fixing clamps, as can be seen in **Figure 3.42** and **Figure 3.43**, are external type which is different to internal ones as shown on the design drawing.
- The yoke plate assembly and balance weight hangers.

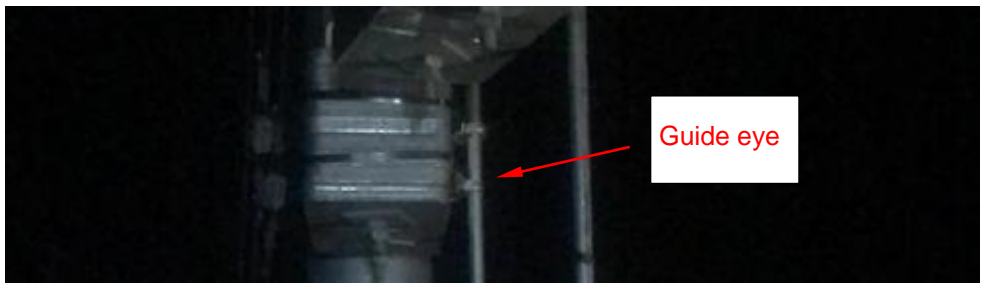
**Figure 3.44: Balance Weight Guide Eyes**

No details are shown on the design drawing, MVA-54-0-S017-DRS-5119\_0.1, of the balance weight guide eyes, with two being installed on each weigh stack as shown in **Figure 3.44**.

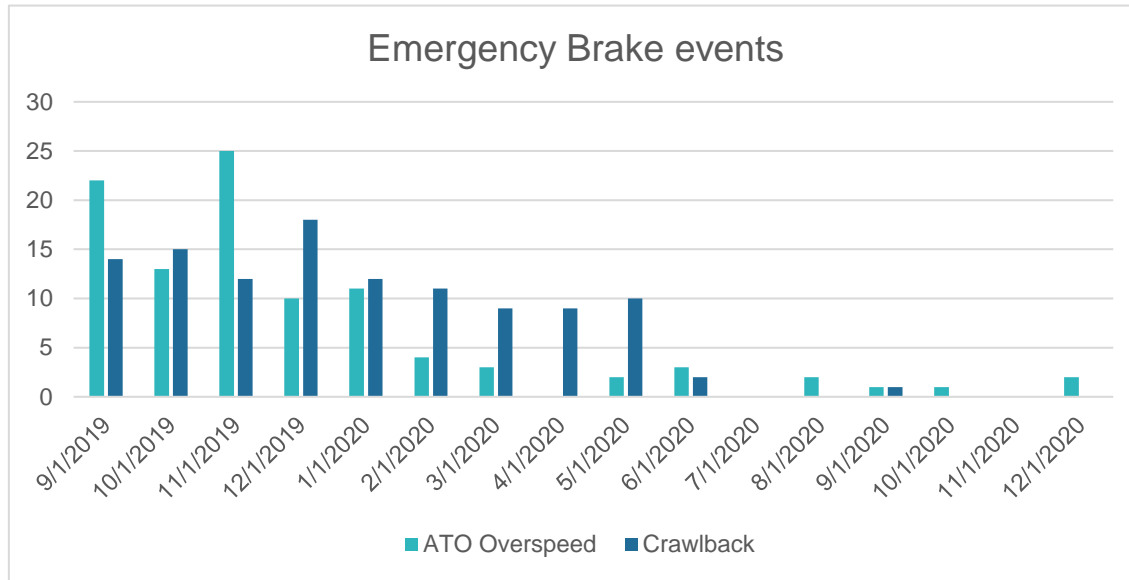
**Figure 3.45: Overview of Emergency Brake Events (Overspeed in ATO and Crawlback) Per Month**

As visible in **Figure 3.45**, from June 2020 onwards, the number of EB due to unauthorized crawlback events has decreased significantly which could be following the upgrade of the Thales CBTC software.

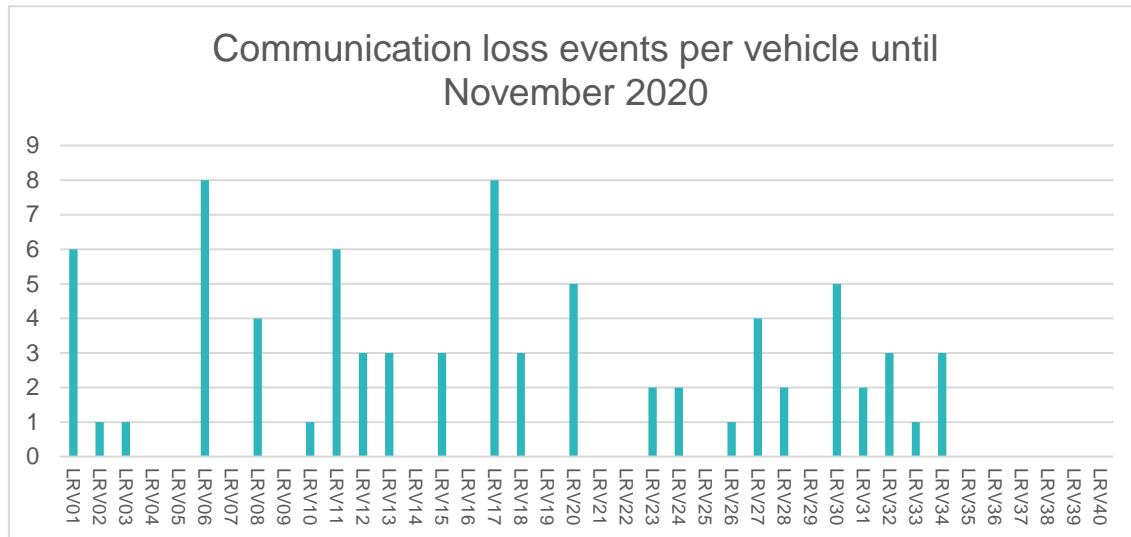
**Figure 3.46: Communication Loss Events Per Vehicle. When Operated in Couple, an Event is Allocated to Both Vehicles**

The issue of communication losses has been analysed in the incident logs. **Figure 3.46** shows the number of times each vehicle was involved in a communication loss event. When operated in coupled mode, an event is allocated to both vehicles. It is visible that LRV06 and LRV17 have experienced most events, followed by LRV01 and LRV11. In 15 of the 39 events (38%), either LRV06 or LRV17 was involved. The figures are not adjusted for distance driven.

The analysis reveals that some vehicles experience a larger number of communication events than others, which indicates that this could be due to isolated vehicle issues. Additional technical and reliability analysis of vehicles experiencing an increased number of communication issues could indicate the actual cause of the issues.

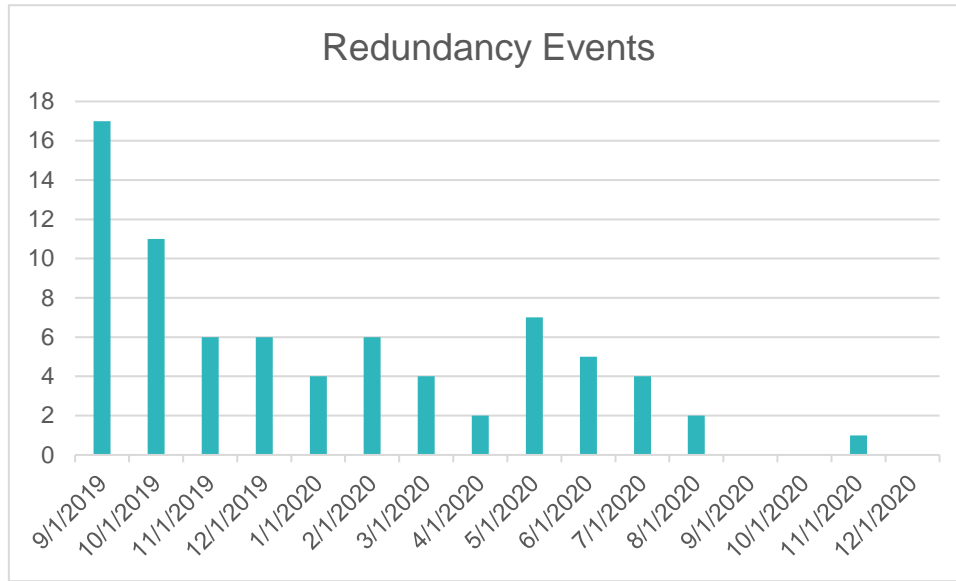
**Figure 3.47: Redundancy Events (ZC, LSRS, CSRS or ATS Operating on Backup System)**

**Figure 3.47** shows that system events related to redundancy were most frequent during the first months of operation. From November 2019 through July 2020, the events occurred at a rather stable level. It is normal that switchovers occur occasionally, with the redundant architecture preventing impact to operations. As such, the early problems with redundancy events are

considered to be start-up problems of the CBTC system and current occurrence rates are considered normal.

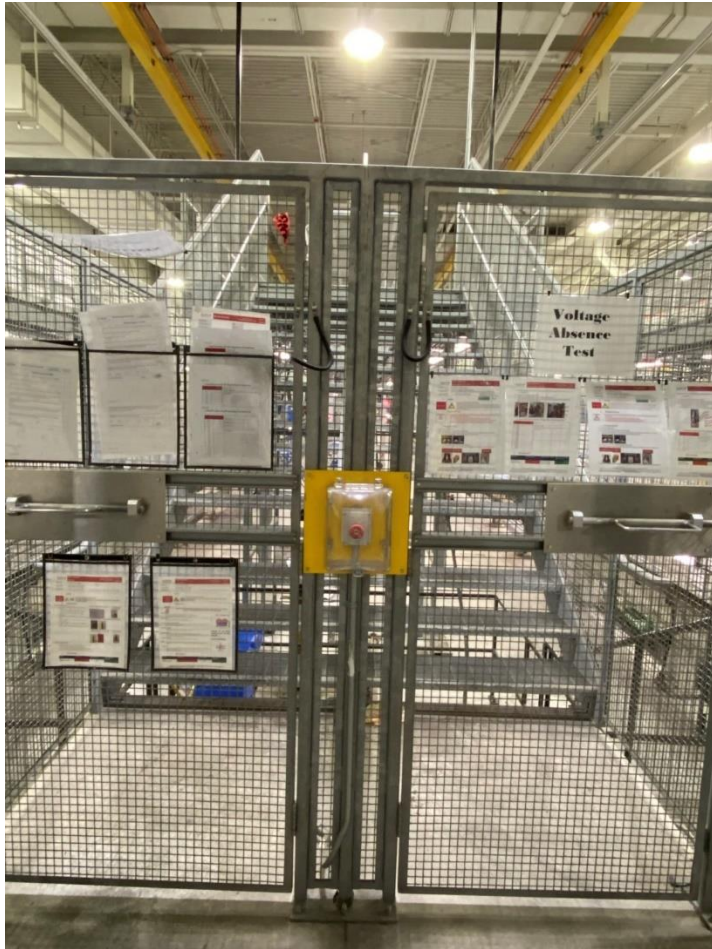
**Figure 4.3: Restricted Access to Mezzanine Area of LMB 1 and 2**

Both LMBs have OCS, access to the mezzanine is restricted to authorized personnel only (**Figure 4.3**).

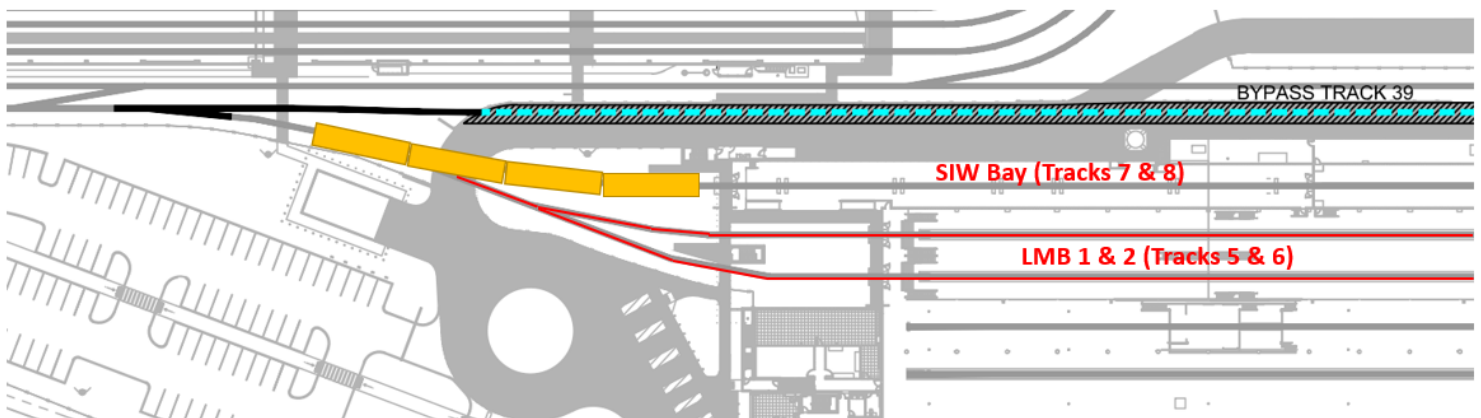
**Figure 4.4: MSF1 Access Issue to LMBs 1 and 2 When a Vehicle is Outside the SIW Bay**

LMBs 1 and 2 currently present two access issues. Access from the east side of the shop can be restricted by vehicles waiting outside the SIW Bays located on tracks 7 and 8 (**Figure 4.4**).
