# **Ottawa LRT Independent Review Report**

April, 2022  
Confidential

# Ottawa LRT Independent Review Report

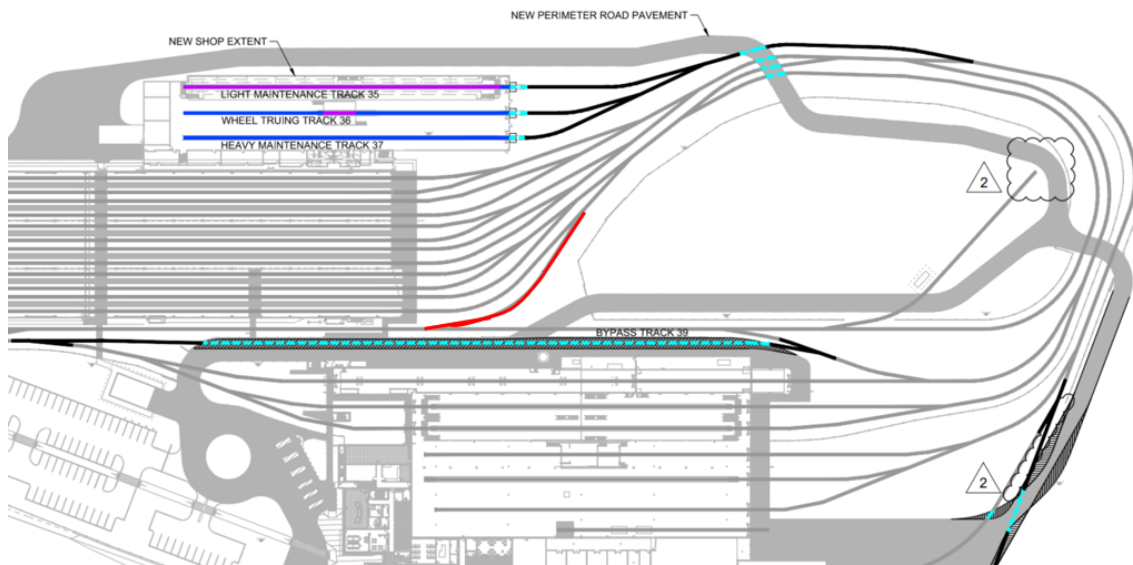
**Figure 4.8: Other Potential Vehicle Launch Tracks**

Other tracks could be used for launching vehicles for revenue service including bypass track 39 and track 22 (**Figure 4.8**). The Mott MacDonald team was informed that bypass track 39 is not used and has not been commissioned as it is part of the project's Stage 2. This constraint adds further to the limited operational efficiency and flexibility of the MSF track layout.

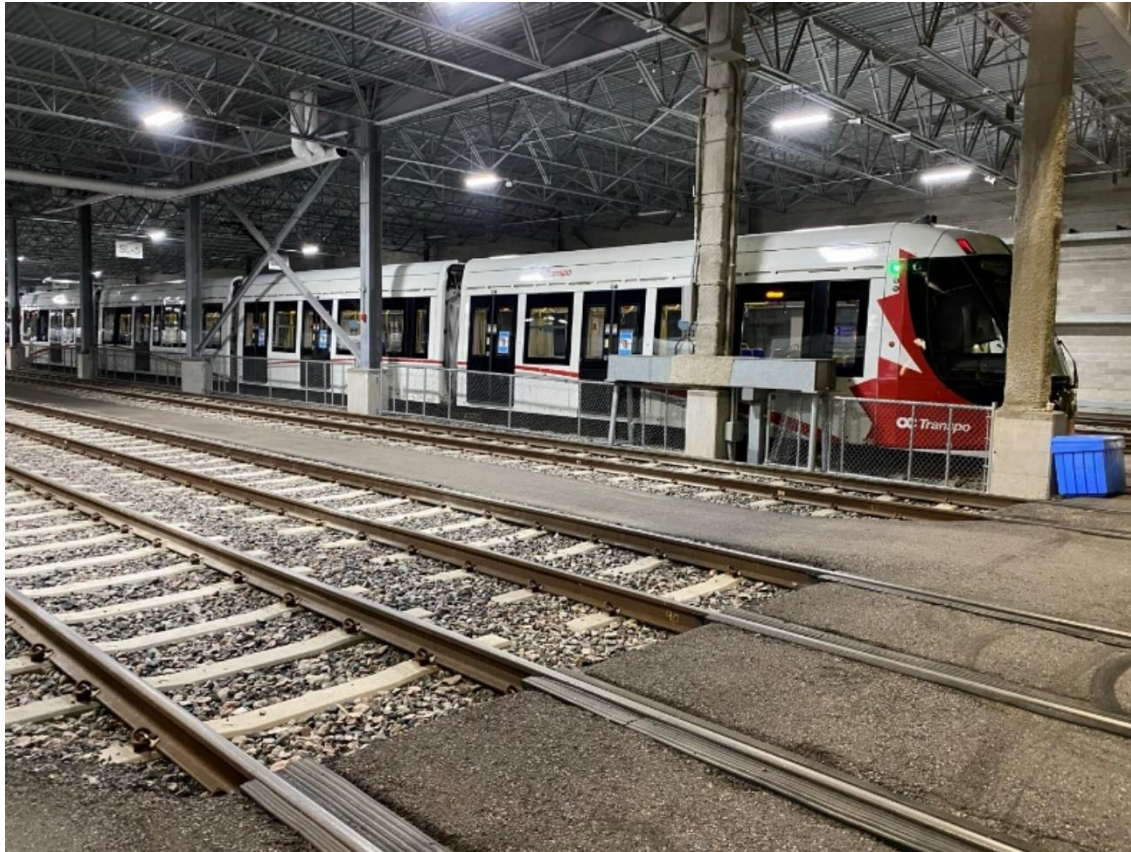
The design of the storage shed also presents challenges to perform preventative maintenance on the vehicle, most specifically daily inspections, and pre-departure inspections. Chain link fencing divides the storage shed at the centre of the building, which does not allow a reasonable working space to open the side skirts on one side of the vehicle. Due to the proximity of the dividing fences, the entirety of the daily inspection cannot be completed in the storage shed if the vehicle is parked on the centre 2 roads (**Figure 4.9** and **Figure 4.10**). In this situation, access to the vehicle exterior is limited to one side of each vehicle and is gained via paved walkways which creates not only a potential risk for the operator accessing the vehicle due to limited clearances but also a risk of the inspection missing a defect or potential safety check.

**Figure 4.9: Dividing Fence at Storage Shed and Limited Staff Access Between Tracks with No Walkway**

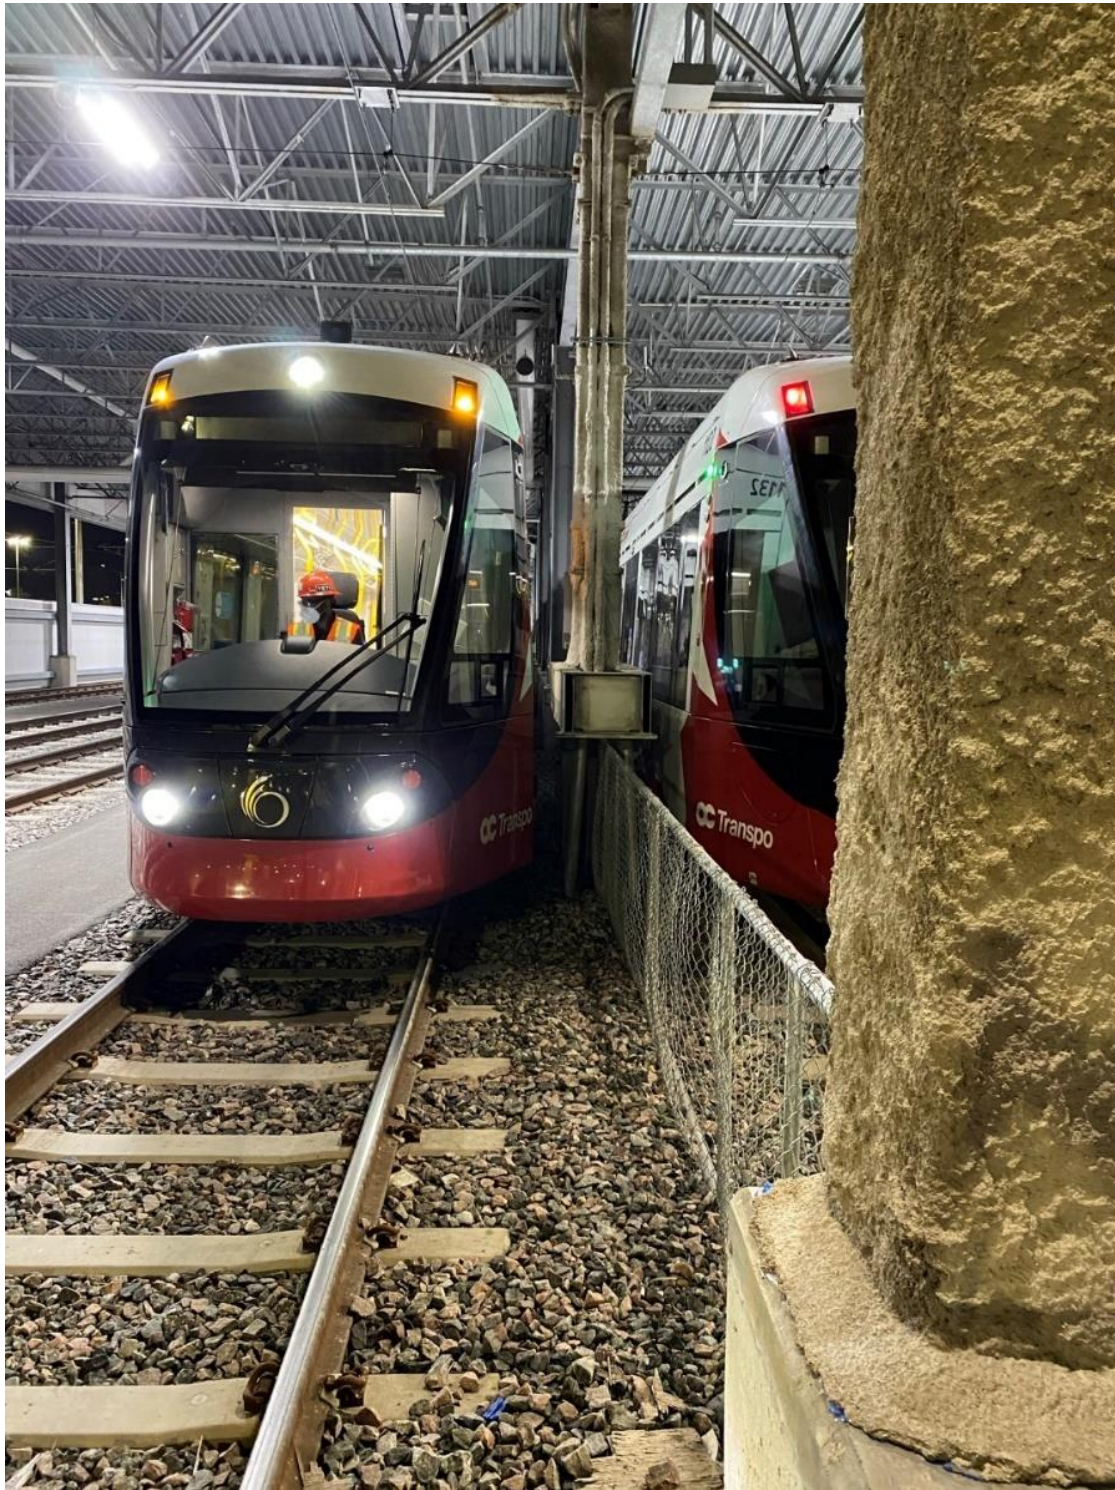
**Figure 4.10: Dividing Fence at Storage Shed with No Staff Access or Safety Clearance**

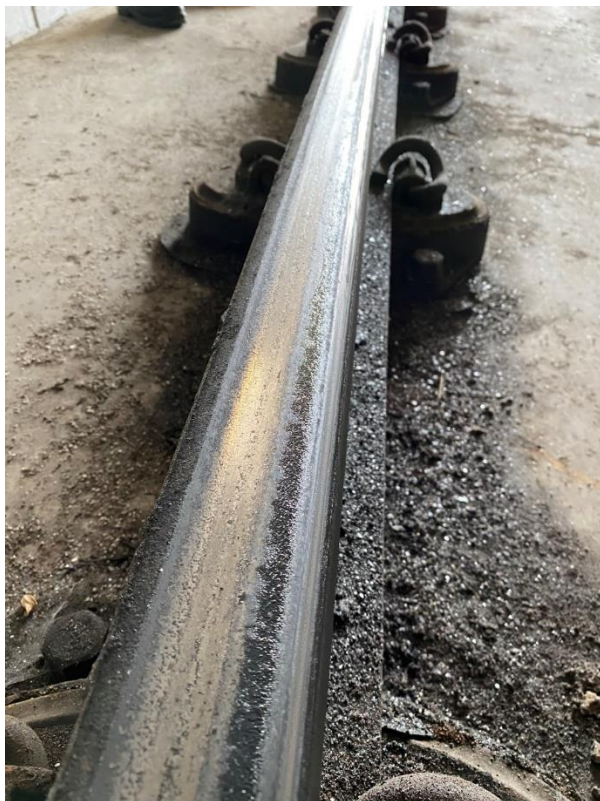
**Figure 4.18: Grease on Top of Rail at East Connector**

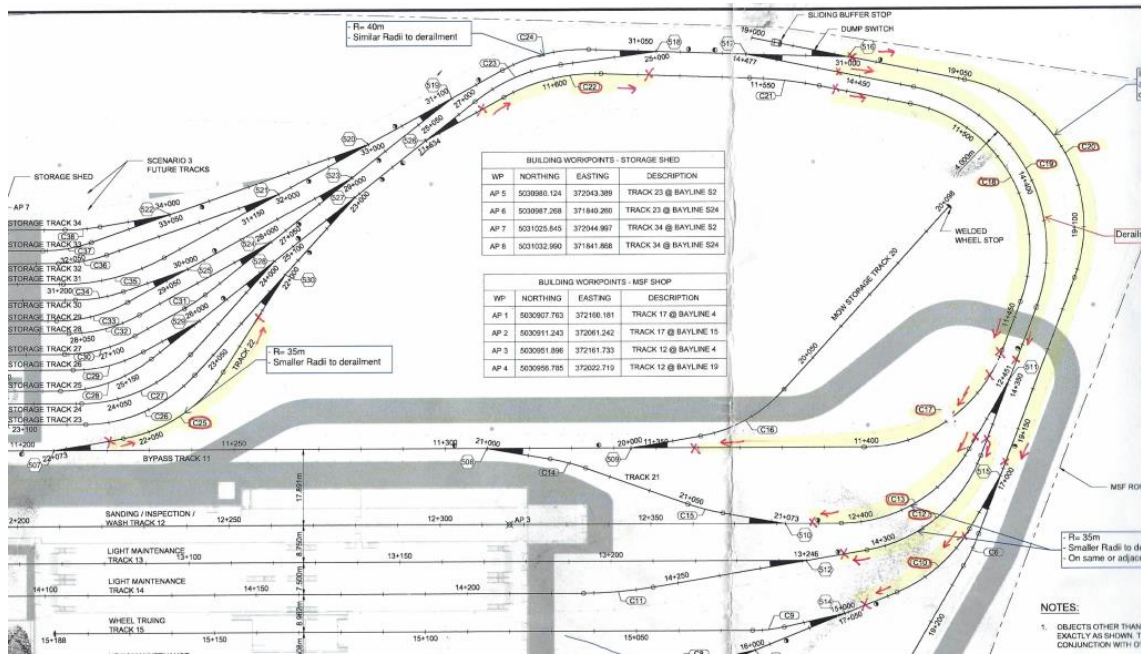
**Figure 4.20: Sample Track Measurements**

**Figure 4.20** shown below indicates the sections of track where the gauge has been measured, using a “Geismar model RTG-2” rolling track gauge. Measurements have been recorded manually in +/- 16th fractions from the standard gauge of 1435mm, e.g., a recorded +1/16 equals to approx. 1437mm. The main purpose of the gauge measurements was to determine whether there is a general trend toward tight gauge through the curves (below 1435mm) or gauge widening.

Throughout several curves, kinks in the rail at weld locations have been observed. At some of those locations the gauge is as tight as 1430mm or as wide as 1443mm.

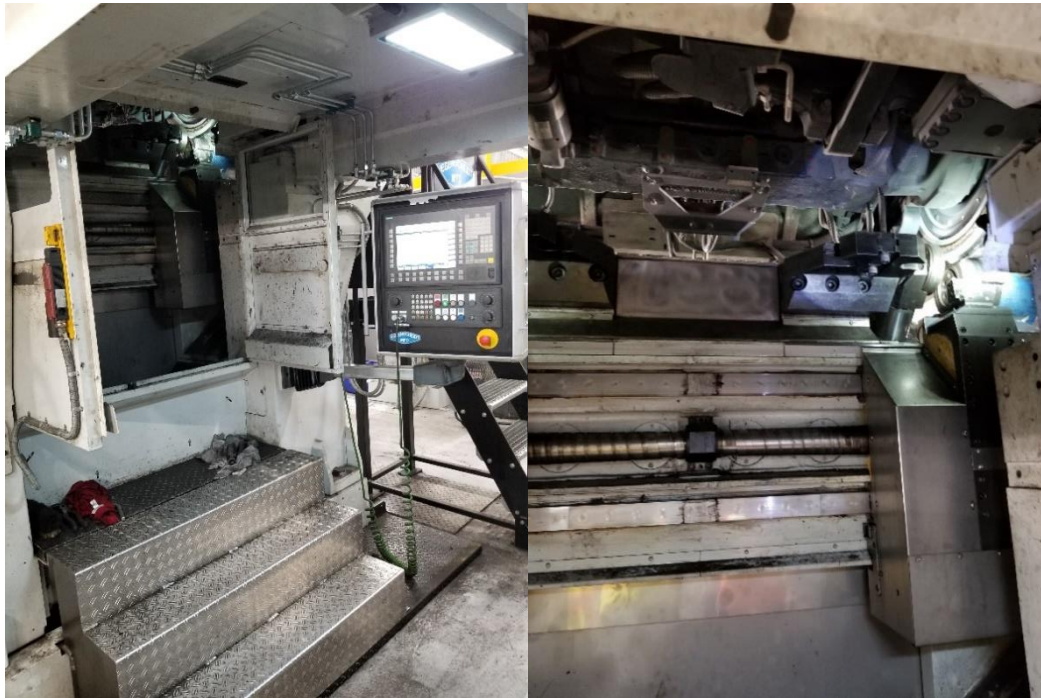
**Figure 4.26: Hegenscheidt U2000-150D Underfloor Wheel Lathe**

The wheel lathe (**Figure 4.26**) used is a Hegenscheidt U2000-150D Underfloor Wheel Lathe supplied by the NSH USA Corporation ([Hegenscheidt U2000-150 Underfloor Wheel Lathe | NSH USA Corporation \(nsh-usa.com\)](http://Hegenscheidt U2000-150 Underfloor Wheel Lathe | NSH USA Corporation (nsh-usa.com))). This machine is capable of tandem machining of two wheel sets simultaneously but was at the time only using one machine head and therefore one wheel set at a time was being machined which is not an efficient method of operation. The machine is also a CNC lathe with automatic positioning, machining and measuring processes available to the operators. Unfortunately, not all of the automatic functions of the machine were being used with the machining process being manually set up and controlled by a member of the team. The automatic measuring of the wheel set was used both before and after the wheel set was machined.

It is considered unusual to have a large number of the maintenance team trained and using the wheel lathe in an MSF. Most facilities have a small, dedicated number (depending on the demand for the work) of their technicians trained and able to operate the wheel lathe as this creates higher levels of skill in the lathe operator as their experience with the machine grows. Having a dedicated team of technicians that operate the wheel lathe provides for high levels of skill within this group as they have a higher frequency of interaction with the machine and its controls, workings and results.

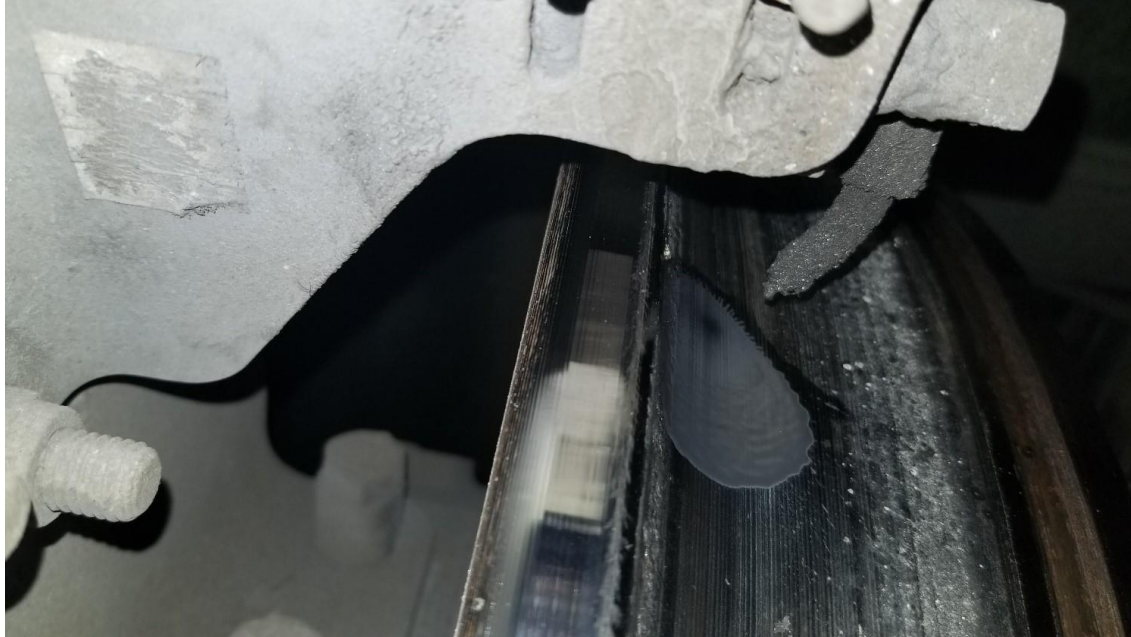
**Figure 4.27: Wheel Flange Lubrication Location**

the gap (page 7 of 17, item h.) between the spray nozzle and the outer diameter of the wheel, however this procedure fails to identify the location of the spray nozzle. The procedure refers to the location of the systems mounting block and its distance from the wheel not the spray nozzle. As shown in the image below (**Figure 4.27**), the alignment and volume of oil delivered by this system can easily apply an amount of oil that leads to the wheel tread having oil in an undesirable area leading to wheel slide situations arising.

It is recommended that Alstom review the procedure and the maintenance instructions related to the setting of the flange lubrication equipment following wheel truing and wheel replacement in order to ensure the alignment is related to the relevant wheel diameter and flange position. This may also require a formal re-training of staff to ensure they are aware of the process necessary to ensure the alignment is correct and made aware of the implications of incorrectly setting the flange lubricator spray nozzles.

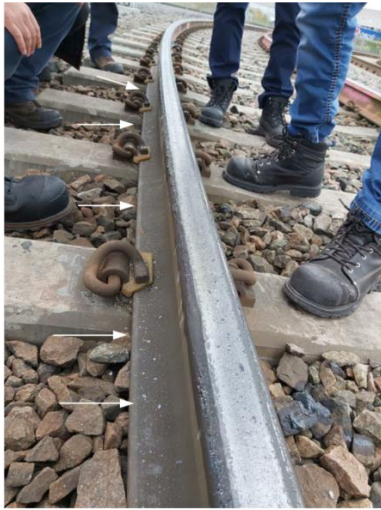
**Figure 5.1: Metal Shavings Along Rail Curve 19**

The incident was reported and investigated in Alstom's Incident Report TN-018 Version A (dated 10-11-2020). In this report (page 8 of 25), Alstom have presented an image (**Figure 5.1**) showing evidence of excessive rail gauge face wear from contact with the wheel flange.

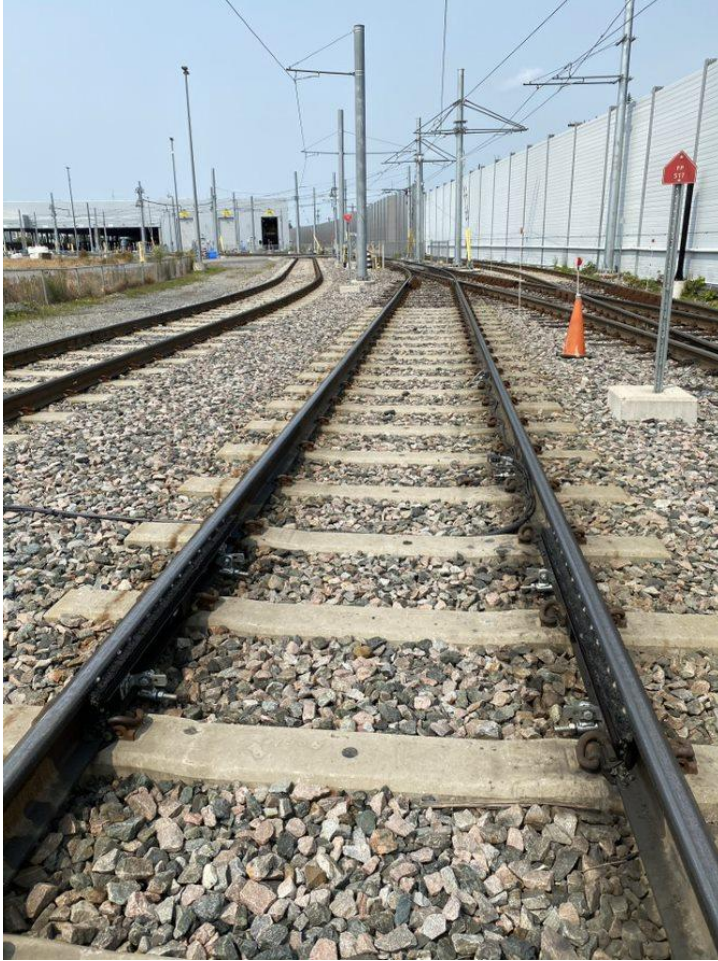
**Figure 5.5: Wheel Flange Lubricator**

Another item viewed during this site visit and as a result of the derailment on curve 19 on track 14 is the installation of a track-mounted wheel flange lubricator (**Figure 5.5**). This device supplies a lubricant at both rails on curve 19 on track 14. The lubricator applies the oil/grease to the wheel flange as the train passes over the device in either direction. This device does not meter the amount of lubricate applied to the wheel flange as it is a coating bath that the wheel flange will pass through. The track-mounted devices are fed from a reservoir and pumping device installed close by the location. However, the level of oil/grease being picked up by the wheel flanges while passing over the lubricator equipment is being applied in excessive amounts which leads to the lubricant being spread onto the rail crown surface from the passage of the wheels leading to potential wheel/rail adhesion issues (e.g., wheel spin/slide).

This wheel flange lubricator should be assisting in the ability of the wheelsets to pass through the curve with less likelihood of the wheel flange climbing the rail and causing a derailment, however, the evidence of the metal shavings on the rail near to the curve suggest that the wheel flange is still in heavy contact with the rail at this location.

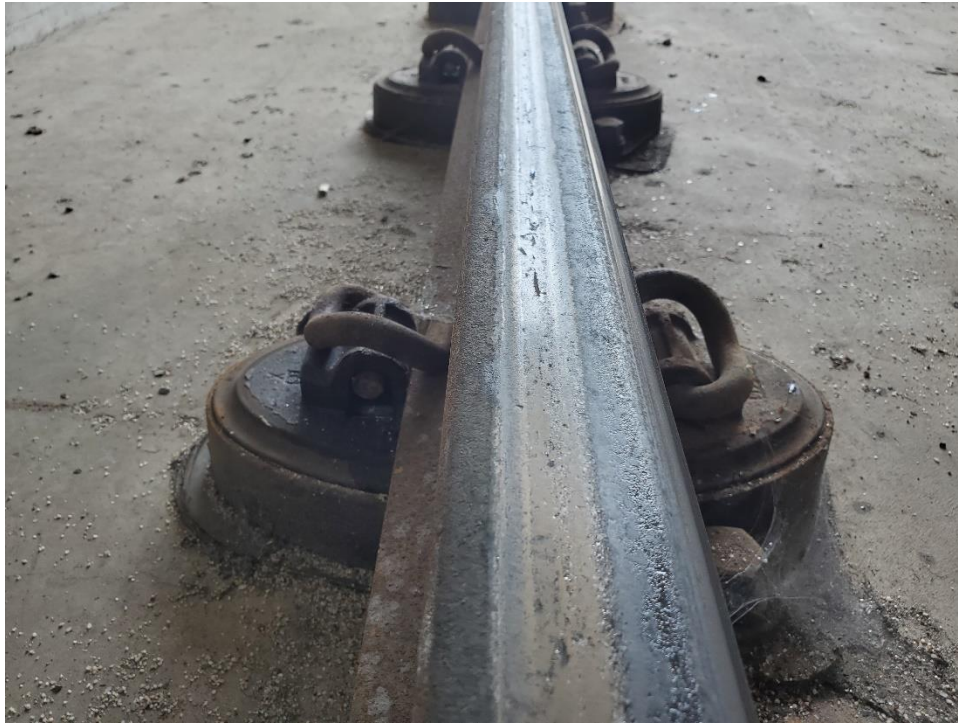
**Figure 5.7: Grease on Rail Crown at Manual Grease Application Location**

Inspection of the rail found grease on both the gauge face and crown. It is clear that grease is being applied to the gauge face. There is significantly more grease on the rail crown in the area where grease is applied manually, than on the rail through the rest of the connector tunnel. The sand on the rail foot and tunnel floor in this area is also contaminated with grease.

The presence of grease on the rail crown either from manual application to the rail or from the vehicle bourn flange lube applicators will have a significant impact on the tractive effort of the vehicle in both acceleration and braking.

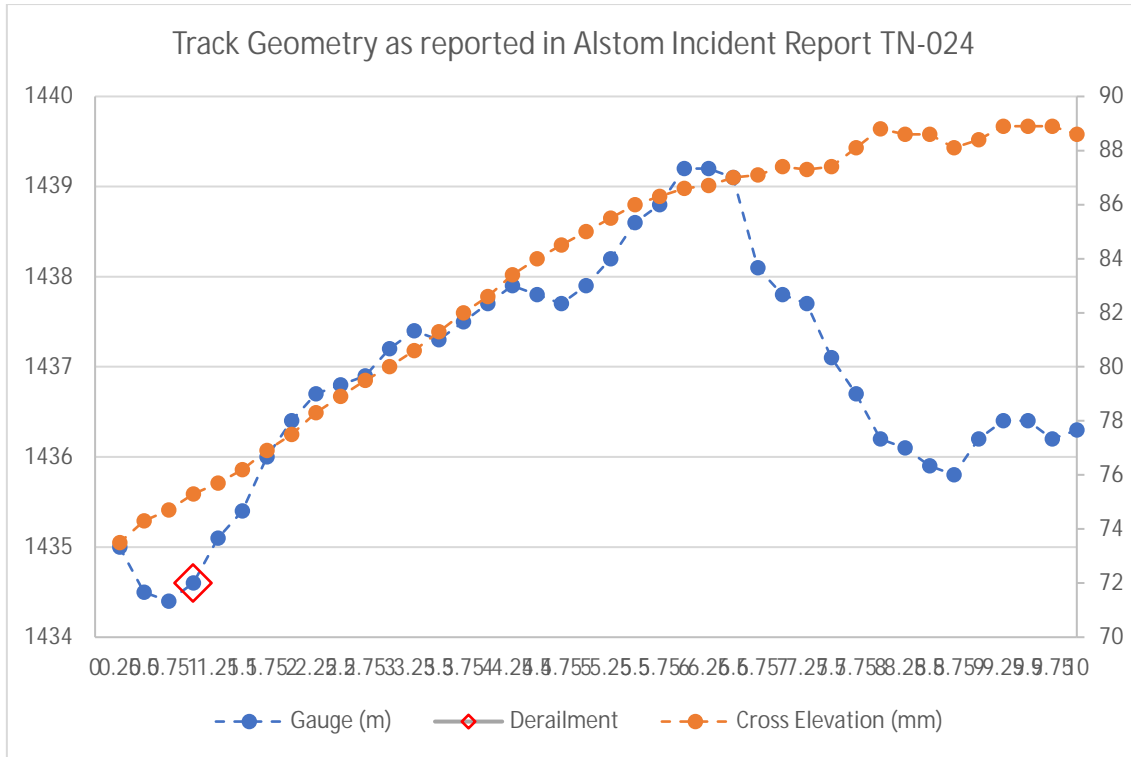
**Figure 5.11: Track Geometry as Reported in Alstom Incident Report TN-024**

The Alstom incident report contained 10m of gauge measurements which include the suspected location of the derailment. If the connector tunnel is considered part of the yard, all of these gauge measurements are within the reported tolerances. It is worth noting that the location identified for the rail climb and therefore derailment location is just after the tightest gauge location. There is also a note in Alstom's incident report TN-018 for LRV1126's yard derailment that "per best practices of fail, it is recommended to have gauge widening in sharp curves." The connector tunnel's tightest curve radius is 55.15m.

Inspection of the East Connector Tunnel showed that at least some of the conditions leading to the derailment of LRV 1126 still remain. No changes to the rail to address the tight gauge were mentioned or discussed as part of our site visit, nor was extending the checkrail to protect against another derailment in the same location.

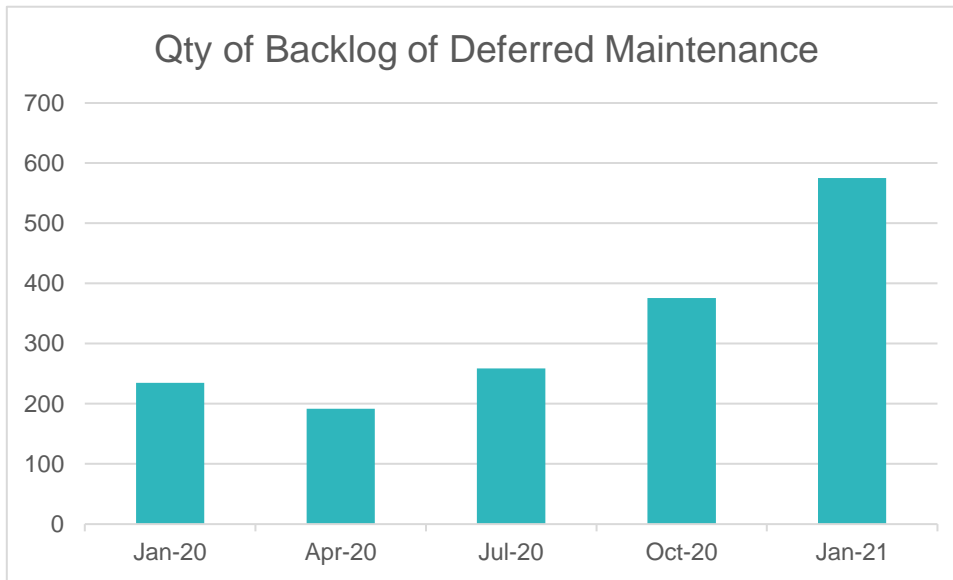
**Figure 3.57: Quantity of Backlog of Deferred Maintenance**

Additionally, there are 40 tasks which have been deferred for 12 months, and another 28 which have been deferred for 15 months. Of these 28 tasks, eight were not continuously listed in every quarterly report. It is not clear if these tasks were re-opened or if they were not included in the deferred maintenance backlog list.

This information combined with the improved availability reporting indicates that Project Co is focusing maintenance resources into keeping the fleet in service, but other maintenance tasks are accumulating. This will be compounded by two factors. First, once the passenger numbers return to a more normal state the COVID-19 reduced service will end, and full/normal service will resume. This will increase demand for service vehicles. Second, based on our Brampton on-site Vehicle Inspector observations it appears that Alstom are using uninstalled new parts originally destined for new vehicle assembly, as well as components from vehicles already delivered to support maintenance activities. Once the full fleet of vehicles have been delivered, these resources may not be available.

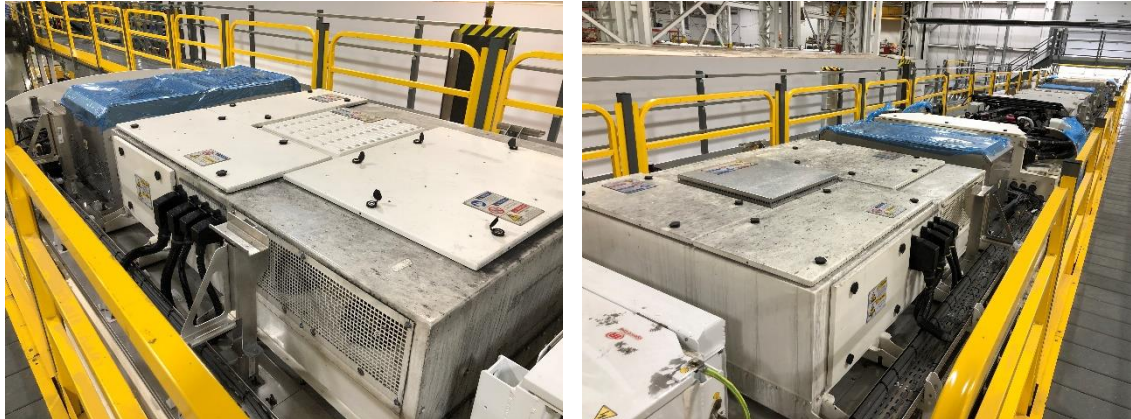
**Figure 3.58: Examples of traction converter containers at Brampton**

These examples of traction converter containers appear to have already been in service on a vehicle still under assembly at Brampton. Note the difference between other new roof equipment containers and the carbon-stained equipment containers, and a mix of both modified/unmodified line inductor ventilation covers.

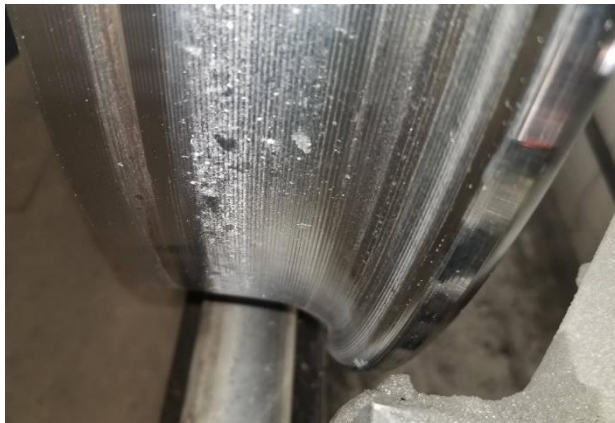
**Figure 3.61: Coarse Machining Lines Observed During Site Inspection**

During the on-site inspection, vehicle wheels which had recently been reprofiled on the wheel lathe were observed. The wheel shows coarse machining lines on both the tire tread and flange. This is typically related to the cutting feed and speed settings of the machining process.

A coarse surface finish increases the potential for the wheel flange climbing against the rail gauge face, potentially causing a derailment. This is especially of concern on the outer rail of a sharp curve and/or switch blade tip.

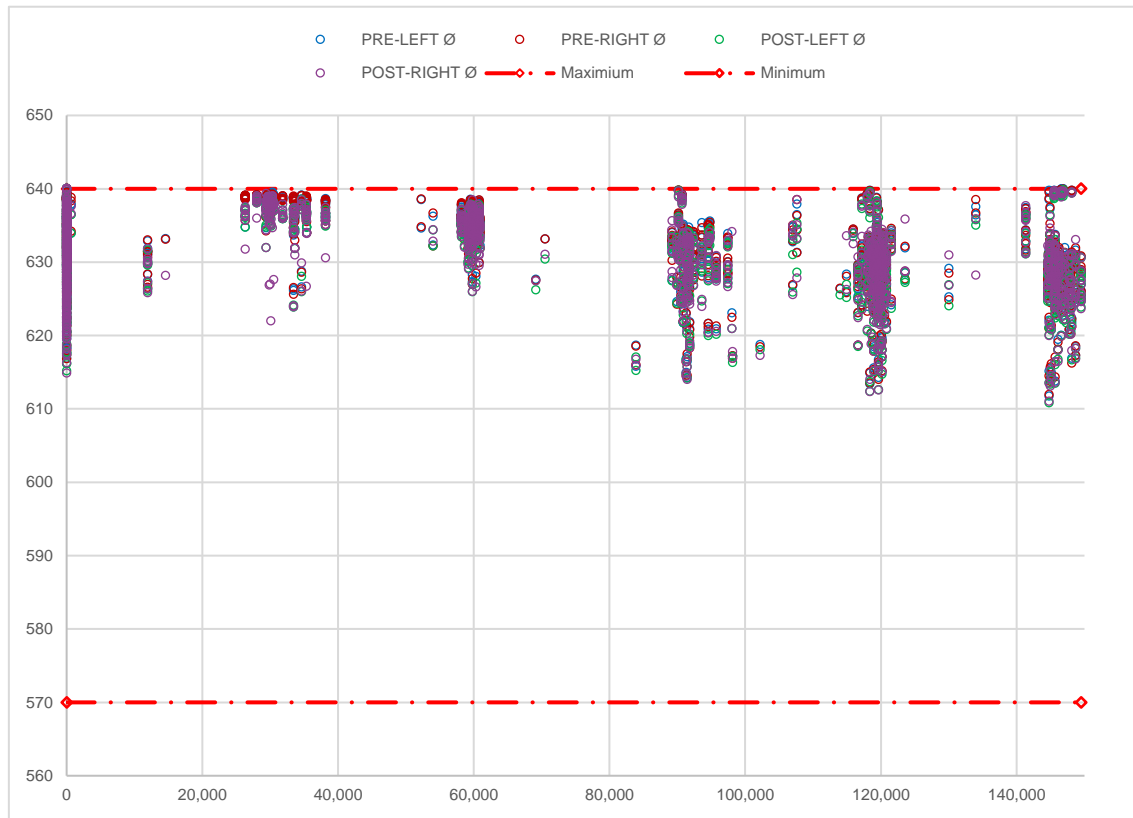
**Figure 3.63: Chart of Wheel Diameter Pre and Post Wheel True**

The wheel diameter data illustrated in **Figure 3.63** below shows clusters of data sets around regular mileage thresholds, with no wheels near the minimum diameter yet. The chart illustrates the magnitude of zero mile entries as mentioned above.

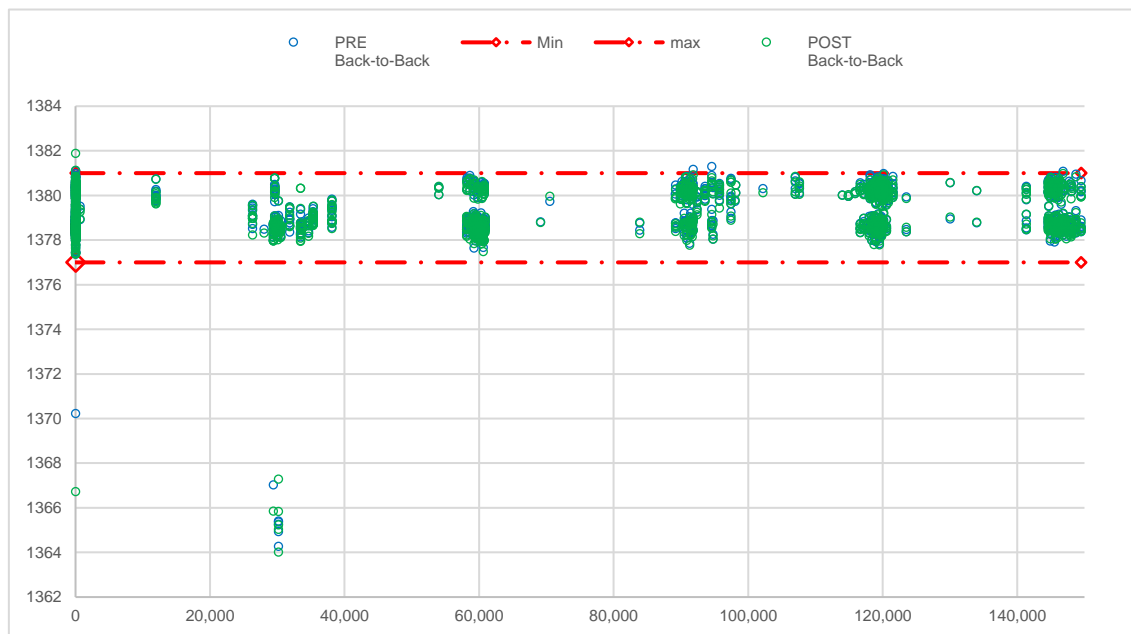
**Figure 3.64: Chart of Back-to-Back Measurements Pre and Post Wheel True**

The back-to-back measurement is a measurement of how far apart the two wheels on an axle are from each other. This is a key data point, as this controls where the wheels interface with the rail gauge face and safe passage through special trackwork without risk of potential derailment. The data shows a cluster of data points around 30,000km, but none after. This is a good indication that corrective measures were taken; however, it does raise the concern of how long those vehicles ran with an out of tolerance back-to-back measurement. It is possible that these vehicles were delivered in this state. Noting that back-to-back dimensions are critical to wheelset guidance through switches and interaction with restraining and guard rails.

Wheel flange and tread profiles and wheel diameters should be carefully managed, and wheel wear measuring and recorded carefully, including knowing the current wheel flange height/thickness (new/worn), tread wear/hollowing, and wheel diameter limits, as any misalignment of one profile, including out of tolerance wheel diameters relative to the other, will affect wheelset conicity, and hence stability and curving performance. The tread, when newly profiled, needs to comply with the requirements set out in the respective standard, for example BS 5892, Parts 3 and 6, EN13260 and AAR Manual of Standards and Recommended Practices. It is recommended to validate the wheel flange and tread profiles, and wheel diameters are being maintained in accordance with the relevant standards and Good Industry Practice.

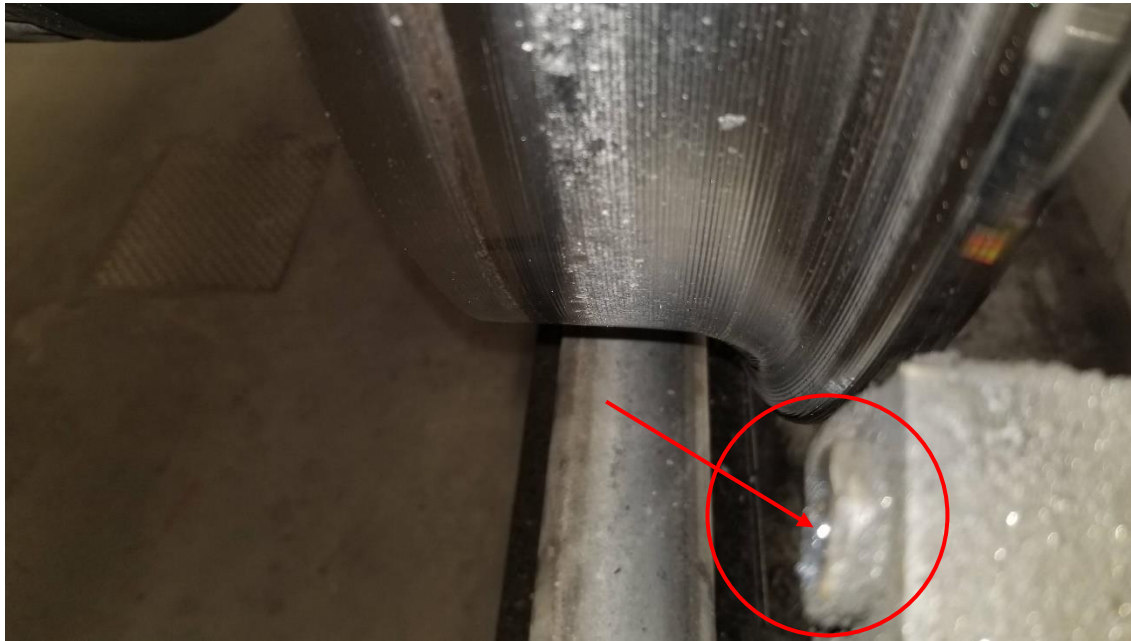
**Figure 3.65: Missing Flange Lubrication Spray Nozzle**

During the on-site visit, it was possible to inspect the on-board wheel flange lubrication system on a sample vehicle. There is only one truck/bogie (LCC1) out of the five installed on each vehicle that is fitted with this system, which includes four lubricant spray nozzles (one for each wheel). While inspecting the equipment, we noticed that one of the four nozzles was missing (see **Figure 3.65**), which would mean the adjacent wheel flange does not receive any lubricant. The missing spray nozzle may result in lubricant leaking onto the running rail surface during the operation of the lubrication system, which is automatically operated on a pre-set timing basis. This could lead to the oil being spread along the rail head by the passing wheels and potentially creating slip/slide conditions for not only this vehicle but others that follow.

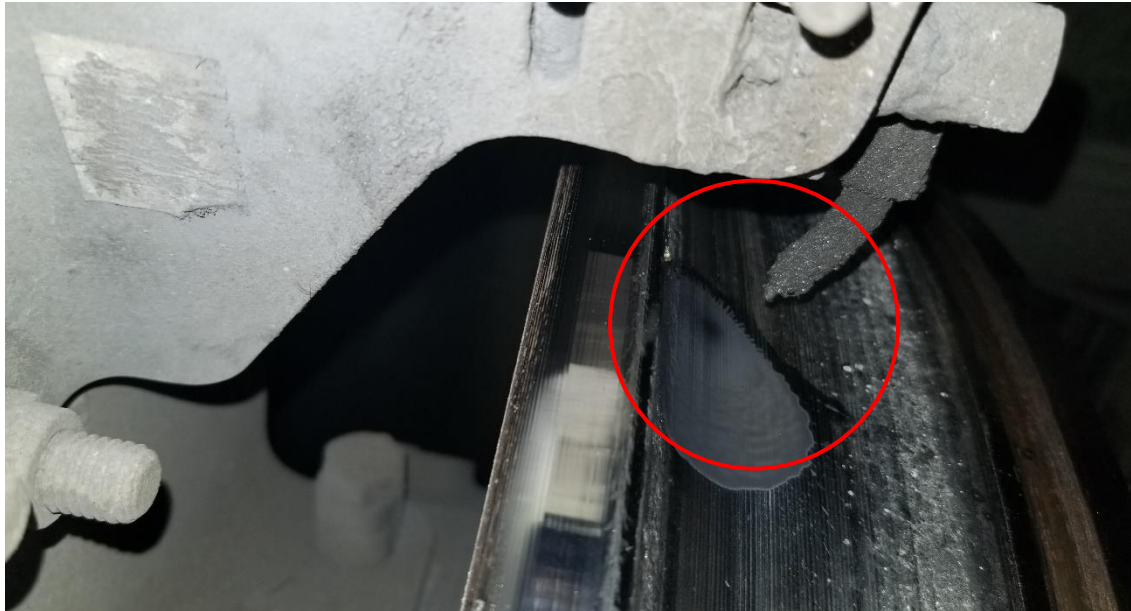
**Figure 3.66: Incorrectly Set Flange Lubrication Spray Nozzle**

It is important to note that the gap clearance setting between each spray nozzle and the wheel flange is critical in ensuring the lubricant is ejected at the correct angle to ensure the flange is lubricated correctly. Otherwise, the amount of lubricant either does not contact the correct area of the flange or it sprays onto the wheel tread, which is likely to result in the wheel transferring the lubricant onto the rail surface (see **Figure 3.66**). This compromises the friction on the wheel tread, leading to wheel slip/slide situations and inherently prevents the lubrication intended for the wheel flanges from being transferred/applied to the gauge face of the rail.

Maintenance staff indicated that the lubricant reservoirs are “topped up” every two months or so even though reservoir is small. The on-board lubricant reservoir needs to be monitored to determine usage to determine the maintenance intervention timescales, as it is not recommended to run between maintenance intervals with no lubricant being applied otherwise the flange/rail conditioning will be lost, which may result in having increased rail/rail wear and potential noise.

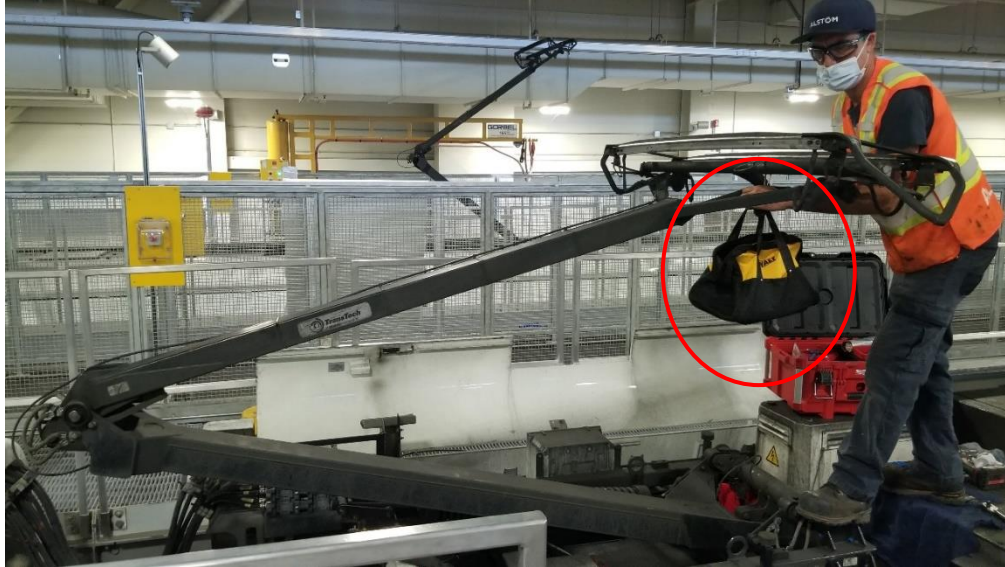
**Figure 3.67: Current Project Co. Pantograph Force Check**

One of the mitigation items specifically mentions ensuring the pantograph spring tension or contact force is set correctly. During an on-site visit, the process of measuring and adjusting the pantograph contact force was observed.

The process includes the use of a tool bag with 23 lbs of weight hung from the pantograph head, and pantograph position checks were observed at three positions: low, medium, and high. The spring pressure was adjusted until the pantograph head stayed stationary. This weight value and upward force checking process could not be validated against the OEM requirements.

The procedure adopted by Alstom does not align with typical OEM maintenance requirements, and therefore the actual force setting cannot be assured. A copy of the OEM maintenance procedure was requested but has not been provided.

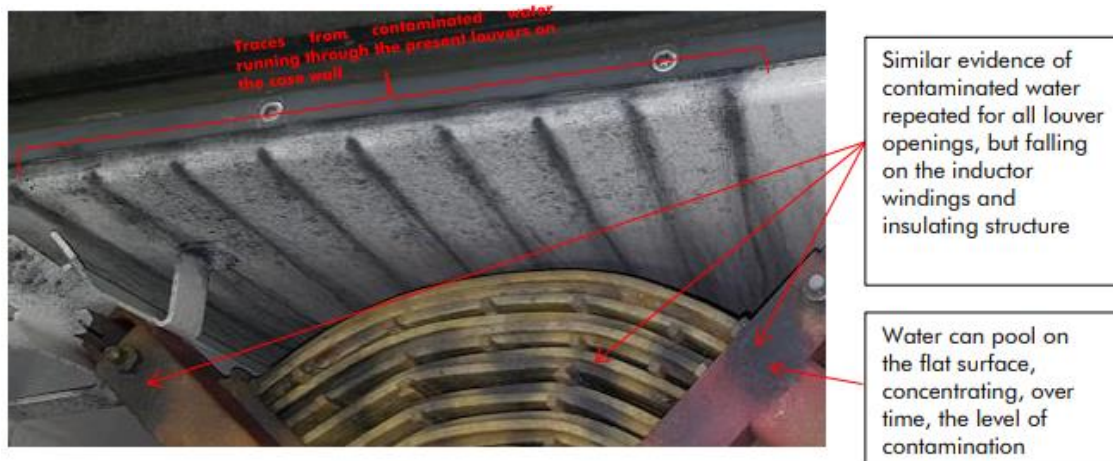
**Figure 3.69: Inductor Compartment of a Typical Traction Case, After 75000 km**

- Pantograph carbon dust deposits
- Copper particles from the OCS
- Salt used from de-icing the roads on over-bridges
- Water ingress

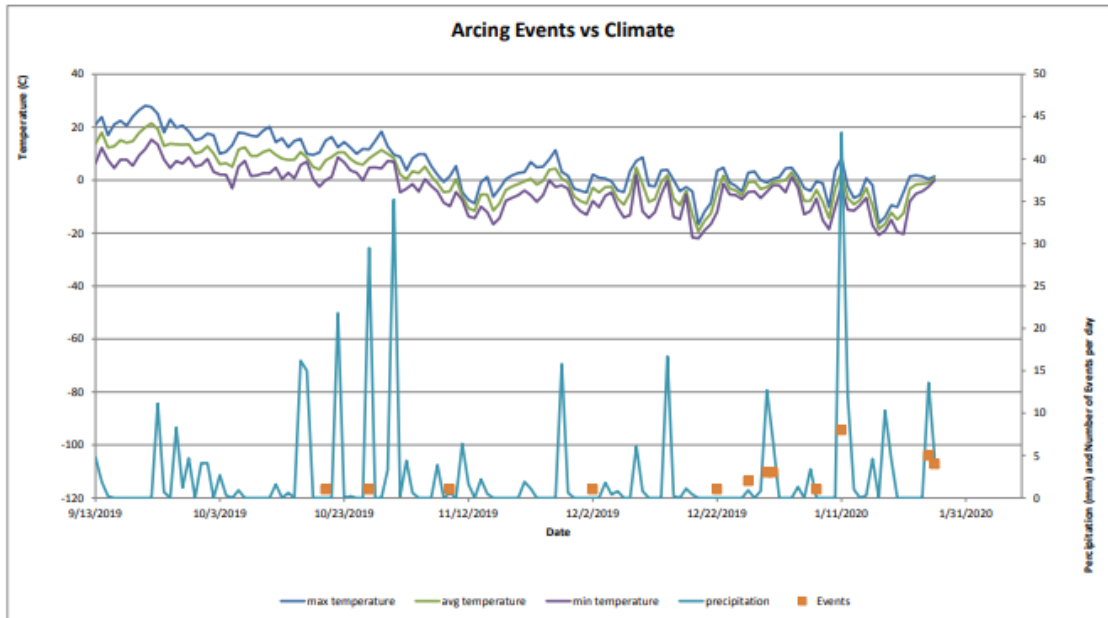
**Figure 3.70: Arcing Events vs Climate**

According to the line inductor failure reports, peaks in failures tend to occur in late December / early January, on days with precipitation and when the temperature is just above 0°C. This is shown in figure below. This implies that failures are most common on rainy and/or freezing rain and/or wet snow mix. On days below 0°C when it is snowing without precipitation, there are no reports of failures. Snow, while it may enter the present louvered ventilation cover design in small quantities, will largely blow off the top of the cover due to train motion. Rain, however, can flow across the surface of the cover, run directly in the louvers in concentrated streams and carry contaminants with it. This is illustrated in the chart below.

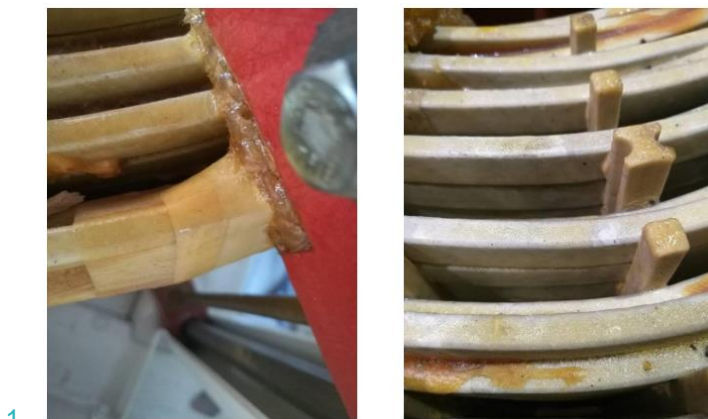
**Figure 3.71: On the Left the Prototype; On the Right Serial Number 169**

Alstom have identified quality issues within the insulation impregnation process. Below illustrates the difference between the prototype (B1841 – AY00000206364) and the failed line inductor (serial number 169).

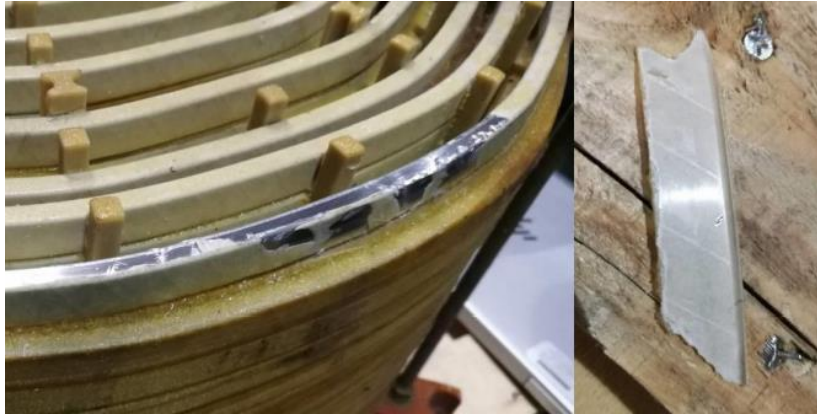
**Figure 3.72: Serial number 169: Single Layer of Nomex on the Individual Conductors**

Tape and filler are not present. Filler is used to avoid accumulation of dust and contamination between the turns.

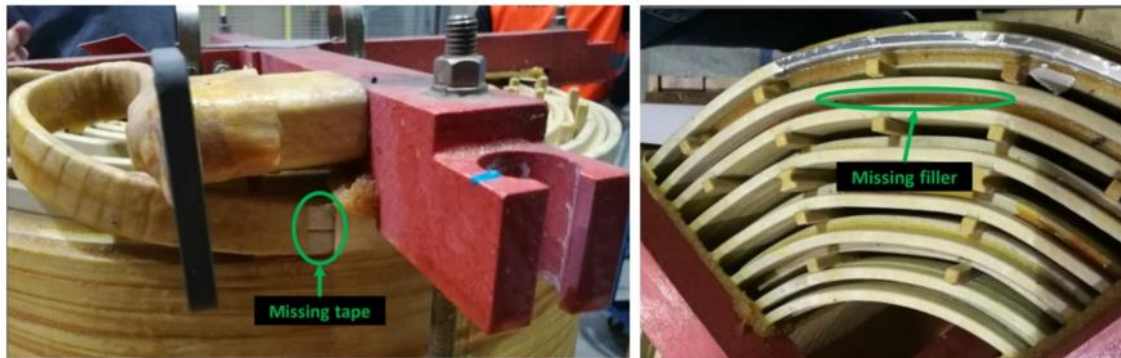
**Figure 3.73: Serial Number 169: Missing Tape and Filler**

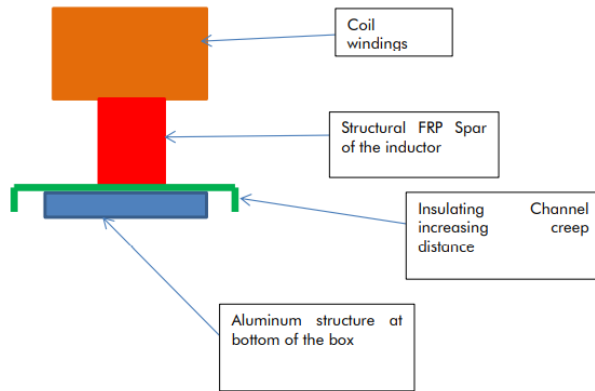
**Figure 3.74: Proposed Short-Term Mitigation**

A proposed priority mitigation and potentially part of the final solution could be envisioned to cover the aluminum cross at the bottom of the inductor enclosure with a fibre-reinforced polymer extruded channel to increase the creepage distance below the inductor on a horizontal plane. The mounting of this channel would be as below viewed from the end of one of the structural spars of the inductor.

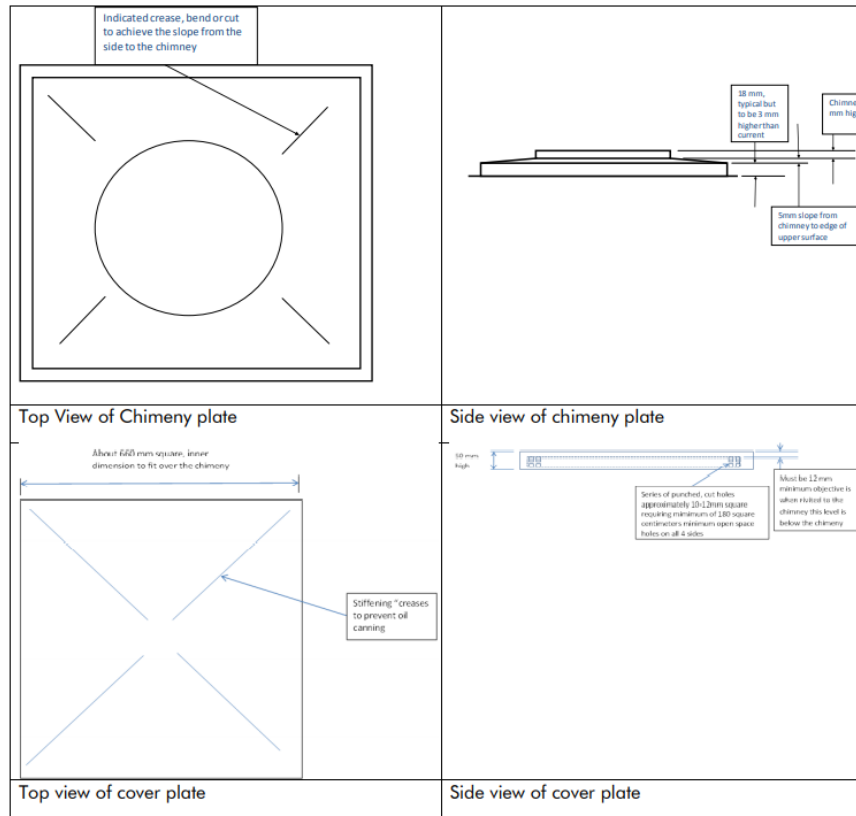
**Figure 3.75: Proposed Case Modifications to Improve the Environment**

- A means to prevent water from directly pouring into the enclosure: the louvered slots should be removed from the cover and replaced with a chimney approximately 10mm high to prevent water flowing into the ventilation openings.
- The chimney should be mounted on a plate with approximately 5mm slope between the edge of the chimney and the edge of the plate to allow any water that gets on that surface to flow off the edge.
- A new cover with a raised shield to prevent rainwater and falling pollution from entering the chimney openings directly.
- The clearance between the rain shield and the chimney needs to be sufficient to provide more than 180cm<sup>2</sup> of area around the circumference (the same total area of the present louvers) for cooling.
- The rain cover requires a grid to prevent ingestion of leaves etc. The grid requires the same minimum 180cm<sup>2</sup> for cooling.

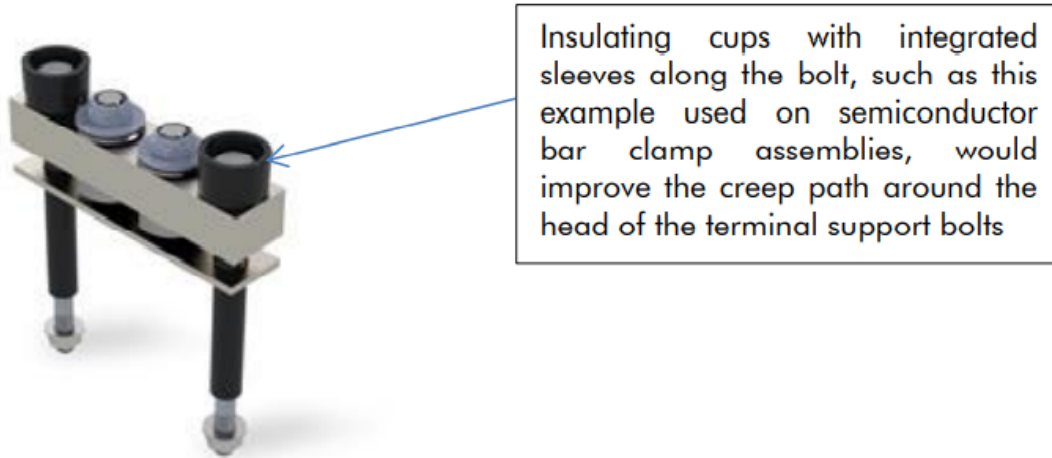
**Figure 3.76: Use of Insulating Cups on the Terminal Support Bolts**
