# **Ottawa LRT Independent Review Report**

April, 2022  
Confidential

# Ottawa LRT Independent Review Report

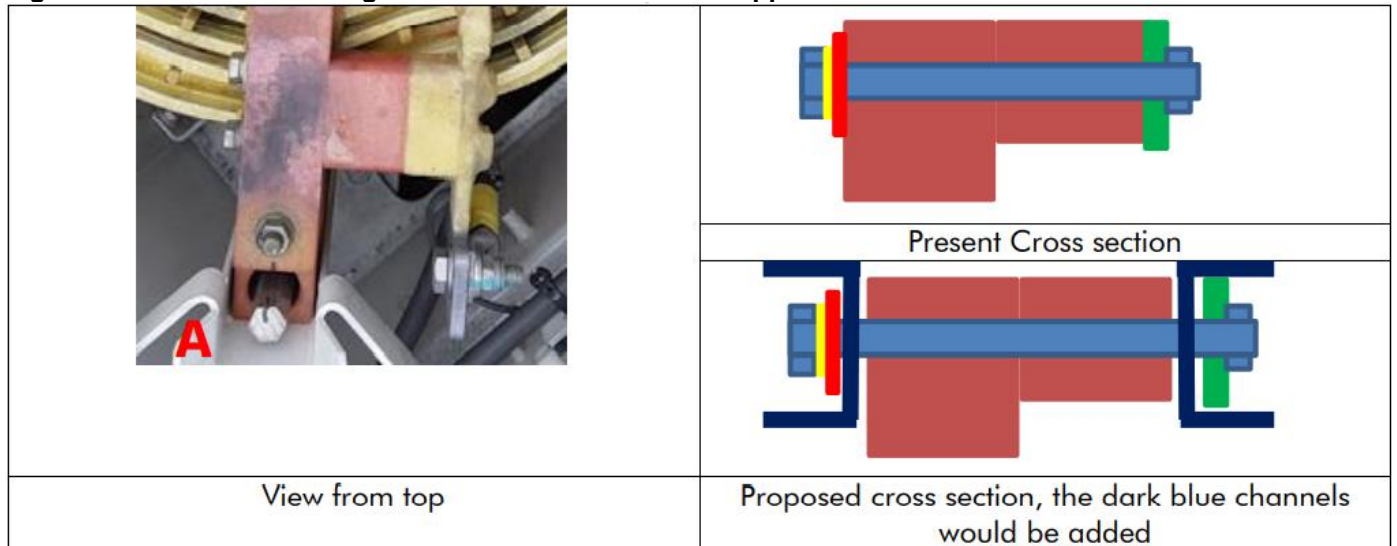
**Figure 3.77: Use of Insulating Channels on the Terminal Support Bolts.**

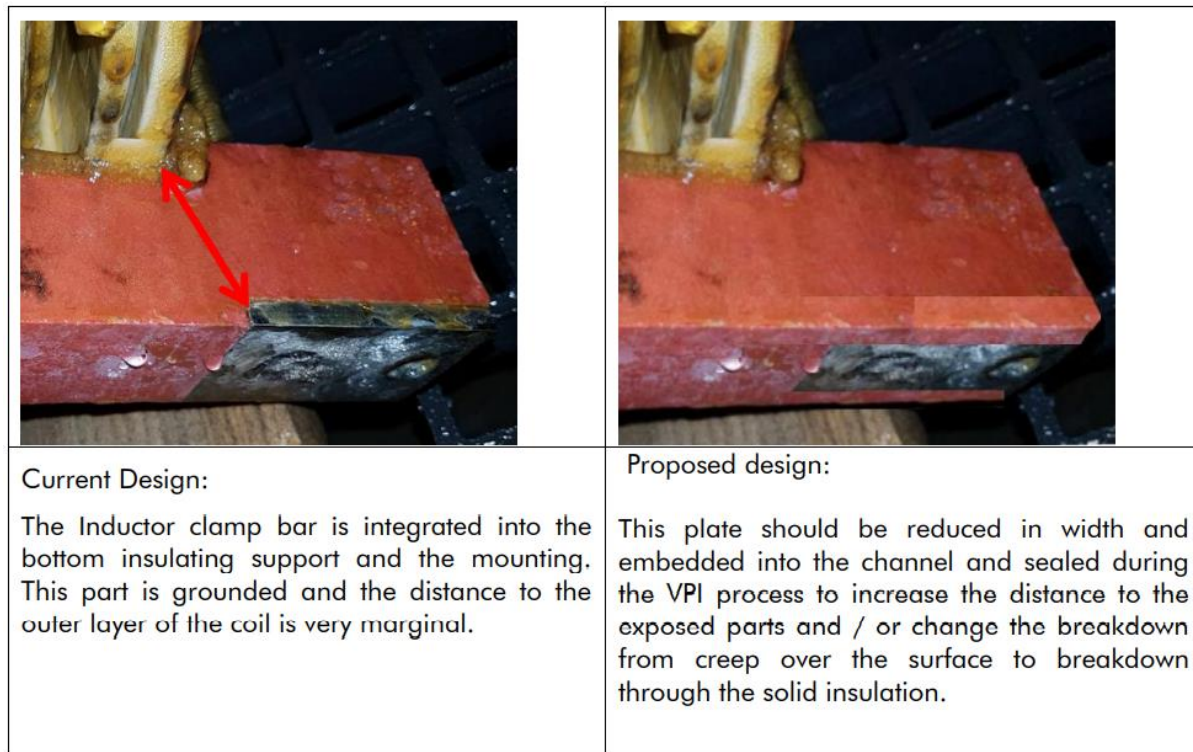
Still to be addressed is the clamping assembly of the inductor, with current design and proposed modifications illustrated and discussed below. Alstom state that this has been seen in some cases to have been the end of the tracking path from the windings to the chassis.

**Figure 3.78: Proposed Creep Distance Improvement**

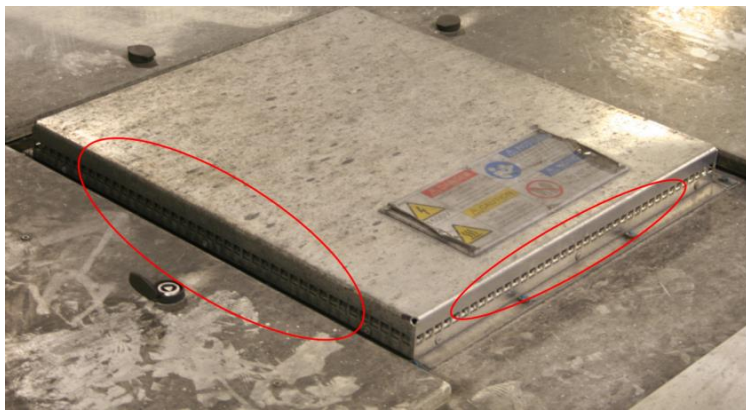
These documents contain information regarding the next steps for mitigation, although they have not confirmed if the small ventilation holes on the new type of line inductor cover could provide sufficient ventilation to the inductors, especially if the holes became blocked by snow, leaves or other contaminants. Should the airflow be restricted, this could lead to potential overheating and deterioration of the line inductors insulation and result in more short circuit/flashovers.

Since these modifications were implemented, and despite requests, there has been no evidence/documentation to demonstrate there is adequate airflow passing through the ventilation holes /temperature of the inductors or use of testing equipment such as: anemometer for air flow, or thermometer for temperature.

**Figure 3.80: New Line Inductor Cover**

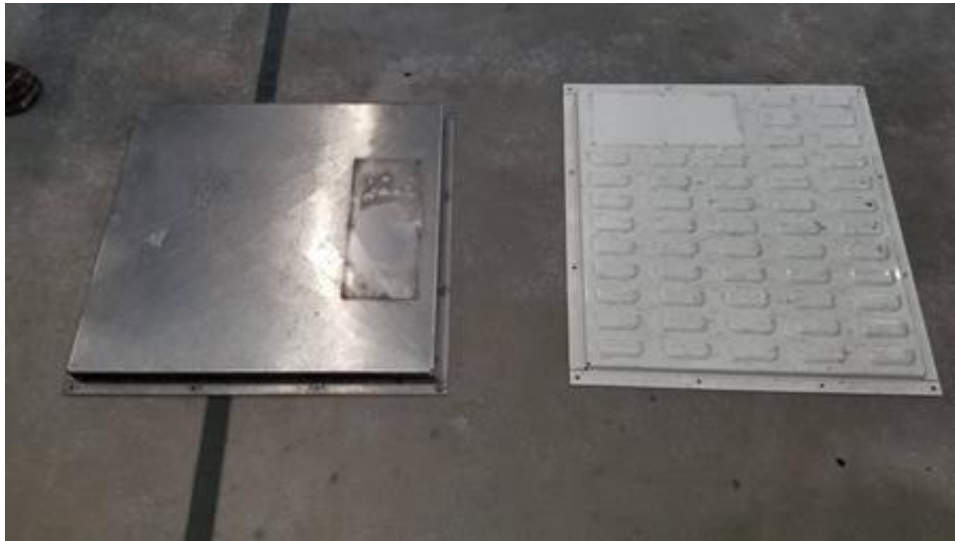
**Figure 3.81: New (Left) and Original (Right) Line Inductor Ventilation Covers**

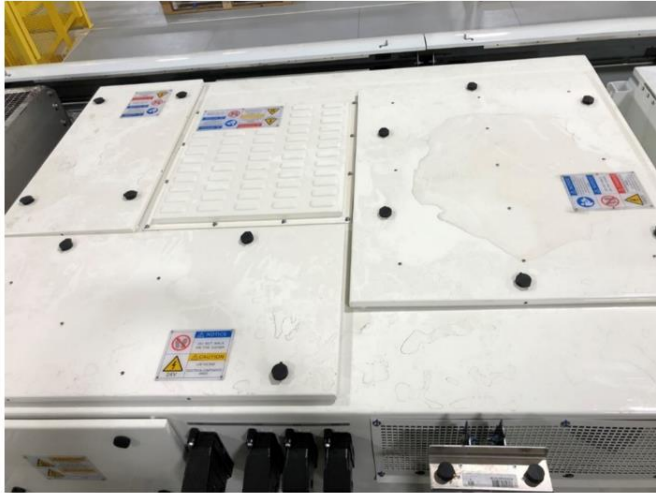
During the pre-shipment inspection at Alstom’s Brampton facility on March 16, 2021, it was observed by Mott MacDonald’s Resident Vehicle Inspector that it appeared that previously used traction converters from revenue vehicles have been installed on 1152, see Figure 3.83 below. Noting that other subsequent new LRVs have also been observed with used equipment mounted on them.

**Figure 3.83: Previously Used Traction Converter Installed on LRV1152**

This assumption is based on the fact that the line inductor ventilation cover shown above is of the original design, with the ventilation openings on the top of the cover (**Figure 3.83**). As previously discussed, the revenue fleet has been undergoing a modification/rectification program since mid 2020 to replace the cover and to rework/replace the inductors as part of the Rectification Plan. Following this finding, Mott MacDonald have since carried out a close inspection of the photographs taken from previous pre-shipment inspections of 1149, 1157 and 1151, this has identified that in addition to 1152, discussed previously above, the other three vehicles also had the original design of cover fitted. These observations are rather discerning as they demonstrate a lack of configuration control between what has been implemented by Project Co on the revenue vehicles and what is being supplied by Alstom on the new vehicles being manufactured at their Brampton facility.

Without further investigation, it is unknown whether the modifications/rectification work identified in the Rectification Plan has also been carried out to each of the line inductor units. Therefore, there is a risk of reintroducing equipment into the Ottawa fleet that has the potential to fail in service, as encountered previously. Also, if our assumption is correct and the traction converters identified, with the original design covers, have been previously removed from revenue vehicles due to earlier in-service failure/faults then there is a further potential risk of repetitive problems being reintroduced into the fleet. Without a robust configuration management system in place to provide the necessary control and traceability of previous faults/repairs/modification status there is a likelihood the fleet and ultimately the passenger service will suffer both in the short/long term.

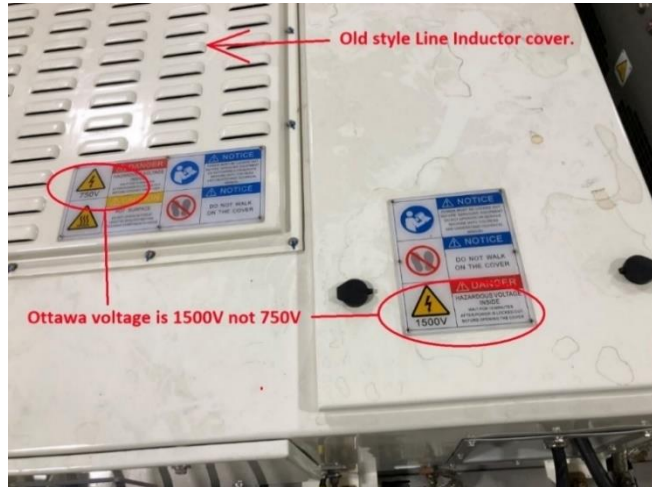
To add further concern about configuration concerns, it was also noted during the pre-shipping vehicle inspections that the high voltage warning tag plate installed on the ventilation cover, indicates 750V instead of the 1500V used for the Ottawa vehicle (**Figure 3.84**). In this case the configuration issue also presents a safety concern related to mislabeling of an electrical component.

**Figure 3.84: Propulsion Converter Indicating the Wrong Voltage and Using the Old-Style Line Inductor Cover**

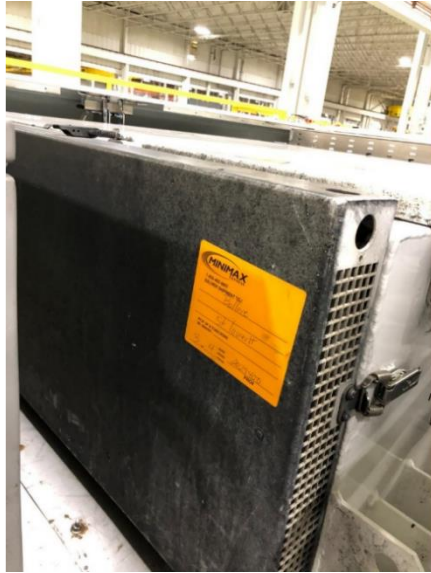
During the LRV pre-shipment inspection of LRV51 at the Brampton manufacturing facility (February 22 to March 5), it was observed by the RVI that two pre-used APS units had been installed on this vehicle. However, it was observed that these APS units at the Brampton facility do not appear to be a retrofit but a repair, as approximately 15 used APS units have been seen on the shop floor at the Brampton facility waiting to be repaired. Without additional information, it is assumed these used units waiting to be repaired are ones that failed during revenue service in Ottawa. There is an area in the Brampton facility dedicated to the repair of APS units, and a representative for the OEM, Adetel, is on-site full time performing the repairs (**Figure 3.86**).

**Figure 3.86: Pre-Used APS Unit Installed**

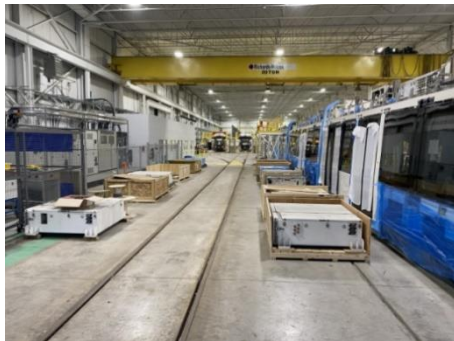
As previously discussed above, the apparent lack of configuration control and traceability for vehicle related modifications/rectifications is a concern, if the repaired/used APS units that are refitted to production vehicles are in an unmodified state i.e., without the proposed software update. This could result in further reliability issues with the new LRVs coming from the Brampton facility.

**Figure 3.87: APS Units on The Brampton Facility Shop Floor**

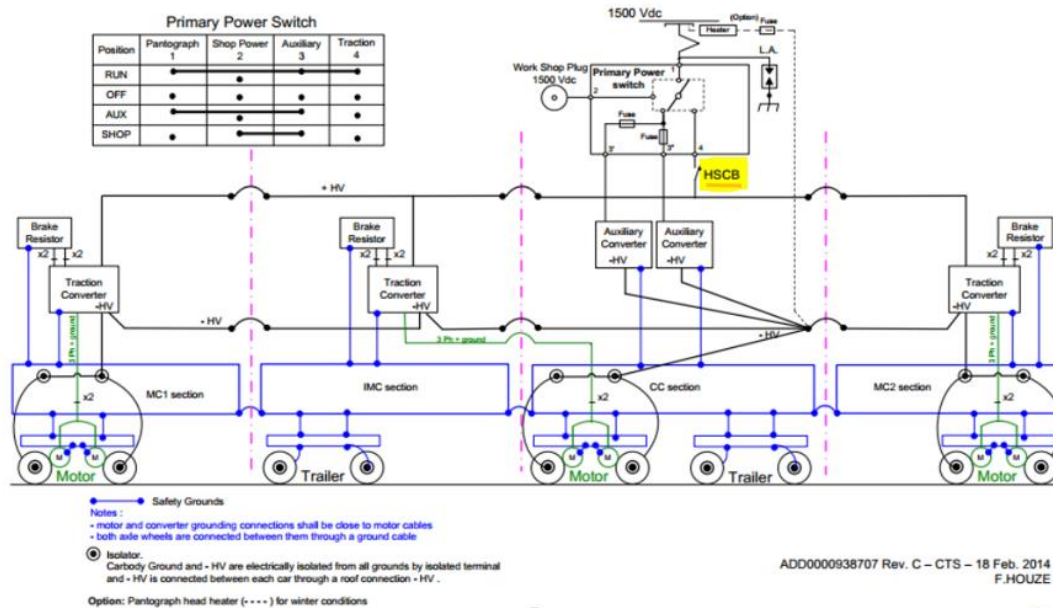
The image below, taken from Alstom's MTNMTN-TLOTT-WMS-003 - Citadis Spirit Vehicle Operating Manual\_Rev E, illustrates that when the HSCB is open, the traction converter will be isolated from the 1500Vdc high voltage supply, as required by 3.23 (c iii) above, whilst the Auxiliary Power Supply will not be affected and remains energised, which goes against requirement 3.23 (d).

**Figure 3.89: Citadis Sprit 404 - 1500Vdc HV Supply Circuits**

Although Alstom's HSCB design is noncompliant to the PA clause 3.23 (d), Mott MacDonald is aware from previous/ongoing experience that Alstom's Citadis Spirit HSCB functionality is in fact consistent with other similar LRV HSCB designs/functions, noting that the PA requirement would result in a total loss of power supply for HVAC, low voltage DC power, battery charging, and lighting for instance, in the event of an emergency brake application.

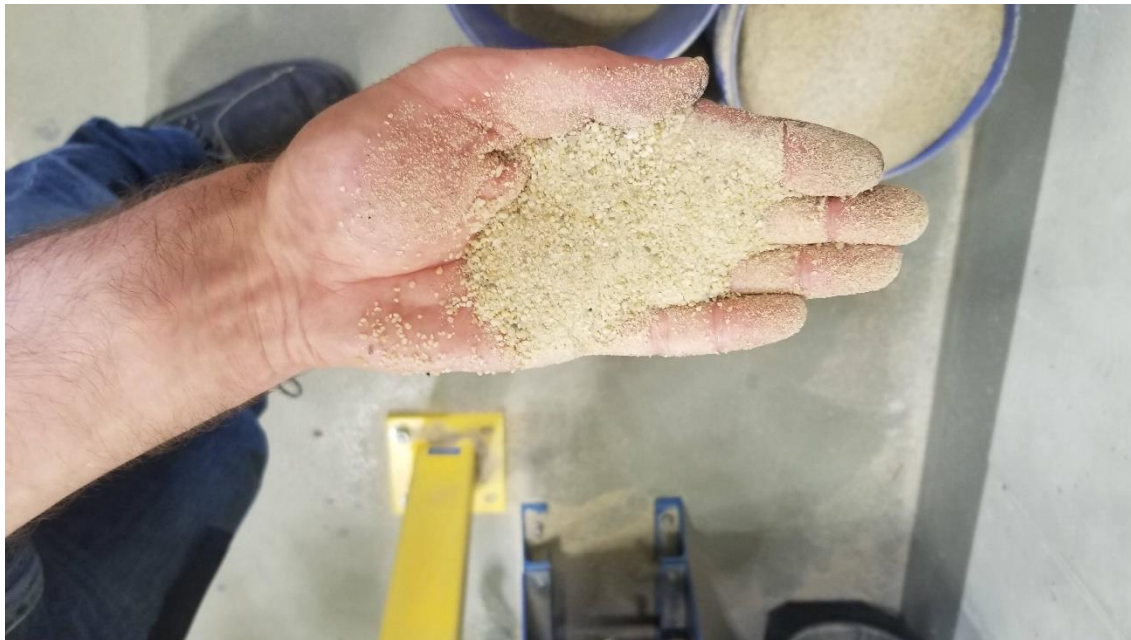
Incorrect sand was initially supplied, which lead to clumping and freezing, clogging the on-board sand delivery system. This sand is an integral part of the vehicle braking and acceleration calculations and may be contributing to the wheel flats/braking/over speeding issues. New sand has now been supplied and was observed as part of the on-site visit.

**Figure 3.90: Photo of New Coarser Sand**

The functionality of the on-board sanding system and new sand type needs to be confirmed against the OEM specification requirements. In addition to the on-board sanding system, the new sand type needs to be confirmed with the MSF sand dispensing system OEM to ensure there are no compatibility issues.

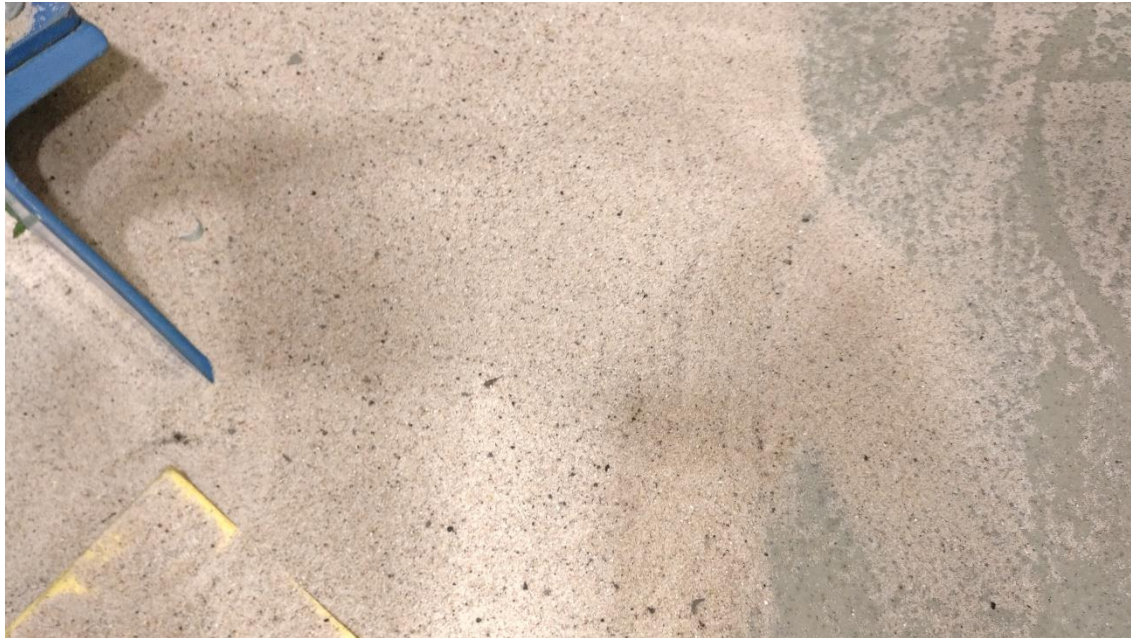
**Figure 3.91: Photo of Original Powdery Sand**

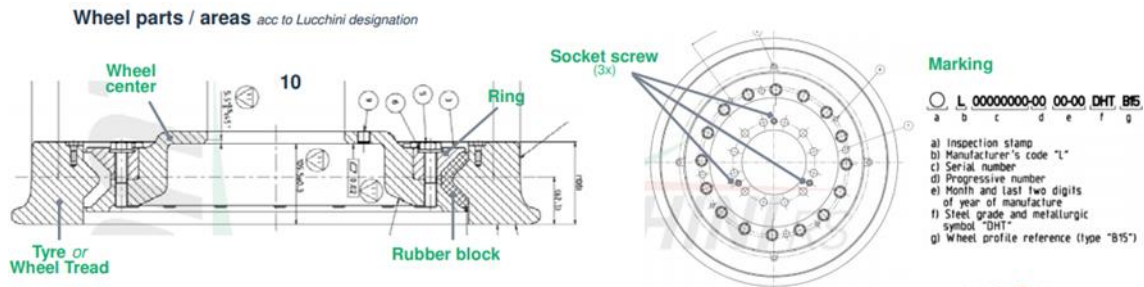
Our initial conclusions from this issue tend to indicate that the root cause has been identified, which was related to the leaving in place of the socket screws during the wheel assembly (see **Figure 3.91**), which protruded out of the threaded holes used to extract and remove the wheel. Additional wheels have since been identified with cracks appearing in the same manner as the previous, but without further information we are unable determine whether they are related to what has been found previously.

Going forward, it is important to understand Alstom’s mitigation strategy for preventing the issue from being repeated during future manufacturing, maintenance, and overhaul of the wheels. However, recent observations by Mott MacDonald at Brampton have identified that wheels are still arriving on-site with the screws still in place and has resulted in new vehicles being sent to Ottawa with them still in place. Mott MacDonald were aware that 1152 had been transported to Ottawa with them in situ, but this would be the last vehicle with them in place.

**Figure 3.92: Wheel Parts Including Socket Screws**

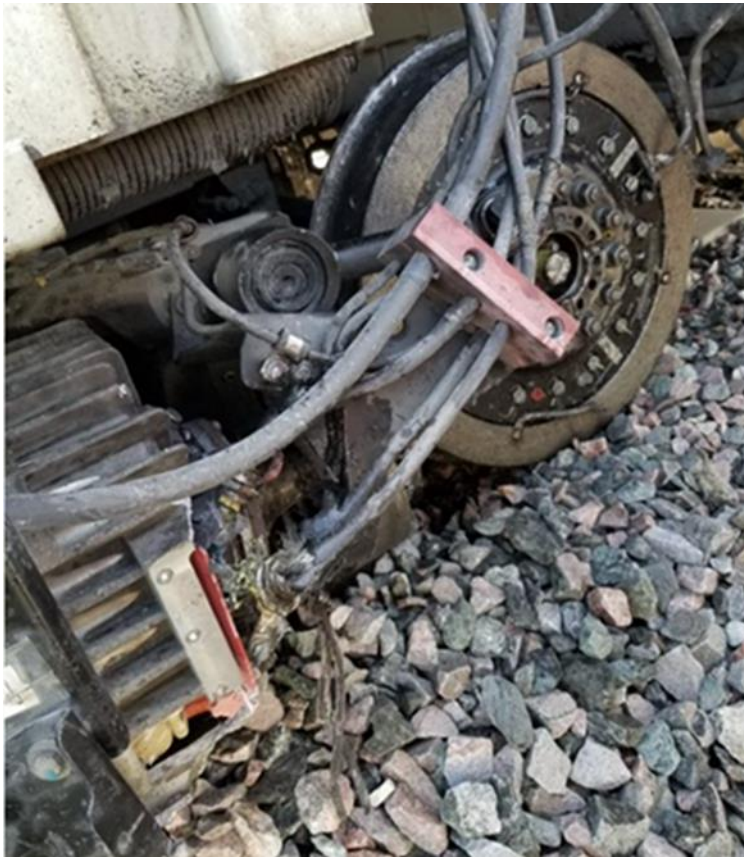
While this Section of Volume 5 is not intended to cover the details of the derailments, as they have been covered elsewhere, it is however important to note that the confirmed primary cause of the September derailment was related to improperly torqued bolts on the gearbox, see **Figure 4.29** below. The investigation identified that there are issues related to maintenance and management practices, which further supports our other observations and findings related to vehicle maintenance concerns.

**Figure 4.29: LRV1121 Derailment September 2021**

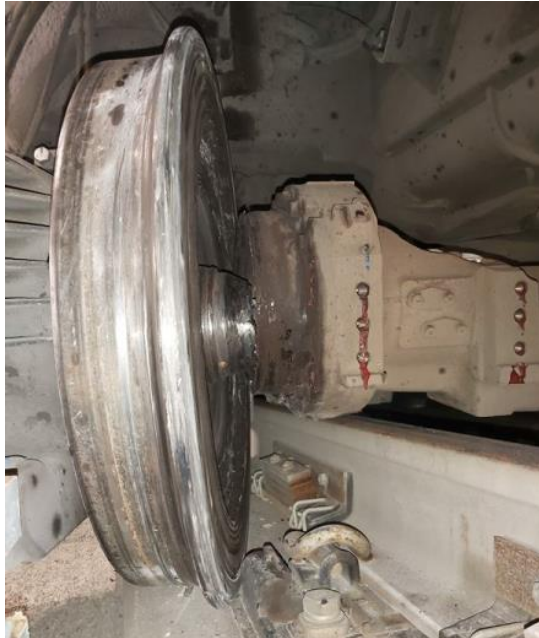
The August derailment was related to a wheel bearing failure on 1119 that resulted in the detachment of a wheel which led to the train being derailed, see **Figure 4.30** below. It is understood that the root cause of this derailment is still under investigation.

**Figure 4.30: LRV1119 Derailment August 2021**

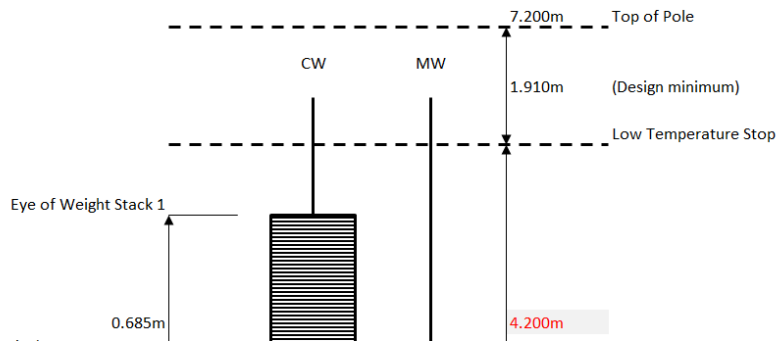
| 7 | Conclusion | 206 |

Weight Stack 1 2.150 m *\*\*\* Set too low \*\*\**  
Weight Stack 2 2.330 m *\*\*\* Set too low \*\*\**
