OC Transpo Transitway Station Design Safety Study

Independent Safety Study

Final Safety Study

September 2021

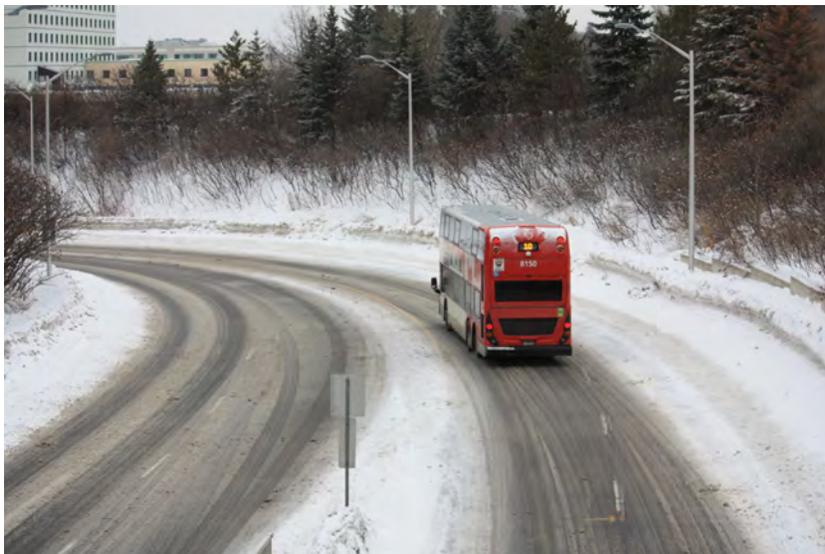
Issue 2: Advisory speed signing for the reverse curve is in one direction only

A curve warning sign with an advisory speed tab of slow to 40 km/h is only in the northbound direction. There is no curve warning advisory speed posted for the southbound direction.

Install an advisory speed sign Tab of 40 km/h with the curve sign in the southbound direction.

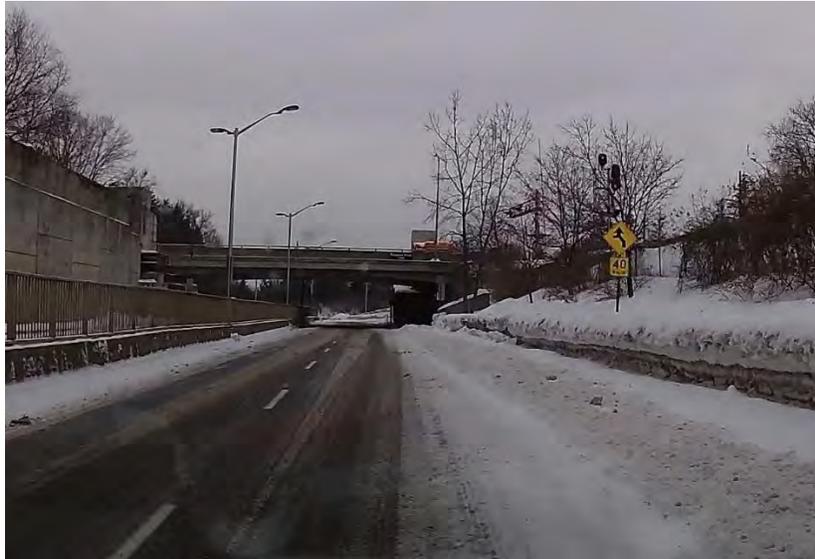
Issue 3: Northbound reverse curve warning sign is located south of the station

The northbound reverse curve warning sign, for the reverse horizontal curve north of the station, is located within the south entrance to the station. At this location, there is a high driver workload, the transit driver is focusing on activity and vehicle movements within the transit station and needs the curve warning information after the station.

Similarly, the southbound reverse curve warning sign of the reverse curve for these curves is located at north entrance to the Riverside Station.

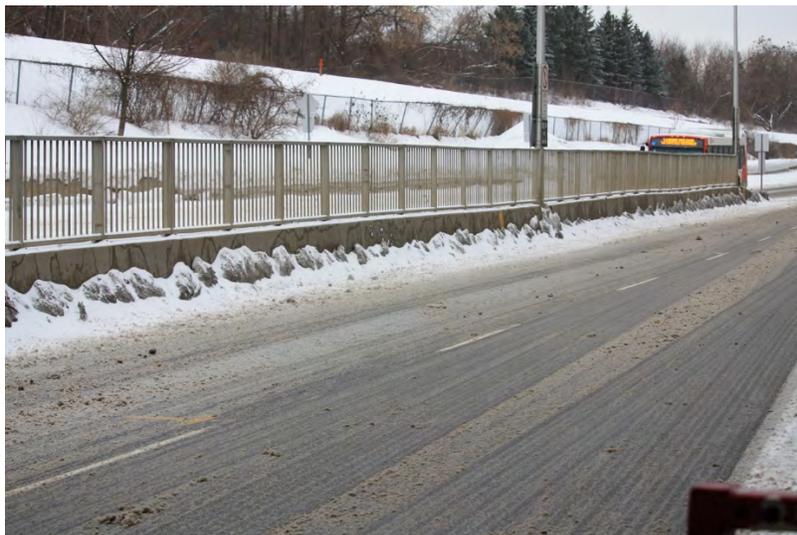
Issue 4: No energy attenuation at the median barrier ends

There is no energy attenuation at the median barrier ends at the entrances into the station. This is especially an issue at the northbound entrance into the station as the speed change from 80 km/h to 50 km/h for northbound vehicles occurs at this point. A transit vehicle may be travelling at 80 km/h at the start of the barrier.

Install an appropriate TL-3 crash cushion attenuator in place of the sloped end. A picture of the TL-3 crash cushion attenuator is shown below.

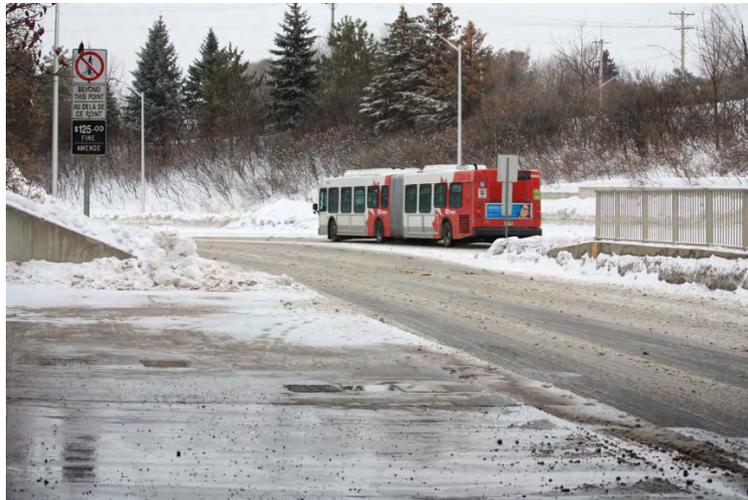
Issue 6: No protection for transit patrons on platform from an errant vehicle

Other than the raised curb along the edge of the transitway, there is no barrier to mitigate an errant vehicle accessing the passenger platform area. This is an issue as an errant vehicle travelling at high speed and encountering the curb at an obtuse angle could potentially mount the curb and enter onto the station platform area.

An 810mm high TL-3 concrete barrier with an appropriate length of need and taper is suggested to shield waiting transit customers from an errant bus mounting the curb on the approach end of the station platform.

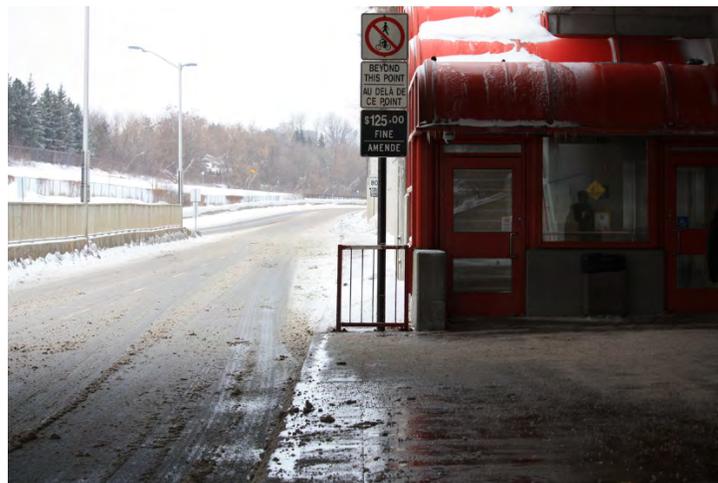
Issue 7: Concrete abutment end located in clear zone

The concrete abutment wall is located within the minimum dimension for a clear zone for an urban roadway. An errant transit vehicle leaving the transitway could run head-on into the barrier.

Remove the concrete abutment or shield it with an appropriate length of need and taper of a TL-3 concrete barrier.

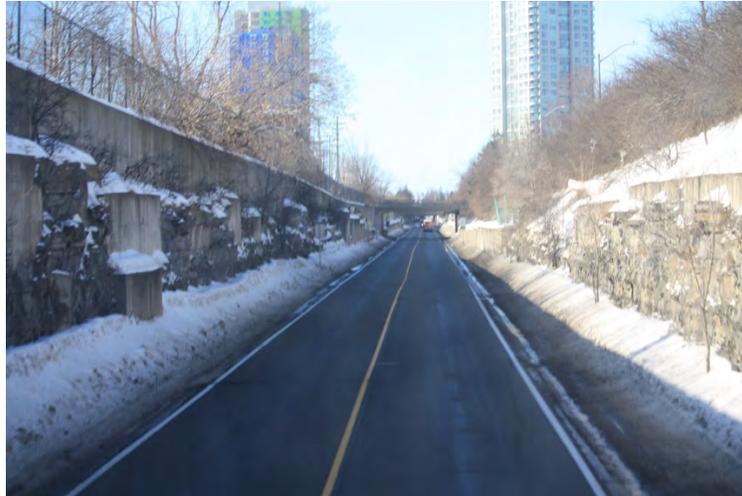
Issue 8: Jagged rock face and wall surface protrusions

Along both the westbound and eastbound approaches to the station, the side walls of the cut section have jagged rock face or wall surface protrusions. This is a potential issue as should a transit vehicle veer outside of the transitway running surface, these protrusions could grab the side of the vehicle resulting in a severe collision with the wall.

Install an appropriate length of need and taper of an anchored TL-3 F-Shape concrete barrier or a Cast-In-Place TL-4 F-shape concrete barrier. The barrier should be installed 1m offset from the edge line.

Note: An unanchored concrete barrier could shift or deflect by a maximum 1.8 metres if hit by a heavy vehicle, but the barrier shift caused by a bus would be less. Any barrier used on the Transitway must have a FHWA acceptance letter specifying the Test Level (TL).

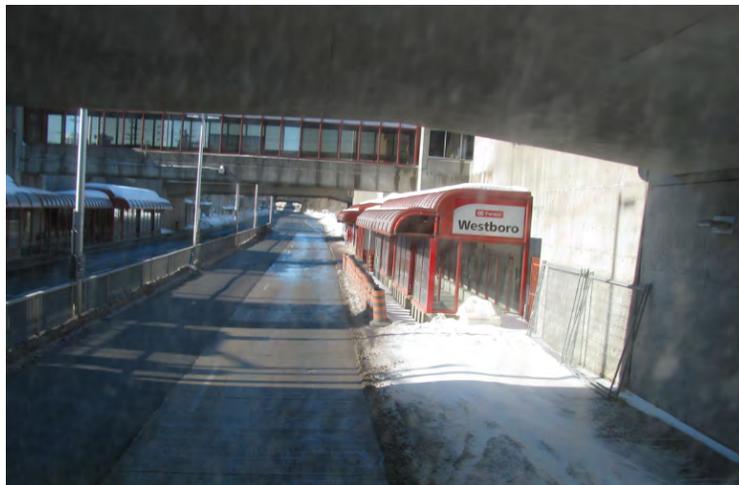
Issue 13: No protection for transit patrons on platform from an errant vehicle

Other than the raised curb along the edge of the transitway, there is no barrier to mitigate an errant vehicle accessing the passenger platform area. This is an issue as an errant vehicle travelling at high speed and encountering the curb at an obtuse angle could potentially mount the curb and enter onto the station platform area.

An 810mm high TL-3 concrete barrier with an appropriate length of need and taper is suggested to shield waiting transit customers from an errant bus mounting the curb on the approach end of the station platform.

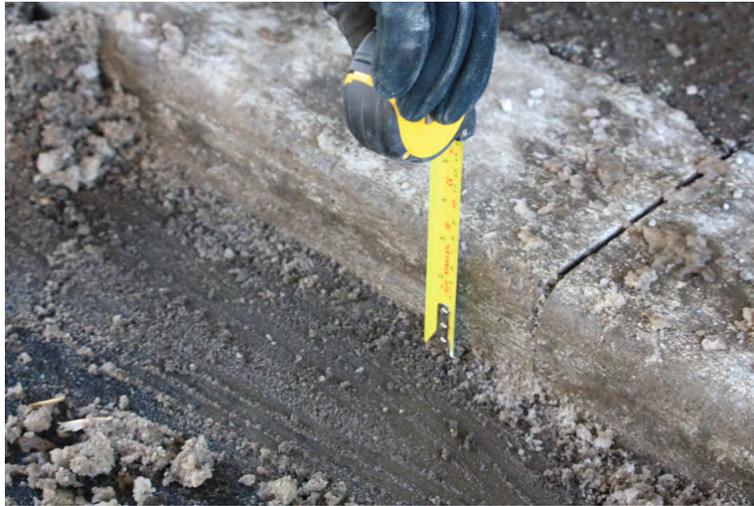
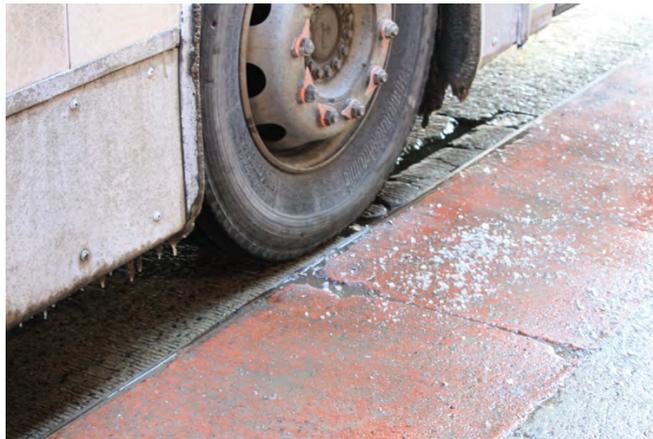
- the size and suspension characteristics of the vehicle
- its impact speed and angle
- the height and shape of the curb itself.

Therefore, the reduced height of the curb may inhibit the ability of the curb to deflect vehicles.

Rebuild the low curb with a 150mm high barrier curb in keeping with the current transitway design guidelines.

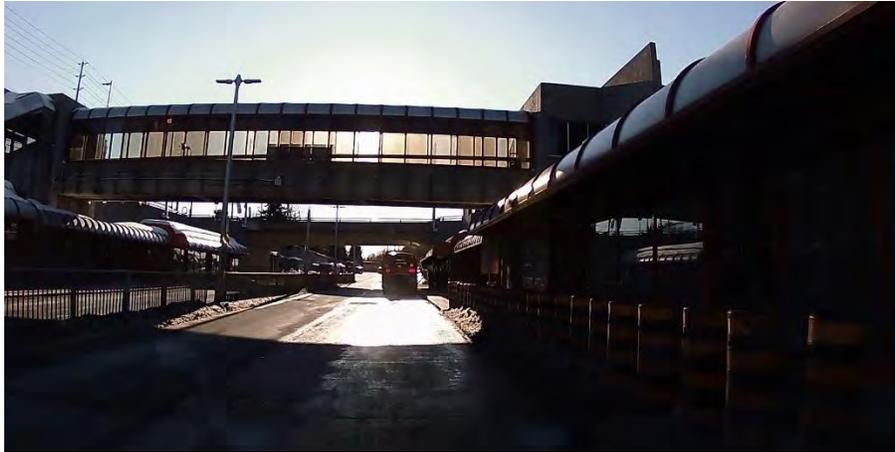
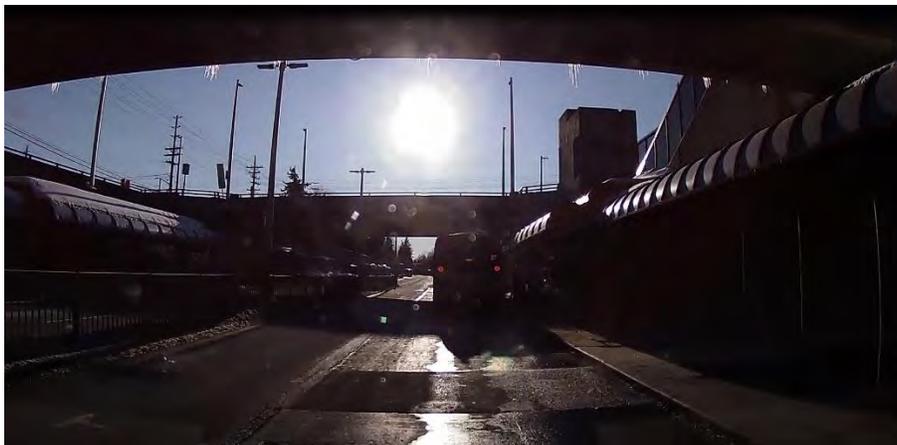
Issue: 18 Position of pedestrian bridge creating shadow area on transitway in advance of station

During sunny days a shadow from the pedestrian bridge is cast onto the transitway at the east end of the station on the westbound approach.

On these days when the sun is positioned in the southern sky directly in line with the Transitway. Drivers may experience bright glare from the sun straight ahead, then a very brief few seconds of darkness immediately followed by a bright sun directly in their cone of vision again. For drivers, this circumstance would test two visual factors in the driving task, adaptation, and glare sensitivity. Adaptation is the ability to change in sensitivity to different levels of light, as adjusting to changes in light upon entering the shadow area. Glare sensitivity is the ability to resist and recover from the effects of glare, as experiencing a reduction in visual performance due to the sun's glare upon exiting the shadow area.

Consider a sunscreen to block out the sunlight on the transitway.

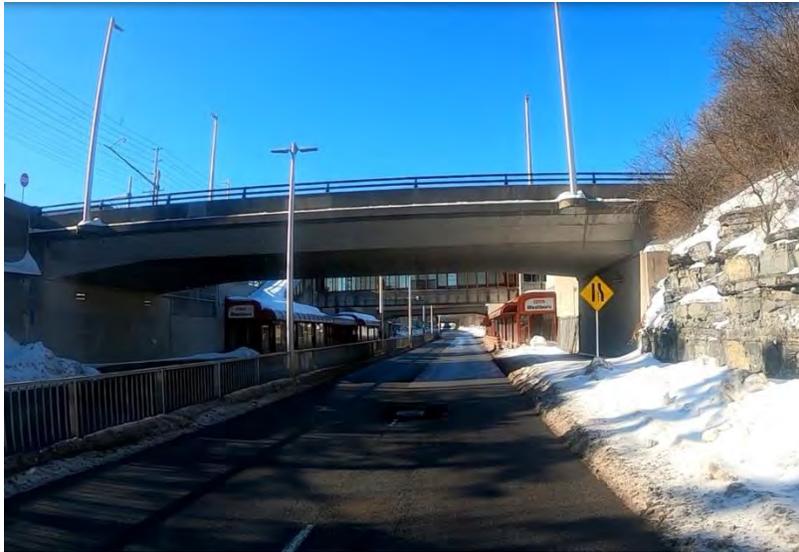
Issue 21: Merge warning signs for lane merges on exiting the Westboro station

The westbound merge warning sign, for the lane merge on exiting the Westboro Station, is located just east of the station. This is a high driver workload location; the transit driver is focusing on activity and vehicle movements within the transit station and does not need the merge warning information until after the station.

In the eastbound direction, there is no merge warning sign to warn drivers of the need to merge as the right lane ends and tapers into the left lane.

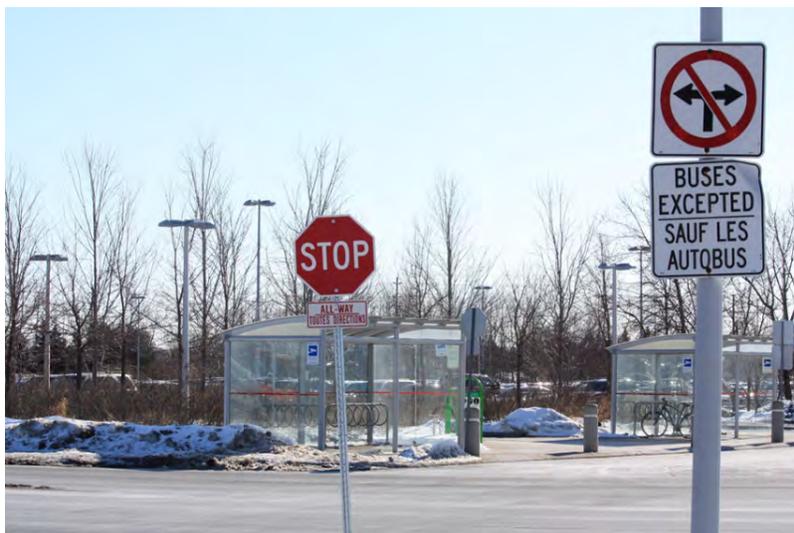
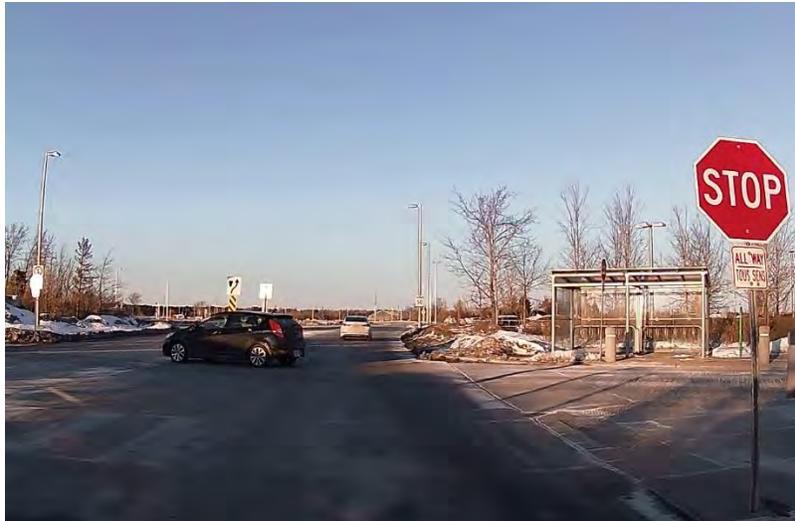
Issue 24: No redundant entry prohibition signs for motorist egress from VIA Rail station

There are turn prohibition signs on the approaches to the crossing of the VIA RAIL Station access and the transitway to advise motorists crossing the transitway not to enter onto the transitway. However, at times this intersection is very busy with many crossing pedestrians as well as vehicles accessing the VIA Rail Station and transit vehicles at the intersection which could distract a driver's attention. Should a driver travelling to and from the rail station not see these turn prohibition signs when approaching the intersection, they may mistakenly turn onto the transitway. As shown in a picture below, a passenger car was observed on the transitway during the onsite audit. There are no signs at the intersection to advise the driver not to enter onto the transitway.

Install Entry Prohibited (RB-23) signs with a Tab “Except Buses” at the throat of the transitway. Double signing is suggested.

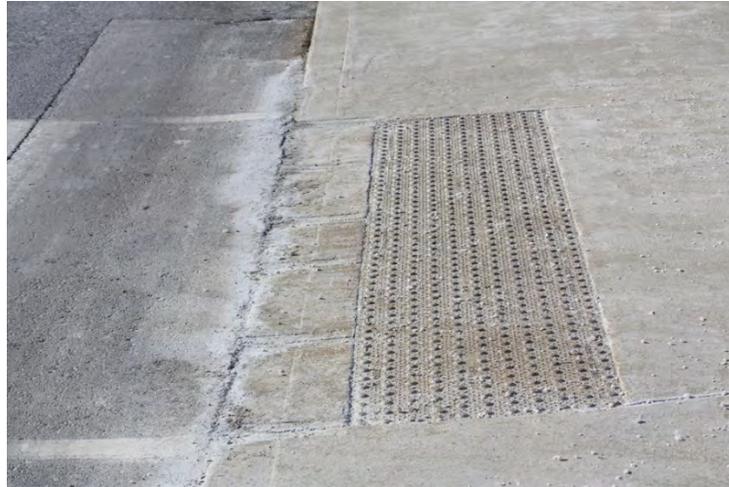
Issue 26: Conspicuity of tactile surface

The tactile surface for the entrance to the crosswalk is not conspicuous in comparison to the concrete sidewalk. Most people with a visual impairment have some sensory abilities but may not be able to discern between objects unless they have high contrast. Many people start to suffer vision loss after the age of 65 years. For these people, there may be a limited perception of the path ahead and obstacles. Such people would need to rely entirely on non-visual indicators to find this textured plate.

Install Accessibility for Ontarian with Disability Act (AODA) approved high tonal tactile surface. Although the colour of the tactile surface is not specified in AODA, the common high contrast colour standard for most jurisdictions in North America is yellow.

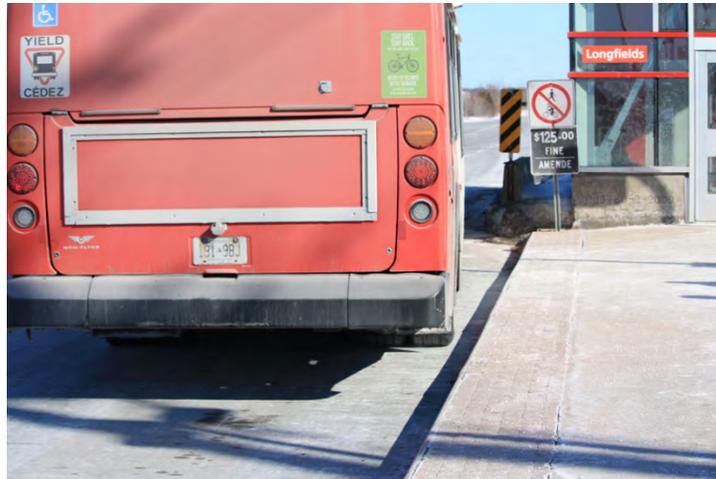
Issue 31: Concrete barrier – Rear swept path of double decker (rear out swing) intrudes onto platform

The rear swept path of transit vehicles leaving the station with an abrupt turning maneuver can intrude onto the passenger platform. This is especially a concern for double decker bus which have a long overhang behind the rear axle.

Remove the concrete barriers with a blunt end from the travel lane. Or install a TL-3 F-Shape concrete barrier along the edge of the platform with a pedestrian railing 1000mm high of appropriate length of need and taper to shield passengers on the platform from the swept path of the articulated bus.

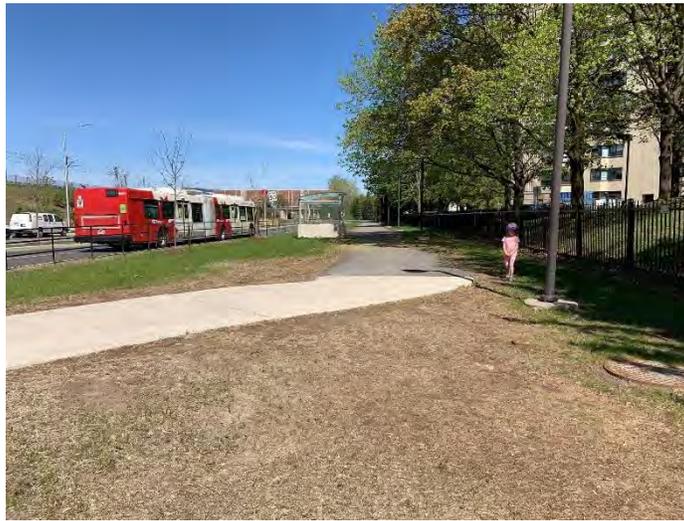
To the southeast, an asphalt MUP transitions to concrete before meeting the crossing. While not regulatory, in Ottawa this is commonly used as a visual queue for cyclists that they should dismount and walk.

It should be confirmed whether a mixed crossride is appropriate and desirable for this location. OTM Book 18 notes that mixed crossrides are “for low volume crossings, particularly at unsignalized locations where practitioners do not anticipate queuing of pedestrians or cyclists”. This does not appear to be a low volume crossing, and queuing of users would be anticipated after trains disembark creating a surge of users.

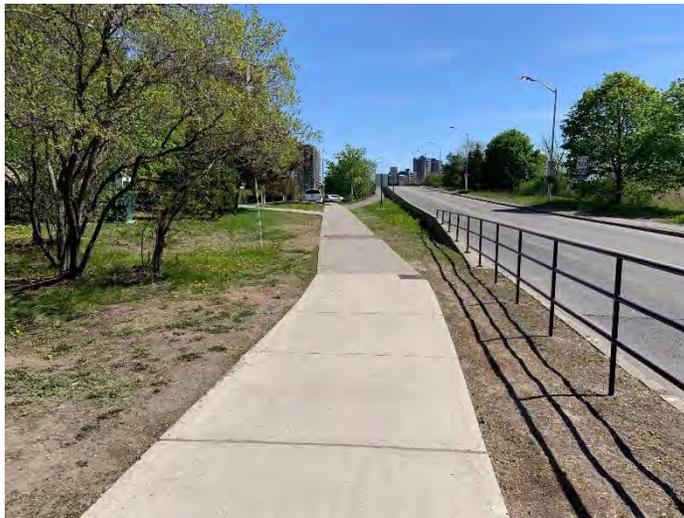
To the south, several sidewalks converge into a single concrete sidewalk. The sidewalks are too narrow to be used as shared facilities.

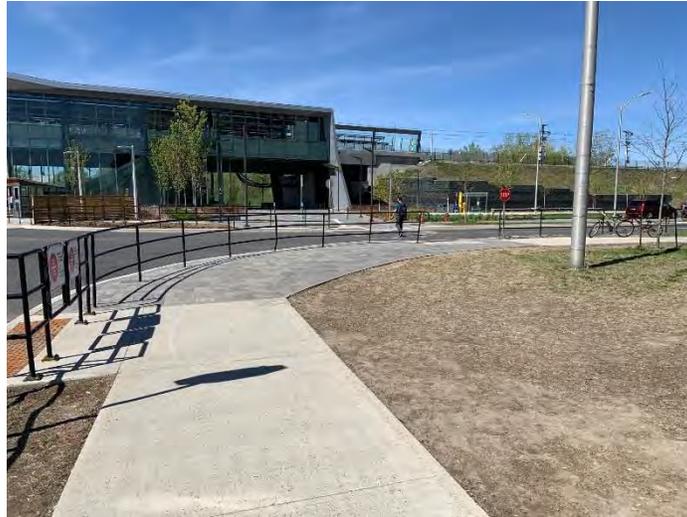
The south and southeast approaches converge into mixing zone with a paver surface, with no guidance to users on the intended use.

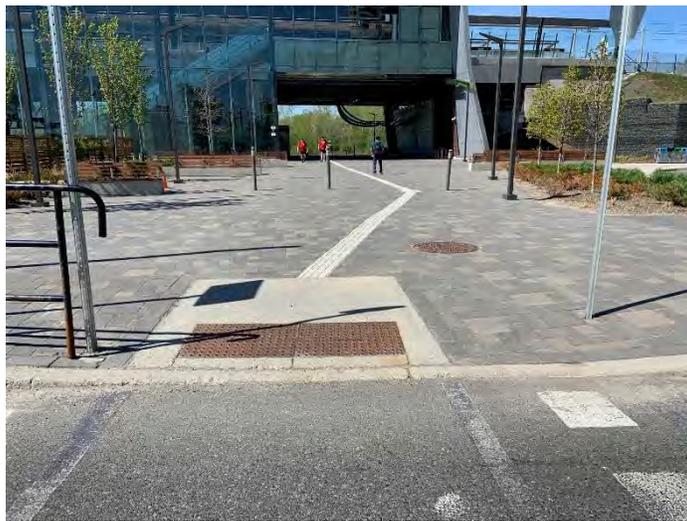
The north side of the crossing meets the station plaza. The paver surface and directional tactile pavers imply to users that it's intended as a pedestrian area, but again no clear guidance is given to users.

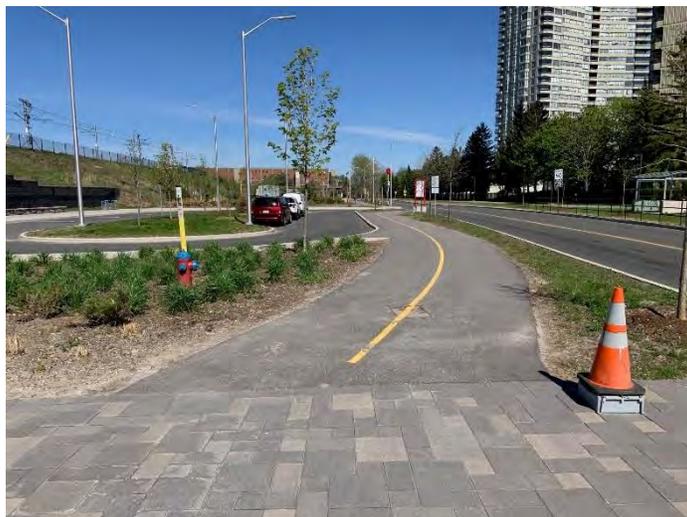
To the northeast, a MUP connects to the plaza without any signage or guidance for users.

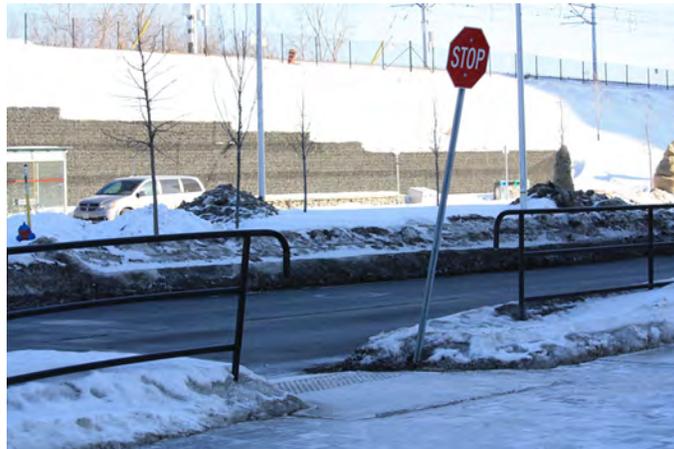
Issue 33: Main Crosswalk – STOP sign for pedestrians mounted too high

For a STOP sign that appears to be oriented to cyclists, the mounting height of the sign is very high.

If the stop sign is to be retained (refer to issue 32), the sign should be mounted at a height of 2m from the sidewalk to the base of the sign to improve the conspicuity for cyclists.

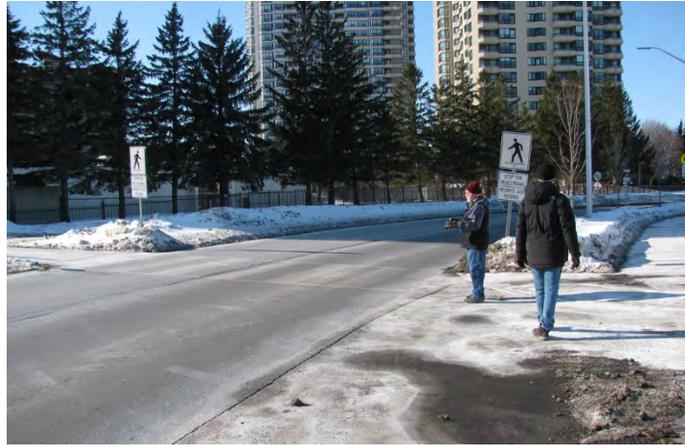
Issue 34: East Crosswalk – Luminaires not over crosswalk

There are no streetlights located immediately at the crosswalk. Therefore, illumination levels will be brighter on the road surface located away from the crosswalk and darker at the crosswalk. This may result in pedestrians in the crosswalk being less likely to be seen at night.

The RSA Team suggests a luminaire or alternatively consider a Rapid Rectangular Flashing Beacons (RRFB). The auditors note there is a commercial product that combines a luminaire that comes on when the RRFB is activated.

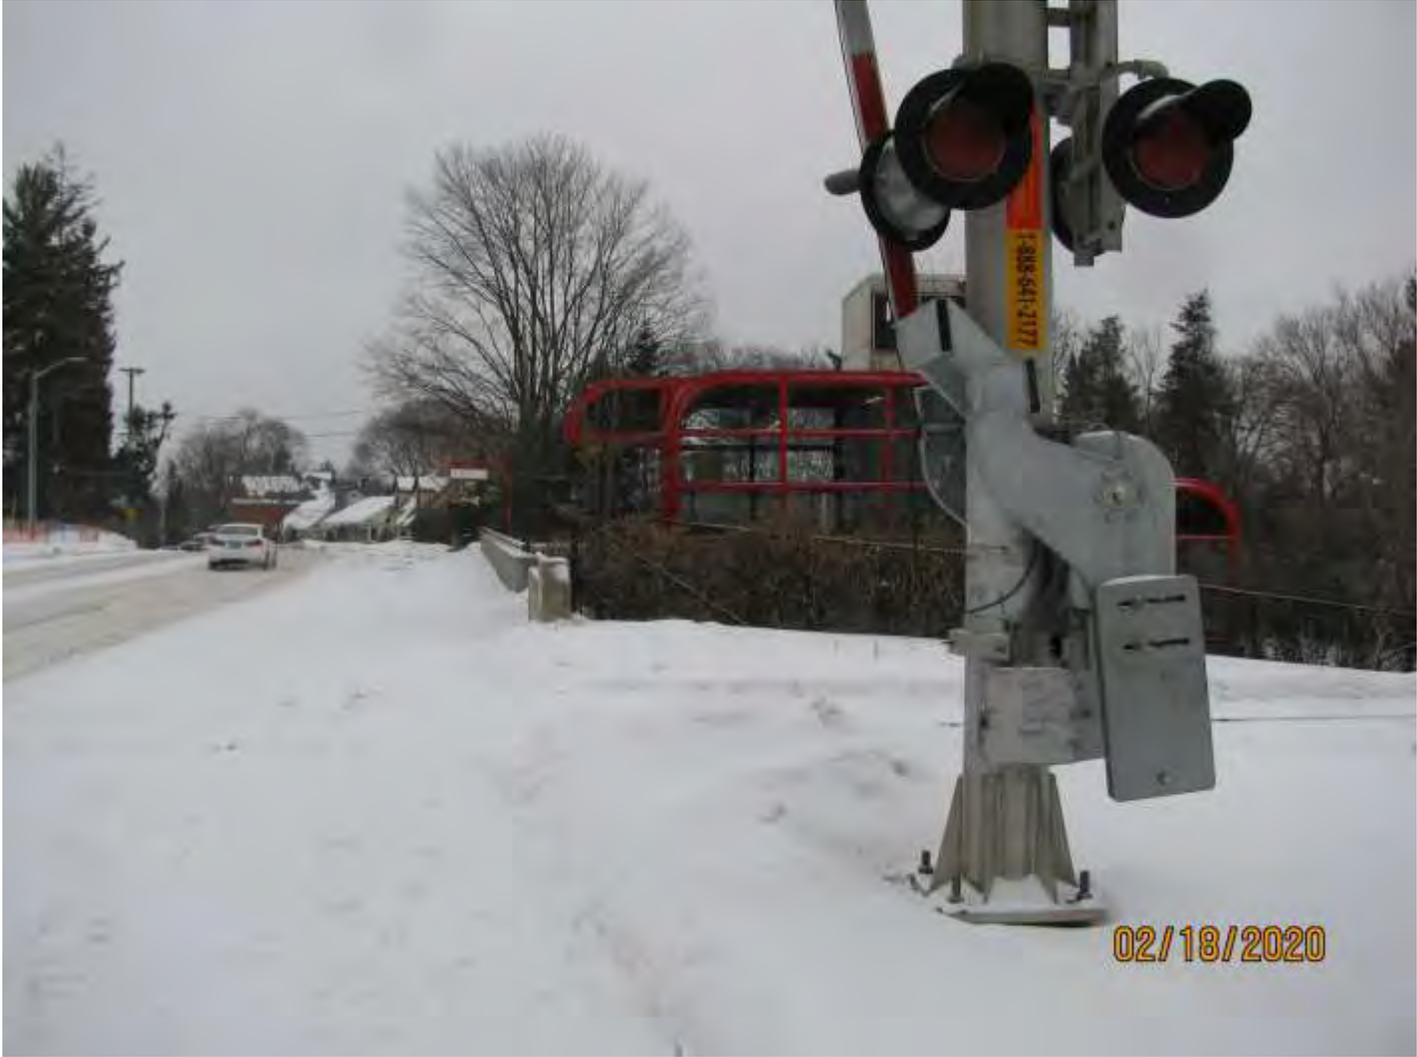
RAILWAY CROSSING

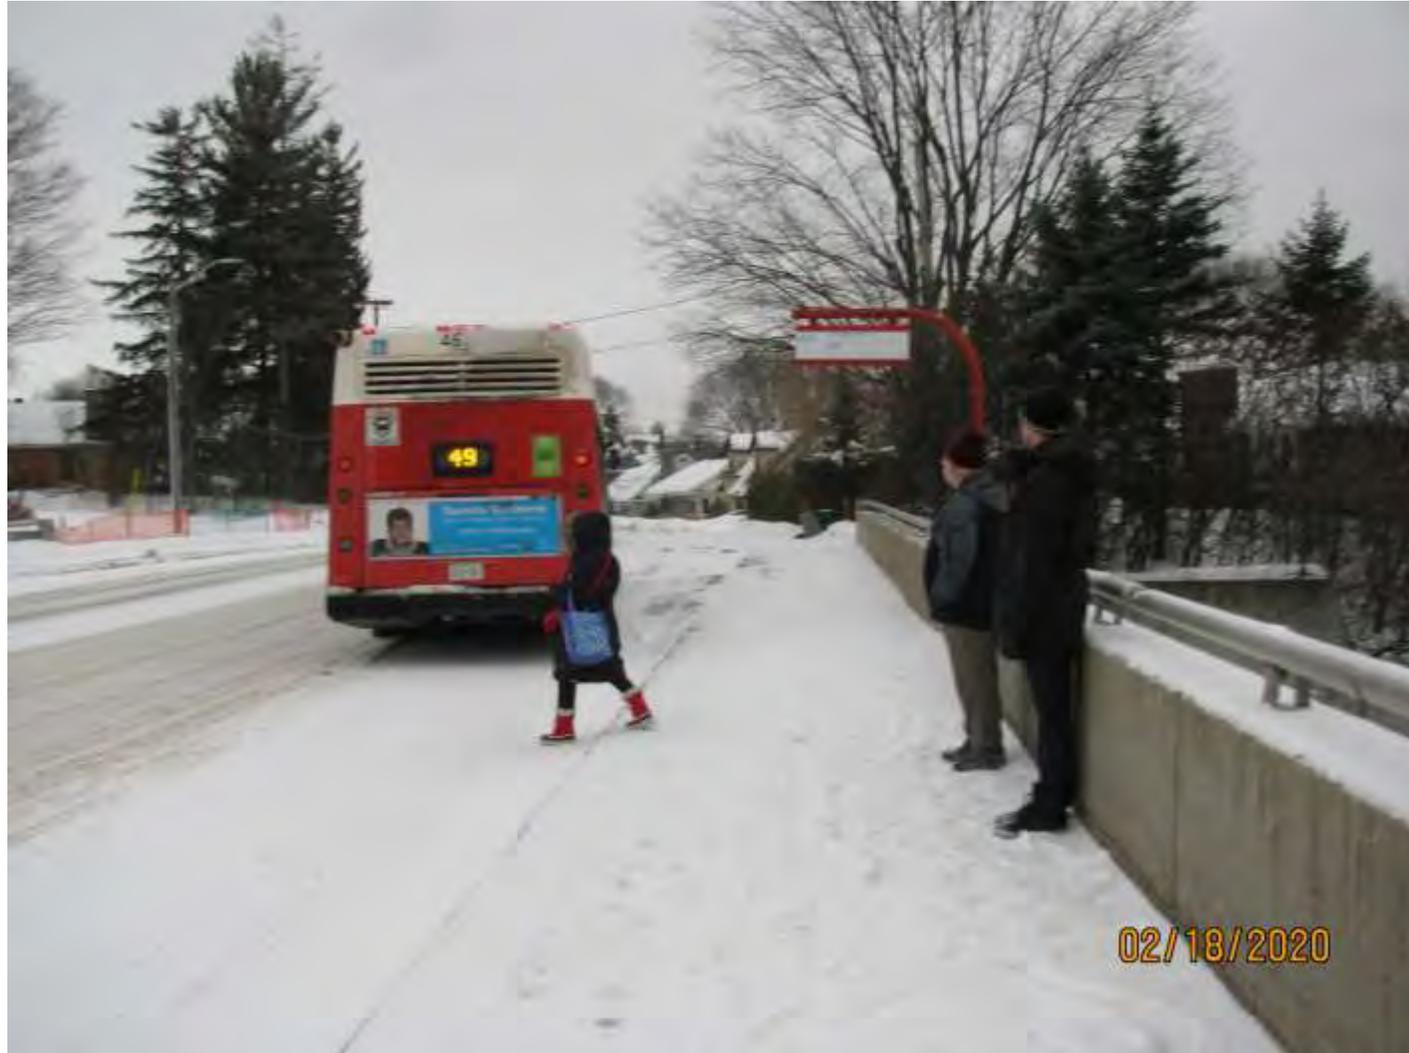
PEDESTRIAN CROSSING ACTIVITY

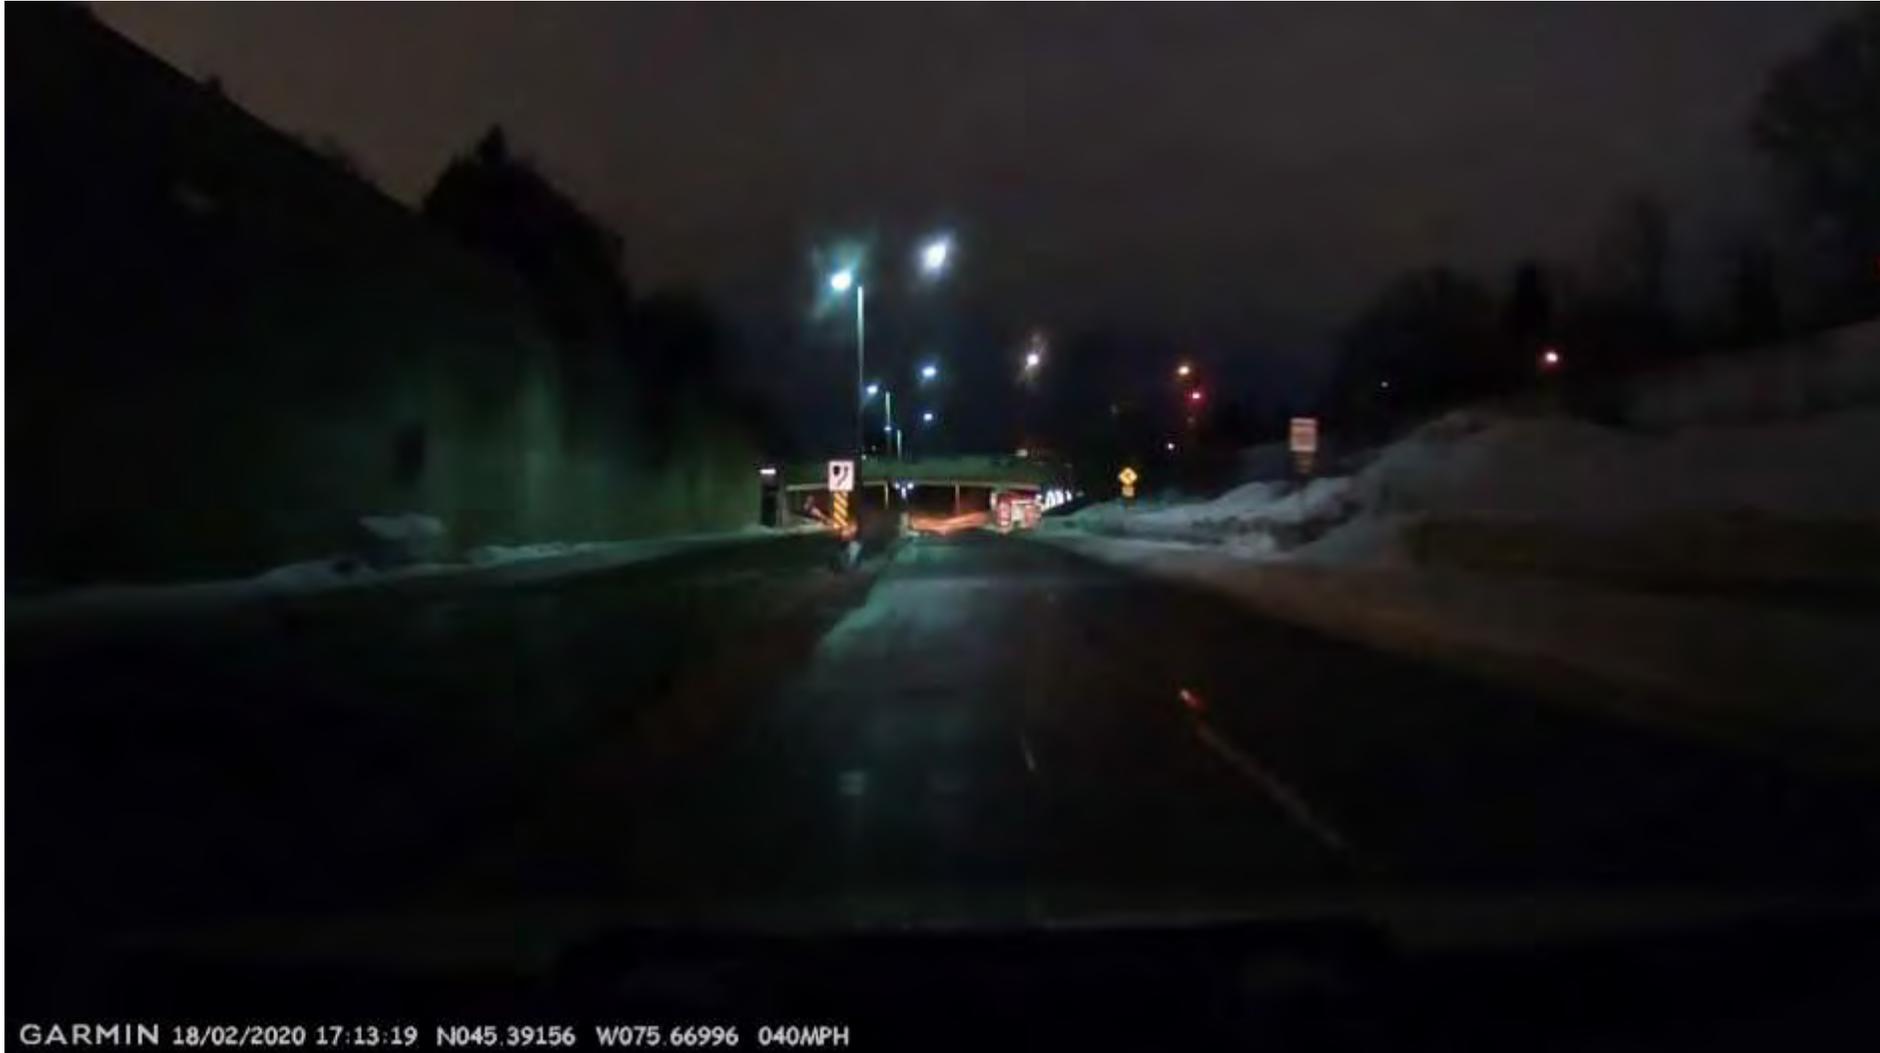
REVERSE CURVE WARNING SIGN ON TRANSITWAY

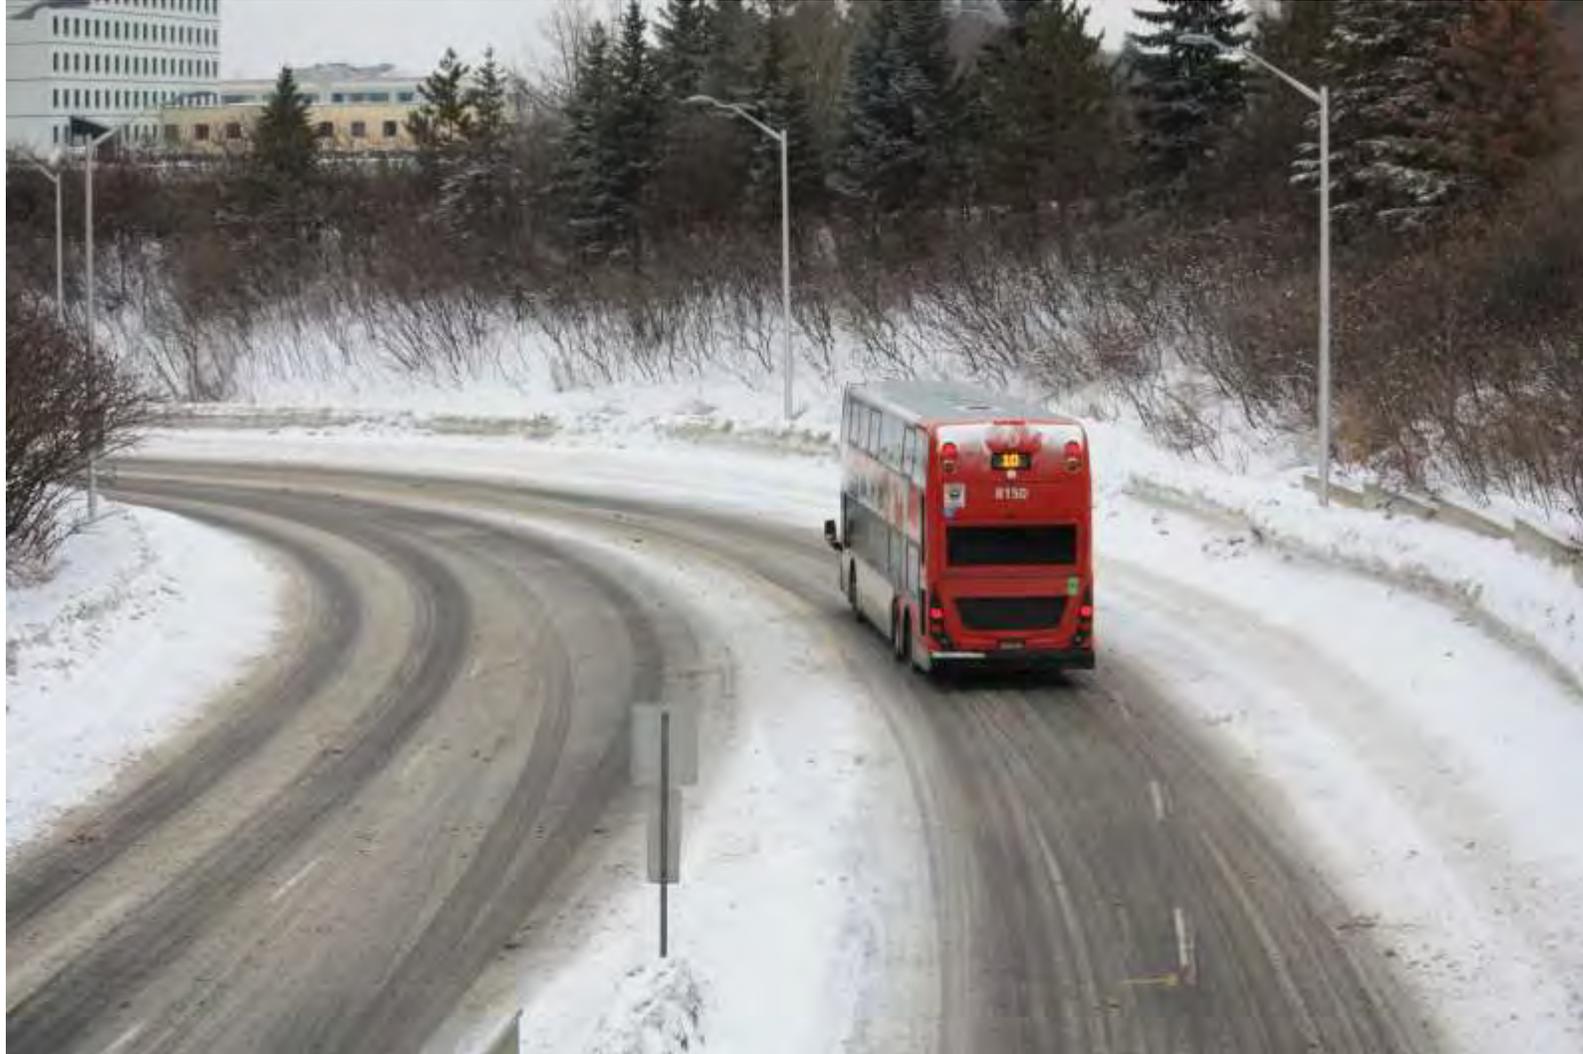
REVERSE CURVES – ADVISORY SPEED SIGNING

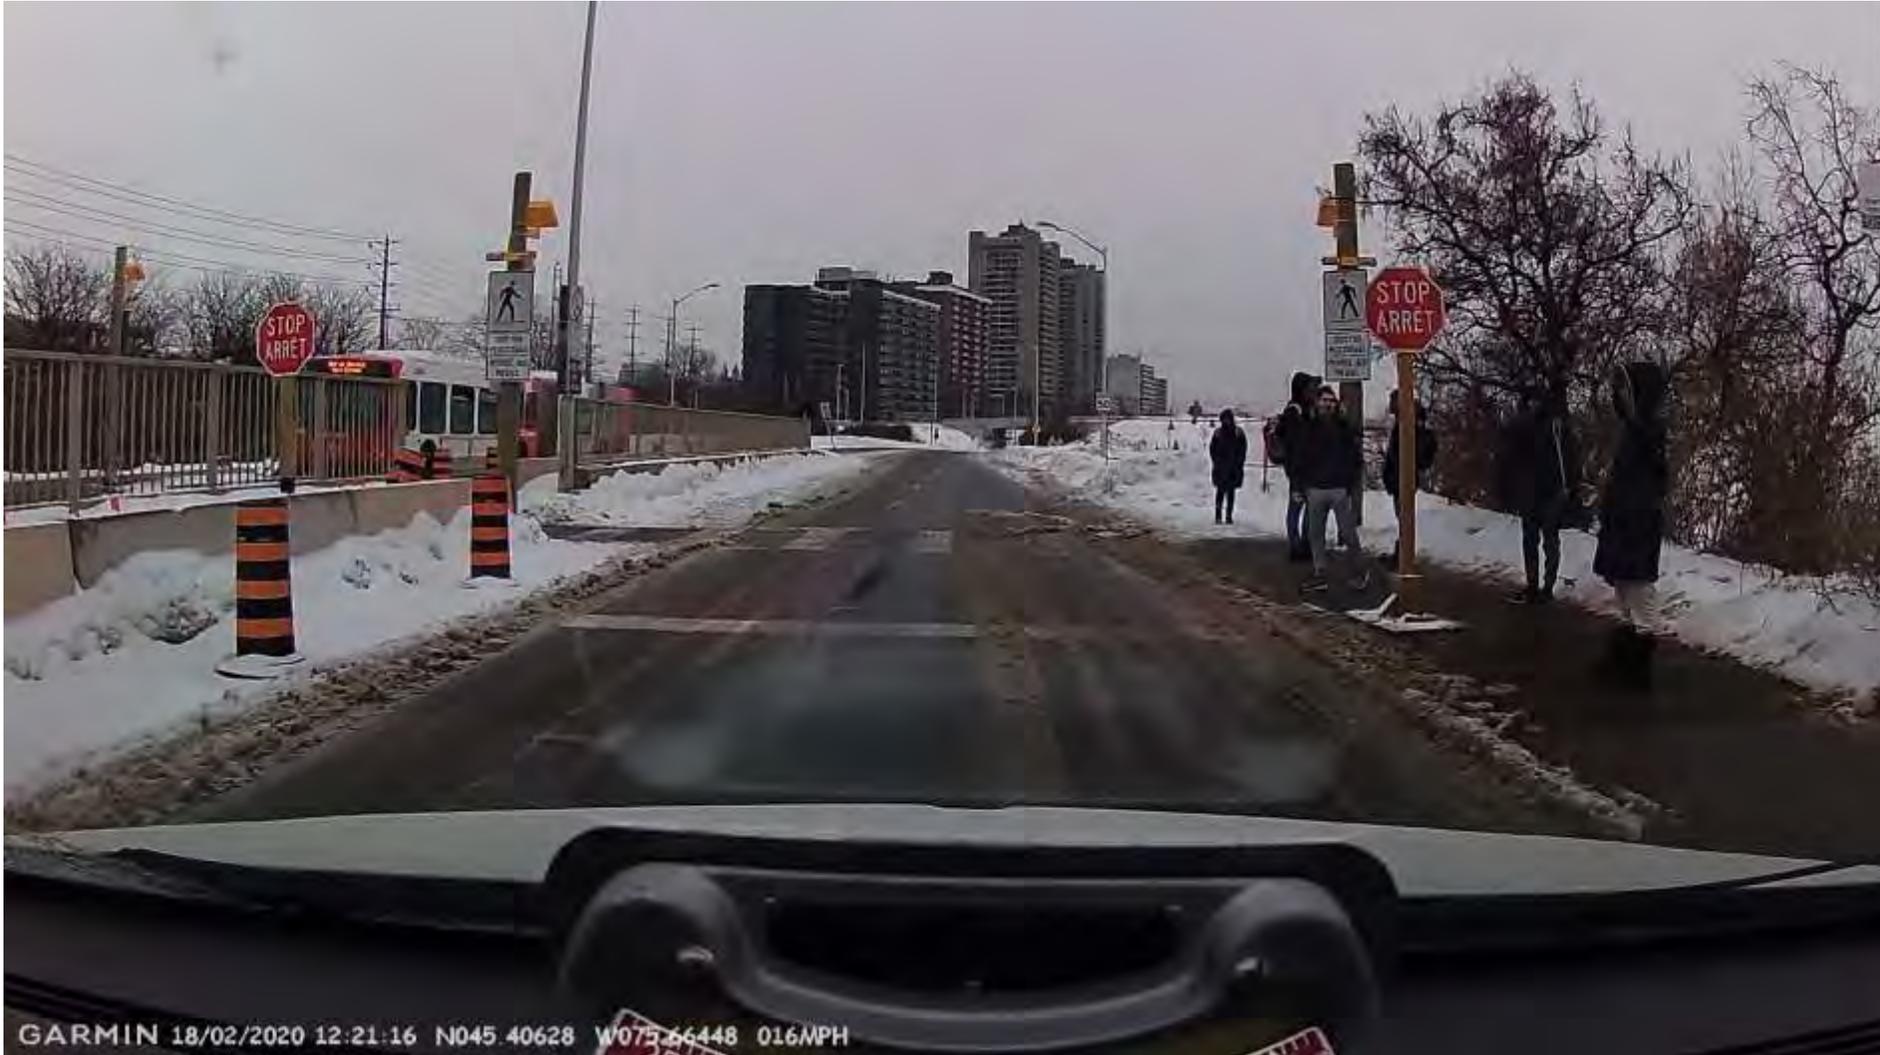
PEDESTRIANS AT TEMPORARY CROSSING

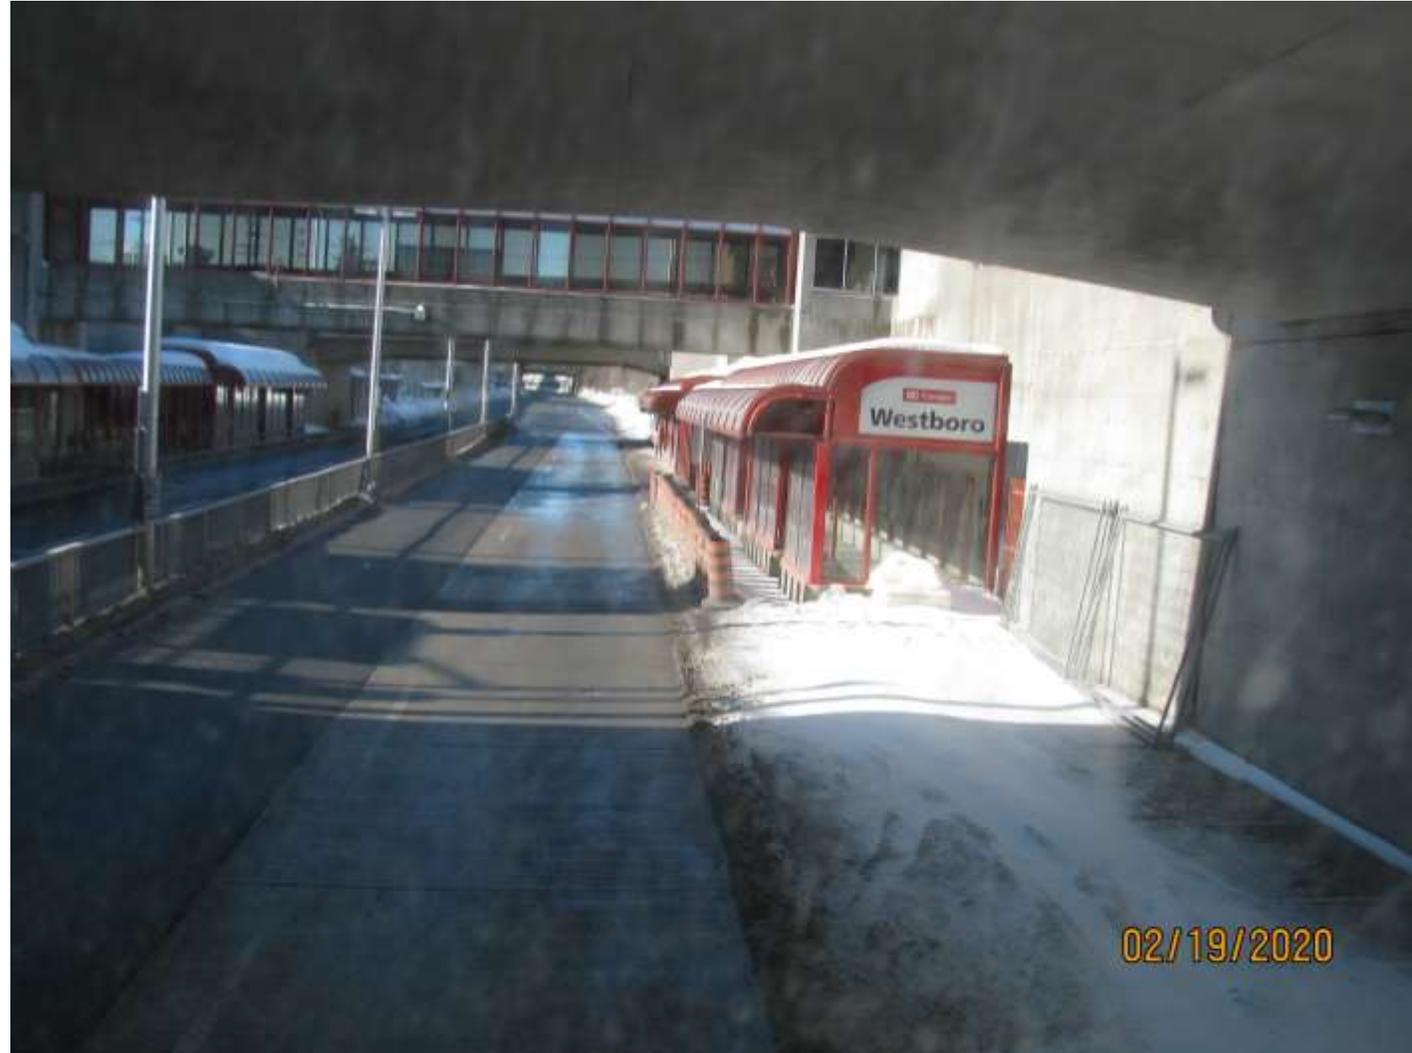
NO PROTECTION FOR TRANSIT PATRONS ON PLATFORM
