OC Transpo Transitway Station Design Safety Study

Independent Safety Study

Final Safety Study

September 2021

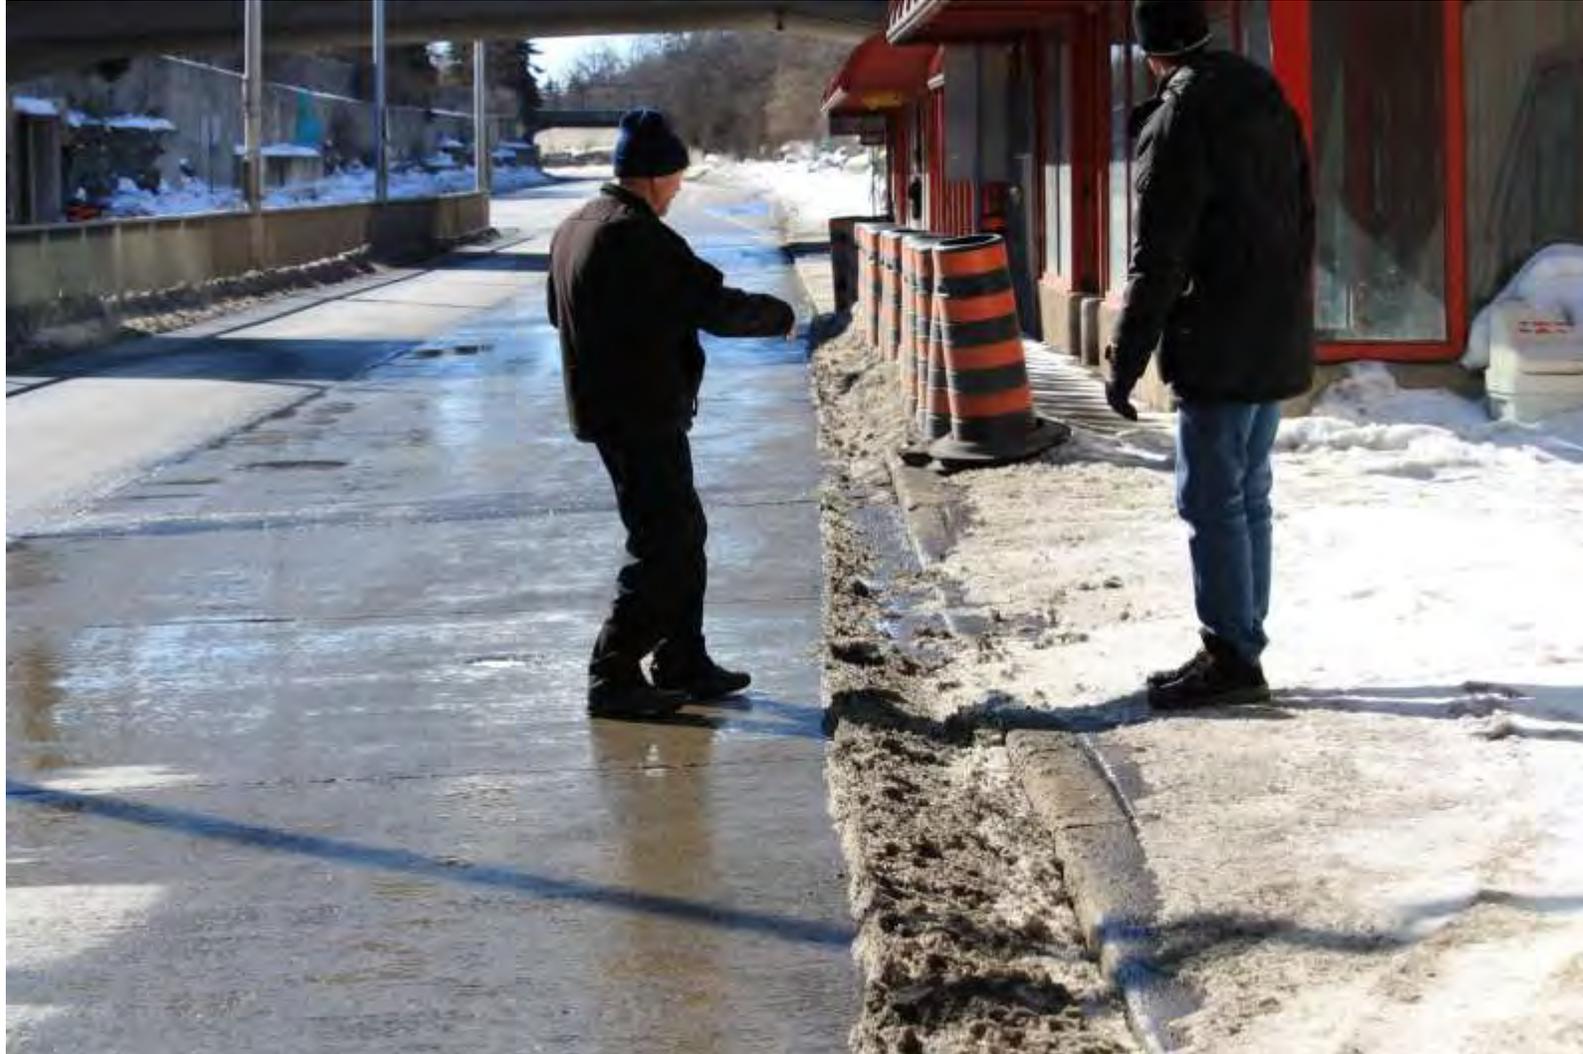
SERVICE VEHICLE LETDOWN LOCATION

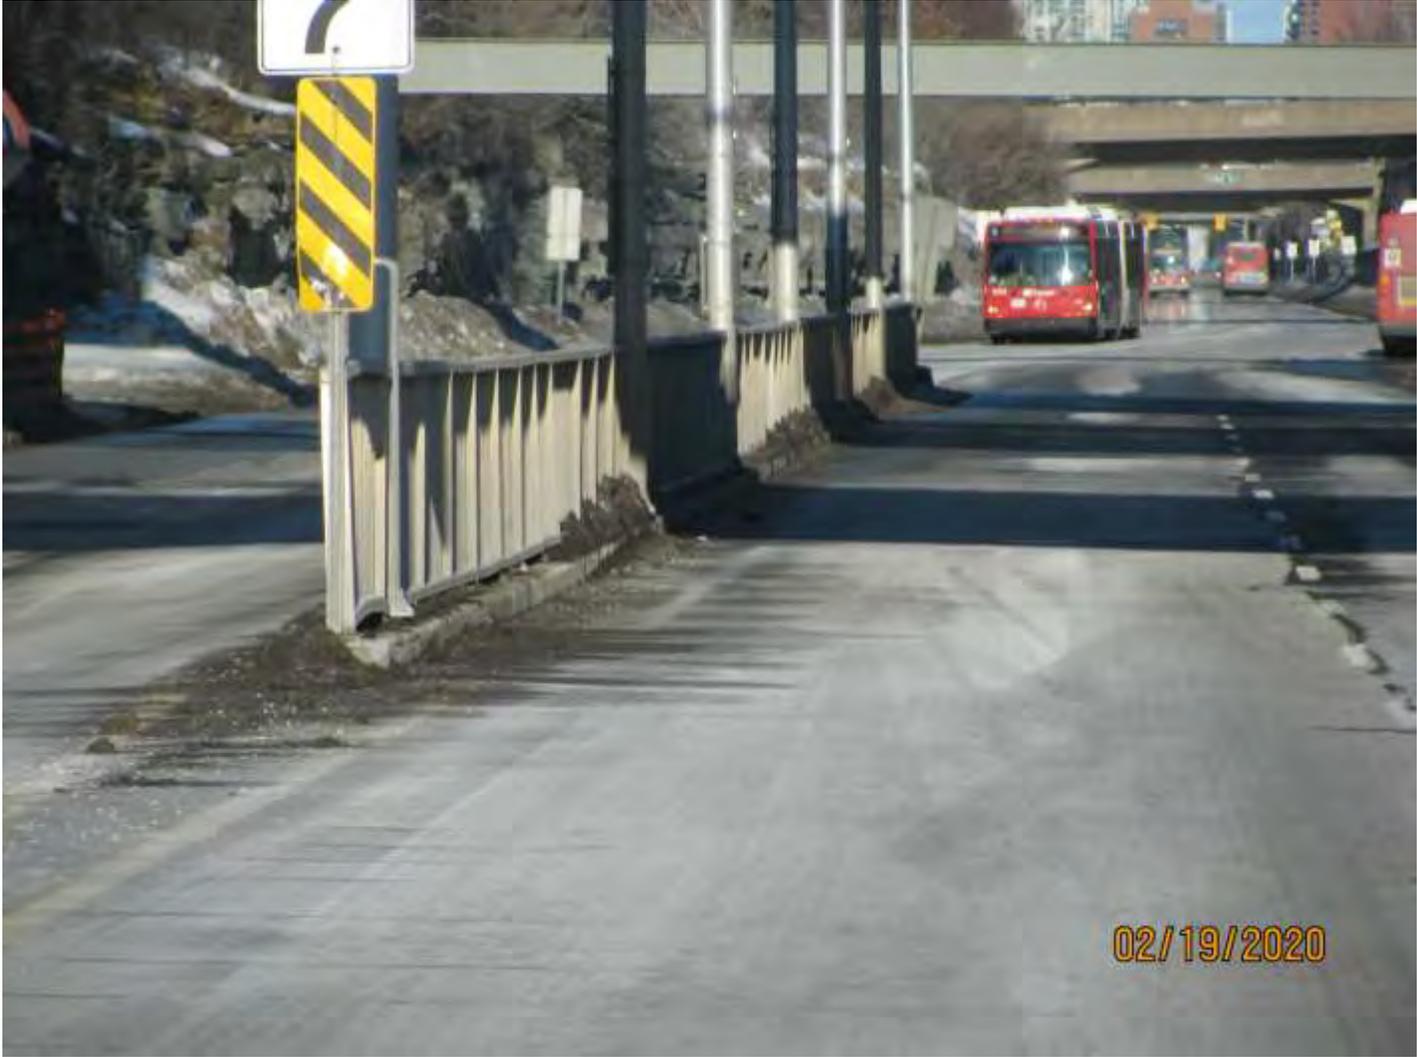
MEDIAN BARRIER DESIGN

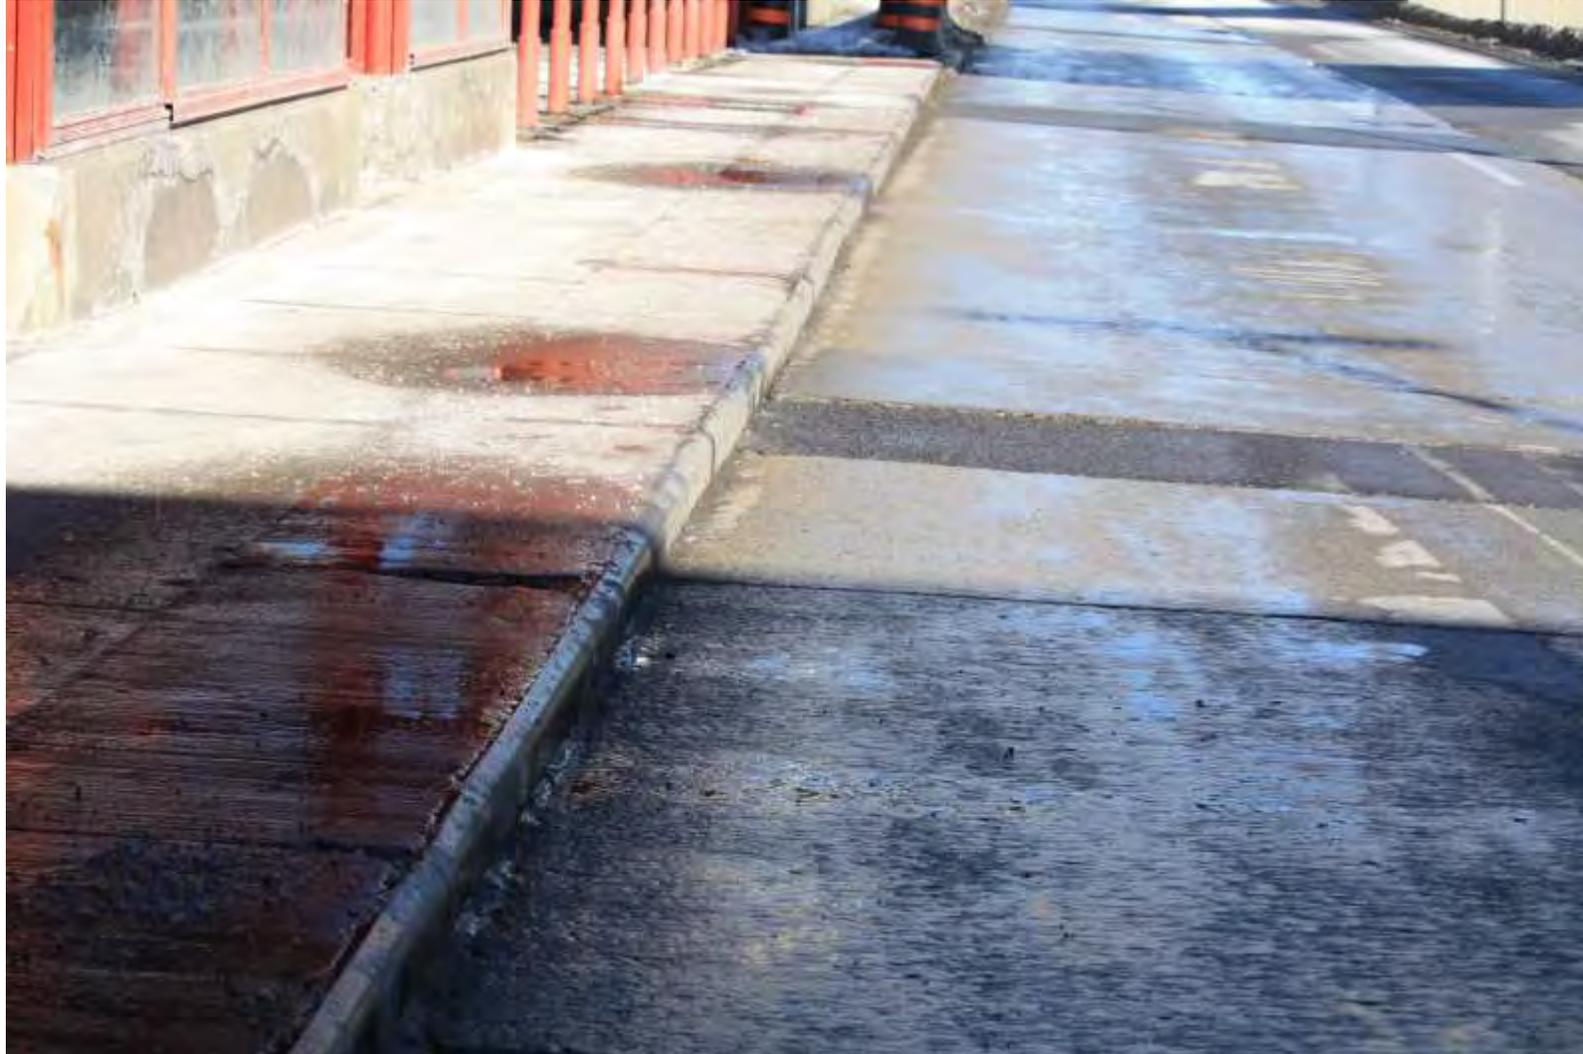
CONSPICUITY OF PLATFORM EDGE

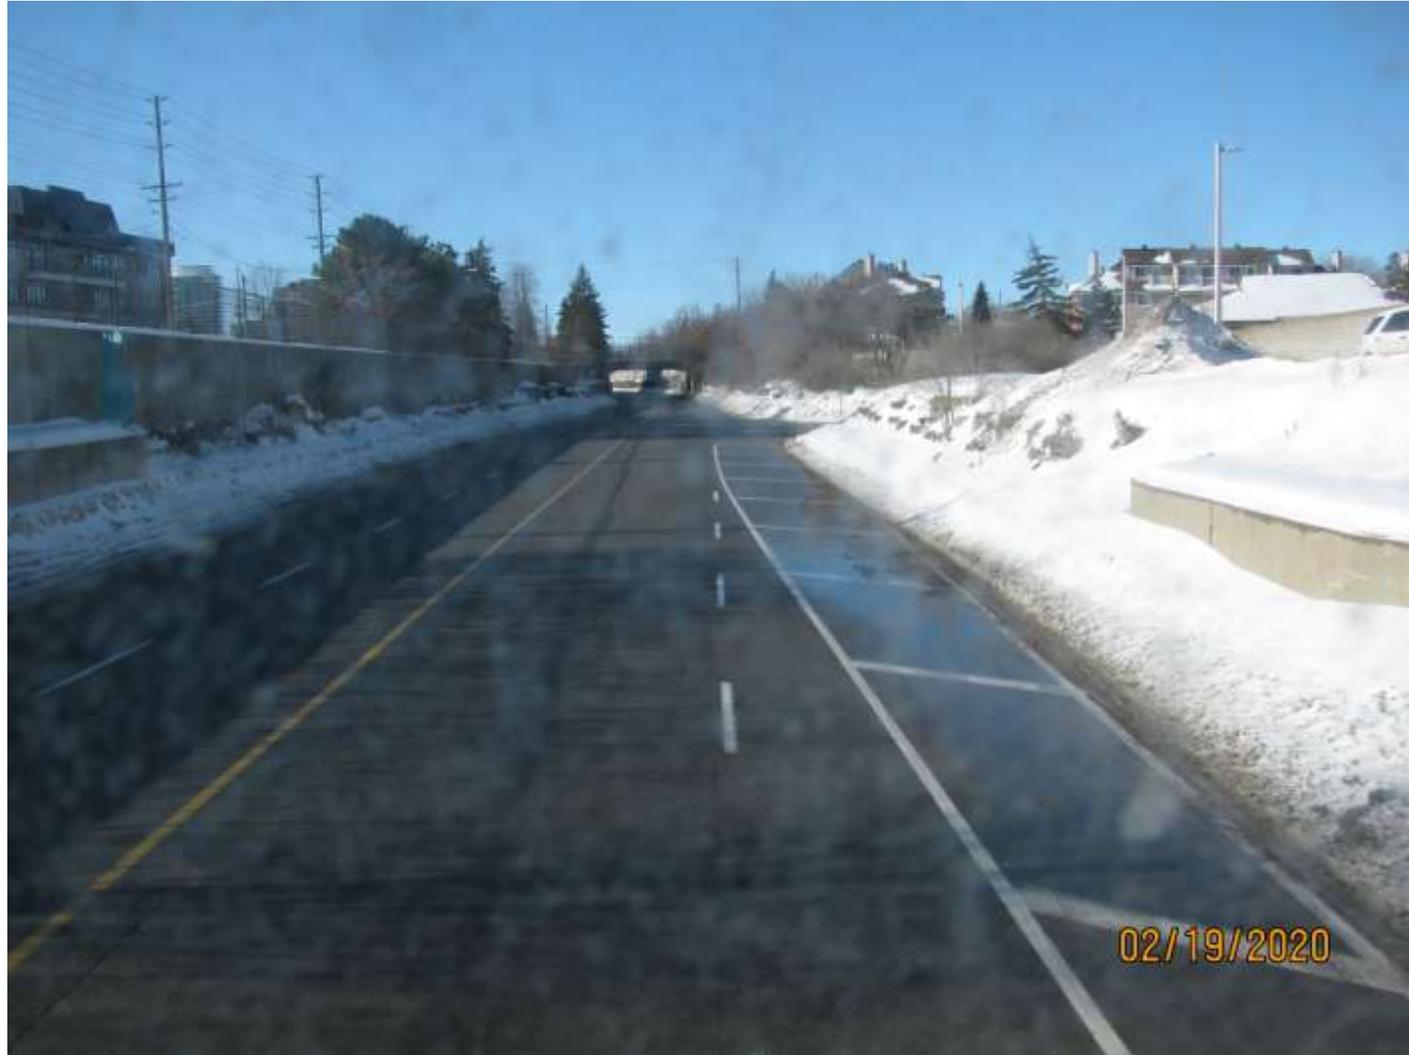
DEPARTURE MERGE

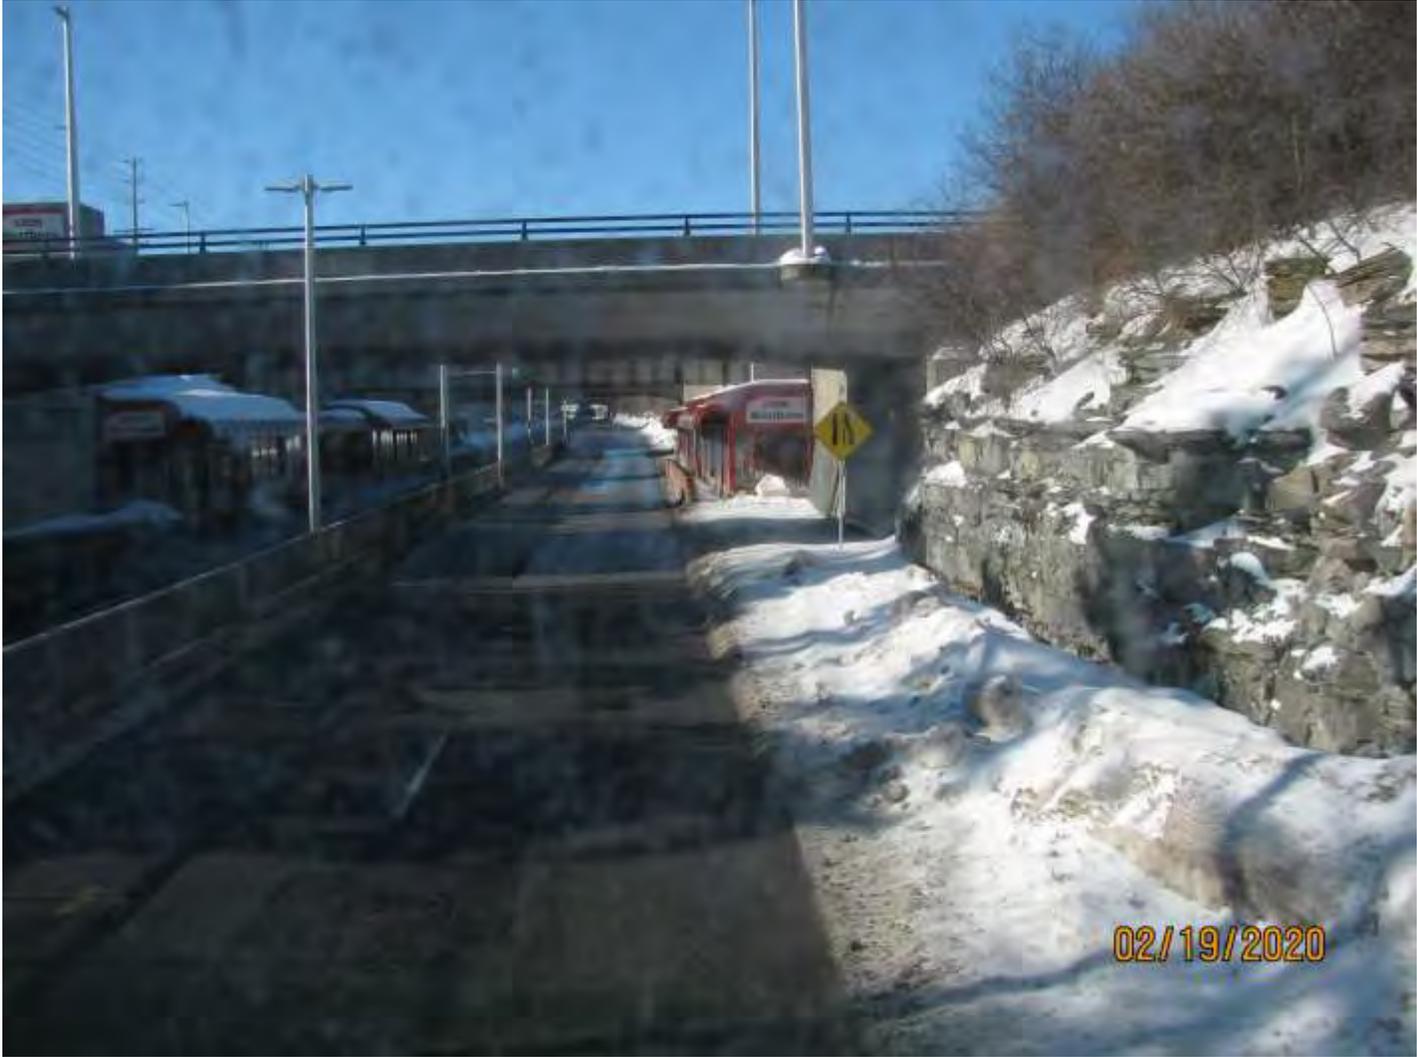
LOCATION OF MERGE WARNING SIGN

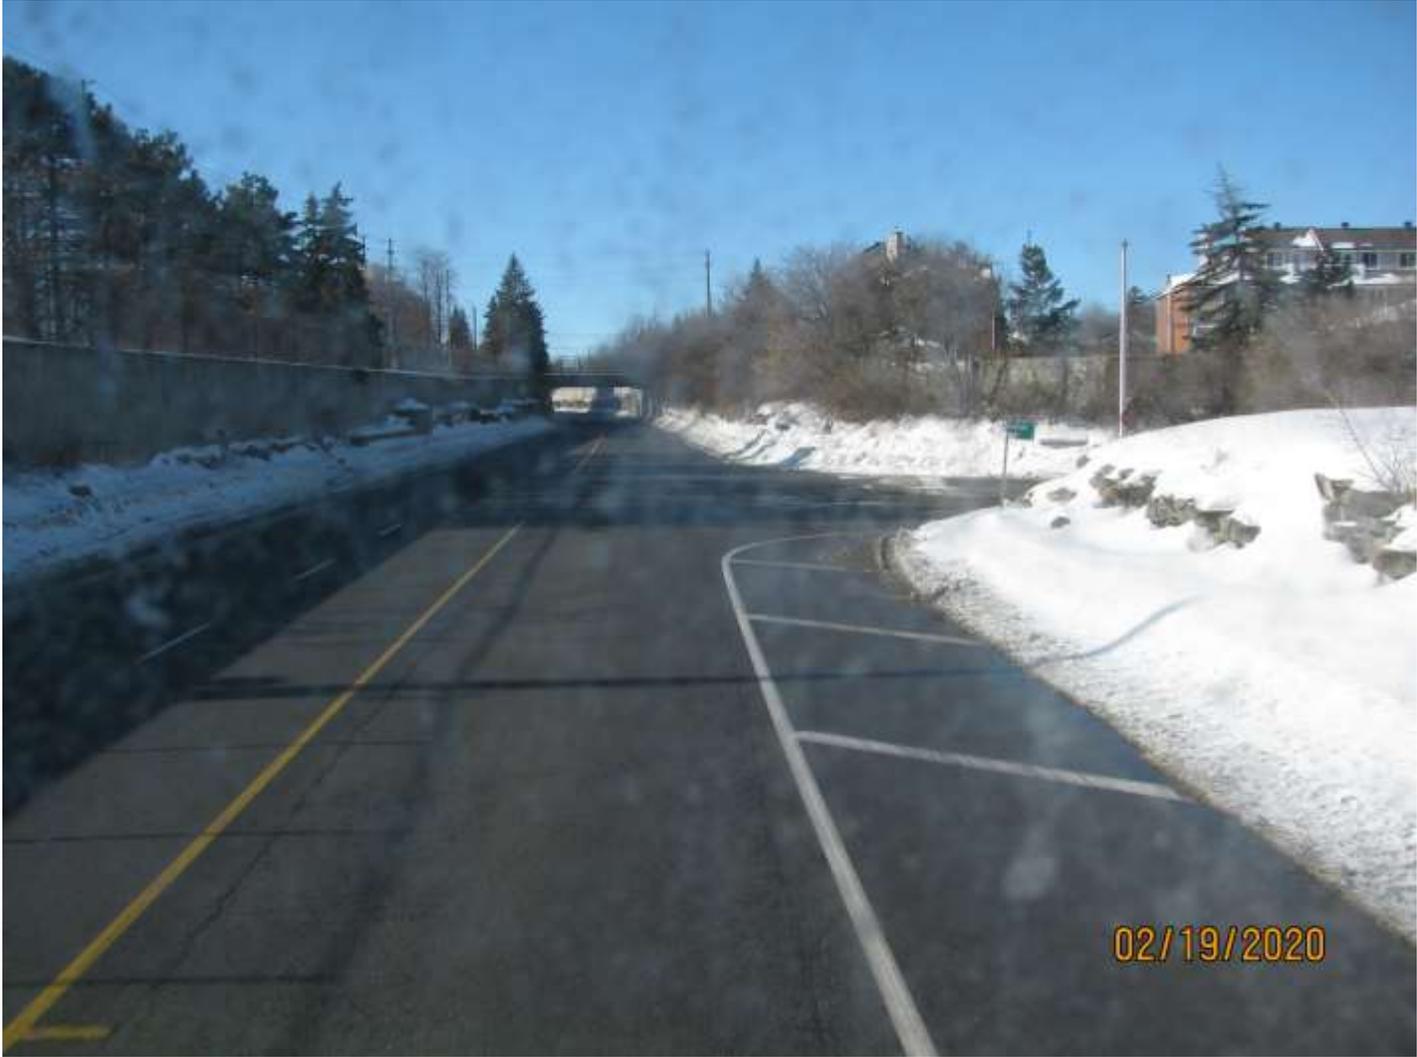
GORE AREA

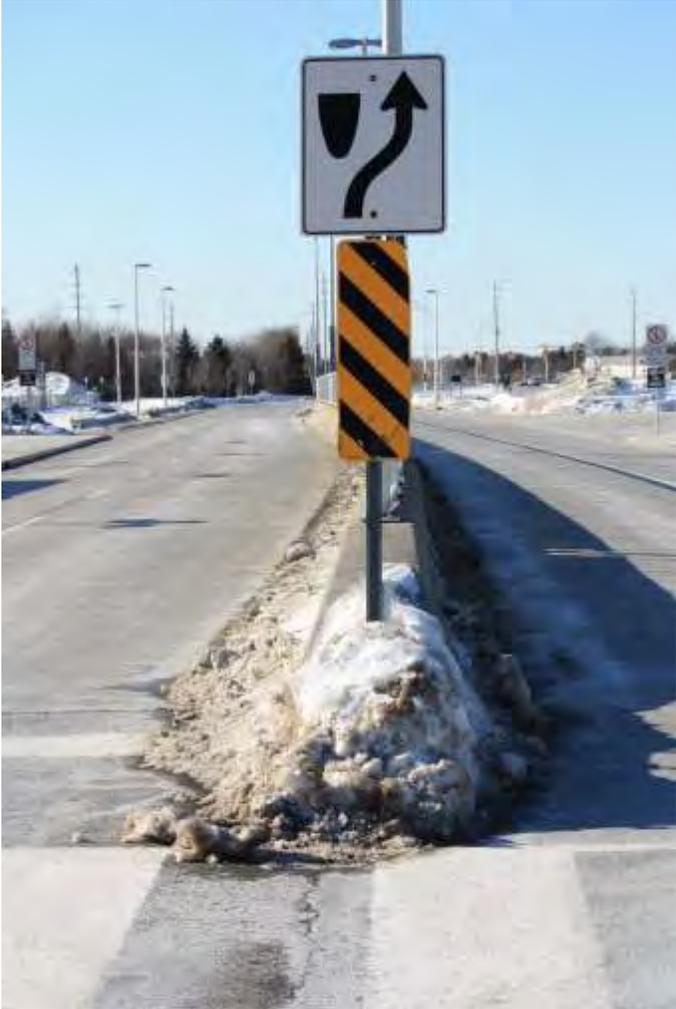
NO ENERGY ATTENUATION AT MEDIAN BARRIER

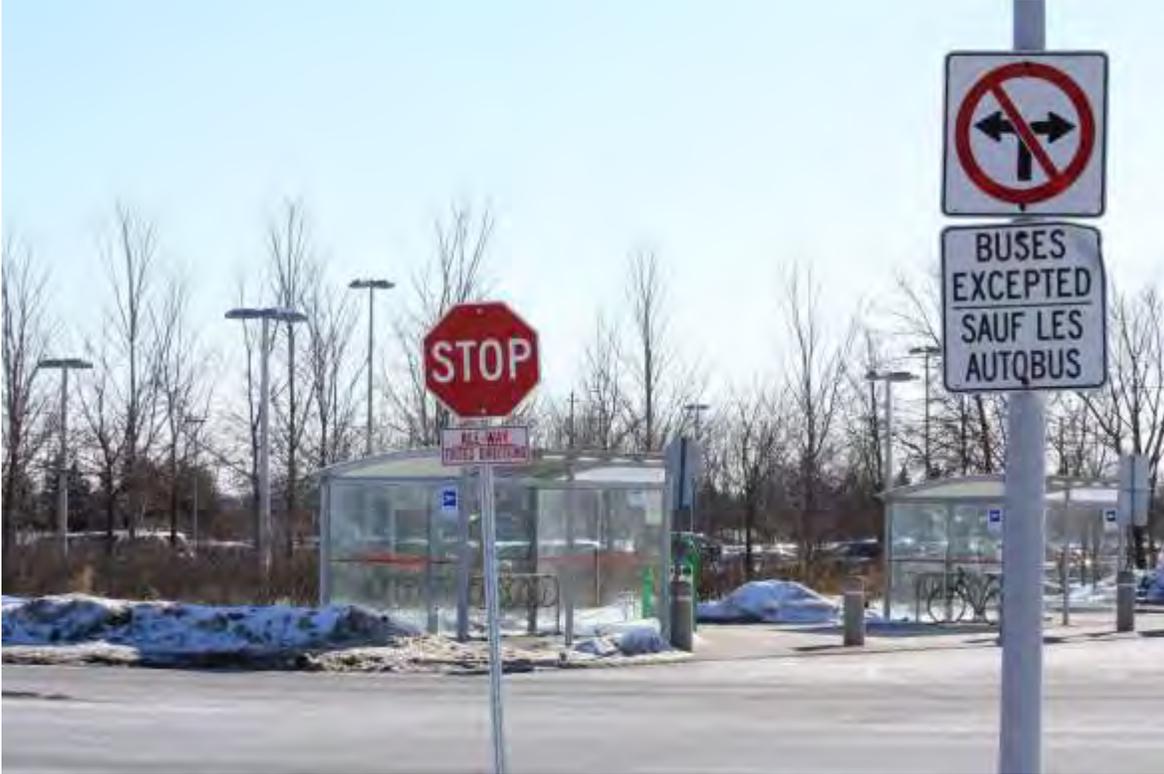
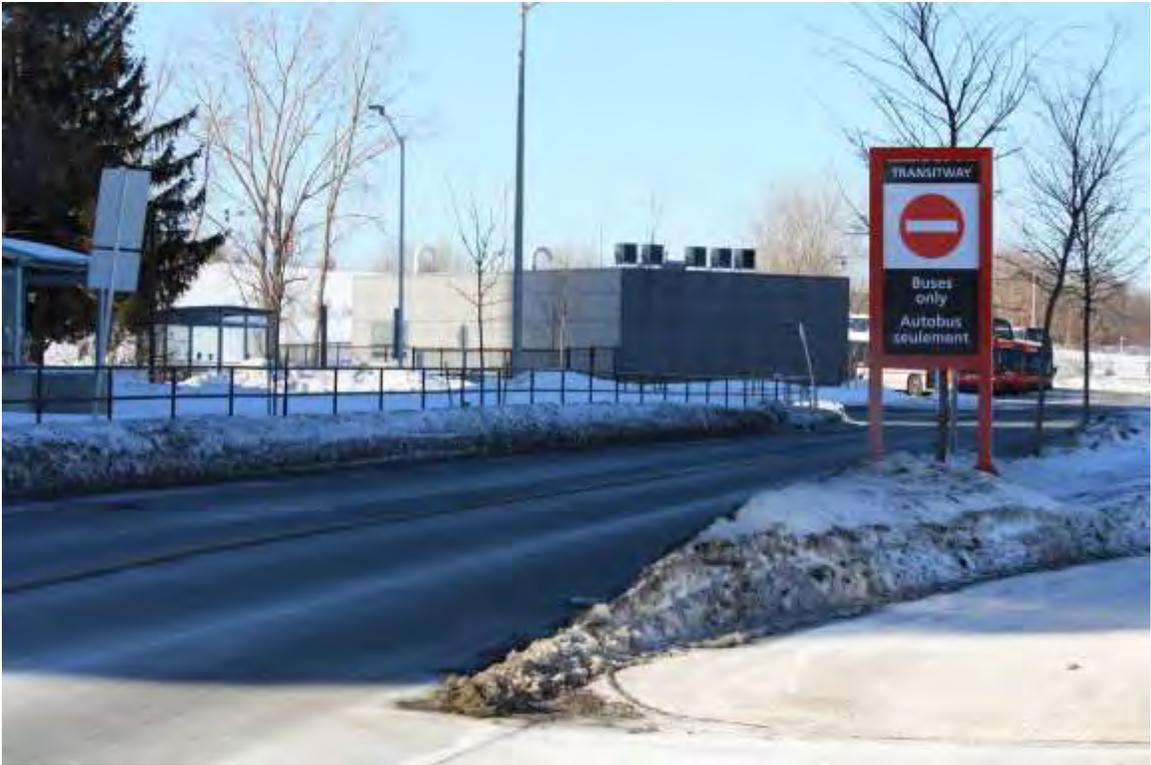
UNAUTHORIZED VEHICLE PROHIBITION SIGNING

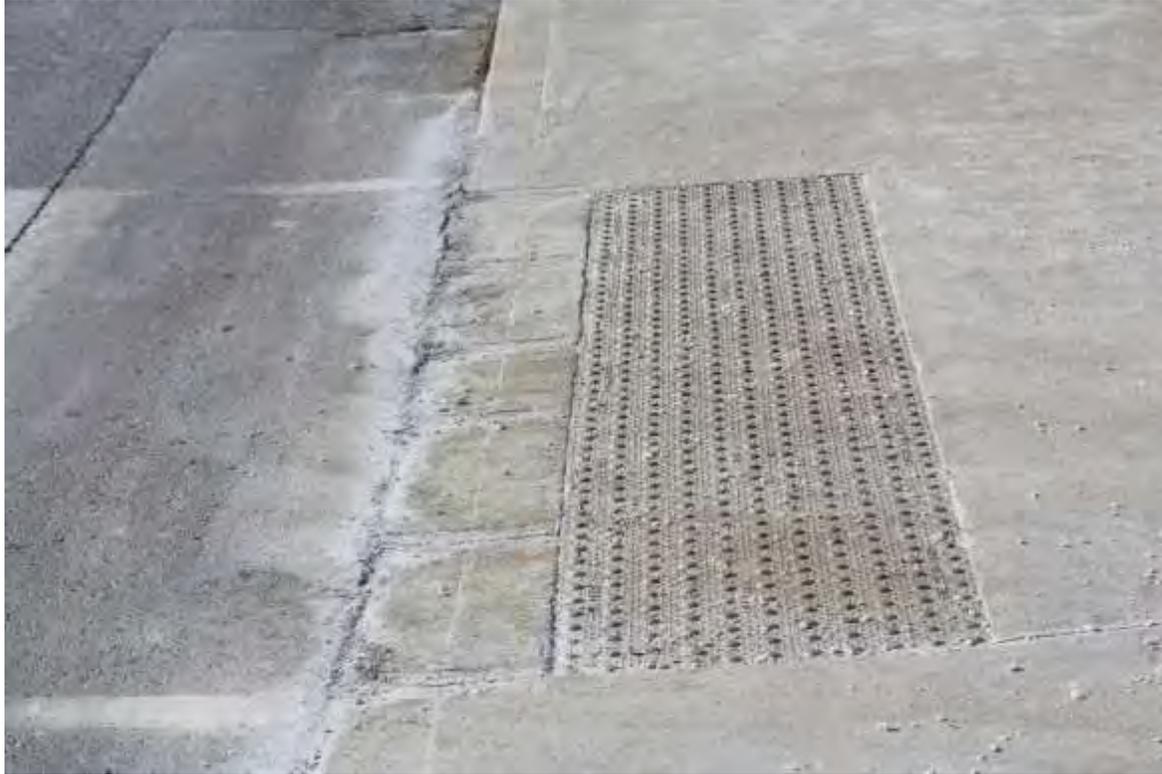
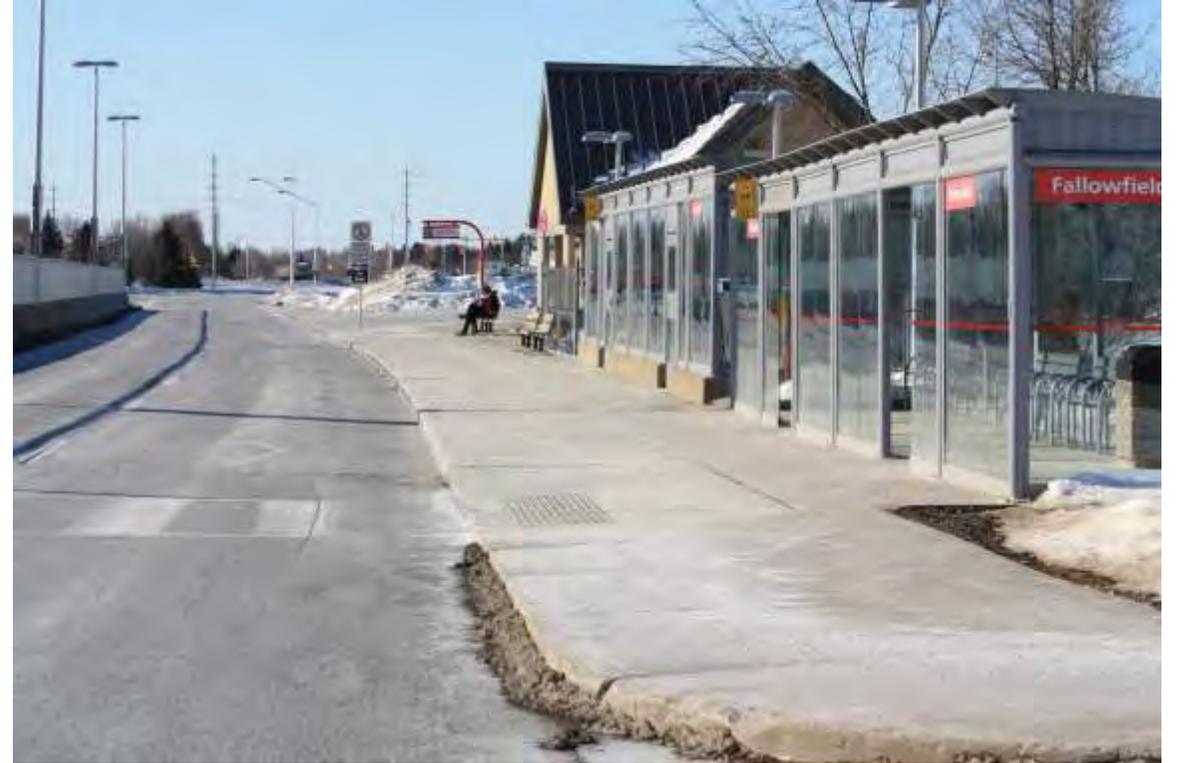
TACTILE SURFACE AT CURB RAMP FOR CROSSWALK

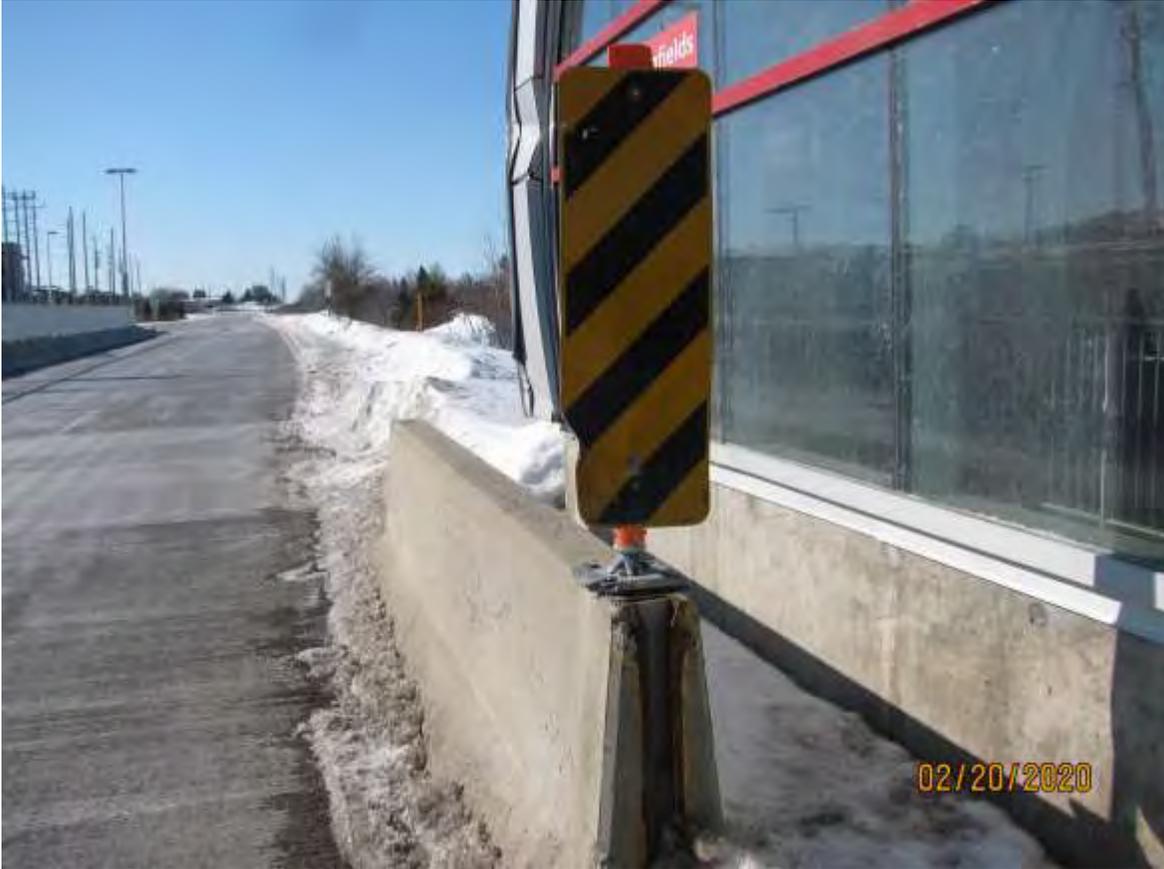
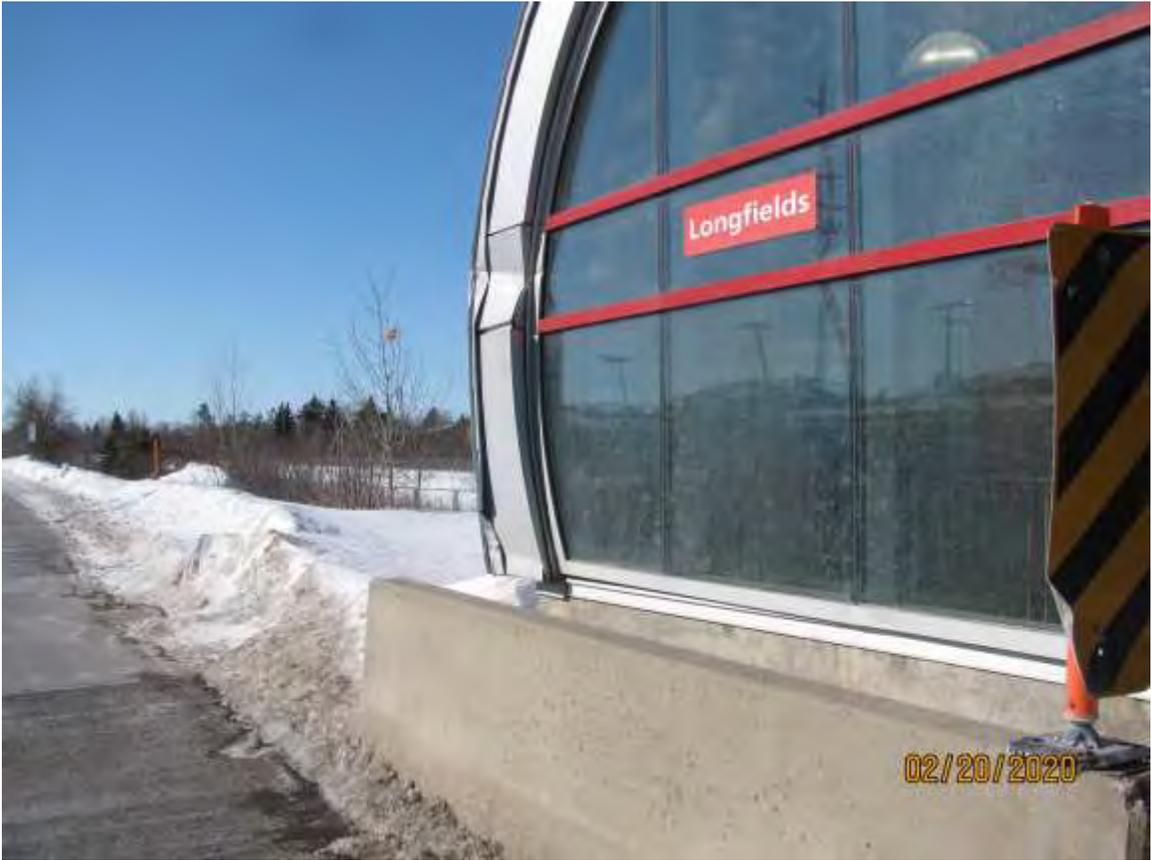
A concrete no-post barrier with a hazard marker has been installed on the road surface of the transitway along the right edge of the right travel lane directly beside the station building. A barrier has been installed in both the southbound and northbound directions. There is damage to the outside of the southbound station building which appears to be caused by a vehicle collision. This appears to be the rationale for the concrete barriers, to protect the station buildings from vehicle collisions. The station buildings are offset about 0.5 metres from the curb face of the transitway. The barriers are fix-objects and a potential hazard to vehicles on the transitway. There is no energy attenuation to lessen the impact of a collision with the barriers. The barriers also narrow the travel lane to 3.0 metres. Vehicles passing the barriers would need shy distance to comfortably avoid colliding with the barrier and this, coupled with the narrowness of the lane forces drivers to intrude into the adjacent lane in order to pass by the barrier.

CONCRETE BARRIER PLACEMENT

Remove the concrete barriers with a blunt end. Install drivable delineators along the base of the building on a 200 mm white line to keep buses away the station and allow the bus to remain in the departure lane. Alternatively, remove the concrete barriers and install a low concrete curb against the base of the station. In either case remove the concrete barrier with the blunt end as it is a hazard.

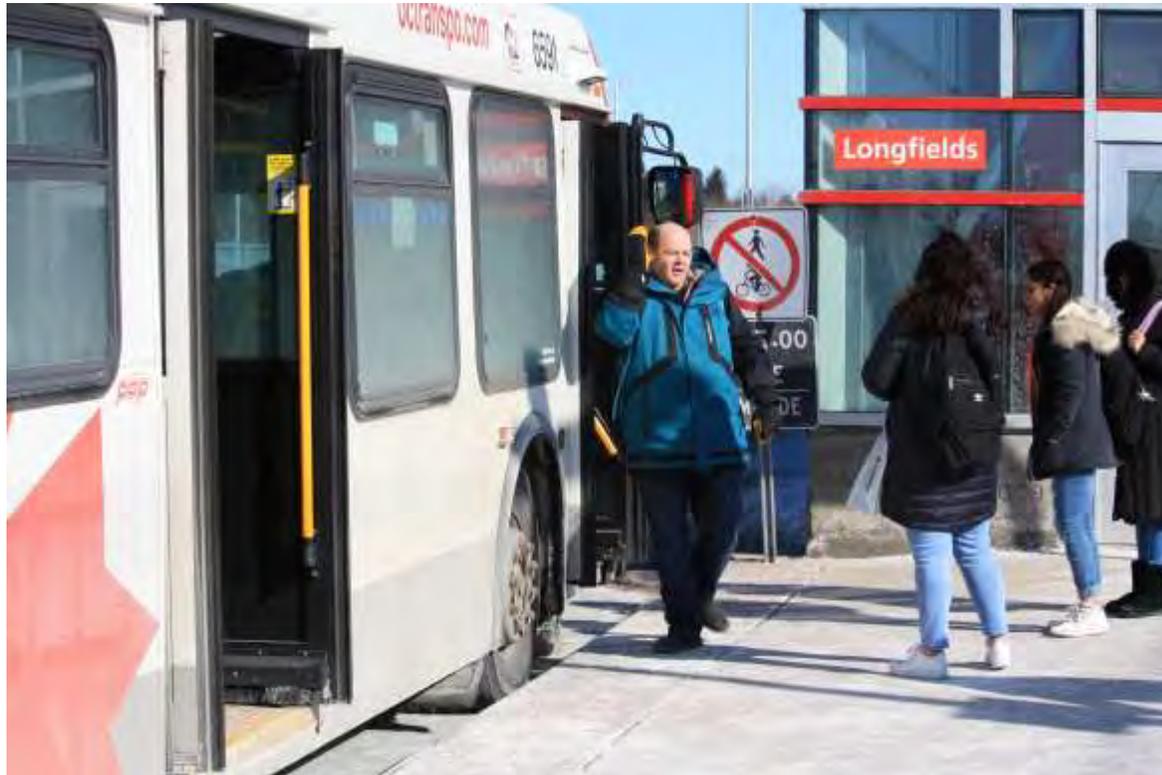
Transit vehicles leaving the station were observed to make abrupt turning maneuvers into the adjacent lane to avoid colliding with the concrete barrier. This presents several safety issues:

ABRUPT BUS MANEUVER DUE TO BARRIER

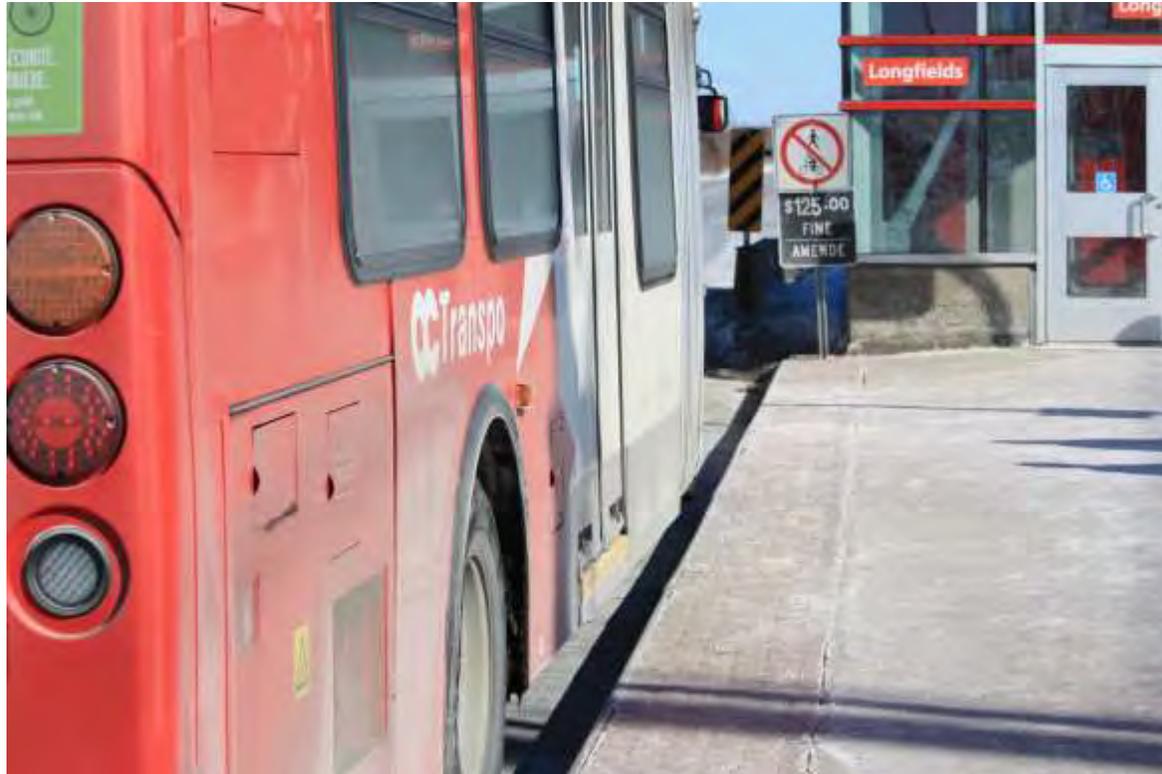
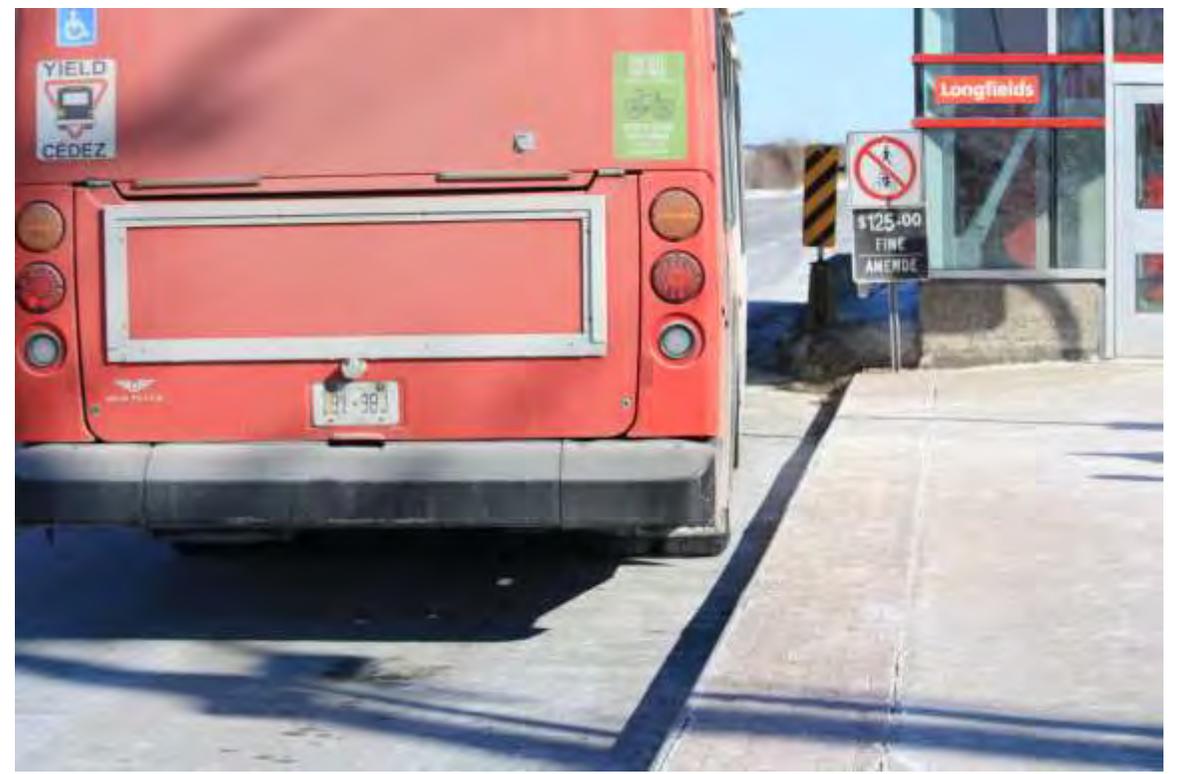
ABRUPT BUS MANEUVER DUE TO BARRIER

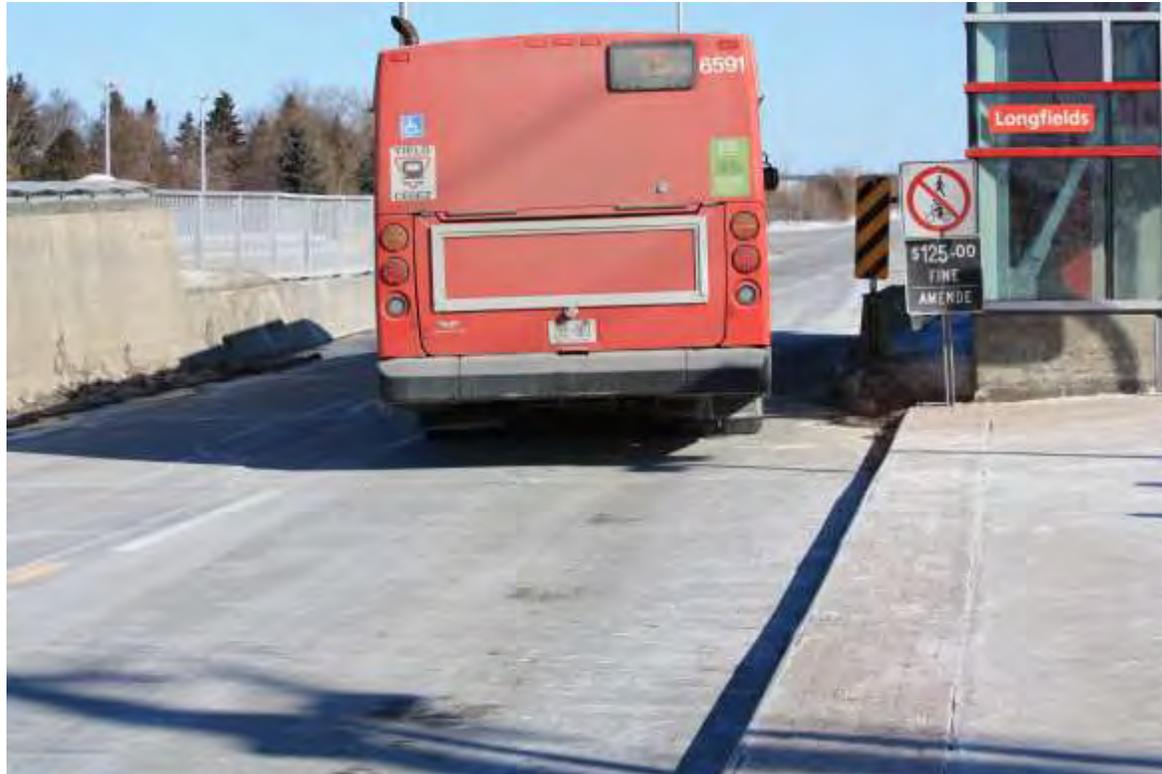
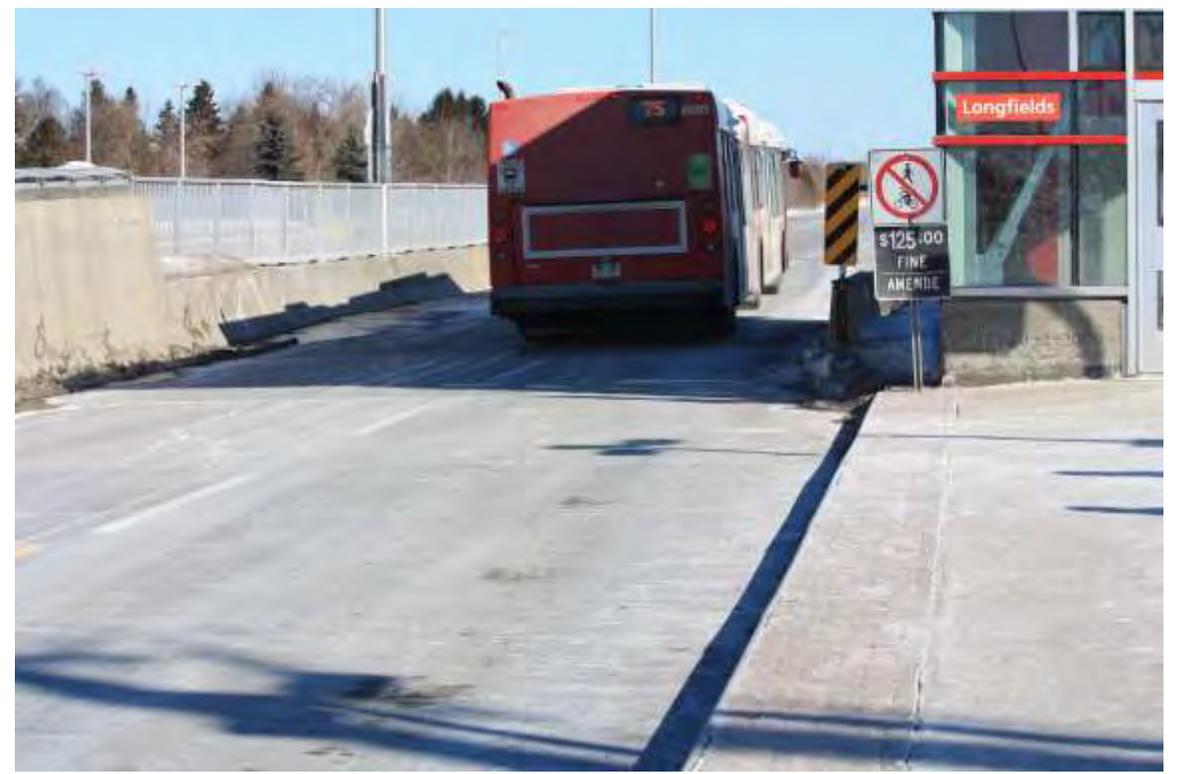
ABRUPT BUS MANEUVER DUE TO BARRIER

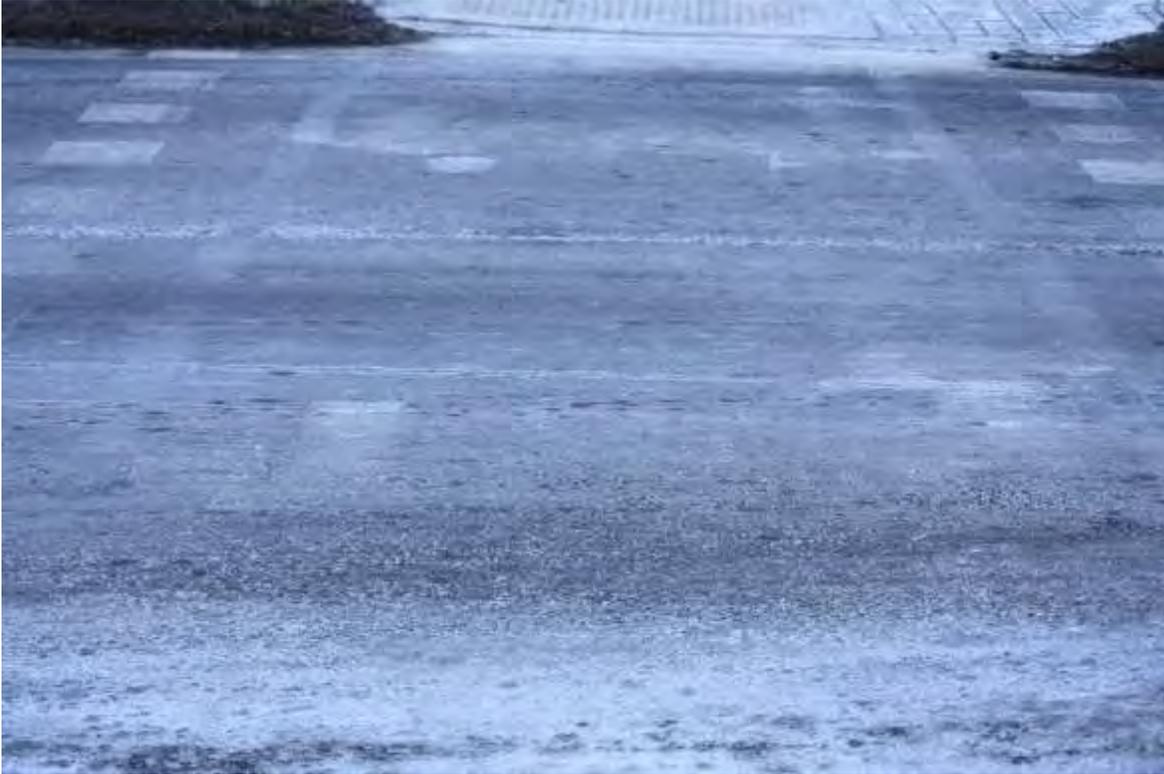
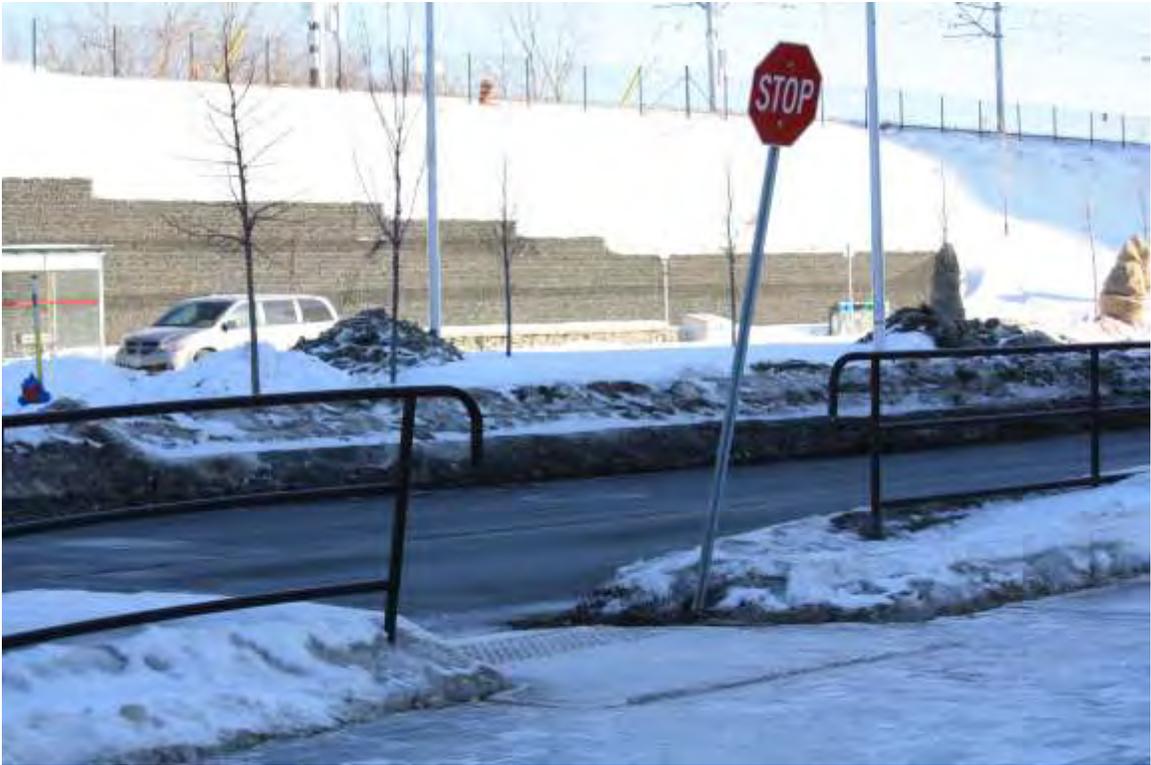
Markings from a previous configuration were black-masked, contrary to City of Ottawa standard practices. The black paint has since worn off, causing the older crosswalk markings to show through. The most recent markings have also worn/faded, making them similar in appearance to the old markings. This has rendered the resulting visible markings non-standard, which could contribute to user confusion.

MAIN CROSSWALK
