OC Transpo Transitway Station Design Safety Study

Independent Safety Study

Final Safety Study

September 2021

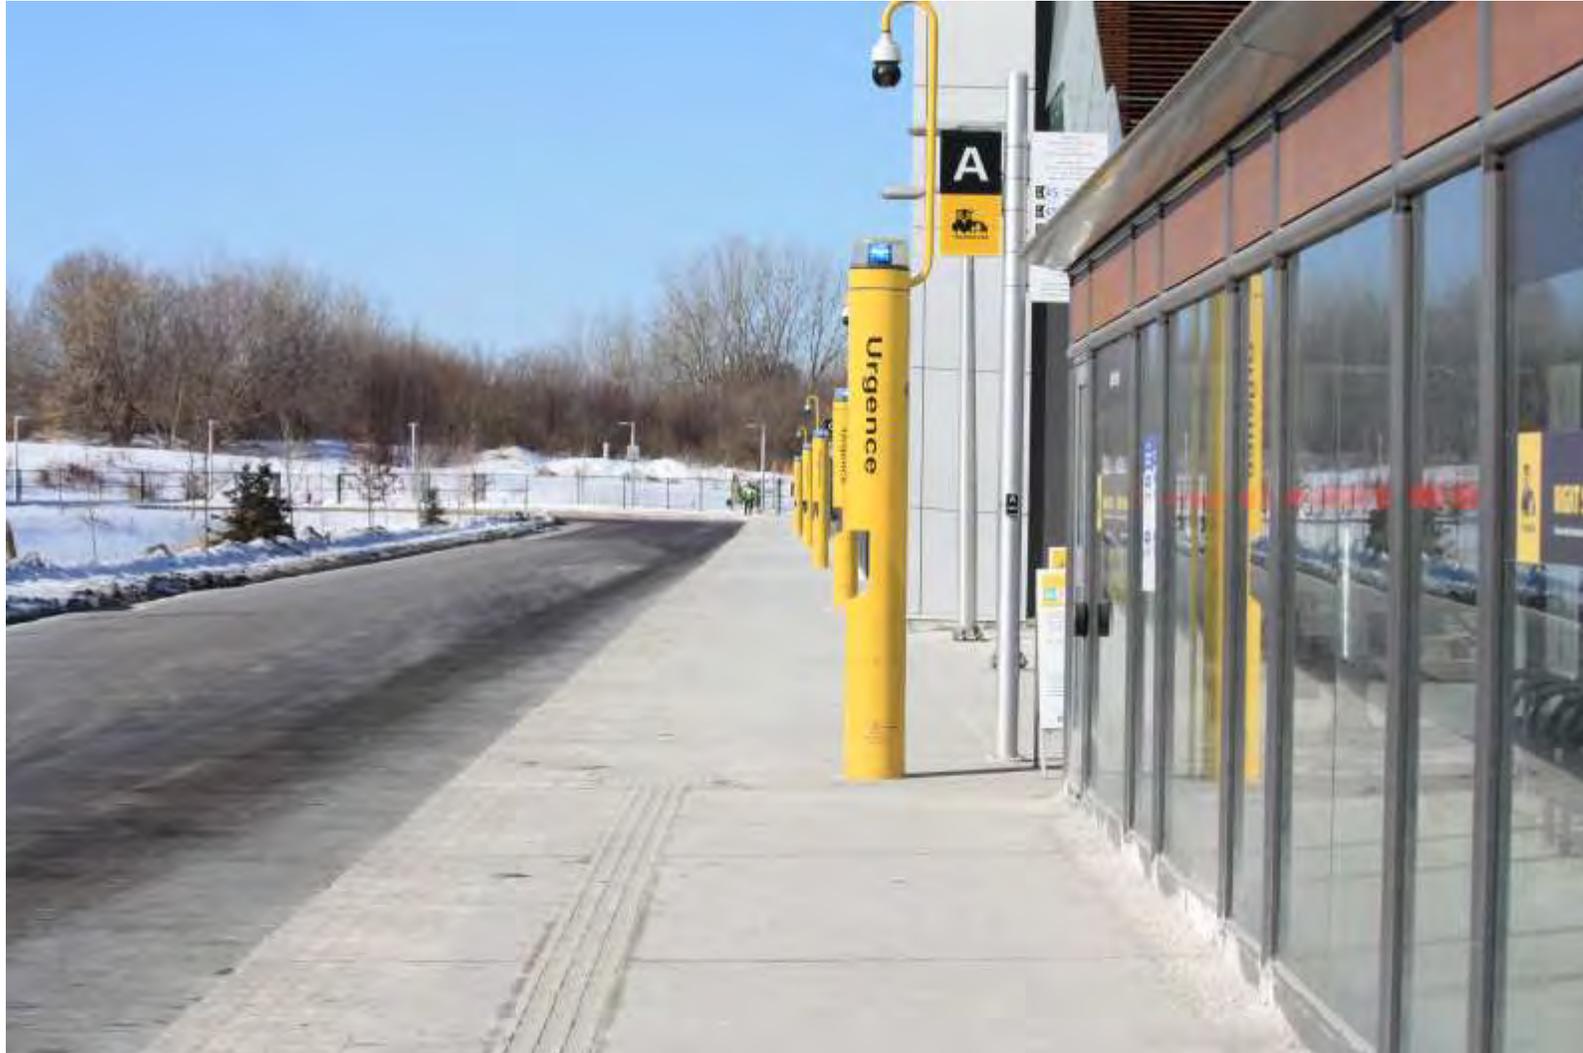
WAYFINDING GROUND LINES

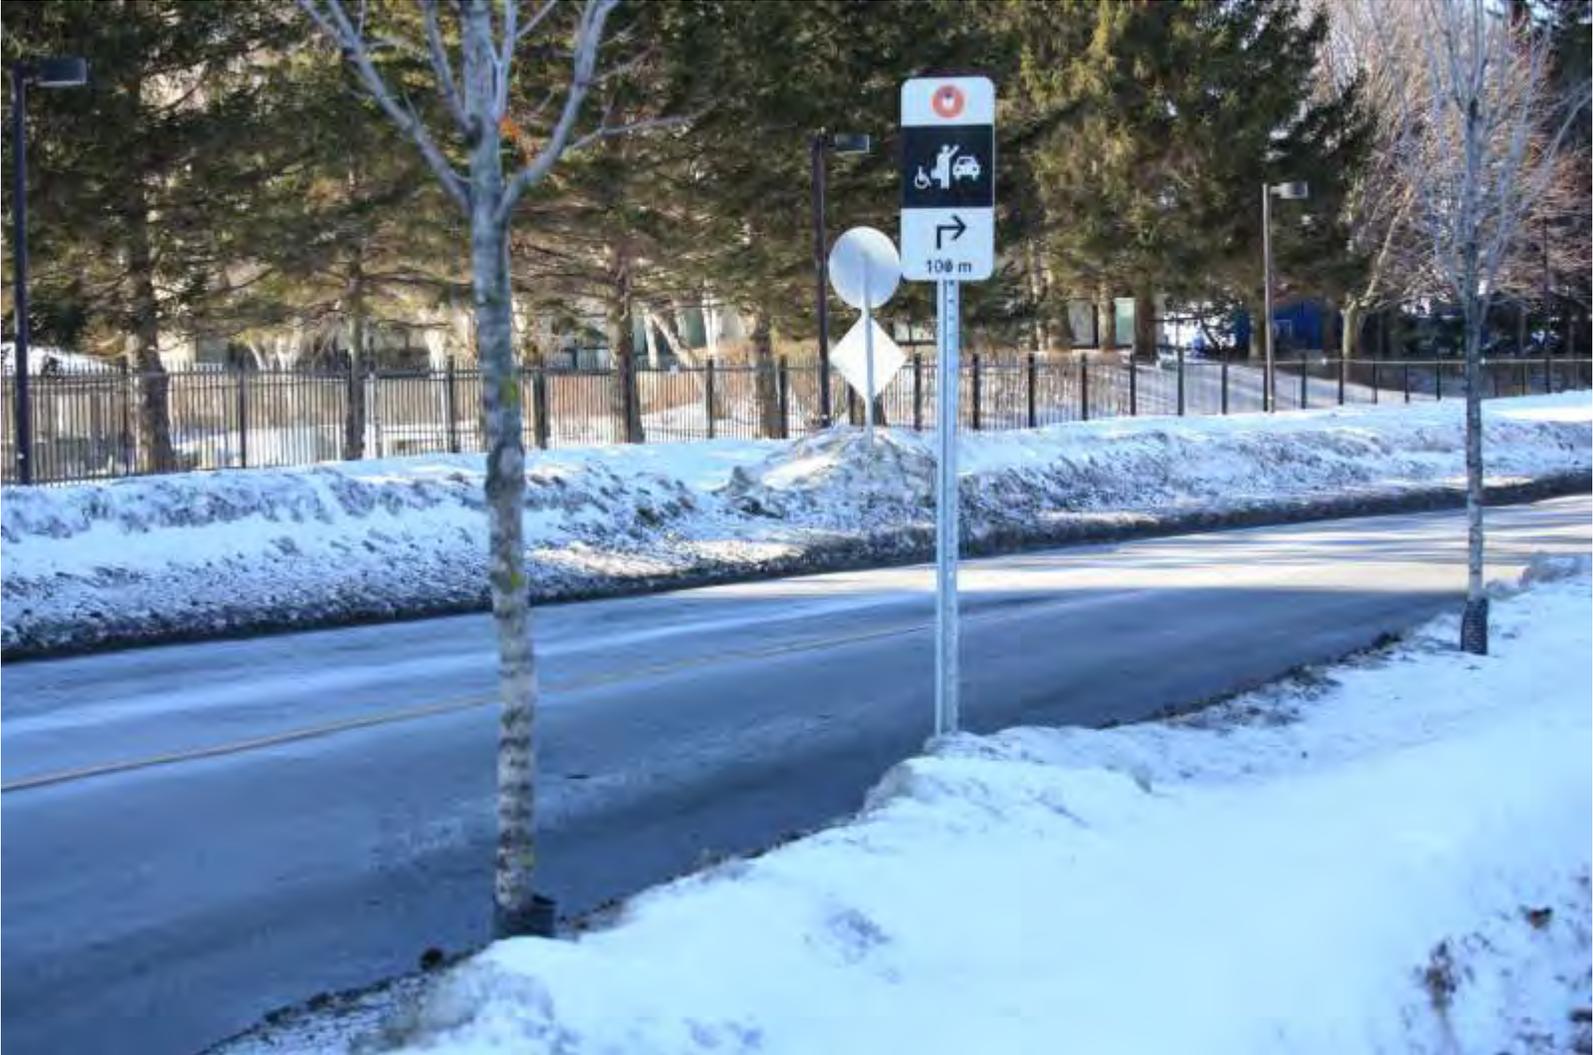
The information or guide sign to direct motorists to the passenger pick-up and drop-off area does not comply with the colour scheme, symbol usage, letter font and letter size for guide signs in Ontario. Consequently, this sign may not be immediately recognized by motorists as an information sign for the attention of motorists and a cause of confusion or missed information.

PPUDO GUIDE SIGN
