**Ottawa Light Rail Transit
Project, Confederation Line**

**Investigation and Root Cause
Analysis of June 8, 2016
Sinkhole on Rideau Street**

**Report Status (Final Draft)
Revision No. 2**

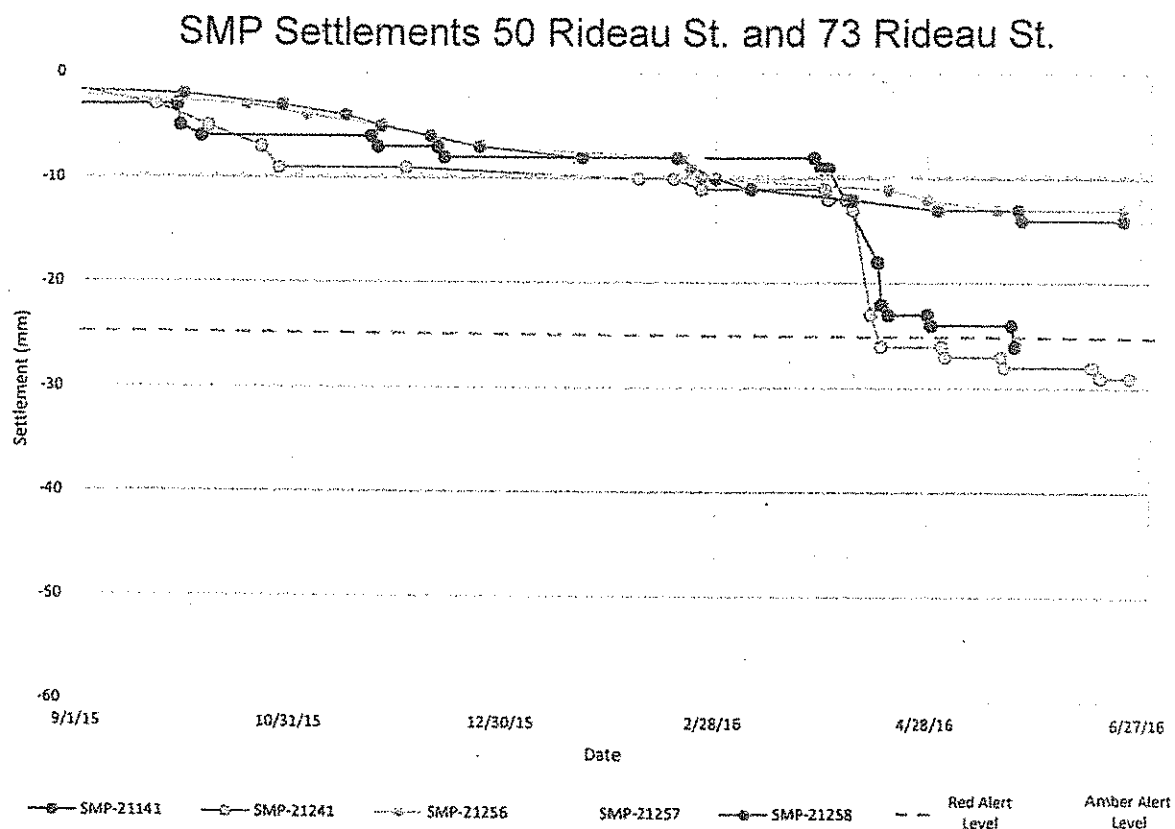
Figure 7-4: SMP Settlements – 50 Rideau St. and 73 Rideau St.

All four of the SMPs at 45 Rideau St and 47-57 Rideau St indicated 2 – 6 mm of additional settlement in the June 8 to June 11-time frame. Prior to June 8 and subsequent to June 11 all of the four SMP settlements were stable. As shown in Figure 7-4, there was no significant settlement effect on the SMPs at 73 Rideau Street (SMPs 21141 and 21241) prior to, during or after June 8.

incurred a 3 mm settlement increase. At the Metropolitan Building, 15 of the 18 monitored SMPs/SSPs were stable at least one month prior to, during and subsequent to June 8, as were three amber alert level locations. Figure 7-4 illustrates that there were three SMPs being monitored at 50 Rideau Street (Rideau Center) (SMPs 21256-21258). All three were stable at least one month prior to, during and subsequent to June 8. Finally, on the East Pedestrian Bridge two of the SMPs had alert level exceedances (one amber and one red) many months prior to June 8 while the remaining six locations were not in alert level. But all of the eight locations were stable prior to, during and subsequent to June 8.
