Appendix B – Photographs

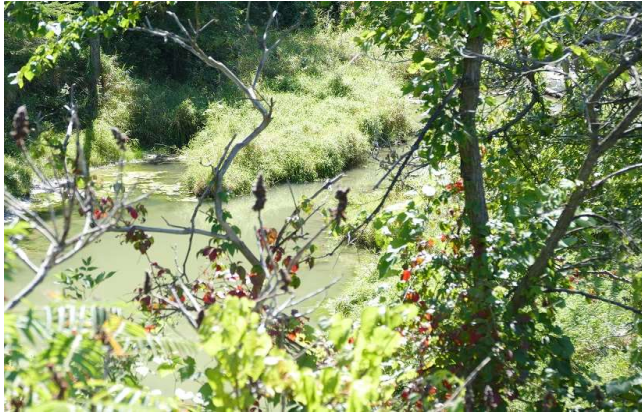
Beckett's Creek – views downstream (1) and upstream (2, 3) of mainstem as visible from Regional Road 174; views are partially obscured by trees and shrubs. Photo 2 shows evidence of slope failure on the southeast bank. Views downstream (4) and upstream (5) from Old Montréal Road. Steep embankments and gully erosion evident upstream (6) and downstream (7, 8) along Old Montréal Road.

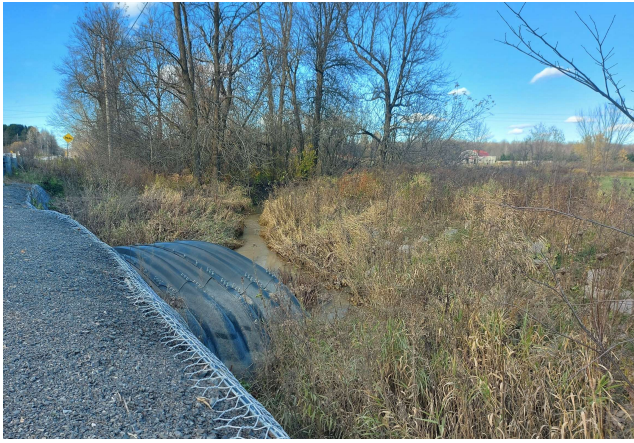
23

Beckett's Creek Tributaries – views downstream (23) and upstream (24) from Birchgrove Road north of Etienne Road. Views downstream (25) and across fields (26) from Sarsfield Road south of Beaton Road. Significant woodland visible on the horizon (26). Views downstream (27) and upstream (28) from Canaan Road, south of Oakwood Drive, showing very minimal flows.

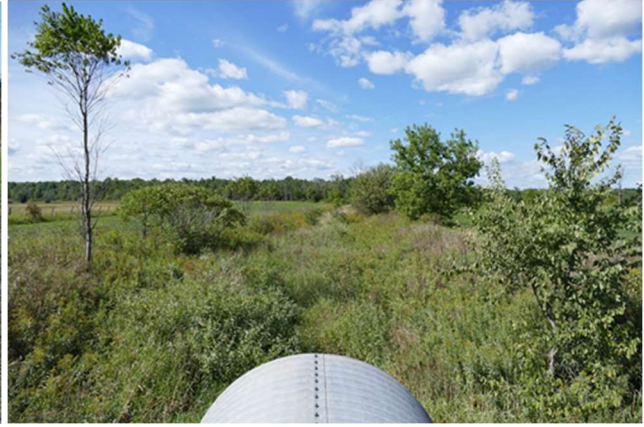
30

Municipal Drains – view of D. LeGault Drain downstream of Birchgrove Road showing submerged culvert (29). View of Beckett Creek Drain downstream (30) along Canaan Road north of Etienne Road. Culvert is perched, making fish passage difficult, and is rusted through in places (31). View of Beckett Creek Drain upstream from Etienne Road (32). View of Mercier Branch Drain north of Innes Road to the west (33) and east (34). Portion of drain has since been cleaned out (34). View of culvert, showing stagnant conditions, along Theodule Vachon Drain at Dunning Road (35).

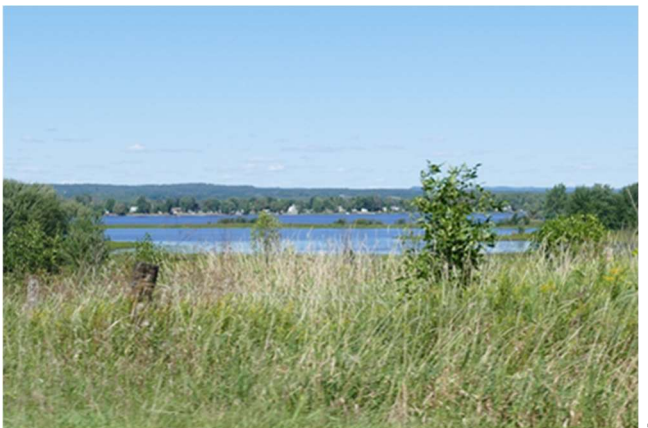
Photo 41 shows a view of the Ottawa River, from Regional Road 174, towards the western extent of the Baie Lafontaine Provincially Significant Wetland.
