Re: 2020 Annual Report, Certificate of Property Use (CPU 0371-8TYQMY)
Lansdowne Park, Urban Park (Zone C)
450 Queen Elizabeth Drive (Part of 945 Bank Street),
Ottawa, Ontario

2020 Annual Report

Certificate of Property Use No. 0371-8TYQMY
Lansdowne Park- Urban Park (Zone C)
450 Queen Elizabeth Driveway (Part of 945 Bank Street)
Ottawa, Ontario
Project No. TZ10100106

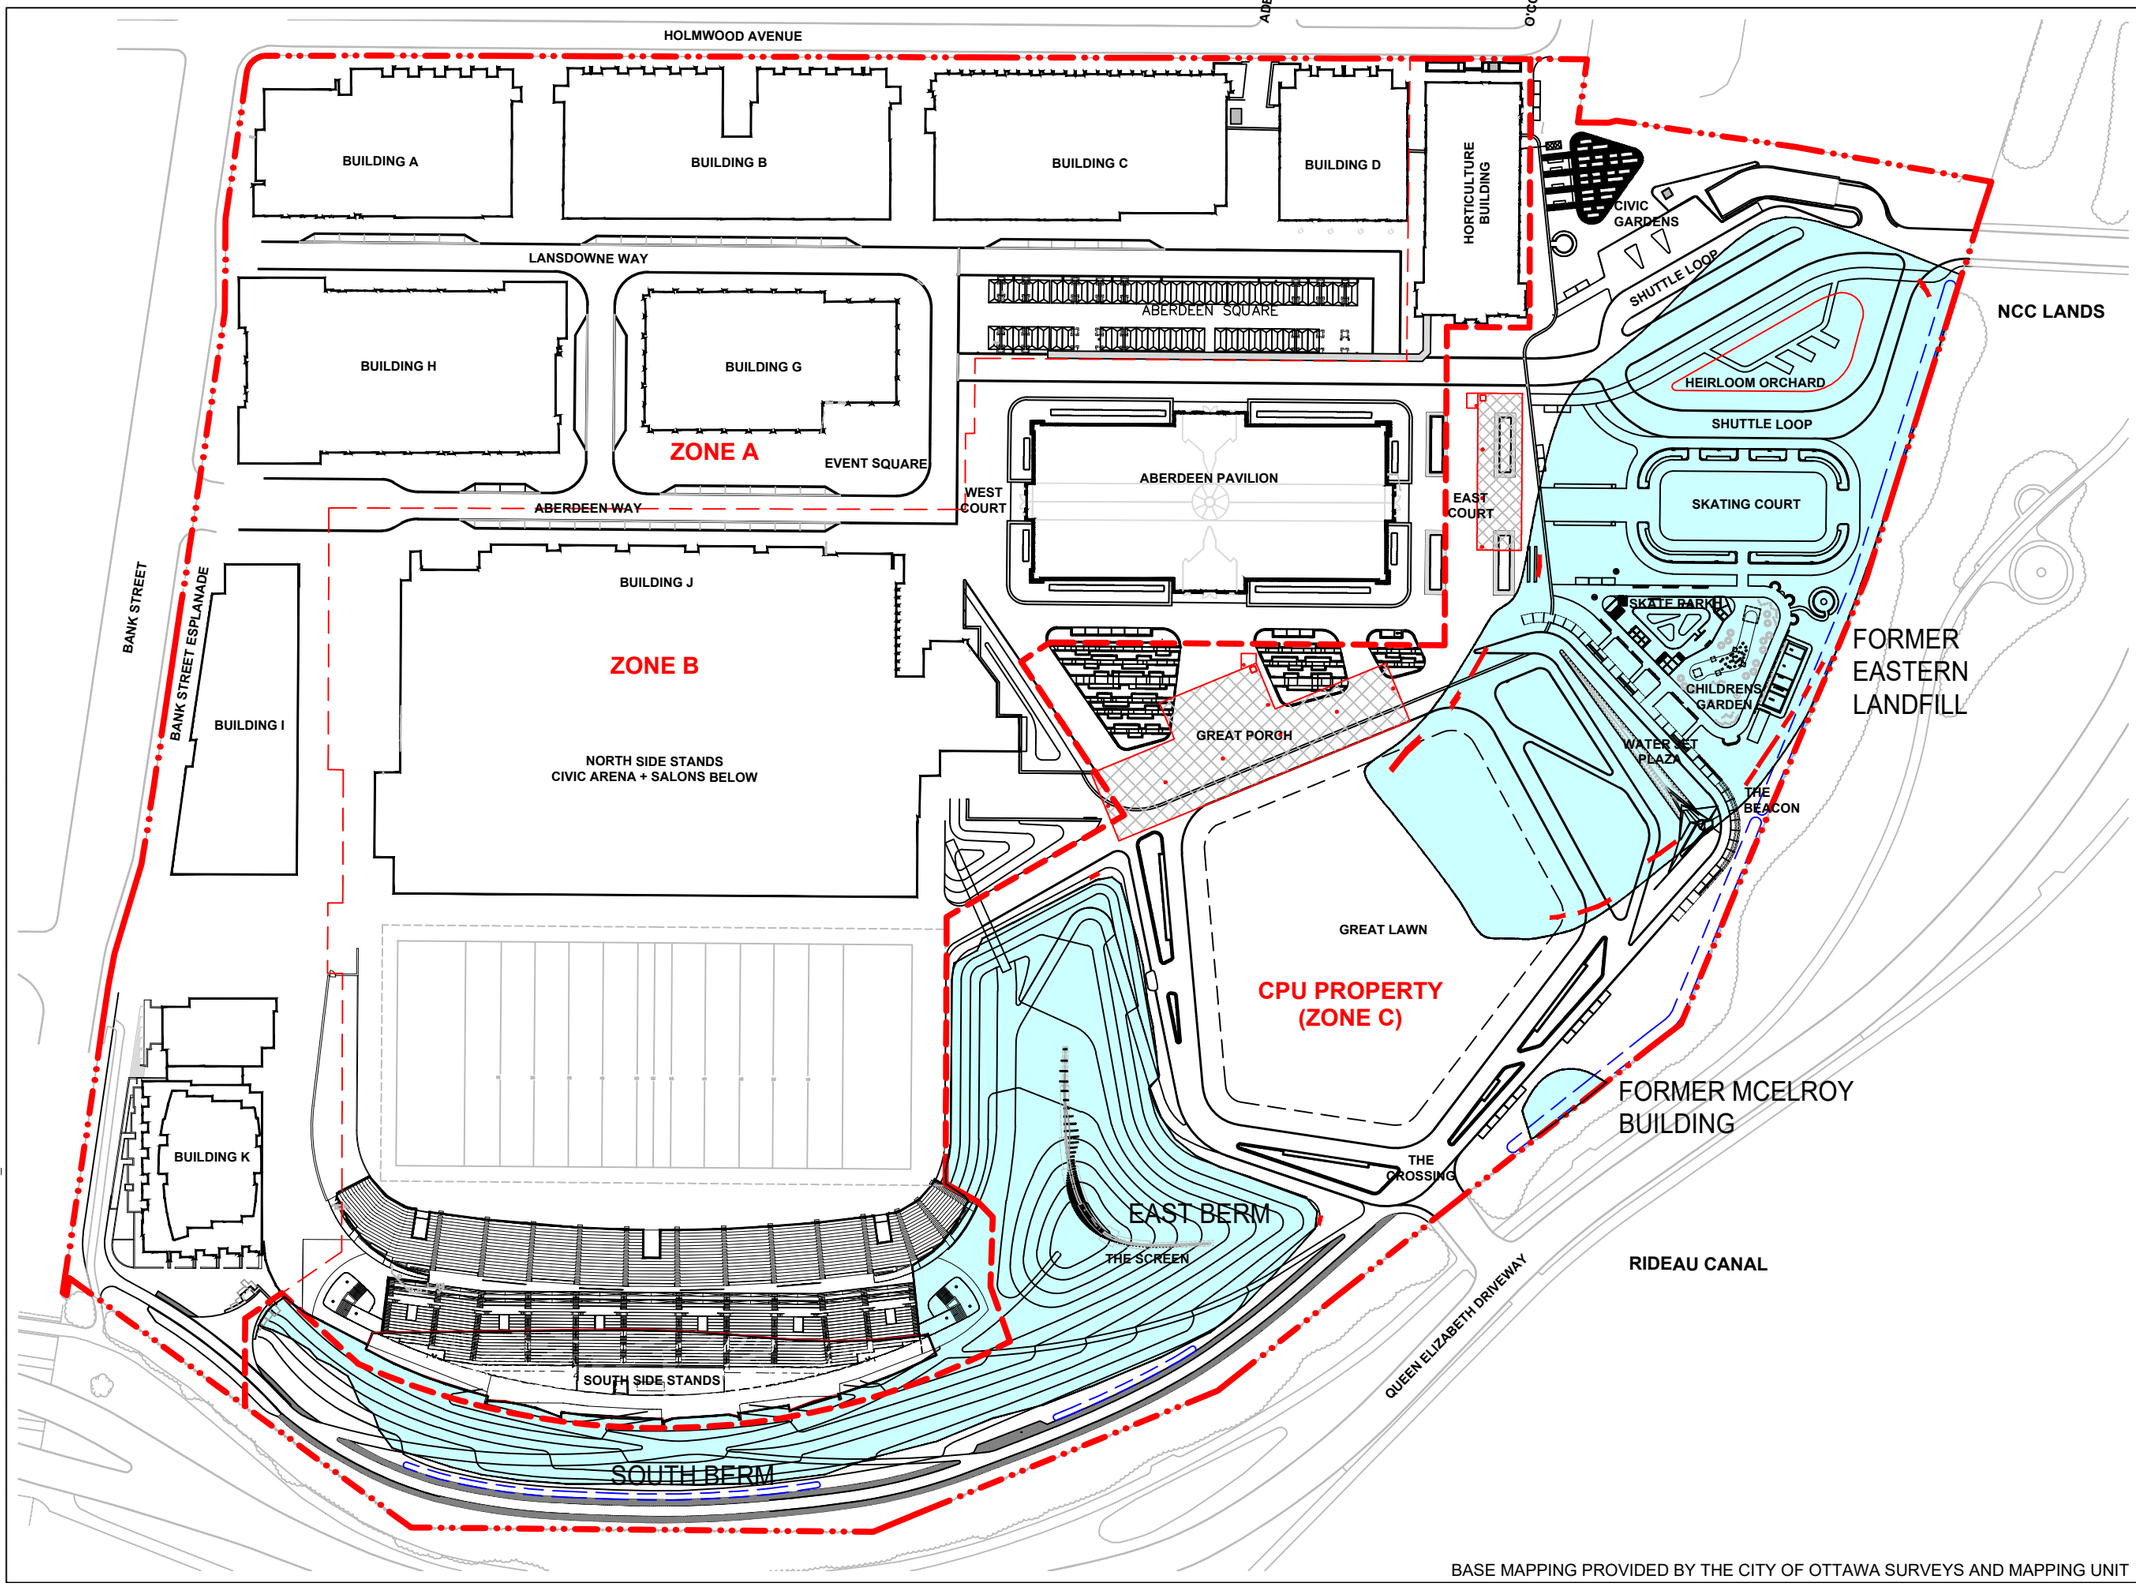
DESIGNED BY:	KDH
DRAWN BY:	JFT
CHECKED BY:	KDH
DATE:	MARCH 2021
SCALE:	1 : 1,600
PROJECT NO:	TZ10100106
FIGURE NO:	3

In 2020, Wood conducted inspections of the RMM implemented in the area of the East and South Berms as part of the Inspection and Maintenance Plan developed for the Site to satisfy the requirements of Condition 4.2.8 of the CPU. Details of the inspections including photo logs are provided in the Risk Management Measures Inspection Logs in Appendix B. The extent of the RMM for the Berm areas is provided on Figure 3.

In 2020, Wood conducted inspections of the RMM implemented in the area of the former Eastern Landfill as part of the Inspection and Maintenance Plan developed for the Site to satisfy the requirements of Condition 4.2.8 of the CPU. Details of the inspections including photo logs are provided in the Risk Management Measures Inspection Logs in Appendix B. The extent of the RMM for the former Eastern Landfill area is provided on Figure 3.

In 2020, Wood conducted inspections of the RMM implemented in the area of the former McElroy Building as part of the Inspection and Maintenance Plan developed for the Site to satisfy the requirements of Condition 4.2.8 of the CPU. Details of the inspections including photo logs are provided in the Risk Management Measures Inspection Logs in Appendix B. The extent of the RMM for the former McElroy Building area is provided on Figure 3.

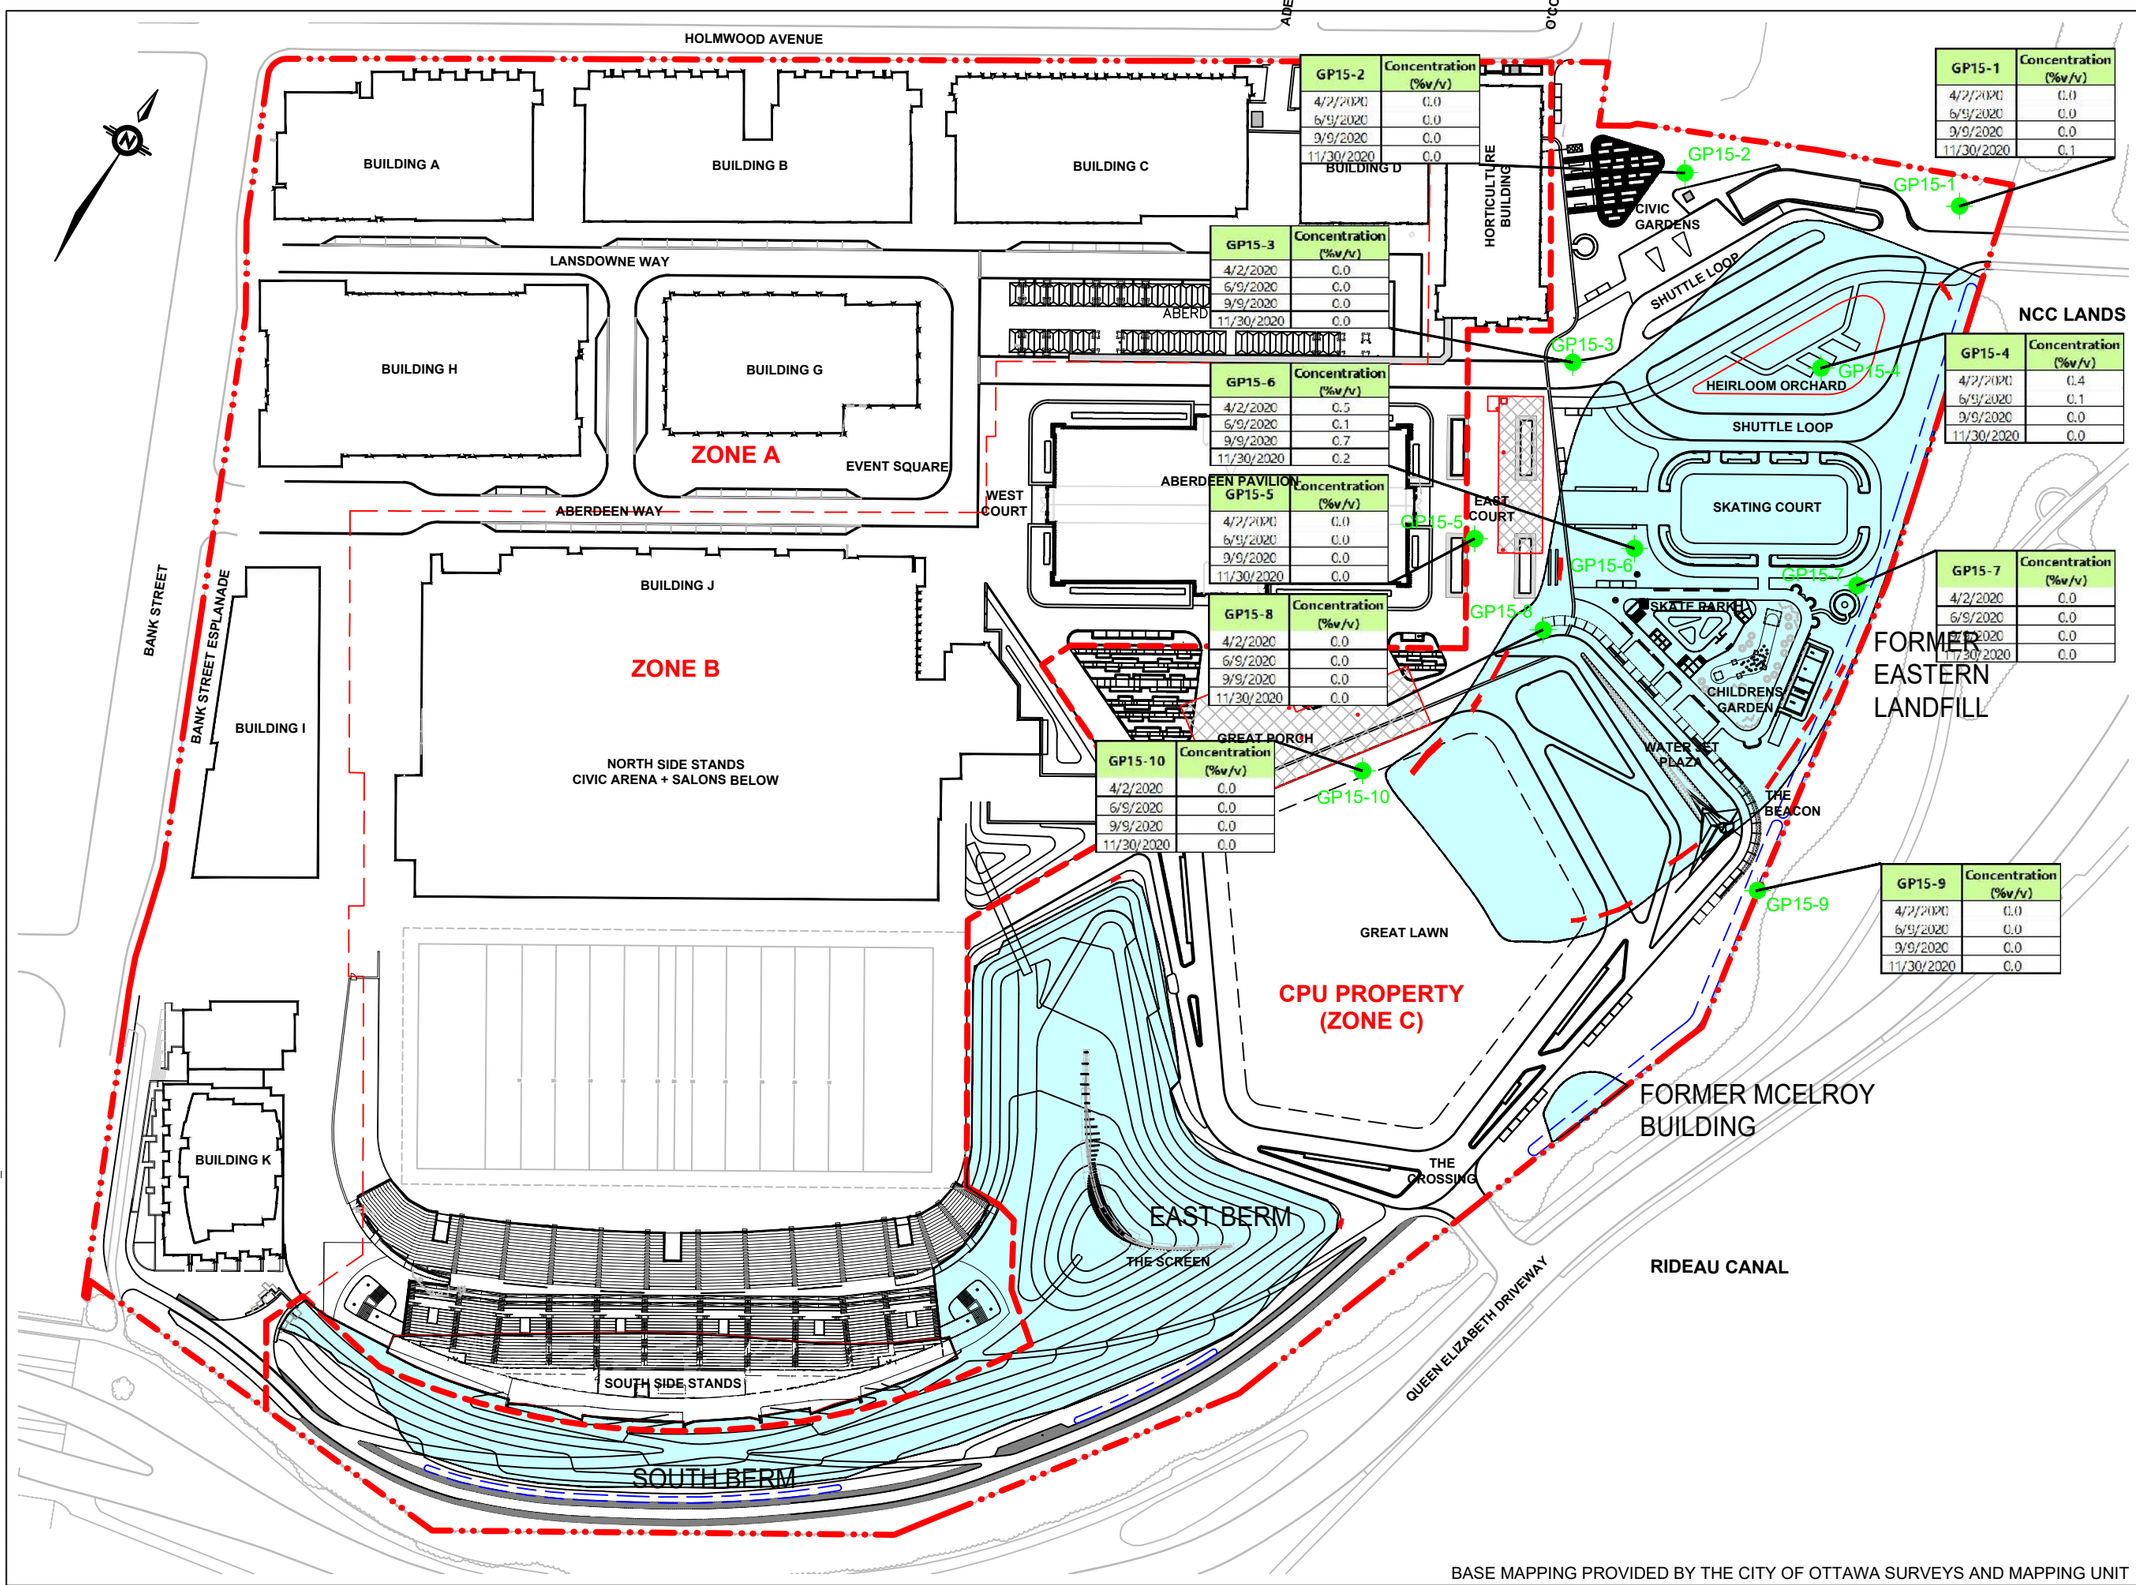
The results of the LFG monitoring program including LFG composition and subsurface pressure are summarized in Table 5 and are shown on Figure 7. Stable methane concentrations were detected at GP15-1 (0.1 vol. % in November), GP15-4 (0.4 vol. % in April and 0.1 vol. % in June) and GP15-6 (0.5 vol. % in April, 0.1 vol. % in June, 0.7 vol. % in September and 0.2 vol. % in February). Based on the methane concentrations noted above, the Site meets the on-site methane concentrations limits as outlined in O.Reg. 232/98 and the recommended methane alert levels provided in Procedure D-4-1.

The fairly consistent presence of low level initial and stable methane concentrations measured at GP15-6 and those reported at GP15-4 in the spring indicate that methane impacts are predominantly confined within the footprint of the former Eastern Landfill. The methane concentrations recorded suggest that any methane present is closely associated with waste deposits and is likely present as pockets trapped beneath less permeable materials. Slight positive pressures were recorded at one or more monitoring events at all ten (10) LFG probes. The slight positive pressures observed suggests that the subsurface methane is not likely to migrate beyond the immediate areas in which it is encountered. With the exception of a slight methane detection at GP15-1 in November 2020, the lack of consistent detectable methane at the LFG probes surrounding the former Eastern Landfill footprint indicates that the subsurface methane is not likely migrating beyond the boundaries of the former landfill.
