2015 ANNUAL REPORT

CERTIFICATE OF PROPERTY USE No. 0371-8TYQMY LANSDOWNE PARK – URBAN PARK (ZONE C) 945 BANK STREET (FORMERLY PART OF 945-1015 BANK STREET) OTTAWA, ONTARIO

March 31, 2016

Project No. TZ10100106

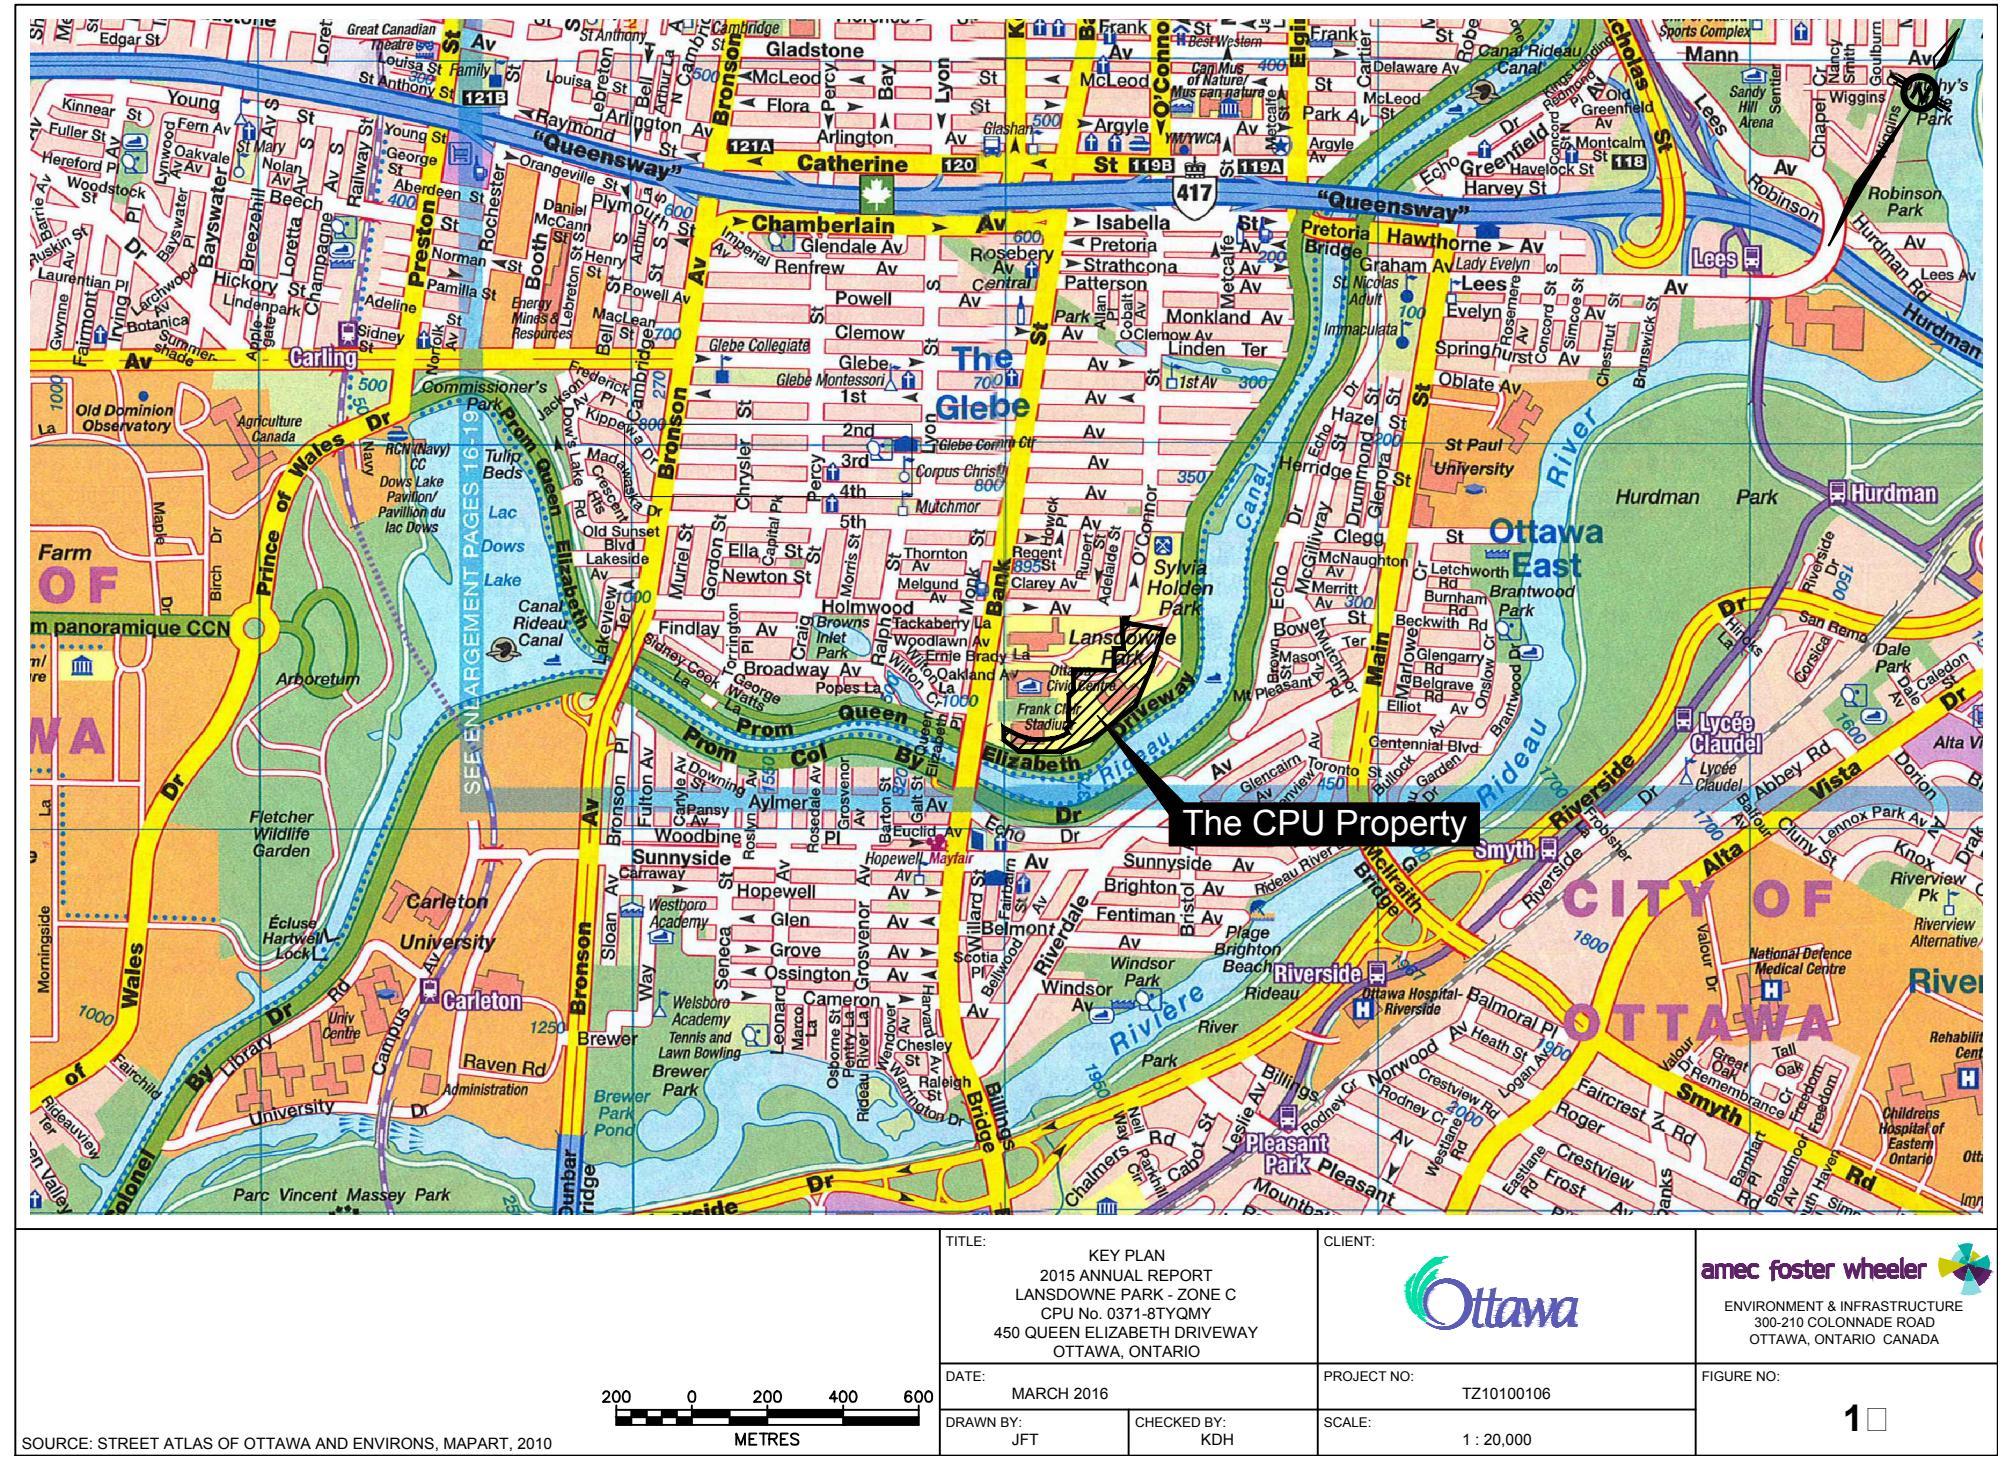
P:\PROJECTS IN PROGRESS\1 ENVIRONMENTAL\2010\TZ101001.06 - CPU IMPLEMENTATION\05_CAD\CPU - ANNUAL REPORT\LANSDOWNE PARK - KEY PLAN.DWG

On November 25, 2013 Certificate of Property Use (CPU) No. 0371-8TYQMY was issued by the Ontario Ministry of Environment and Climate Change (MOECC), formerly the Ministry of the Environment (MOE) for the Lansdowne Park – Urban Park (Zone C) property located at 945 Bank Street (formerly part of 945 - 1015 Bank Street) in Ottawa, Ontario (hereinafter referred to as the "CPU Property"). A key plan showing the location of the CPU Property is provided on Figure 1.

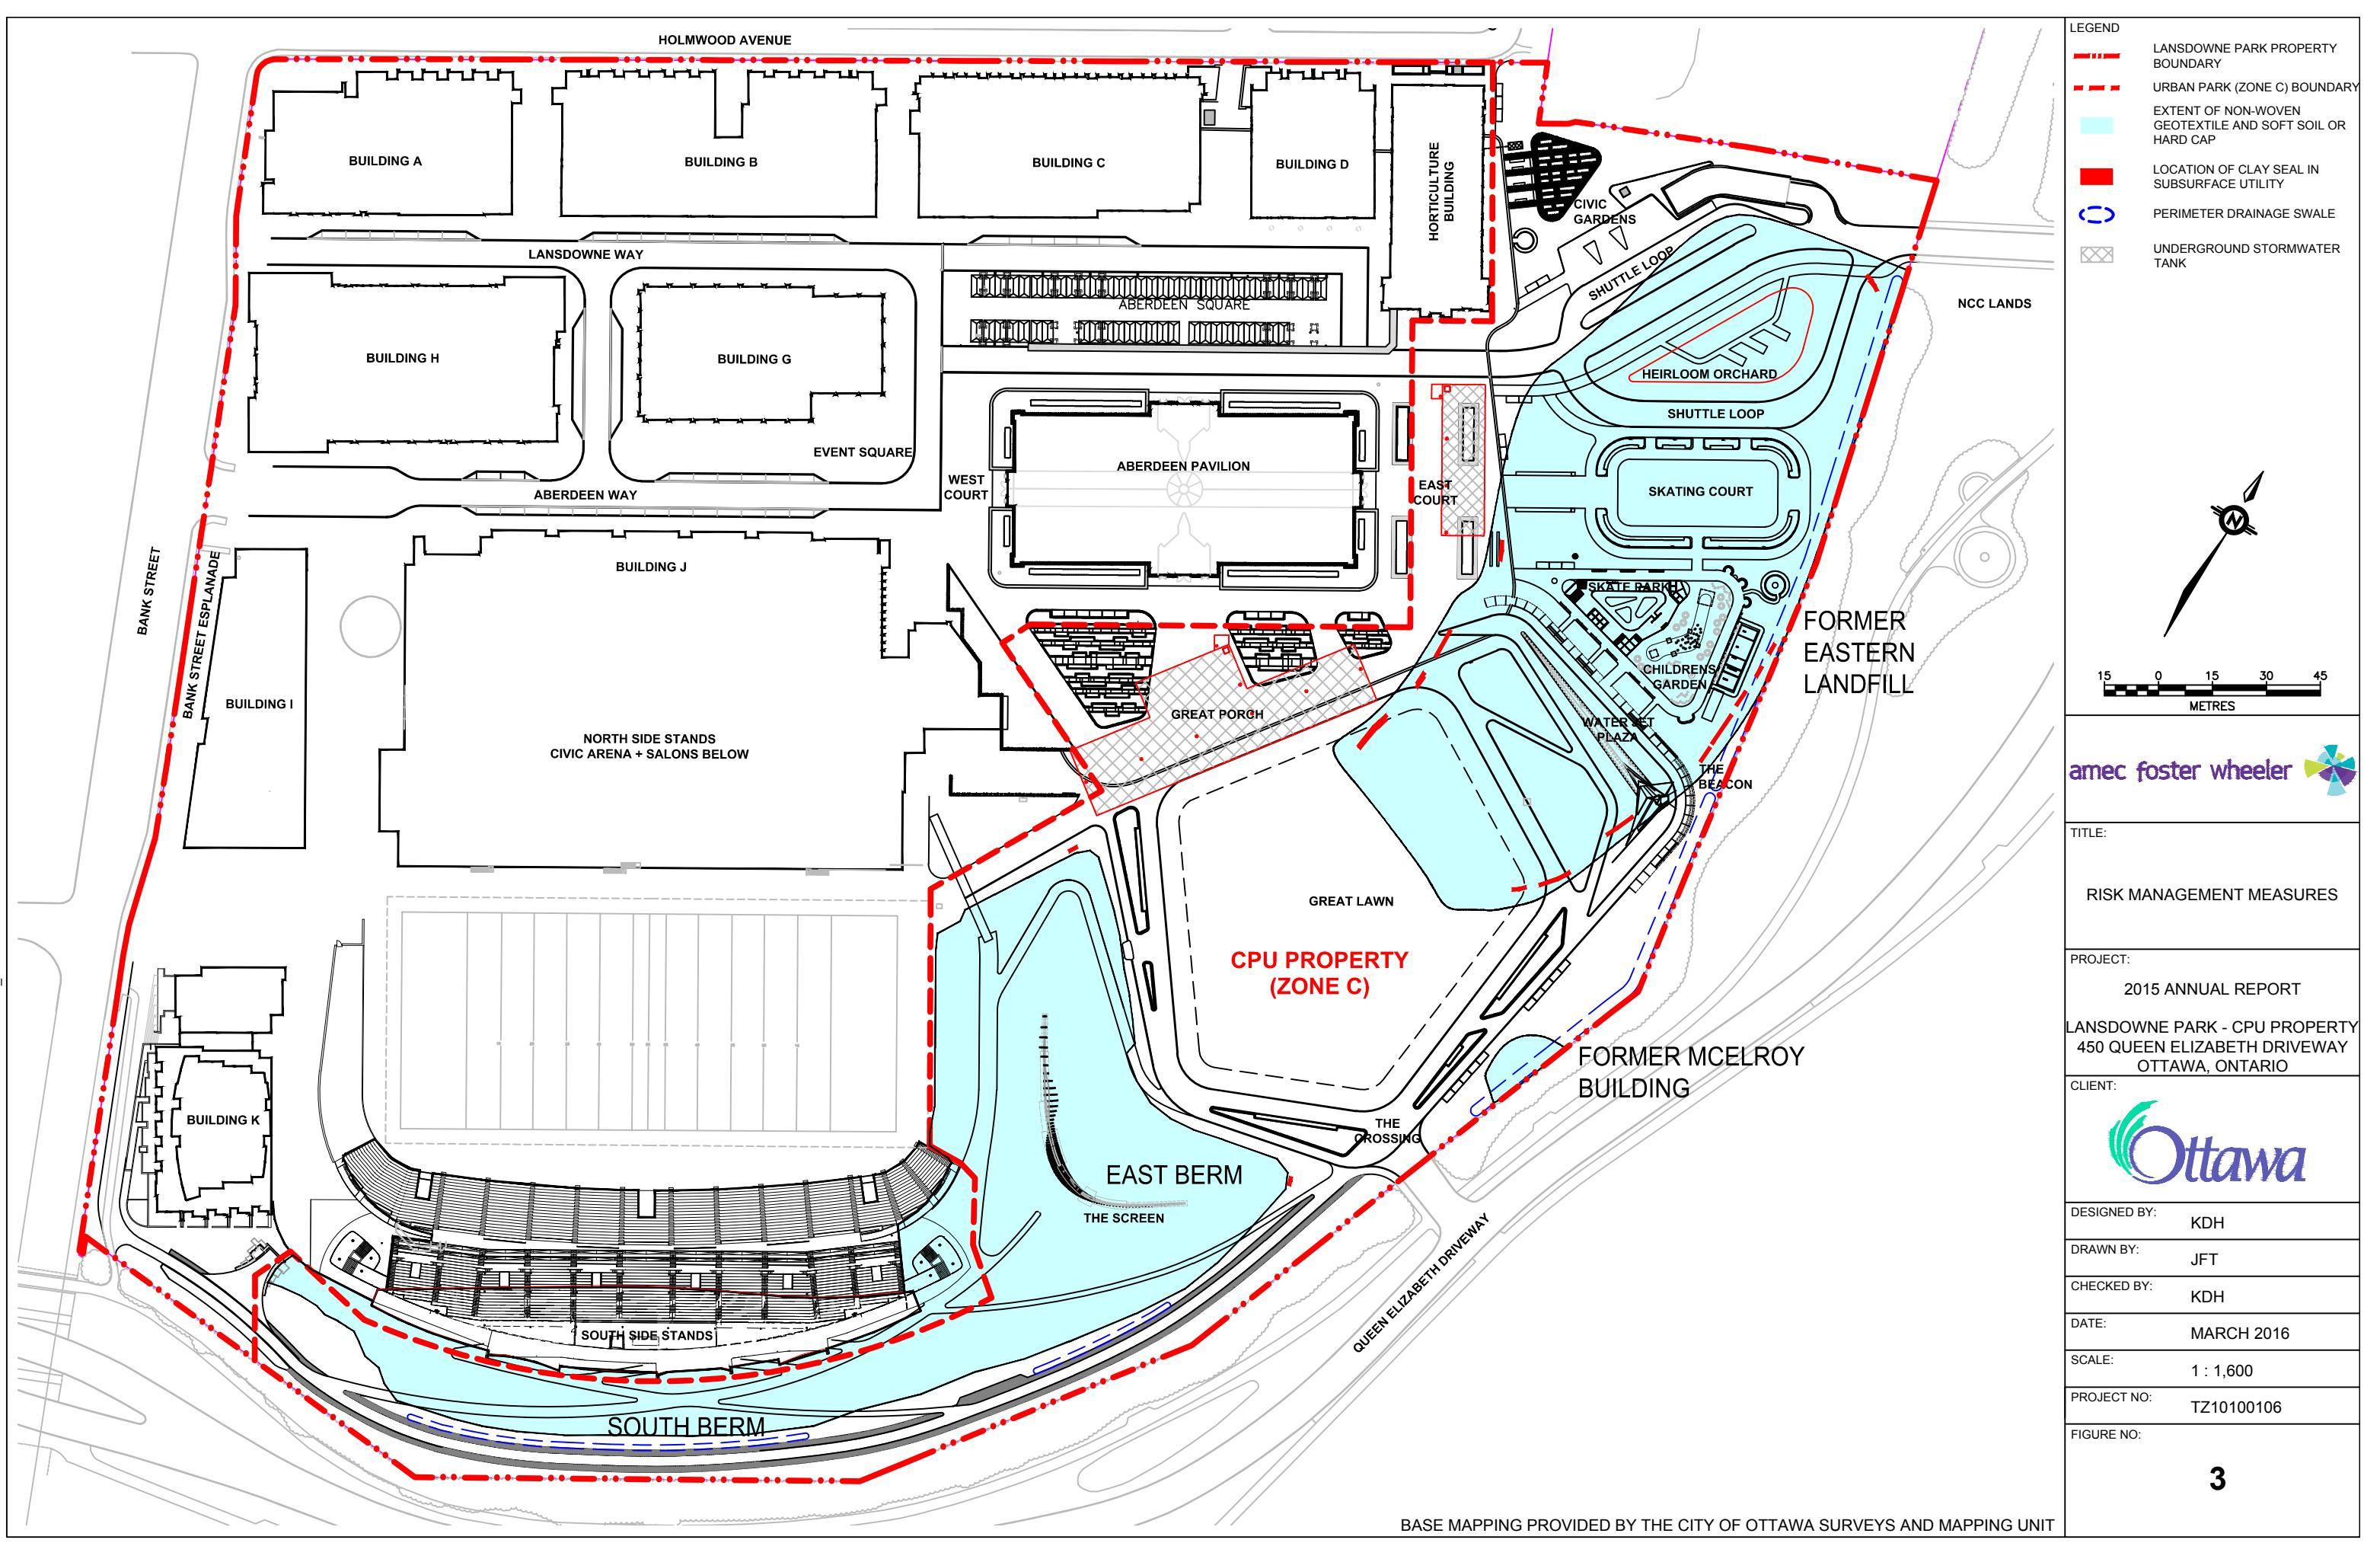
The redevelopment construction works were completed at the CPU property in the summer of 2015 and inspections of the East and South Berms were subsequently conducted as part of the Inspection and Maintenance Plan developed for the Site in accordance with the requirements of Condition 4.2.8 of the CPU. Details of the inspections including photo logs are provided in the Risk Management Measures Inspection Logs in Appendix B. The extent of the RMM for the Berm areas is provided in Figure 3.

The redevelopment construction works were completed at the CPU property in the summer of 2015 and inspection of the former eastern landfill area were conducted as part of the Inspection and Maintenance Plan developed for the Site to satisfy the requirements of Condition 4.2.8 of the CPU. Details of the inspections including photo logs are provided in the Risk Management Measures Inspection Logs in Appendix B. The extent of the RMM for the former eastern landfill area is provided in Figure 3.

Construction works were completed at the CPU property in the summer of 2015 and inspection of the former McElroy Building area were conducted as part of the Inspection and Maintenance Plan developed for the Site to satisfy the requirements of Condition 4.2.8 of the CPU. Details of the inspections including photo logs are provided in the Risk Management Measures Inspection Logs in Appendix B. The extent of the RMM for the former McElroy Building area is provided in Figure 3.

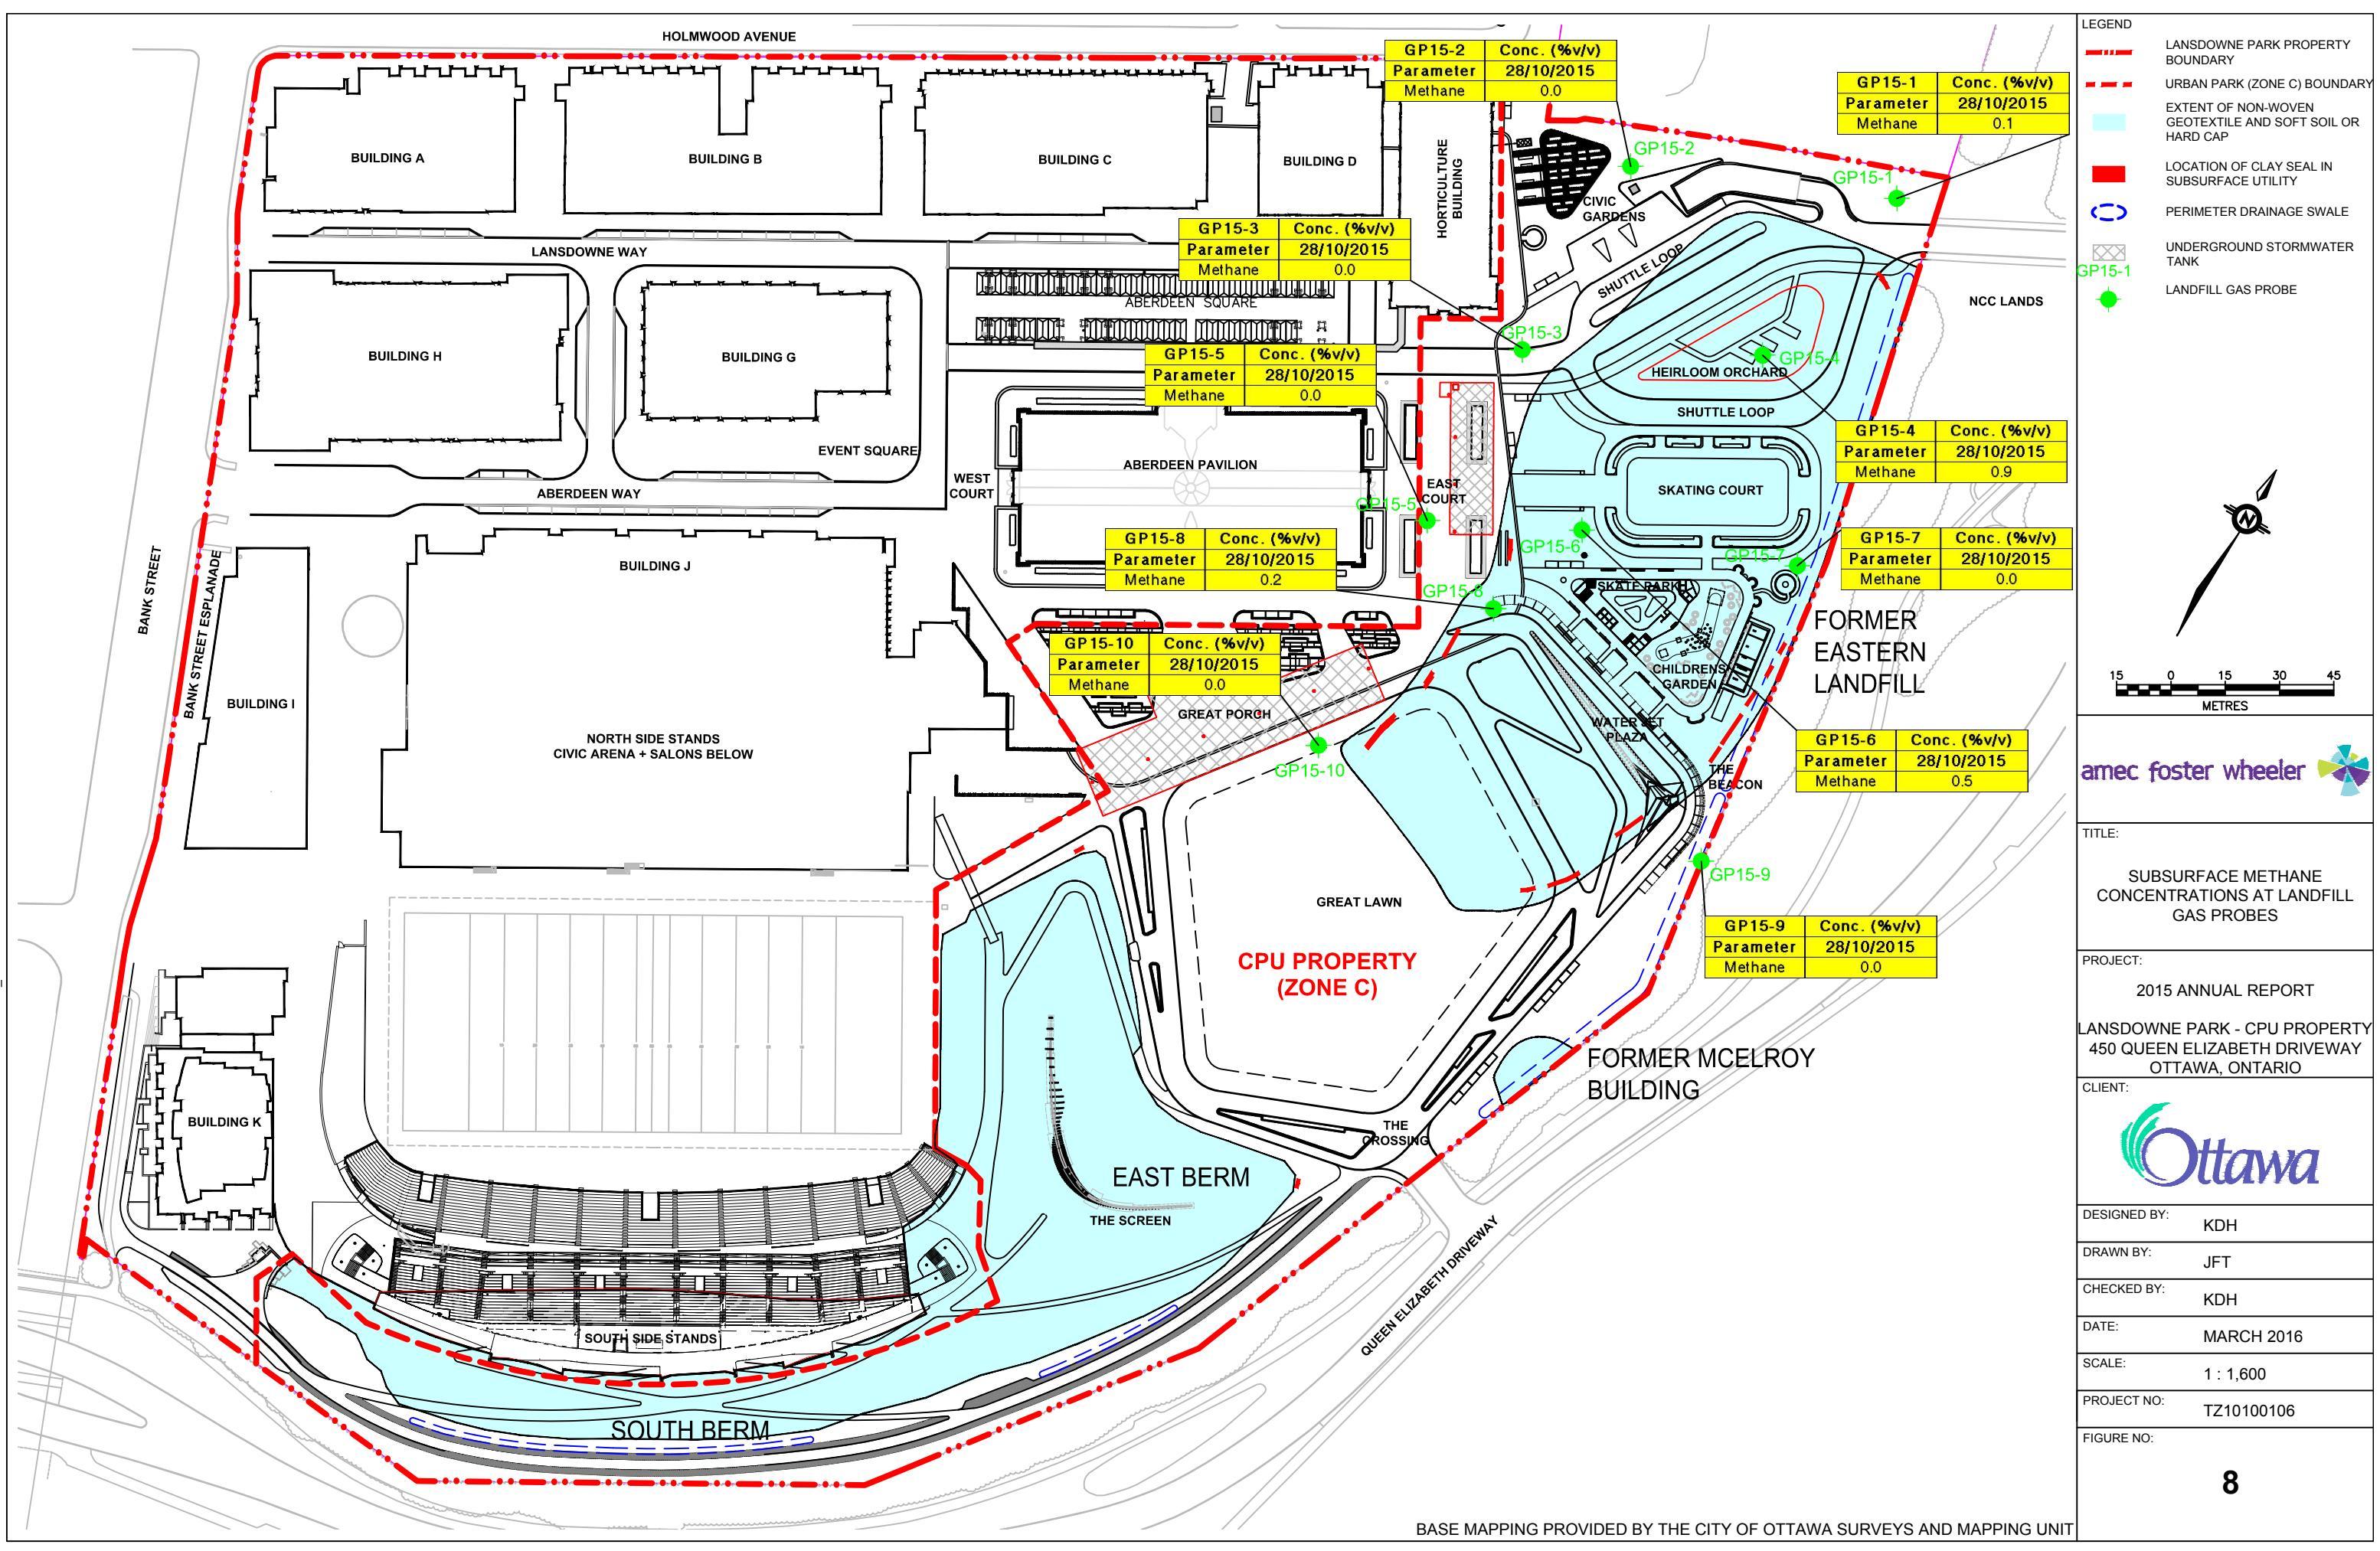
The results of the LFG monitoring program including LFG composition and subsurface pressure are summarized in Table 6 and are shown on Figure 8. One notable subsurface pressure of -1.0 was recorded at GP15-2 during the 2015 monitoring event. Stable methane concentrations were detected at the following four (4) LFG probe locations including: GP15-1 (0.1 vol. %), GP15-4 (0.9 vol. %), GP15-6 (0.5 vol. %) and GP15-8 (0.2 vol. %). Based on the methane concentrations noted above, the Site meets the on-site methane concentrations limits as outlined in O.Reg. 232/98 recommended methane levels and the alert provided in Procedure D-4-1.
