2014 ANNUAL REPORT

CERTIFICATE OF PROPERTY USE NO. 0371-8TYQMY LANSDOWNE PARK – URBAN PARK (ZONE C) 840 QUEEN ELIZABETH DRIVE (FORMERLY PART OF 945-1015 BANK STREET) OTTAWA, ONTARIO

Project No. TZ10100106

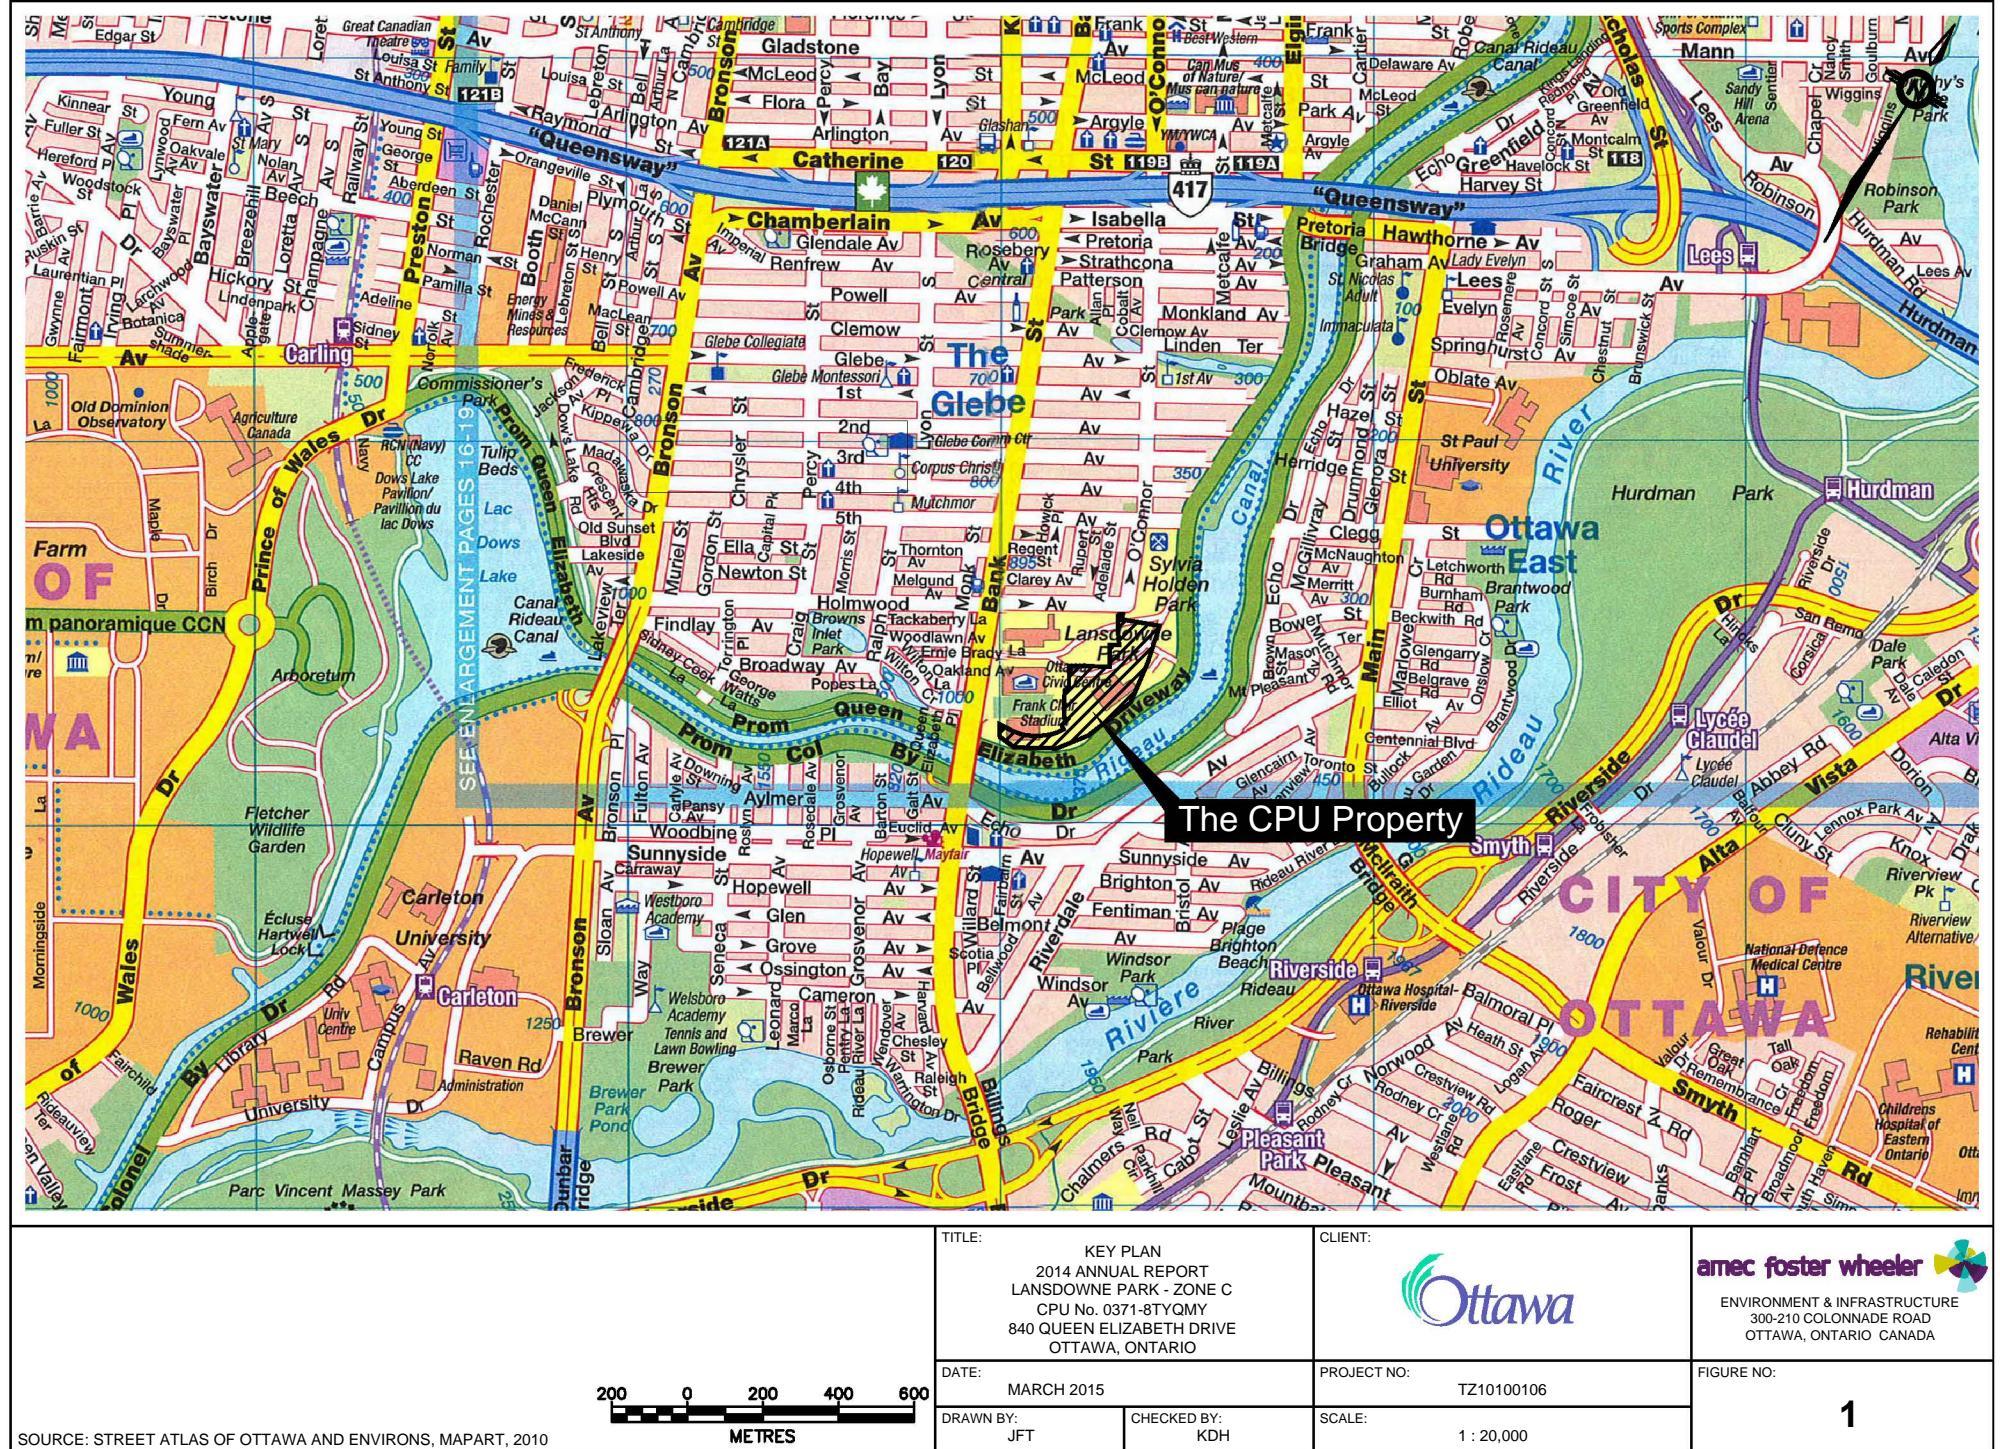
On 25 November 25 2013 Certificate of Property Use (CPU) No. 0371-8TYQMY was issued by the Ontario Ministry of Environment and Climate Change (MOECC) for the Lansdowne Park – Urban Park (Zone C) property located at 840 Queen Elizabeth Drive (formerly part of 945 - 1015 Bank Street) in Ottawa, Ontario (hereinafter referred to as the "CPU Property"). A key plan showing the location of the CPU Property is provided on Figure 1.

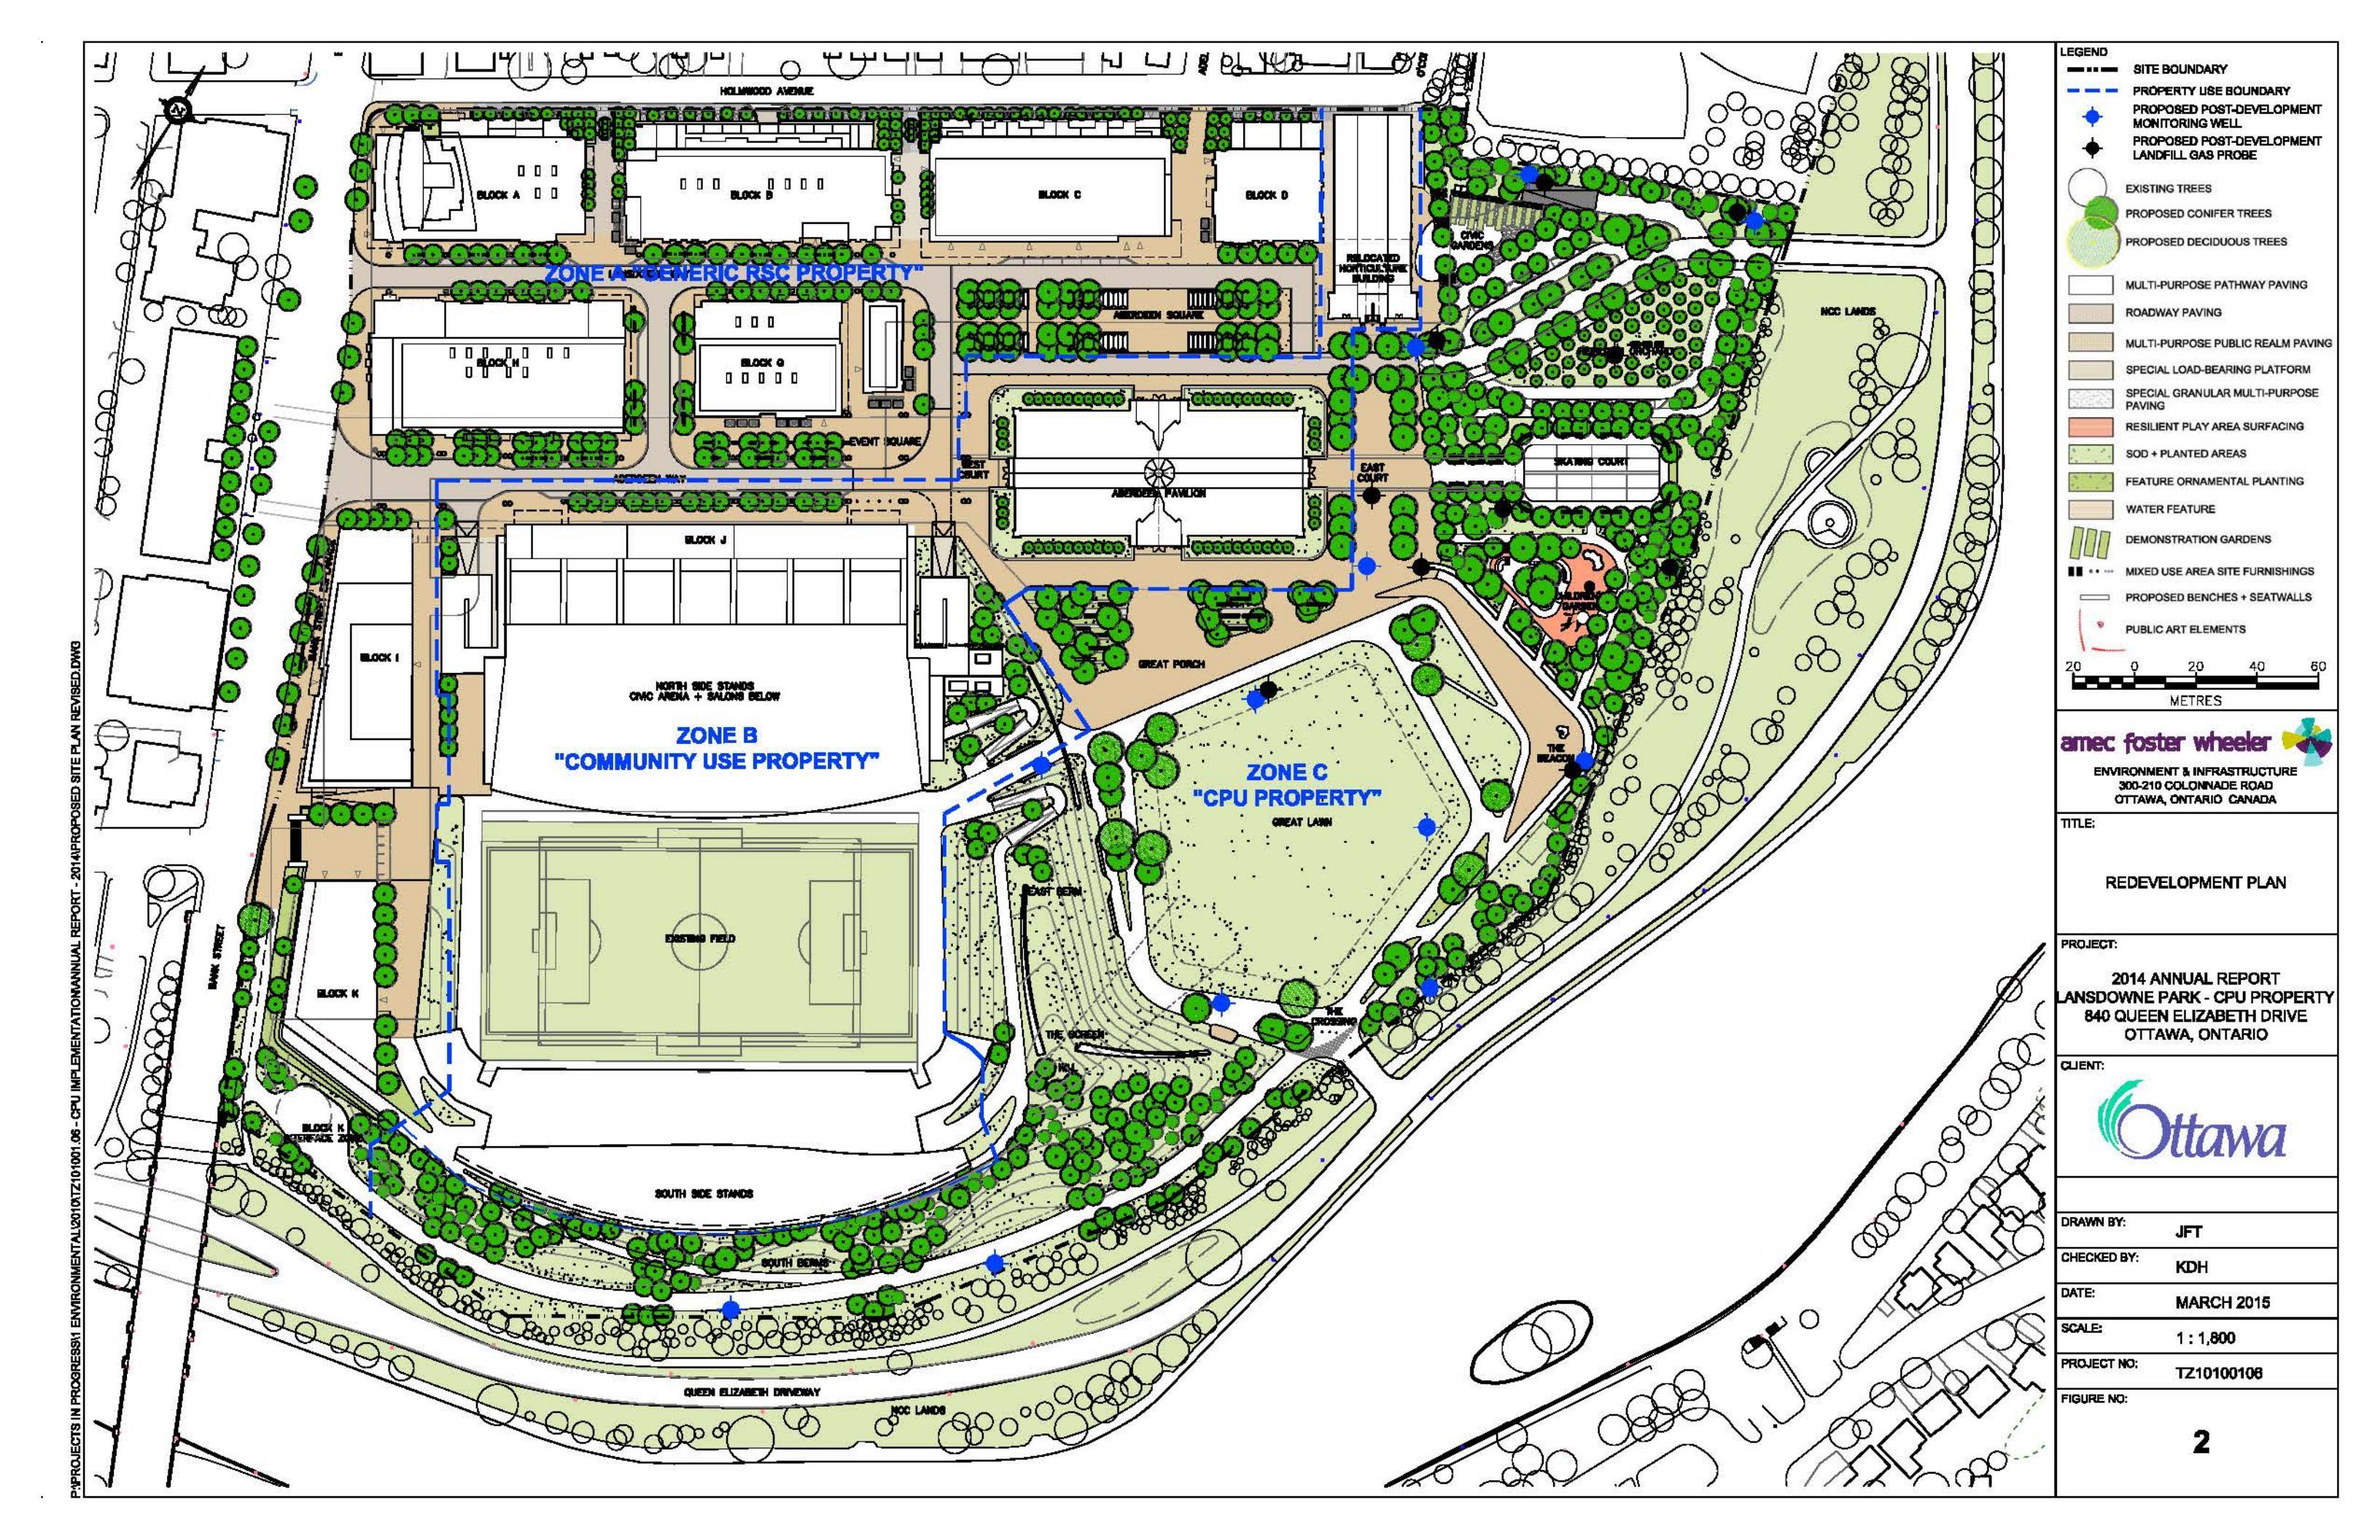
A plan depicting the above-noted redevelopment plan for Lansdowne Park is provided on Figure 2.

- Constructing a mixed-use area that includes retail, office, and residential property uses along the north and west portions of the site (Zone A);
- Refurbishing Frank Clair Stadium (sports stadium) / Civic Centre (arena complex) and relocating and refurbishing the Horticultural Building (Zone B); and,

• Creating a large urban park along the east and south portions of the site (Zone C).
