OC Transpo Transitway Station Design Safety Study

Independent Safety Study

Final Safety Study

September 2021

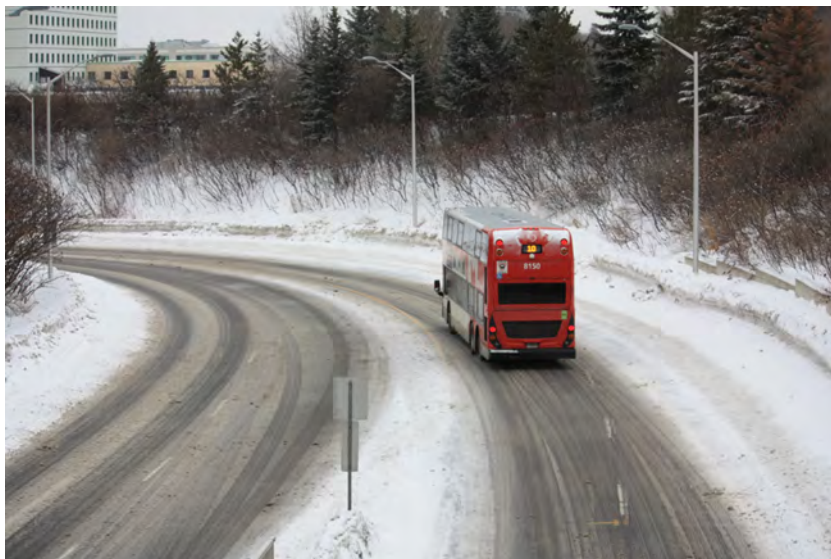
Issue 2: Advisory speed signing for the reverse curve is in one direction only

A curve warning sign with an advisory speed tab of slow to 40 km/h is only in the northbound direction. There is no curve warning advisory speed posted for the southbound direction.

Install an advisory speed sign Tab of 40 km/h with the curve sign in the southbound direction.

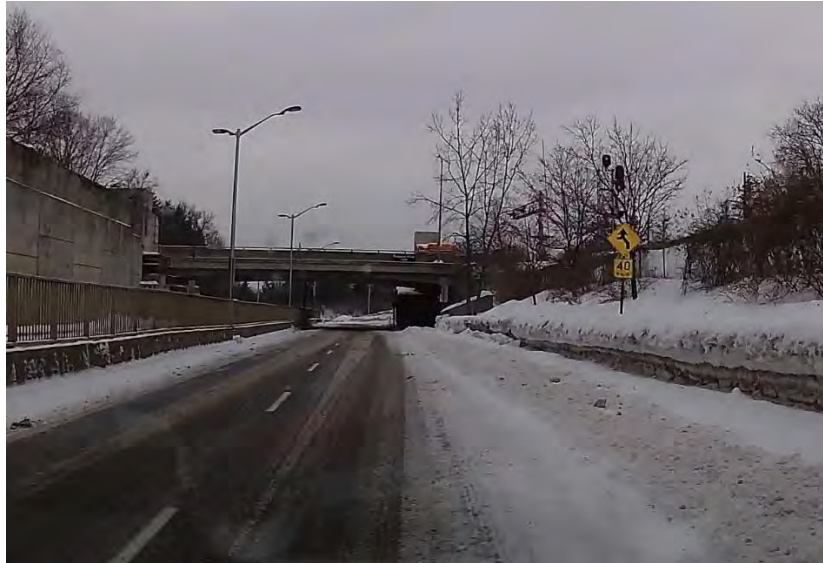
Issue 3: Northbound reverse curve warning sign is located south of the station

The northbound reverse curve warning sign, for the reverse horizontal curve north of the station, is located within the south entrance to the station. At this location, there is a high driver workload, the transit driver is focusing on activity and vehicle movements within the transit station and needs the curve warning information after the station.

Similarly, the southbound reverse curve warning sign of the reverse curve for these curves is located at north entrance to the Riverside Station.

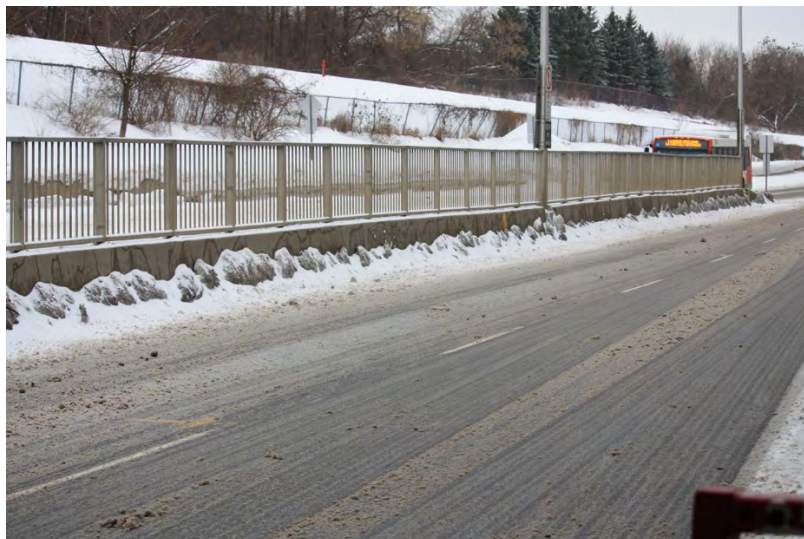
Issue 4: No energy attenuation at the median barrier ends

There is no energy attenuation at the median barrier ends at the entrances into the station. This is especially an issue at the northbound entrance into the station as the speed change from 80 km/h to 50 km/h for northbound vehicles occurs at this point. A transit vehicle may be travelling at 80 km/h at the start of the barrier.

Install an appropriate TL-3 crash cushion attenuator in place of the sloped end. A picture of the TL-3 crash cushion attenuator is shown below.

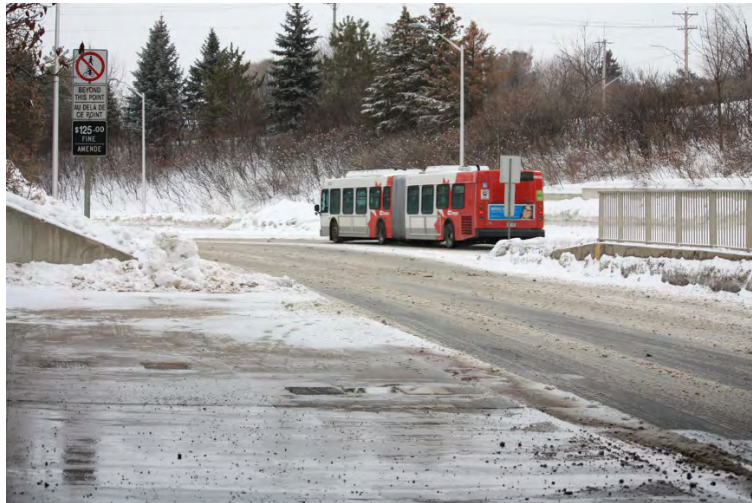
Issue 6: No protection for transit patrons on platform from an errant vehicle

Other than the raised curb along the edge of the transitway, there is no barrier to mitigate an errant vehicle accessing the passenger platform area. This is an issue as an errant vehicle travelling at high speed and encountering the curb at an obtuse angle could potentially mount the curb and enter onto the station platform area.

An 810mm high TL-3 concrete barrier with an appropriate length of need and taper is suggested to shield waiting transit customers from an errant bus mounting the curb on the approach end of the station platform.

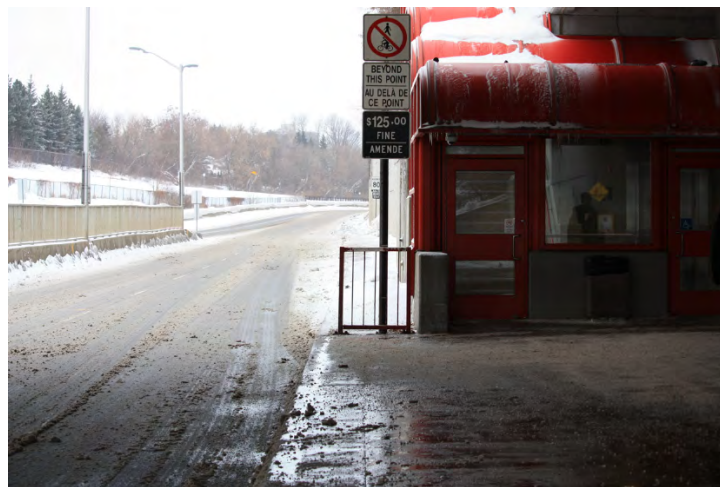
Issue 7: Concrete abutment end located in clear zone

The concrete abutment wall is located within the minimum dimension for a clear zone for an urban roadway. An errant transit vehicle leaving the transitway could run head-on into the barrier.

Remove the concrete abutment or shield it with an appropriate length of need and taper of a TL-3 concrete barrier.

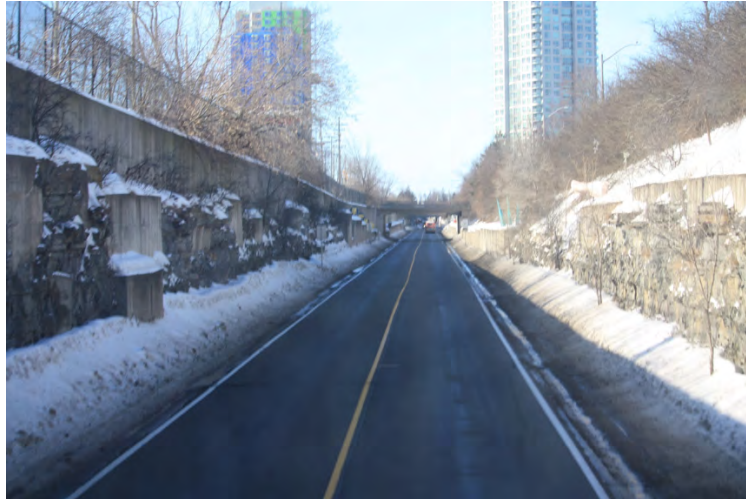
Issue 8: Jagged rock face and wall surface protrusions

Along both the westbound and eastbound approaches to the station, the side walls of the cut section have jagged rock face or wall surface protrusions. This is a potential issue as should a transit vehicle veer outside of the transitway running surface, these protrusions could grab the side of the vehicle resulting in a severe collision with the wall.

Install an appropriate length of need and taper of an anchored TL-3 F-Shape concrete barrier or a Cast-In-Place TL-4 F-shape concrete barrier. The barrier should be installed 1m offset from the edge line.

Note: An unanchored concrete barrier could shift or deflect by a maximum 1.8 metres if hit by a heavy vehicle, but the barrier shift caused by a bus would be less. Any barrier used on the Transitway must have a FHWA acceptance letter specifying the Test Level (TL).

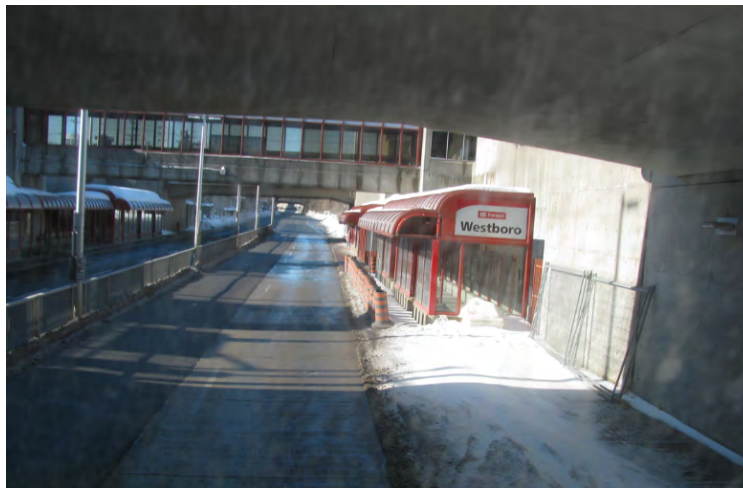
Issue 13: No protection for transit patrons on platform from an errant vehicle

Other than the raised curb along the edge of the transitway, there is no barrier to mitigate an errant vehicle accessing the passenger platform area. This is an issue as an errant vehicle travelling at high speed and encountering the curb at an obtuse angle could potentially mount the curb and enter onto the station platform area.

An 810mm high TL-3 concrete barrier with an appropriate length of need and taper is suggested to shield waiting transit customers from an errant bus mounting the curb on the approach end of the station platform.

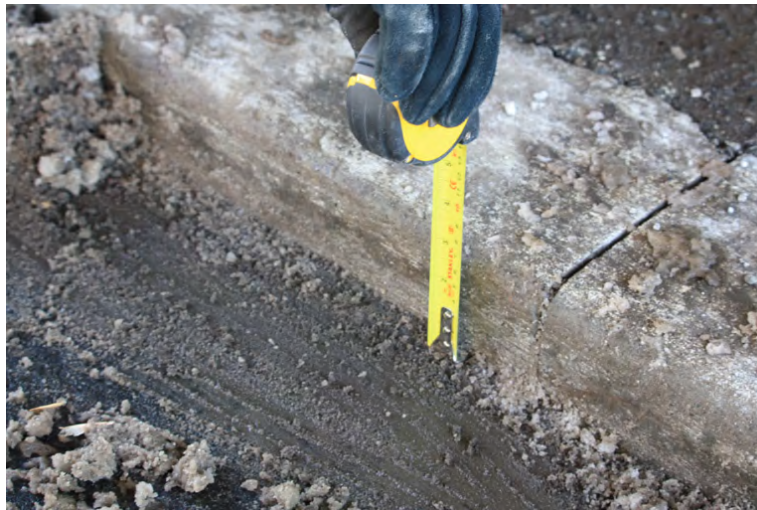
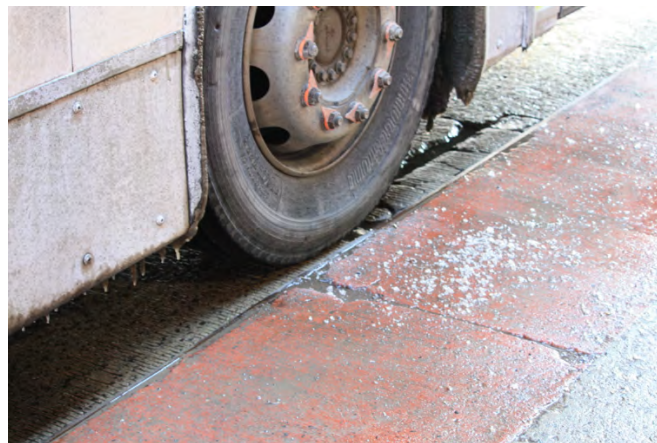
- the size and suspension characteristics of the vehicle
- its impact speed and angle
- the height and shape of the curb itself.

Therefore, the reduced height of the curb may inhibit the ability of the curb to deflect vehicles.

Rebuild the low curb with a 150mm high barrier curb in keeping with the current transitway design guidelines.

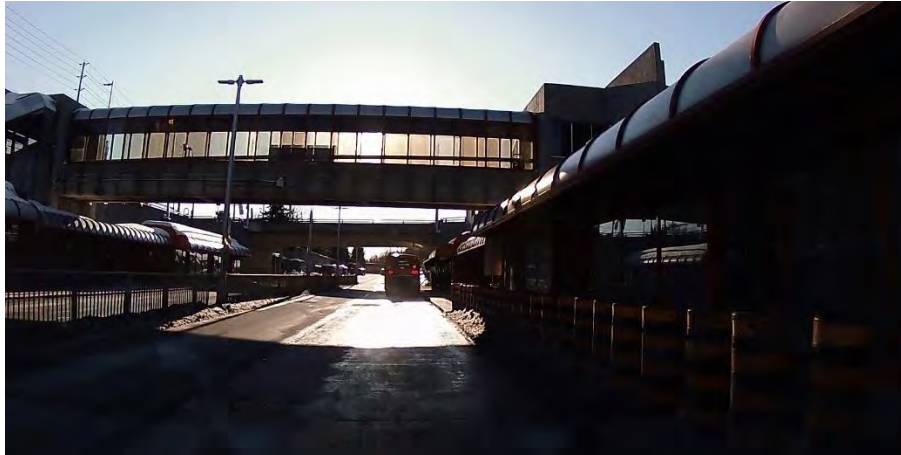
Issue: 18 Position of pedestrian bridge creating shadow area on transitway in advance of station

During sunny days a shadow from the pedestrian bridge is cast onto the transitway at the east end of the station on the westbound approach.

On these days when the sun is positioned in the southern sky directly in line with the Transitway. Drivers may experience bright glare from the sun straight ahead, then a very brief few seconds of darkness immediately followed by a bright sun directly in their cone of vision again. For drivers, this circumstance would test two visual factors in the driving task, adaption, and glare sensitivity. Adaption is the ability to change in sensitivity to different levels of light, as adjusting to changes in light upon entering the shadow area. Glare sensitivity is the ability to resist and recover from the effects of glare, as experiencing a reduction in visual performance due to the sun's glare upon exiting the shadow area.

Consider a sunscreen to block out the sunlight on the transitway.

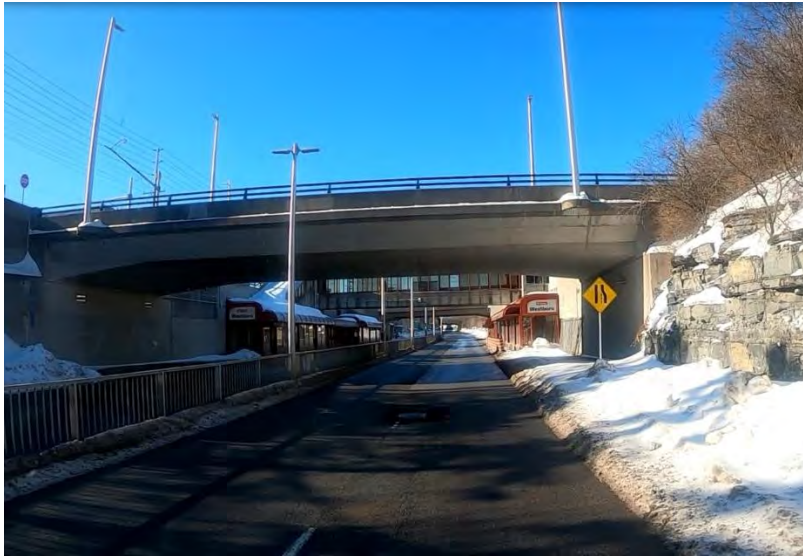
Issue 21: Merge warning signs for lane merges on exiting the Westboro station

The westbound merge warning sign, for the lane merge on exiting the Westboro Station, is located just east of the station. This is a high driver workload location; the transit driver is focusing on activity and vehicle movements within the transit station and does not need the merge warning information until after the station.

In the eastbound direction, there is no merge warning sign to warn drivers of the need to merge as the right lane ends and tapers into the left lane.

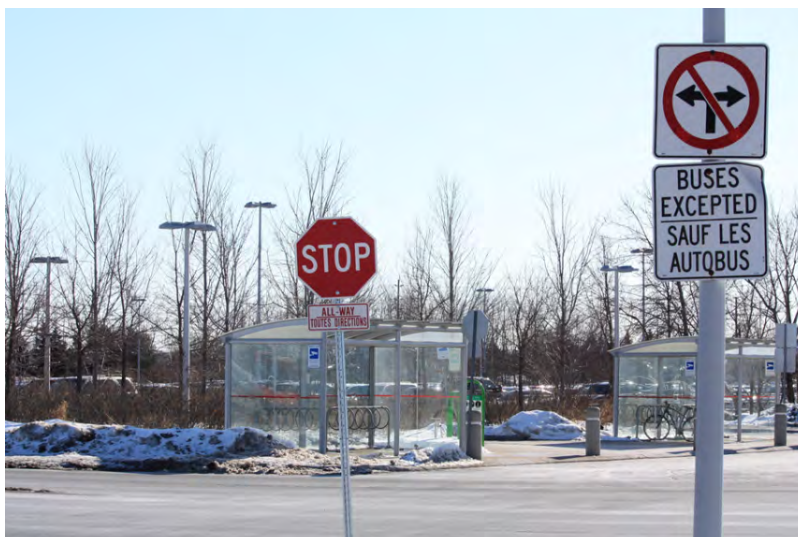
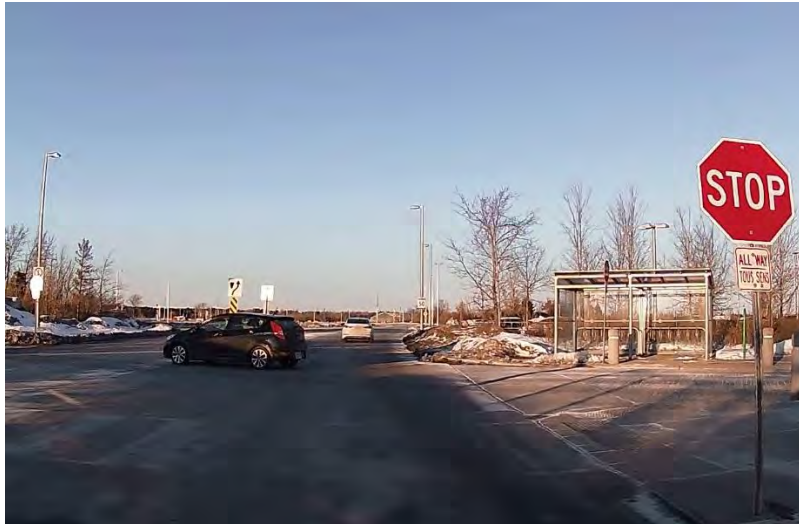
Issue 24: No redundant entry prohibition signs for motorist egress from VIA Rail station

There are turn prohibition signs on the approaches to the crossing of the VIA RAIL Station access and the transitway to advise motorists crossing the transitway not to enter onto the transitway. However, at times this intersection is very busy with many crossing pedestrians as well as vehicles accessing the VIA Rail Station and transit vehicles at the intersection which could distract a driver's attention. Should a driver travelling to and from the rail station not see these turn prohibition signs when approaching the intersection, they may mistakenly turn onto the transitway. As shown in a picture below, a passenger car was observed on the transitway during the onsite audit. There are no signs at the intersection to advise the driver not to enter onto the transitway.

Install Entry Prohibited (RB-23) signs with a Tab “Except Buses” at the throat of the transitway. Double signing is suggested.

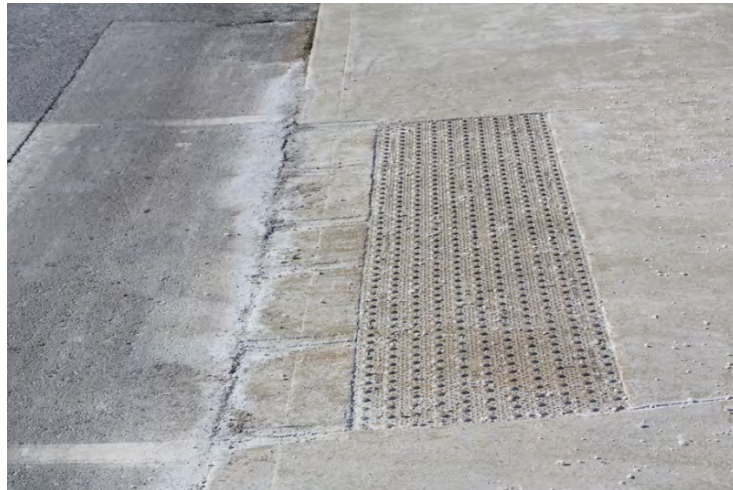
Issue 26: Conspicuity of tactile surface

The tactile surface for the entrance to the crosswalk is not conspicuous in comparison to the concrete sidewalk. Most people with a visual impairment have some sensory abilities but may not be able to discern between objects unless they have high contrast. Many people start to suffer vision loss after the age of 65 years. For these people, there may be a limited perception of the path ahead and obstacles. Such people would need to rely entirely on non-visual indicators to find this textured plate.

Install Accessibility for Ontarian with Disability Act (AODA) approved high tonal tactile surface. Although the colour of the tactile surface is not specified in AODA, the common high contrast colour standard for most jurisdictions in North America is yellow.

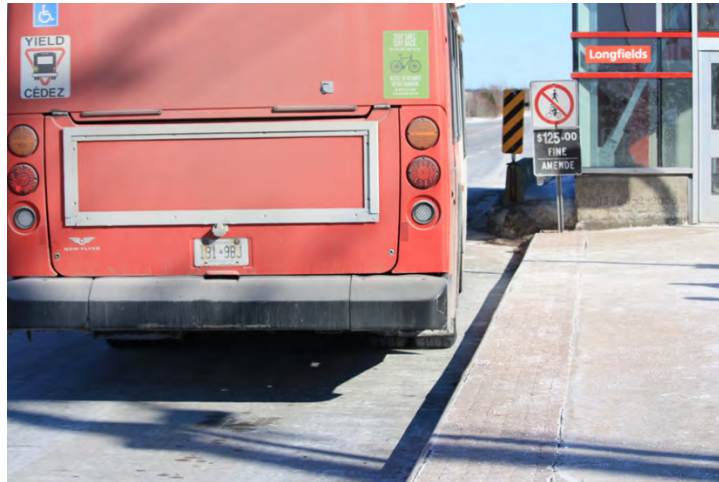
Issue 31: Concrete barrier – Rear swept path of double decker (rear out swing) intrudes onto platform

The rear swept path of transit vehicles leaving the station with an abrupt turning maneuver can intrude onto the passenger platform. This is especially a concern for double decker buses which have a long overhang behind the rear axle.

Remove the concrete barriers with a blunt end from the travel lane. Or install a TL-3 F-Shape concrete barrier along the edge of the platform with a pedestrian railing 1000mm high of appropriate length of need and taper to shield passengers on the platform from the swept path of the articulated bus.

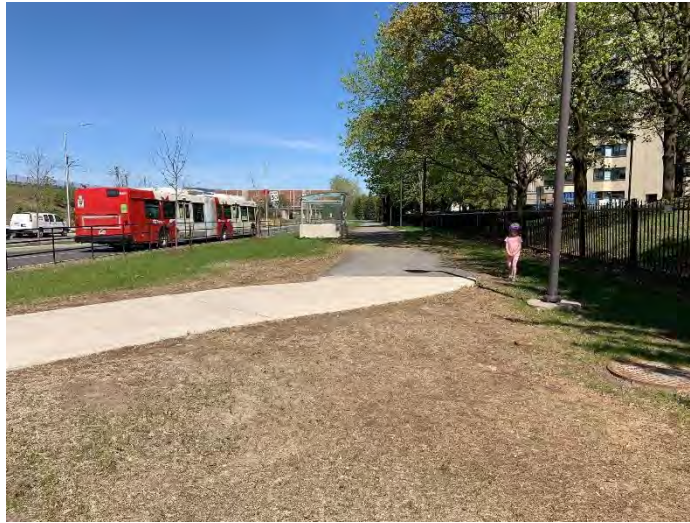
To the southeast, an asphalt MUP transitions to concrete before meeting the crossing. While not regulatory, in Ottawa this is commonly used as a visual queue for cyclists that they should dismount and walk.

It should be confirmed whether a mixed crossride is appropriate and desirable for this location. OTM Book 18 notes that mixed crossrides are “for low volume crossings, particularly at unsignalized locations where practitioners do not anticipate queuing of pedestrians or cyclists”. This does not appear to be a low volume crossing, and queuing of users would be anticipated after trains disembark creating a surge of users.

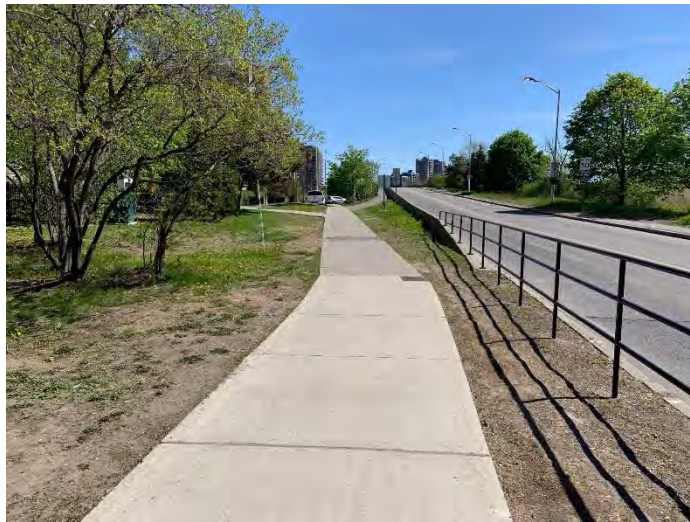
To the south, several sidewalks converge into a single concrete sidewalk. The sidewalks are too narrow to be used as shared facilities.

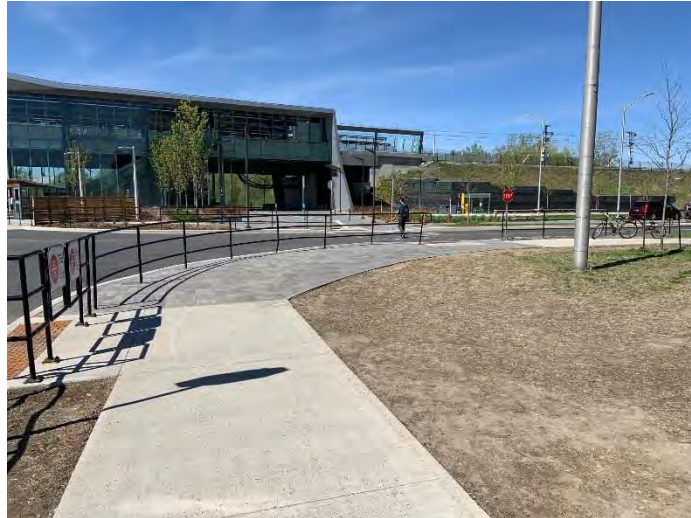
The south and southeast approaches converge into mixing zone with a paver surface, with no guidance to users on the intended use.

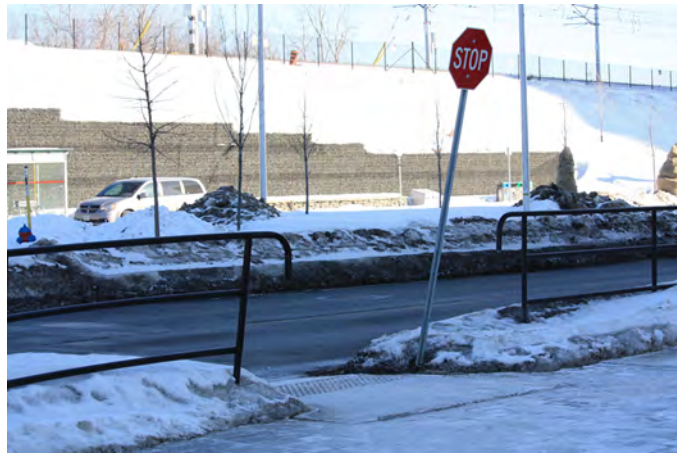
Issue 33: Main Crosswalk – STOP sign for pedestrians mounted too high

For a STOP sign that appears to be oriented to cyclists, the mounting height of the sign is very high.

If the stop sign is to be retained (refer to issue 32), the sign should be mounted at a height of 2m from the sidewalk to the base of the sign to improve the conspicuity for cyclists.

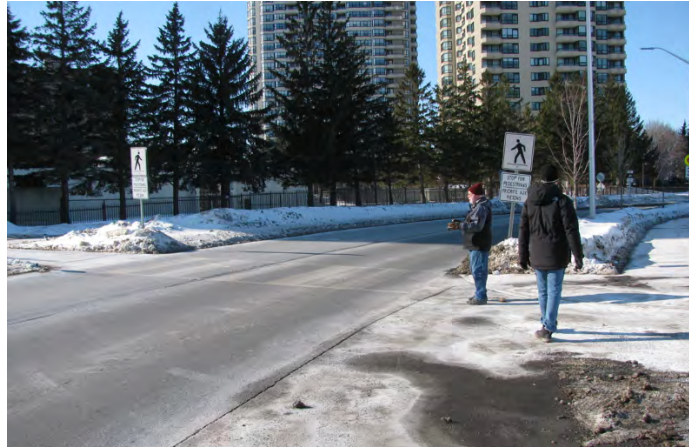
Issue 34: East Crosswalk – Luminaires not over crosswalk

There are no streetlights located immediately at the crosswalk. Therefore, illumination levels will be brighter on the road surface located away from the crosswalk and darker at the crosswalk. This may result in pedestrians in the crosswalk being less likely to be seen at night.

The RSA Team suggests a luminaire or alternatively consider a Rapid Rectangular Flashing Beacons (RRFB). The auditors note there is a commercial product that combines a luminaire that comes on when the RRFB is activated.

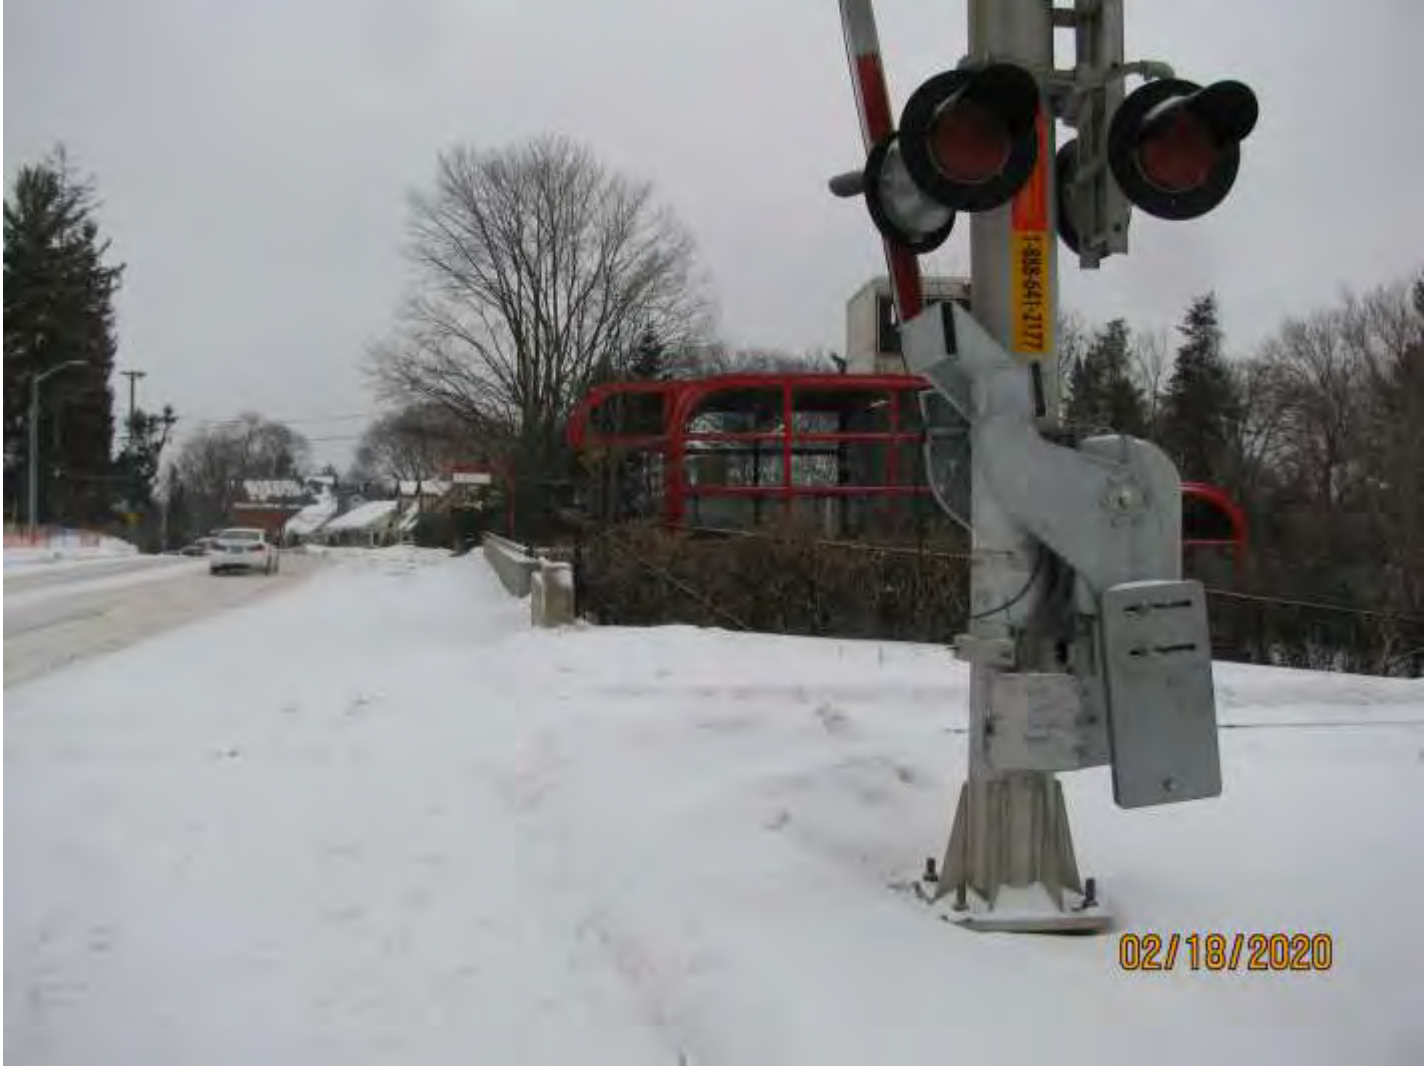
RAILWAY CROSSING

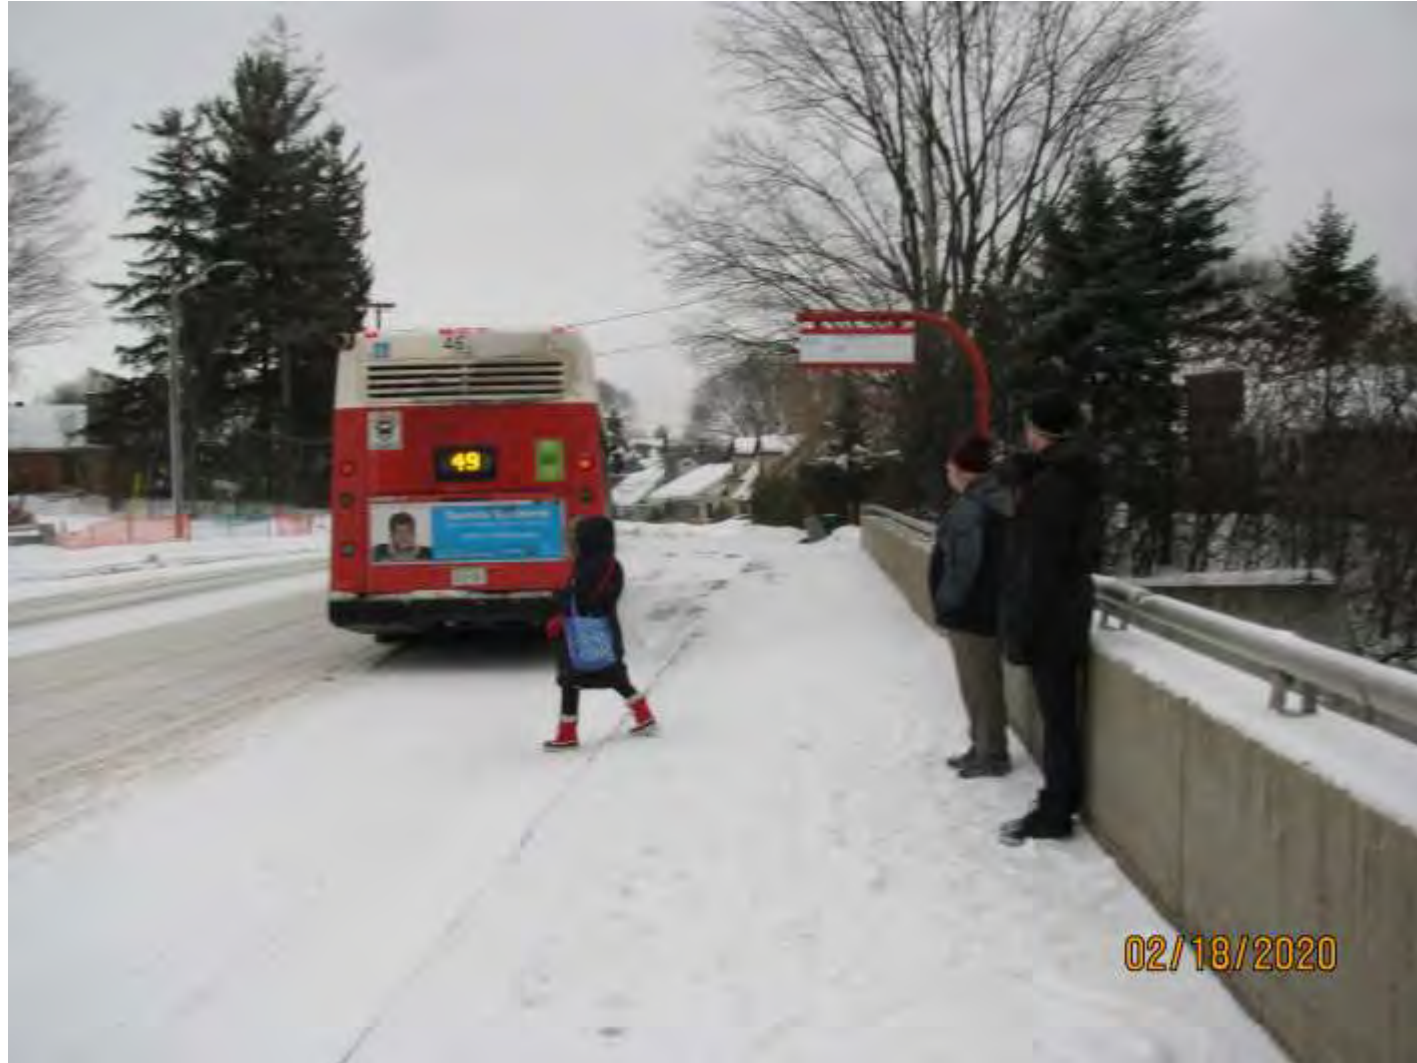
PEDESTRIAN CROSSING ACTIVITY

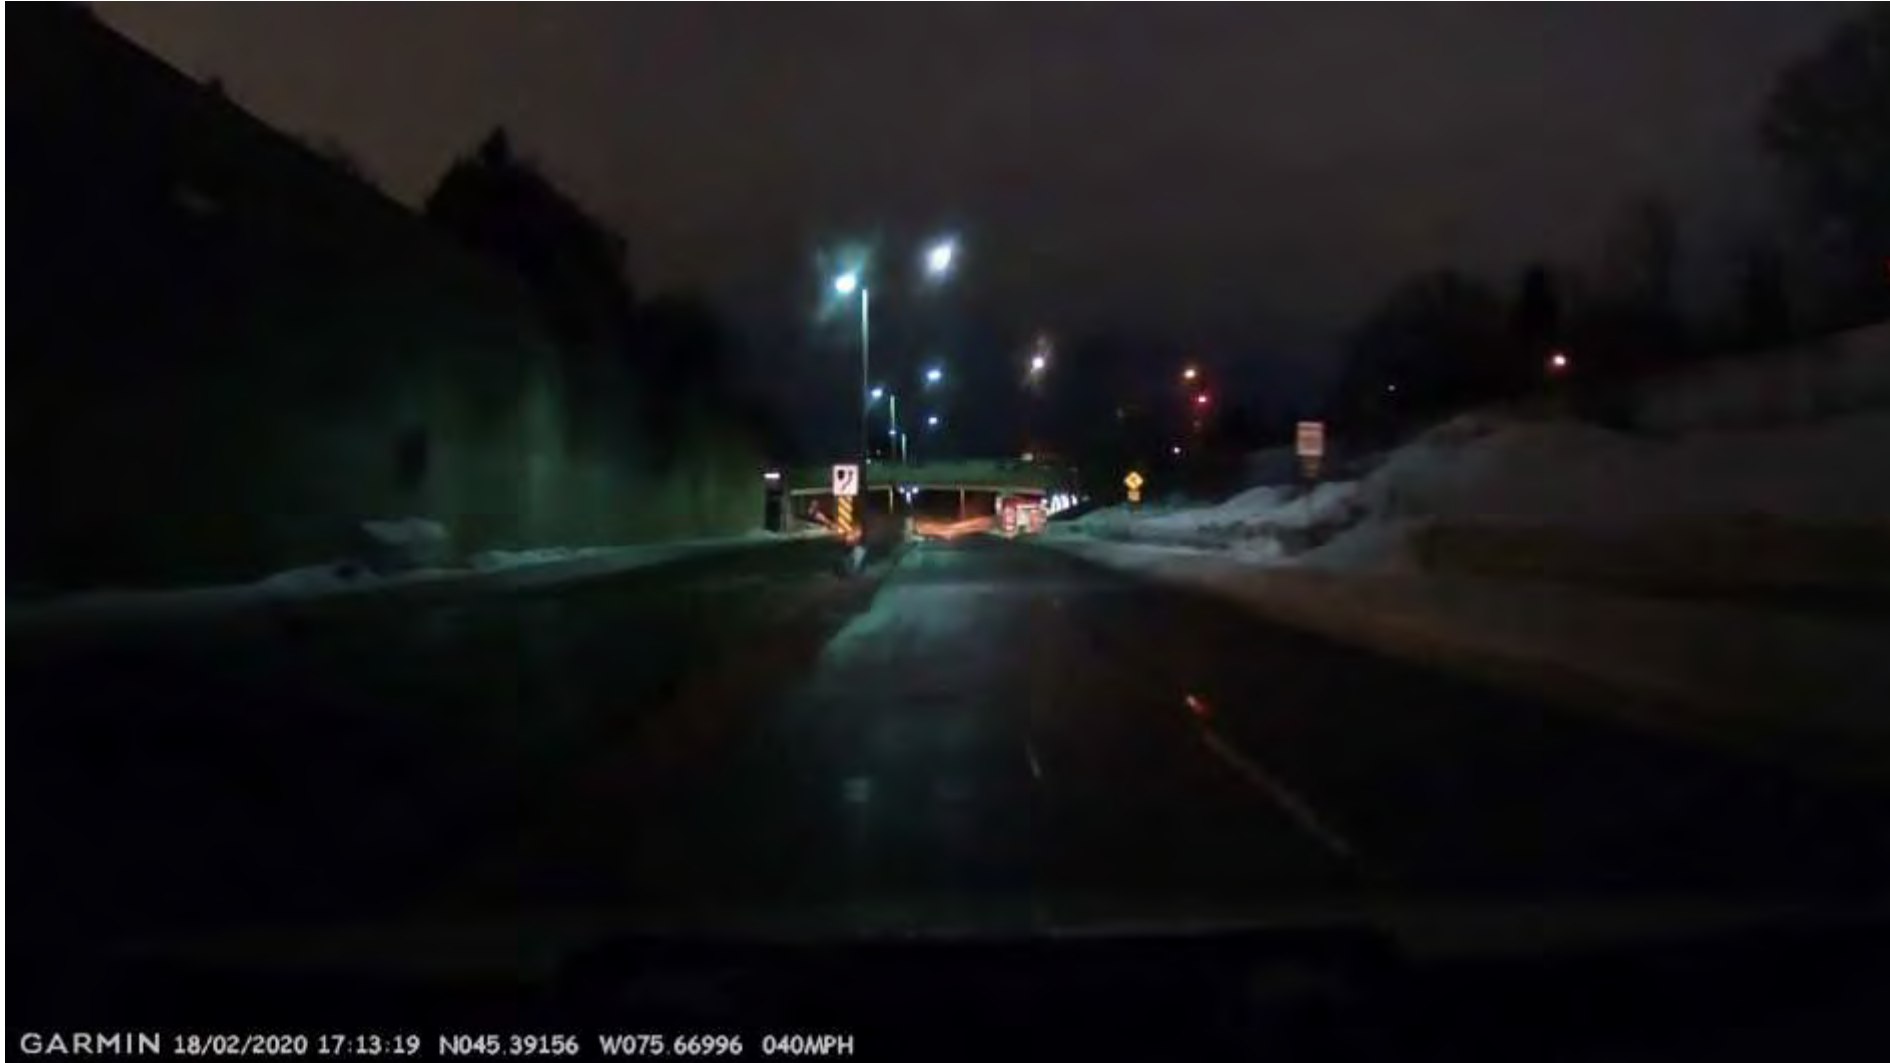
REVERSE CURVE WARNING SIGN ON TRANSITWAY

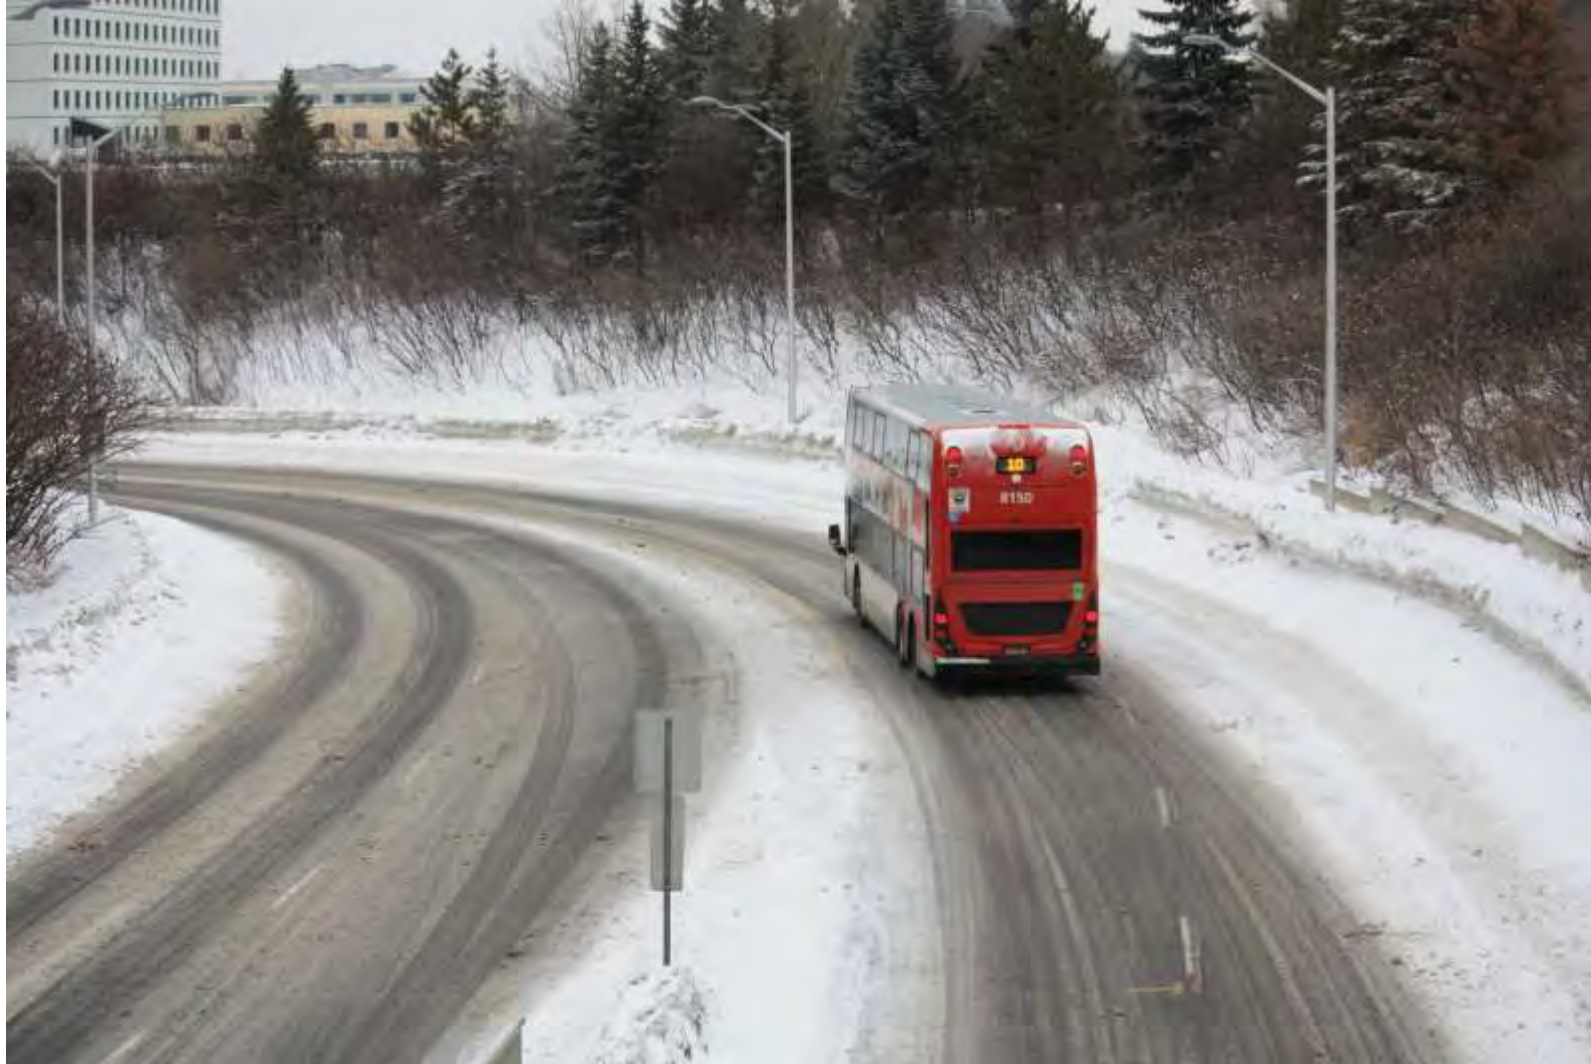
REVERSE CURVES – ADVISORY SPEED SIGNING

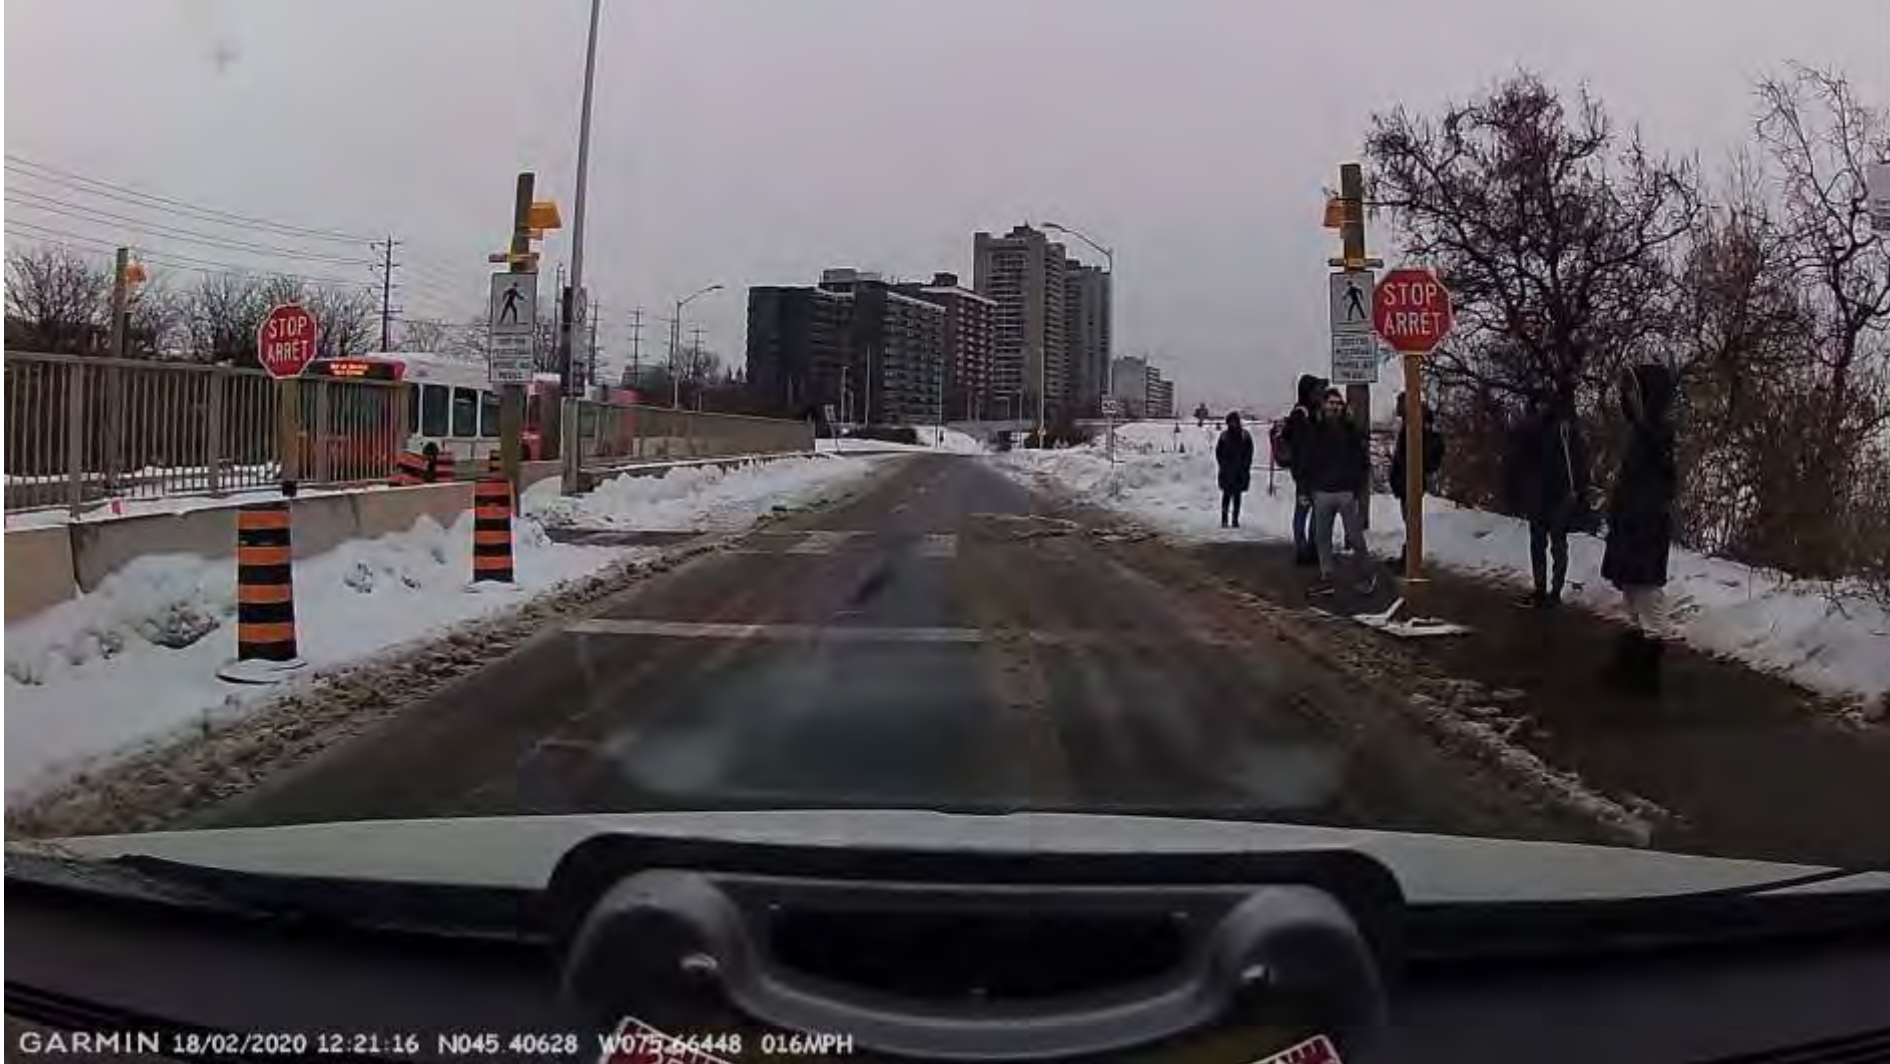
PEDESTRIANS AT TEMPORARY CROSSING

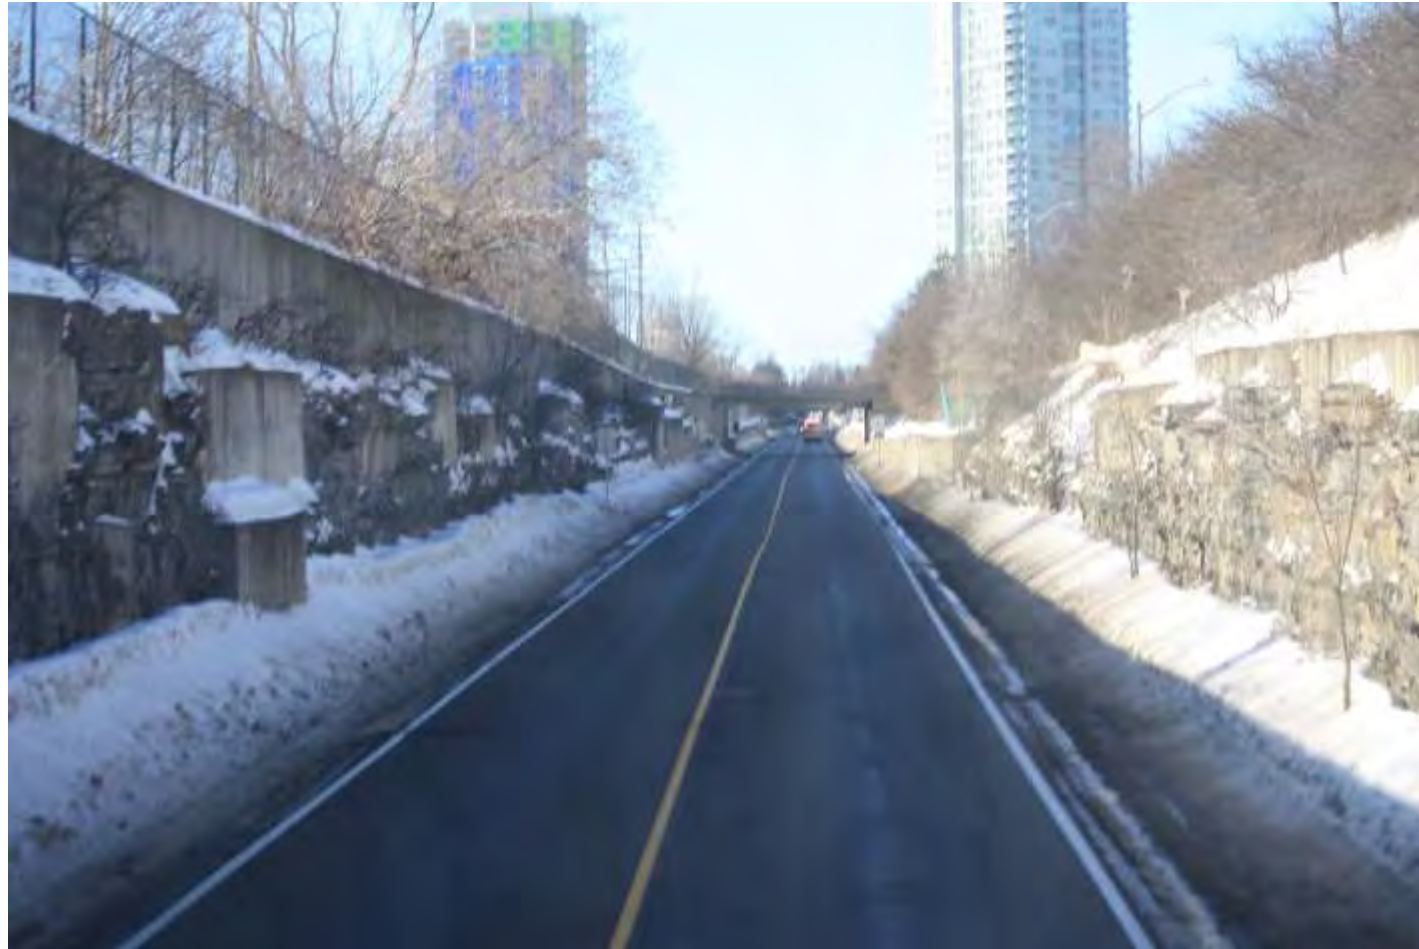
ROCK CUTS AND WALL SURFACE PROTRUSIONS

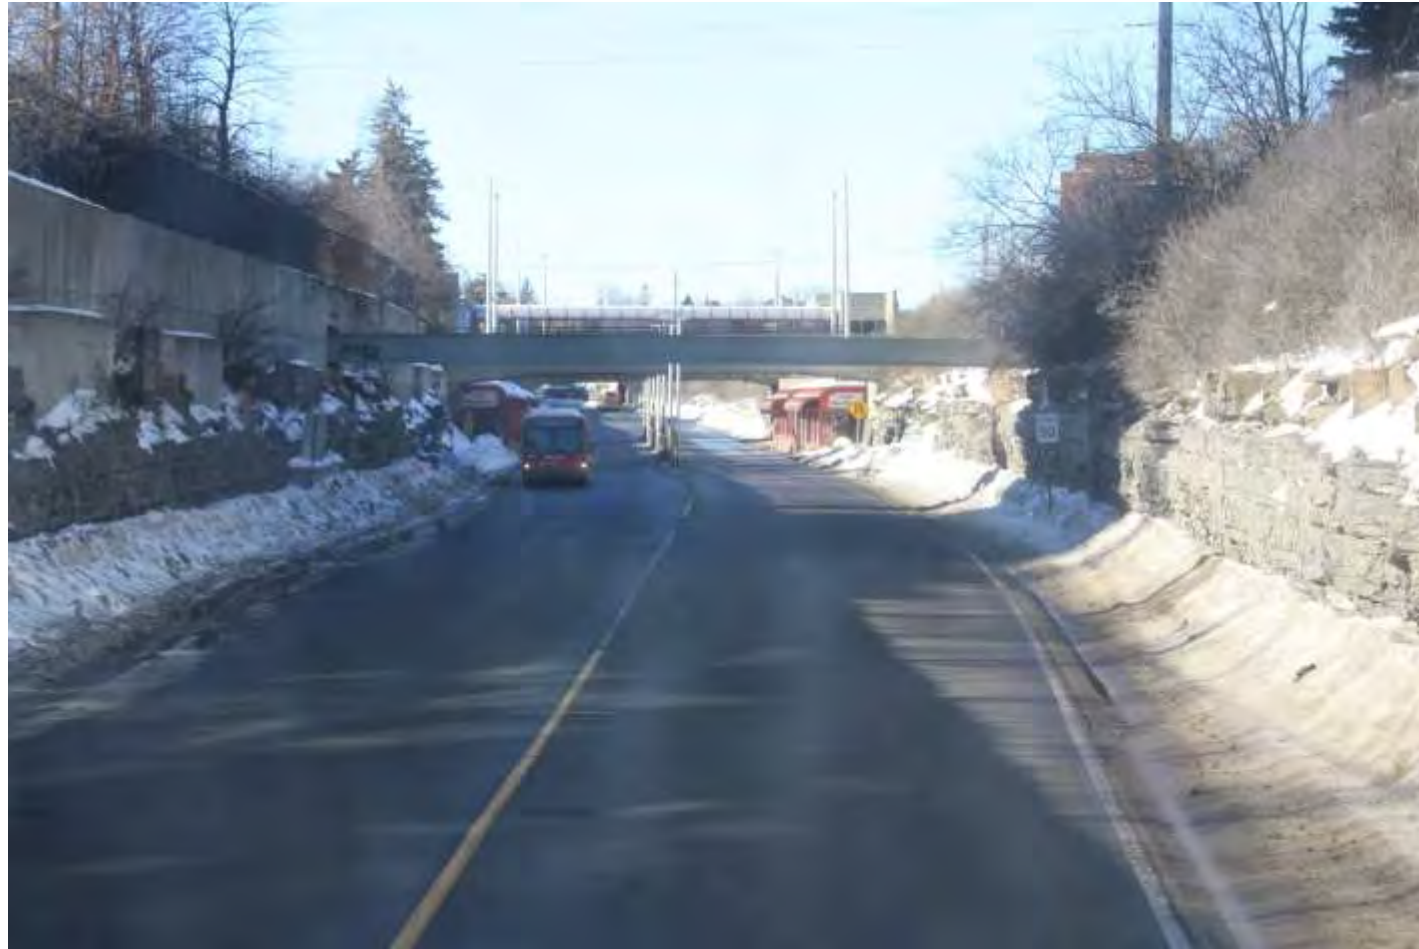
LIGHT AND SHADOWS DUE TO SUN ANGLE
