OC Transpo Transitway Station Design Safety Study

Independent Safety Study

Final Safety Study

September 2021

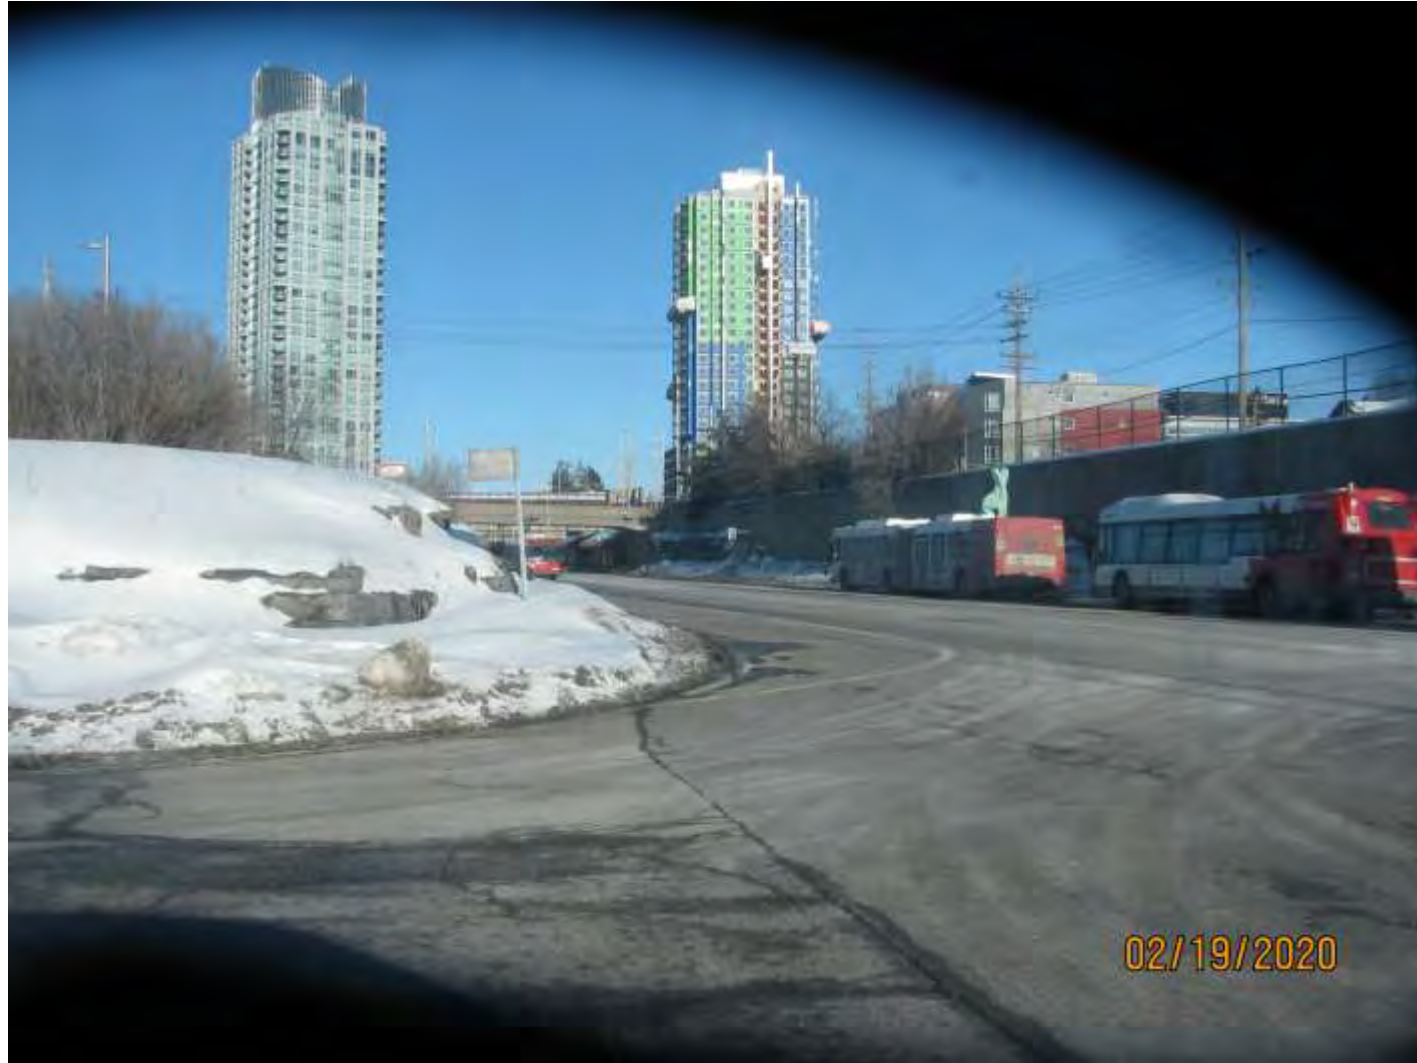
INTERSECTION SIGHT DISTANCE

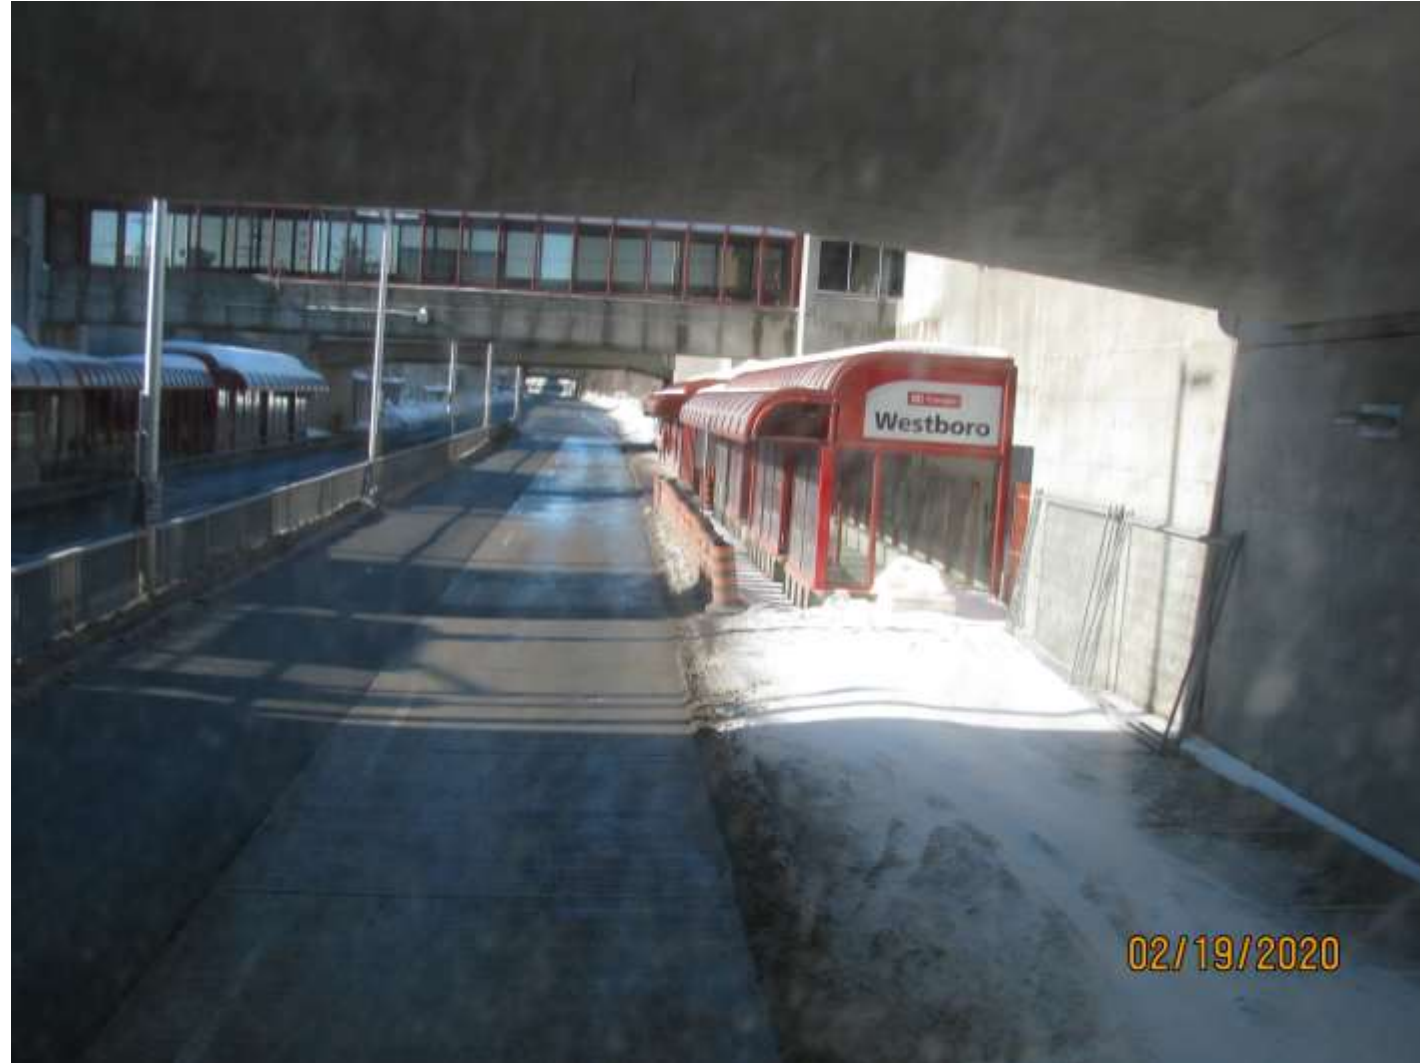
NO PROTECTION FOR TRANSIT PATRONS ON PLATFORM

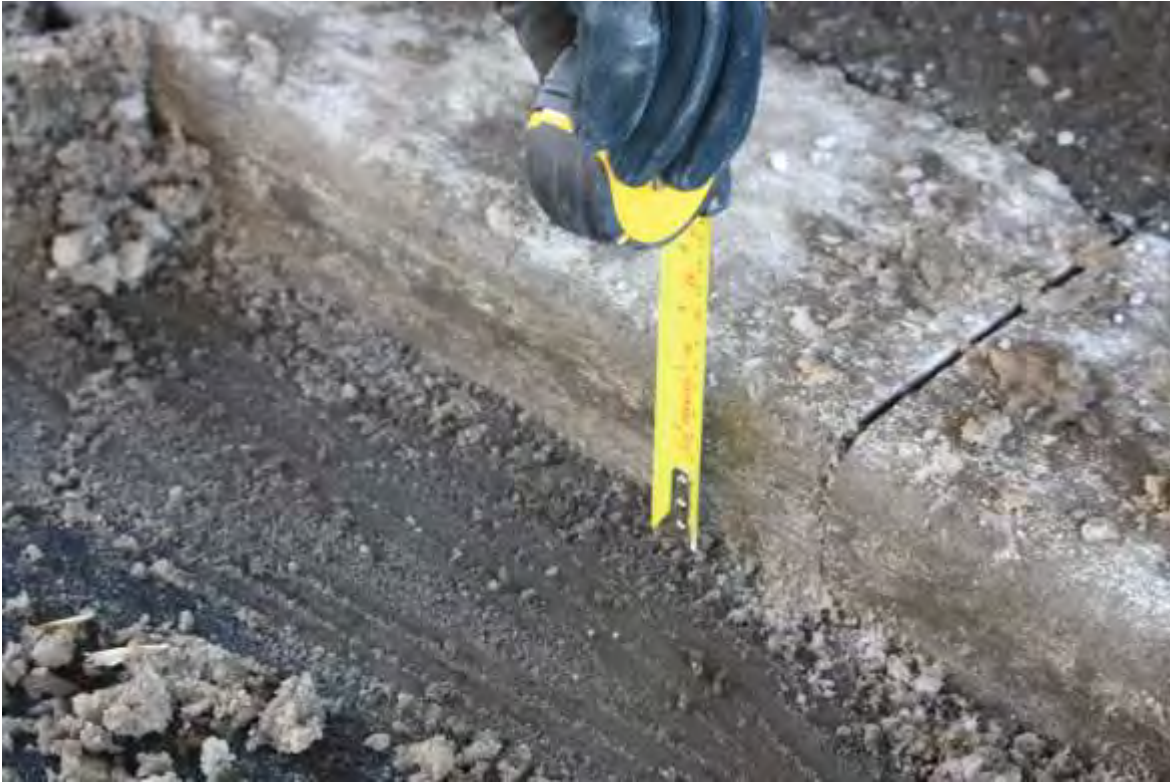
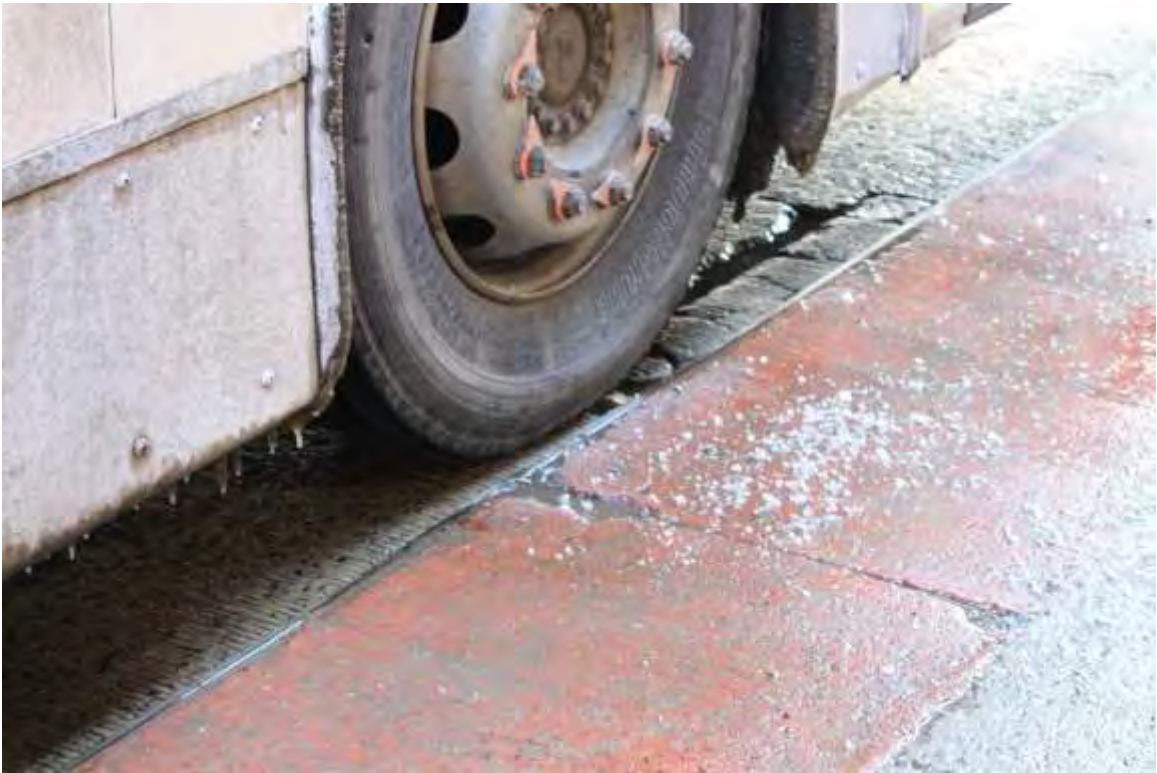
CURB HEIGHT AT STATION

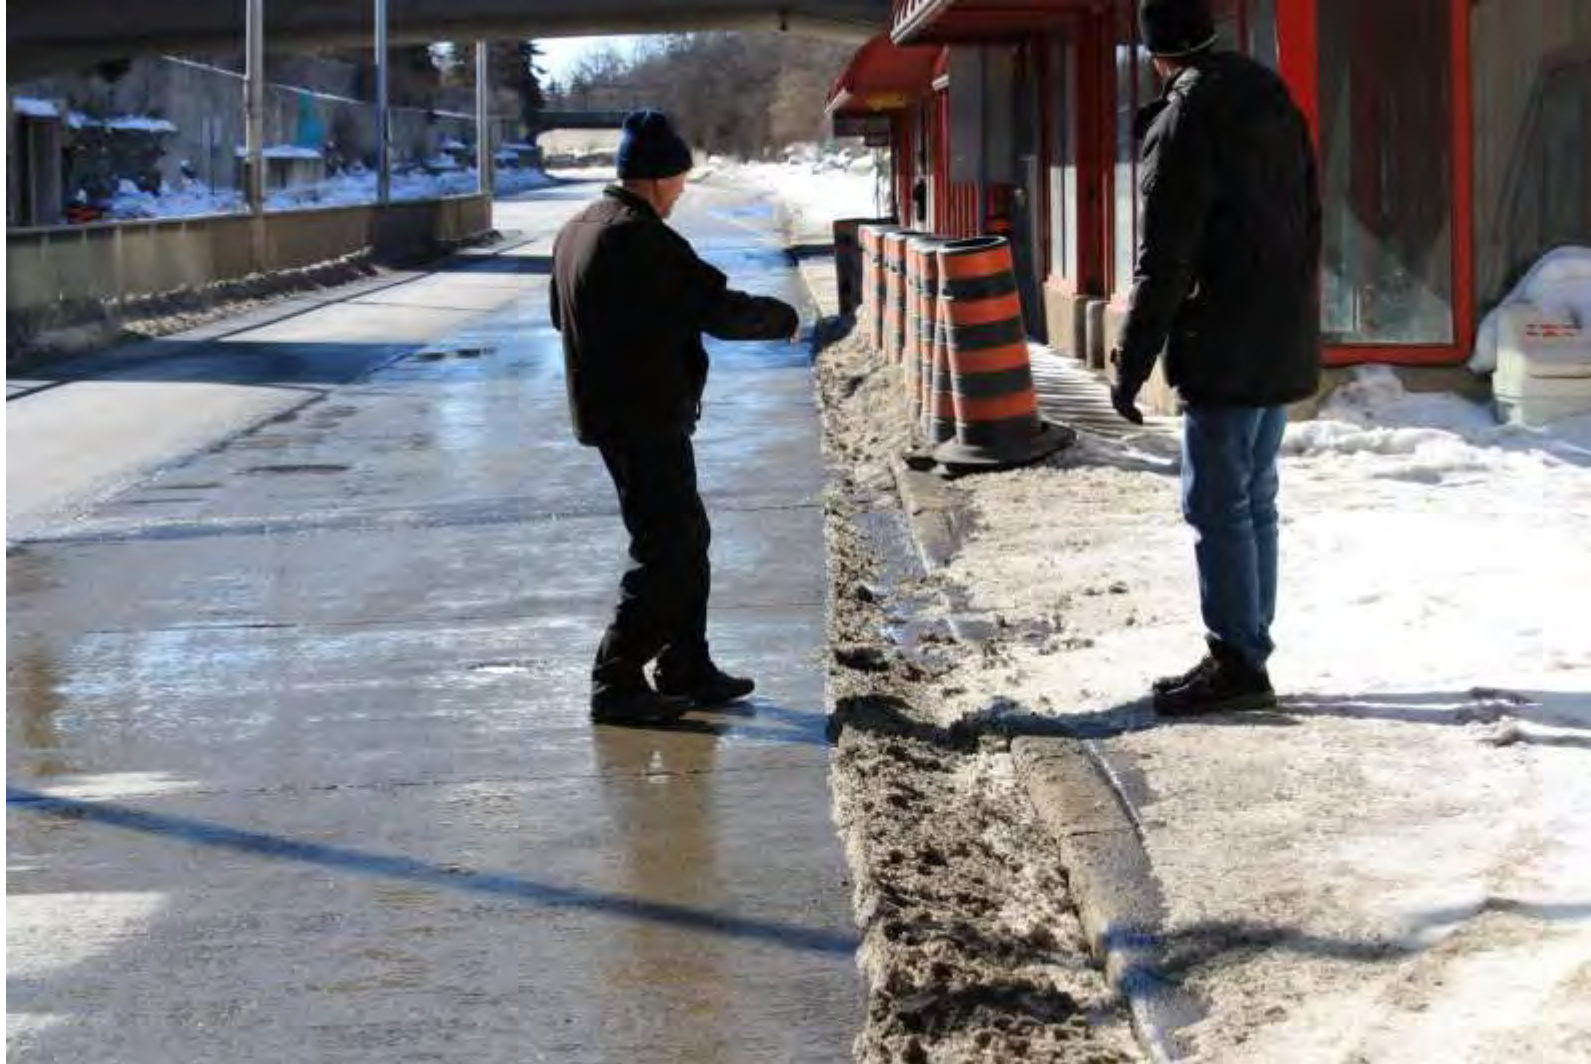
SERVICE VEHICLE LETDOWN LOCATION

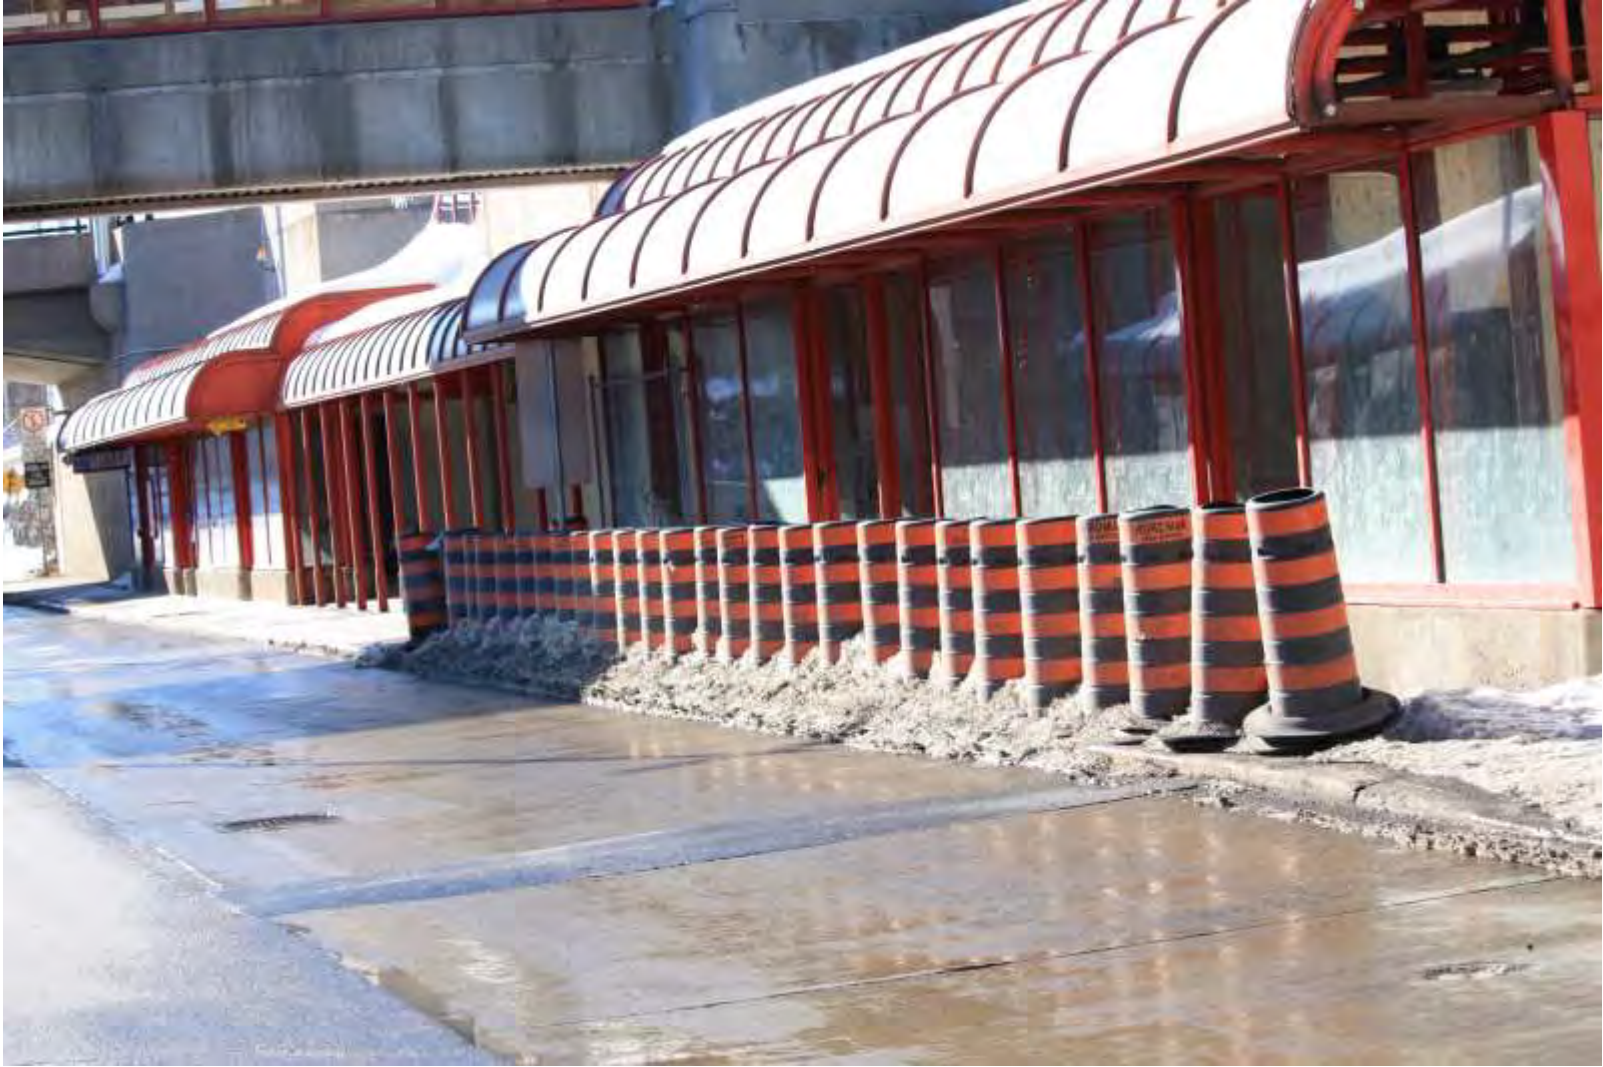
CURVED SHAPE OF CANOPY

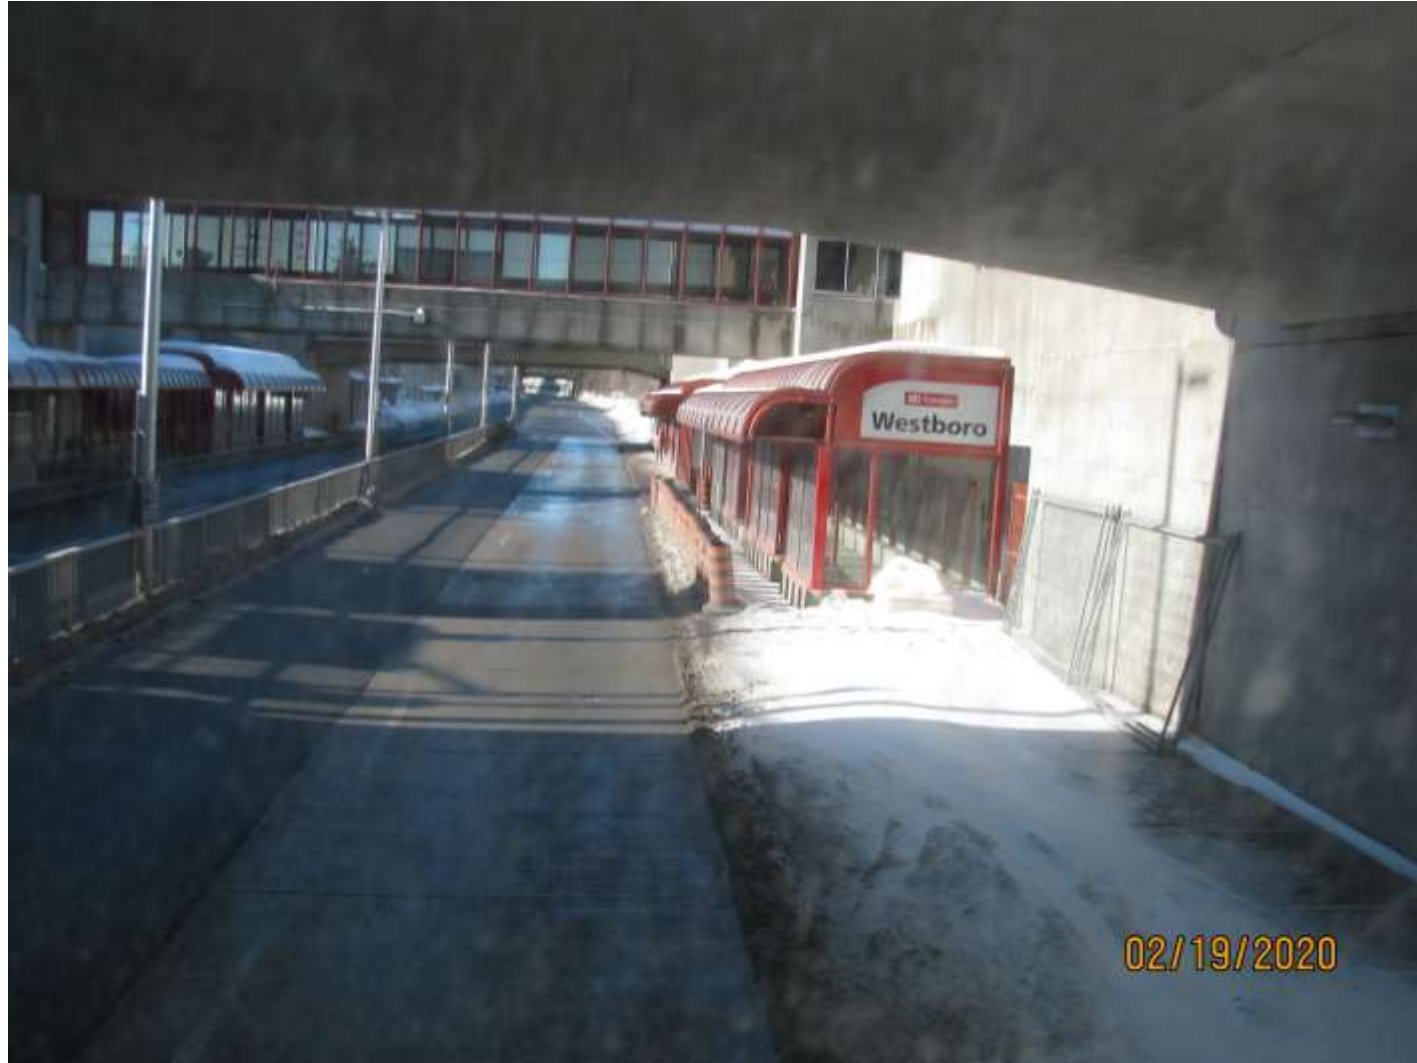
PEDESTRIAN BRIDGE CREATING SHADOW ON TRANSITWAY

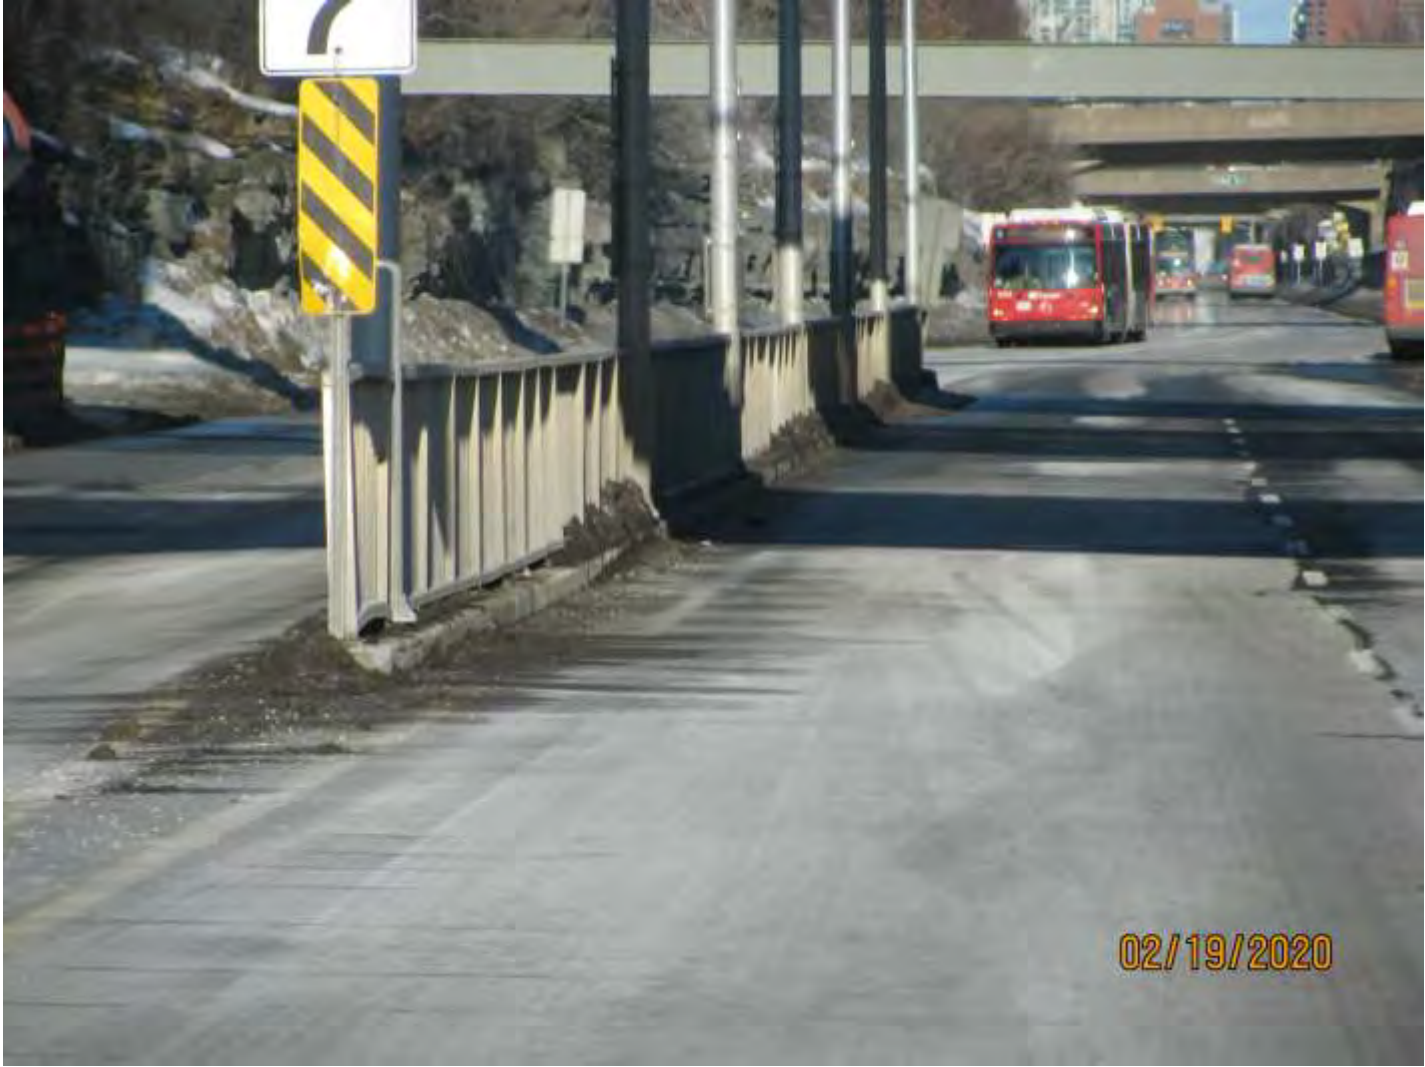
MEDIAN BARRIER DESIGN

Replace the median fencing with a TL-3 F-Shape 810mm concrete barrier and TL-3 crash cushion end treatments.

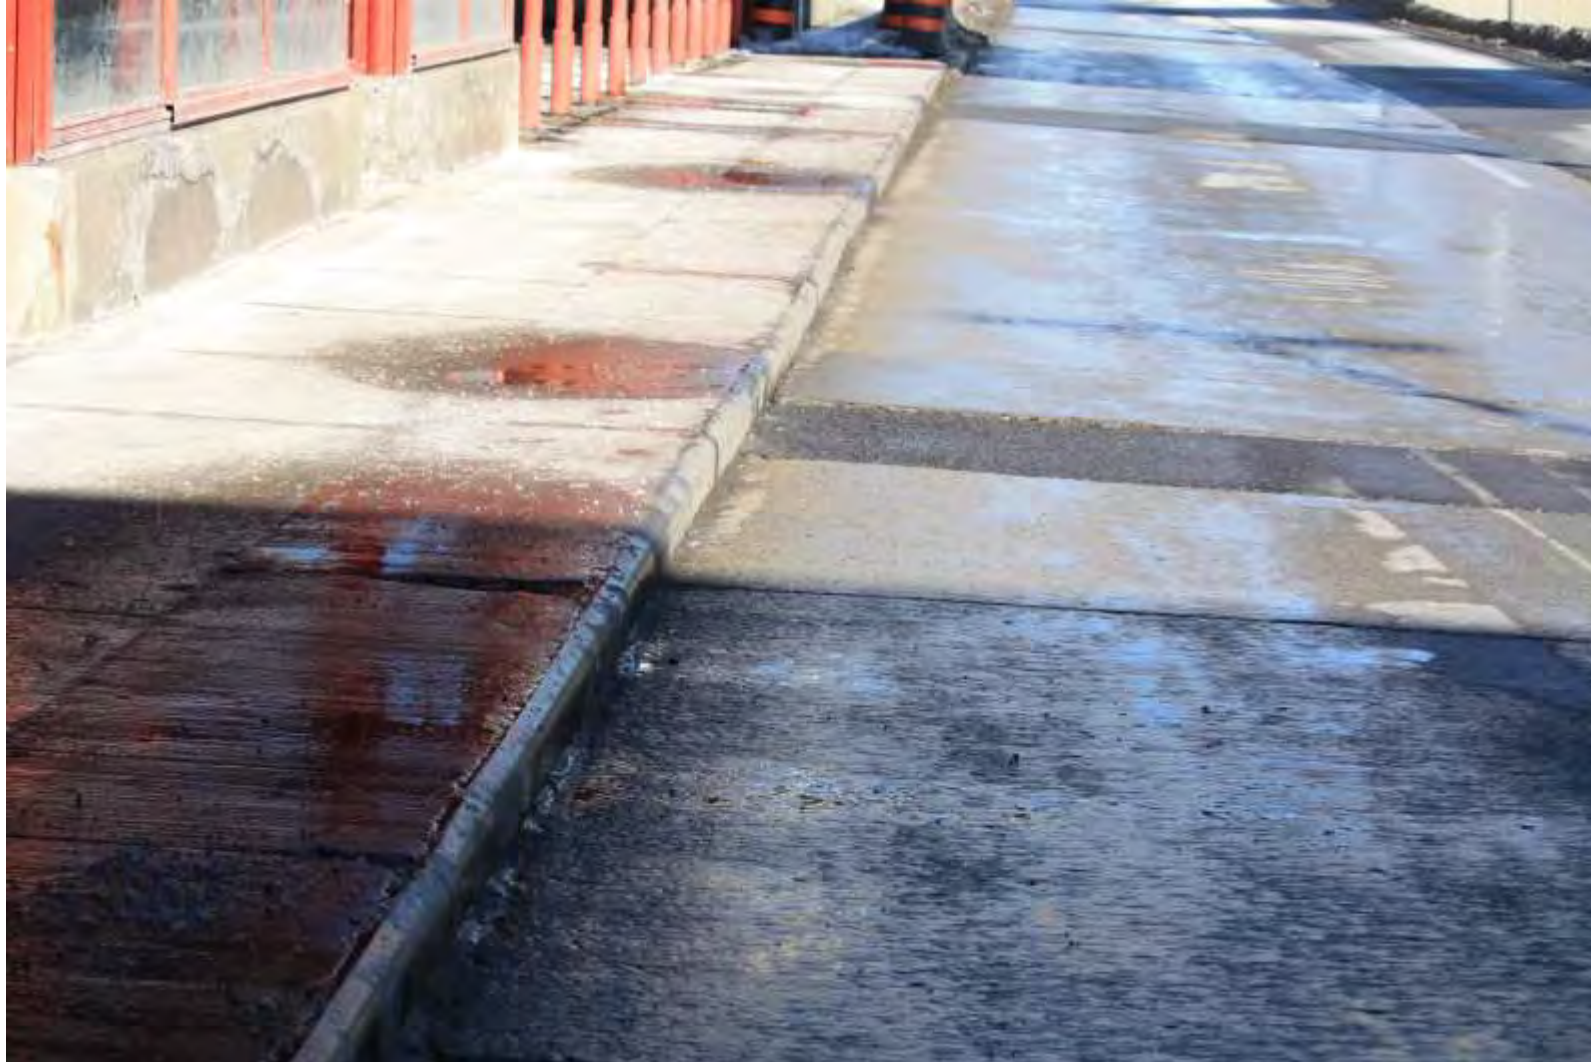
CONSPICUITY OF PLATFORM EDGE

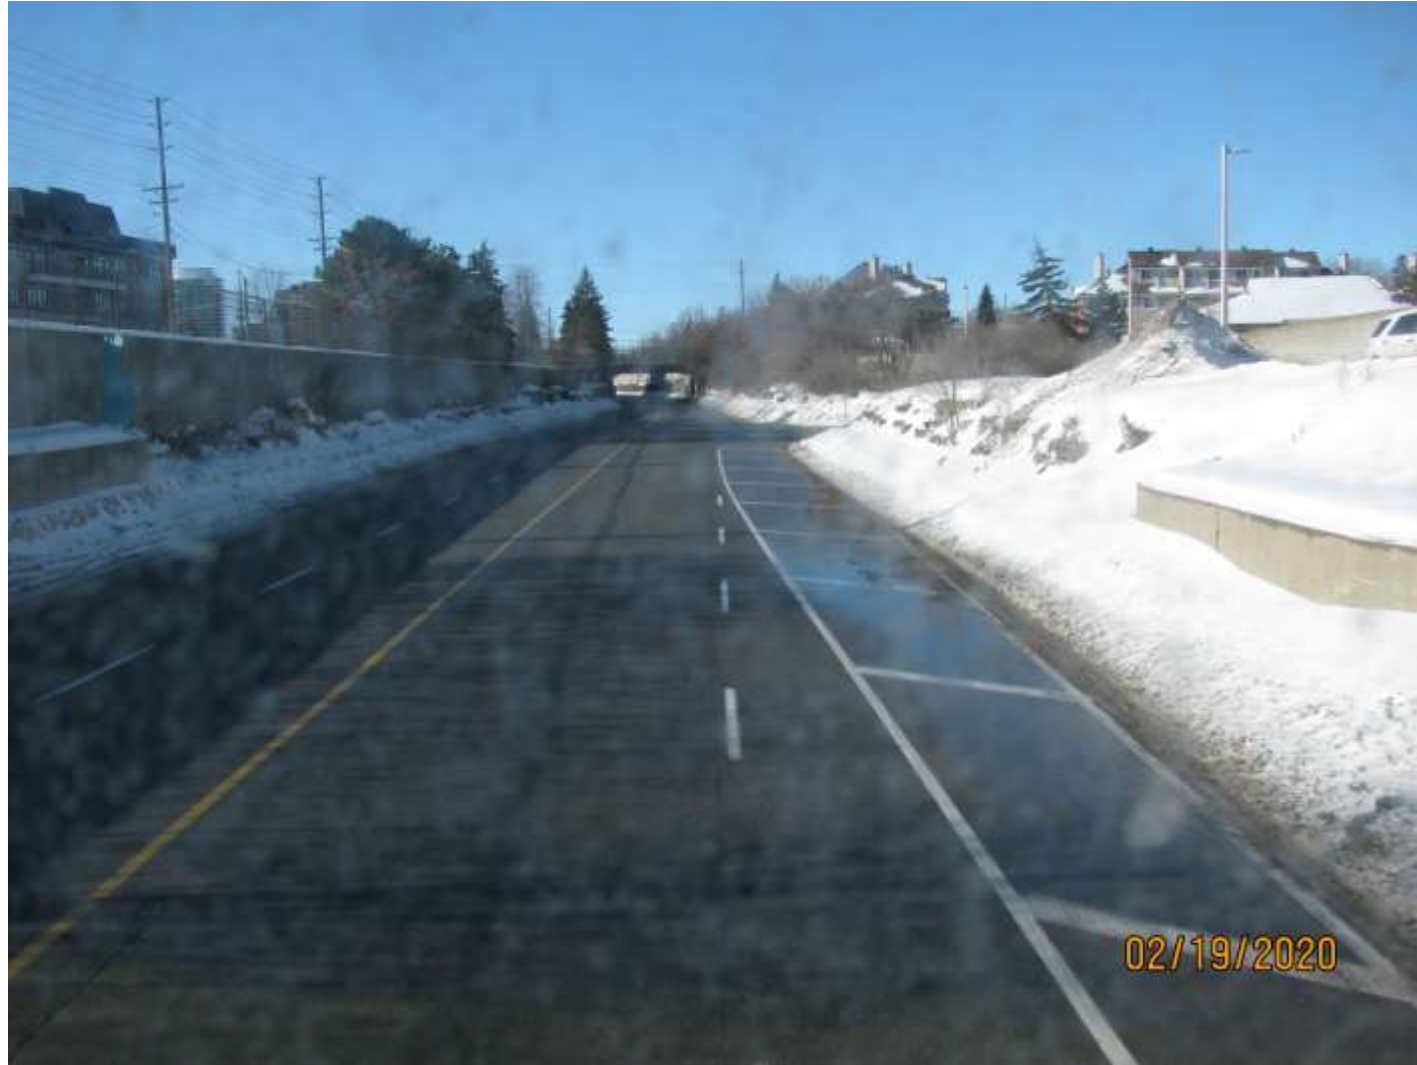
DEPARTURE MERGE

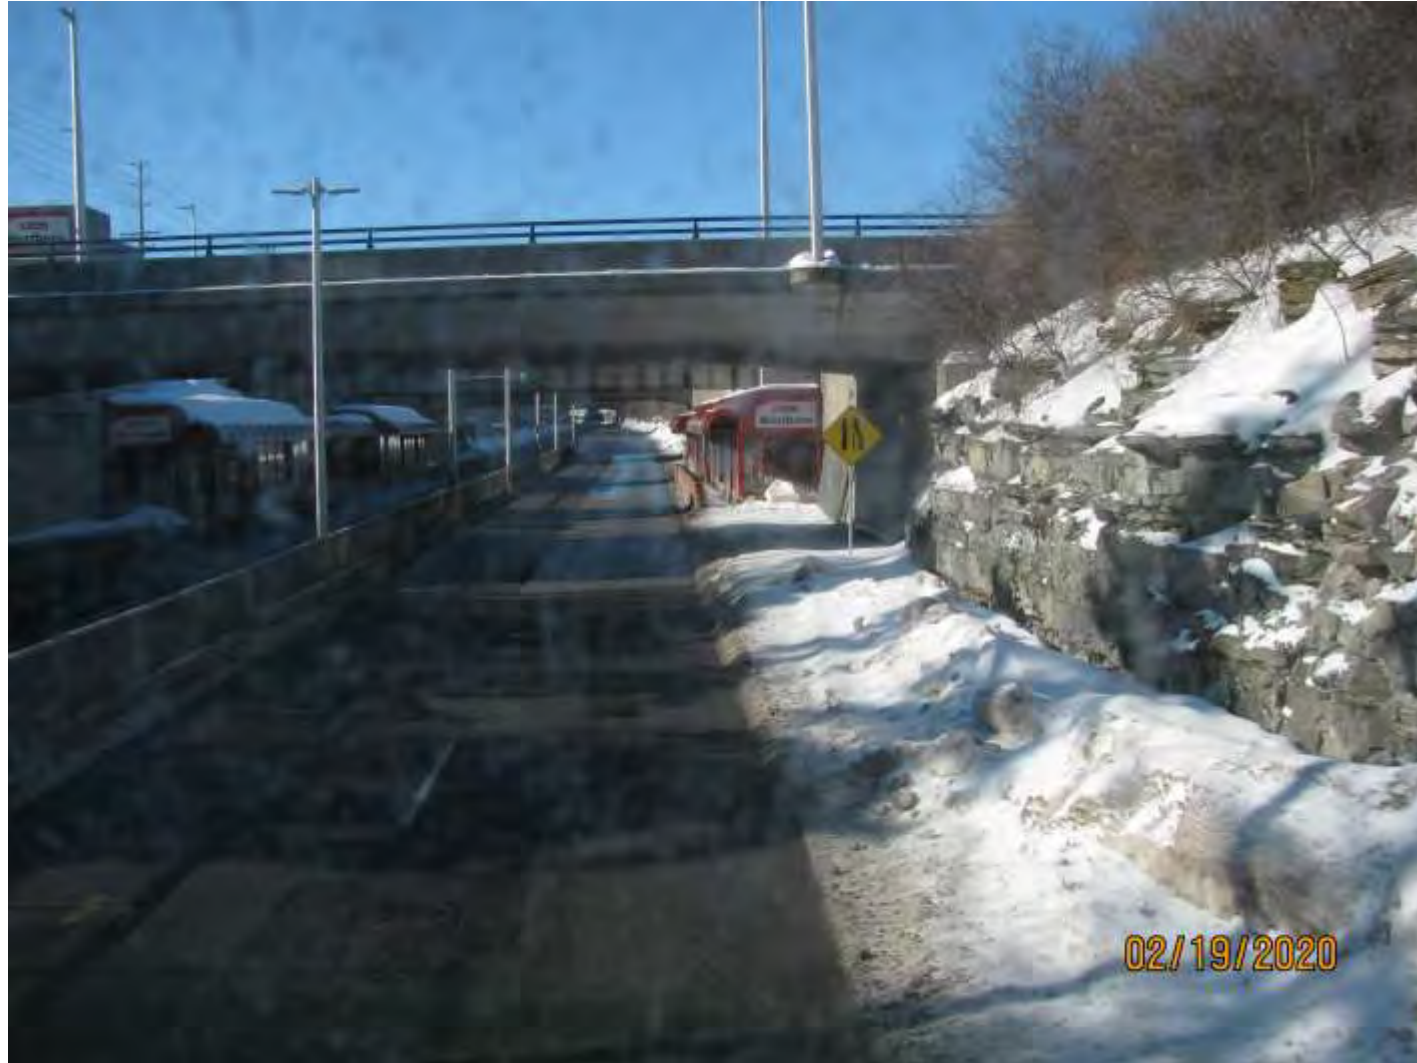
LOCATION OF MERGE WARNING SIGN

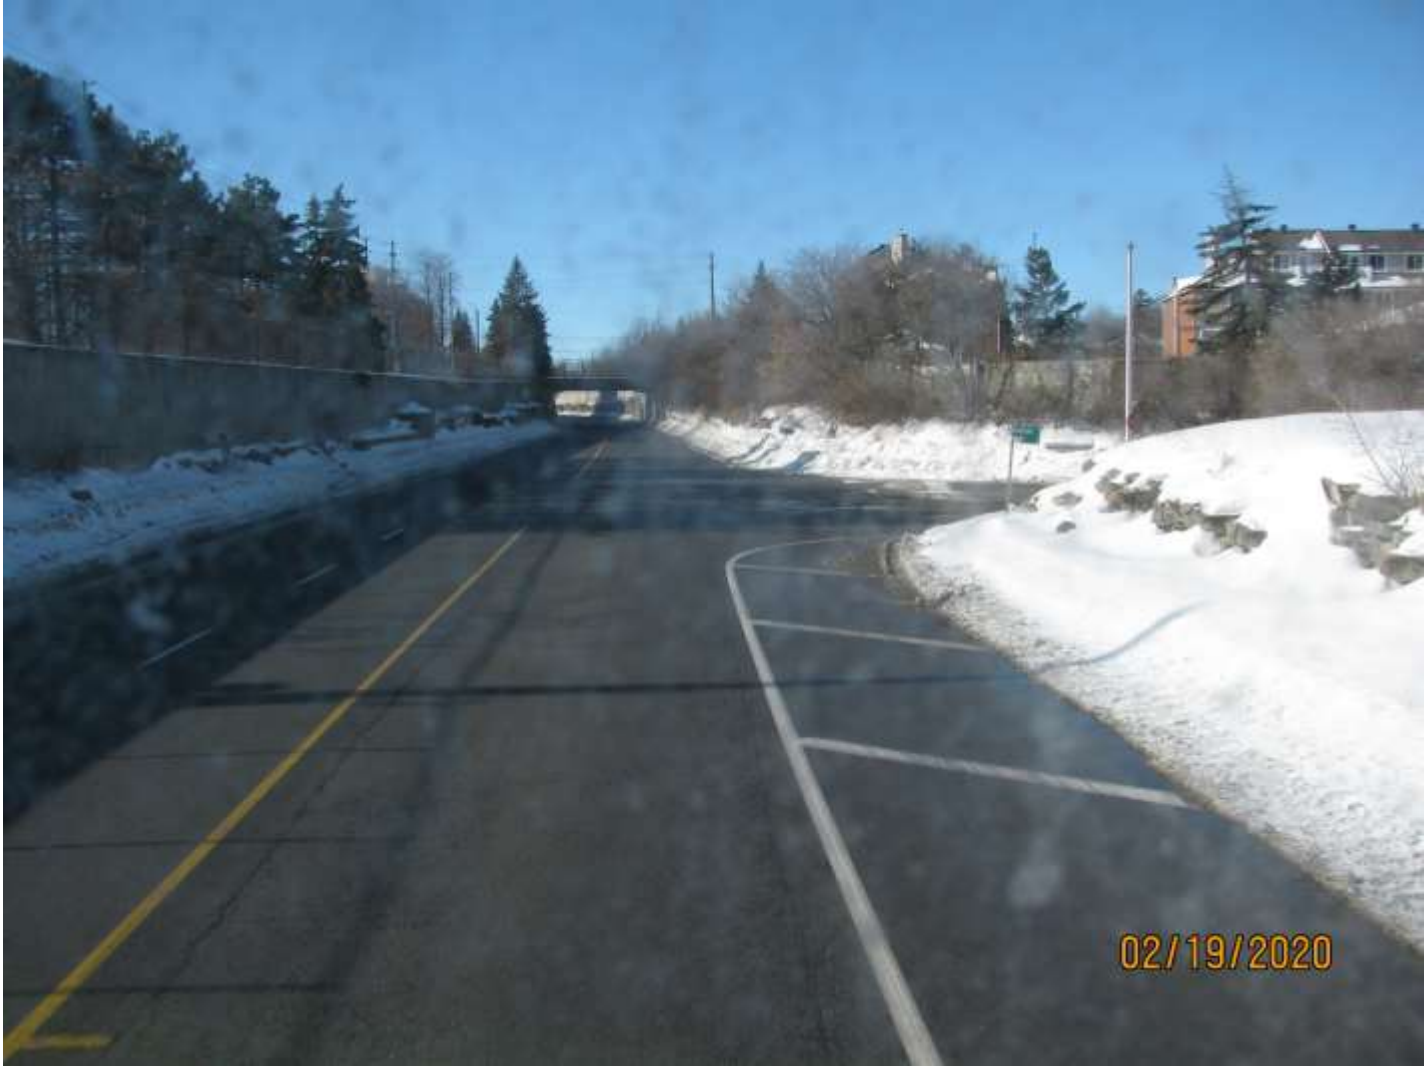
GORE AREA

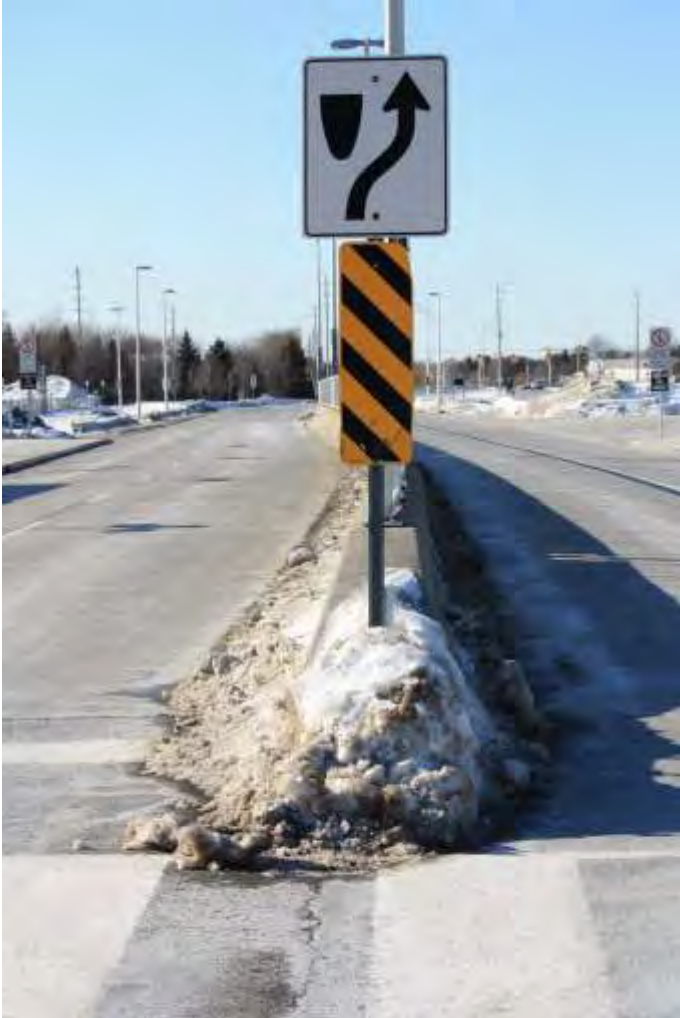
NO ENERGY ATTENUATION AT MEDIAN BARRIER

Replace the sloped ends with an appropriate TL-3 crash cushion.

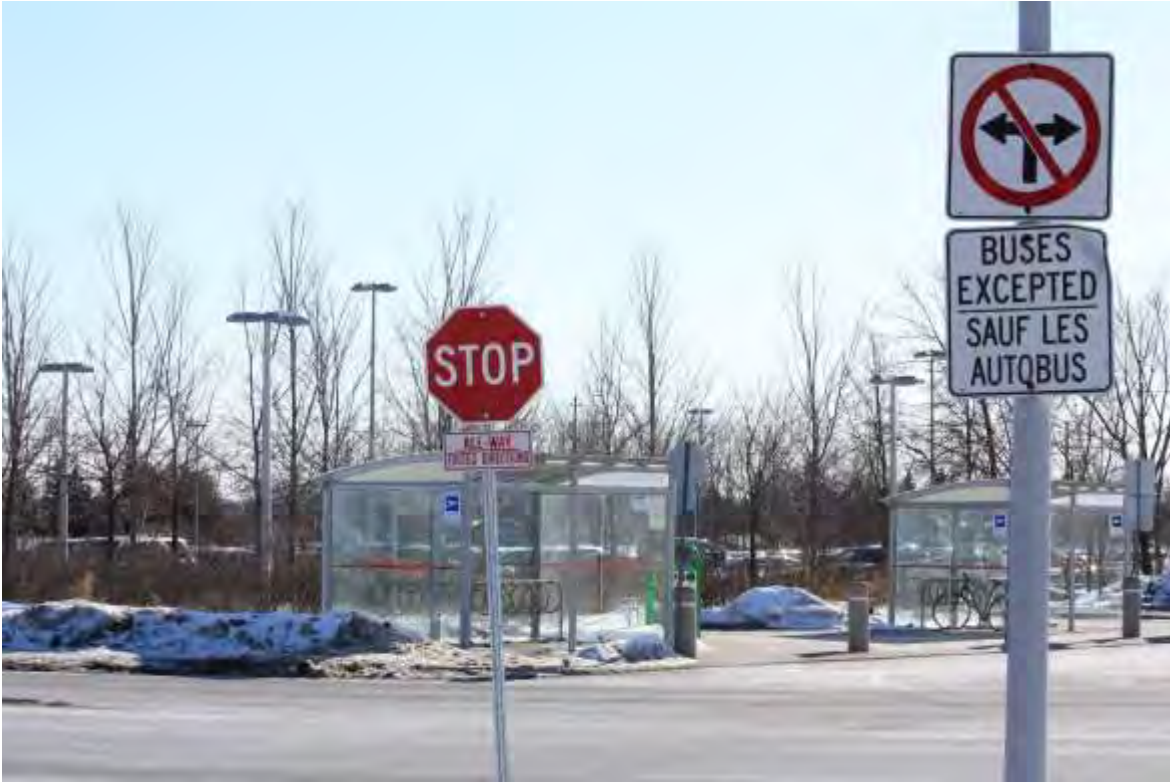
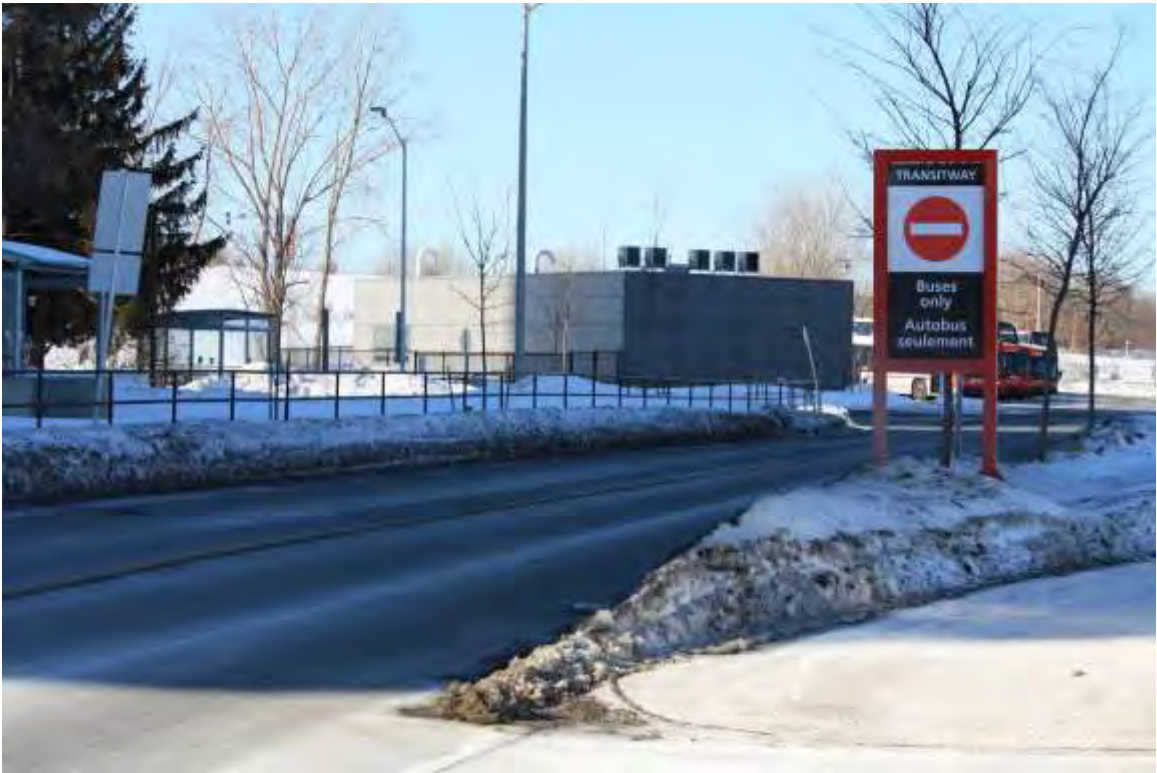
UNAUTHORIZED VEHICLE PROHIBITION SIGNING

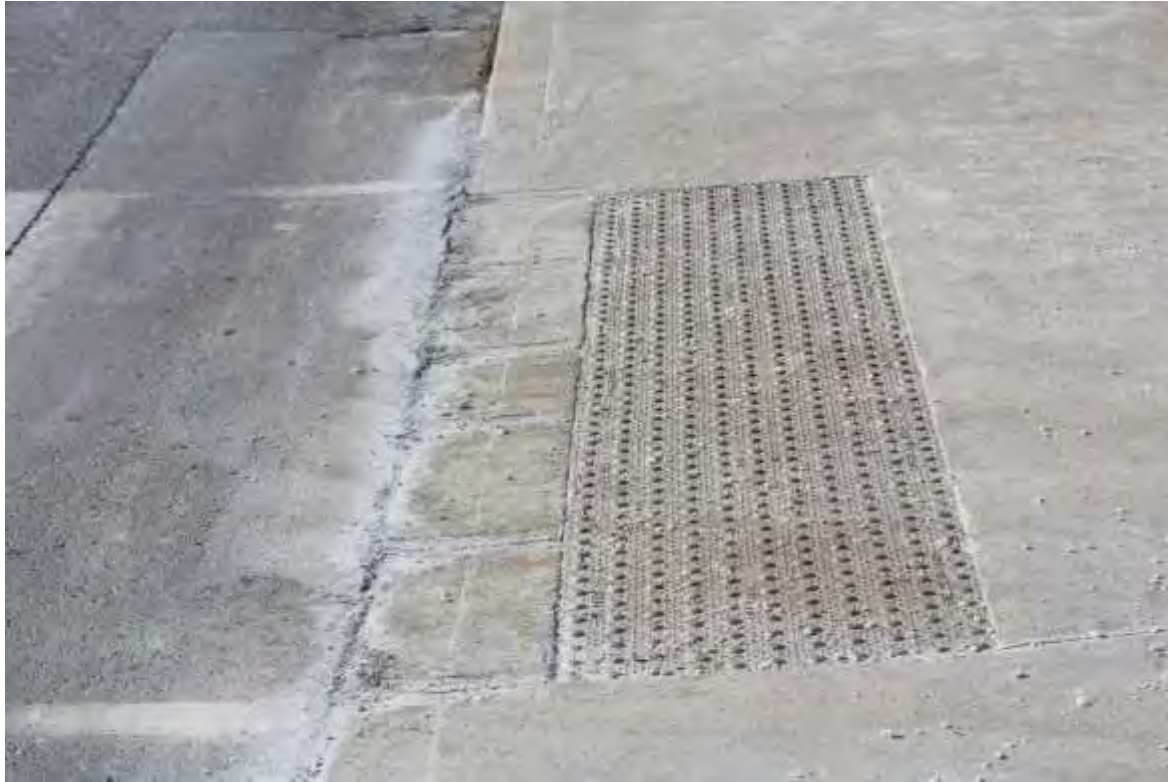
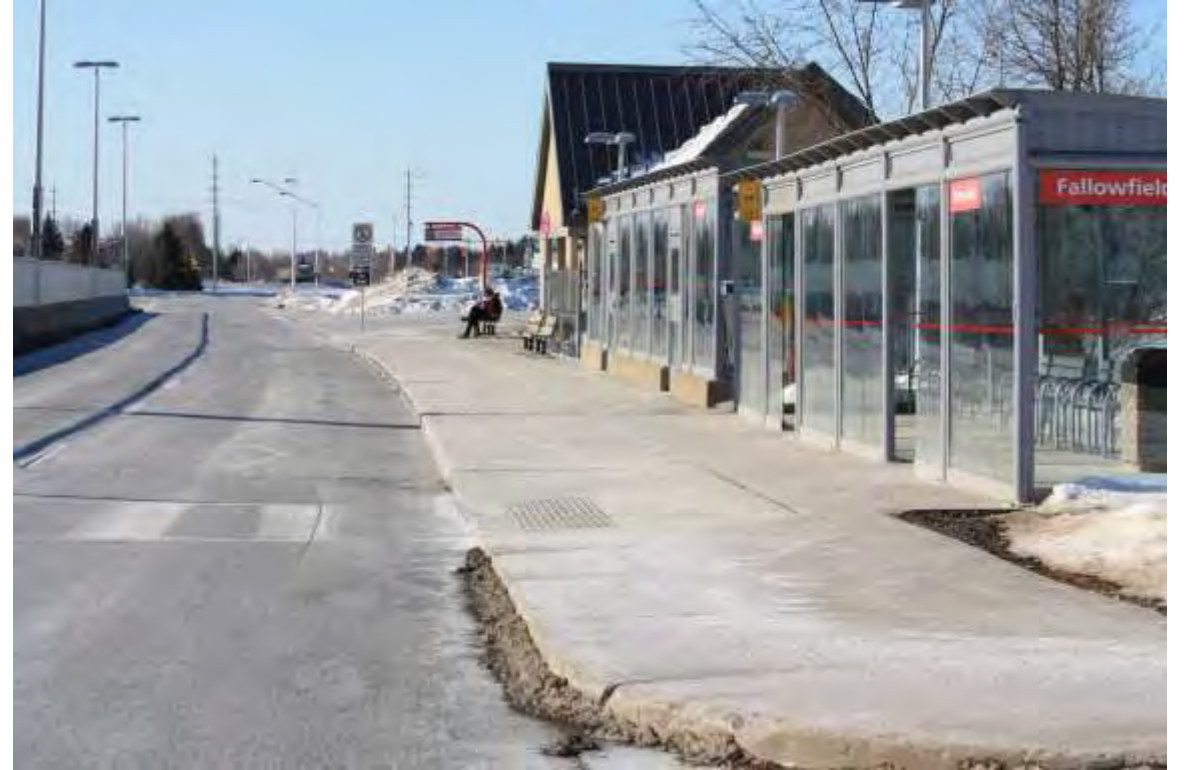
TACTILE SURFACE AT CURB RAMP FOR CROSSWALK
