OC Transpo Transitway Station Design Safety Study

Independent Safety Study

Final Safety Study

September 2021

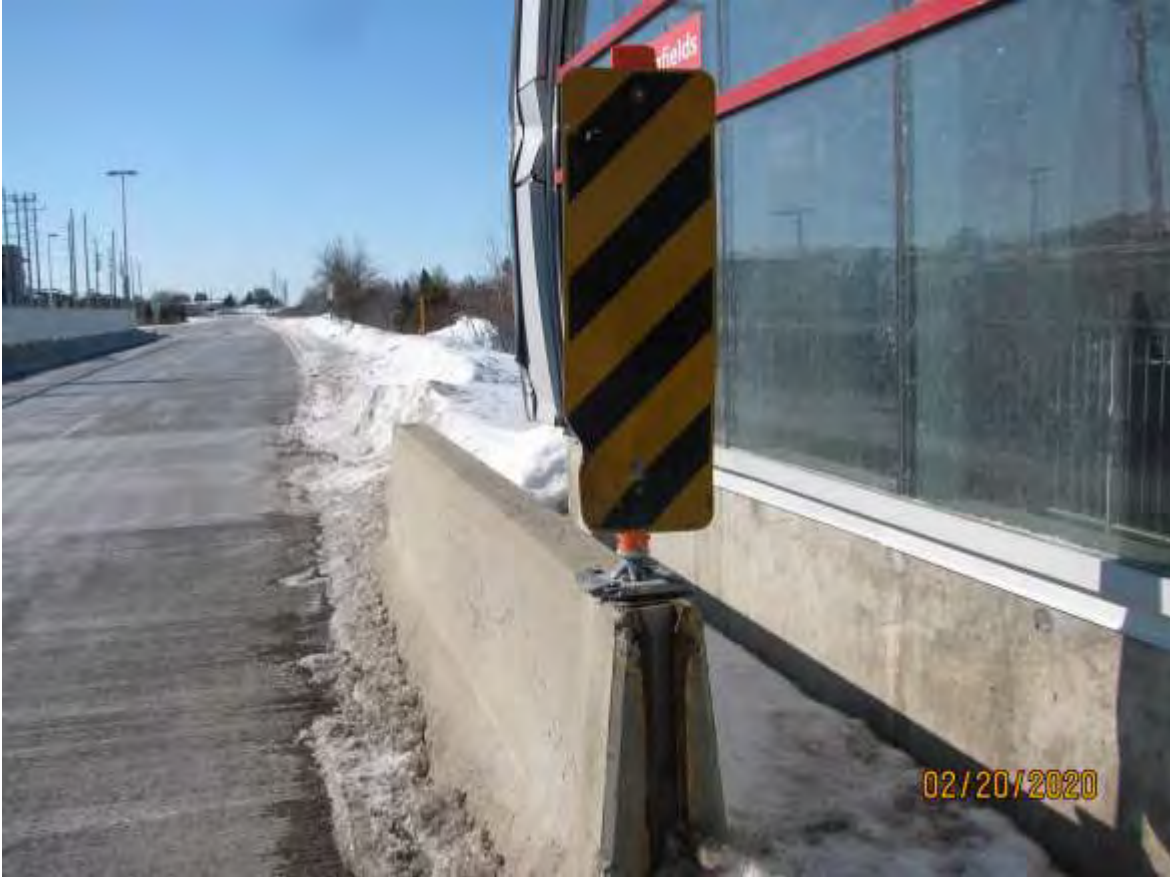
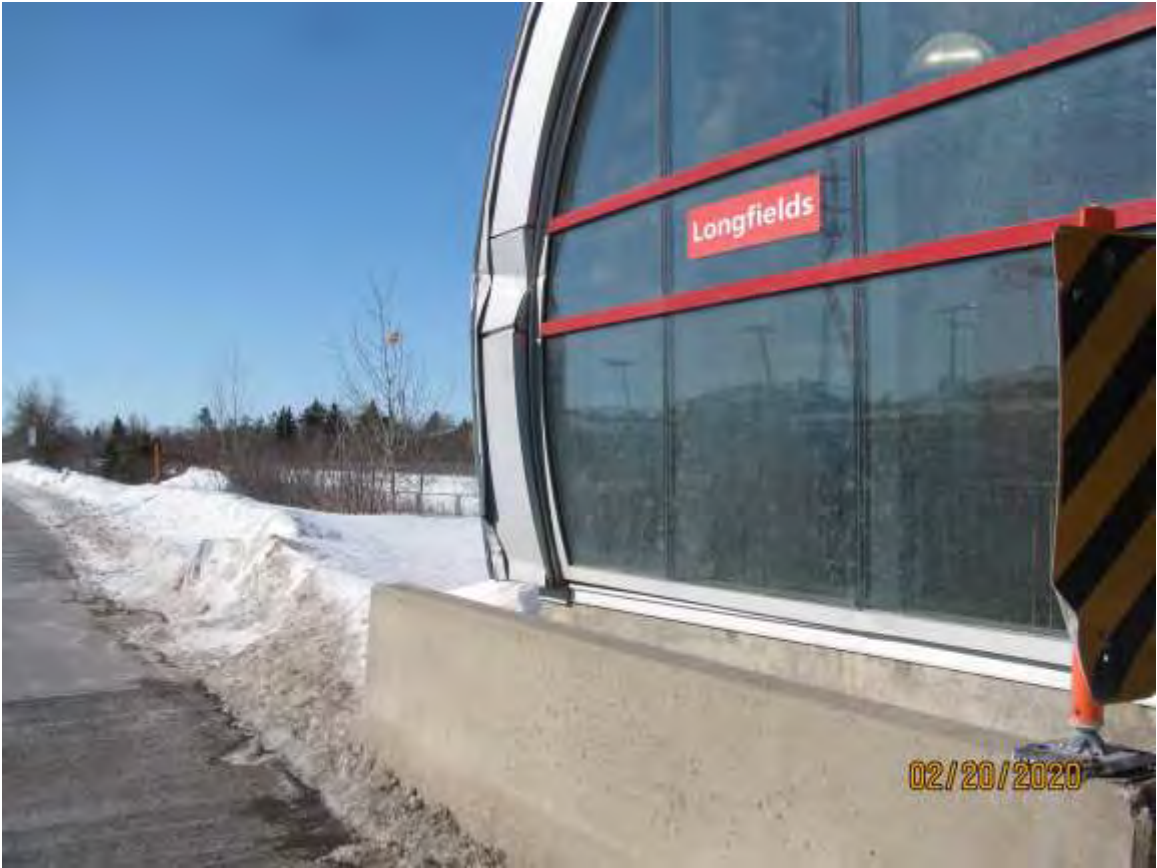
A concrete no-post barrier with a hazard marker has been installed on the road surface of the transitway along the right edge of the right travel lane directly beside the station building. A barrier has been installed in both the southbound and northbound directions. There is damage to the outside of the southbound station building which appears to be caused by a vehicle collision. This appears to be the rationale for the concrete barriers, to protect the station buildings from vehicle collisions. The station buildings are offset about 0.5 metres from the curb face of the transitway. The barriers are fix-objects and a potential hazard to vehicles on the transitway. There is no energy attenuation to lessen the impact of a collision with the barriers. The barriers also narrow the travel lane to 3.0 metres. Vehicles passing the barriers would need shy distance to comfortably avoid colliding with the barrier and this, coupled with the narrowness of the lane forces drivers to intrude into the adjacent lane in order to pass by the barrier.

CONCRETE BARRIER PLACEMENT

Remove the concrete barriers with a blunt end. Install drivable delineators along the base of the building on a 200 mm white line to keep buses away the station and allow the bus to remain in the departure lane. Alternatively, remove the concrete barriers and install a low concrete curb against the base of the station. In either case remove the concrete barrier with the blunt end as it is a hazard.

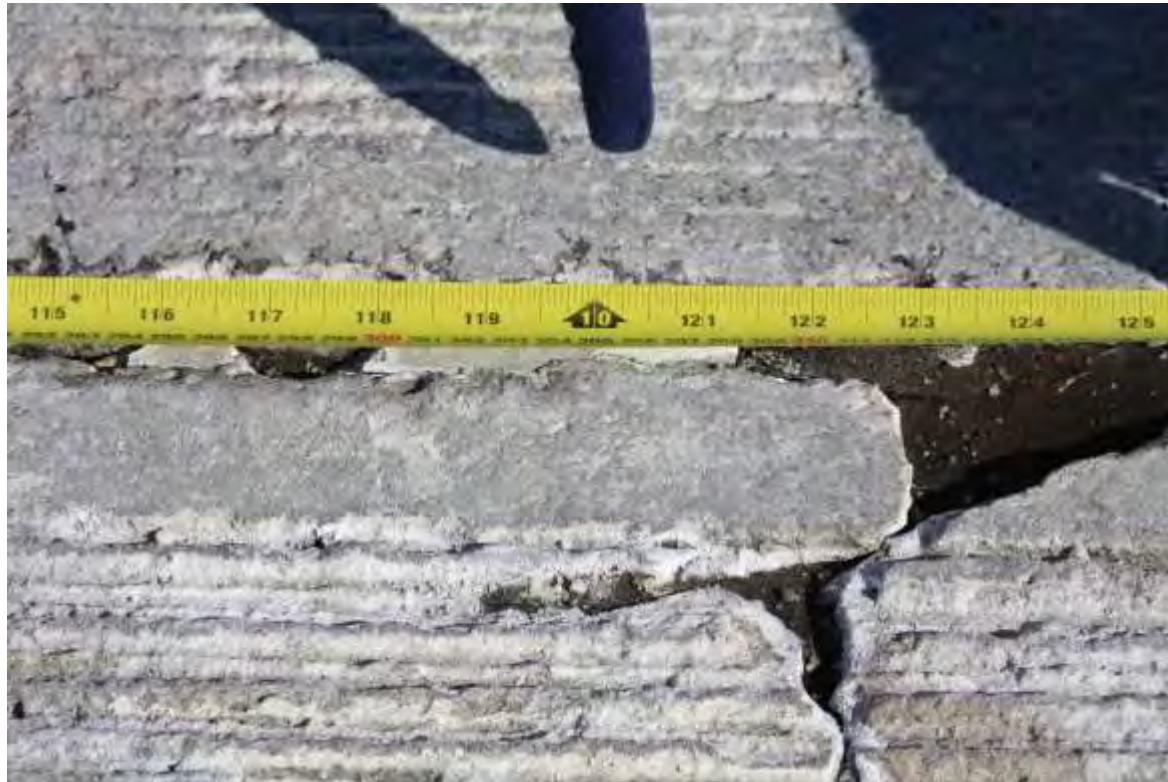
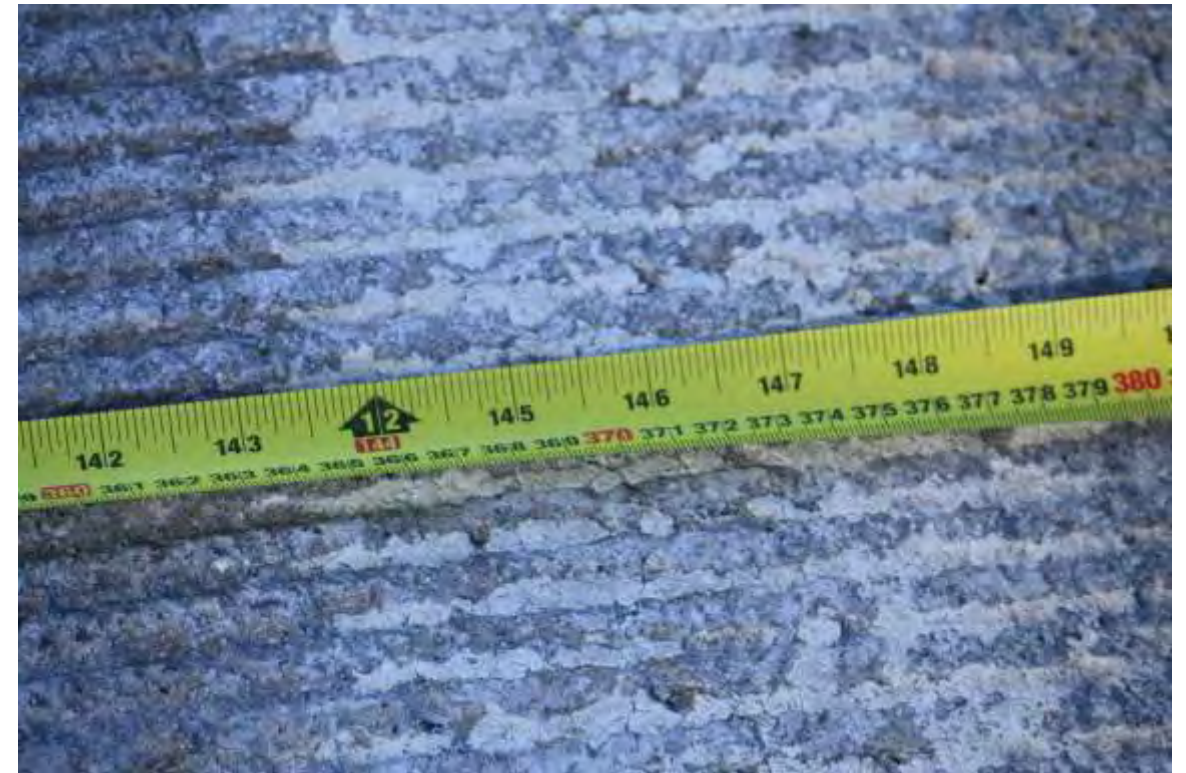
TRAVEL LANE WIDTH NARROWING DUE TO BARRIER

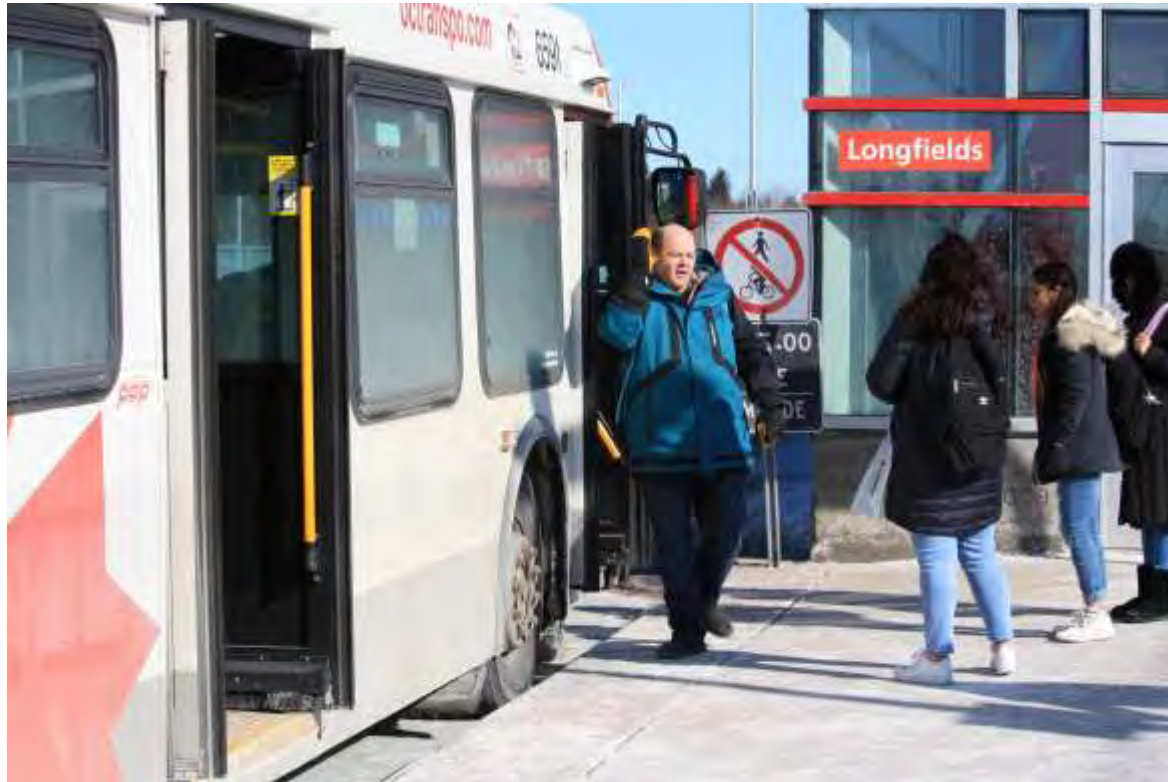
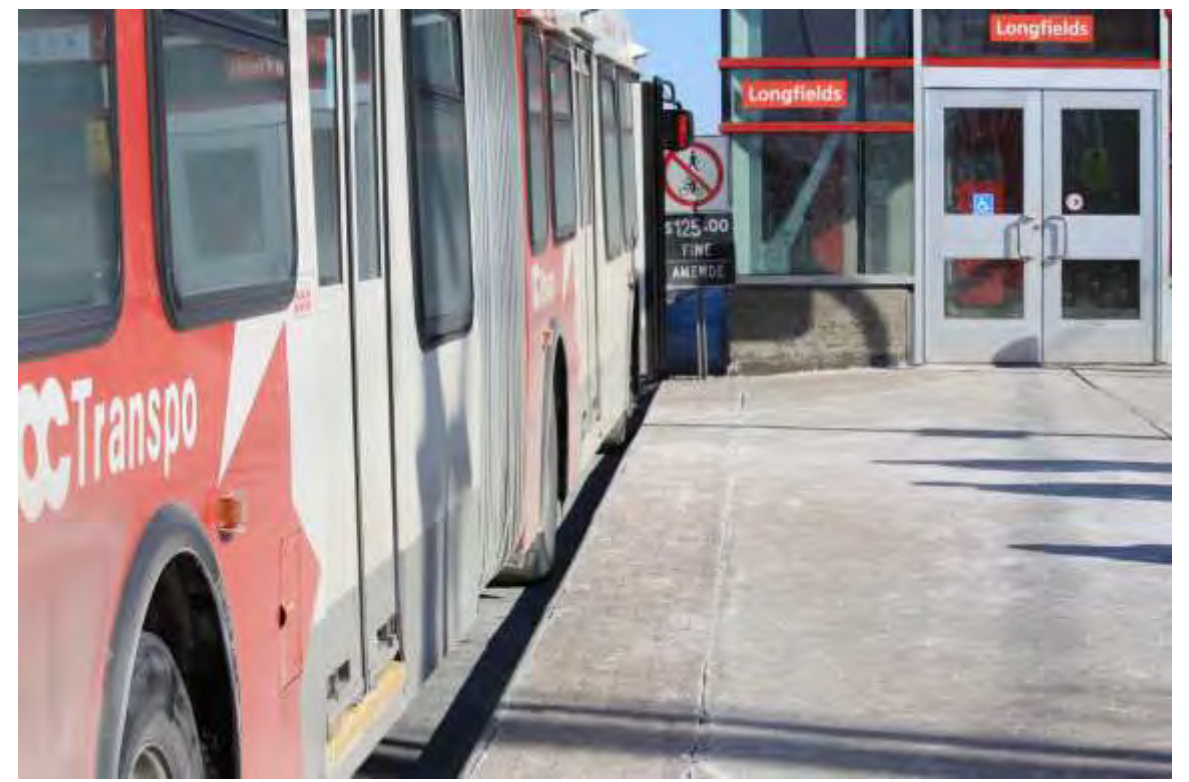
Transit vehicles leaving the station were observed to make abrupt turning maneuvers into the adjacent lane to avoid colliding with the concrete barrier. This presents several safety issues:

ABRUPT BUS MANEUVER DUE TO BARRIER

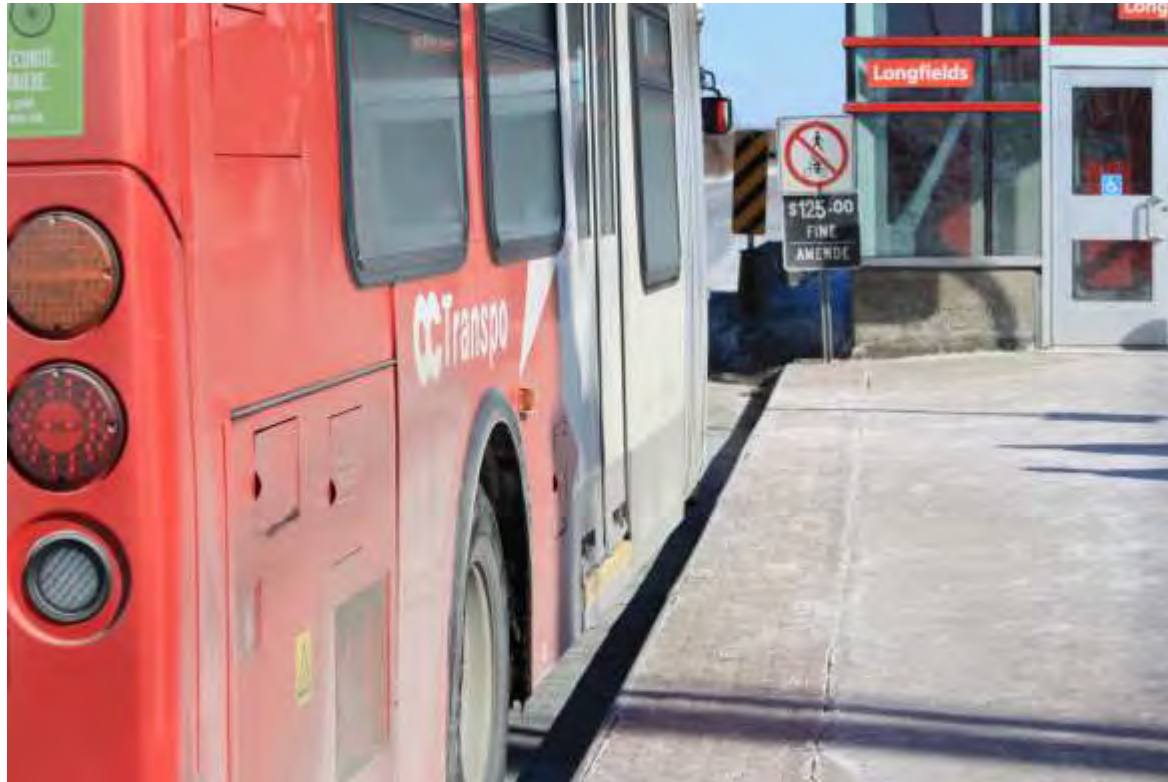
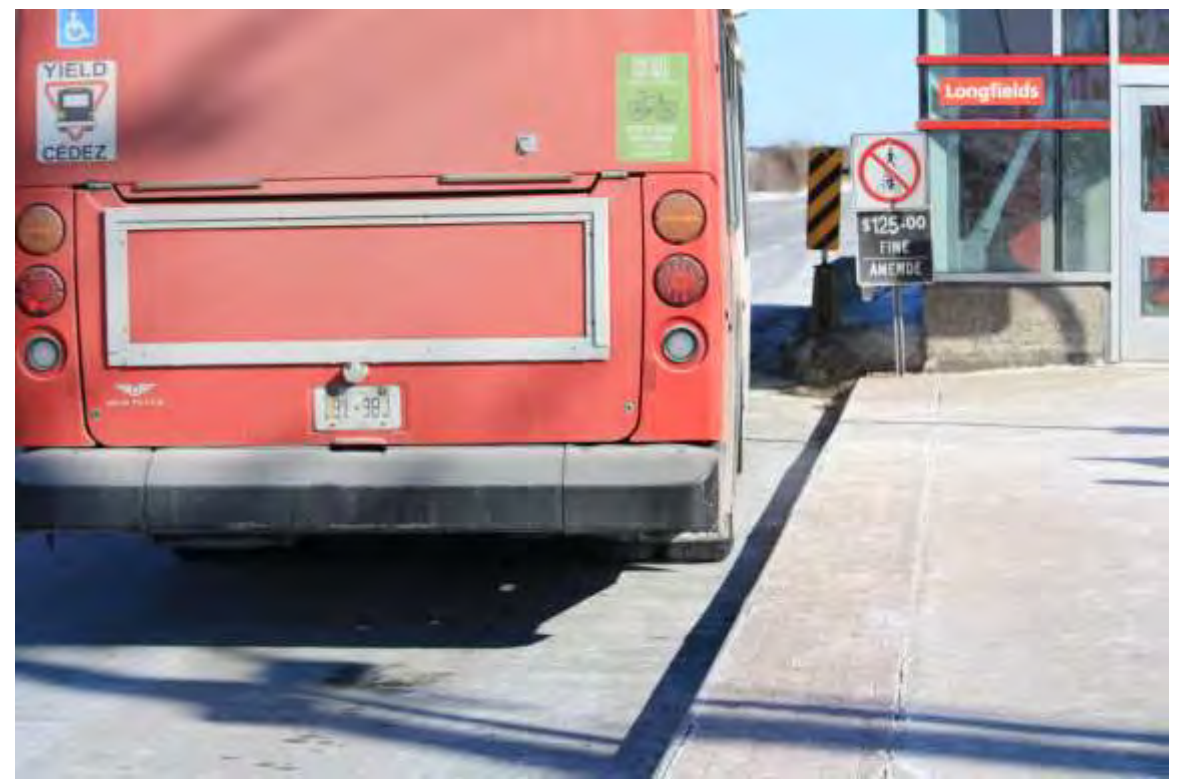
ABRUPT BUS MANEUVER DUE TO BARRIER

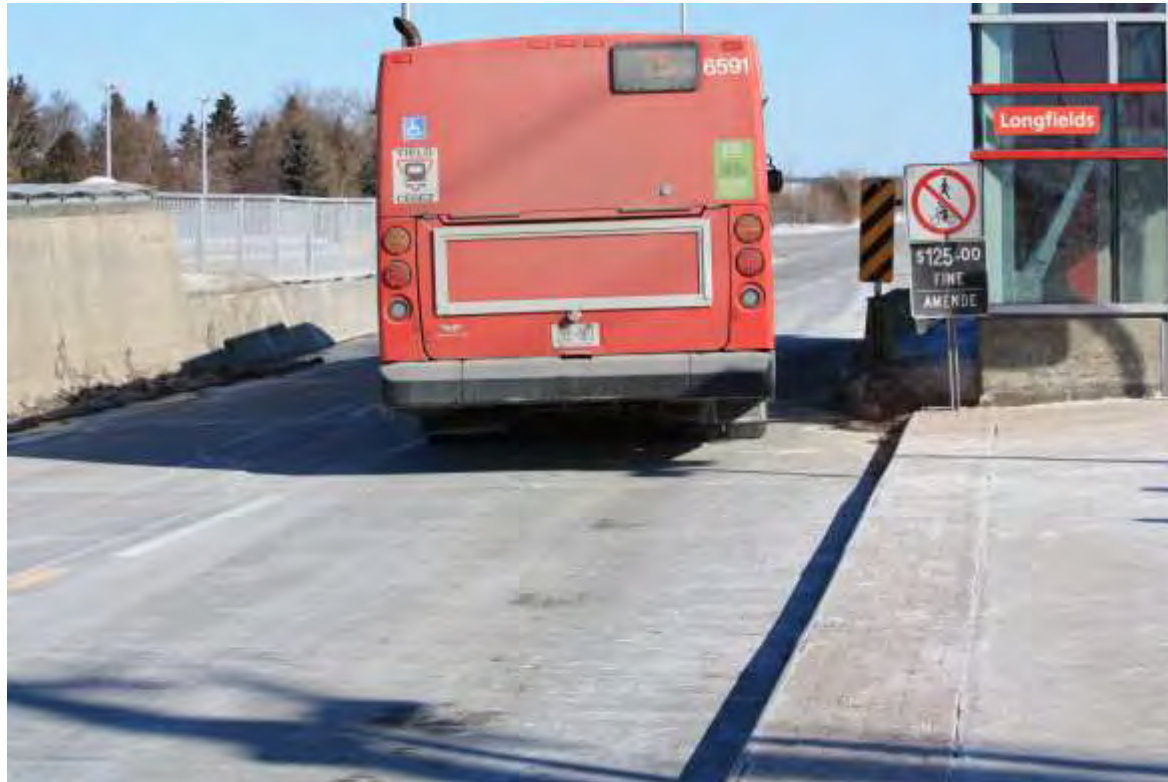
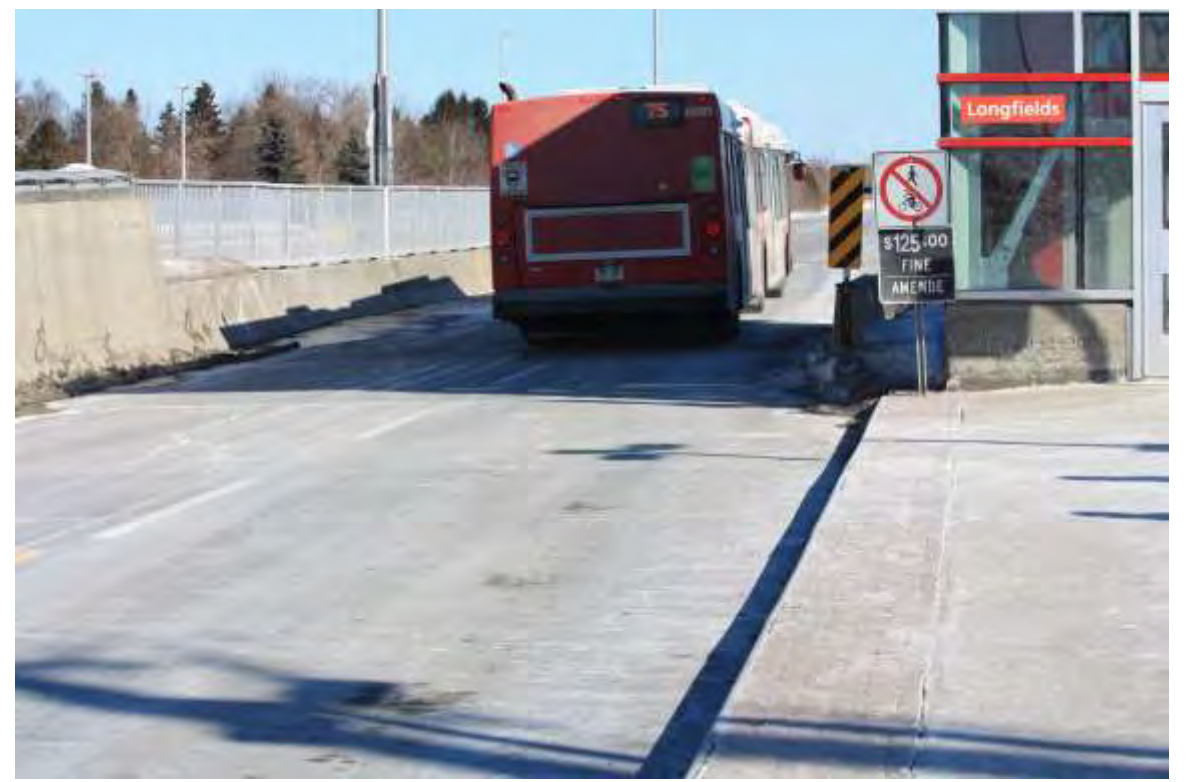
ABRUPT BUS MANEUVER DUE TO BARRIER

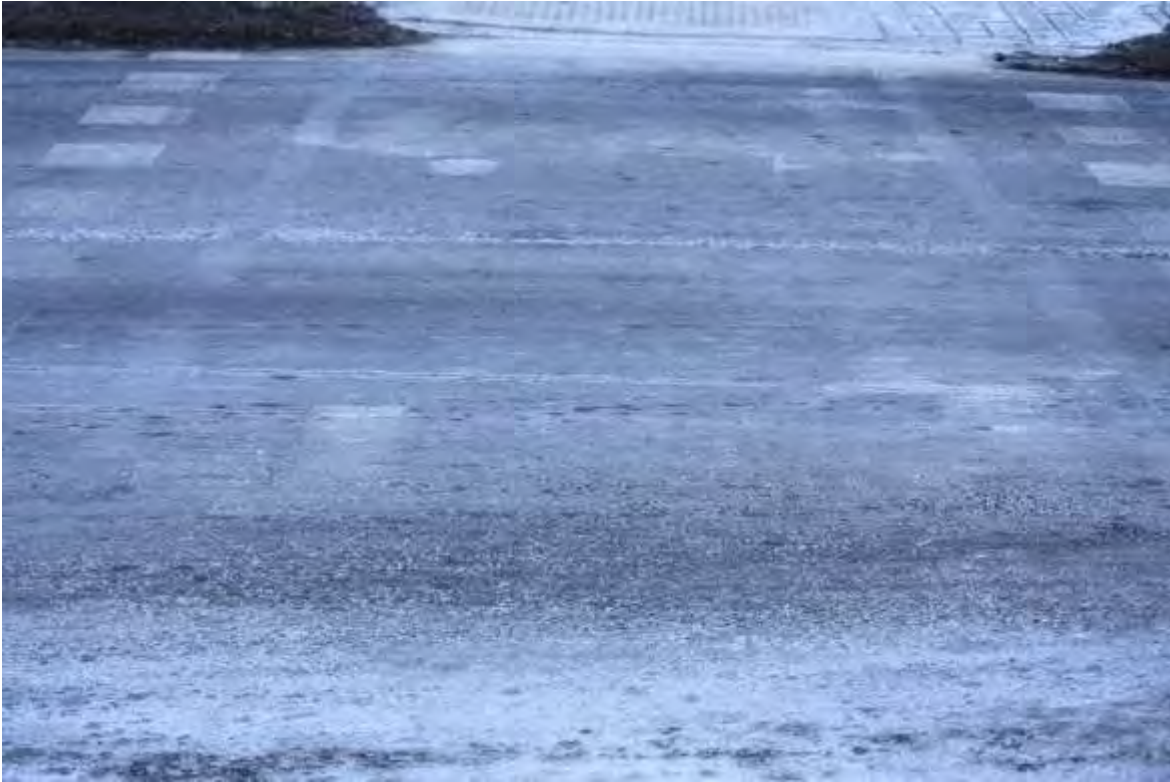
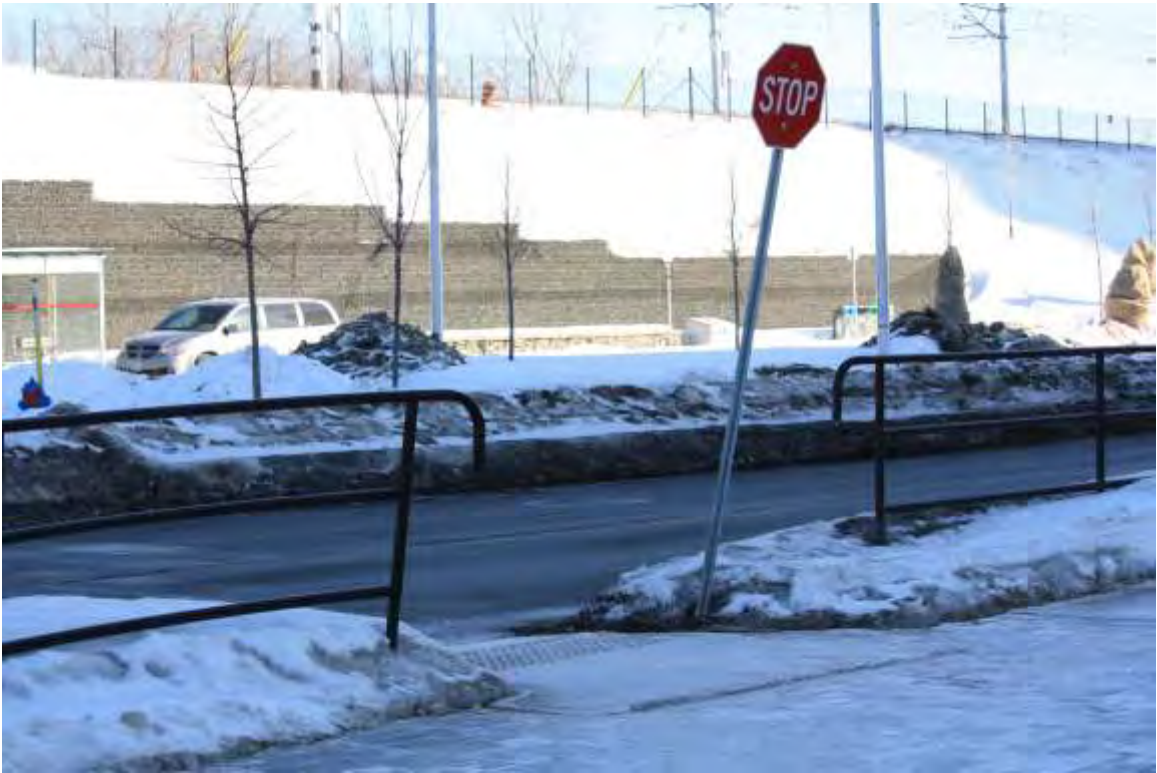
Markings from a previous configuration were black-masked, contrary to City of Ottawa standard practices. The black paint has since worn off, causing the older crosswalk markings to show through. The most recent markings have also worn/faded, making them similar in appearance to the old markings. This has rendered the resulting visible markings non-standard, which could contribute to user confusion.

MAIN CROSSWALK

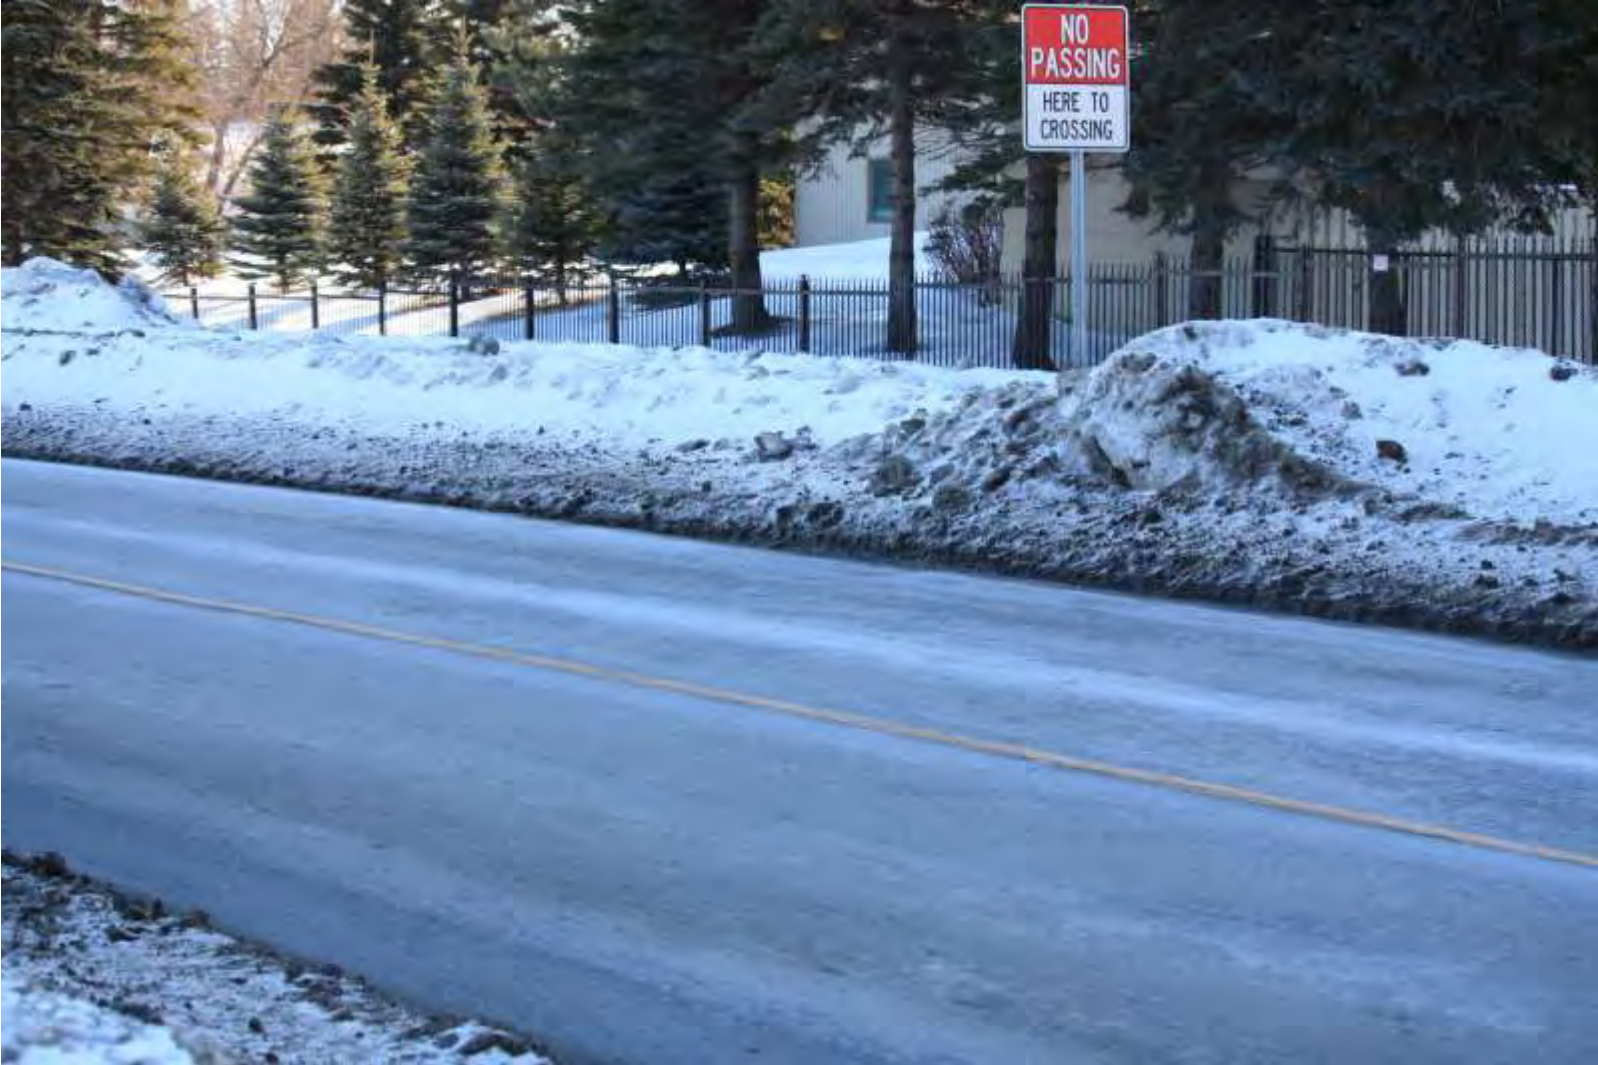
CONFLICTING ROAD MARKINGS AND ROADSIDE SIGNING

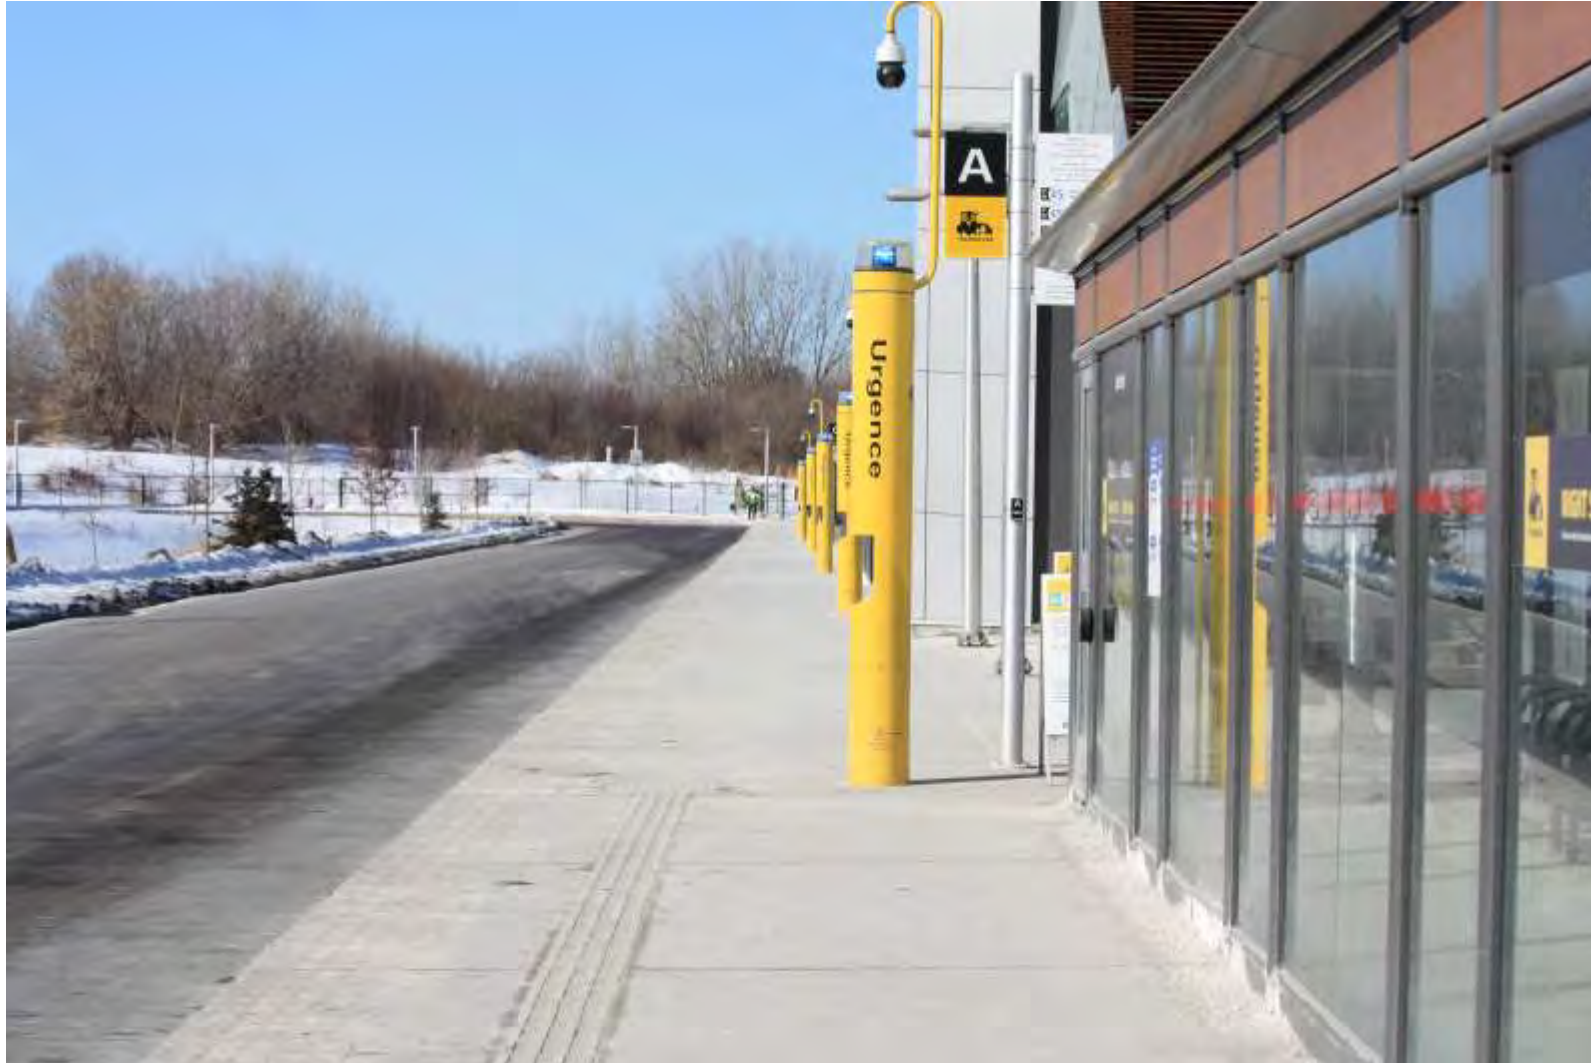
WAYFINDING GROUND LINES
